**THE COLLAPSE  
OF  
THE DOFASCO NO. 2 ORE BRIDGE  
MARCH 28th 1995  
HAMILTON ONTARIO**

TIMOTHY VERHEY, B.Eng.

A Project

Master of Engineering

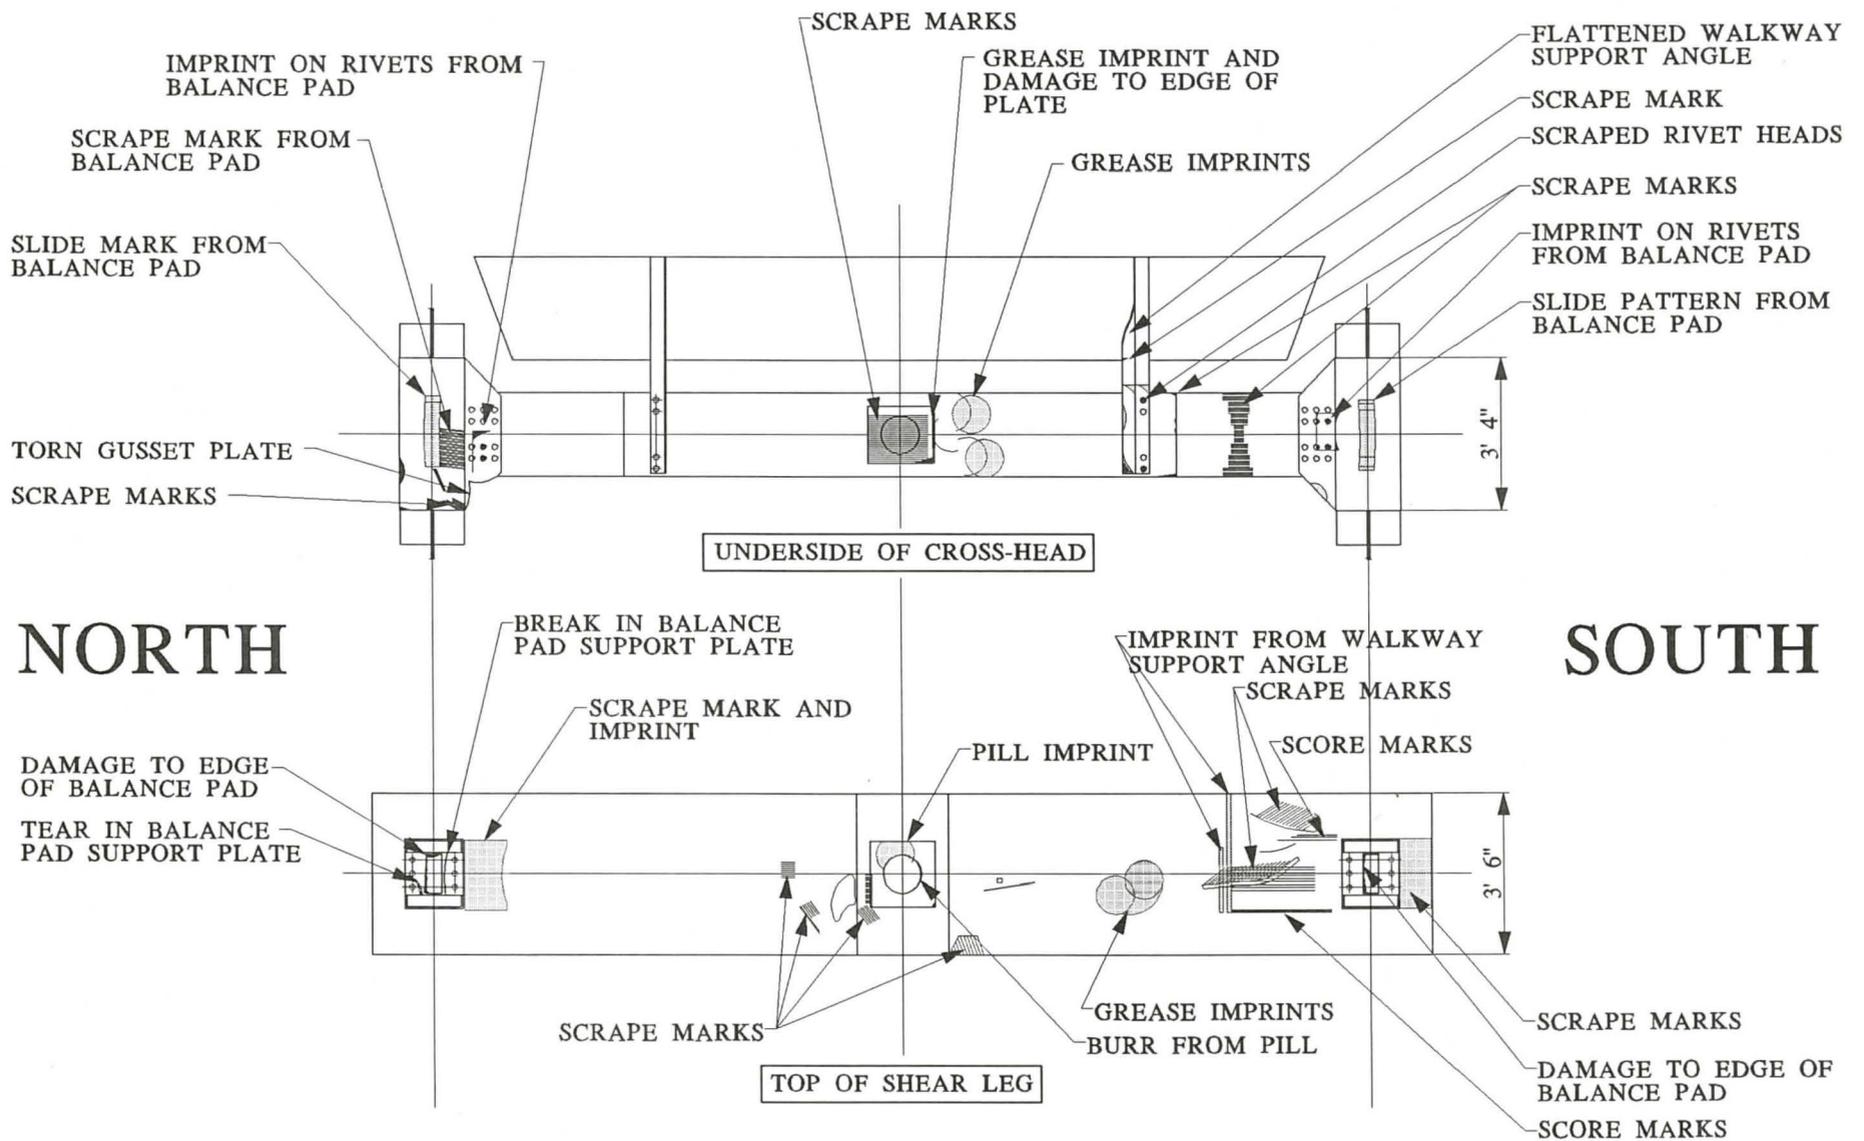
**FIGURE 20:** Damage and markings on cross-head and top of Shear Leg looking from above.

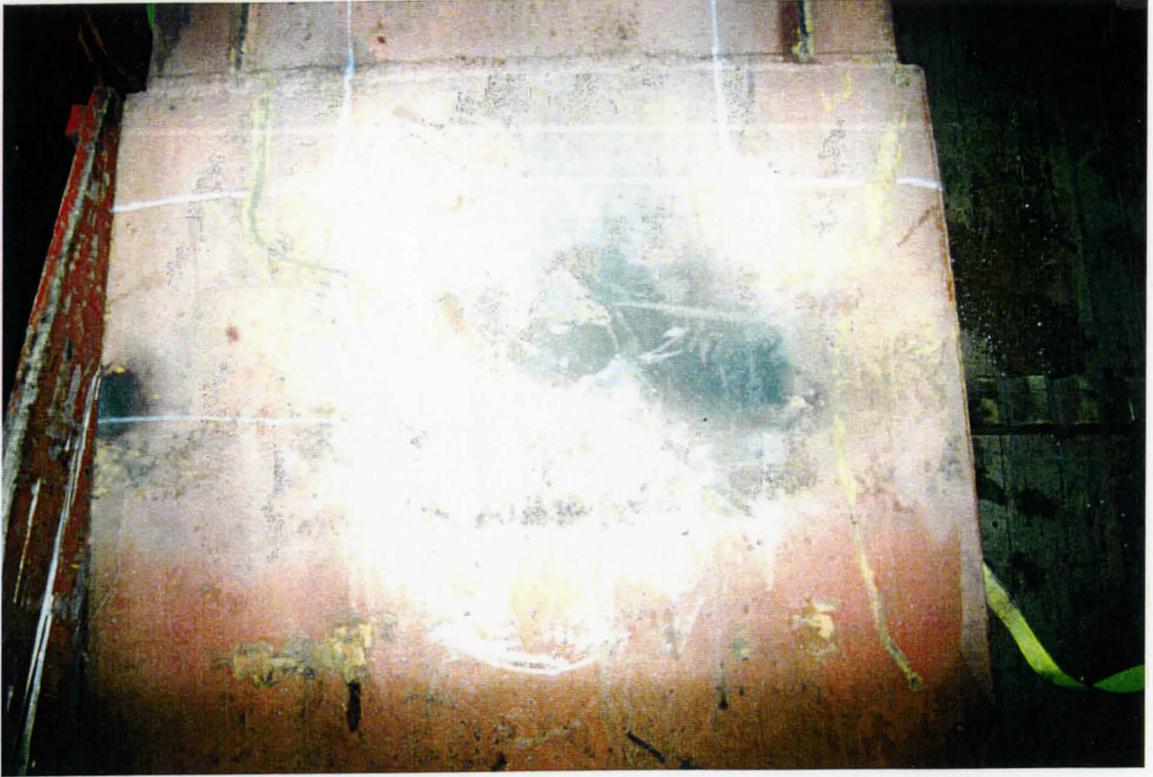
**FIGURE 21: Damage and markings on inside face of South Leg of Shear Leg.**

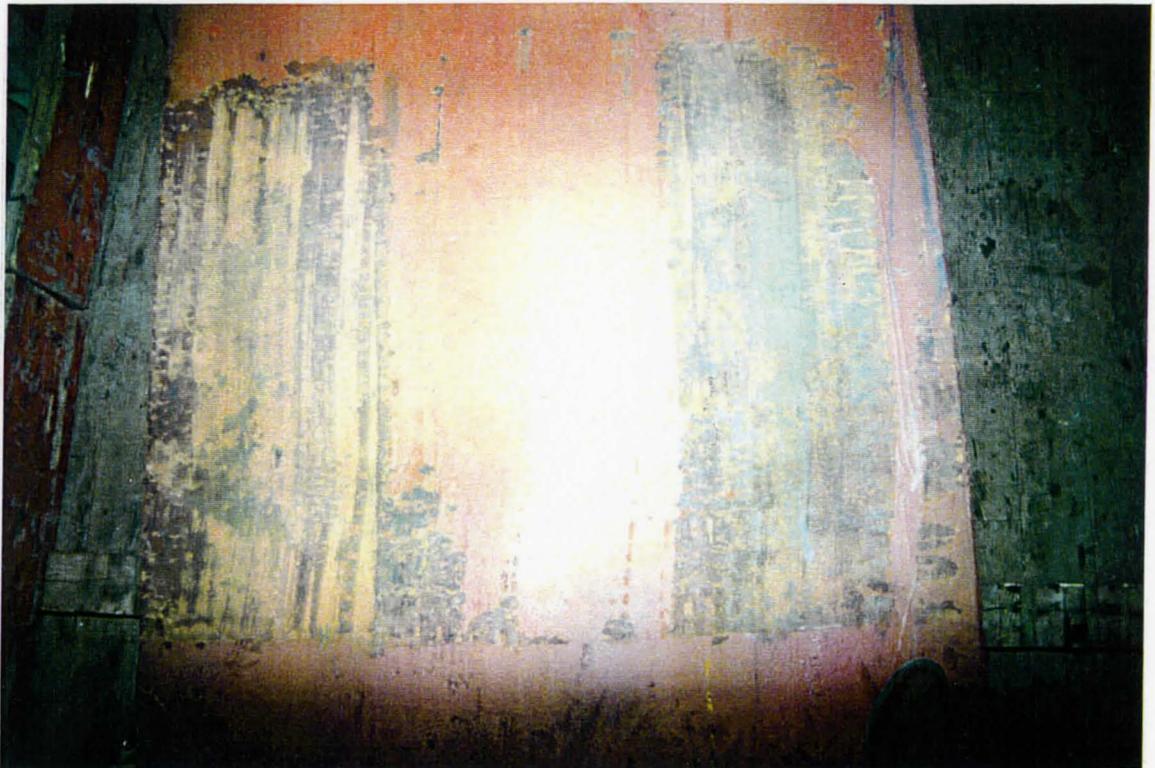
**FIGURE 22: Damage and markings on inside face of South Leg of Shear Leg.**

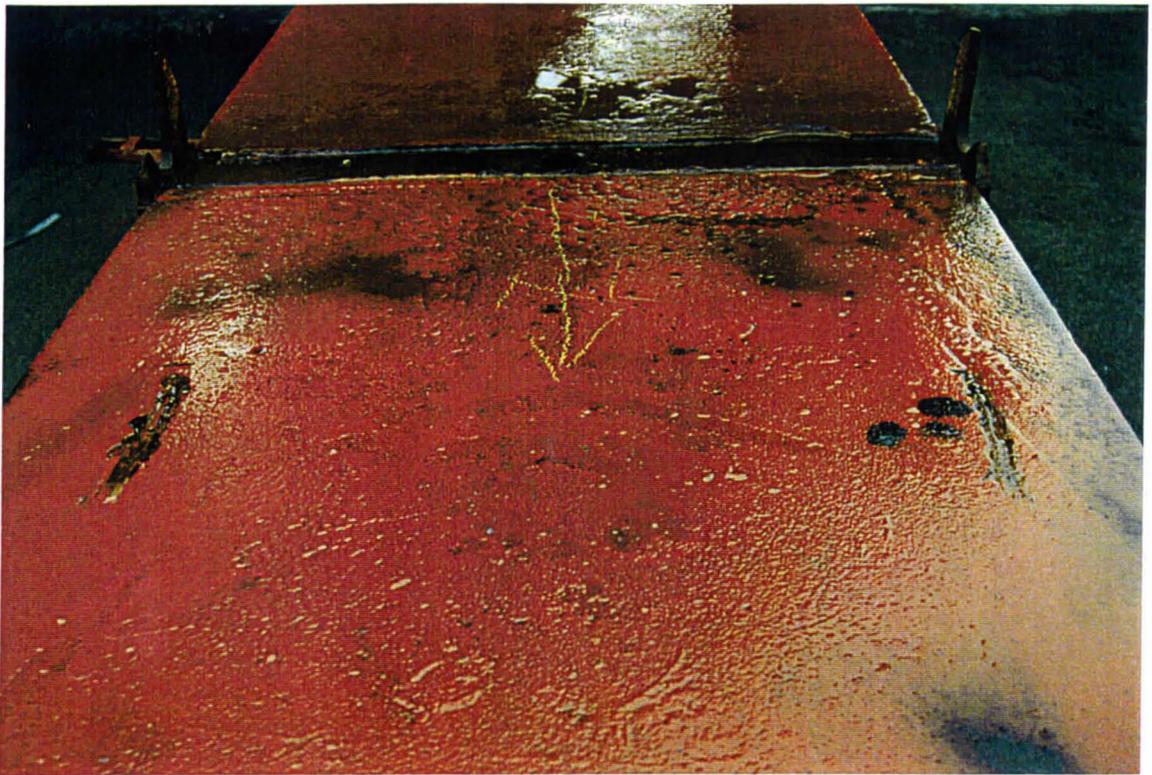
**FIGURE 23:** Damage and markings on top of south equaliser beam.

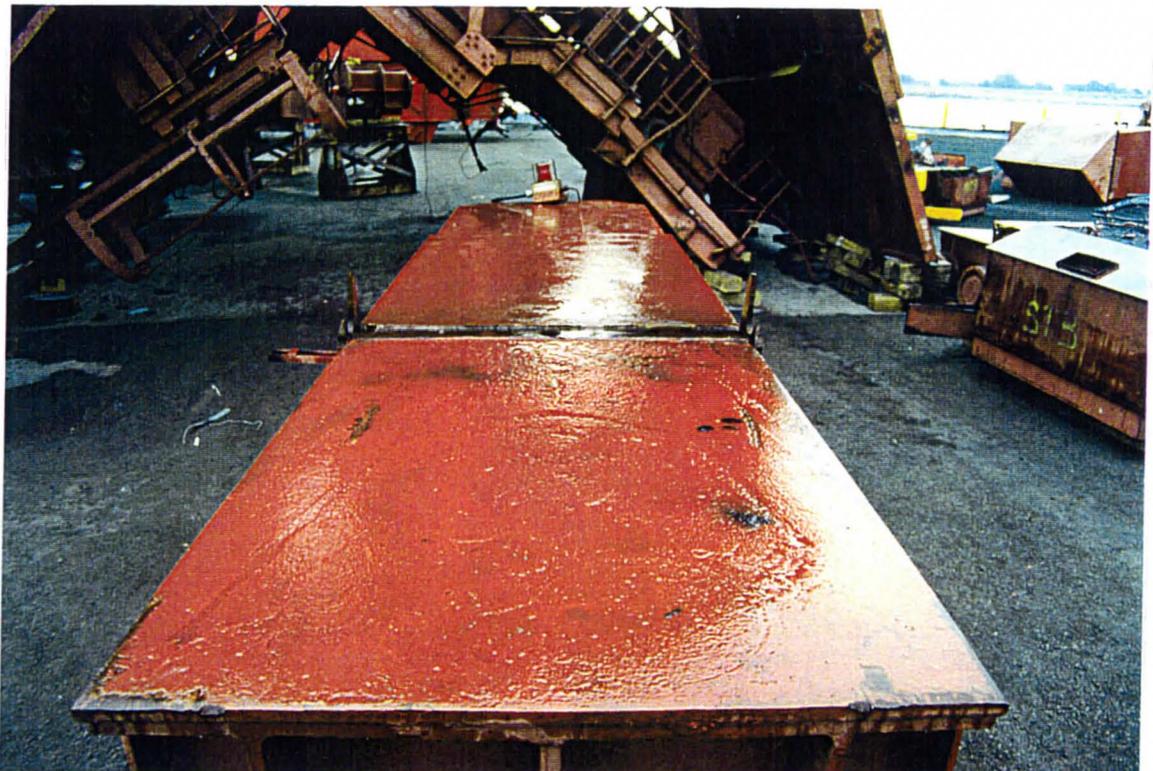
**FIGURE 24:** Damage and markings on top of south equaliser beam.

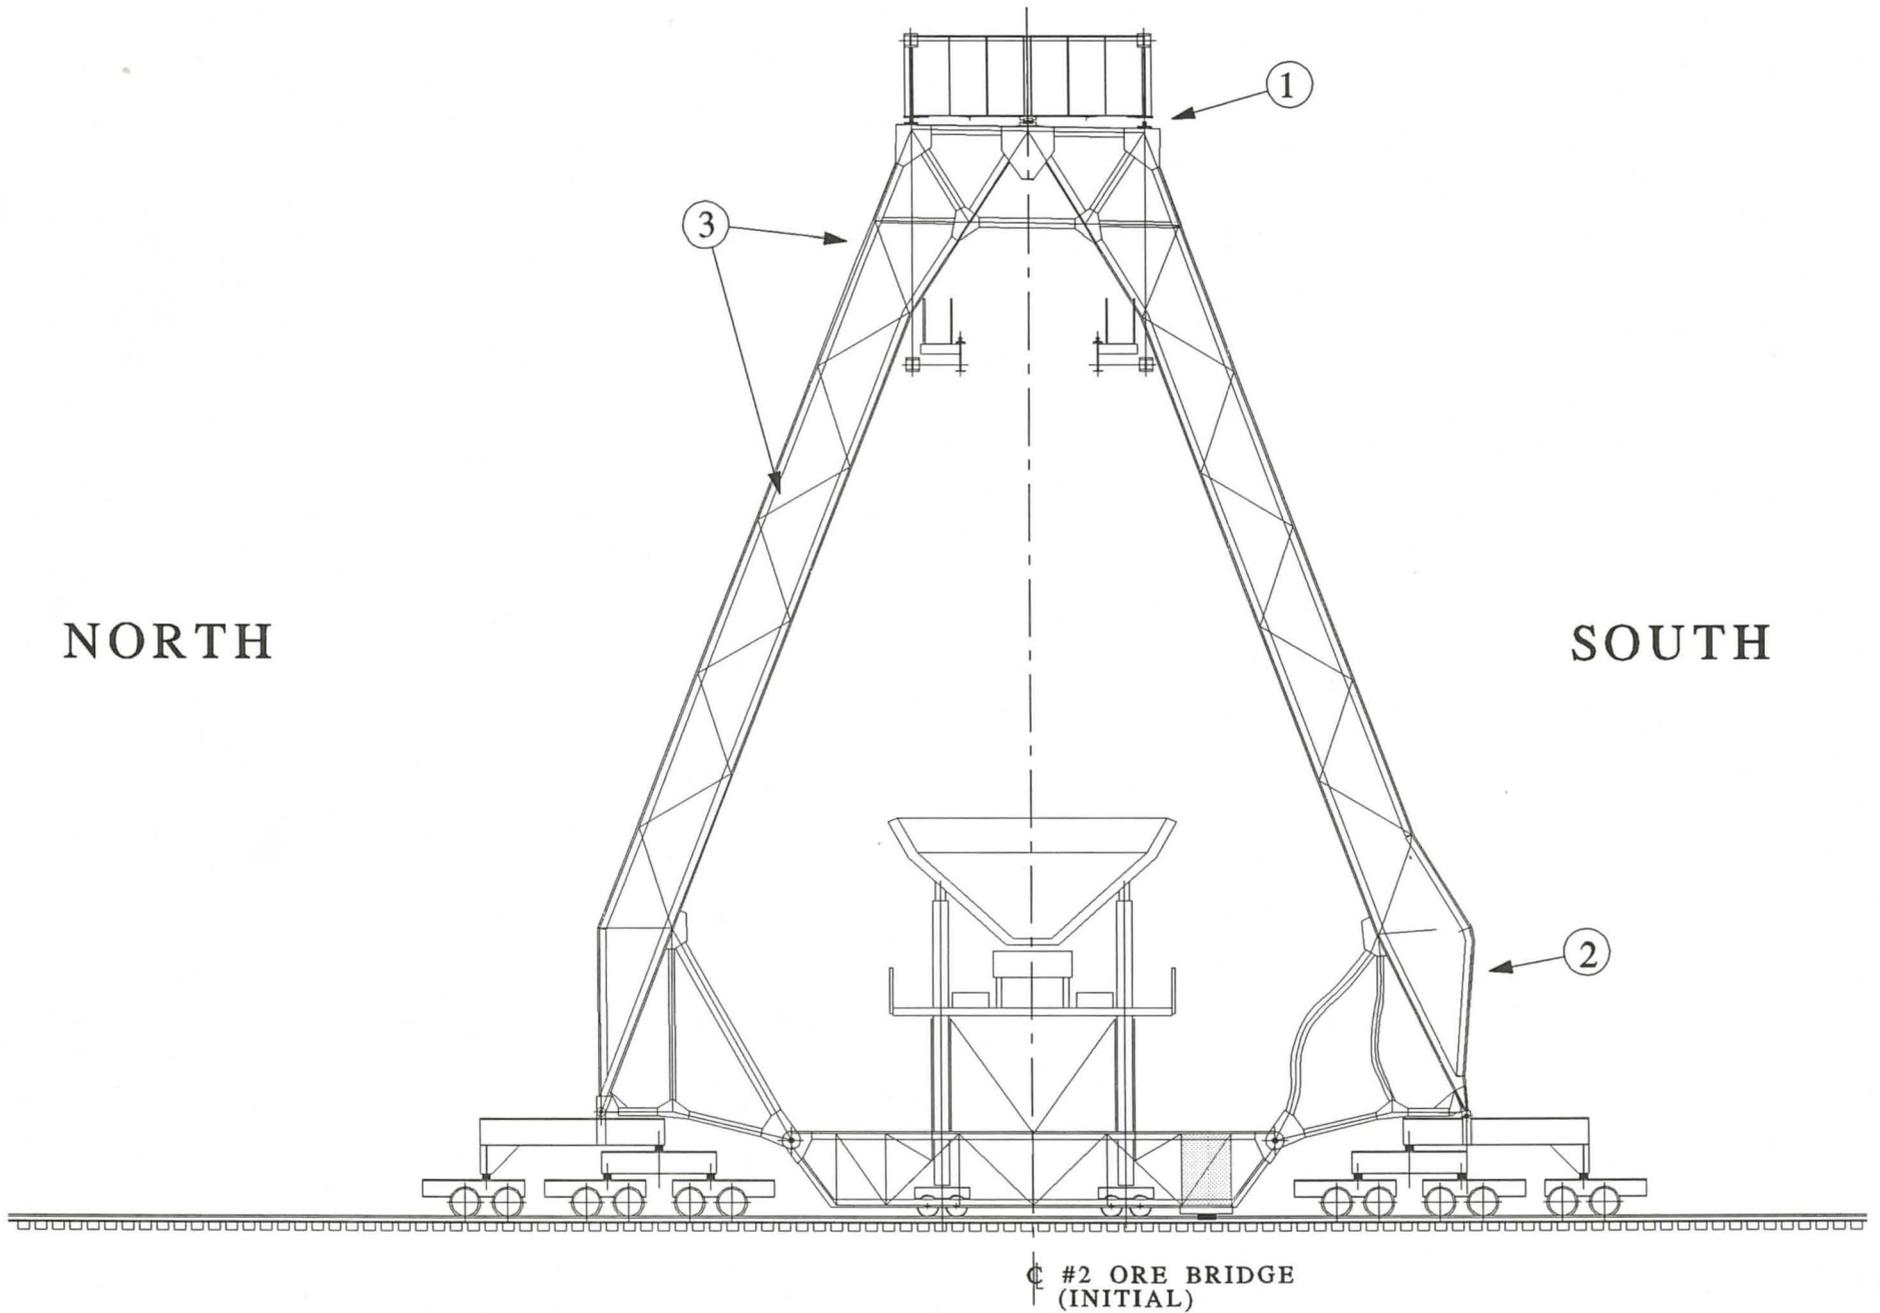
In Figure 27, the first stages of the collapse are depicted, which included the top of the south leg separating from the underside of the main span (1). This action must have been the result of structural damage initiating within the south leg of the Shear Leg. The most obvious location for this damage was at the bottom (2).

A closer examination of the bottom of the south leg indicated the tie-plate had failed near the weld at the rocker block, allowing the tie brace at the bottom of the south leg of the Shear Leg to separate from the leg. Various markings around the bottom of the south leg required the horizontal web member at the bottom of the south leg, which runs between the inside and outside legs, to have pulled apart. As well, the vertical and diagonal braces must have buckled, as illustrated.

**FIGURE 27: Collapse of Shear Leg of No.2 Ore Bridge (looking east).  
Sequence 1 (See text for notes)**

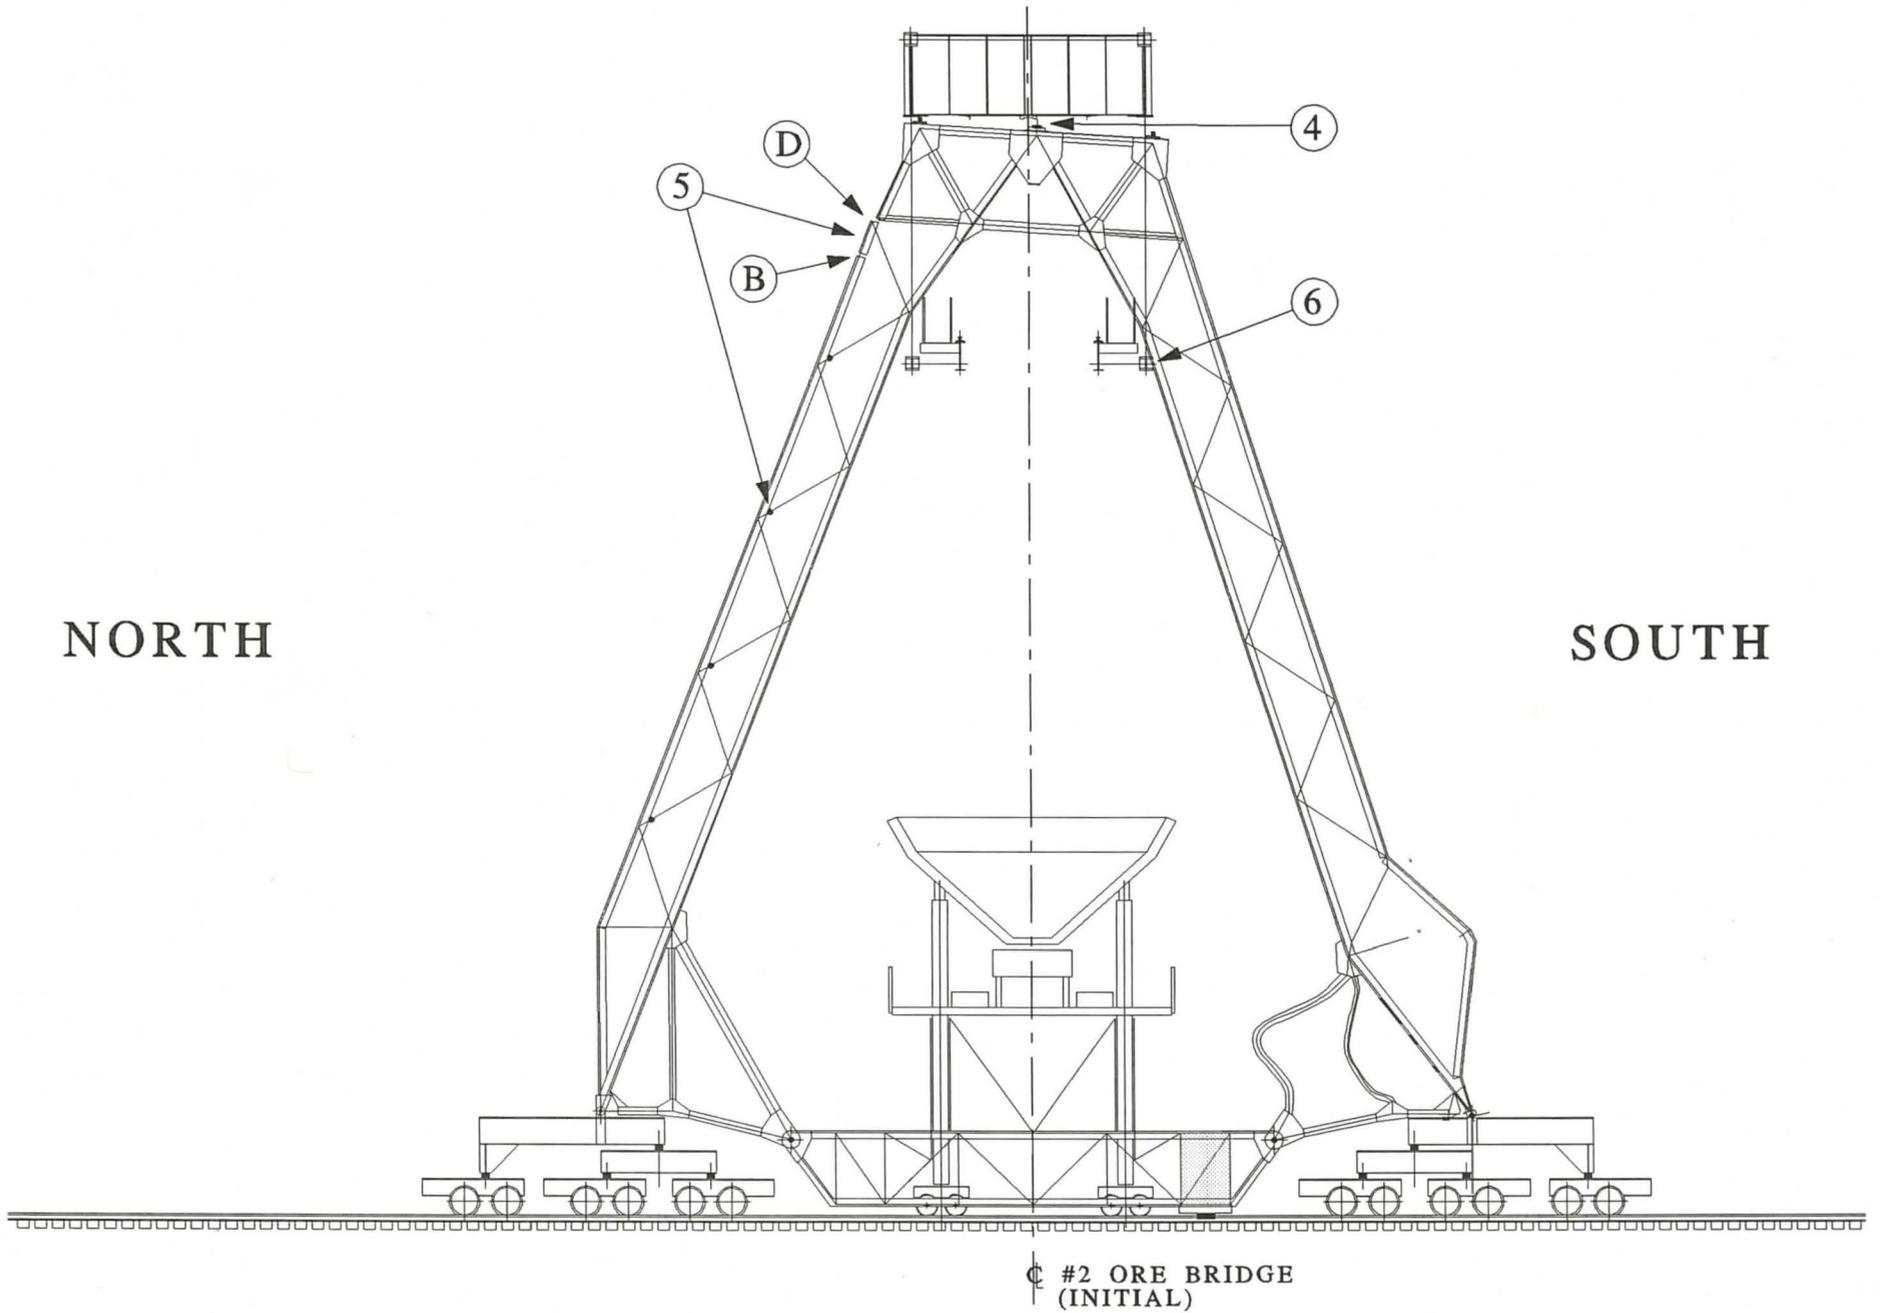
The entire top of the Shear Leg was now rotating towards the south, relative to the underside of the cross-head, and the south balance pad ended up outside the south side of the main span. The entire weight of the main span was now bearing directly on the north balance pad, which was also sliding south underneath the cross-head. This action placed unusual bending stresses in the top of the north leg causing further structural damage (5).

The outside flange of the north leg fractured and separated at locations marked "B" and "D". All the tension diagonals also fractured, with minimal initial distortion of the north leg.

**FIGURE 28: Collapse of Shear Leg of No.2 Ore Bridge (looking east).  
Sequence 2 (See text for notes)**

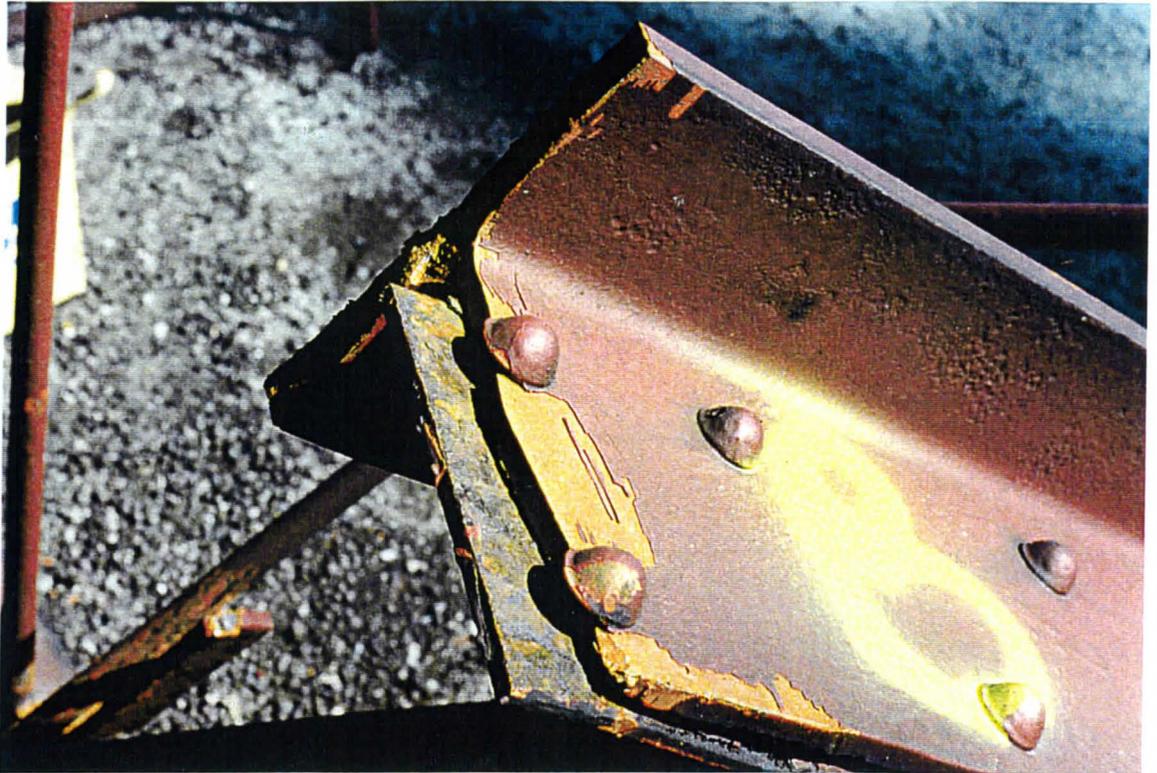
Figures 29 and 30 record the fractured north leg at locations "B" and "D", while Figures 31 and 32 record a typical failed tension diagonal. Heavy scraping at the location of the impact of the bottom chord of the main span with the inside of the south leg is recorded in Figure 33.

**FIGURE 29: Failed connection "B". (See Figure 28)**

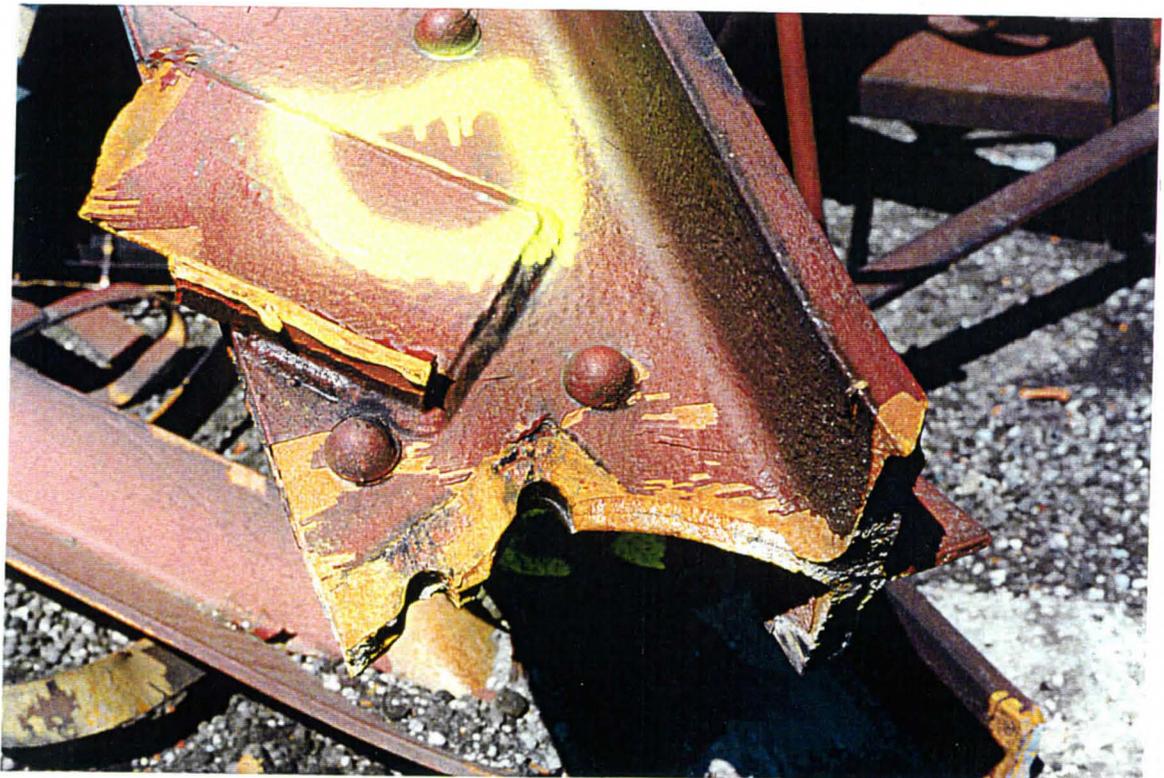
**FIGURE 30: Failed connection "D". (See Figure 28)**

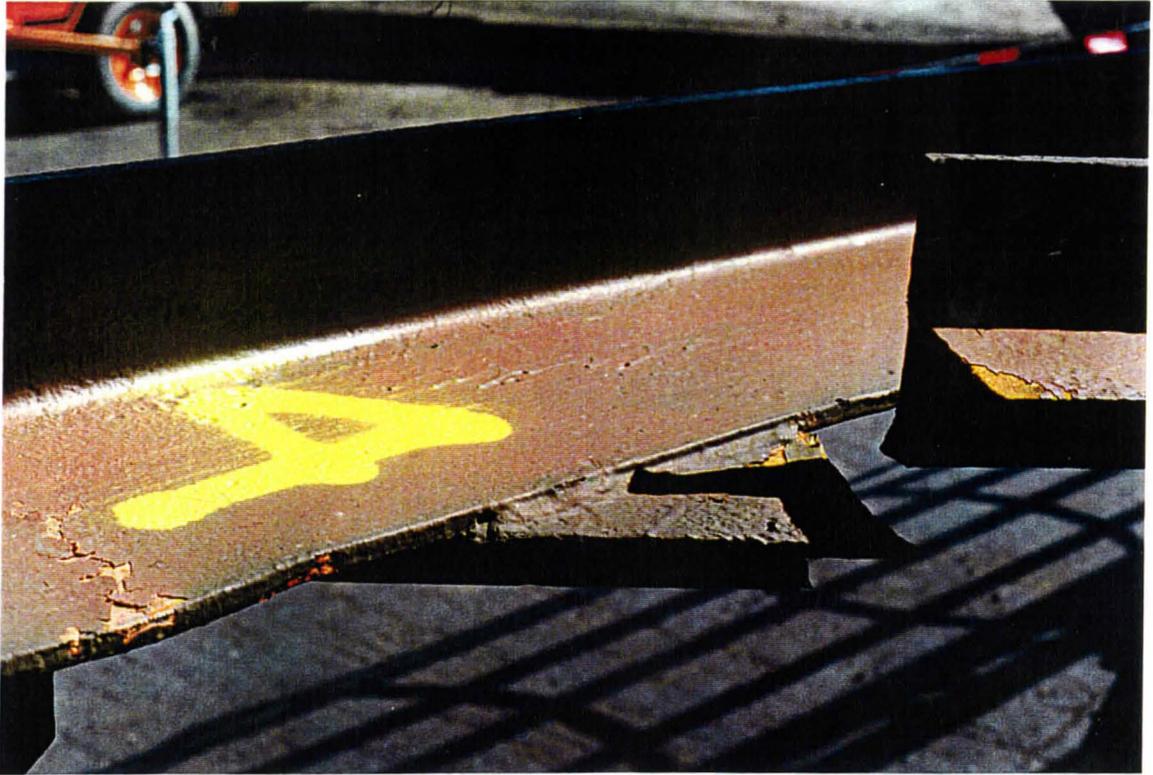
**FIGURE 31:** Failed tension diagonal in North Leg of Shear Leg.

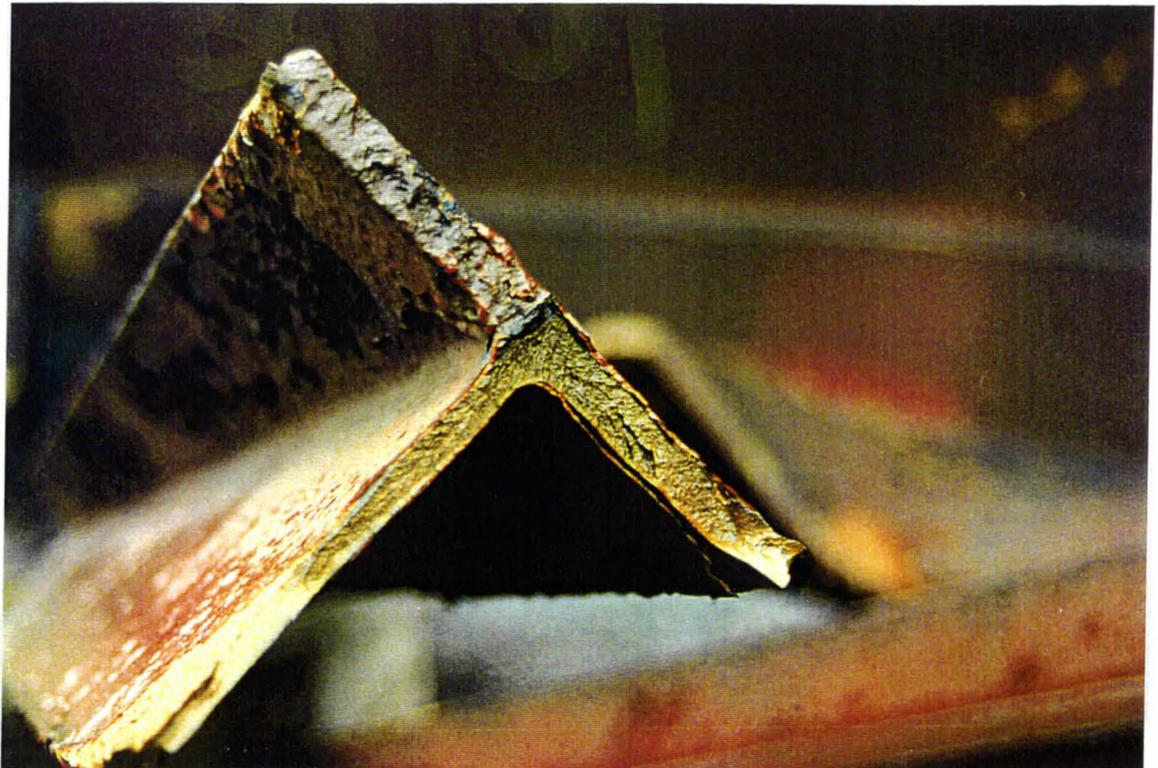
**FIGURE 32:** Closeup view of typical fracture face of failed tension diagonals in North Leg of Shear Leg.

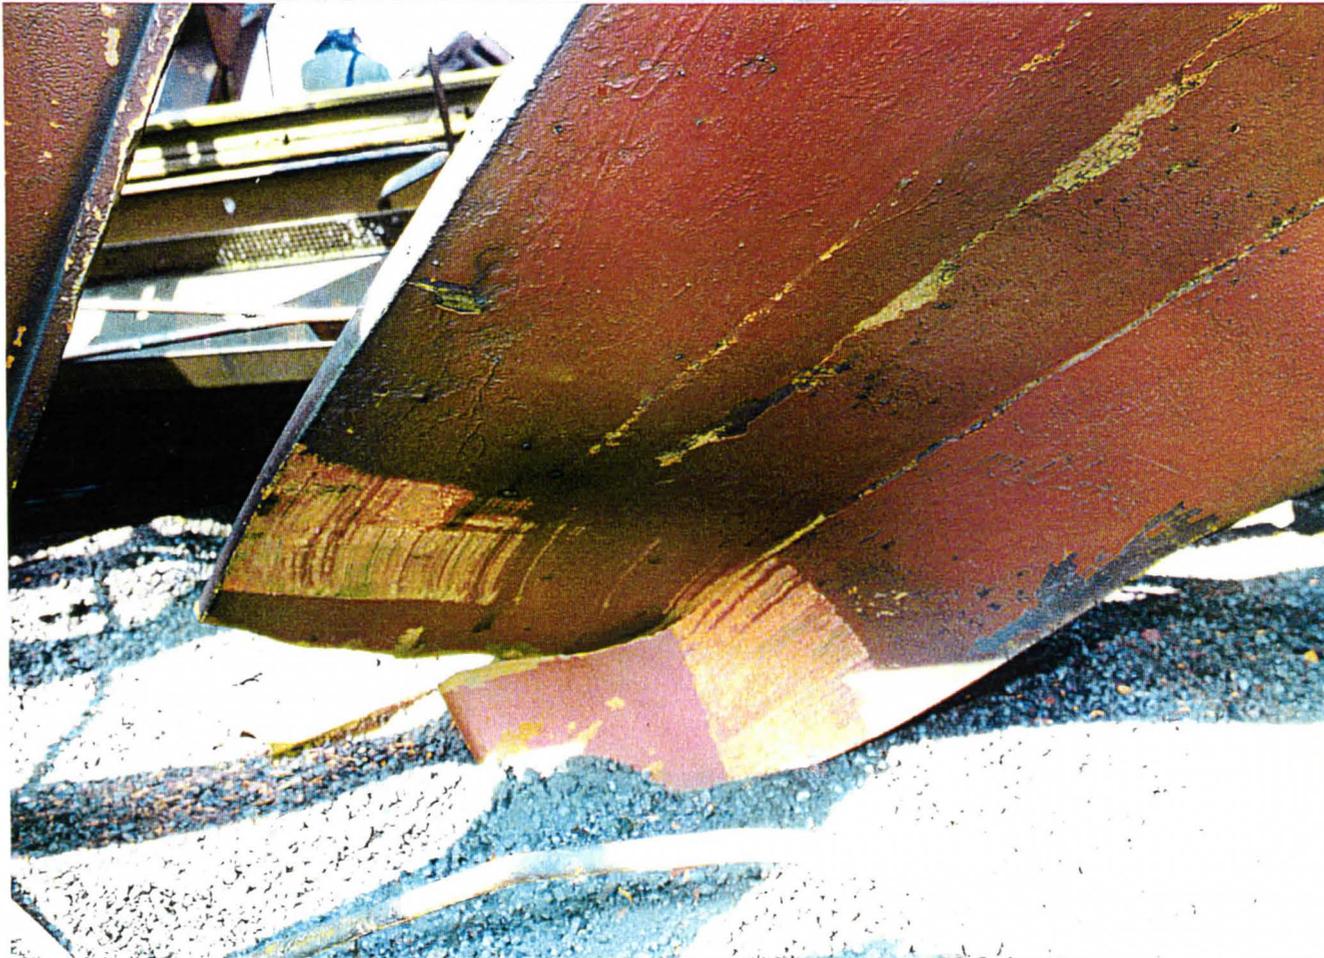
**FIGURE 33: Impact damage to inside face of South Leg of Shear Leg near the haunch section.**

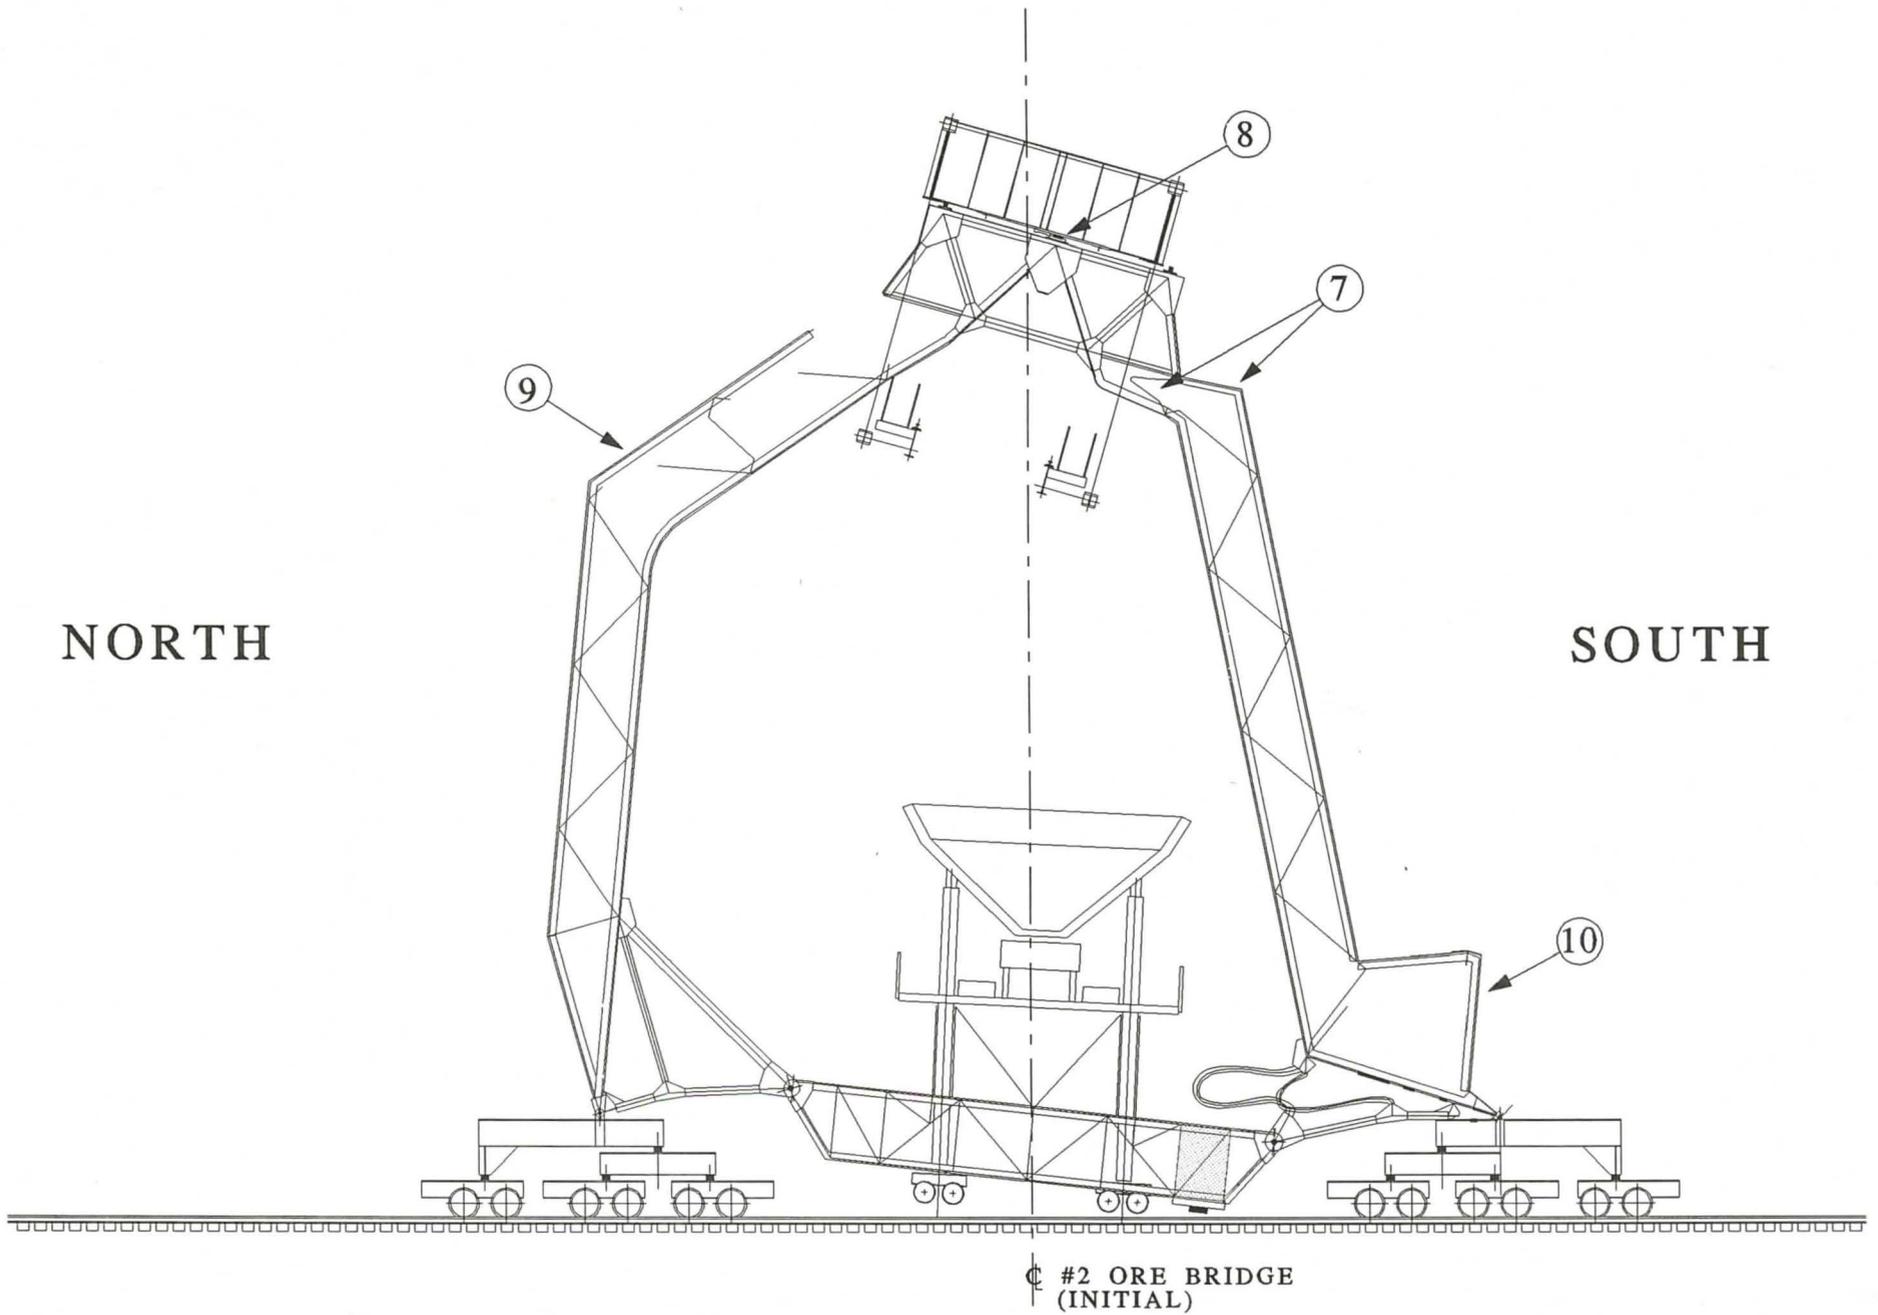
In Figure 34, the main span has begun to drop and rotate towards the south, as the lower portion of the south leg continued to collapse inwards. This behaviour was enhanced by the buckled diagonal members at the top of the south leg and the hinge forming at that point (7). The main span had now also become wedged against the top of the Shear Leg by the keeper rings which originally held the pill, (8). The weight of the main span on the damaged Shear Leg continued to distort the upper portions of the north leg (9) and lower portions of the south leg (10).

Lastly the operator recalled the hopper vibrating and shaking violently and then suddenly shooting out to the north from underneath the main span. It is suspected he saw the cumulative result of the hopper being jostled about, Figure 34; the hopper moving south as the ties straightened, (14 in Figure 35); then the hopper shaking as the ties tightened, (17 in Figure 36); before the ties failed in tension, (19 in Figure 39); which allowed the sill truss and hopper to move rapidly towards the north.

**FIGURE 34: Collapse of Shear Leg of No.2 Ore Bridge (looking east).  
Sequence 3 (See text for notes)**

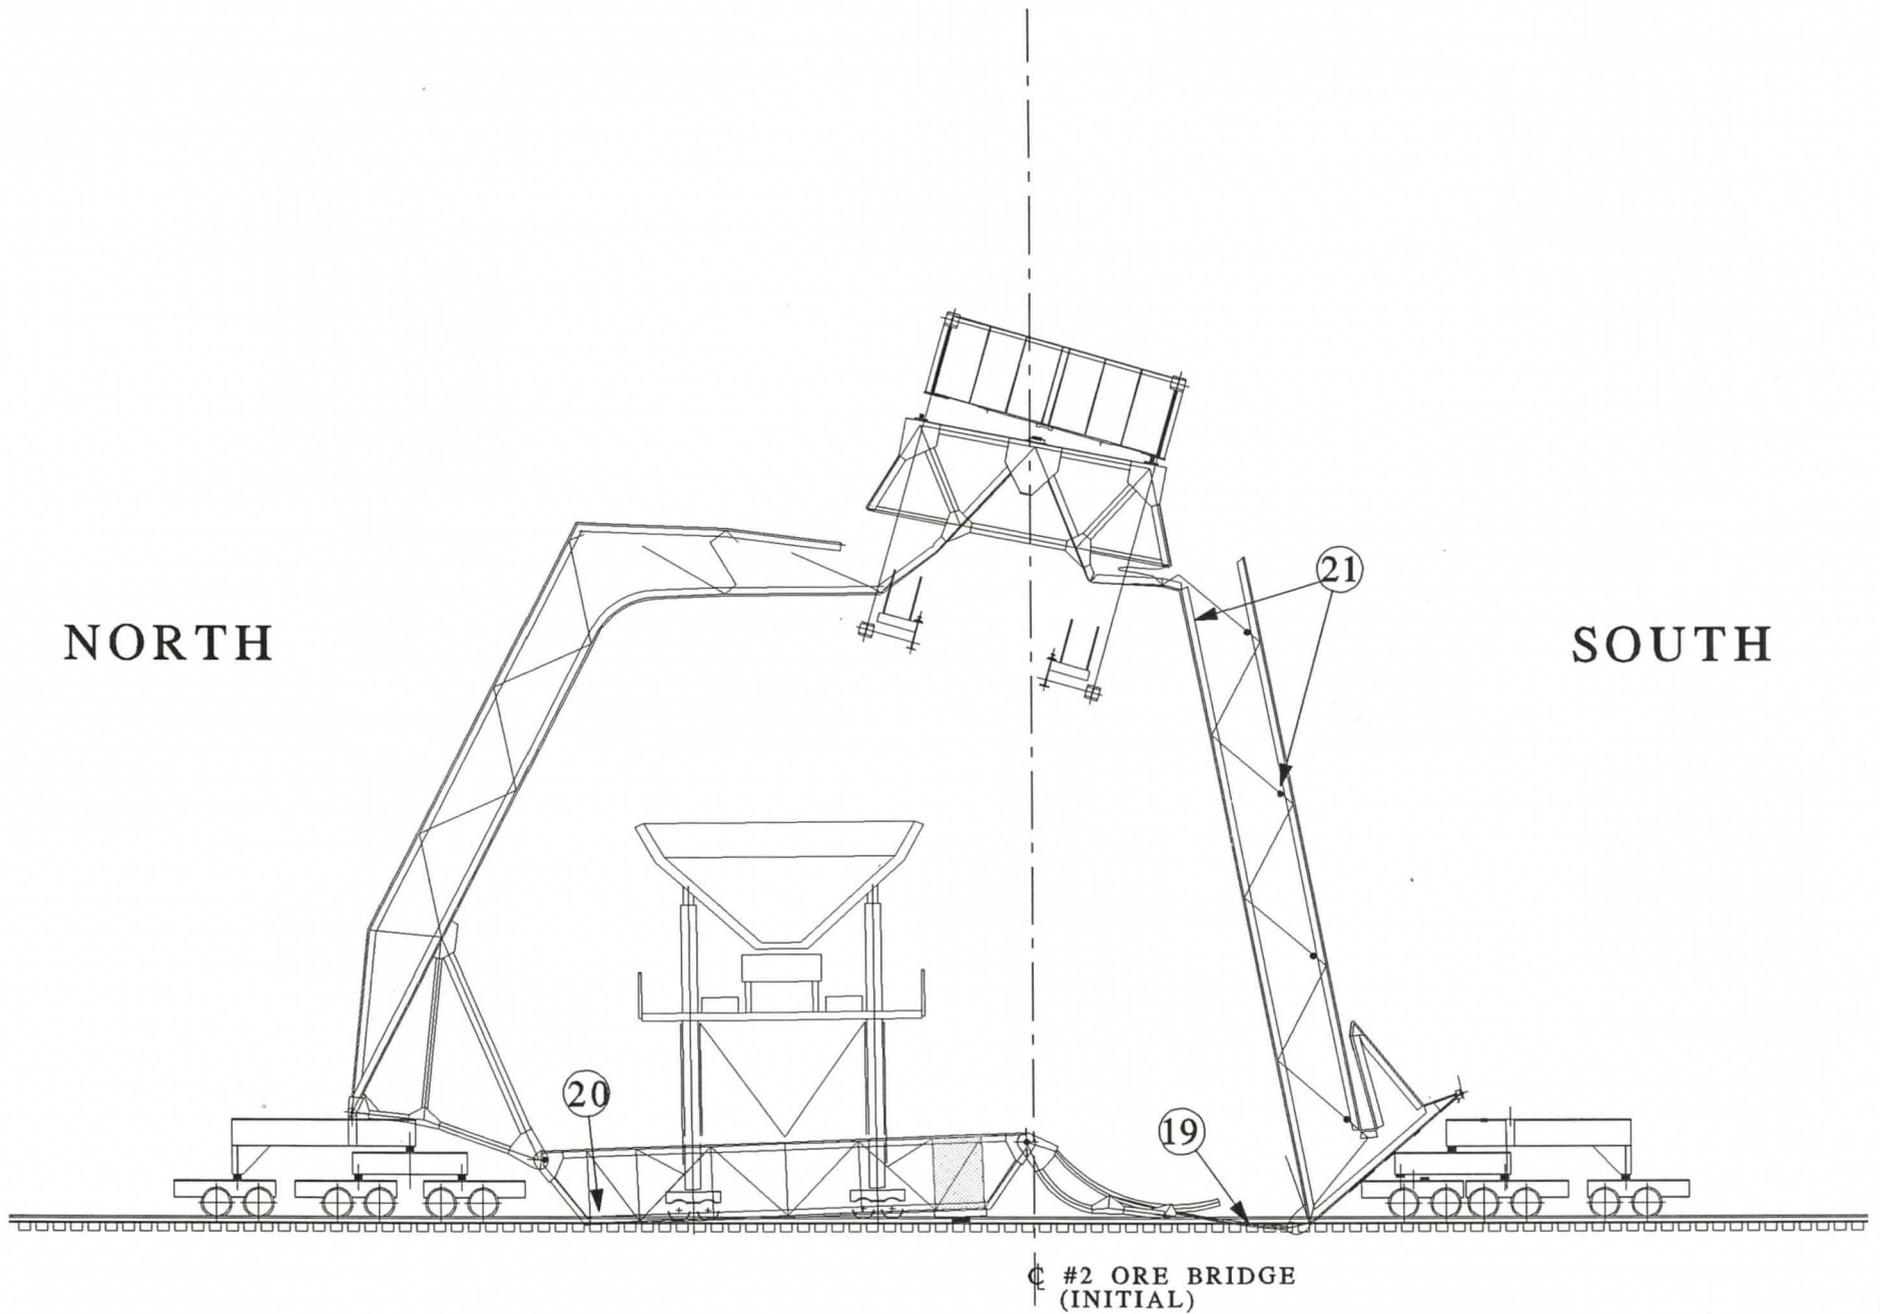
Once the inside of the south leg contacted the ground, Figure 39, and the ties which originally held the north and south trucks together had pulled free (19), the north leg was completely released from the south leg, along with the sill truss and hopper. With the bottom of the south leg firmly embedded in the ground, the entire weight of the falling main span also impacted on the top of the south leg, fracturing the tension diagonals in

**FIGURE 39: Collapse of Shear Leg of No.2 Ore Bridge (looking east).  
Sequence 6 (See text for notes)**

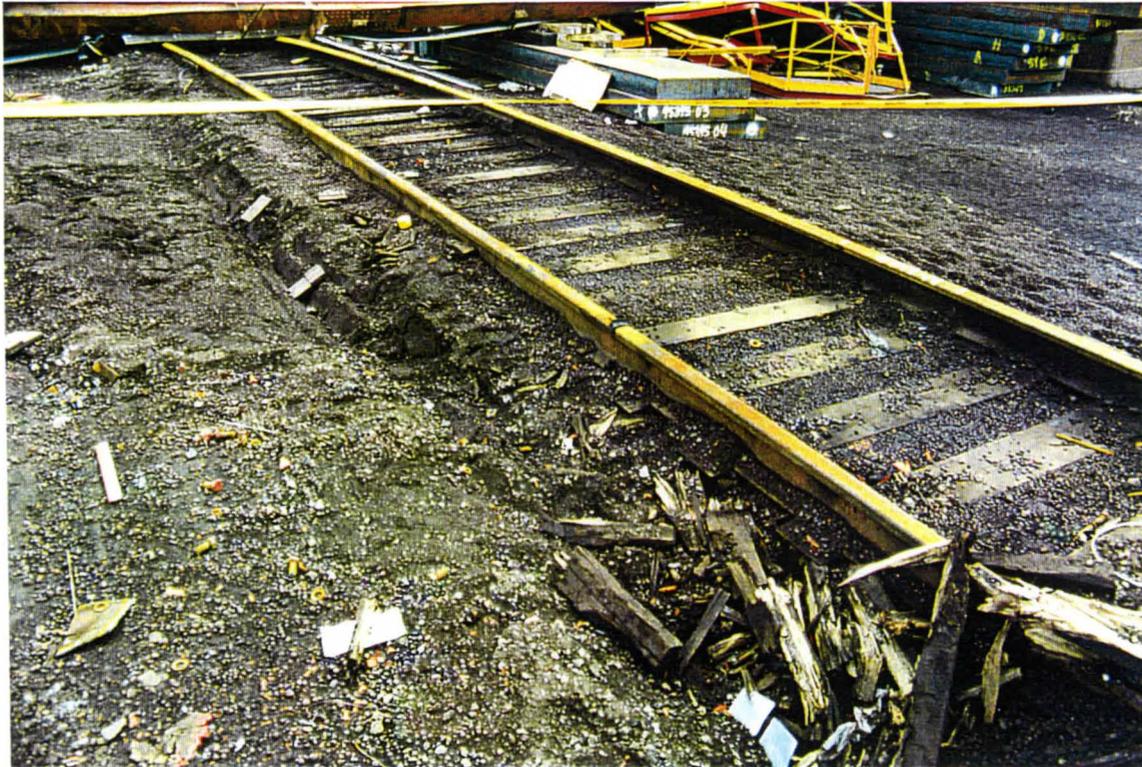
**FIGURE 40:** View of damage to railway ties and ballast from the northerly movement of the sill truss and hopper.
