**THE COLLAPSE  
OF  
THE DOFASCO NO. 2 ORE BRIDGE  
MARCH 28th 1995  
HAMILTON ONTARIO**

TIMOTHY VERHEY, B.Eng.

A Project

Master of Engineering

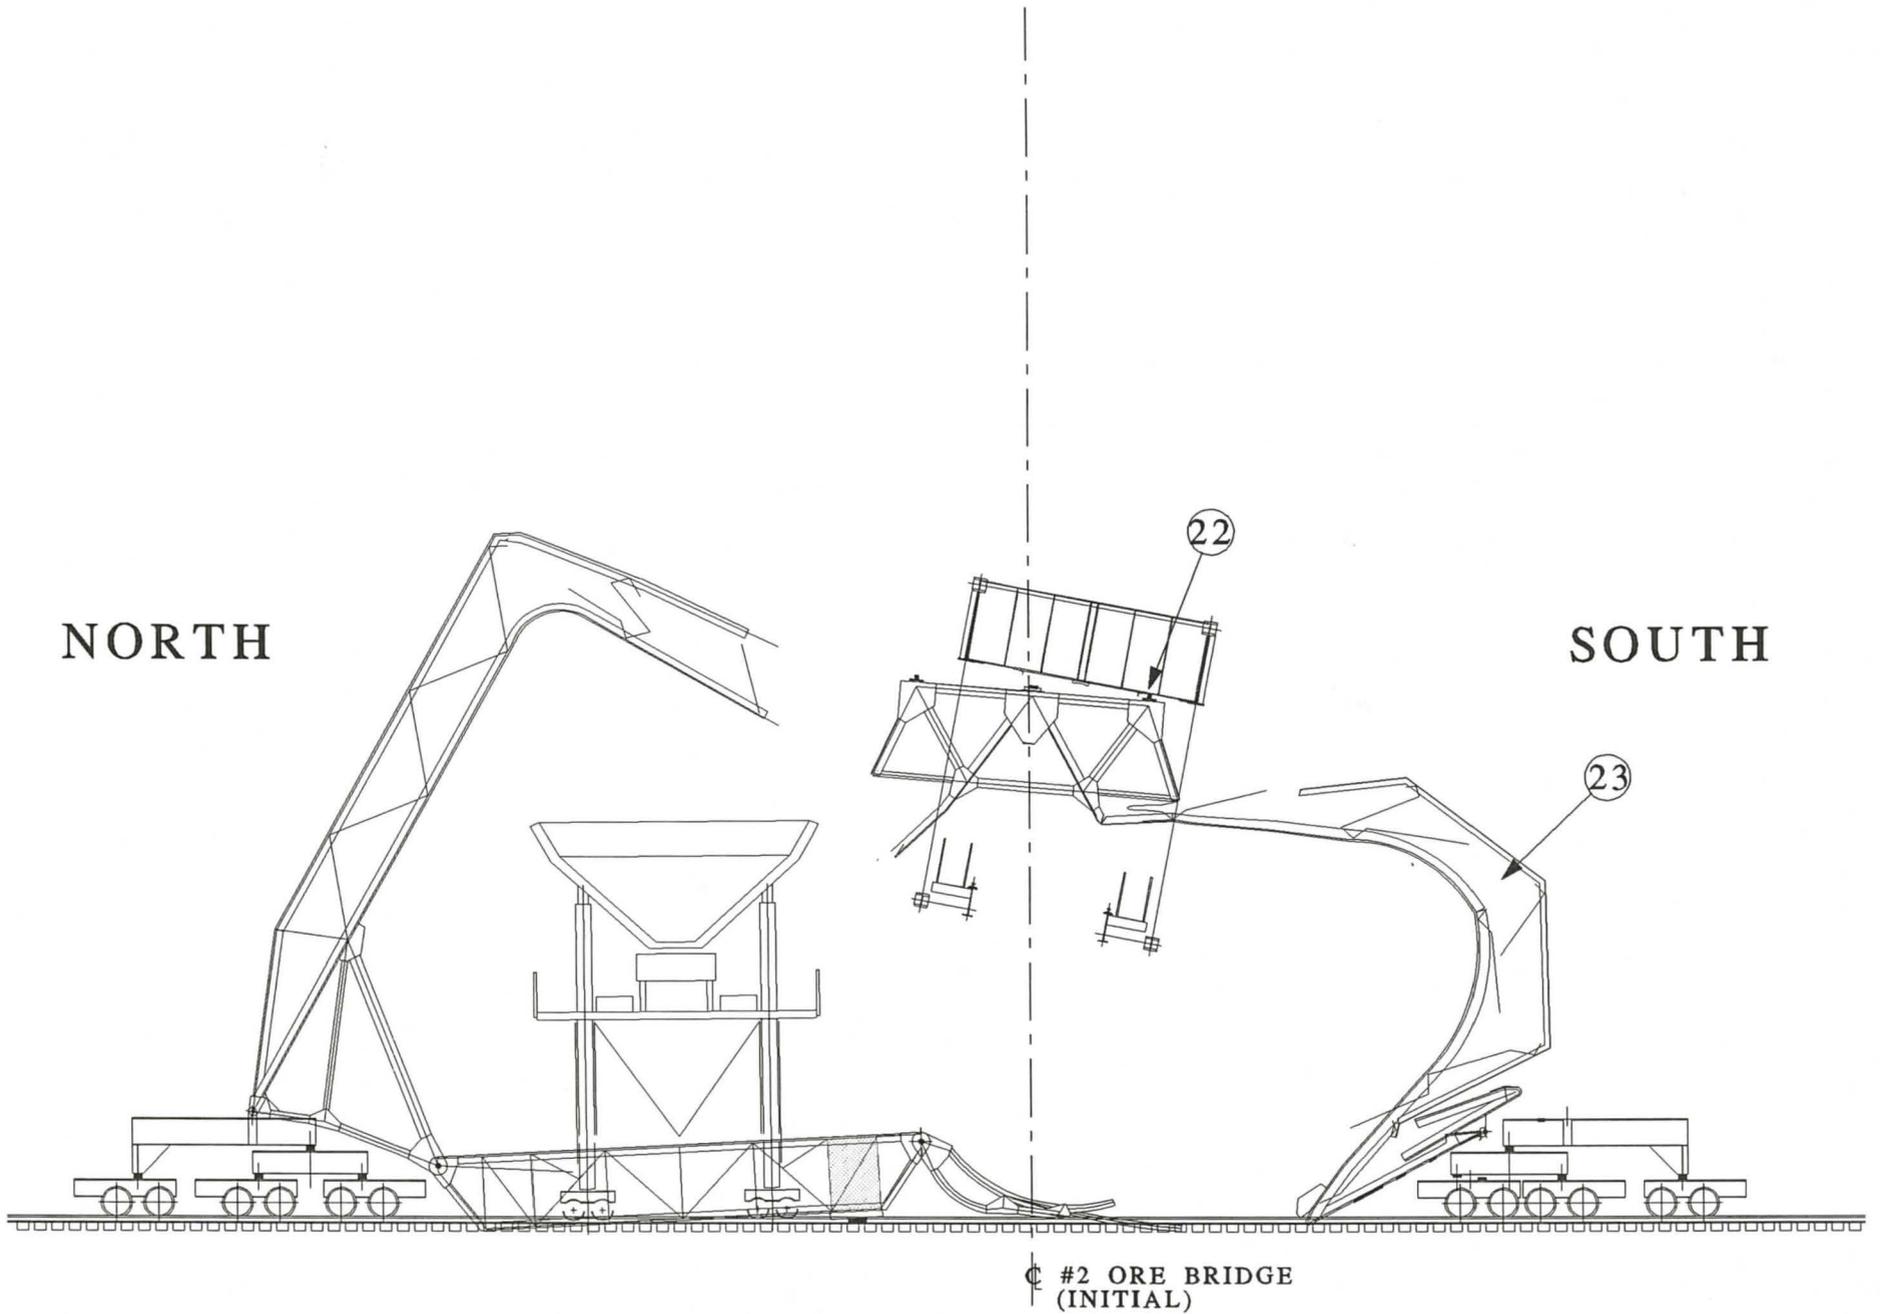
In Figure 41, the main span is shown continuing its free fall as the haunch section slides under the cross-head and then breaks completely free (22), slipping out through the north side of the main span. The south leg, which had lost the stiffening benefit of its diagonals, had minimal bending capacity and was bent over double, fracturing the inside flange of the leg, (23). Figure 42 is a view of the south leg, after it was removed from the wreckage.

**FIGURE 41: Collapse of Shear Leg of No.2 Ore Bridge (looking east).  
Sequence 7 (See text for notes)**

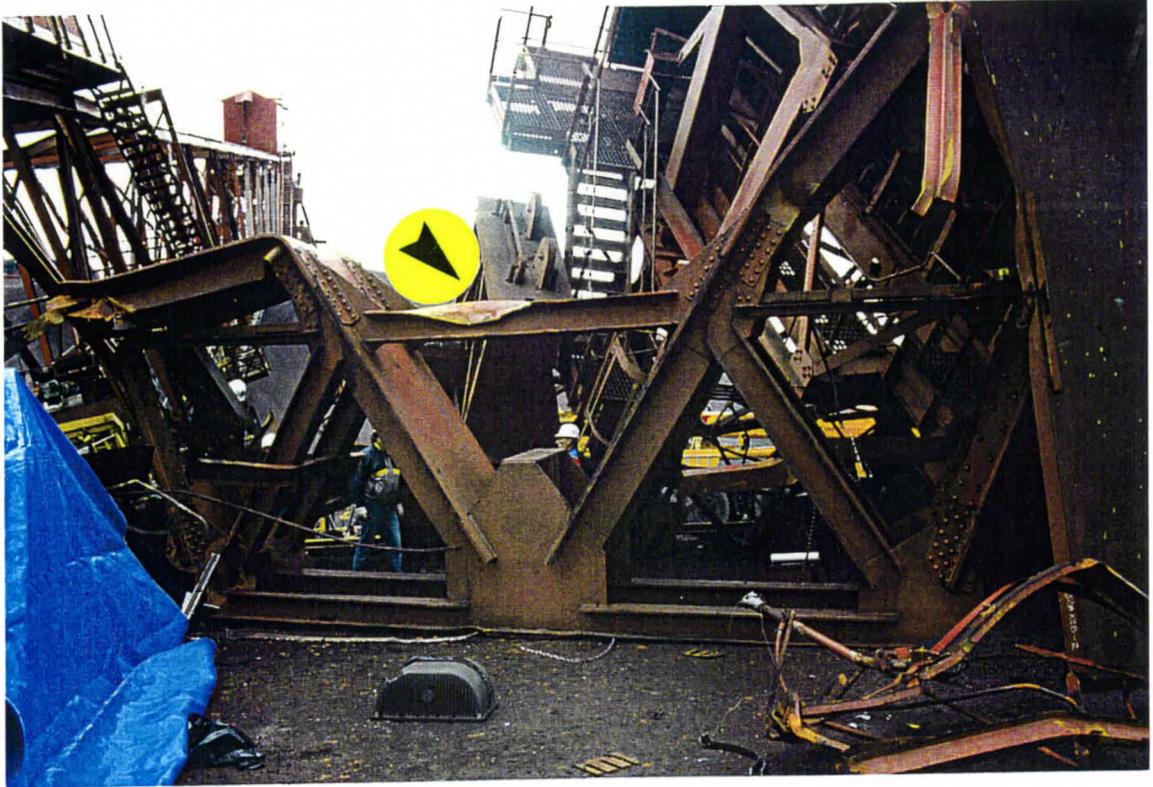
Figure 44 records the upside down haunch. It is believed the haunch landed on the south bottom chord of the main span, damaging the middle tie member or cross beam, as noted in the Figure, then flipped towards the north landing upside down under the hopper. Figure 45 records the main span on top of the tie members.

**FIGURE 44:** Final location of haunch section (Arrow notes damage to cross beam).

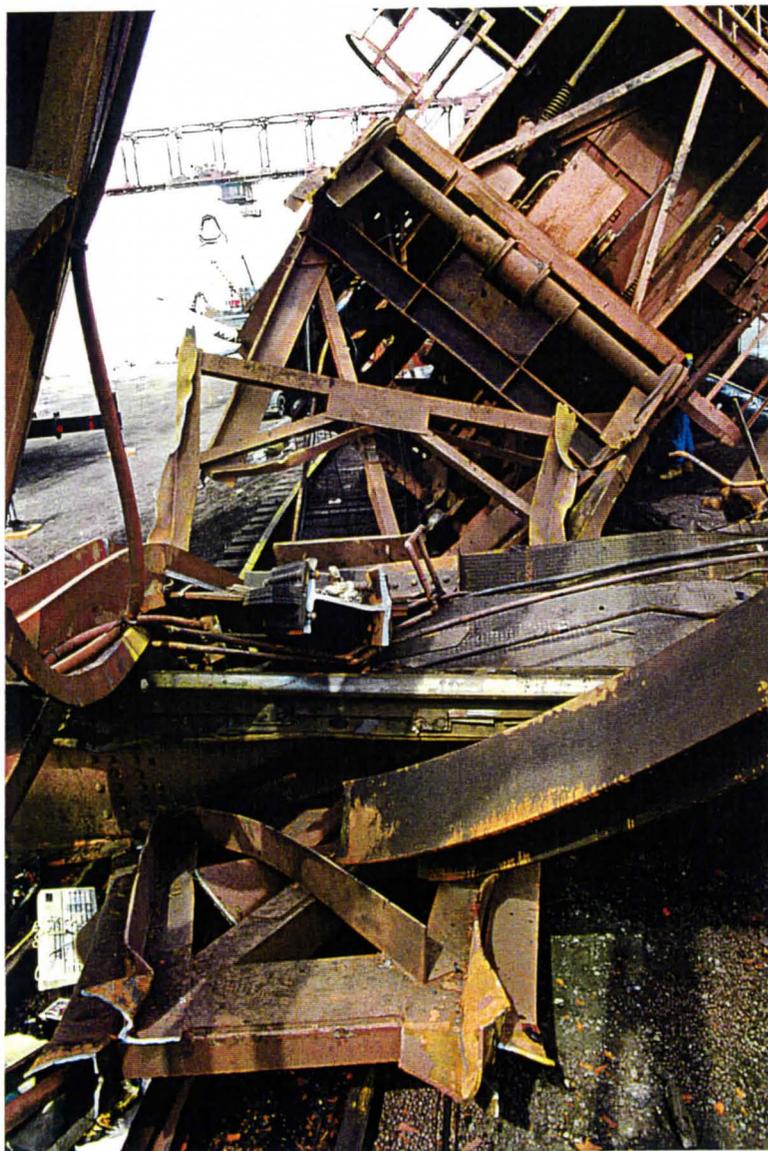
**FIGURE 45:** Final location of tie-brace underneath the north bottom chord of the main span.

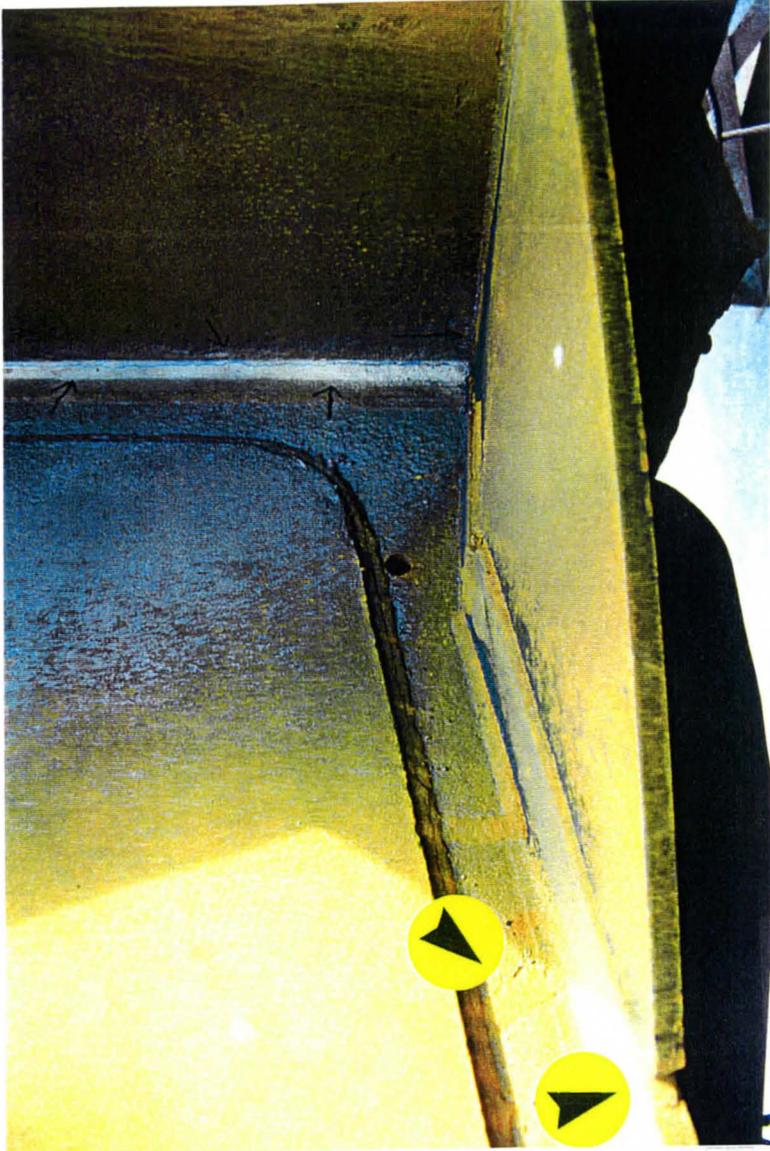
**FIGURE 74:** Closeup view of weld repairs in the tie-plate region.

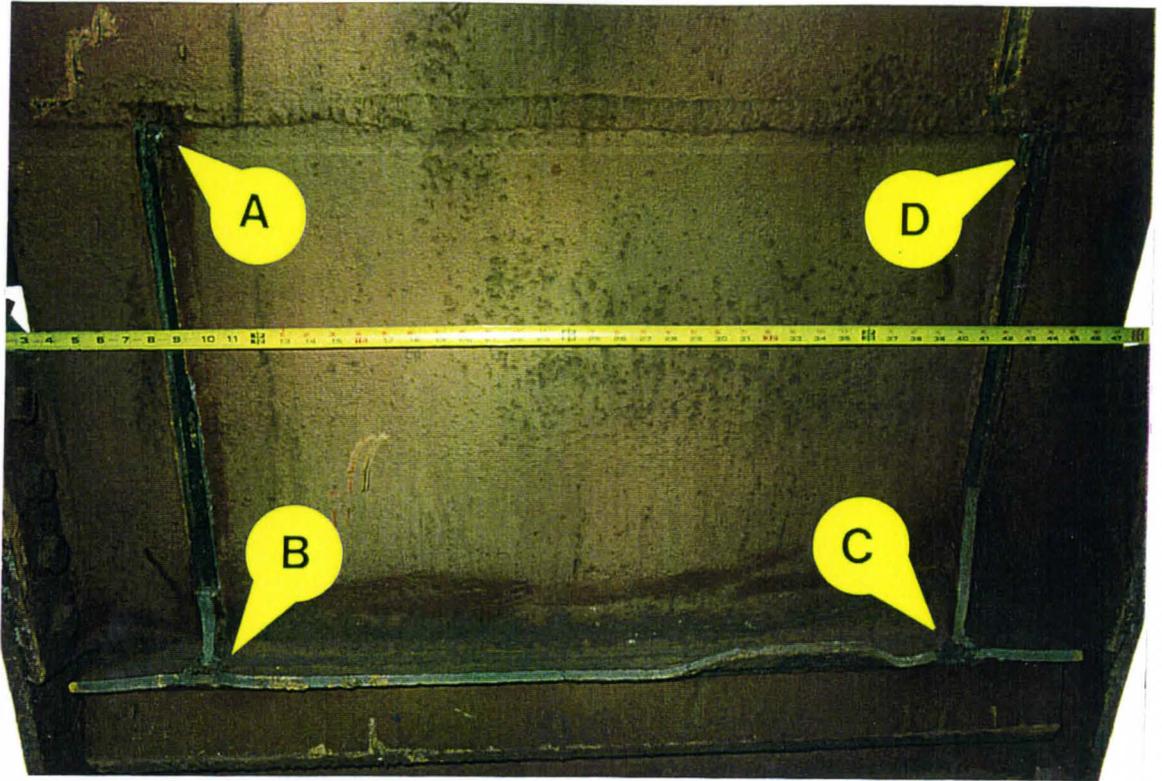
**FIGURE 78:** View of tie-plate and gusset fracture face at the inside face of South Leg of Shear Leg. (See text for notes)

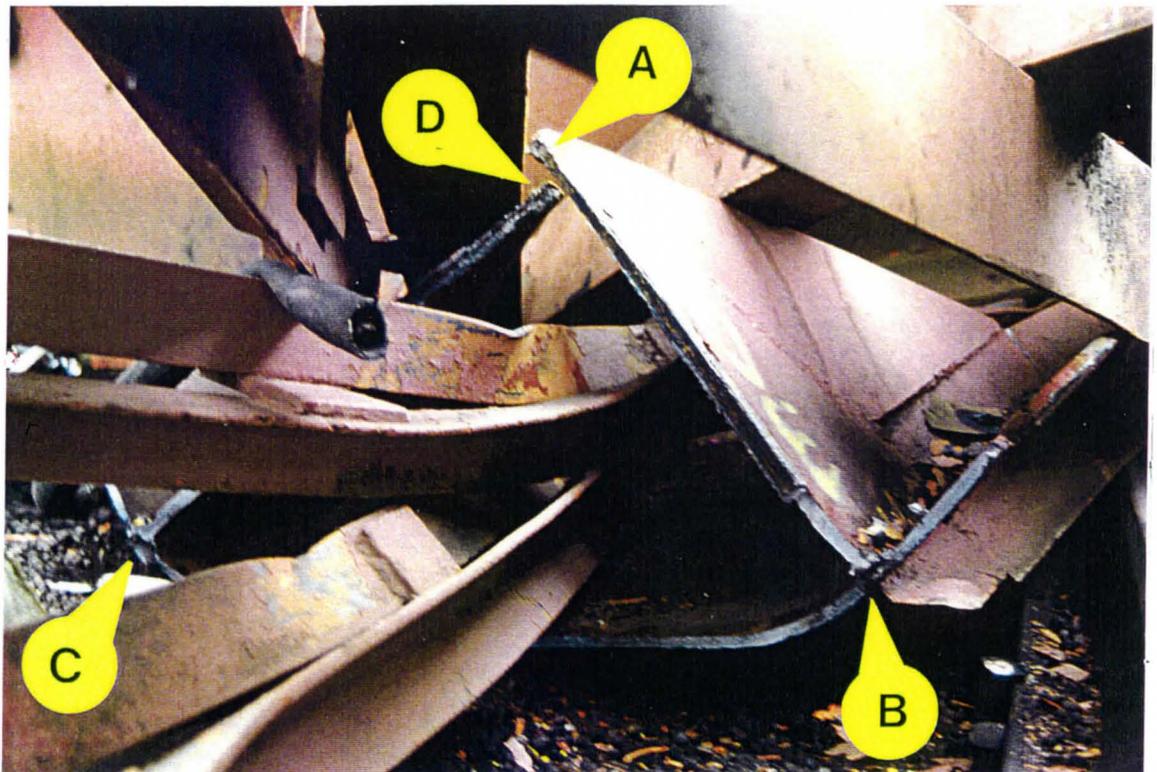
**FIGURE 79:** View of tie-plate and gusset fracture face. (See text for notes)

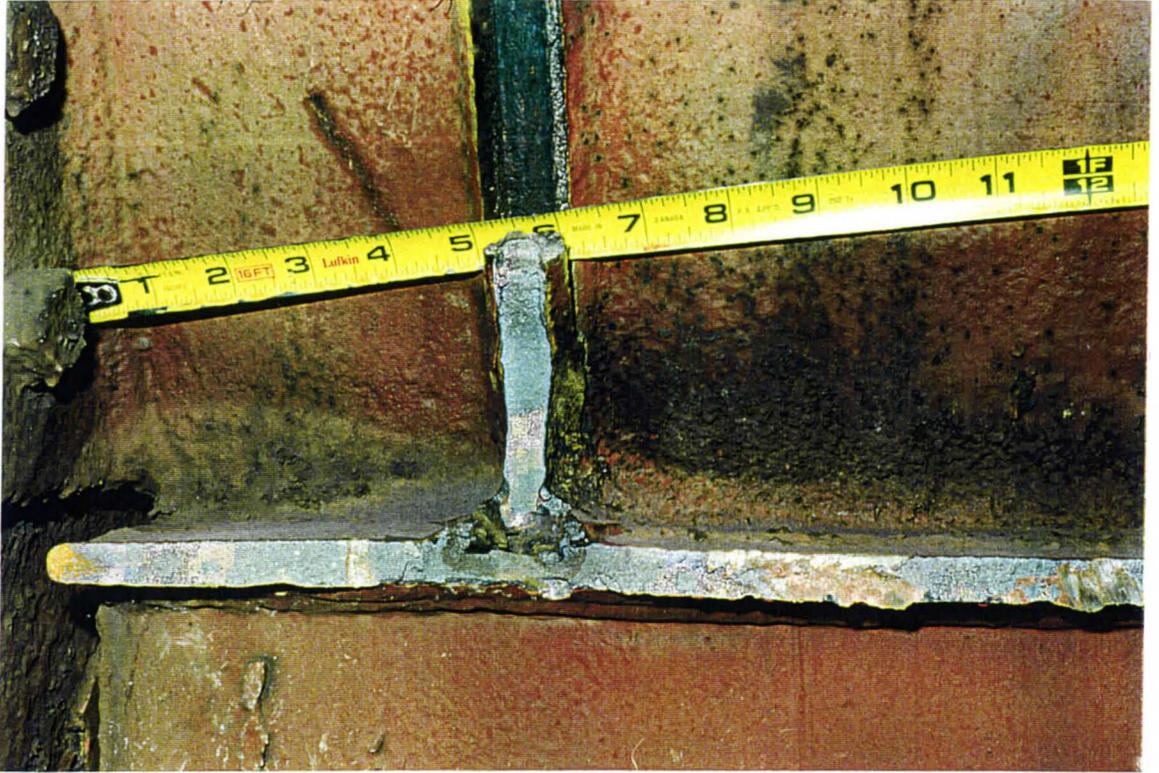
**FIGURE 80:** Closeup view of fracture face where the tie-plate intersects the east gusset.

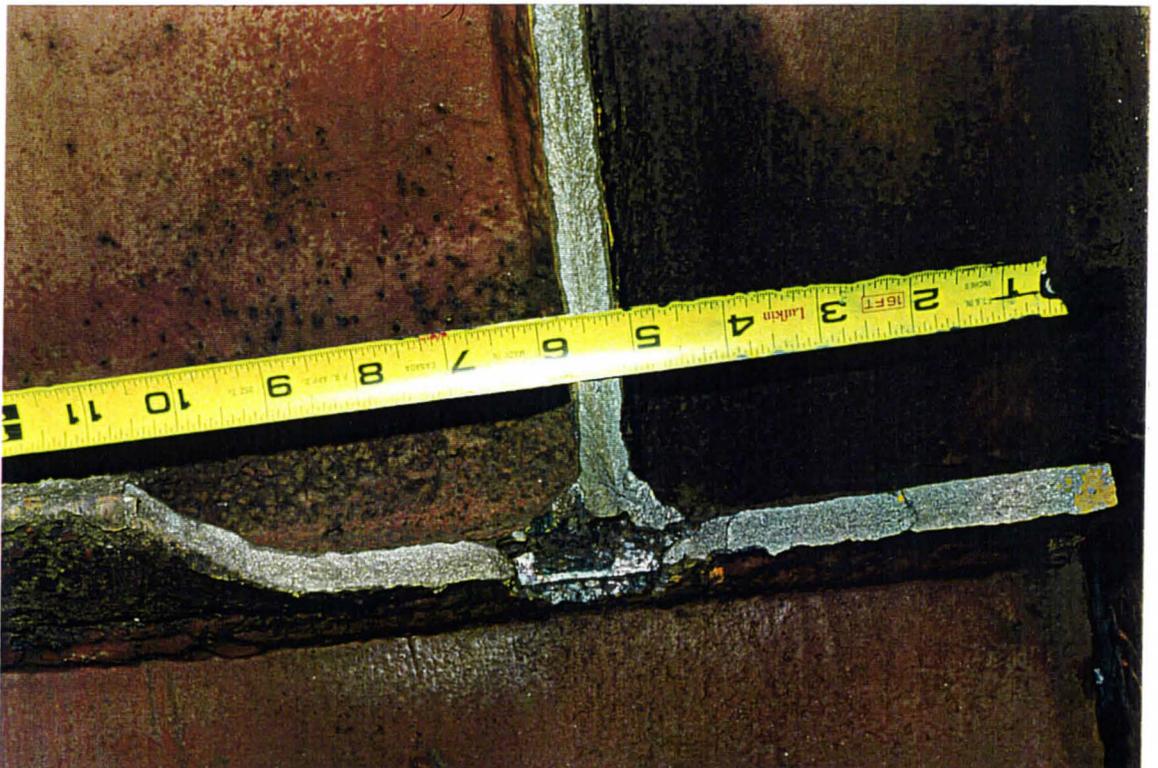
**FIGURE 81:** Closeup view of fracture face where the tie-plate intersects the west gusset.

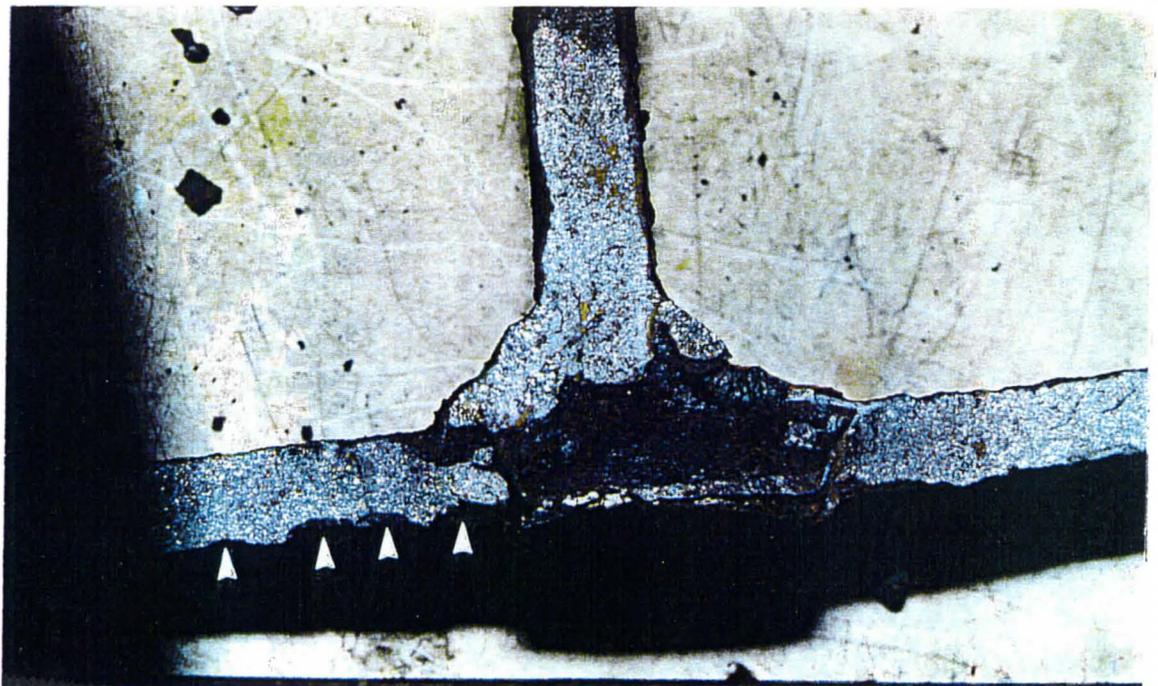
**FIGURE 84:** Closeup view of fracture face where the tie-plate intersects the west gusset. (Arrows note corrosion pits and fatigue cracks) (Wood, 1995)

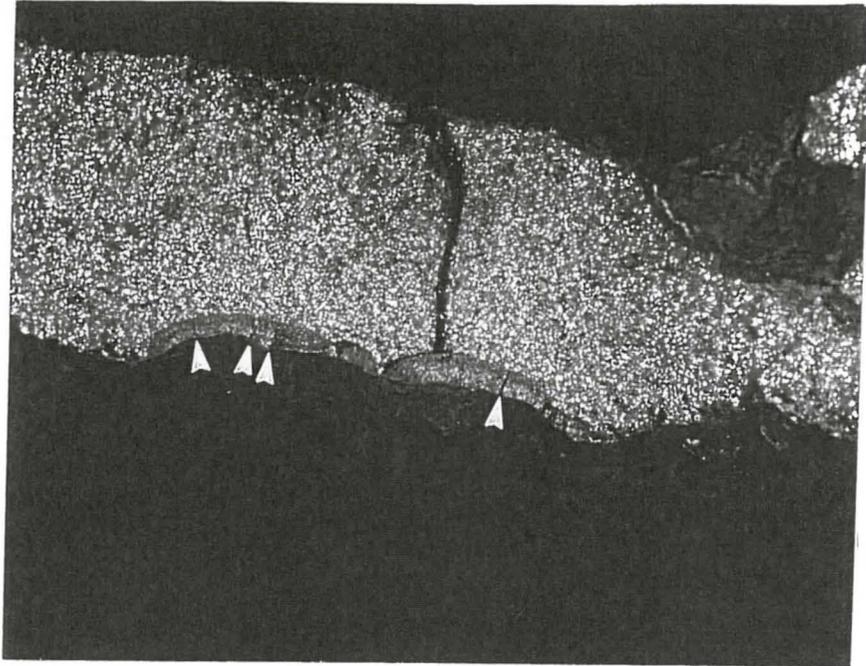
**FIGURE 85:** Magnified view of corrosion pits and fatigue cracks at the underside of the tie-plate. (Arrows identify ratchet marks) (Wood, 1995)

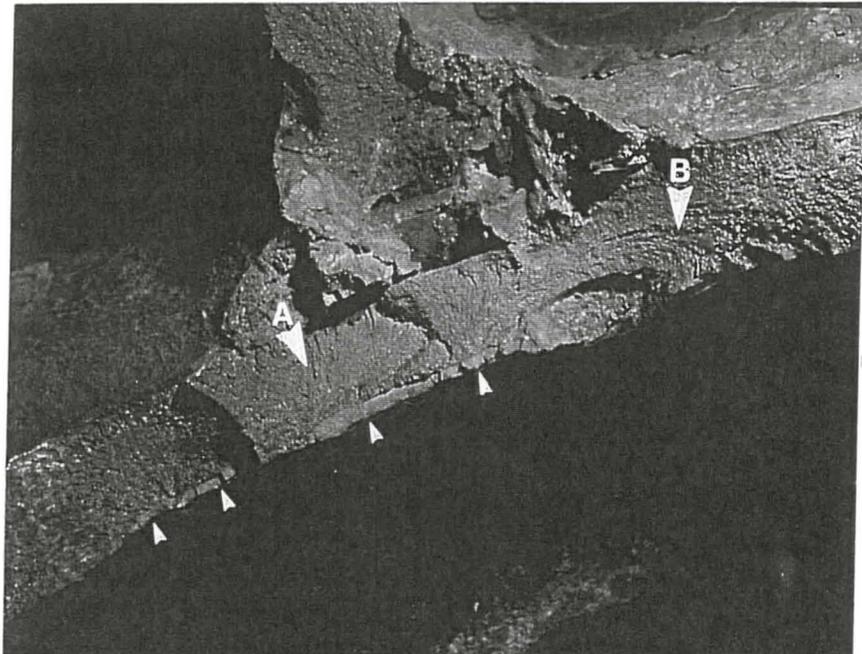
**FIGURE 86:** Closeup view of fracture face where the tie-plate intersects the east gusset under oblique lighting. (See text for notes) (Wood, 1995)
