Effect of Cyclic Deformation on the Corrosion of Coated AA6xxx
Hem Flanges

Effect of Cyclic Deformation on the Corrosion of Coated AA6xxx

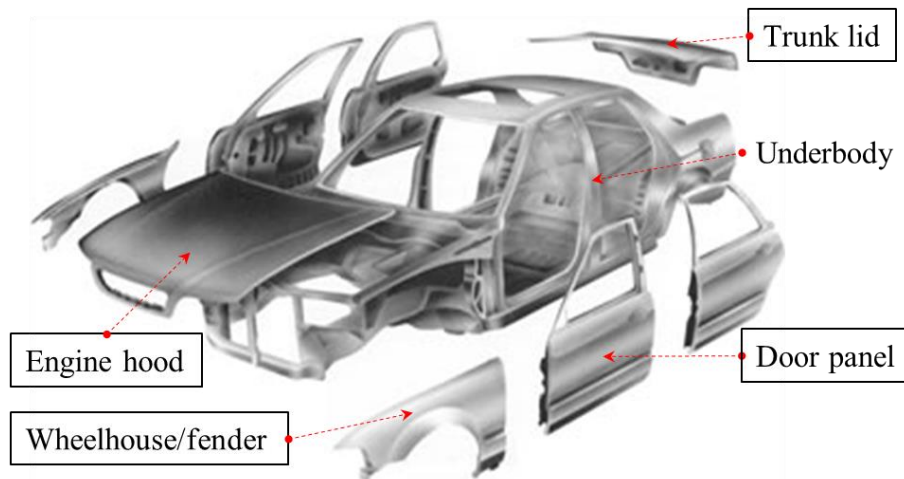
Figure 1.1: Schematic of an auto body showing the underbody and the different components of sheet enclosures including engine hood, wheelhouse, door panel, and trunk lid [9].

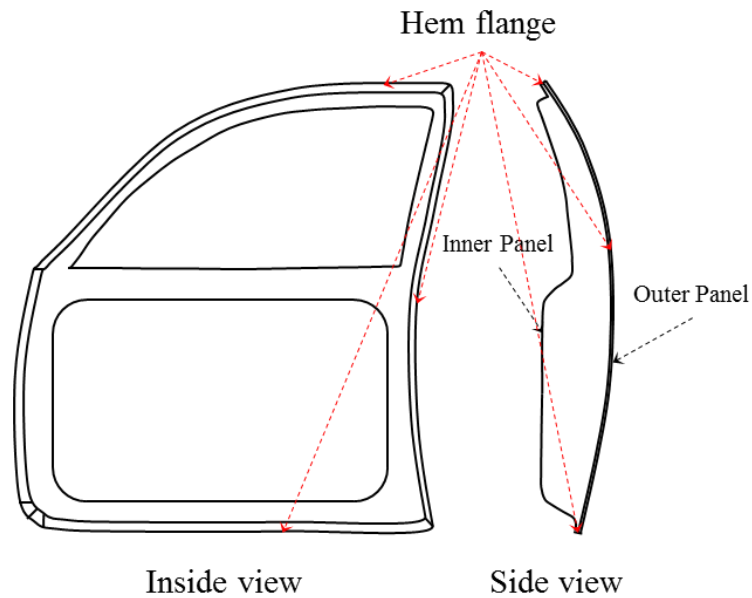
Figure 1.2: Schematics of a car door with the location of a hem flange indicated by the red arrows.

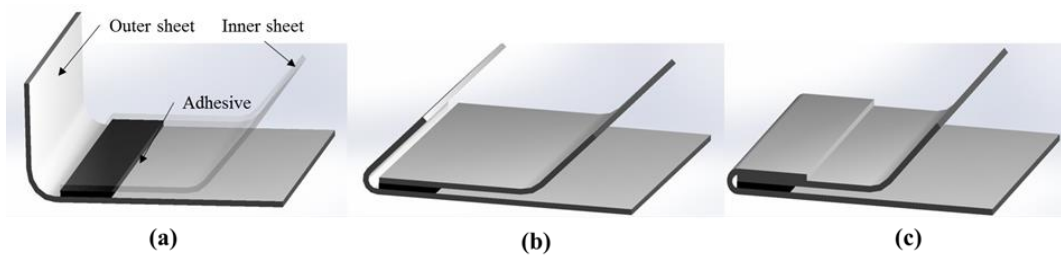
Figure 1.3: Schematics of a generic three-step hemming operation: (a) flanging, (b) pre-hemming, and (c) hemming.

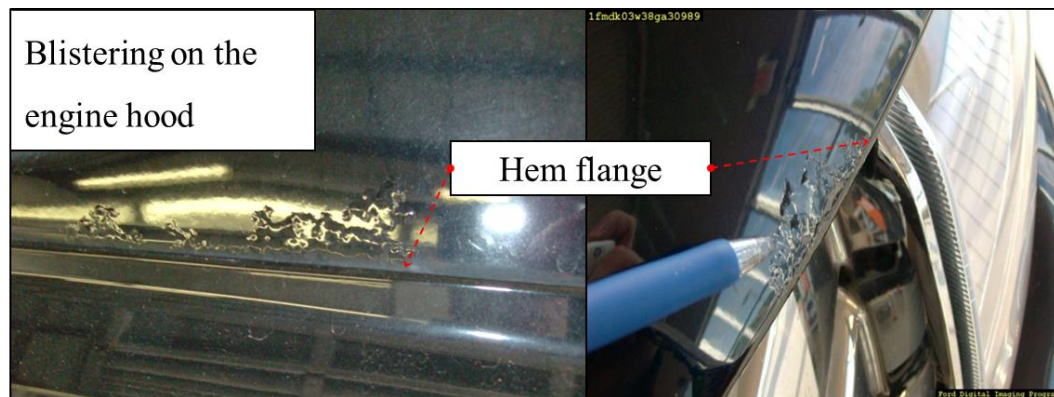
Figure 1.4: Photograph of blistering adjacent to a hem flange on the engine hood.

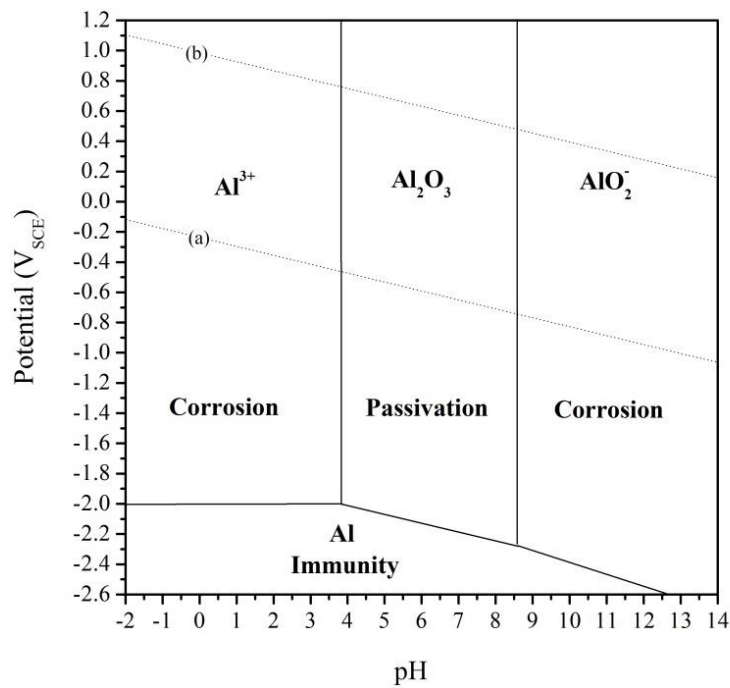
Figure 2.1: Pourbaix diagram (E-pH) of pure Al at 25°C in aqueous solution. The lines (a) and (b) correspond to water stability and its decomposed product [21].

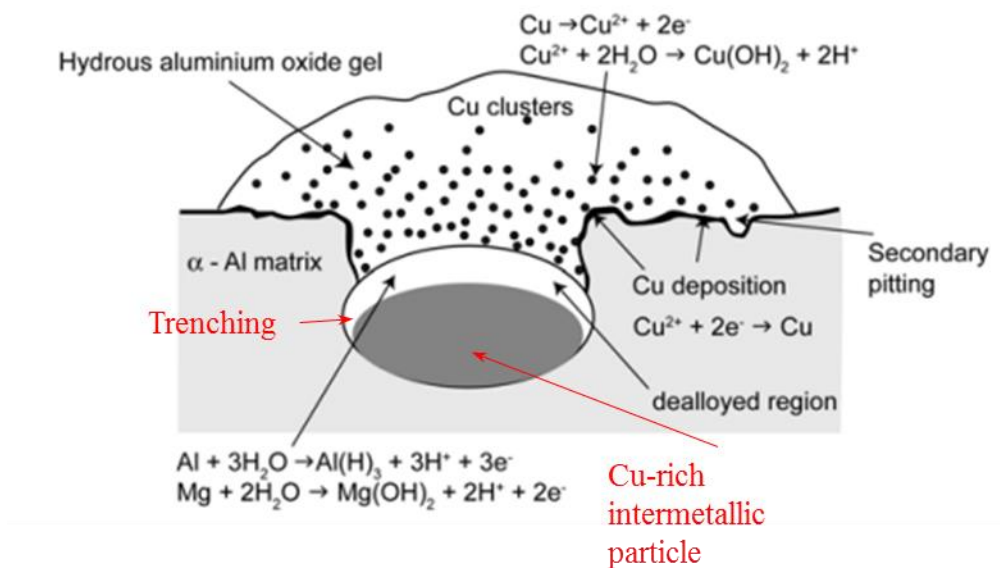
Figure 2.3: 8. Schematic of trenching around a Al₂CuMg particle with an Al matrix [32].

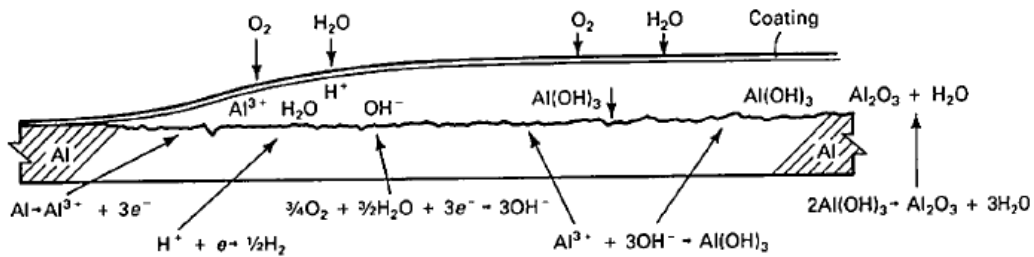
Figure 2.4: Schematic for filiform corrosion of Al [30].

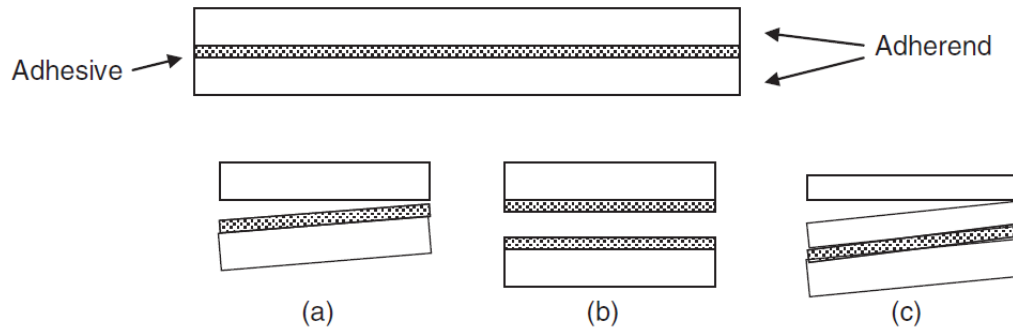
Figure 2.8: Schematics of three adhesive bond failure modes: (a) adhesive failure, (b) cohesive failure in the adhesive layer, and (c) adherend failure [53].

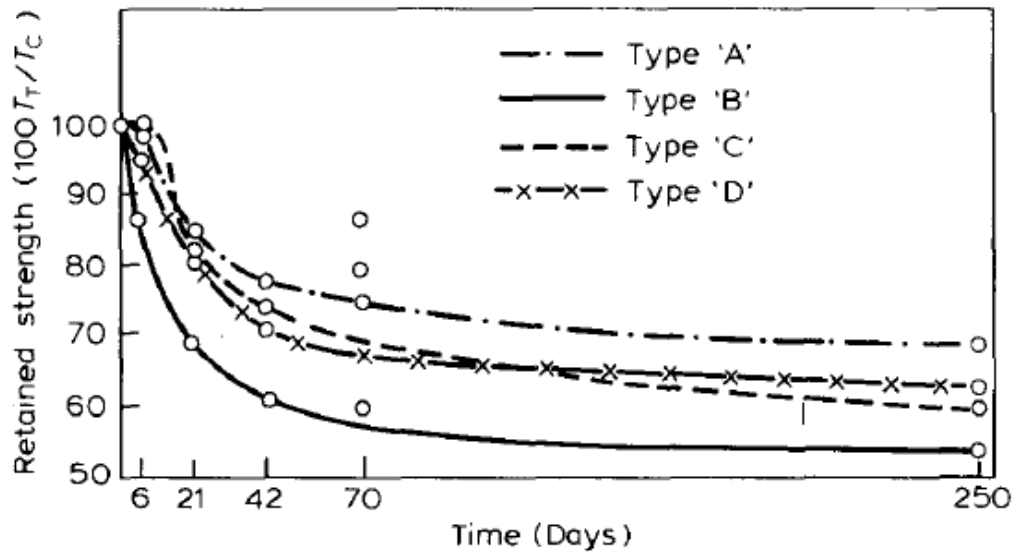
Figure 2.9: Effect of 70 °C and 90% RH exposure on tensile lap shear joint-strength.

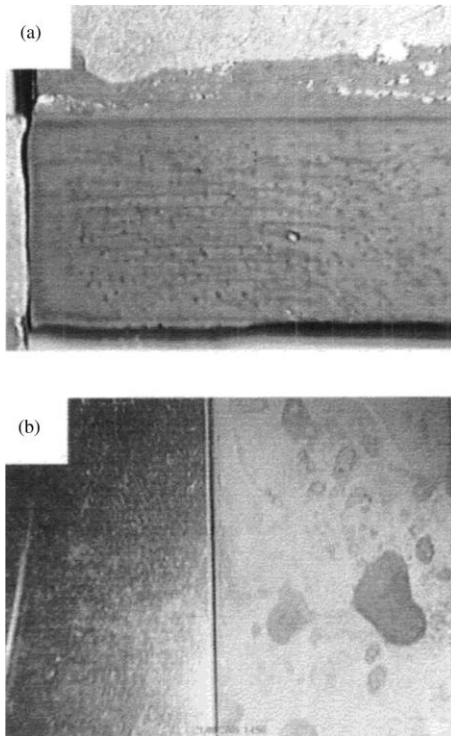
Figure 2.10: Macrographs of (a) the debonded area (adhesive failure) of the joint and (b) two Al substrates prior to corrosion (on the left) and after corrosion in a saline environment (on the right) [60].

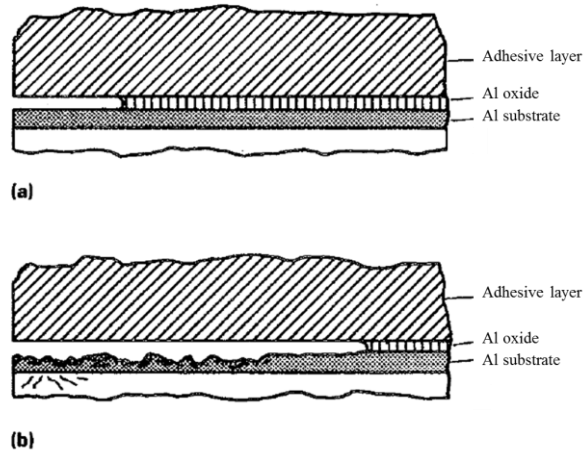
Figure 2.11: Schematics illustrating the causes of adhesive failure on an Al substrate. (a) Corrosion of adhesive-Al oxide interface. (b) Corrosion of interface and substrate

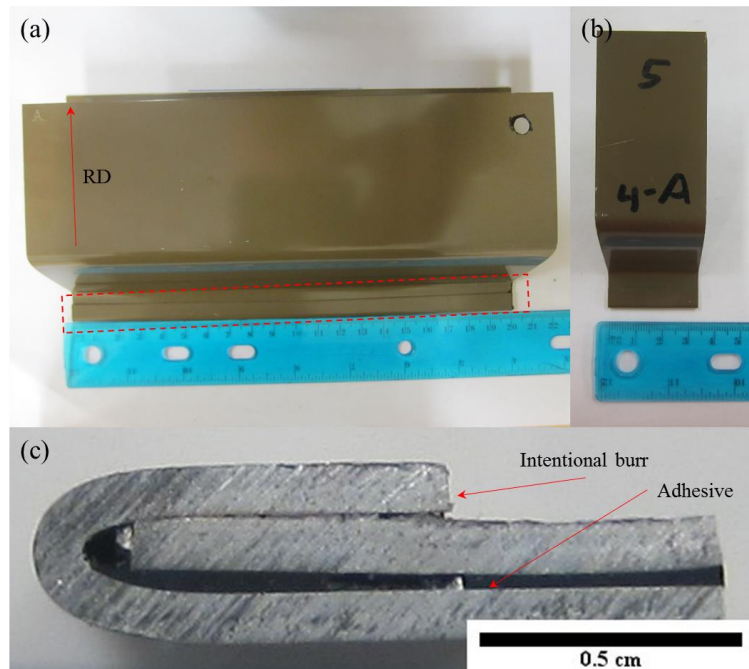
Figure 4.1: Top-view of (a) an as-received full-size coupon and (b) a sub-size coupon. (c) Cross-sectional view of a hem flange, taken from the section highlighted by the red frame in (a).

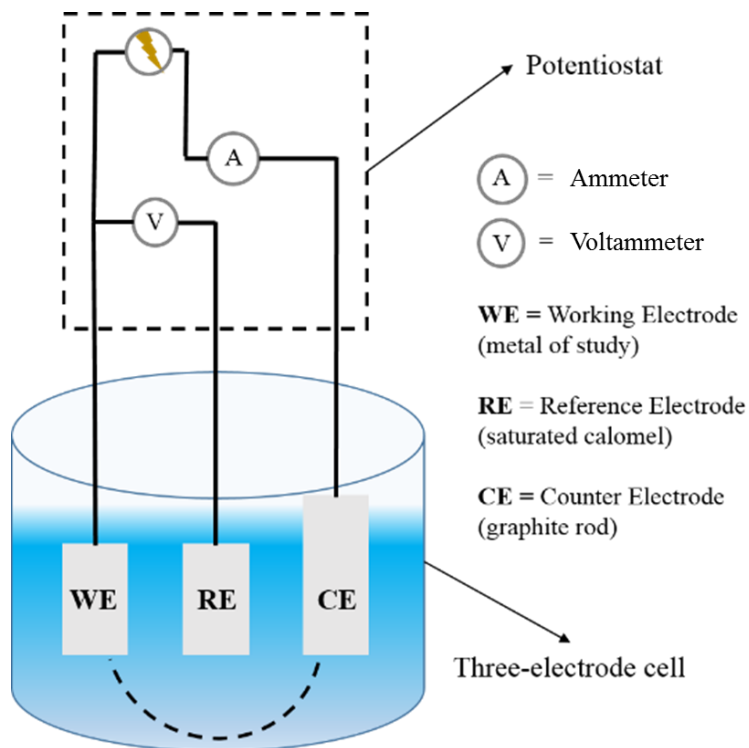
Figure 4.5: Schematic representation of the standard three-electrode setup used for open circuit and potentiodynamic polarization measurements.

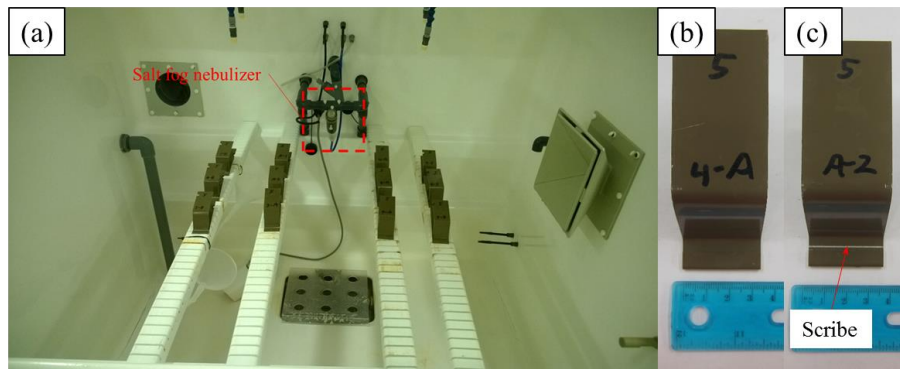
Figure 4.9: (a) Experimental setup for the Ford L-3190 cyclic corrosion testing of sub-size hem flange coupons. (b) Top-view photograph of a hem flange coupon. (c) Top-view photograph of a scribed hem flange coupon.

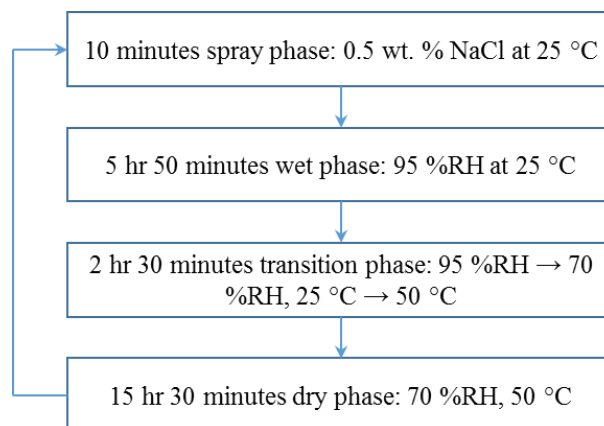
Figure 4.10: Flowchart of the daily repetitive Ford L-3190 salt spray cycle.

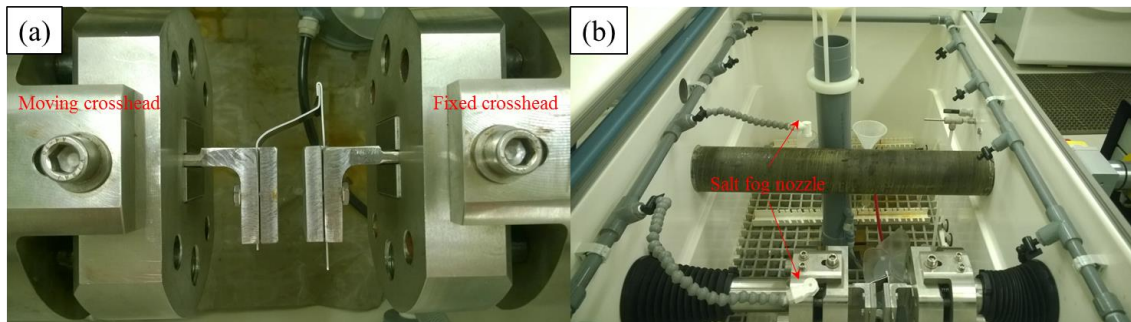
Figure 4.11: (a) Photograph of the experimental setup top-view for the cyclic loading test of sub-size hem flange coupons; (b) photograph of the testing frame and the salt spray chamber.

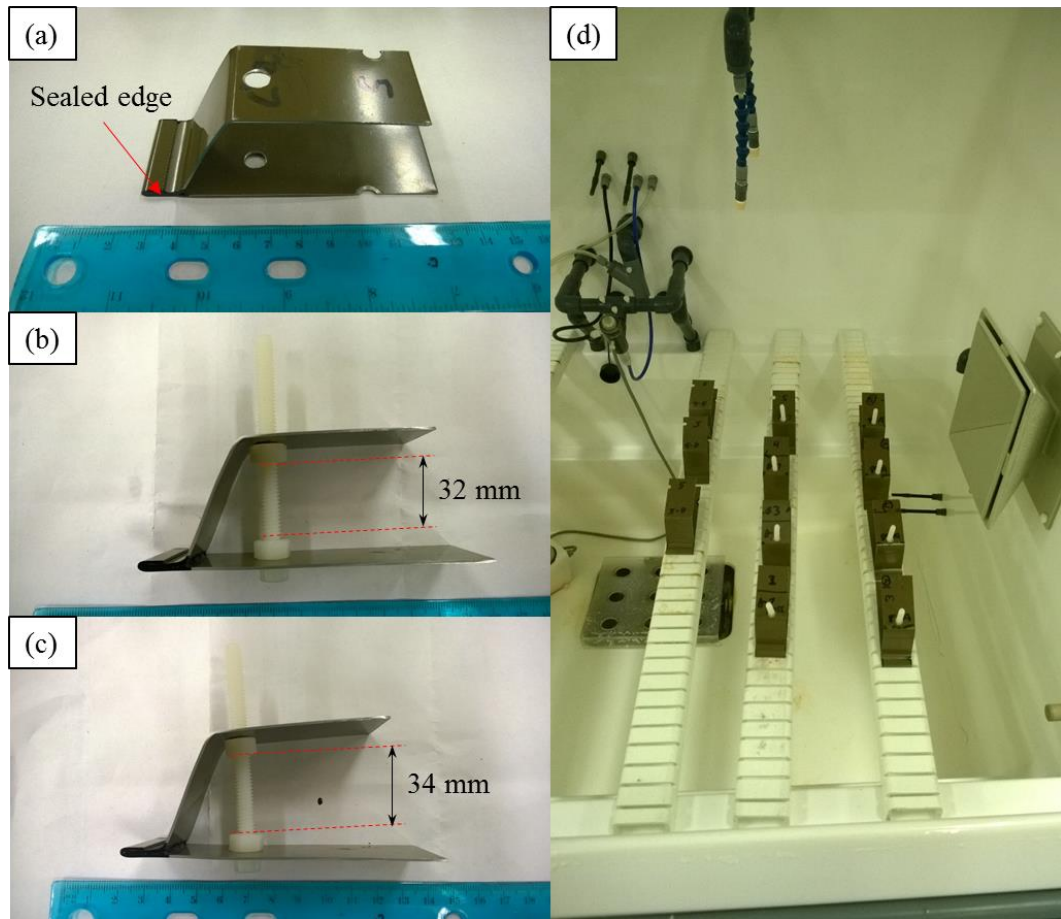
Figure 4.12: Photograph of (a) a hem flange coupon with two holes drilled, (b) a hem flange coupon at neutral position with a plastic bolt placed through the holes, (c) a hem flange coupon held at +2 mm position, and (d) the layout within the chamber.

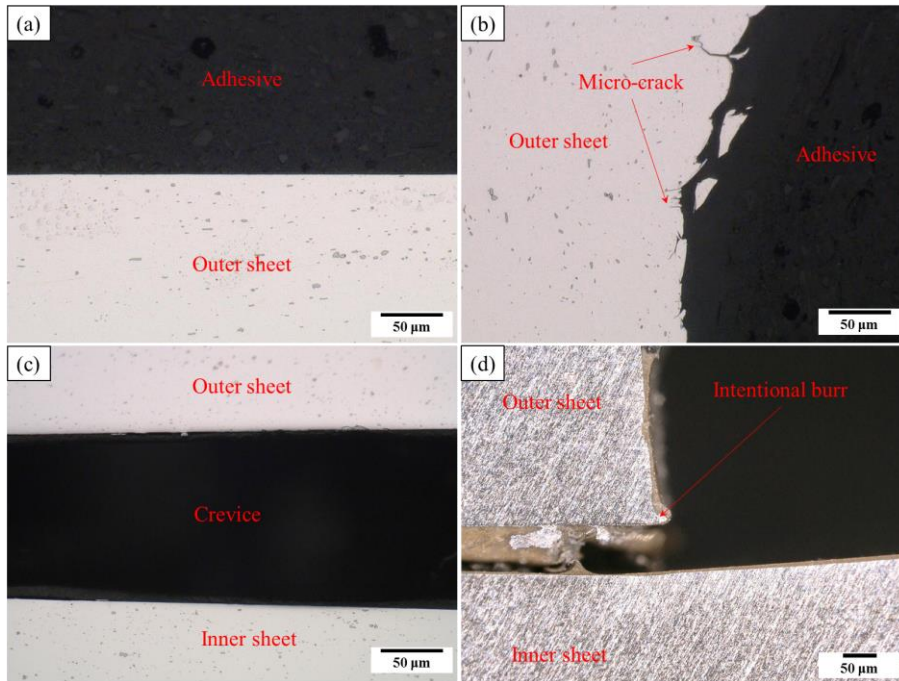
Figure 5.2: Cross-sectional LOM images of the four areas within a hem flange coupon: (a) area A, (b) area B, (c) area C, and (d) area D.

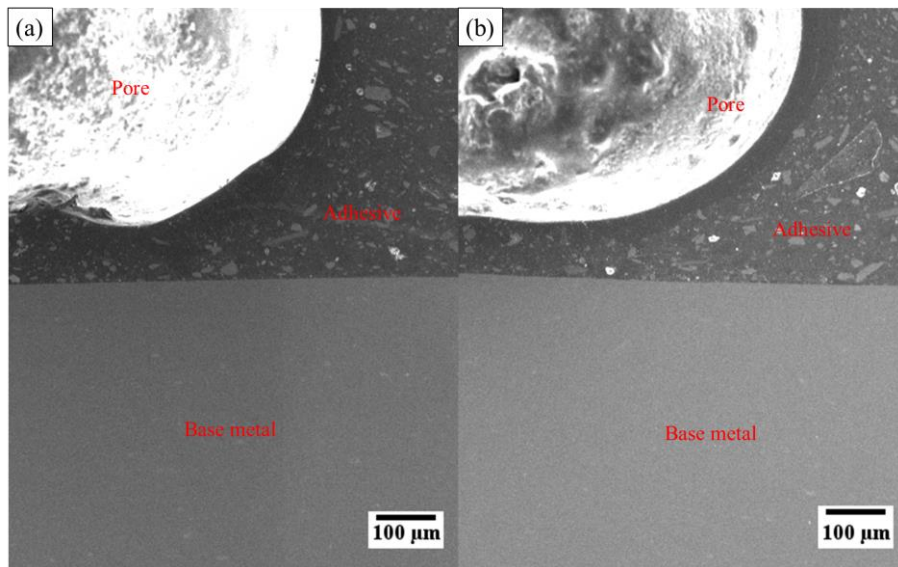
Figure 5.3: Cross-sectional secondary electron images of area A. (a) AA6022, (b) AA6111.

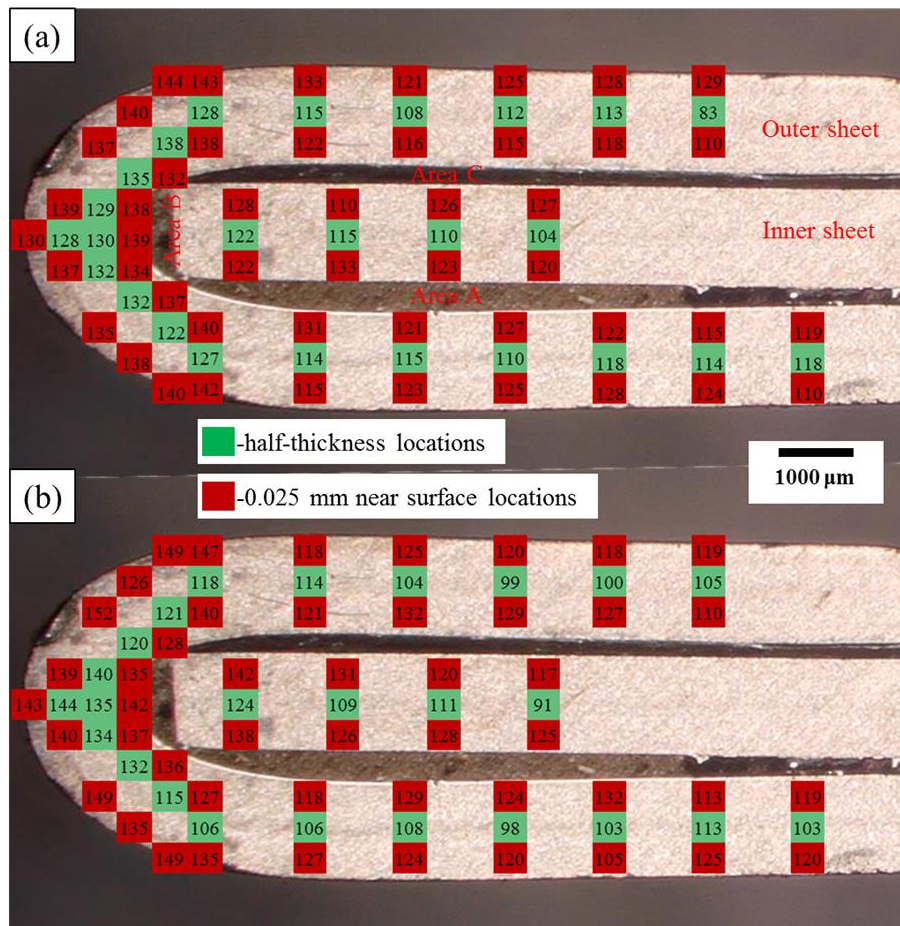
Figure 5.5: Vicker's hardness (HV) measurements of an (a) AA6022 and (b) AA6111 hem flange coupon.

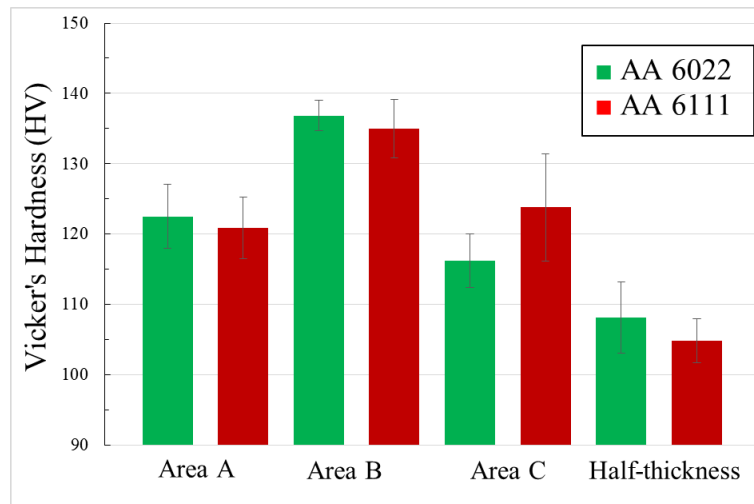
Figure 5.6: Average hardness of the inner surface of the outer sheet at area A, B, and C taken at the half-thickness locations. Errors bars represent the 95% CI.

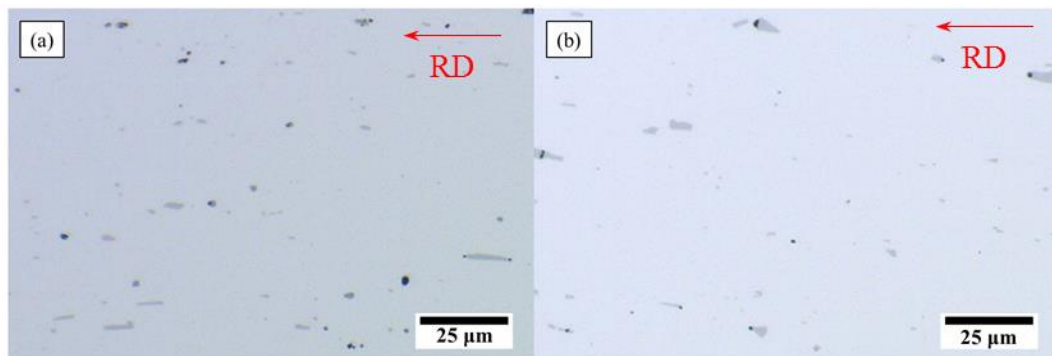
Figure 5.7: Plan-view LOM images of (a) AA6022, and (b) AA6111 revealing coarse intermetallic particles in the inner sheet of both alloys.

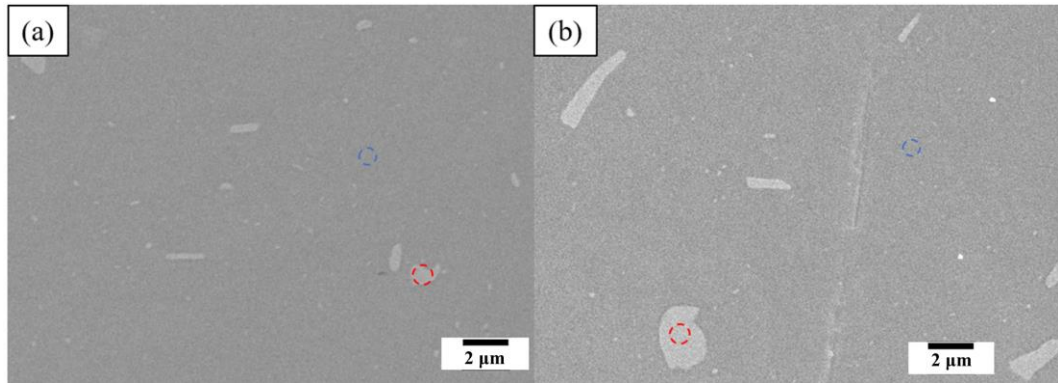
Figure 5.8: Plan-view secondary electron images of (a) AA6022, and (b) AA6111 inner sheet at 8 keV. Sites for EDS analysis are superimposed: red circles for intermetallic particles and blue circles for the Al matrix.

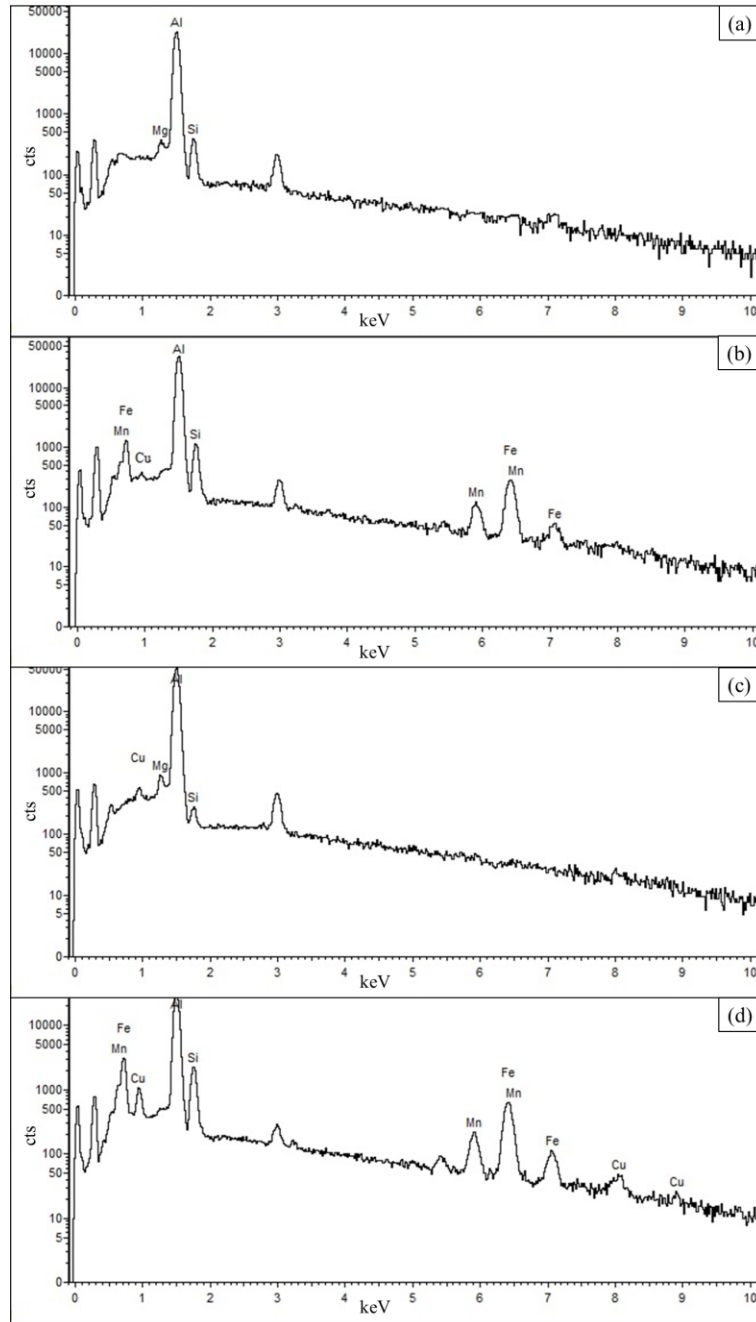
Figure 5.9: EDS spectra (counts vs. keV) of (a) AA6022 matrix and (b) AA6022 inter-metallic particle; (c) AA 6111 matrix and (b) AA6111 intermetallic particle.

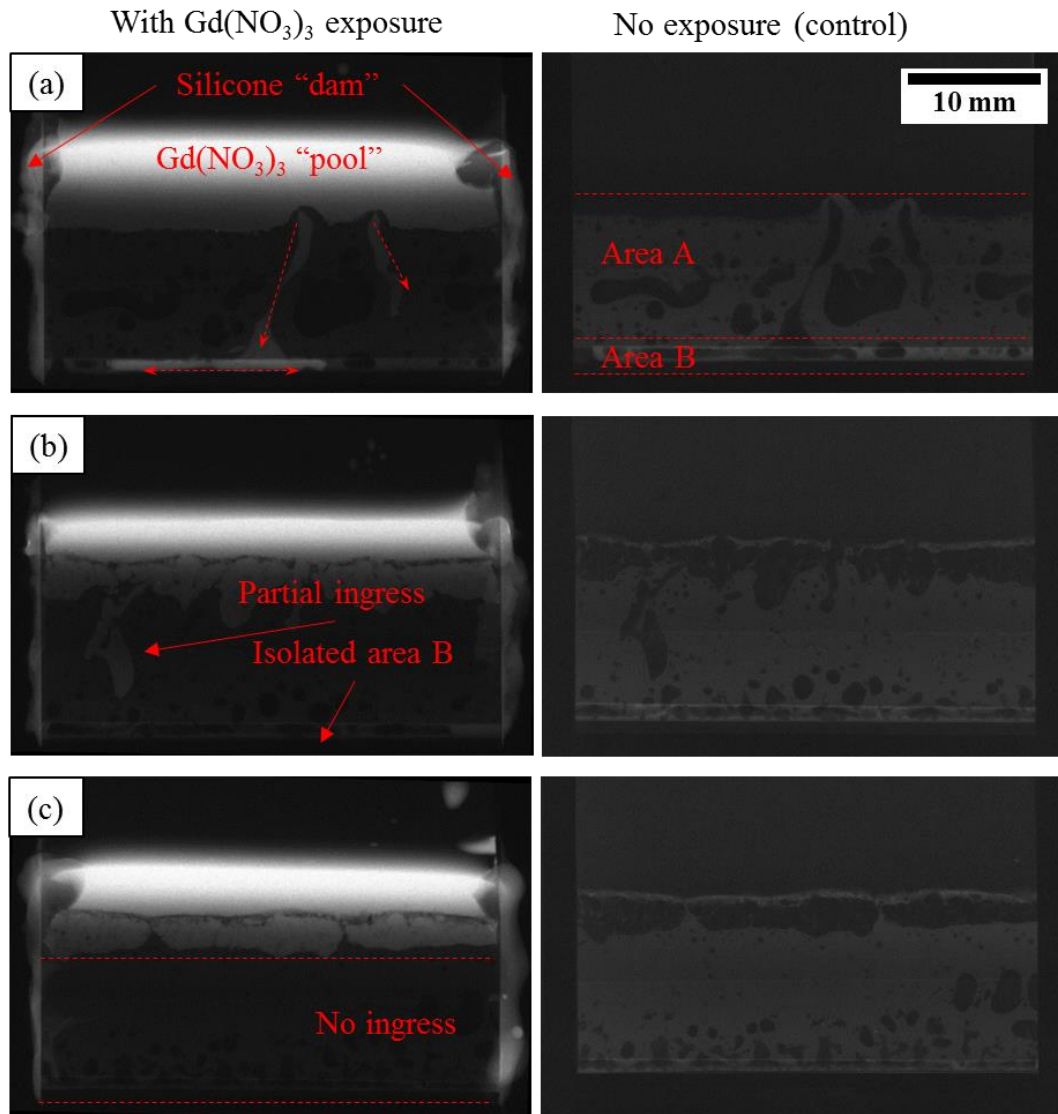
Figure 5.12: Neutron images of AA6022 hem flange coupons filled with $\text{Gd}(\text{NO}_3)_3$ solution showing various extents of solution ingress through an interconnected pore network: (a) both areas A and B showing solution ingress, (b) area A showing solution ingress and (c) neither areas A nor B showing ingress.

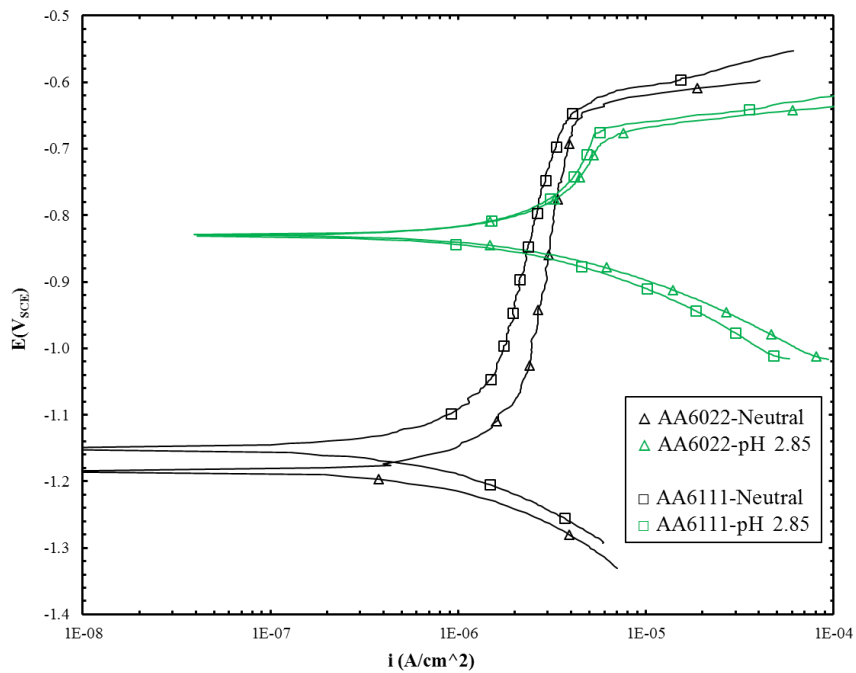
Figure 5.15: Typical potentiodynamic polarization curves for AA6022 and AA6111 in 0.1 M deaerated neutral and pH 2.85 NaCl solution.

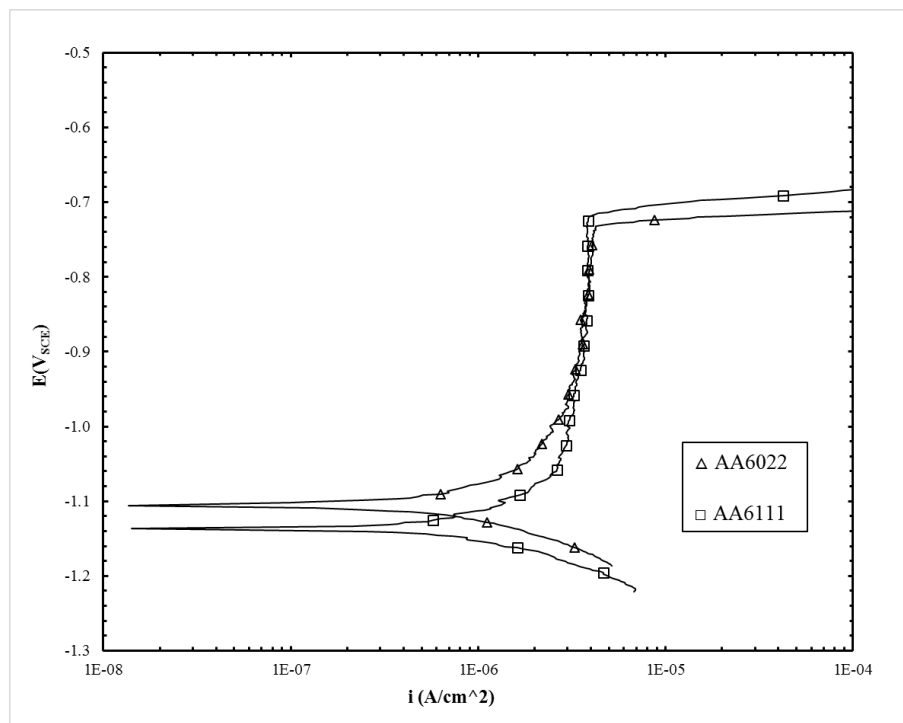
Figure 5.16: Typical potentiodynamic polarization curves for the tensile outer surface of AA6022 and AA6111 outer sheet in 0.1 M deaerated neutral NaCl solution.

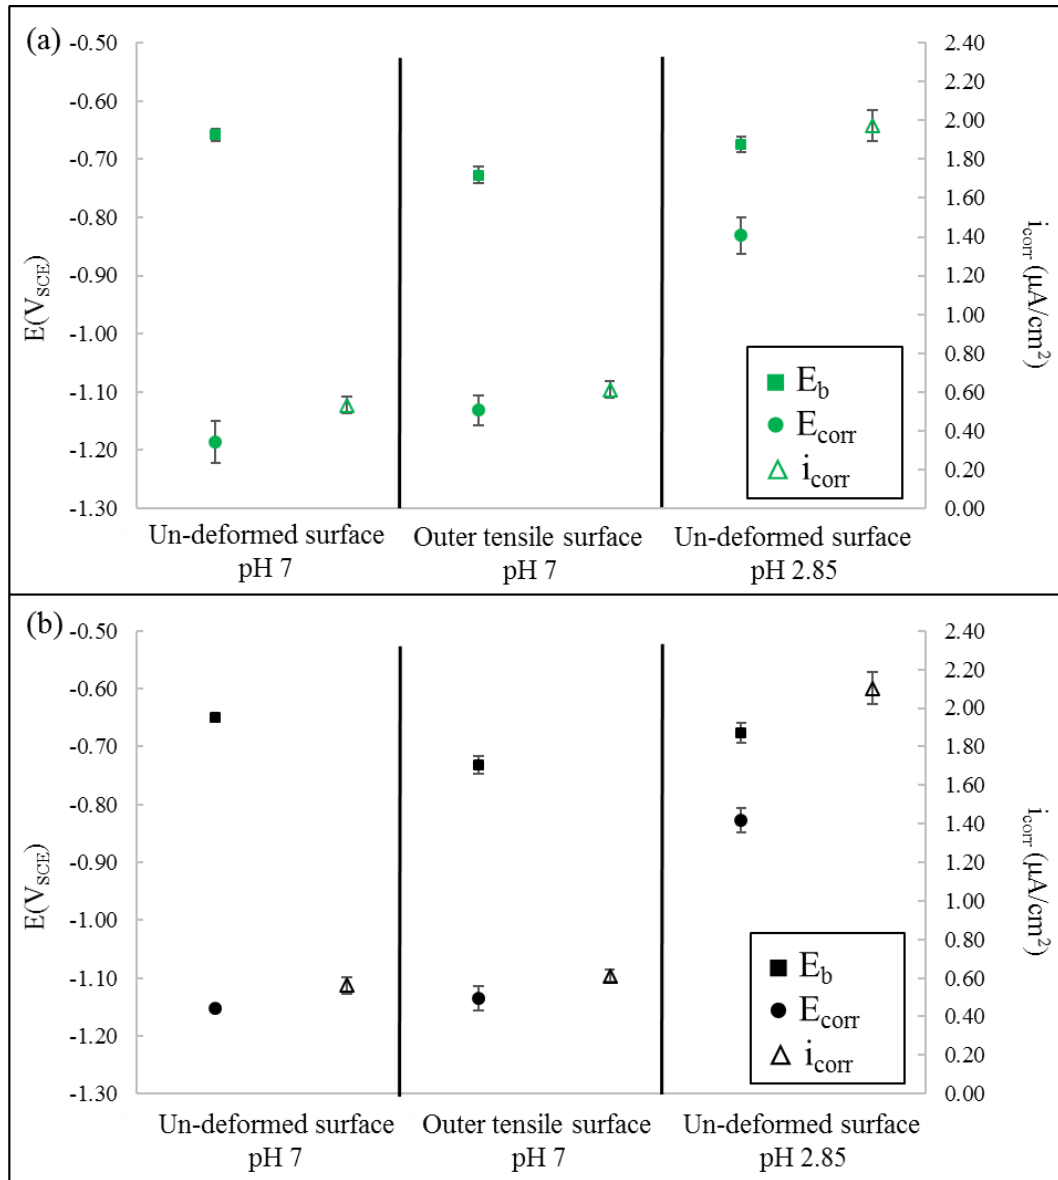
Figure 5.17: Statistics of breakdown potential (E_b), corrosion potential (E_{corr}), and average corrosion current density (i_{corr}) of (a) un-deformed surface (pH 7 and 2.85) and outer tensile surface of AA6022, and (b) un-deformed surface (pH 7 and 2.85) and outer tensile surface of AA6111 in 0.1 M NaCl solution.

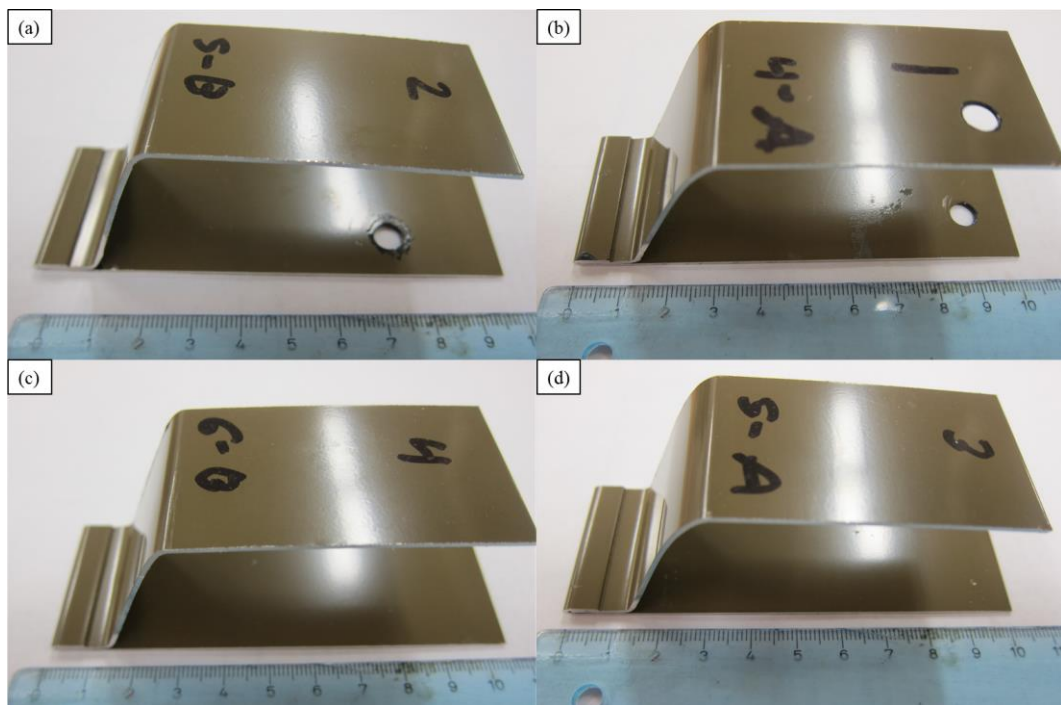
Figure 5.18: Photographs of hem flange coupons (a) AA6022 and (b) AA6111 after six-week Ford L-3190 cyclic corrosion exposure; (c) AA6022 and (d) AA6111 after twelve-week Ford L-3190 cyclic corrosion exposure.

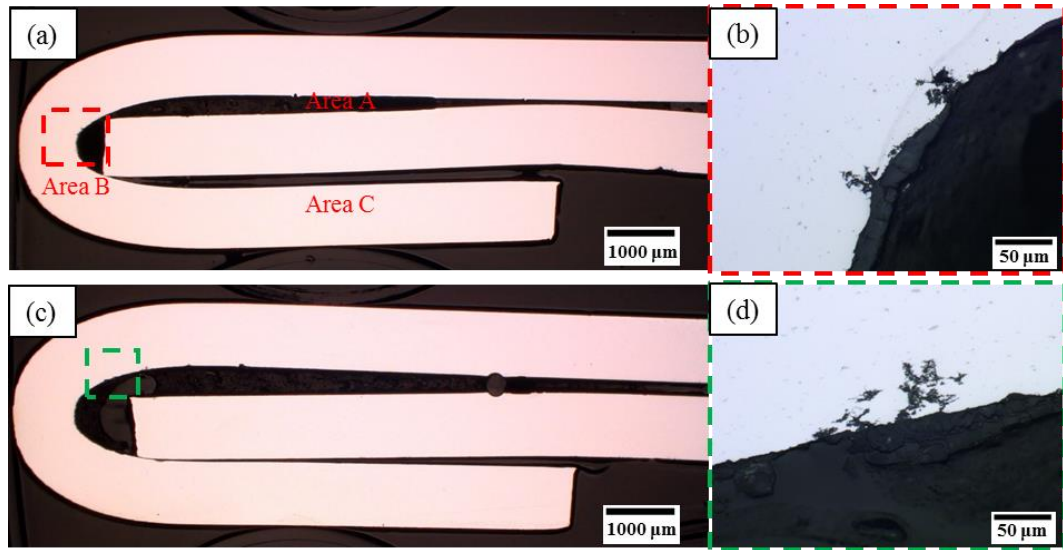
Figure 5.19: Cross-sectional LOM images of hem flange coupons after six weeks of Ford L-3190 exposure (a) AA6022 hem flange coupon, (b) higher magnification view of red frame; (c) AA6111 hem flange coupon and (d) higher magnification view of green frame.

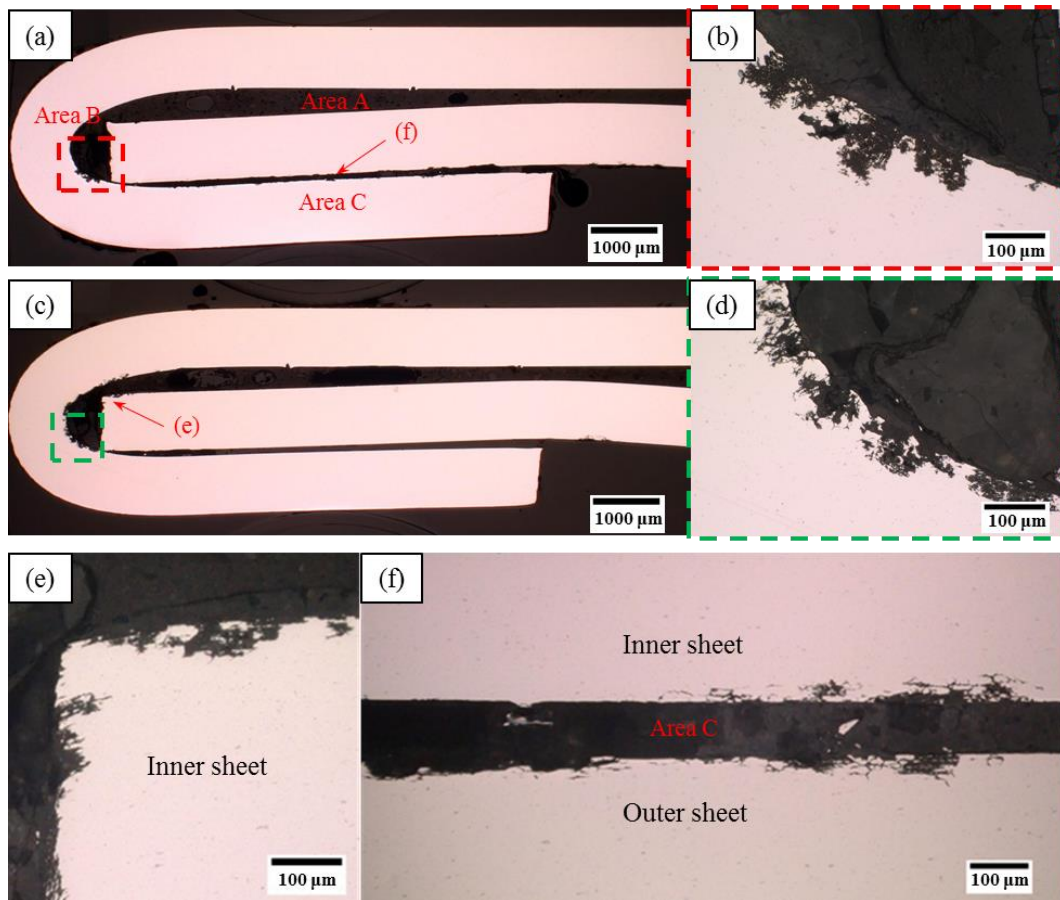
Figure 5.20: Cross-sectional LOM images of hem flange coupons after twelve weeks of Ford L-3190 exposure (a) AA6022 hem flange coupon, (b) higher magnification view of red frame; (c) AA6111 hem flange coupon, (d) higher magnification view of green frame; (e) higher magnification of AA6111 inner sheet adjacent to area B and (f) higher magnification of AA6111 inner sheet adjacent to area C.

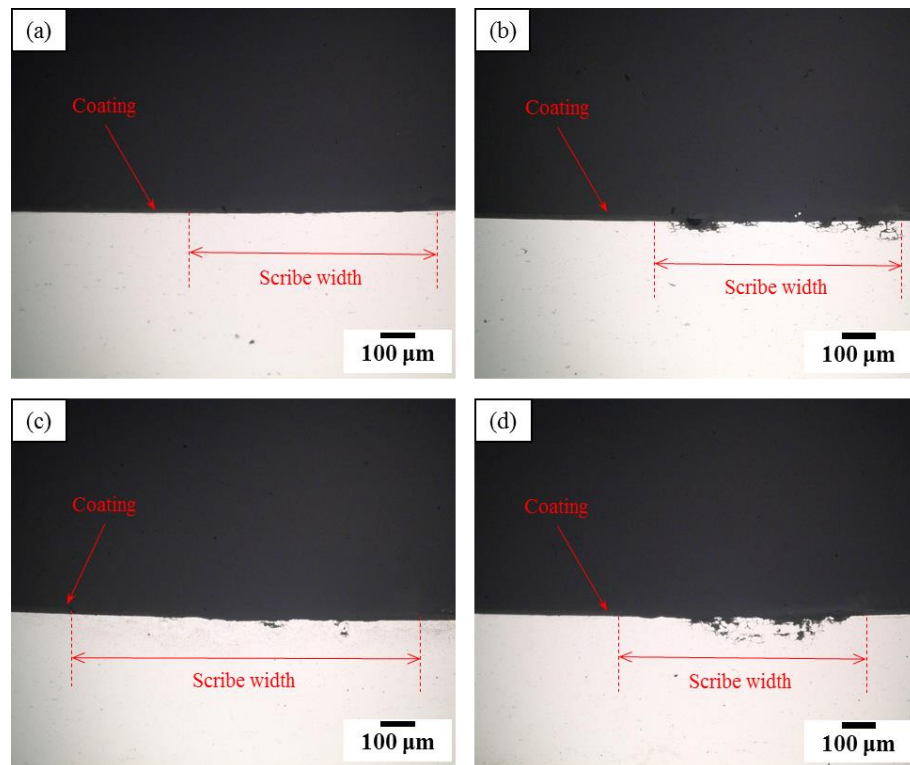
Figure 5.21: Cross-sectional LOM images of the scribe in area D. (a) AA6022 hem flange coupon after six-week exposure, and (b) after twelve-week exposure; (c) AA6111 hem flange coupon after six-week exposure, and (d) after twelve-week exposure.

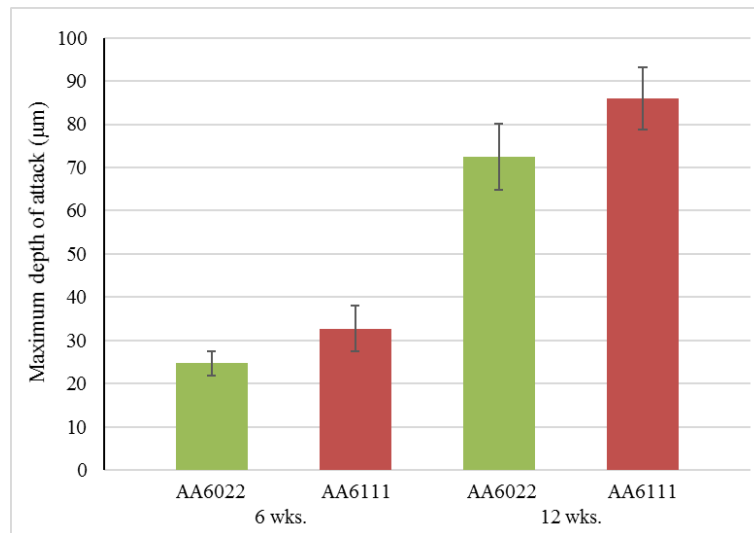
Figure 5.22: Maximum depth of attack in area B of AA6022 and AA6111 hem flange coupons after six and twelve weeks of Ford L-3190 exposure. Error bars represent 95% CI.

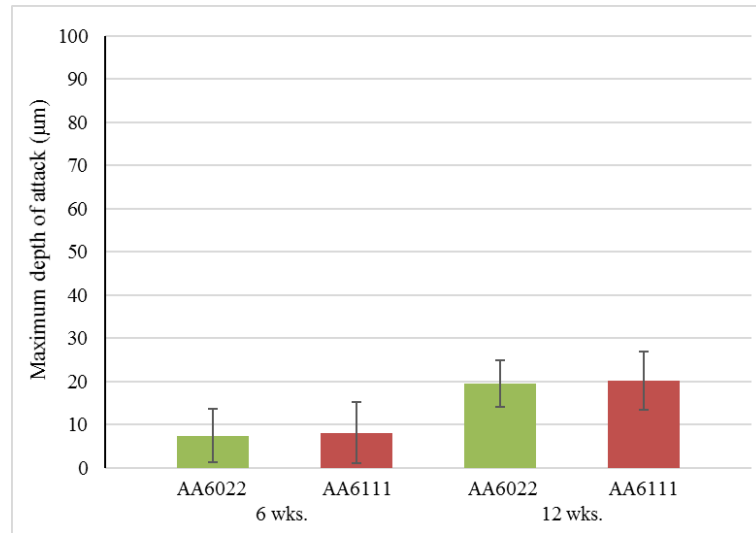
Figure 5.23: Maximum depth of attack in area D of AA6022 and AA6111 hem flange coupons after six and twelve weeks of Ford L-3190 exposure. Error bars represent 95% CI.

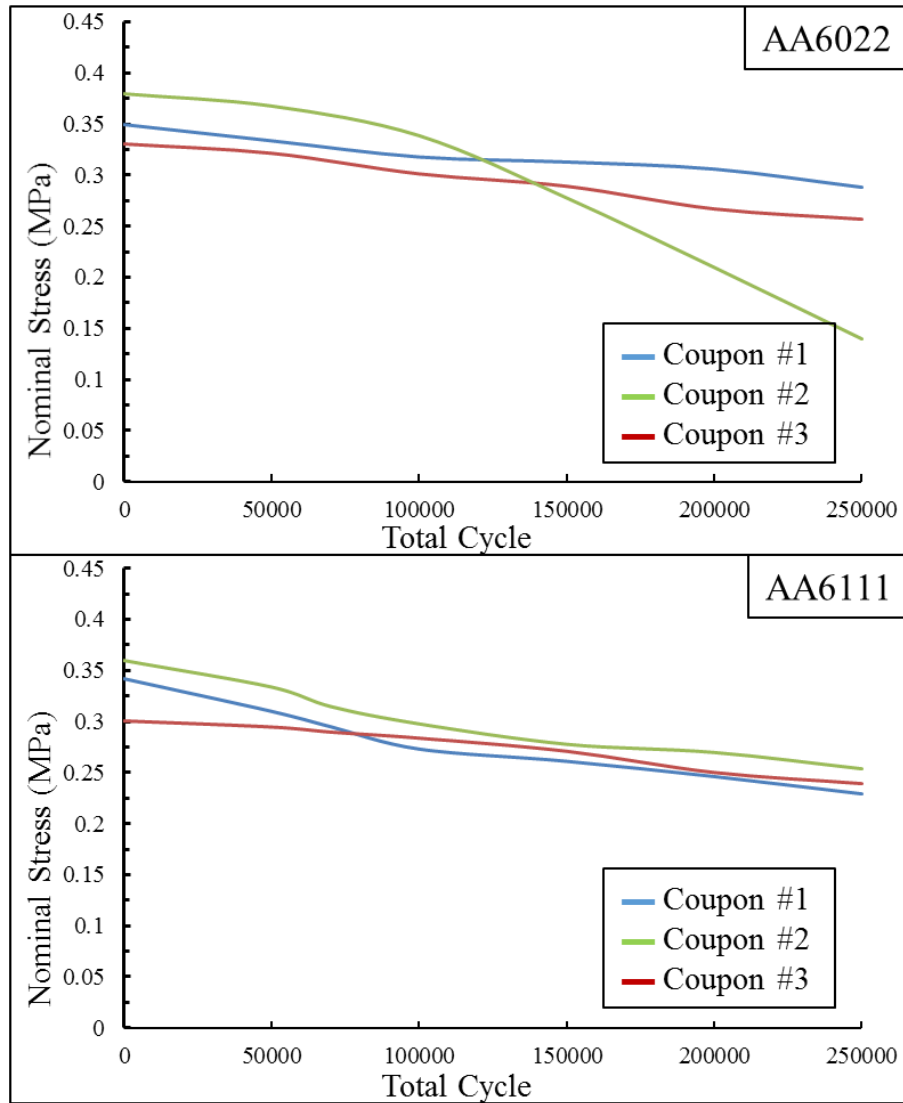
Figure 5.24: Applied nominal stress versus total cycle curves for a triplicate set of as-received AA6022 and AA6111 hem flange coupons.

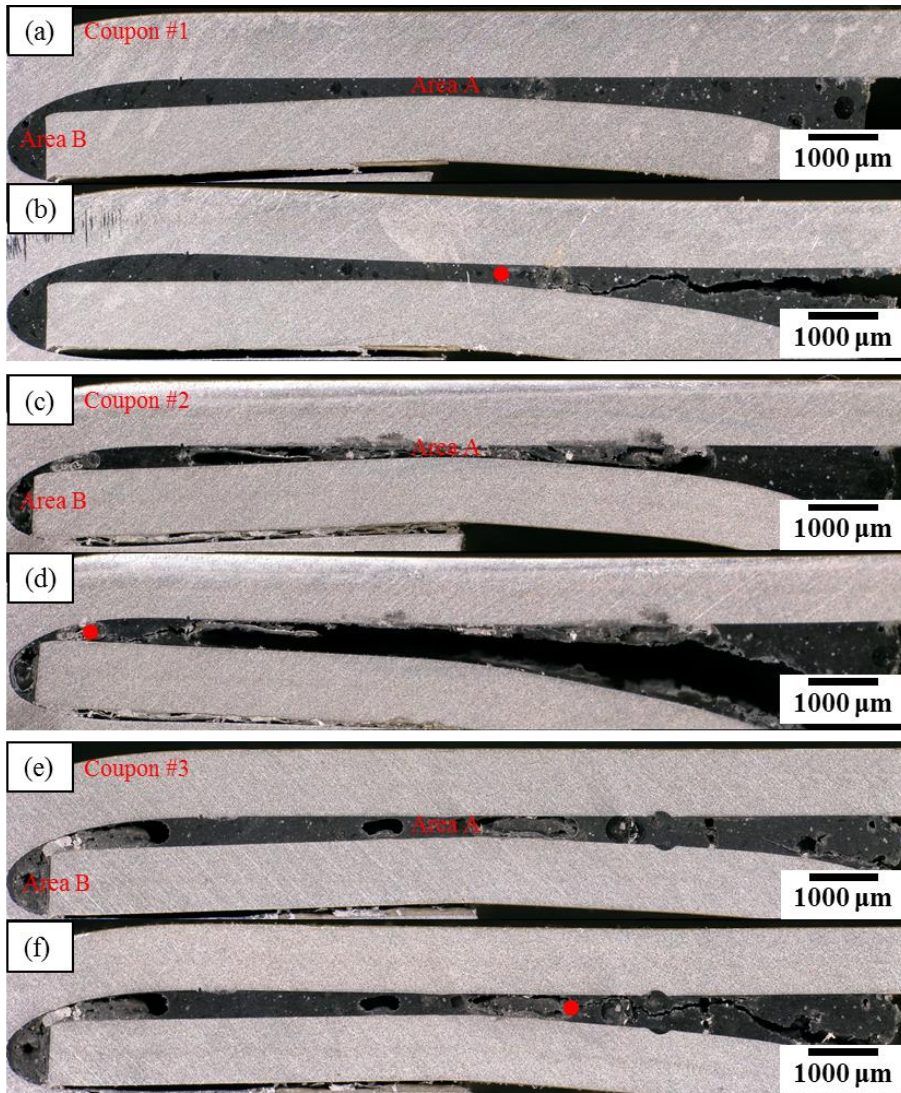
Figure 5.25: Side-view LOM images of the triplicate set of AA 6022 coupons subjected to cyclic deformation: coupon #1 after (a) 0 cycles and (b) 250,000 cycles; coupon #2 at (c) 0 cycles and (d) 250,000 cycles; coupon #3 at (e) 0 cycles and (f) 250,000 cycles. Crack tips are marked by red dots (●).
