Effect of Cyclic Deformation on the Corrosion of Coated AA6xxx
Hem Flanges

Effect of Cyclic Deformation on the Corrosion of Coated AA6xxx

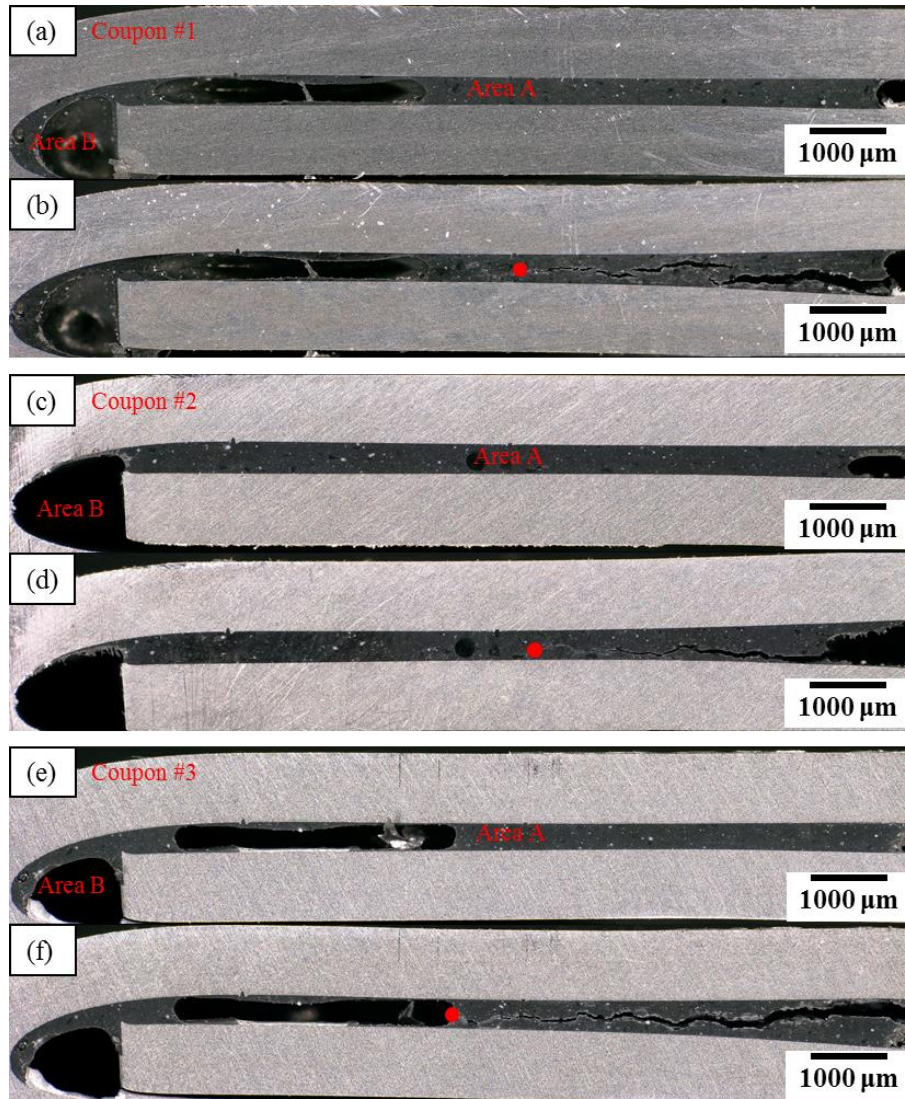
Figure 5.26: Side-view LOM images of the triplicate set of AA6111 coupons subjected to cyclic deformation: coupon #1 after (a) 0 cycles and (b) 250,000 cycles; coupon #2 at (c) 0 cycles and (d) 250,000 cycles; coupon #3 at (e) 0 cycles and (f) 250,000 cycles. Crack tips are marked by red dots (●).

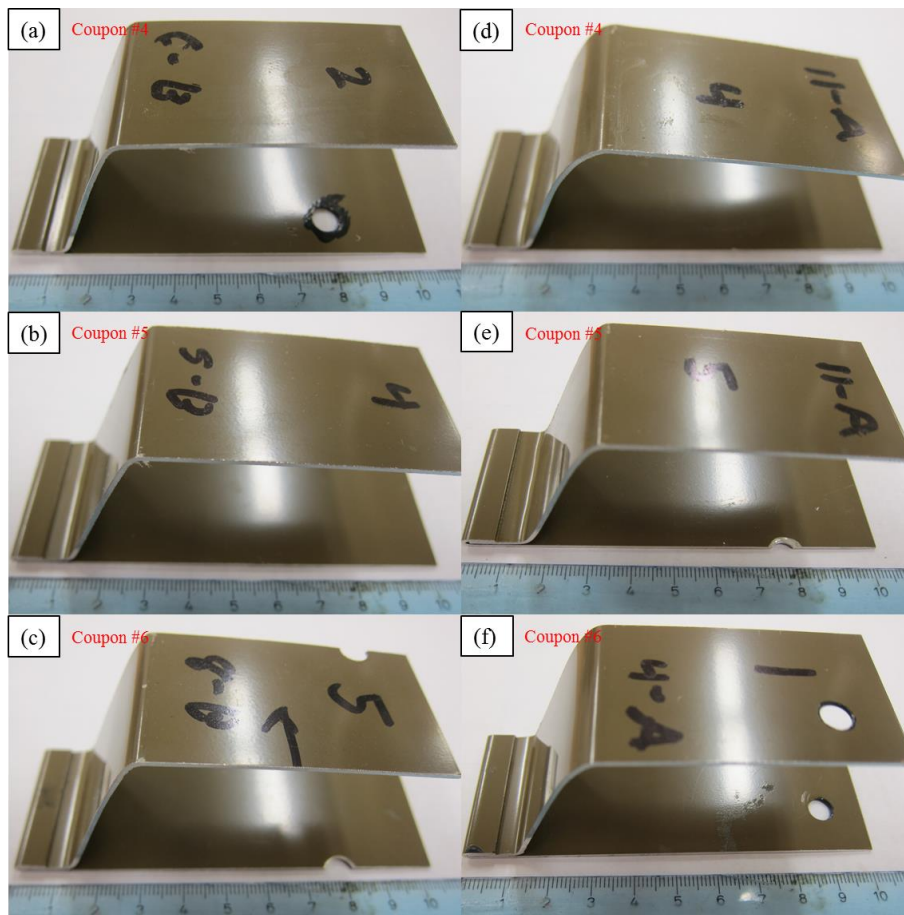
Figure 5.27: Photographs of previously corroded (Ford L-3190 for six weeks) hem flange coupons (#4-6) of (a)-(c) AA6022 and (d)-(f) AA6111.

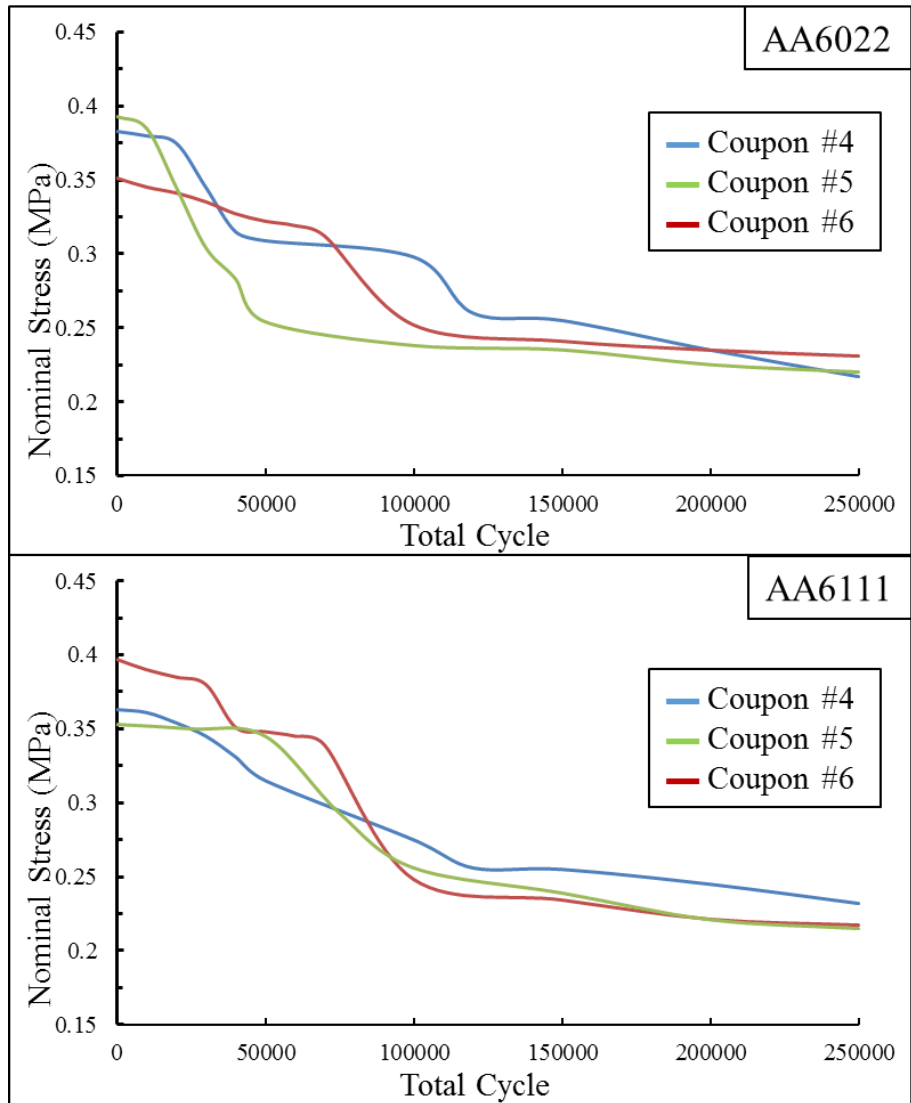
Figure 5.28: Applied nominal stress versus total cycle curves for set of triplicate set of AA6022 and AA6111 hem flange coupons that were previously corroded (Ford L-3190 for six weeks)

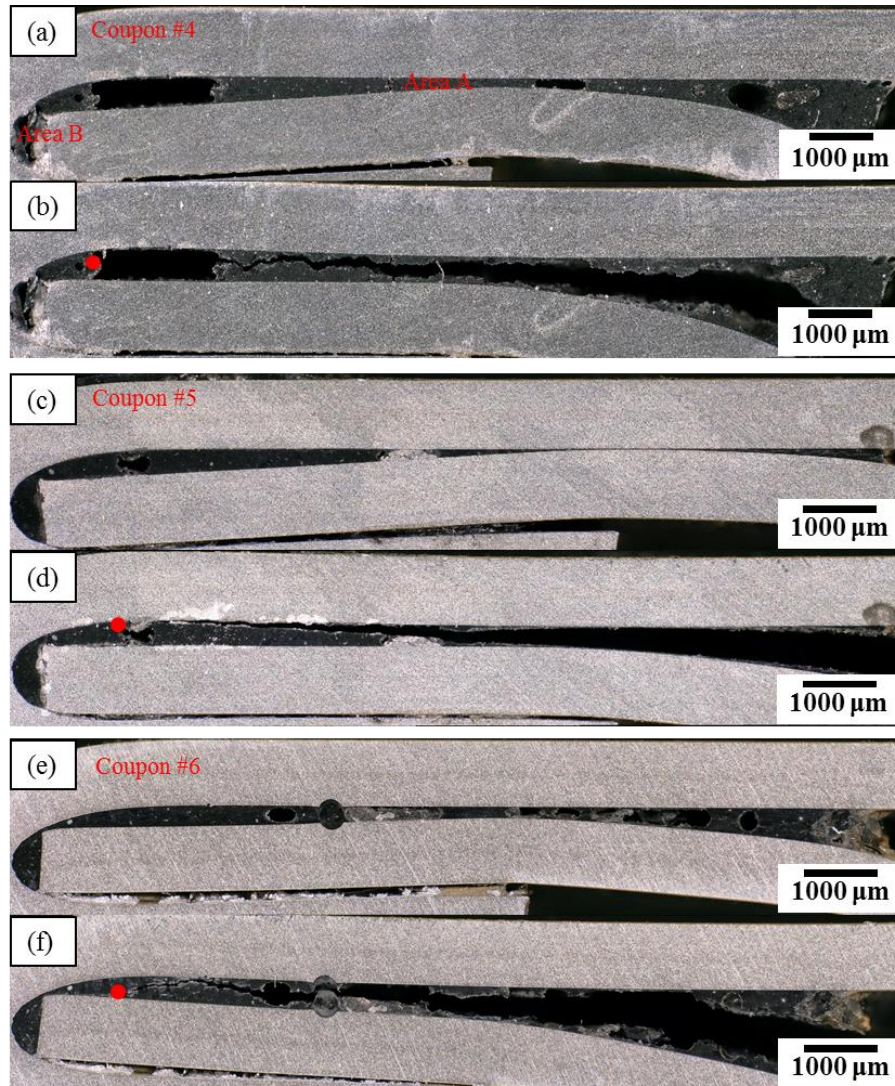
Figure 5.29: Side-view LOM images of the triplicate set of AA6022 coupons that were previously corroded (FORD L-3190 for six weeks): coupon #4 after (a) 0 cycles and (b) 100,000 cycles; coupon #5 after (c) 0 cycles and (d) 100,000 cycles; coupon #6 after (e) 0 cycles and (f) 100,000 cycles. Crack tips are marked by red dots (●).

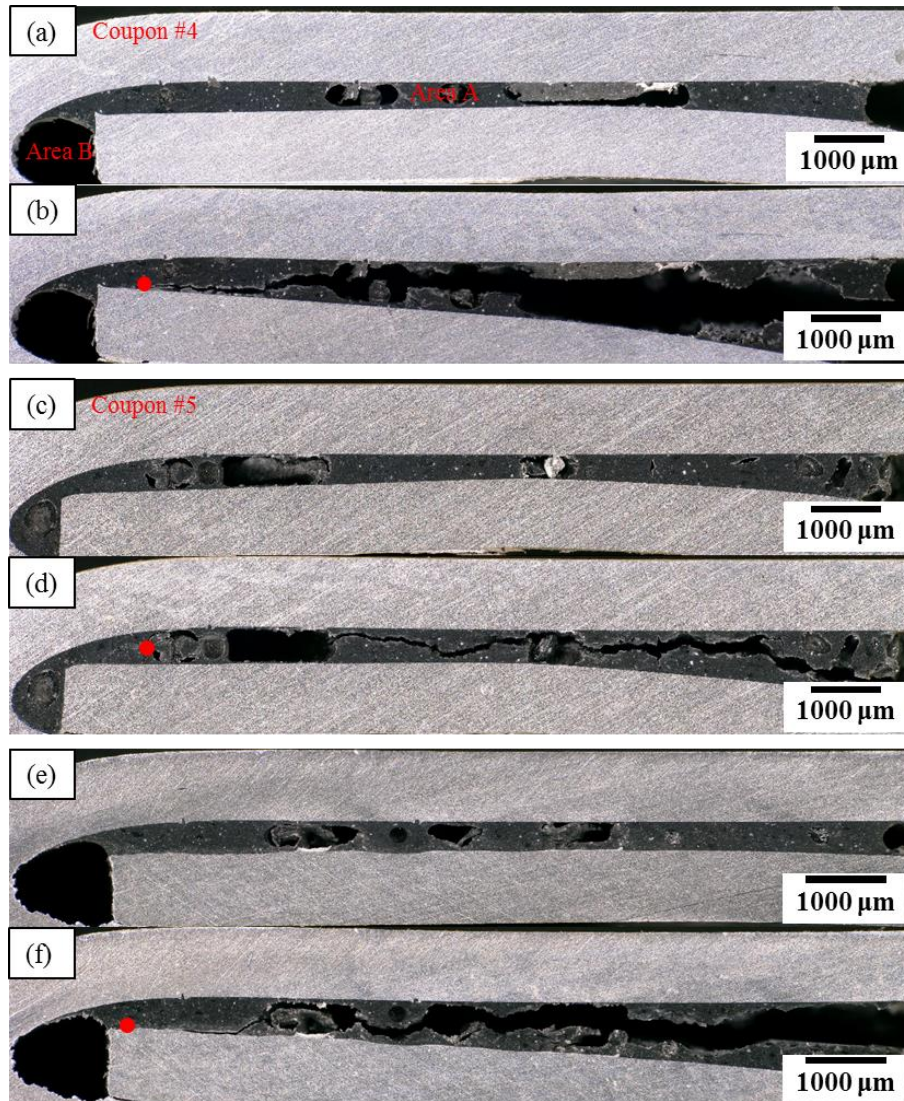
Figure 5.30: Side-view LOM images of the triplicate set of AA6111 coupons that were previously corroded (FORD L-3190 for 6 weeks): coupon #4 after (a) 0 cycles and (b) 100,000 cycles; coupon #5 after (c) 0 cycles and (d) 100,000 cycles; coupon #6 after (e) 0 cycles and (f) 100,000 cycles. The crack tips are marked by red dots (●).

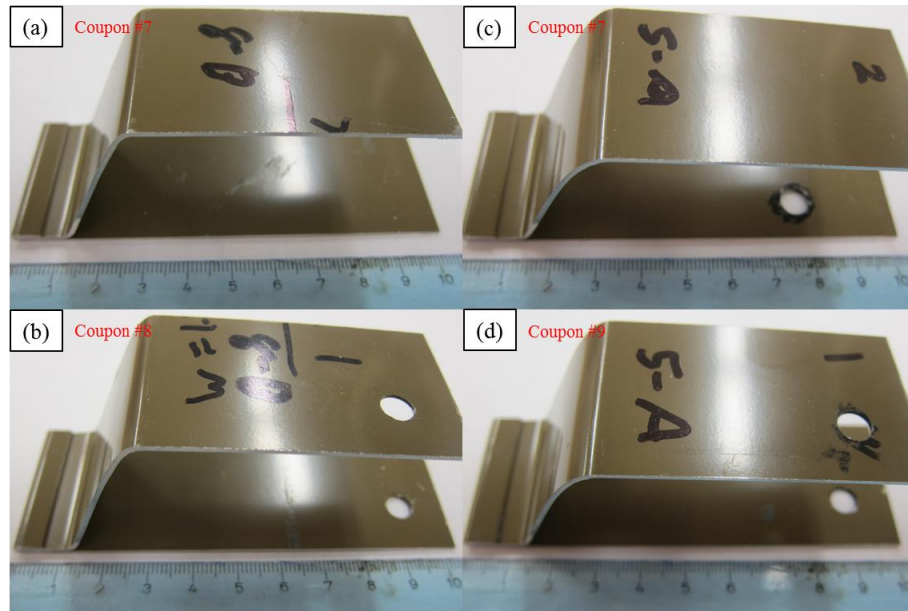
Figure 5.31: Photographs of previously corroded (Ford L-3190 for twelve weeks) hem flange coupons (#7 and #8) of (a), (c) AA6022 and (c), (d) AA6111.

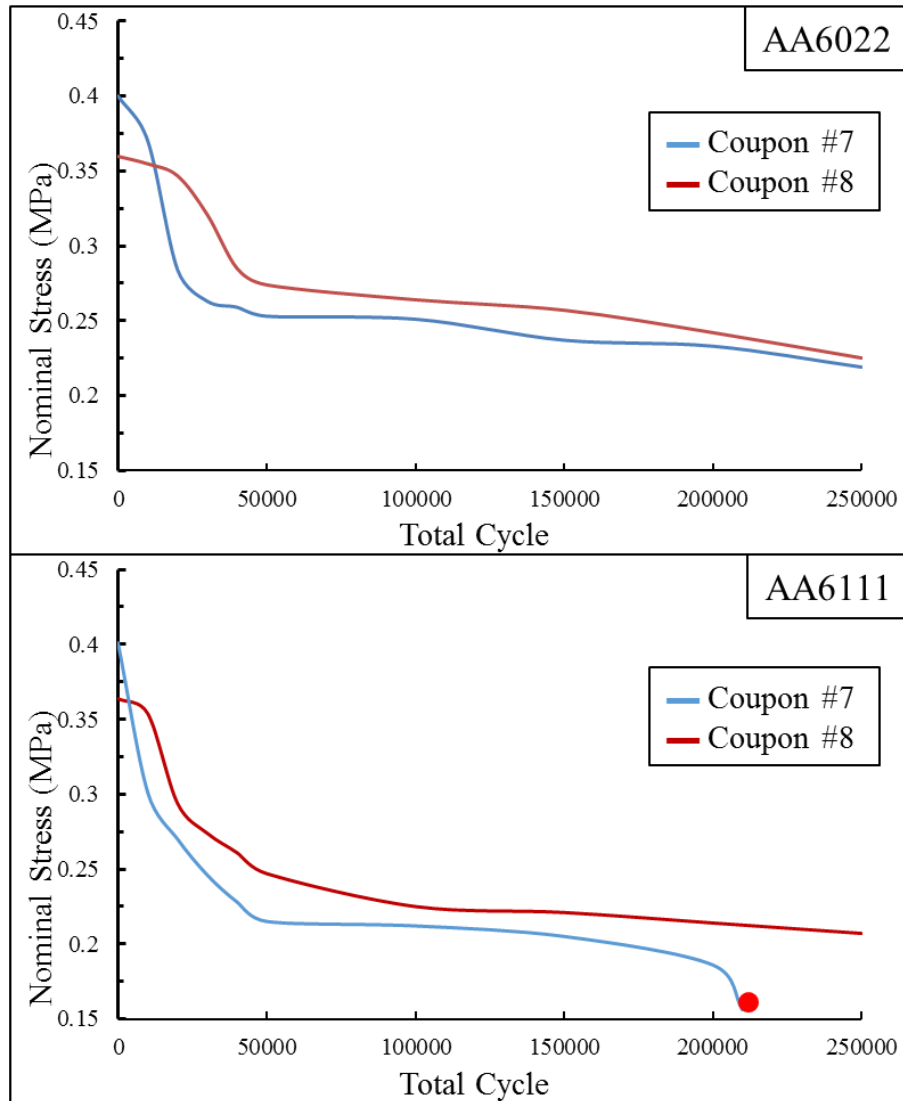
Figure 5.32: Applied nominal stress versus total cycle curves a duplicate set of AA6022 and AA6111 hem flange coupons that were previously corroded (Ford L-3190 for 12 weeks). The red dot indicates the point of fracture.

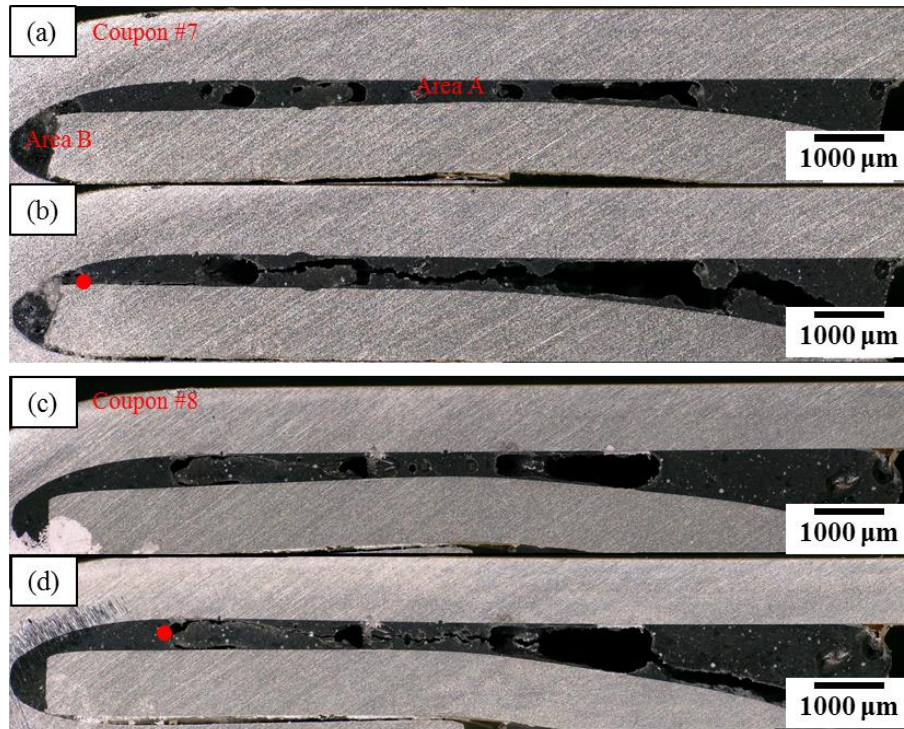
Figure 5.33: Side-view LOM images of the duplicate set of AA6022 coupons that were previously corroded (FORD L-3190 for 12 weeks): coupon #7 after (a) 0 cycles and (b) 100,000 cycles; coupon #8 after (c) 0 cycles and (d) 100,000 cycles. The crack tips are marked by red dots (●).

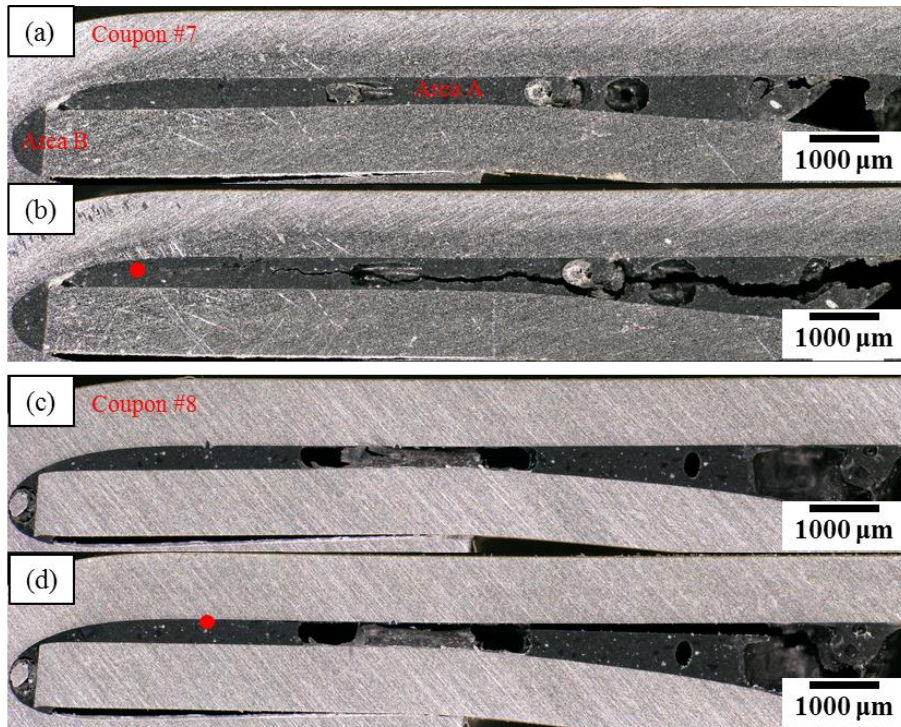
Figure 5.34: Side-view LOM images of the duplicate set of AA6111 coupons that were previously corroded (FORD L-3190 for 12 weeks): coupon #7 after (a) 0 cycles and (b) 100,000 cycles; coupon #8 at (c) 0 cycles and (d) 100,000 cycles. The crack tips are marked by red dots (●).

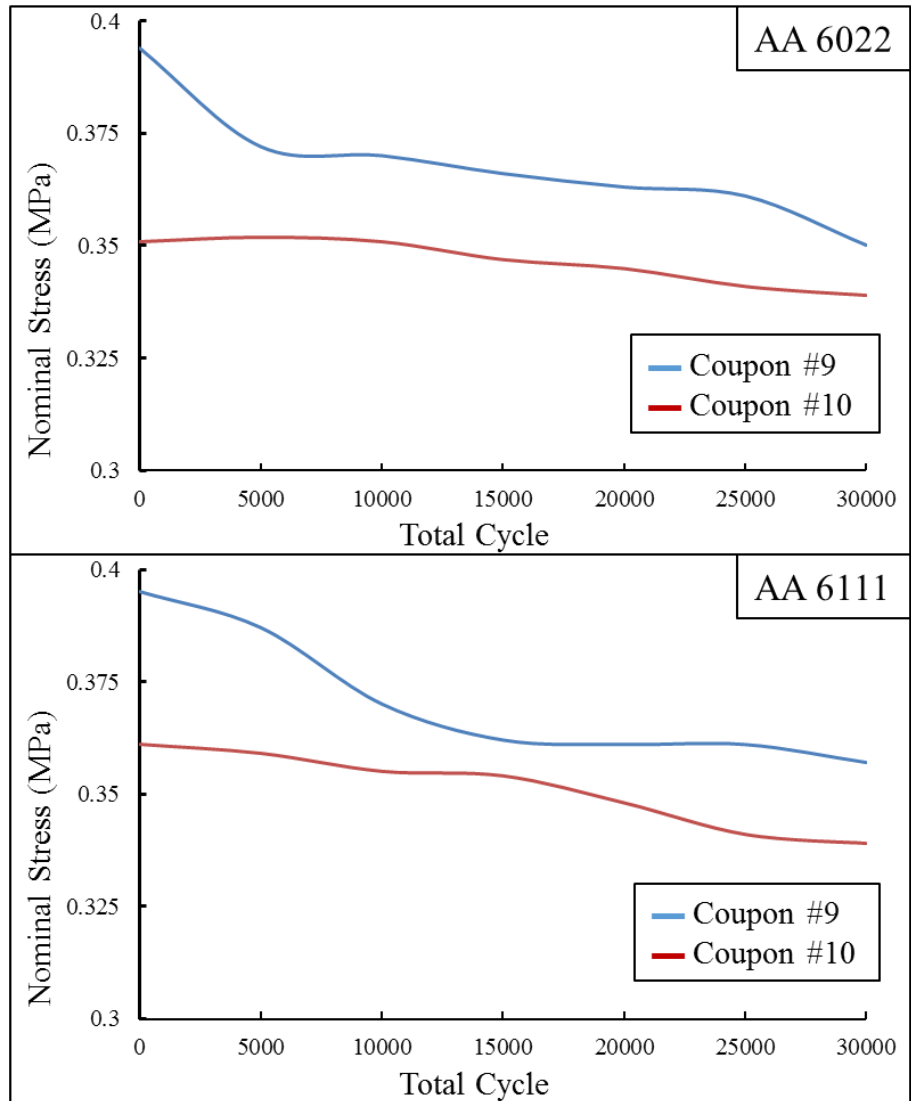
Figure 5.35: Applied nominal stress versus total cycle curves of 30,000 cycles for a duplicate set of as-received AA6022 and AA6111 hem flange coupons.

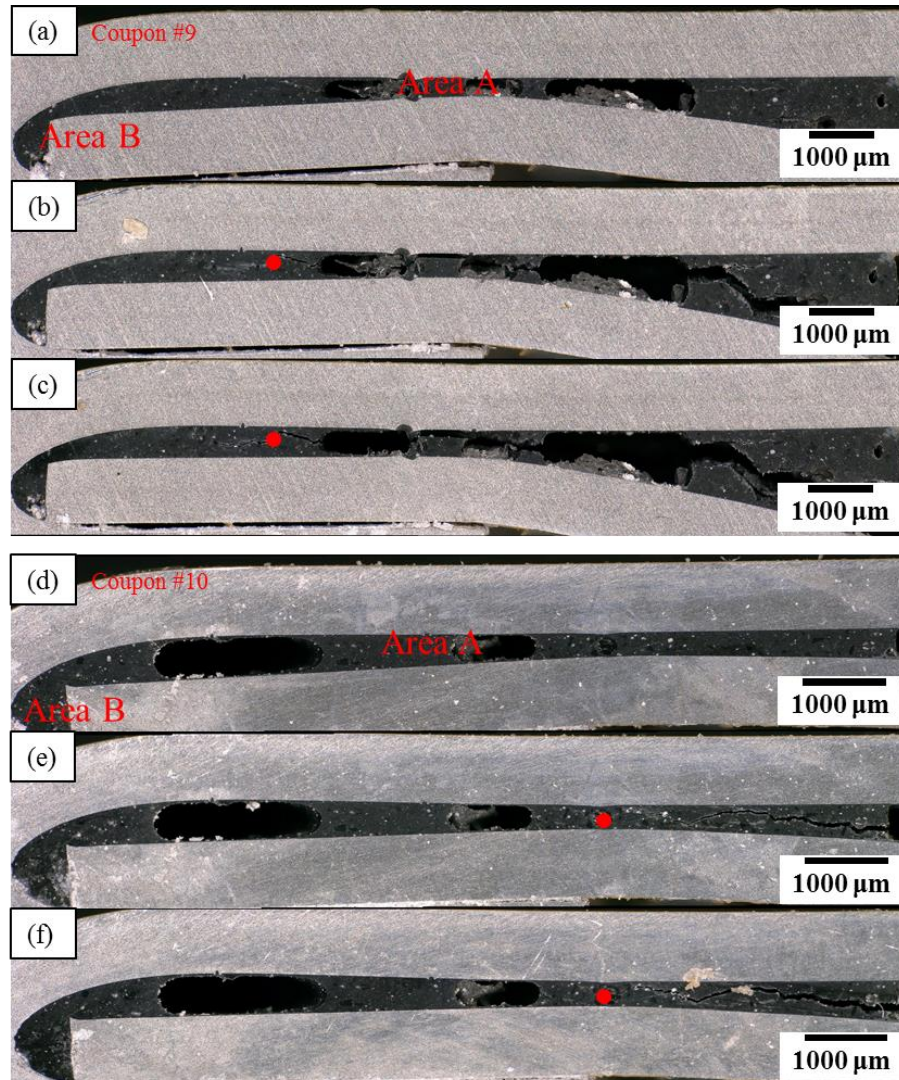
Figure 5.36: Side-view LOM images of the duplicate set of AA6022 coupons: coupon #9 after (a) 0 cycles without cyclic corrosion exposure, (b) 30,000 cycles without cyclic corrosion exposure and (c) 30,000 cycles with subsequent cyclic corrosion exposure (Ford L-3190 for six weeks); coupon #10 after (d) 0 cycles without cyclic corrosion exposure, (e) 30,000 cycles without cyclic corrosion exposure and (f) 30,000 cycles with subsequent cyclic corrosion exposure (Ford L-3190 for 6 weeks). The crack tips are marked by red dots (●).

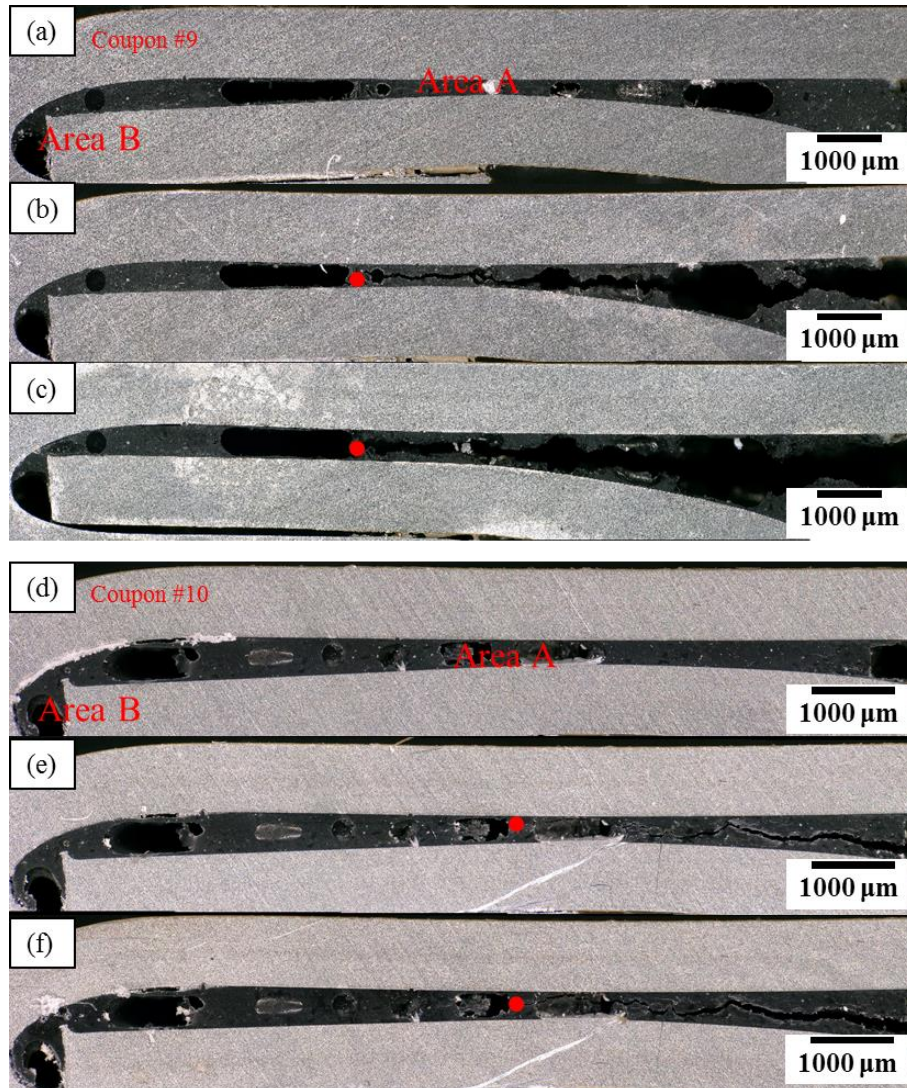
Figure 5.37: Side-view LOM images of the duplicate set of AA6111 coupons: coupon #9 after (a) 0 cycles without cyclic corrosion exposure, (b) 30,000 cycles without cyclic corrosion exposure and (c) 30,000 cycles with subsequent cyclic corrosion exposure (Ford L-3190 for 6 weeks); coupon #10 after (d) 0 cycles without cyclic corrosion exposure, (e) 30,000 cycles without cyclic corrosion exposure and (f) 30,000 cycles with subsequent cyclic corrosion exposure (Ford L-3190 for 6 weeks). The crack tips are marked by red dots (●).

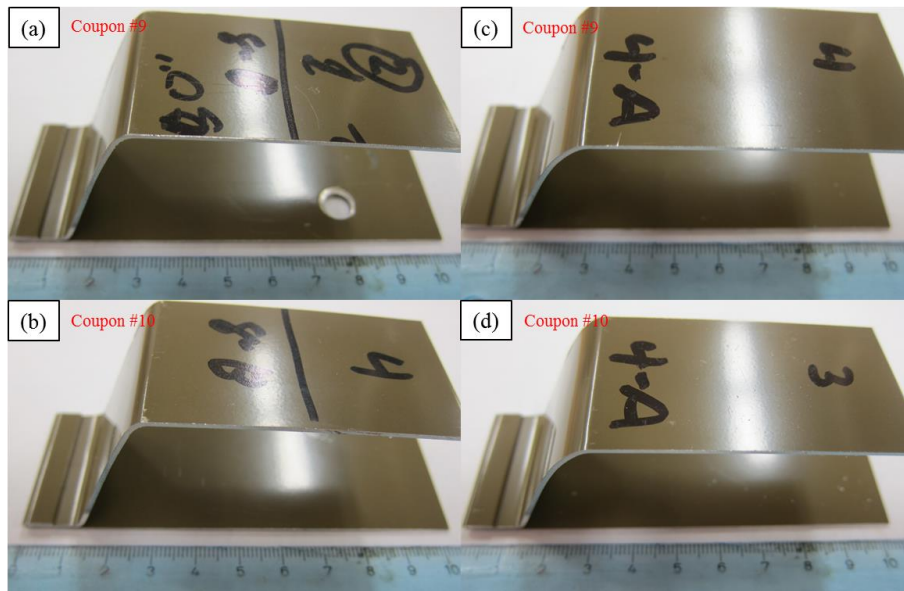
Figure 5.38: Photographs of as-received hem flange coupons (#9 and #10) of (a), (b) AA6022 and (c), (d) AA6111 after six weeks of Ford L-3190 exposure.

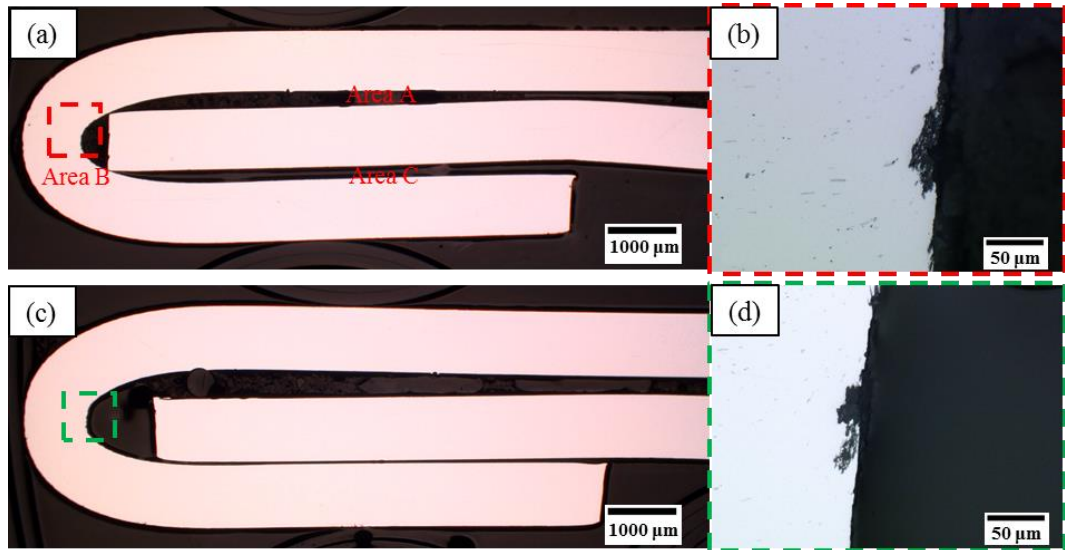
Figure 5.39: Cross-sectional LOM images of coupons after 30,000 cycles of deformation then 6 weeks of Ford L-3190 exposure: (a) AA6022 coupon #9 (b) higher magnification view of red frame, (c) AA6111 coupon #10 and (d) higher magnification view of green frame.

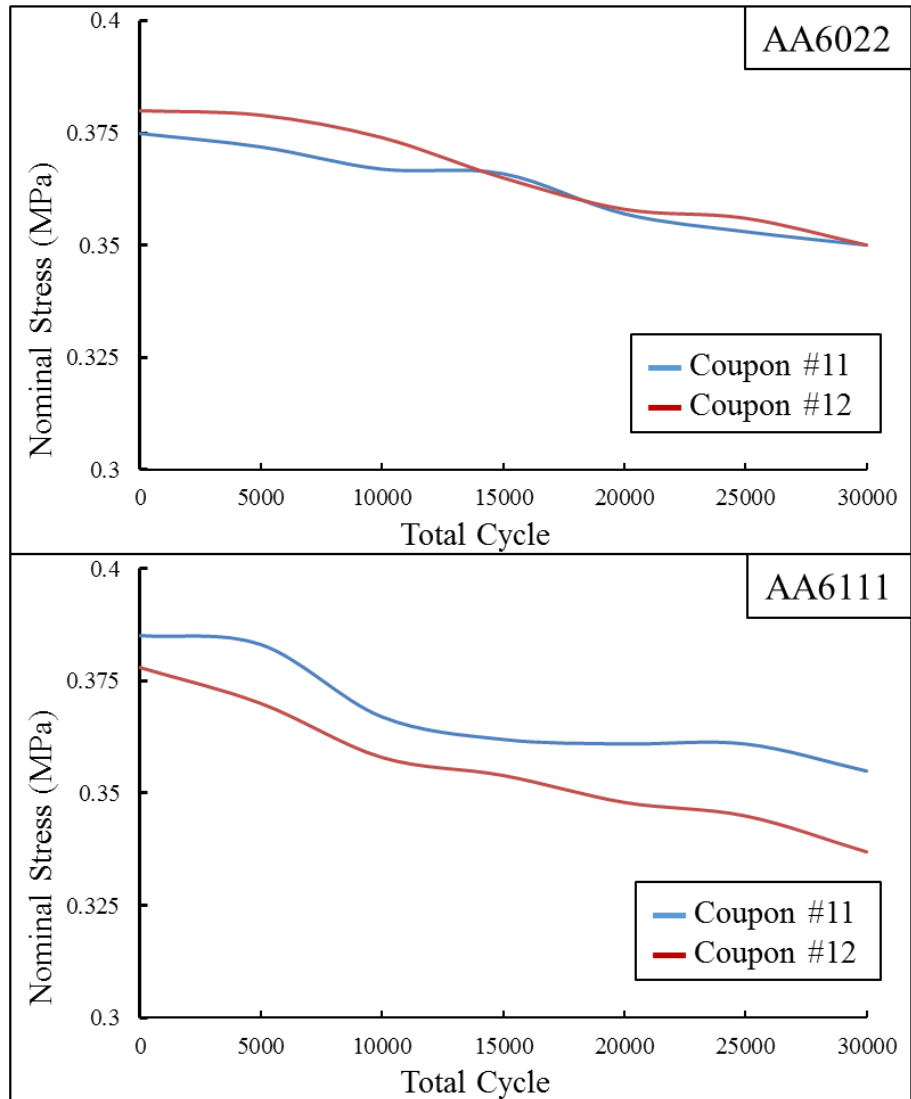
Figure 5.40: Applied nominal stress versus total cycle curves associated with the pre-cracking of a duplicate set of as-received AA6022 and AA6111 hem flange coupons.

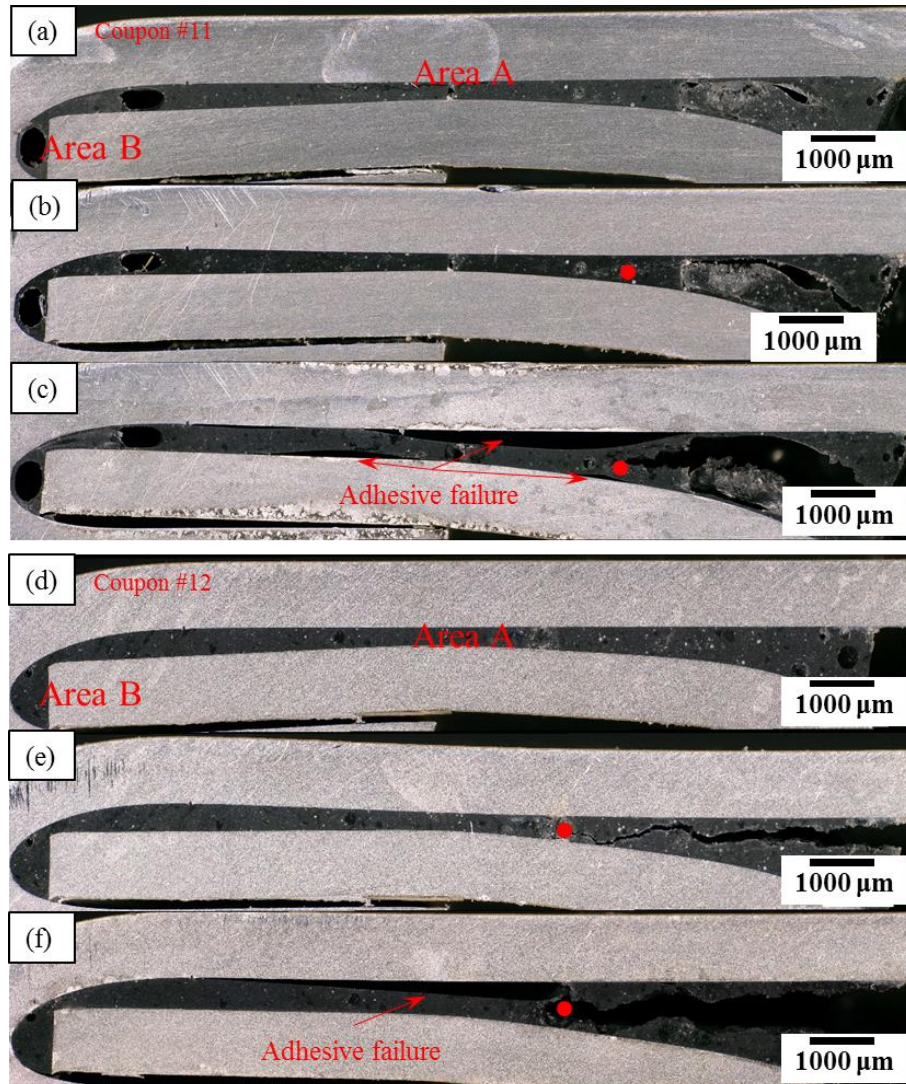
Figure 5.41: Side-view LOM images of the duplicate set of AA6022 coupons: coupon #11 after (a) 0 cycles without cyclic corrosion exposure, (b) 30,000 cycles without cyclic corrosion exposure and (c) 30,000 cycles with subsequent corrosion exposure (Ford L-3190 for 6 weeks) with static stress superimposed; coupon #12 after (d) 0 cycles without cyclic corrosion exposure, (e) 30,000 cycles without cyclic corrosion exposure and (f) 30,000 cycles with subsequent corrosion exposure (Ford L-3190 for 6 weeks) . The crack tips are marked by red dots (●).

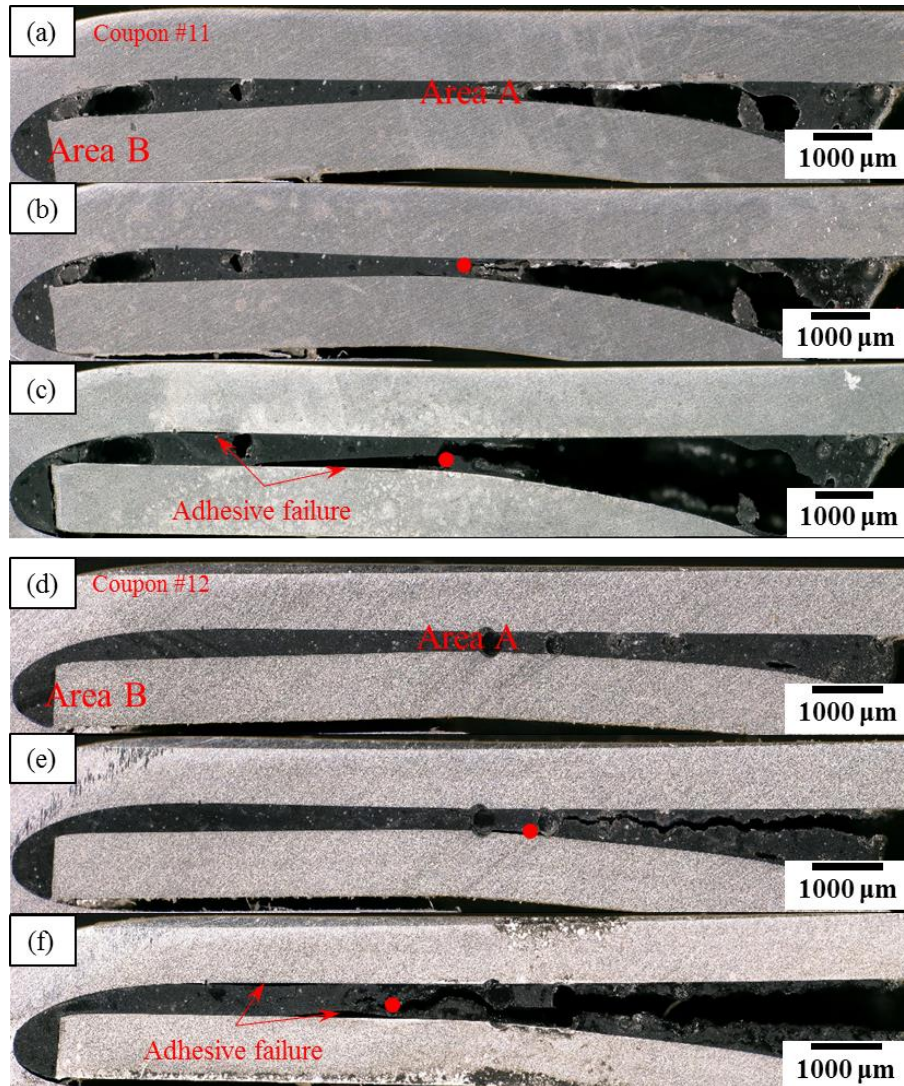
Figure 5.42: Side-view LOM images of the duplicate set of AA6111 coupons: coupon #11 after (a) 0 cycles without cyclic corrosion exposure, (b) 30,000 cycles without cyclic corrosion exposure and (c) 30,000 cycles with subsequent corrosion exposure (Ford L-3190 for 6 weeks) with static stress superimposed; coupon #12 after (d) 0 cycles without cyclic corrosion exposure, (e) 30,000 cycles without cyclic corrosion exposure and (f) 30,000 cycles with subsequent corrosion exposure (Ford L-3190 for 6 weeks) . The crack tips are marked by red dots (●).

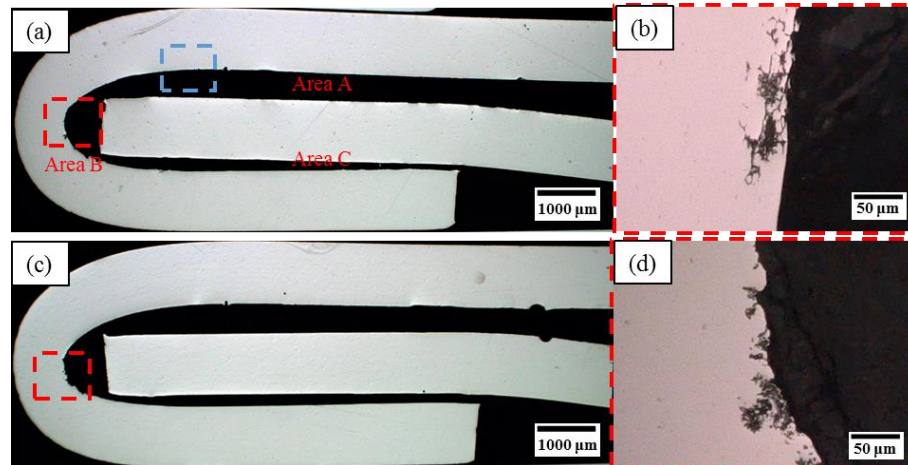
Figure 5.43: Cross-sectional LOM images of coupons after 30,000 cycles of deformation then 6 weeks of Ford L-3190 exposure with static stress superimposed: (a) AA6022 coupon #12 (b) higher magnification view of red frame, (c) AA6111 coupon

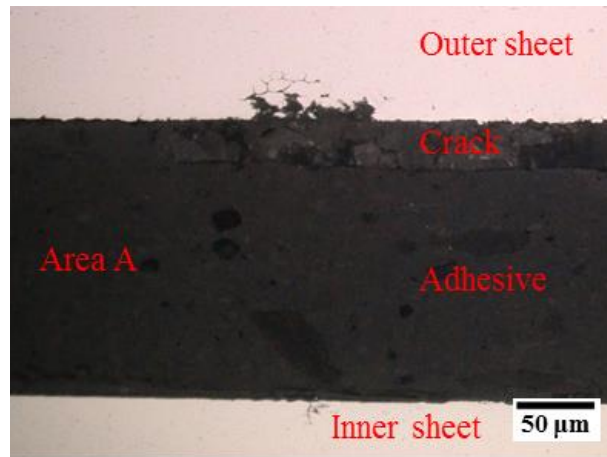
Figure 5.44: High magnification view of Figure 5.43(a) blue frame showing corrosion damage in area A after the adhesive delaminated from outer sheet.

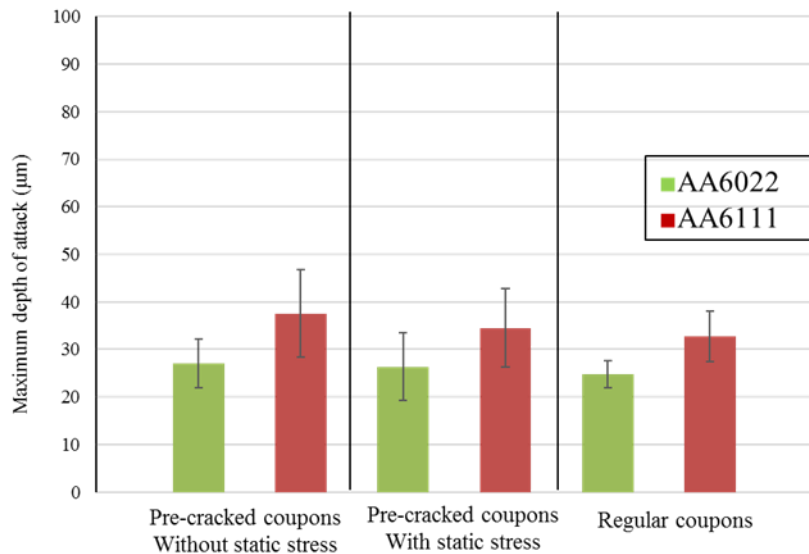
Figure 5.45: Maximum depth of attack in area B of pre-cracked coupons after six-week exposure in Ford L-3190 cyclic corrosion test. Without static stress: AA6022 #9 and AA6111 #10. With static stress superimposed: AA6022 #12 and AA6111 #12.

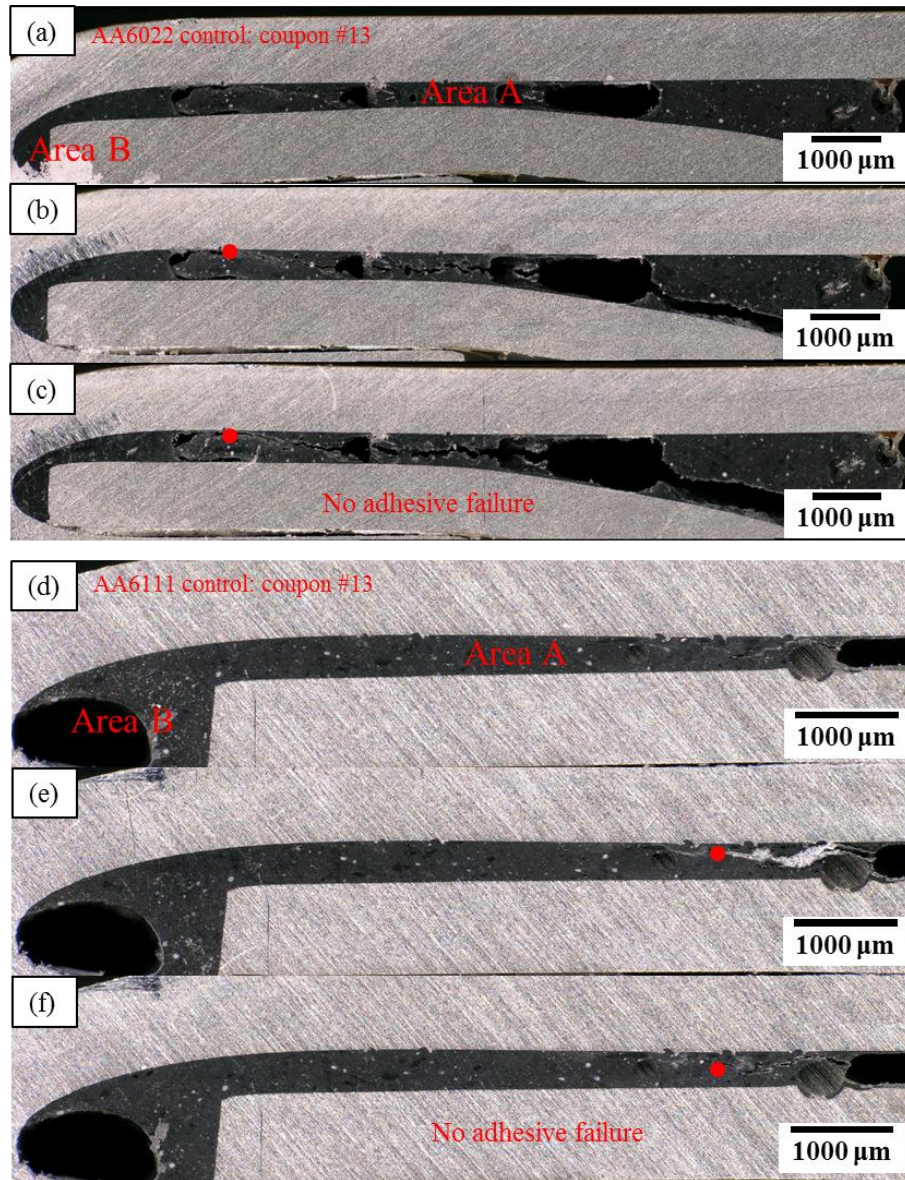
Figure 5.46: Side-view LOM images of duplicate sets of control coupons: AA6022 coupon #13 after (a) 0 cycles, (b) 30,000 cycles, and (c) 30,000 cycles with subsequent lab air exposure for 6 weeks with static stress superimposed; AA6111 coupon #13 after (d) 0 cycles, (e) 30,000 cycles, and (f) 30,000 strain cycles with subsequent lab air exposure for 6 weeks with static stress superimposed. The crack tips are marked by red dots (●).

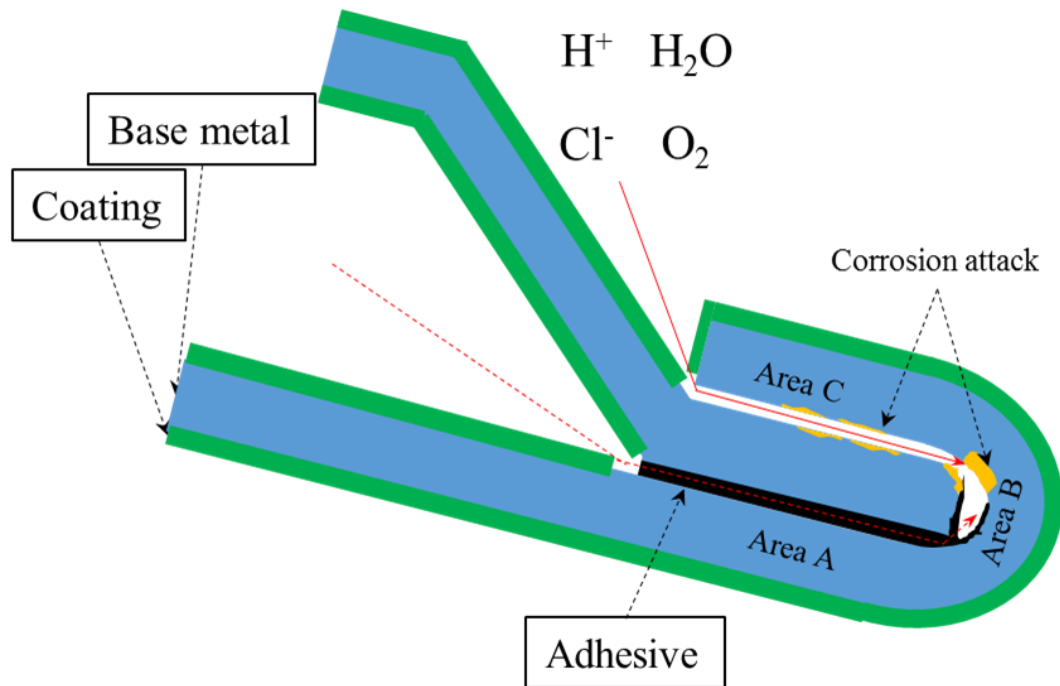
Figure 6.1: Schematic of the corrosion damage accumulated within the hem flange joint. The coupon is slightly tilted to reflect the sample geometry during the cyclic corrosion exposure.

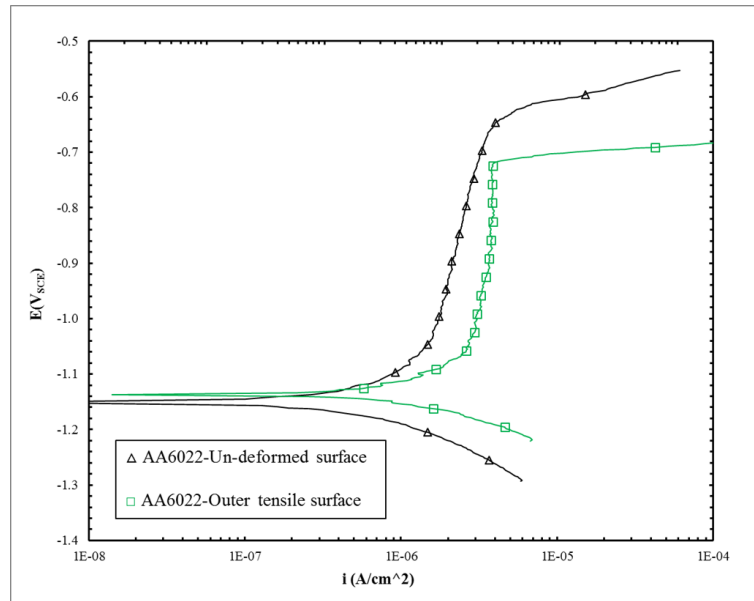
Figure 6.2: Typical potentiodynamic polarization curves for the un-deformed surface and the outer tensile surface of AA6022 hem flange coupon in 0.1 M deaerated neutral NaCl solution.

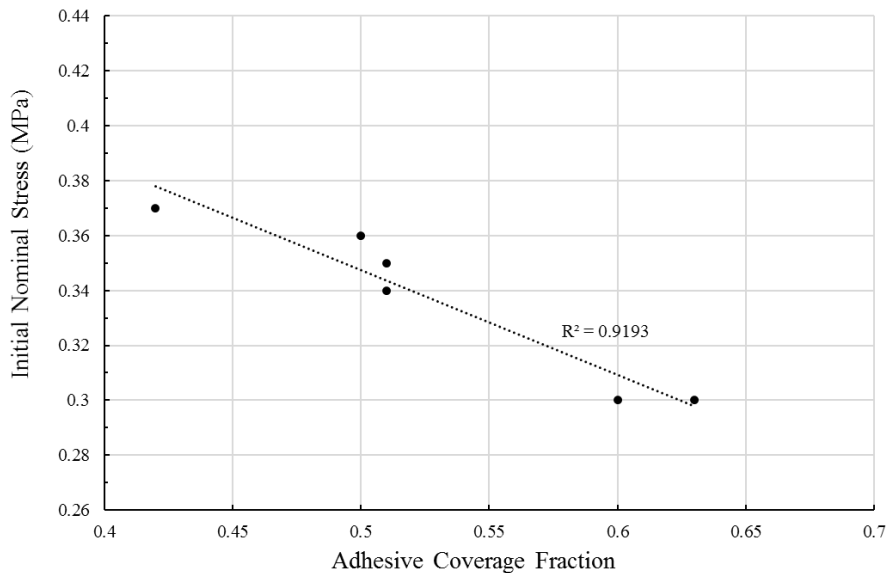
Figure 6.3: Initial nominal stress (MPa) vs. ACF plot of as-received hem flange coupons. Dashed line represents the trend line.

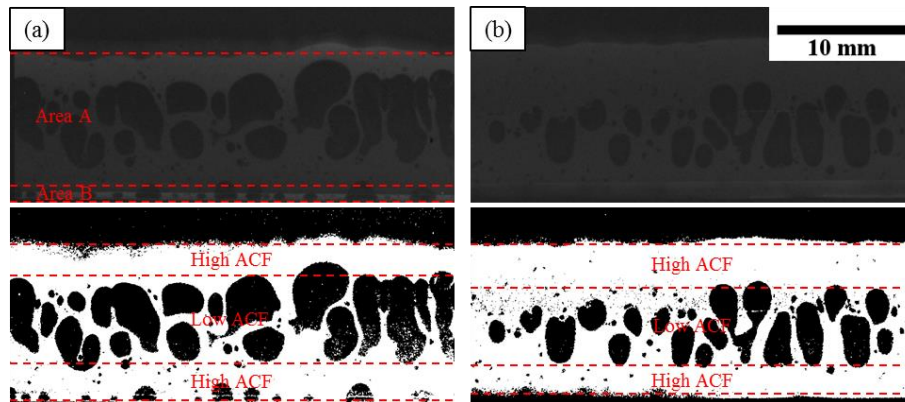
Figure 6.4: Neutron radiograph image and corresponding image after thresholding of (a) AA 6022 coupon #4 and (b) AA 6111 coupon #6.

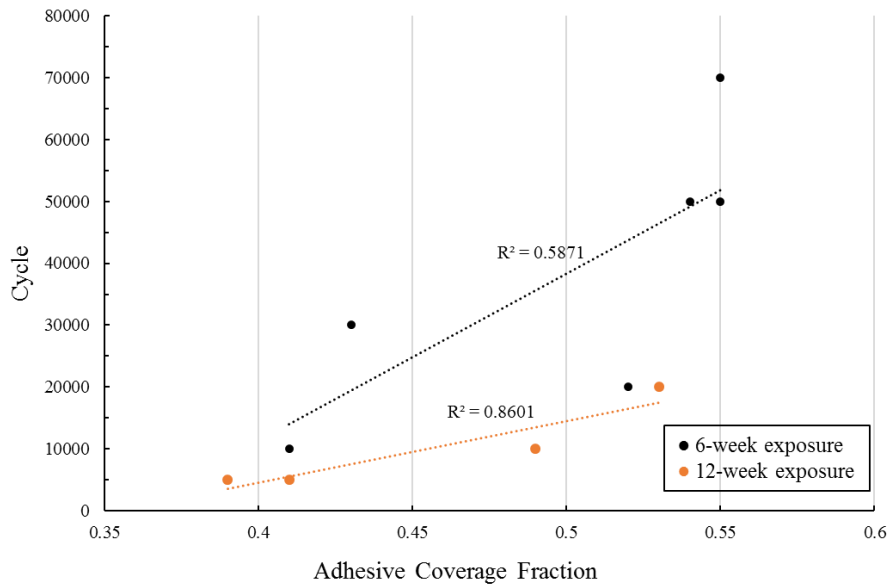
Figure 6.5: Cycles to first nominal stress drop vs. ACF plots of previously corroded coupons. Dashed lines represent the trend lines.
