THE DEVELOPMENT OF A RIGID POLYURETHANE FOAM-REINFORCED
RESILIENT MASONRY WALL SYSTEM

A Thesis

McMaster University

MASTER OF APPLIED SCIENCE (2012)
(Civil Engineering)

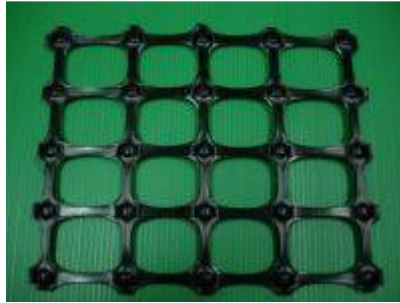
Figure 2-1: Industrial Geo-grid (Redman and Smith, 2009)

Two types of polymer mesh that have been used to retrofit unreinforced masonry structures are an industrial geo-grid as seen in Figure 2-1 and a weaker mesh which is typically used as fencing on construction sites. The polymer mesh is wrapped around the wall with varying levels of coverage and then coated with a mud plaster.

When the walls of a structure are fully covered with geo-grid mesh, the system behaves as a rigid body, and only small cracks develop. The failure of this system is that a wall can slide off of its foundation when subjected to deflections greater than 100 mm, even though there is no significant damage to the building. When subjected to deflections of 120 mm or larger, the walls can exhibit torsion which may lead to further cracking and sliding at the base of the structure (Redman and Smith, 2009).

When only 75% of the structure is covered in geo-grid mesh, vertical cracks may develop at wall corners in addition to diagonal cracks along the longitudinal walls when the building is subjected to deflections greater than 80 mm. However, the walls will be able to stay together, as the mesh is able to hold the wall together, as it provides control of the walls displacement and provides a way to redistribute stresses within the system (Redman and Smith, 2009).

When the geo-grid mesh covers only 50% of a wall area, it provides an insufficient amount of reinforcement. Large cracks may develop at deflections greater than 80mm and at larger deflections there will be a large amount of severe structural damage (Redman and Smith, 2009).

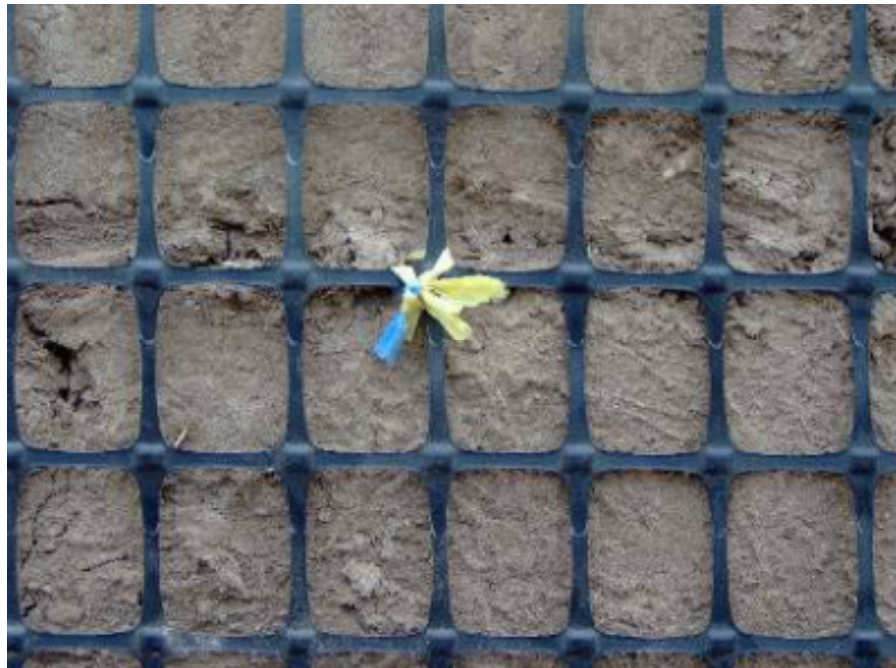
Figure 2-2: Geomesh that is tied to adobe wall (Blondet et al., 2010)

In order for the geogrid mesh system to work, it must be tied to both sides of the adobe wall using a plastic string as shown in Figure 2-2, and then anchored to the foundation. At the top of the wall, the mesh must be attached to a wooden ring beam. This setup allows the geomesh to increase the stiffness, strength and deformation capacity of the walls it is reinforcing by absorbing the tensile stresses that the adobe masonry is unable to resist on its own. In addition to its tensile system capabilities, the geomesh is able to contain the large broken pieces that can come off a wall during an earthquake, thus keeping the form of the walls together, still supporting the roof and thus avoiding collapse of the structure. At a cost of only \$1.50 U.S. per m², this is a material that shows great promise.

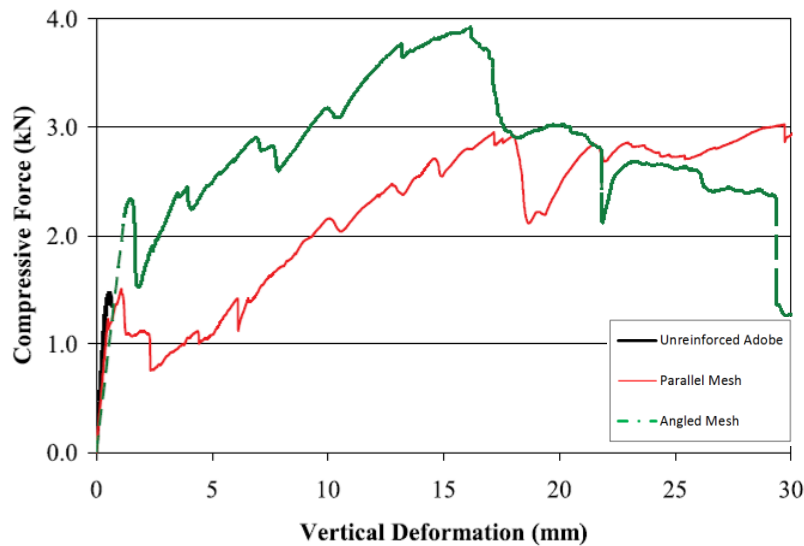
Figure 2-3: Comparison of Parallel and Angled Polypropylene Mesh (Guragain et al., 2005)

The efficiency of different mesh orientations was analyzed at the University of Tokyo, looking at mesh oriented parallel to the adobe masonry blocks, as well as mesh inclined at a 45° angle. As can be seen in Figure 2-3, the mesh oriented at a 45° angle provided more strength than the horizontal and vertical mesh. This orientation is stronger, as the angled mesh produces a high confining effect, and as the vertical deformation increases as the cracks become wider, the angled reinforcement is working at its optimum level. However, even though the angled mesh provides greater strength, the parallel mesh provides a maintained high level of strength which can be considered to improve the behaviour of the structure significantly. The parallel mesh is also much easier to manufacture and install and therefore would be the optimum solution of mesh orientation (Guragain et al., 2005).

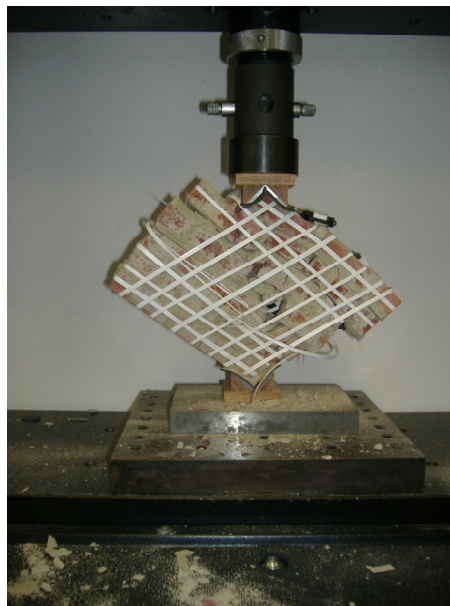
Figure 2-4: Failure of Retrofitted Specimen Under Compressive Loading (Guragain et al., 2005)

When compressive force is applied, a non-retrofitted specimen immediately splits into two pieces at the presence of the first diagonal crack, leaving no residual strength left in the specimen. However, in the retrofitted case as in Figure 2-4, cracks develop at a much slower rate, followed by a drop in strength. The reinforcement has no effect until cracking occurs; however after cracks develop the polypropylene mesh acts to regain the strength that was lost by the formation of cracks, and also acts to maintain stability of a completely cracked specimen. It can be seen in Figure 2-3 that although the reinforced specimen exhibits a drop in strength after initial cracking, it is able to retain 60% of its peak strength. Further drops in strength occurred with the formation of new cracks but were regained by the readjusting and packing of the polypropylene mesh. At a strength of approximately 2.9 kN the bands begin to fail, however as the other bands are able to take over the additional stresses, there is not a significant or drastic reduction in the strength of the specimen, and any lost strength is easily recovered. The final strength of the retrofitted specimen reached 3.0 kN which is double the initial specimen strength of 1.5 kN, while sustaining deformations 45 times larger than the non-retrofitted specimen (Guragain et al., 2005).

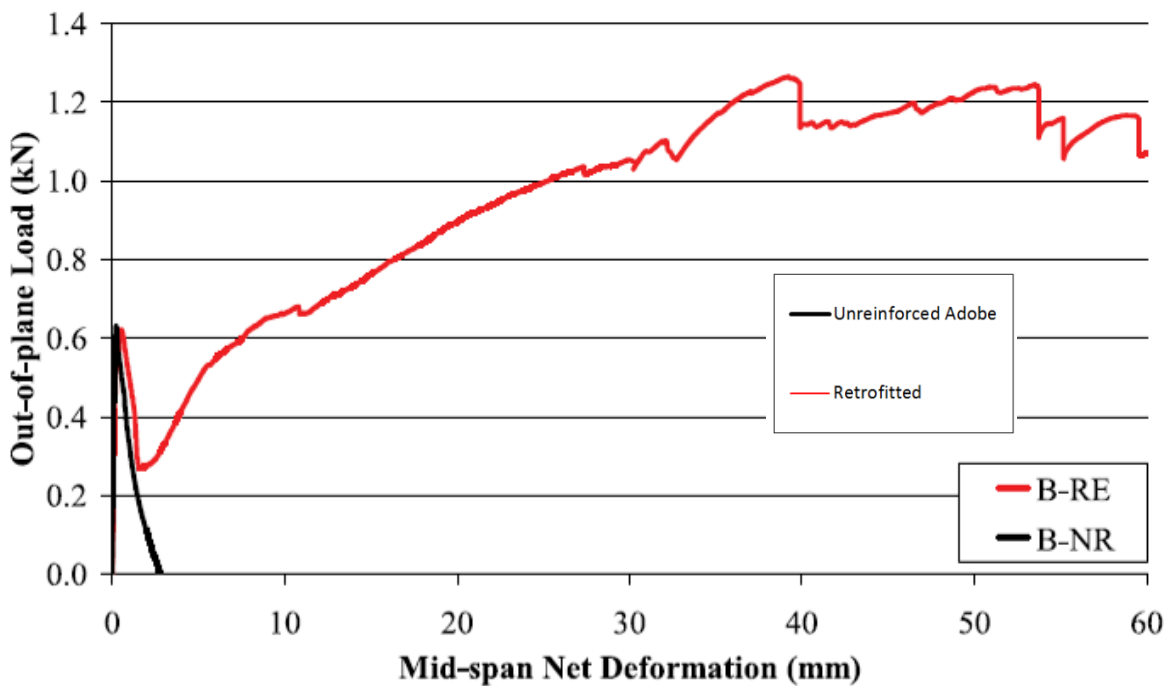
Figure 2-5: Out-of-Plane Load Variation With and Without Polypropylene Mesh Retrofitting (Guragain et al., 2005)

When considering out-of-plane loading of the non-retrofitted masonry, the specimen exhibits immediate failure after the first crack develops at mid-span, as can be seen in Figure 2-5. The only remaining residual strength left in the specimen is due to the interlocking of bricks and the application of load under the displacement control method. However, it can be seen that this behaviour can be significantly improved with the presence of the polypropylene meshing. In the retrofitted case, after initial cracking the specimen was able to retain 45% of its peak strength and was able to gradually regain its strength due to the effects of the mesh, reaching a final strength of double the initial peak specimen strength. It can also be seen that the retrofitted specimen was able to sustain mid-span deflections 60 times larger than the non-retrofitted specimen under out-of-plane loading (Guragain et al., 2005).

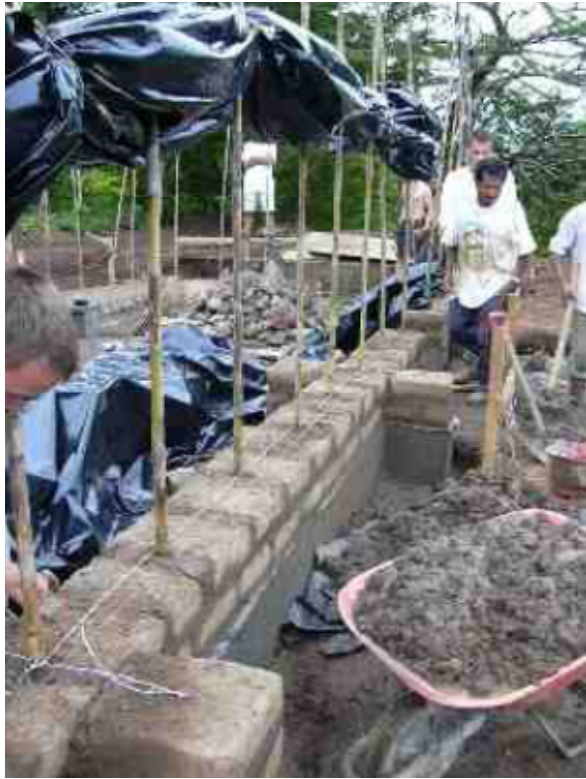
Figure 2-6: Adobe Wall Under Construction with Bamboo Reinforcement (Redman and Smith, 2009)

Bamboo reinforcement has the potential of increasing the amount of seismic activity that a building can handle before it reaches ultimate collapse. The bamboo system uses many components acting together such as buttresses, a ring beam, and both internal horizontal and vertical reinforcement out of bamboo. The application of bamboo used internally in the masonry as reinforcement is shown in Figure 2-6. This same system may also be applied as a retrofitting method by applying the vertical bamboo reinforcement on the external sides of the structure. This method may actually be simpler, as it avoids construction problems such as the alignment of the reinforcement and the trimming of the bricks. The retrofit arrangement may be seen in Figure 2-7 (Redman and Smith, 2009).

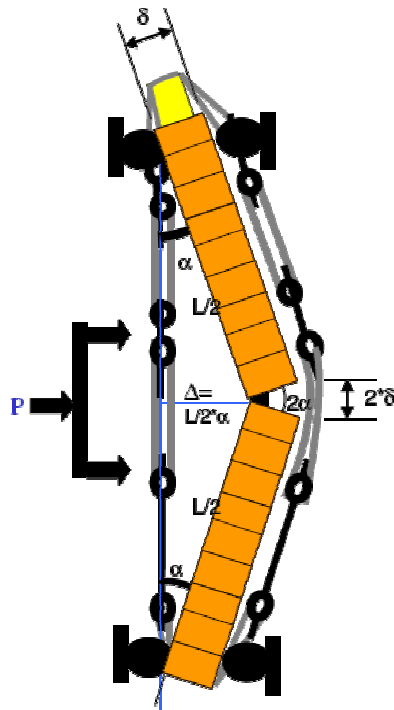
Figure 2-9: Post-Cracking Strength Improvement Mechanism of STR (Gölalmiş and Turer, 2007)

Figure 2-9 demonstrates how scrap tire reinforcement works to improve the post-cracking strength of URM. When tire-reinforced wall specimens begin to act in the non-linear range, their increase in strength is governed by the compressive strength of the wall, and hence both the normal and hybrid system act in a similar manner. The drift ratio and energy dissipation capabilities of the system are governed by the stiffness of the scrap tire reinforcement. As the wall is loaded, the reinforcement becomes more flexible, and the drift capacity and energy dissipation capabilities of the system increase, making it an effective post-tensioning mechanism. Note that due to the elastic nature of the scrap tire reinforcement, the deformations in the nonlinear range has fully recovered (Gökalmiş and Turer, 2007).

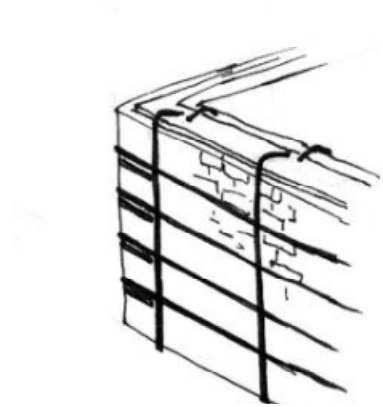
Figure 2-10: Reinforcing in an Adobe House with Tire Straps (Charleson, 2009)

This reinforcement method cuts tires into thin straps approximately 5m long, and uses them as reinforcement, joining the straps using a simple nailed joint. As in the post-tensioning tire reinforcement case, the tires pass over and under the wall; however there is no post-tensioning applied. Instead, the tires are applied to the wall both vertically and horizontally to act as a large dual system as see in Figure 2-10 (Charleson, 2009).

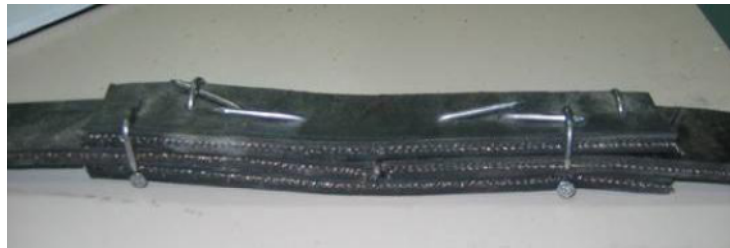
Figure 2-11: Nailed Joint (Charleson, 2009)

Straps are connected together by overlapping the straps to form a butt joint as can be seen below in Figure 2-11. Nails on either side of the joint are bent around the overlapped tire so as to prevent any premature failure of the rubber and nail (Charleson, 2009).

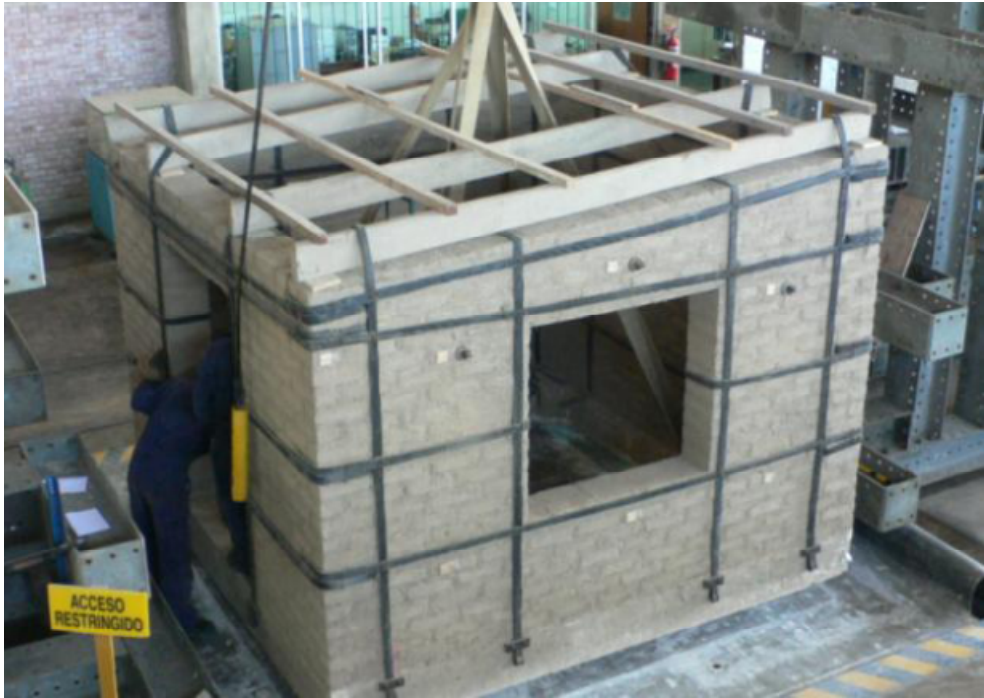
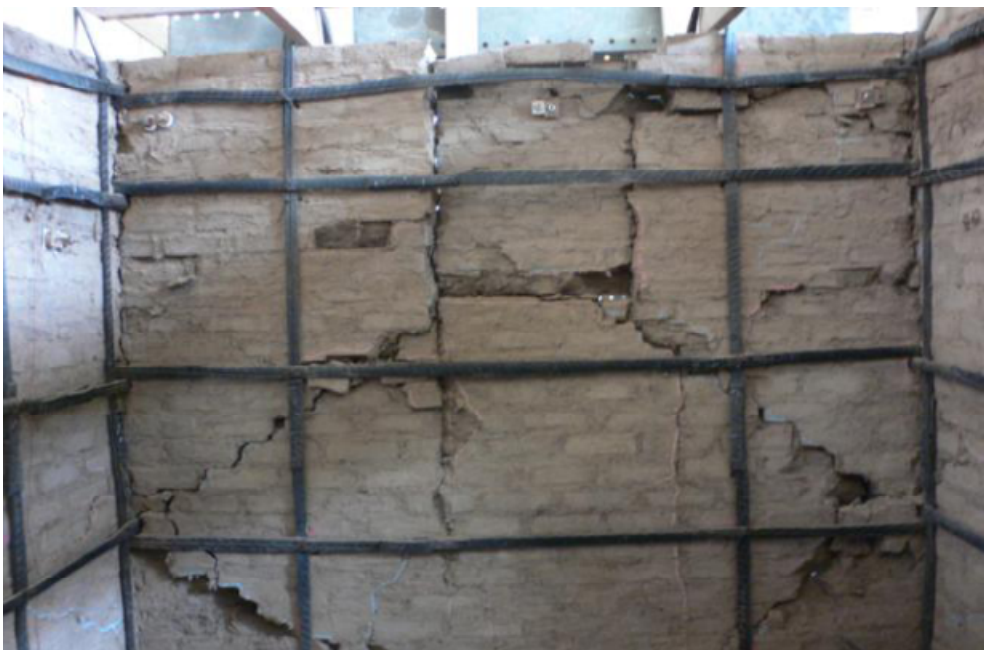
This system of reinforcement was tested on a full-scale adobe house at the Catholic University of Peru in Lima, where they subjected the house to a mild, moderate and severe earthquake in order to assess the system and the damage that would result, as depicted in Figure 2-12. When subjected to mild shaking, no damage was observed. As intensity built to simulate a moderate earthquake, vertical cracks began to form at the corners of the large rear wall, which would have normally collapsed if the building had not been horizontally reinforced and restrained. The rear walls also exhibited cracking due to out-of-plane failure; however no cracking developed in the in-plane direction. When subjected to a severe earthquake, the structure did experience significant damage, but was not in any danger of collapse. Out-of-plane failure had a significant effect on the building, with the walls suffering large cracks while the piers experienced moderate cracking. However, only one block was dislodged from the system at the location of significant out-of-plane failure. As can be seen in Figure 2-13, there was substantial damage to the wall, but the system acted together to keep the wall together and prevent collapse (Charleson, 2009).

Figure 2-12: Adobe House Used to Analyse System Level Earthquake Response (Charleson, 2009)

Figure 2-13: Damage to Rear Wall of Structure After Severe Shaking (Charleson, 2009)

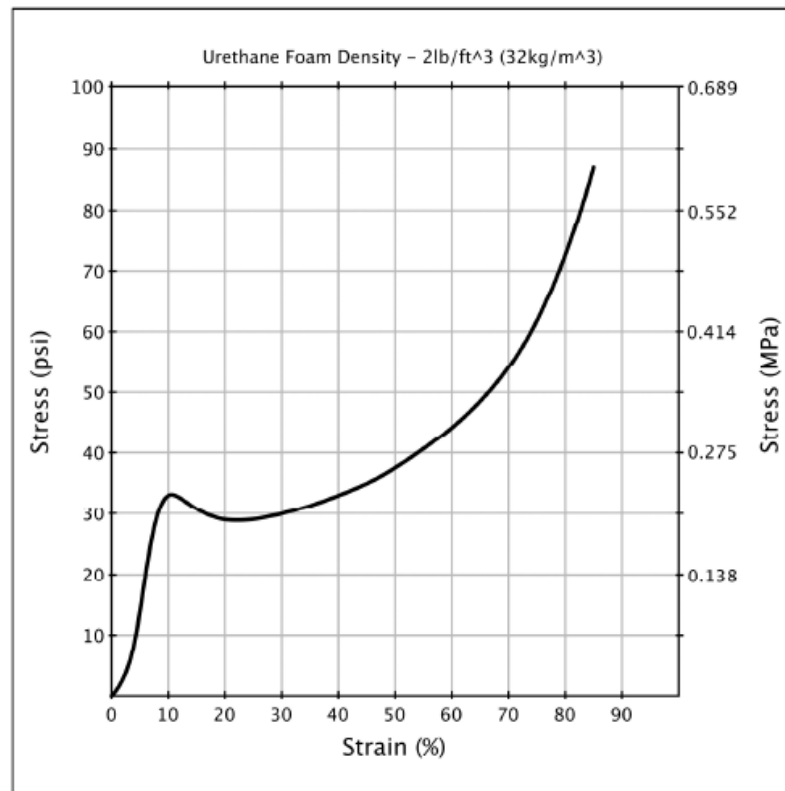
Figure 2-15: Stress-Strain Curve for Polyurethane Foam (Dupont, 1998)

The stress-strain curve for rigid polyurethane foams contains an elastic region in which stress is nearly proportional to strain. This elastic region can vary from 5-10% of total strain, and is only limited by the yield point of the material. This stress-strain relationship can be found in Figure 2-15 for a low-density polyurethane. Beyond this

yield point, the foam has little elastic recovery, as the cell structure of the foam is crushed and permanently deformed. At this point on the curve, a plateau forms and deflection continues to increase with little to no increase in stress. For low-density foams, this plateau can extend up to 70% strain in compression. As foam density increases, the extent of this plateau decreases proportional to the increase in density. The stress-strain curve is also sensitive to the loading rate, with a higher loading rate resulting in a decreased plateau length. Beyond this plateau region, the polymer increased in both strength and stiffness and it becomes denser (Dupont, 1998).

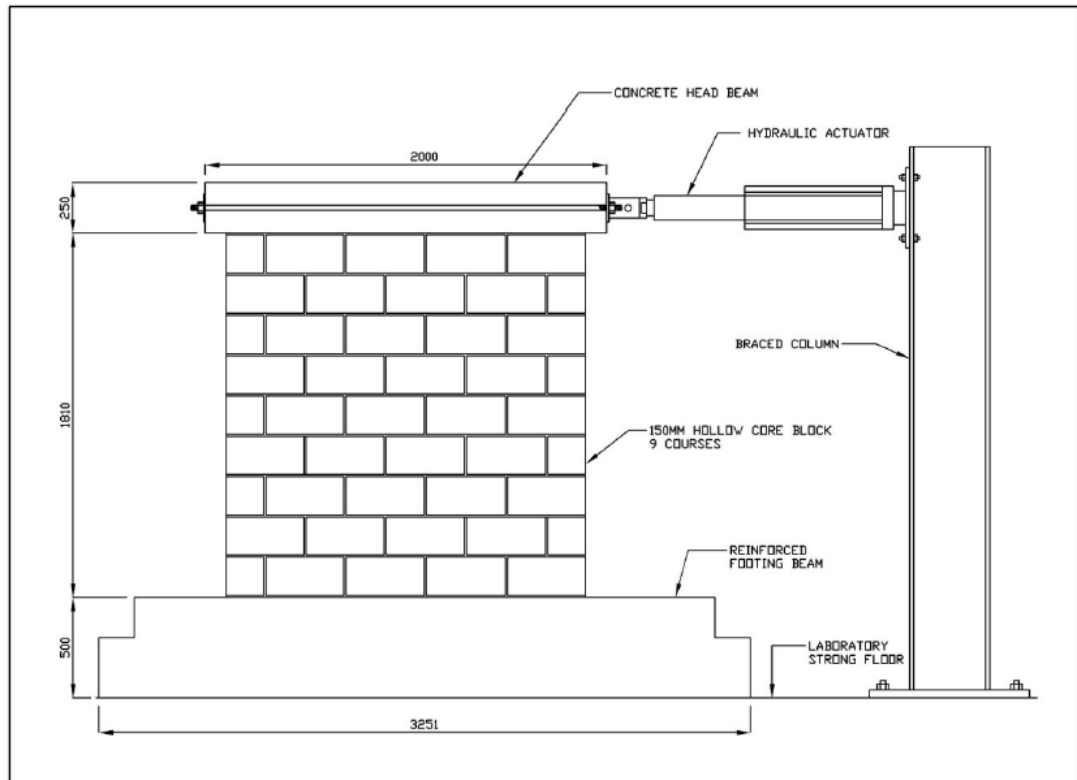
Figure 2-16: Wall Test Set-up (Ing, 2010)

The walls were constructed using standard materials and practices, with overall wall dimensions of 1810 mm tall by 1790 mm wide. The test set-up for the shear wall tests is shown in Figure 2-16. Bolted to the strong floor, this reaction frame provided adequate strength and stiffness to test the walls (Ing, 2010).

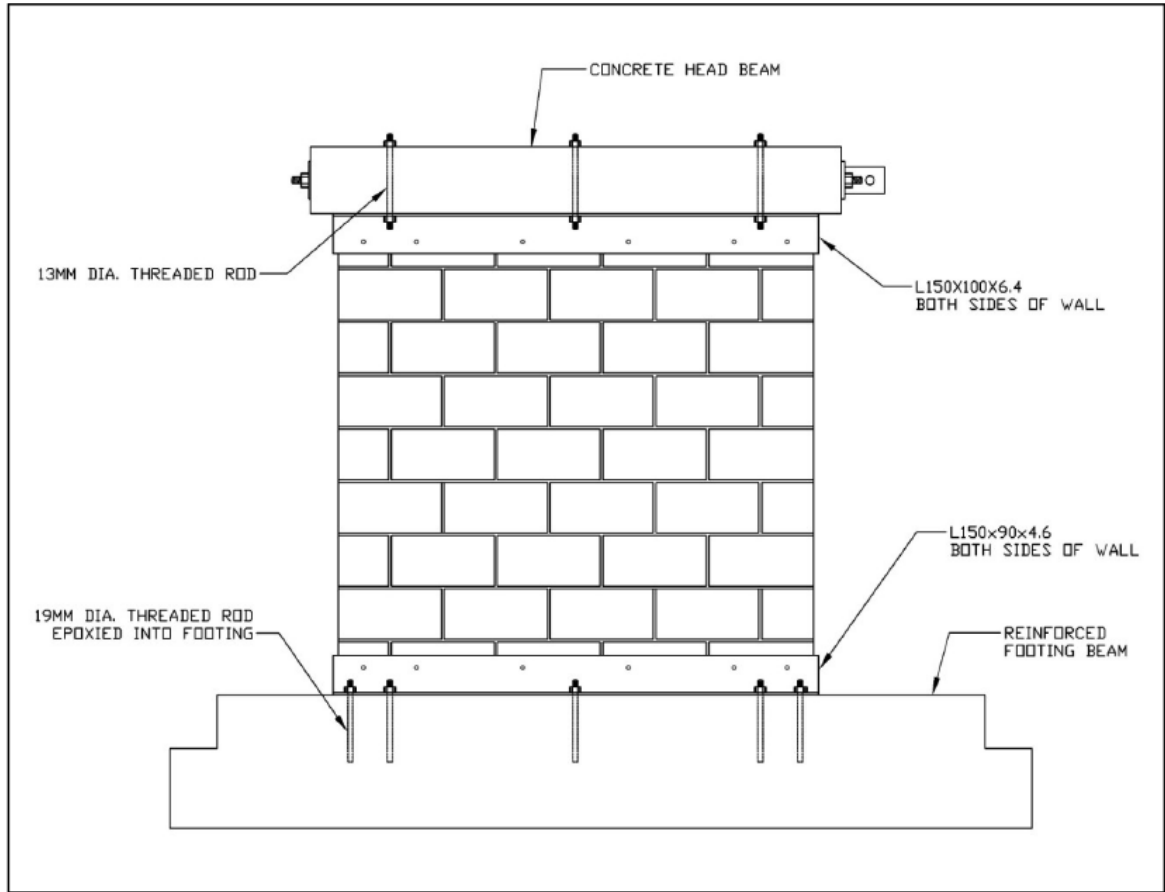
Figure 2-17: Reinforcement of Wall Into Header and Footer Beams (Ing, 2010)

With the weakest and more critical failure planes being located along the top and base mortar joints, it was necessary to upgrade these joints to ensure a failure plane within the wall and not along these critical joints. Steel angles were bolted through the wall at the top and base courses and anchored into the head and base beams using threaded not, as shown in Figure 2-17 (Ing, 2010).

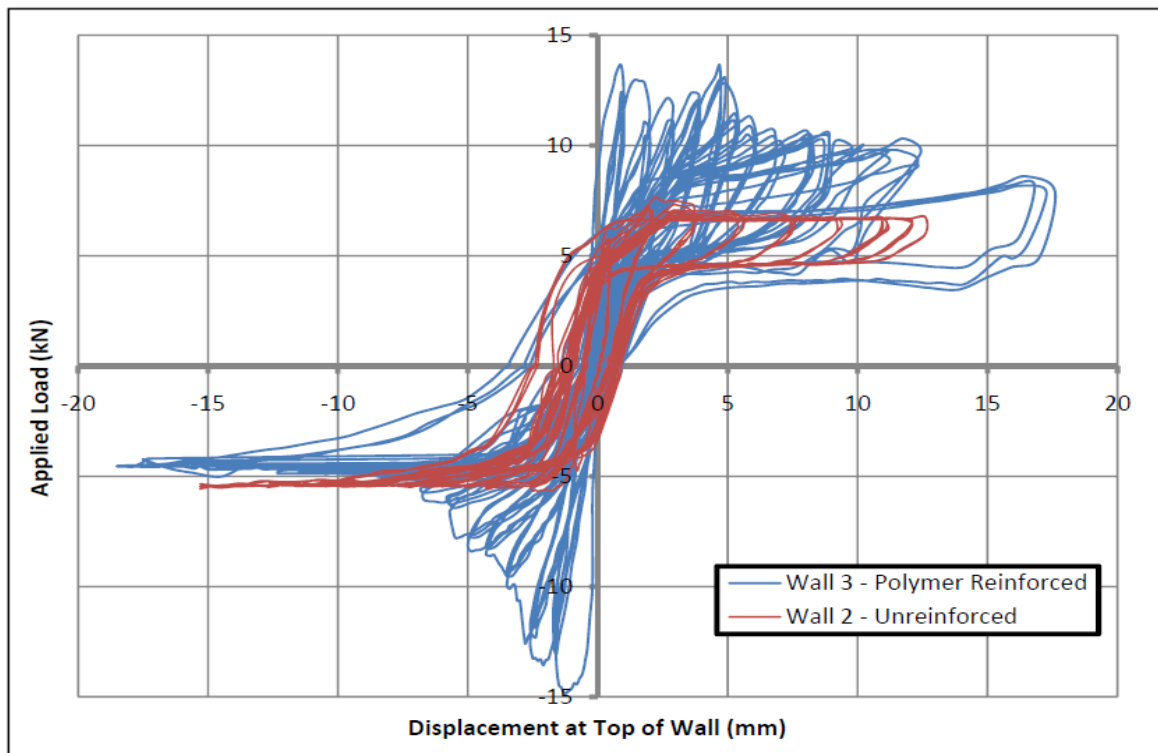
Figure 2-18: Comparison Between Polymer Reinforced and Plain URM Wall Response (Ing, 2010)

A comparison of an unreinforced and polymer reinforced wall specimen is shown in Figure 2-18. The polymer core of the polyurethane foam reinforced wall was able to increase the tensile and shear capacities of the specimen, providing the wall with higher initial strength as compared to the URM specimen. The foam reinforced specimen exhibited greater energy dissipation capacity, as after peak load was reached and initial failure occurred, each polymer core had to be progressively overloaded, allowing the system to maintain close to peak loads over a range of displacements. As polymer cores ruptured and cracks widened, the wall capacity gradually diminished to the point that it exhibited similar behaviour to the URM specimen. At this time when the polymer cores had ruptured and the wall was not able to maintain any residual strength, the wall exhibited sliding behaviour. The polyurethane foam reinforcement was able to increase energy absorption of the URM wall by 167% (Ing, 2010).

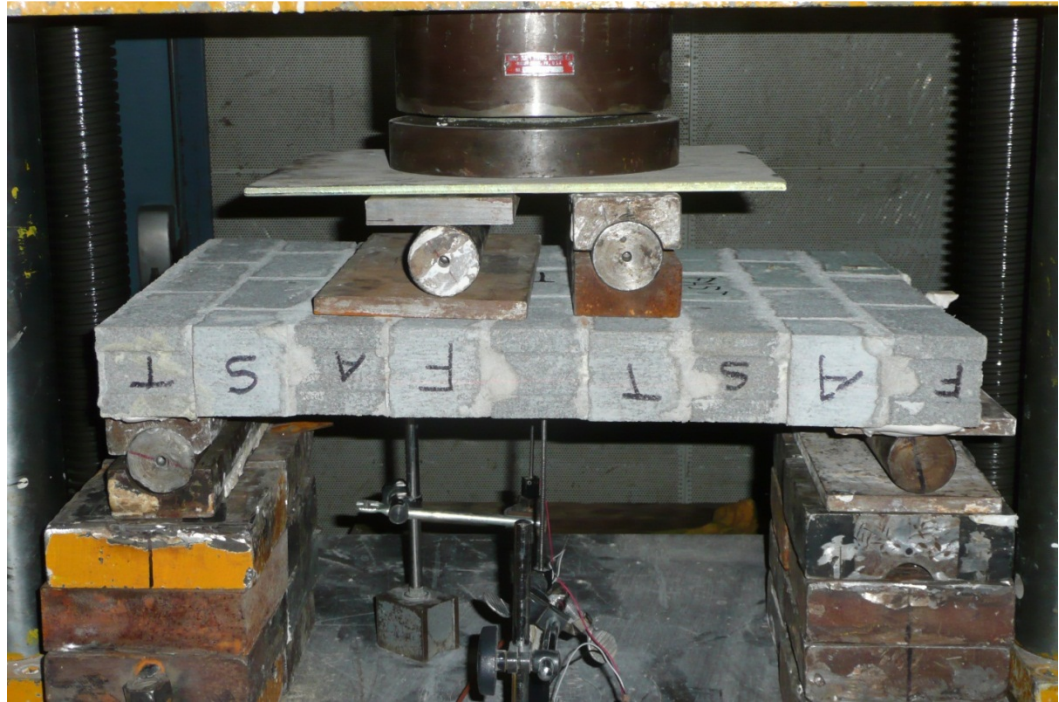
Figure 3-5: Wallette Test Set-up for Out-of-Plane Loading

The wallette specimens were tested under simply supported 2 point monotonic out-of-plane loading. The span between supports for all specimens was kept the same at 560mm and the spacing between the central load lines was 150mm for the polyurethane-reinforced wallettes. The two point loading beam allows the failure path to be either toothed or straight within the constant moment region. In order to transfer the main load to these smaller load beams, a spreader plate was used. Linear variable differential transducers (LVDT's) with 30mm stroke were used to measure the midspan deflection of each specimen. Figure 3-5 shows the test set-up and instrumentation of a typical wallette specimen.

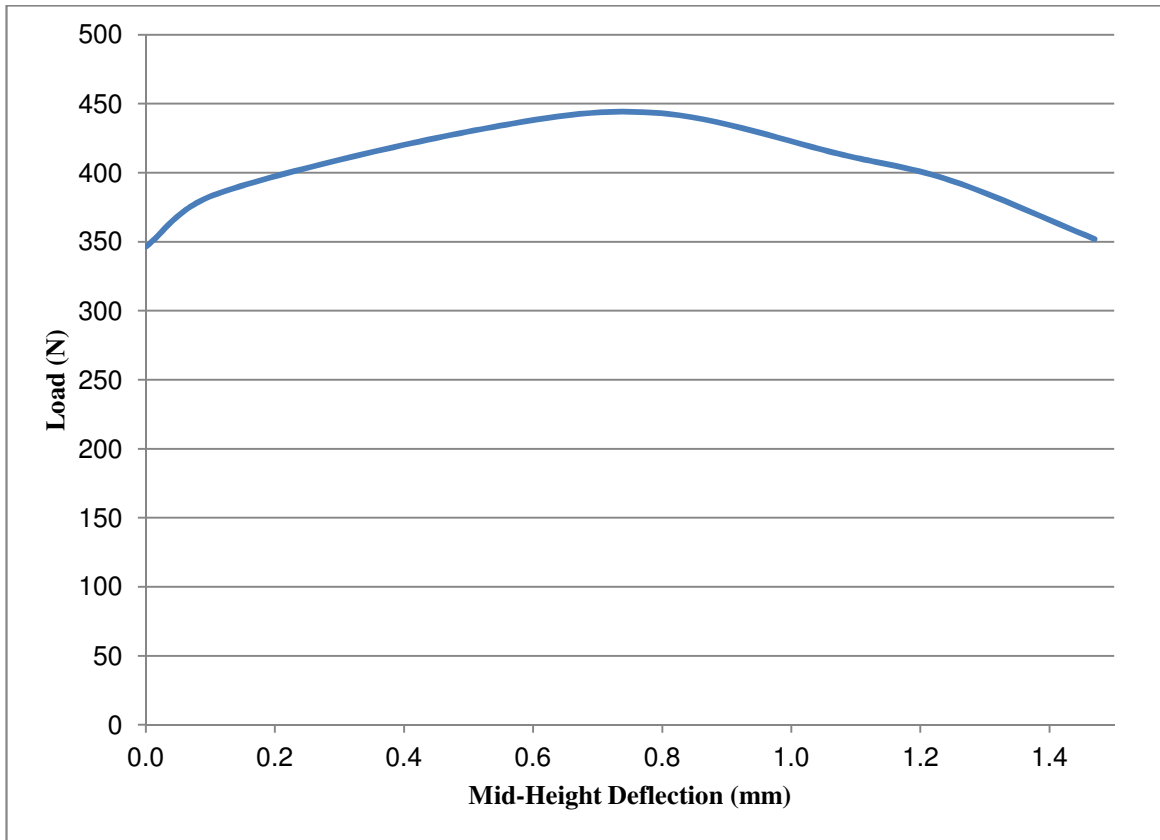
Figure 3-6: Load vs. Mid-Height Displacement for A-2 Wall 2A

The load versus mid-height deflection diagram is shown below in Figure 3-6 and clearly shows the quick failure of this foam during testing. The maximum load capacity that the wallette was able to withstand was just under 450N, and with such a small area under the load-deflection curve, it can be seen that the wallette was able to absorb just a small amount of energy before it reached ultimate failure. As the majority of the specimen's load capacity came from the superimposed load from the loading apparatus and not from applied loading, this shows how much of an influence the loading from the loading beam had on the testing.

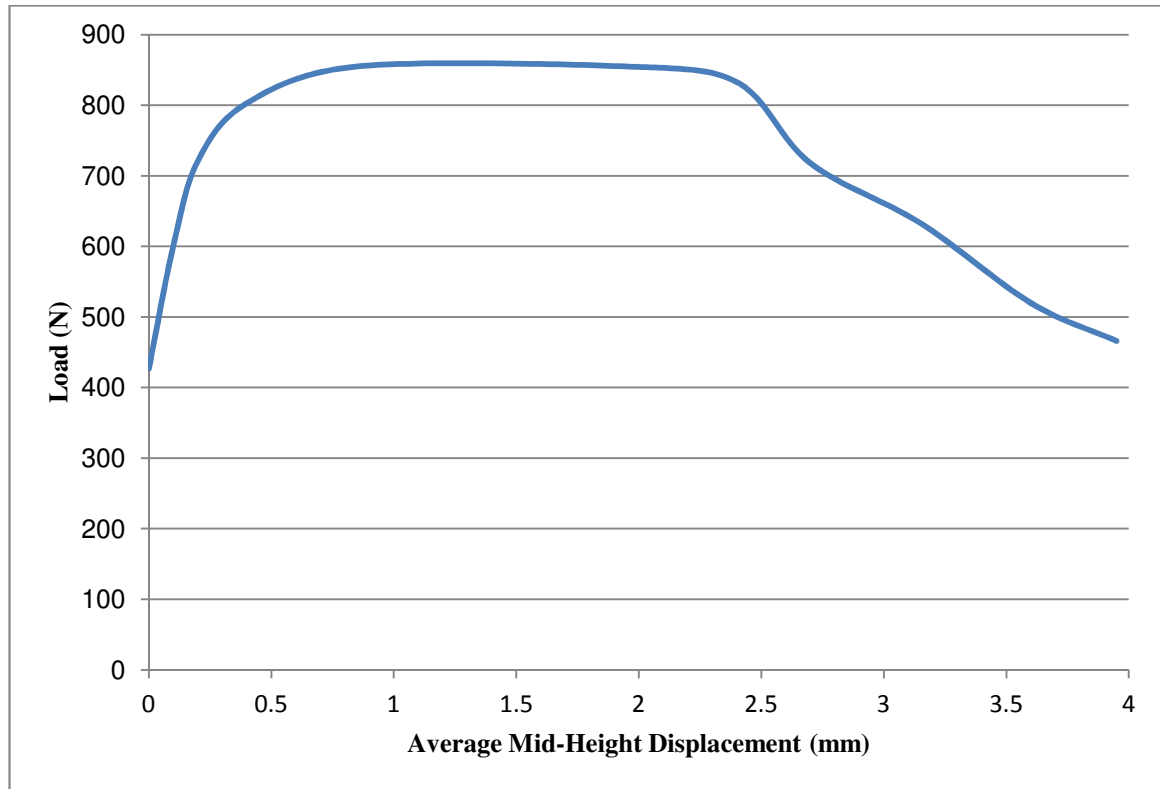
Figure 3-7: Load vs. Average Mid-Height Displacement for B-1 Polyurethane Foam

When the loading beam was initially applied to the B-1 wallette, the wallette experienced an average deflection of 1.1mm at the mid-height of the specimen. When the main loading was applied, a crack opened up near the fixed load and continued to propagate until it developed along the entire width of the specimen. This crack eventually opened up slightly and then gave out suddenly when the specimen reached ultimate failure. In Figure 3-7, the load versus deflection diagram shows a load-deflection response more typical of the behaviour expected for a full-size wall. The B-1 wallette was able to withstand a force of 850N for the extent of its loading time, pre-cracking. After the first crack opened up, releasing most of its 2,937Nmm of built-up energy, the specimen was quick to fail as can be seen in the figure by the consecutive drops in load over a period of only 1mm of deflection. After testing was complete, it was verified that the B-1 foam did in fact fill every cell of the specimen.

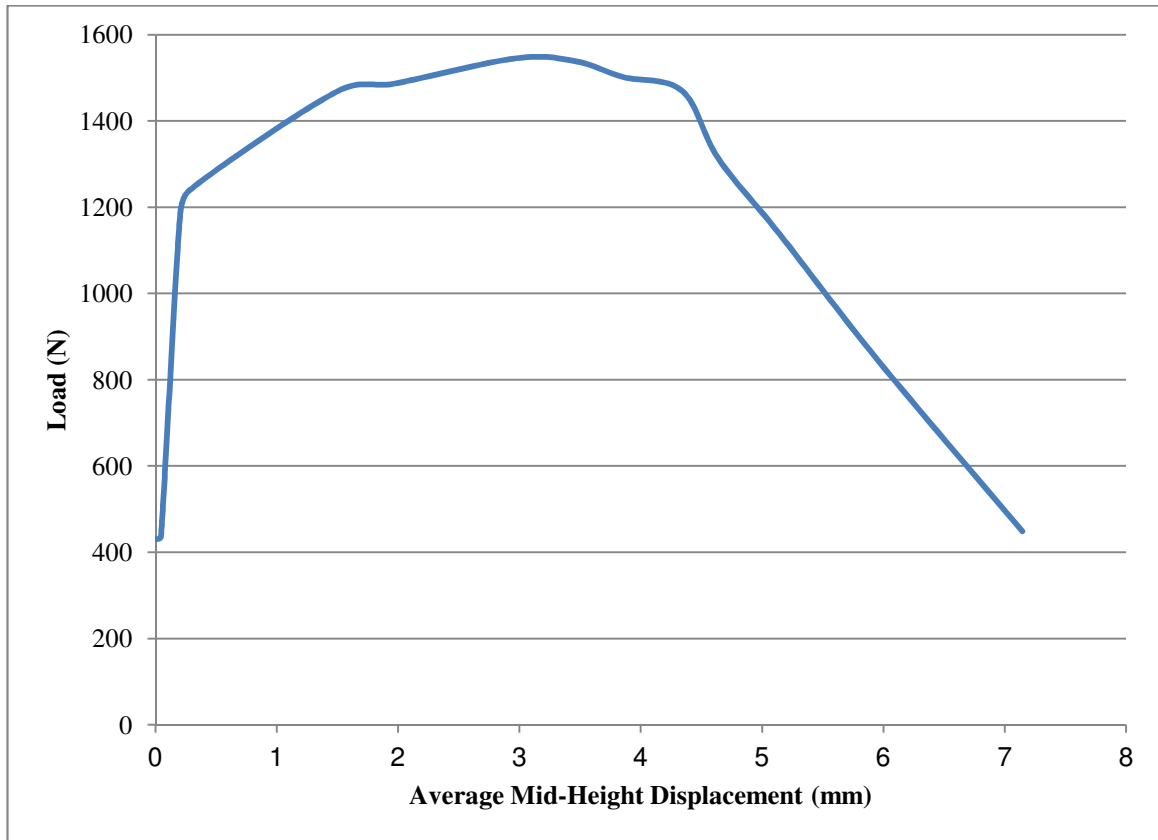
Figure 3-8: Load vs. Average Mid-Height Displacement for B-2 Polyurethane Foam

The B-2 polyurethane foam wallette was tested under the same conditions as the B-1 foam, and the additional weight of the heavy loading beam was again accounted for. The application of the loading beam caused an initial deflection of only .046mm, which is very small compared to the initial deflections of the previously tested polyurethane foams. This superior performance of the B-2 polyurethane foam can again be seen in the load versus deflection diagram shown in Figure 3-8. The B-2 foam wallette was able to carry loads up to 1.575kN and reach deflections over 7mm before ultimate failure was reached. This specimen was able to absorb 8,743Nmm of energy, far and above the energy dissipating capabilities of the other foam wallettes. The trench foam wallette cracked along the exact same mortar joint near the fixed load as the B-1 foam wallette, however the extent that this crack pattern was able to widen and open up before reaching ultimate failure was significantly greater than the B-1 foam specimen.

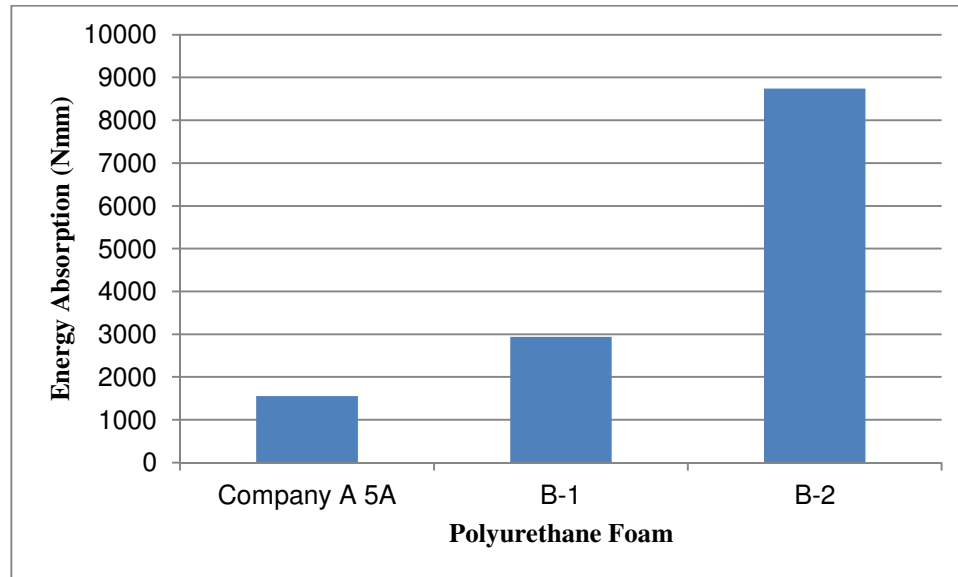
Figure 3-9: Energy Absorption of Polyurethane Foam Wallettes

In a direct comparison of the energy absorption capabilities of each of the three foams in Figure 3-9, the B-2 foam clearly outperforms the other two specimens; with an energy absorption capability almost double that of the Company A 5A wallette, and almost three times that of the B-1 polyurethane foam.

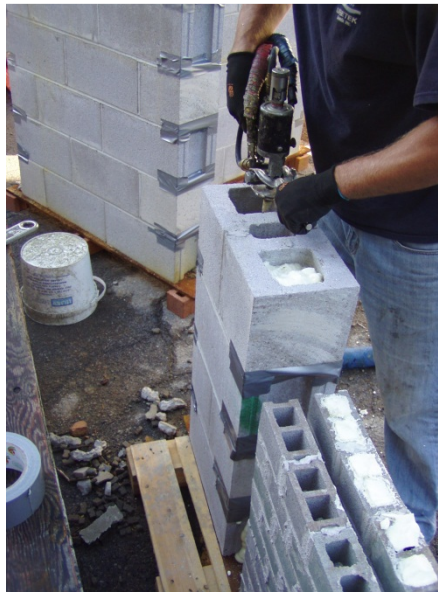
Figure 4-2: Polyurethane Foam Injection into Compression Assemblage

As the masonry assemblages were quite short in height, the polyurethane foam was able to be injected by inserting a rod down the length of the masonry core, and raising the rod accordingly as the foam rose. This process, which can be seen below in Figure 4-2 was repeated for each core. The mortar in the masonry assemblages was allowed to cure for at least 28 days before the polyurethane foam injection process.

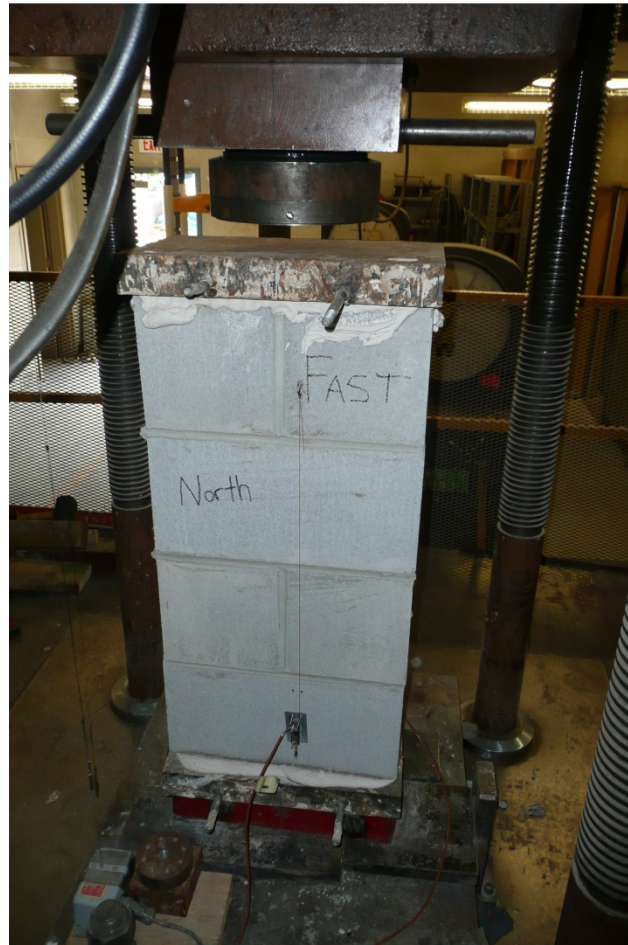
The compression test set-up is shown in Figure 4-3 and illustrates the configuration of the masonry assemblage within a compression test machine. The load applied was monitored by a load cell within the floor of the machine, and was connected to a data acquisition system which recorded the readings. LVDT's were affixed to the masonry on each side of the assemblage to monitor deflections over the whole height of the specimen. The LVDT's were located so as to span every mortar joint where most of the assemblage's deflection was likely to occur.

Figure 4-3: Compression Test Set-up

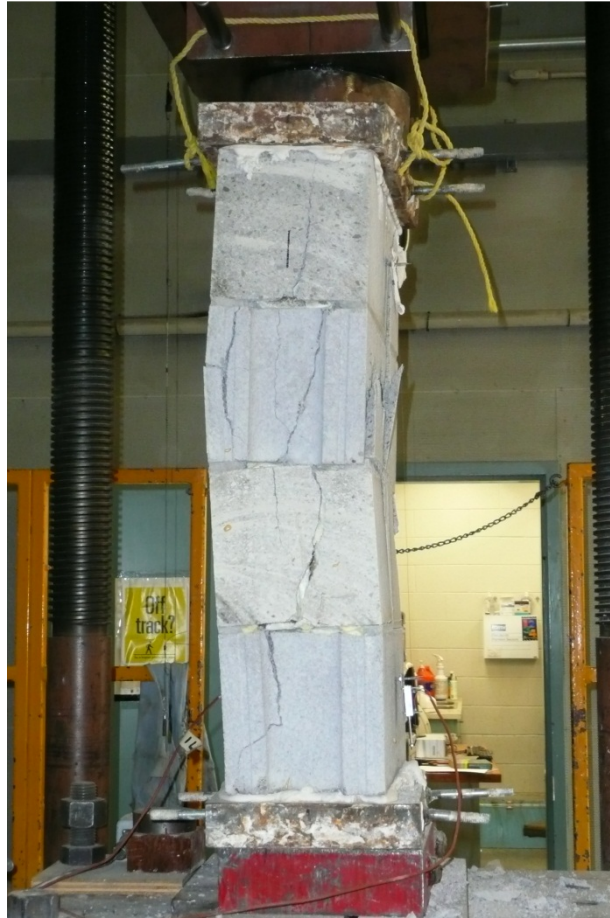
Figure 4-4: Fast Poly-mor Compression Assemblage Post Failure

assemblages filled with foam were able to significantly increase their load capacity after these initial side cracks developed, and far surpass the load carrying capacity of the unreinforced assemblage, increasing their load carrying capacity on average by 42%. This significant increase in failure load may be attributed to the increased cross-sectional area of the specimens and the strong tensile strength of the polyurethane foam. The benefit of the polyurethane foam reinforcement is that it is able to stabilize the face shell after web splitting, thus enabling the prism to carry more load as the face shell is still standing as one assemblage with no collapse. Even at ultimate failure, none of the foam-reinforced specimens suffered disintegration and all were capable of supporting their own self-weight as can be seen in Figure 4-4. The bond strength between the polyurethane foam and the inner masonry block surface held all of the failed pieces of the assemblage together, preventing them from collapsing. This is particularly important as such bonding effect (acting as a structural integrity reinforcement) can significantly prevent catastrophic URM collapse.

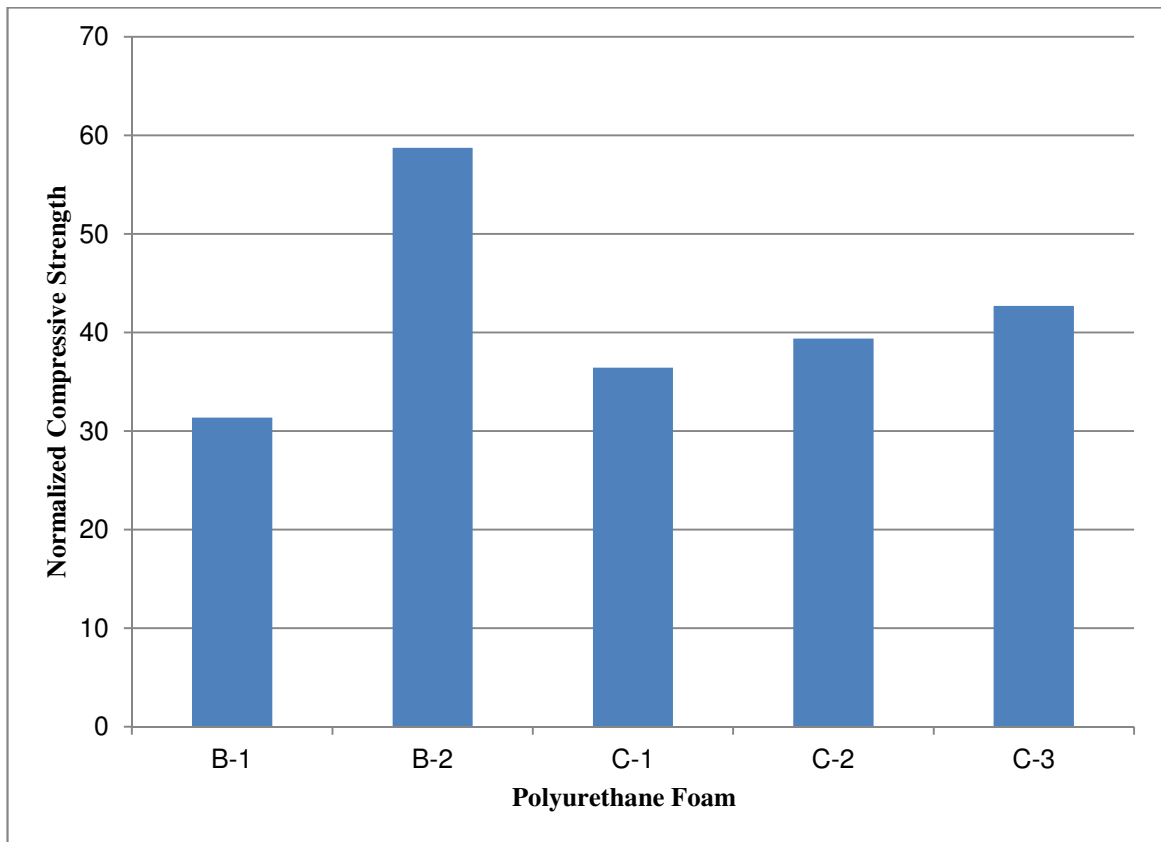
Figure 4-5: Increase in Compression Strength, Normalized to the Unreinforced Specimen

Also of note, is that as the density of the specimen provided by each company increased from low- to high-density, the ultimate load that the masonry assemblage was able to carry increased likewise. The increase in compressive capacity as polyurethane foam density increased can be seen more clearly in Figure 4-5. As the medium-density foam provided by Company B was the highest performing foam overall, this testing also shows that although an increase in density does increase polyurethane foam's compressive strength, there are other factors within the make-up of the foam that contribute to the making of a stronger foam. The strain profiles of each assemblage are shown in Figure 4-6.

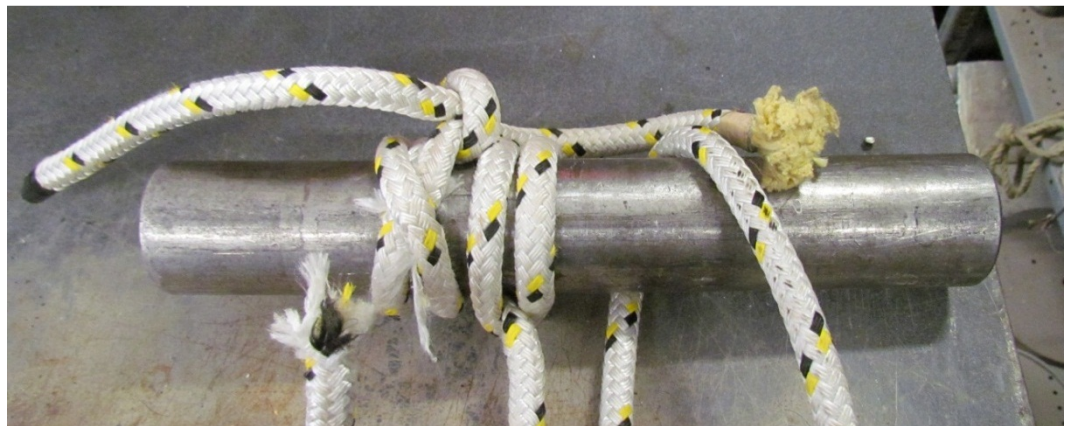
To test the ultimate capacity of each rope, the rope was stretched using the tinius compression machine. As shown in Figure 5-1 below, the rope being tested was tied around a steel cylinder using a clove hitch knot, creating a loop. This loop was then threaded through the center of the tinius machine and secured and made taut by

Figure 5-1: Clove Hitch Knot

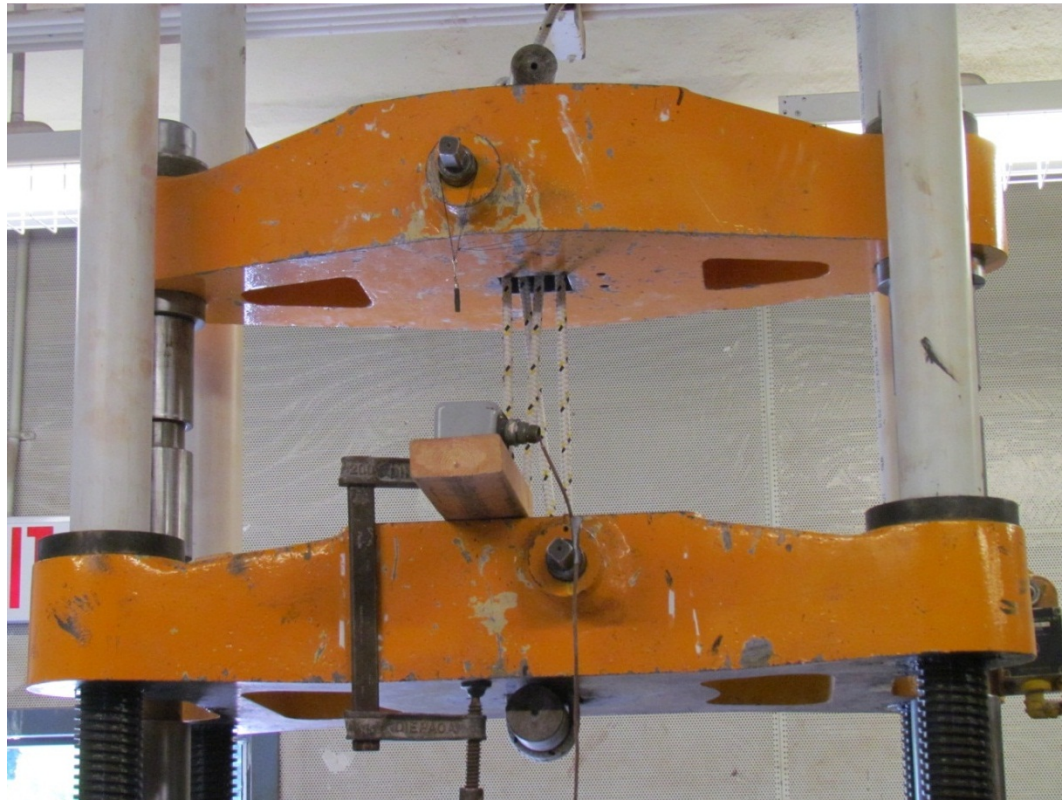
Figure 5-2: Rope Test Set-up

suspending another steel cylinder through the lower section of the loop, and raising/lowering the tinius machine until the rope became taught, which is shown in Figure 5-2. By increasing the distance between the two sections of the tinius, the rope became increasingly taught until failure was reached. Failure normally occurred at the top of the loop where the clove hitch overlapped, however there were instances where the rope broke at the very bottom of the loop. There were also cases when the ropes failed prematurely; when the outer material of the rope was too slippery, which under extreme tension caused the knots in the rope to come undone. In the case of ropes that have an outer layer and an inner core, the outer core tended to break first, leaving the remaining inner core completely intact – which then required additional testing of the inner core on its own.
