THE DEVELOPMENT OF A RIGID POLYURETHANE FOAM-REINFORCED
RESILIENT MASONRY WALL SYSTEM

A Thesis

McMaster University

MASTER OF APPLIED SCIENCE (2012)
(Civil Engineering)

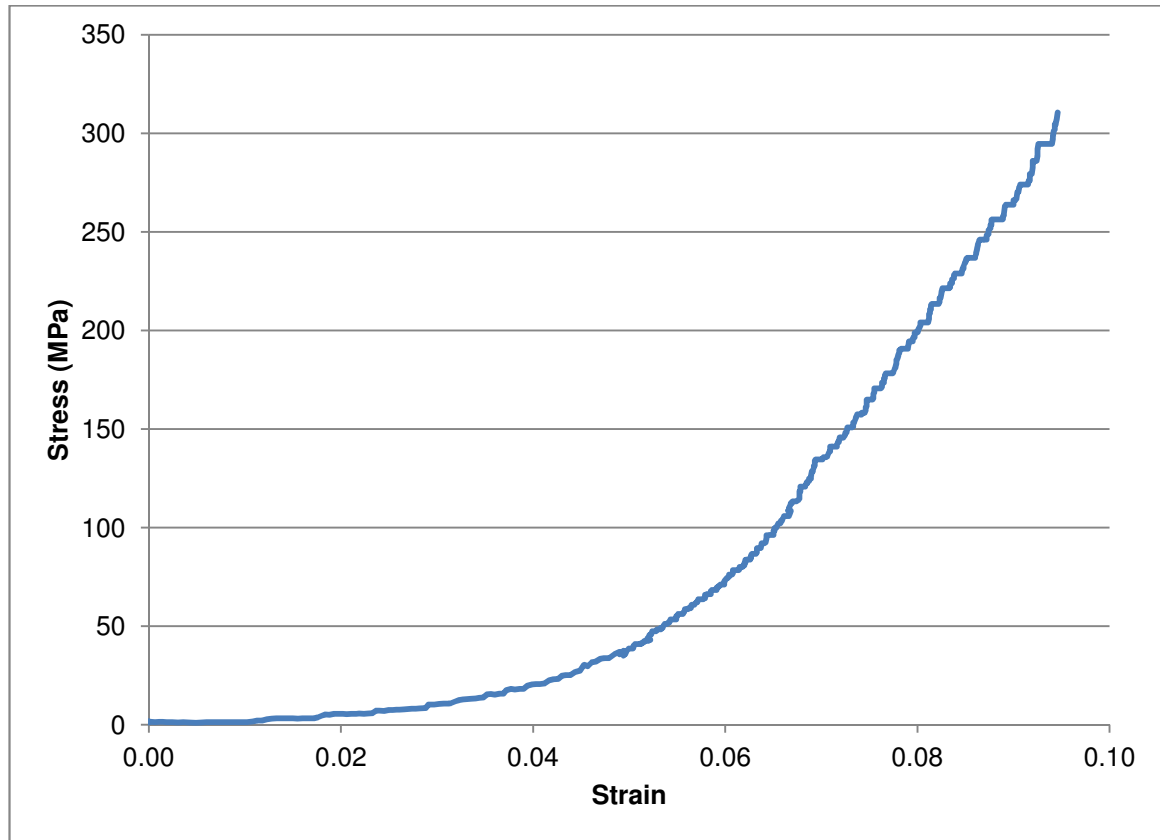
Figure 5-3: Stress vs. Strain of Rope I

In order to select the appropriate rope to use in conjunction with the polyurethane foam to reinforce masonry walls, it was important to use a rope that would not fail during the testing of the masonry walls. The use of the rope in this test is to provide tension to the foam/masonry system – acting as steel re-bar does when it is reinforced with grout in current masonry construction. Keeping this in mind, the high strength rope I was used in the construction of the masonry walls reinforced with rope and polyurethane foam. This rope was the less expensive of the high-performing ropes, at a cost of \$2 per foot, and also had a braided outer covering of its thick, braided aramid fibre inner core, which provided an excellent surface for the polyurethane foam to bond to. The stress vs. strain diagram of the selected rope is shown below in Figure 5-3. The rope was able to withstand a stress of 307MPa before it severed due to the applied tensile force.

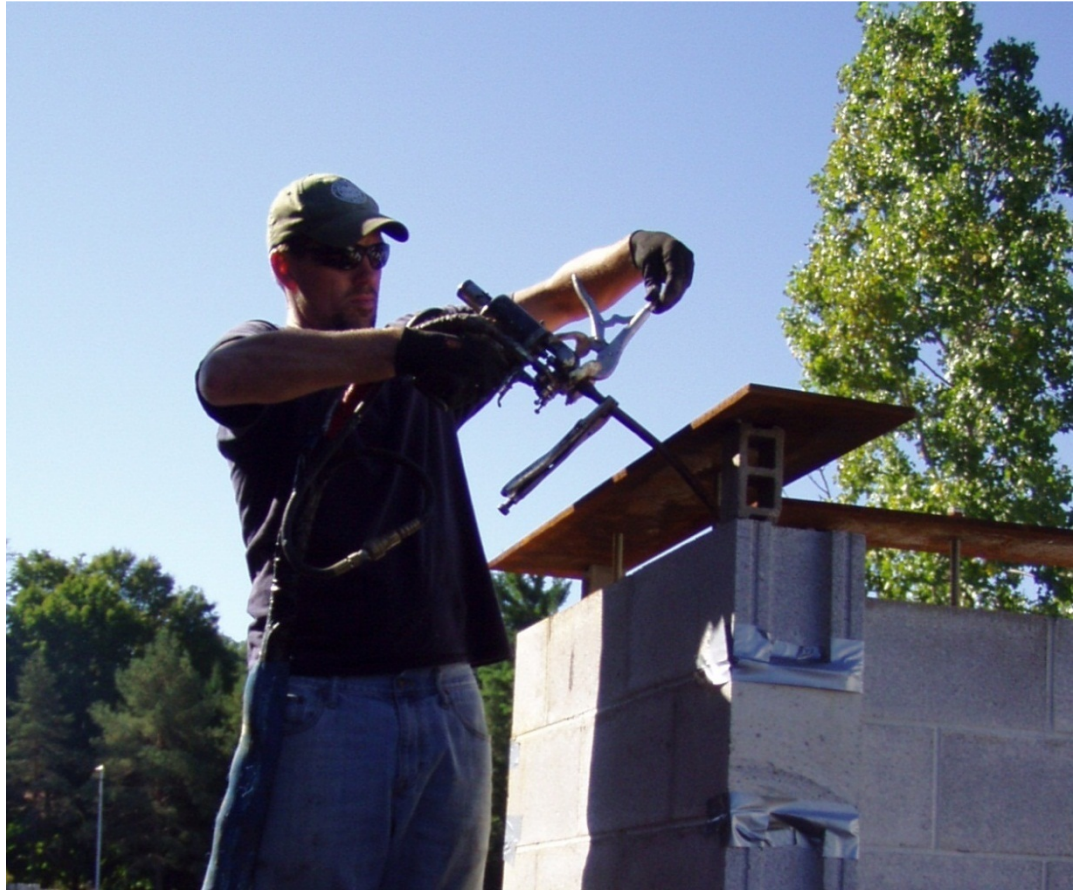
In this method, each cell of the masonry wall is filled individually. A copper rod is inserted down the length of the masonry cell to approximately mid-height. A nozzle is attached to the top end of the rod, connecting the rod to the hose where the polyurethane foam is pumped in from a truck. This method can be seen in Figure 5-4. The foam is then injected, and the liquid polymer flows to the very bottom of the cell. As more material is injected, the foam begins to rise and the copper rod is withdrawn as the rising foam reaches its bottom tip.

Figure 5-4: Top-Down Injection

There are many flaws with this method of injection. Firstly, this method allows the polyurethane foam to freely expand upwards as it fills the masonry cells. This means, that the density of the foam product is that of its free-blown density. If this foam was made to be confined, it can reach much higher densities, which can invariably lead to much higher strengths within the material. If say, the top of the wall was made to be closed off and no longer open to the air, and then a hole drilled at the top through which one could insert the copper rod, this method would result in much denser foam.

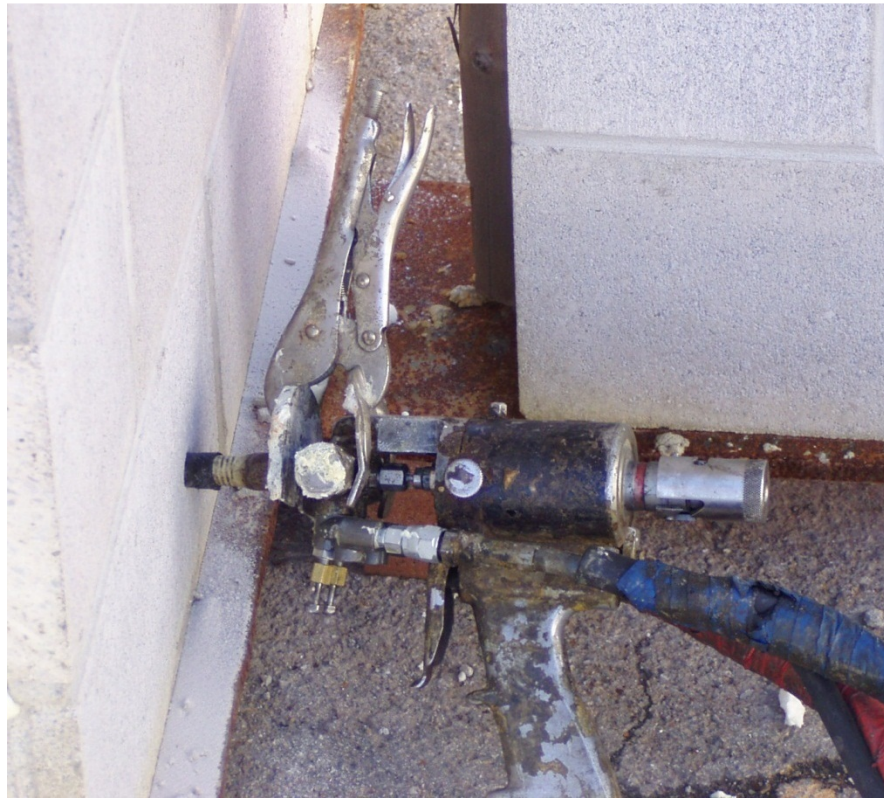
This method utilizes the air voids between the cores, by specifically planning for the liquid foam to travel across the cells. For the single injection point method, one hole is drilled into either the mortar bed or the face shell of the masonry block at the base of the wall. The pressurized hose is then inserted into the drilled hole, and the foam is injected into the opening as can be seen in Figure 5-5. Enough material is injected into the wall to appropriately fill the entire wall.

Figure 5-5: Injection Apparatus and Set-up

This method is only suitable for smaller walls that are only a block or two wide, so as to avoid hollow voids within the walls. In order to check if foam has been able to

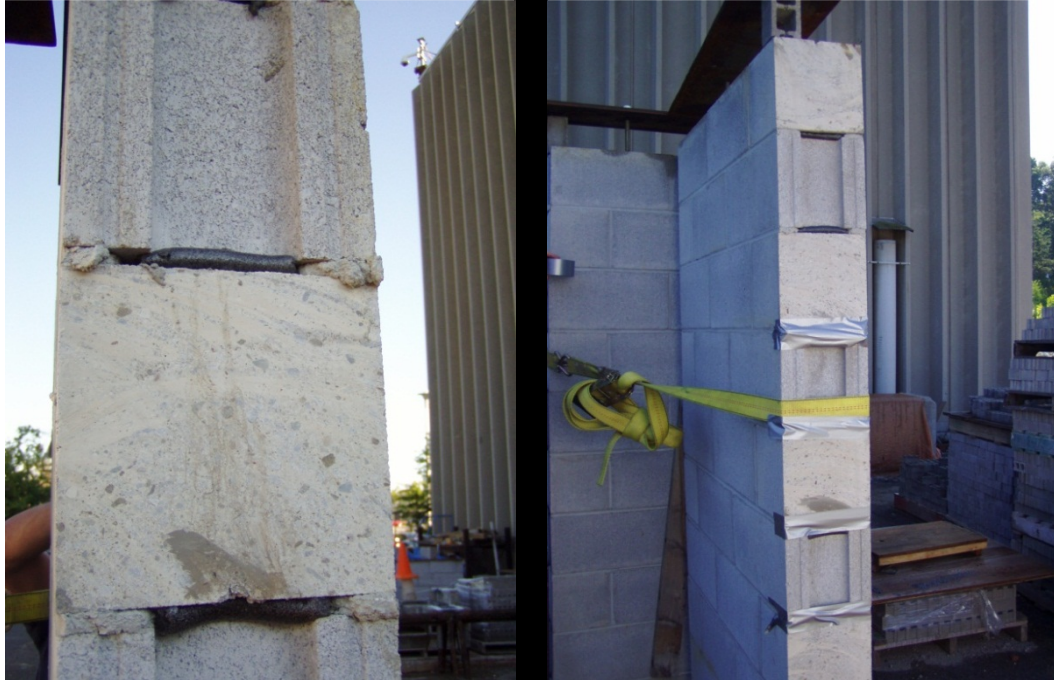
stuffed into these openings and secured with duct tape, which can be seen below in Figure 5-7. In some places, the pressure of the expanding polyurethane foam after injection was able to push out the foam tubing and remove the duct tape from the wall, showing the force and power it can have.

Figure 5-7: Injection Preparation For Walls With Company B Polyurethane Foam

The walls injected with B-1 and B-2 polyurethane foams were both pre-existing walls built by a previous student. They are 1m (two and a half blocks) wide and 2.2m (11 courses high). These walls were filled using method number one, the top-down injection process. As these were the first walls injected with foam, the injection techniques had not yet been perfected. These 2.2m walls were built leaving open air voids where any half block was exposed to the outside edge of the wall. This meant that liquid polyurethane would make its way out of these openings, which would result in a great loss in material, and also would decrease the confining effect that the masonry is supposed to have on the foam so as to densify it. To counteract this problem, small pieces of foam tubing were

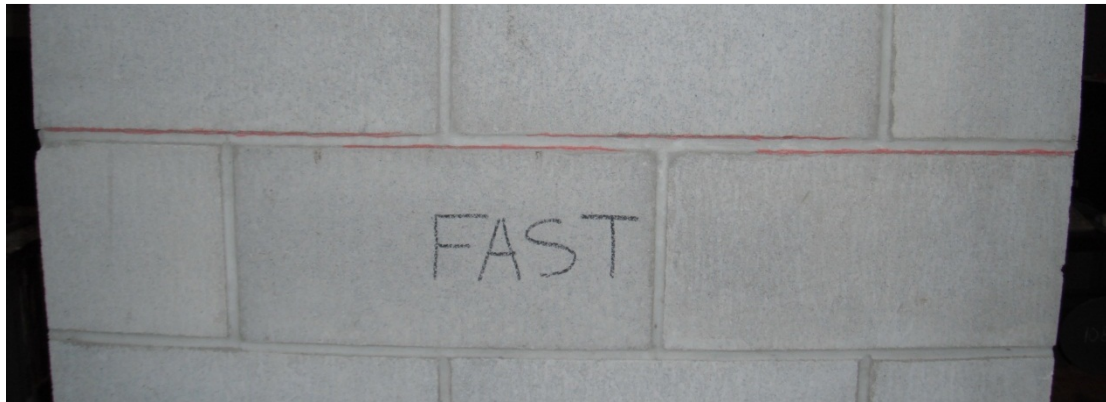
As the wall specimen experienced its period of high loading, the complete crack pattern was able to form. Within the first 2.5mm of deflection, the crack pattern shown below in Figure B-0-3 had formed, forming cracks travelling across the entire width of

Figure B-0-3: Close-up of Initial Crack Pattern at a Deflection of 2.5mm of B-1 2.2m Wall

the wall between the fifth and sixth rows of blocks. As loading continued, this same crack pattern further developed and spread out. Between a deflection of 10mm and 12.5mm an additional crack pattern formed between the sixth and seventh layer of blocks which almost exactly mirrored the initial crack pattern that had first formed at a deflection of 2.5mm. After the formation of this extra row of cracks, the wall lost its strength as both rows of cracks opened up. Upon continued loading, the initial crack pattern governed and gradually opened up as deflection increased. The evolution of this crack pattern can be seen in Figure B-0-4 and Figure B-0-5.

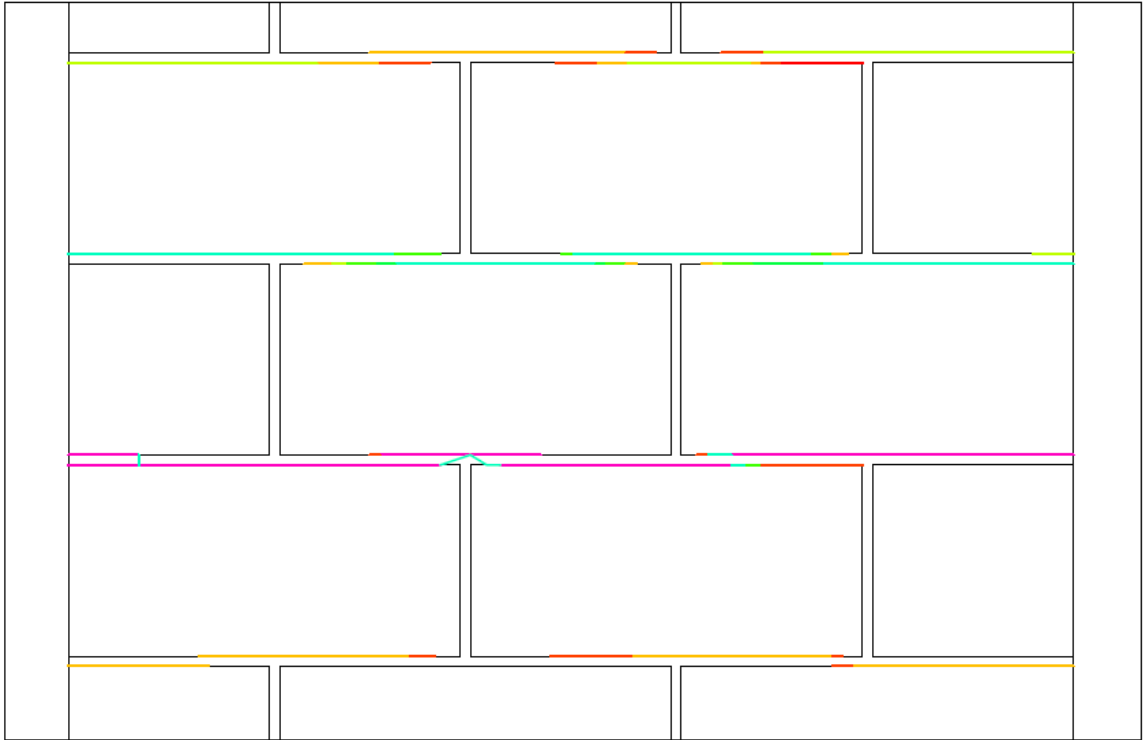
Figure B-0-8: Close-up of Crack Pattern of B-2 2.2m Wall

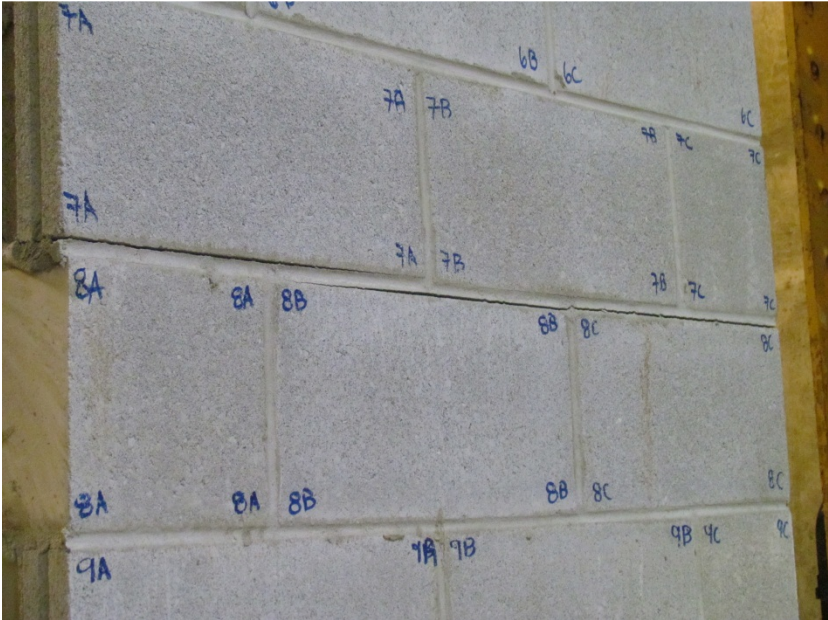
The crack pattern shown below in the photograph in Figure B-0-10 was the first crack in the wall and the formation of this crack can be seen graphically in the first peak of the load-displacement curve above. Following the formation of this crack, no new cracks formed. Instead, this one crack simply widened, leading to the collapse of the wall. The crack occurred between the seventh and the eighth row of blocks which is within the expected cracking region of the middle third of the wall, and is in fact as close to the middle of the wall as possible. The crack pattern can also be seen in Figure B-0-11 and Figure B-0-12.

Figure B-0-10: Cracking Pattern of Unreinforced 3 m Control Wall

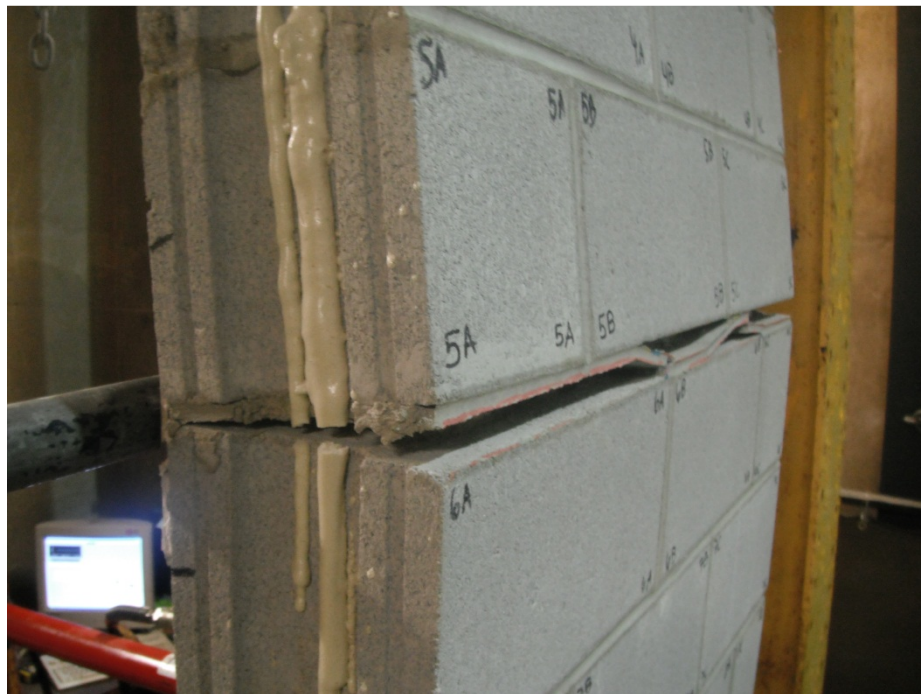
The wall was able to sustain further loading as the crack continued to form along the length of the wall. At a deflection of 15mm the wall was almost fully cracked, and the loss in strength at this point in time can be clearly seen in the lateral load versus lateral displacement graph at this location. Between the displacement of 15mm and 17.5mm the wall cracking became very loud as the mortar split apart, and the crack widened significantly. After this point, under continued loading no new cracks were formed, with the previous crack pattern simply widening over time until the wall reached ultimate failure.

Figure B-0-20: Cracking Pattern of Medium Density C-2 3m Wall

expected to occur. As the crack occurred so high within this range, it would be expected that this wall behaved at the lower end of its capacity. If the crack would have formed at mid-height as was the case for the low density wall, it could be expected that a greater deflection could have been reached at the point when the wall reduced its loading.

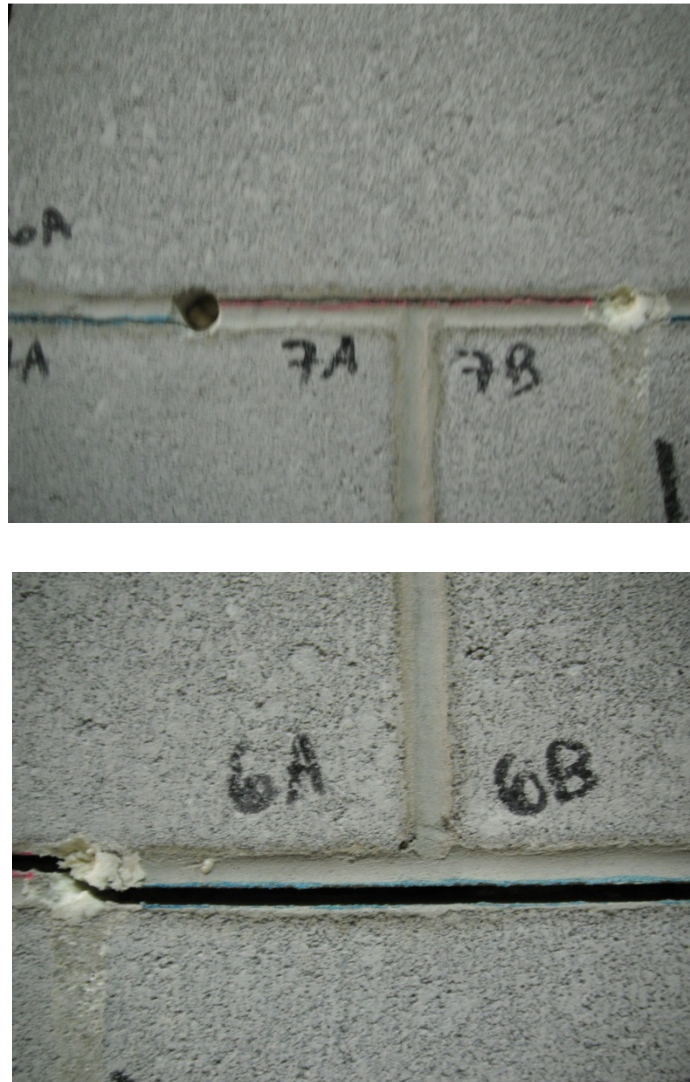
Figure B-0-24: Sudden Widening of Main Crack in High Density C-3 3m Wall

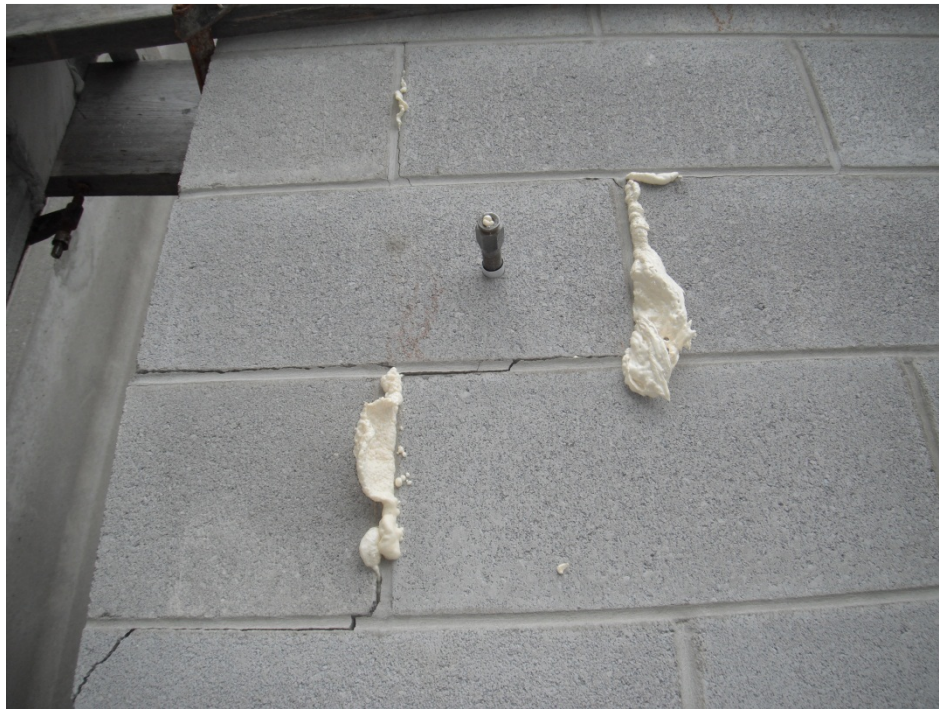
Figure B-0-28: Pre-mature Failure of B-2 Wall With Three Roped Cells Due to Expansive Force of the Foam
