**PROCESS OPTIMIZATION IN MACHINING: AN APPLIED RESEARCH
APPROACH**

**A Thesis Submitted to the School of Graduate Studies in Partial Fulfilment
of the Requirements for the Degree Master of Applied Science.**

McMaster University © Copyright by Simon Oomen-Hurst, September 2012

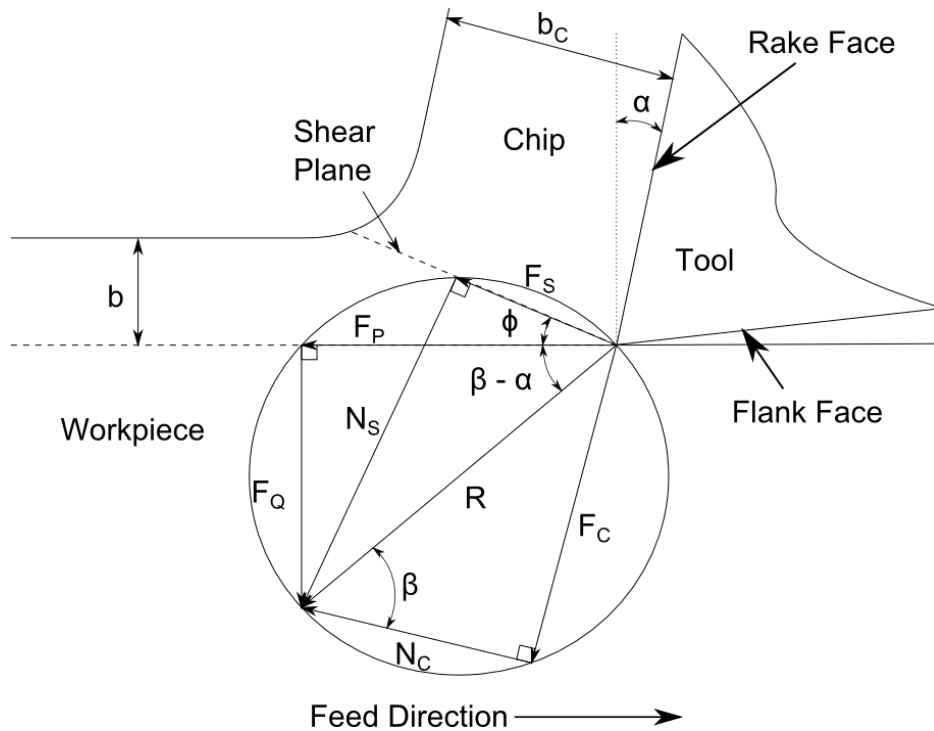
Figure 2.2-2 – Cutting forces diagram for orthogonal cutting according to Merchant's model

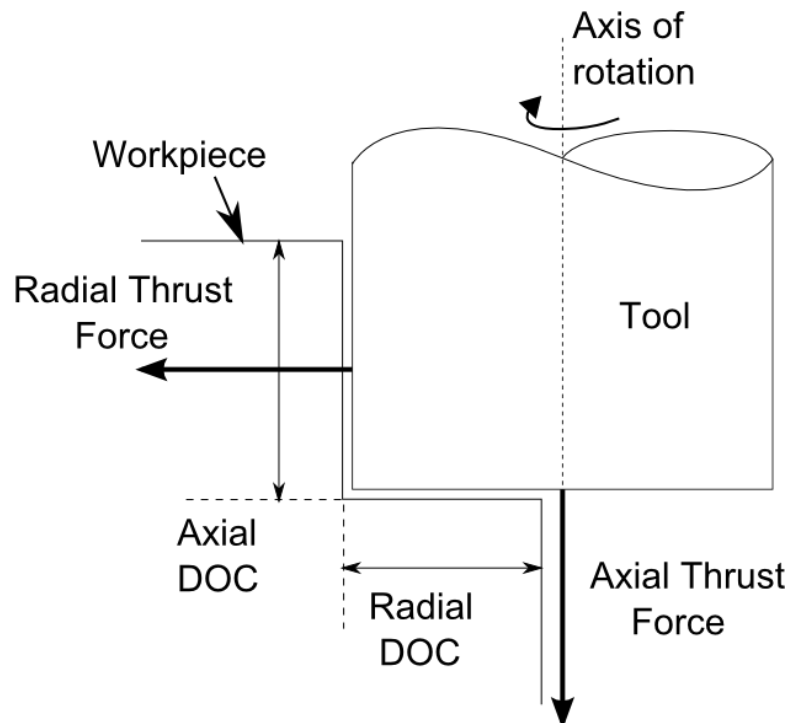
Figure 2.2-3 – Cutter showing both axial and radial engagement with a workpiece

In the following work, it is necessary to understand three forces involved in milling. The three are essentially cutting force (F_p) and thrust force (F_Q) for two faces, as shown in Figure 2.2-3. Cutting is occurring on both the axial and radial faces of the tool, and applying the orthogonal assumption means that there will be a cutting force and a thrust force for each. The cutting force for both edges act in the same direction, and can be represented as a resultant cutting force. The thrust forces for each face act perpendicular to the face. In this work, the axial thrust force is described as the "thrust force", and the radial thrust force is described as the "side force".

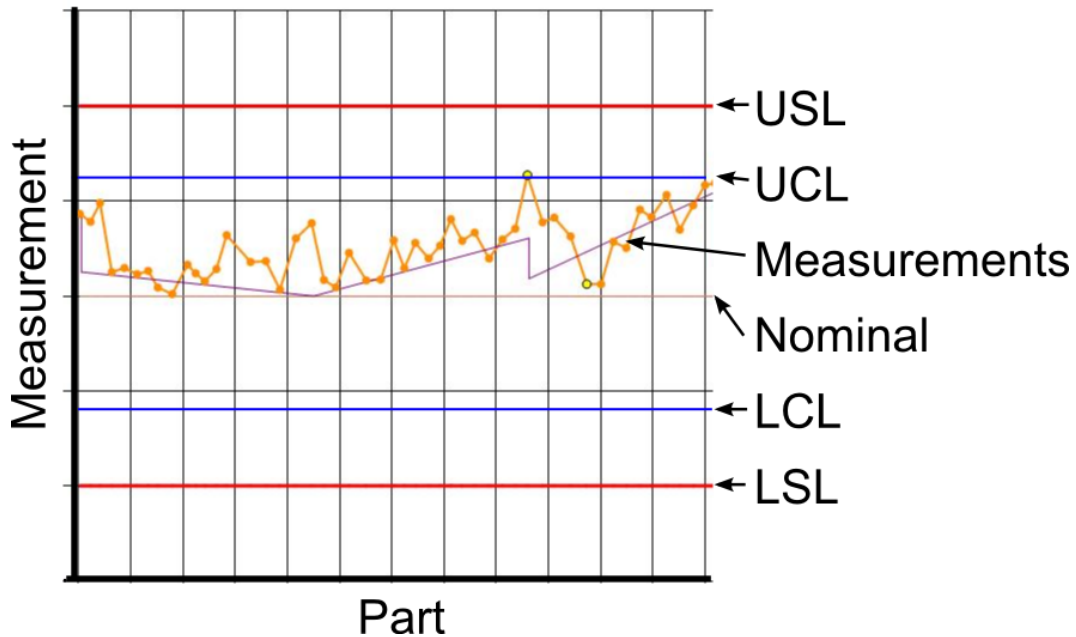
Figure 2.5-1 – Sample control chart

understanding of control charts. A sample control chart showing some necessary terminology is shown in Figure 2.5-1 and explained in Table 2.5-1.

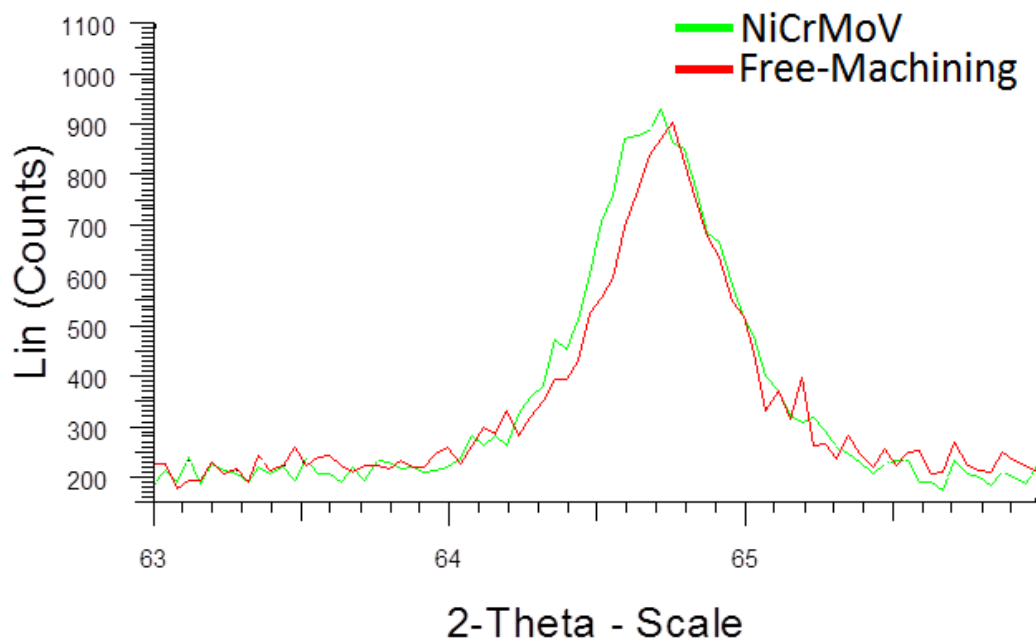
Figure 3.1-6 – X-Ray Rontgen Diffraction comparison plot for NiCrMoV steel sample

Due to the inconclusive results in the SEM and optical inspection methods discussed in Section 1.1, X-ray Rontgen Diffraction (XRD) inspection was selected to identify the microstructure of martensite qualitatively with a high degree of certainty and to verify conclusions drawn from SEM and optical methods. Figure 3.1-6 provides a plot comparing the martensite lines of both NiCrMoV and the free-machining sample. This data allows for identification of the crystal structure of the material, which corresponds to ferrite, austenite or martensite. Processed results are shown in Table 3.1-4.

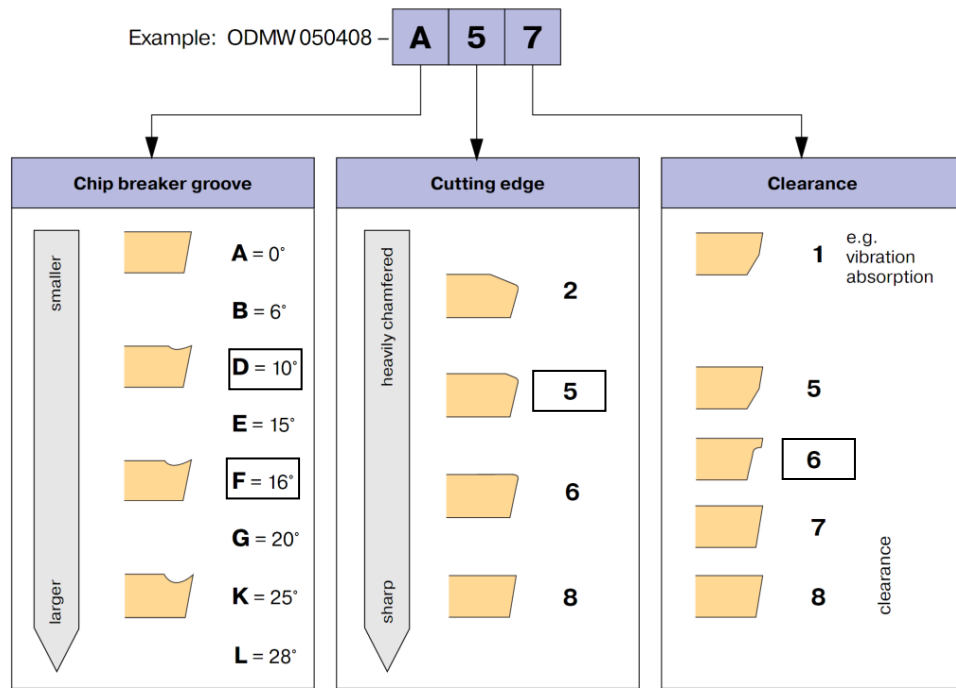
Figure 3.2-1 – Walter Tools chip breaker geometry for inserts (Walter Tools, 2007)

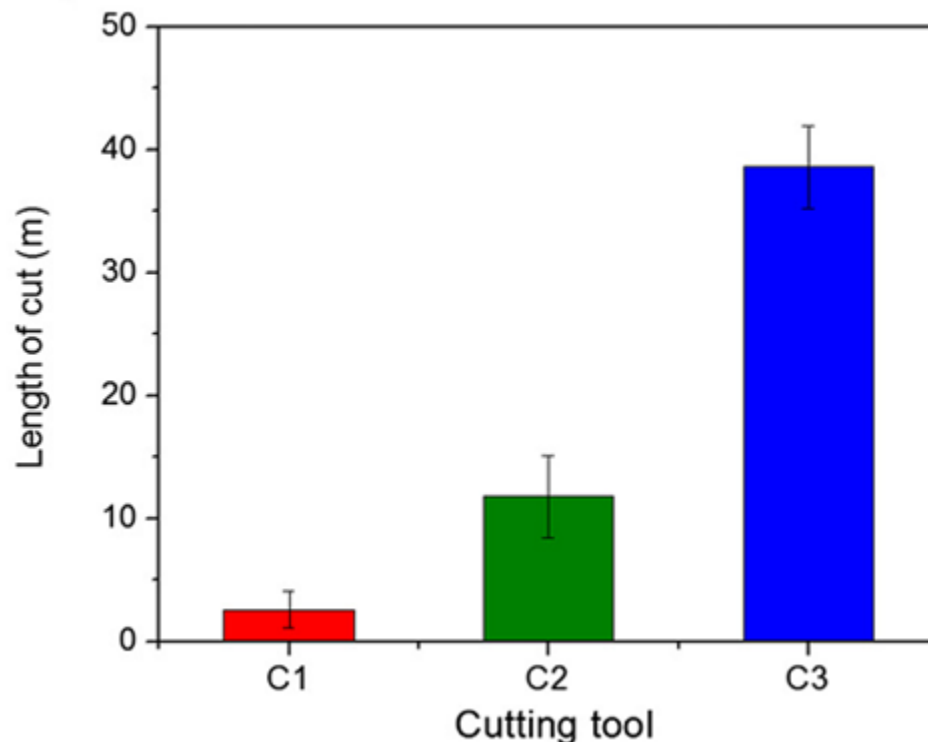
Figure 3.2-4 – Insert performance (tool life)

Insert C3 showed the best tool life of the tested inserts (PVD deposited TiAlN/ Al₂O₃/ZrN; 16° rake angle). C3 lasted an impressive 193 passes before reaching the failure criteria, which was approximately ~50 m cutting length. This is a 1200% improvement over C1, and over a 300% improvement over the baseline tooling, C2.

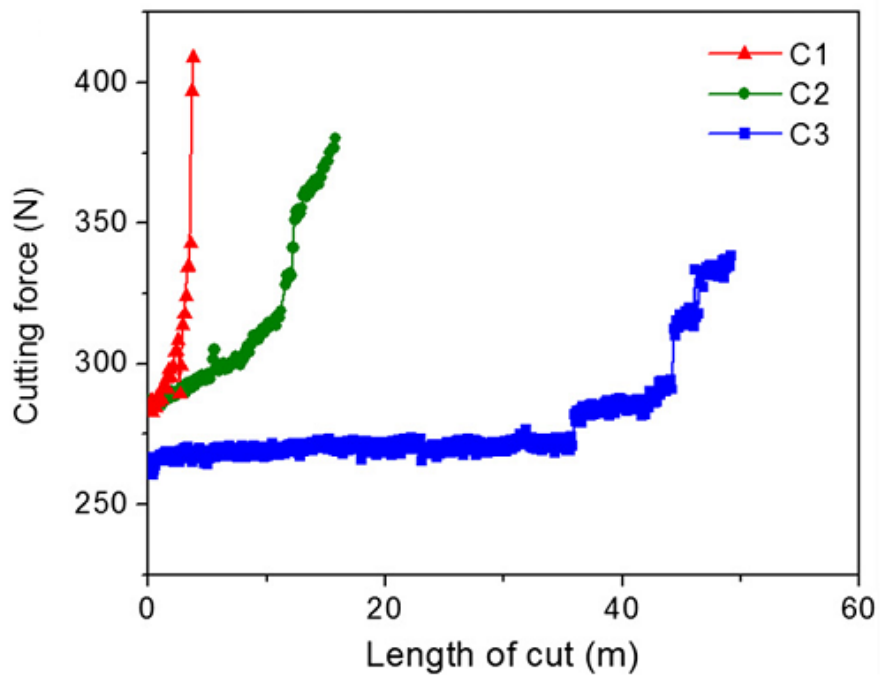
Figure 3.2-7 – Plot of cutting forces for each insert over the course of tool life

Figure 3.2-7 – Plot of cutting forces for each insert over the course of tool life shows the cutting forces for each insert, and C3 does show a significant decrease in cutting force, however this may just be an artifact of the fact that C3 had reduced flank wear compared with the other inserts. This reduced flank wear may have been responsible for the low cutting forces seen. To ensure the lowered force is the result of tool performance and not flank wear, flank wear compared to cutting force is shown in Figure 3.2-8 – Flank wear vs. Cutting forces. For all levels of flank wear, C3 showed lower cutting forces. It is therefore clear that the reduced force is not an artifact of reduced levels of flank wear.

compared to C1 and C2. The cutting force (X), the most dominant force during the cutting process, is plotted vs. length of cut in Figure 3.2-7 for the inserts. In comparing Figure 3.2-6 and Figure 3.2-7, it is clear there is a strong correlation between cutting force and flank wear. As seen in this graph, the cutting forces for the C3 insert remain very steady through testing and only increase once significant wear had occurred. This confirms the extremely low and stable wear seen in flank wear measurements of C3 tools, not showing any significant increase in cutting force until higher wear rates in the 35.7–44.0 m range.

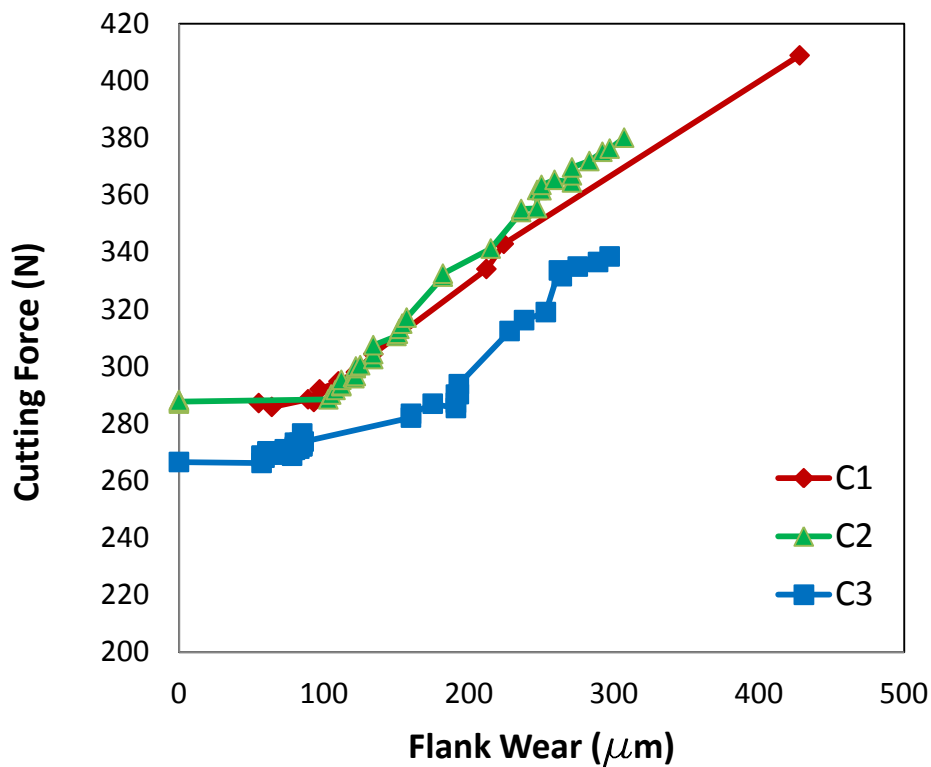
Figure 3.2-8 – Flank wear vs. Cutting forces

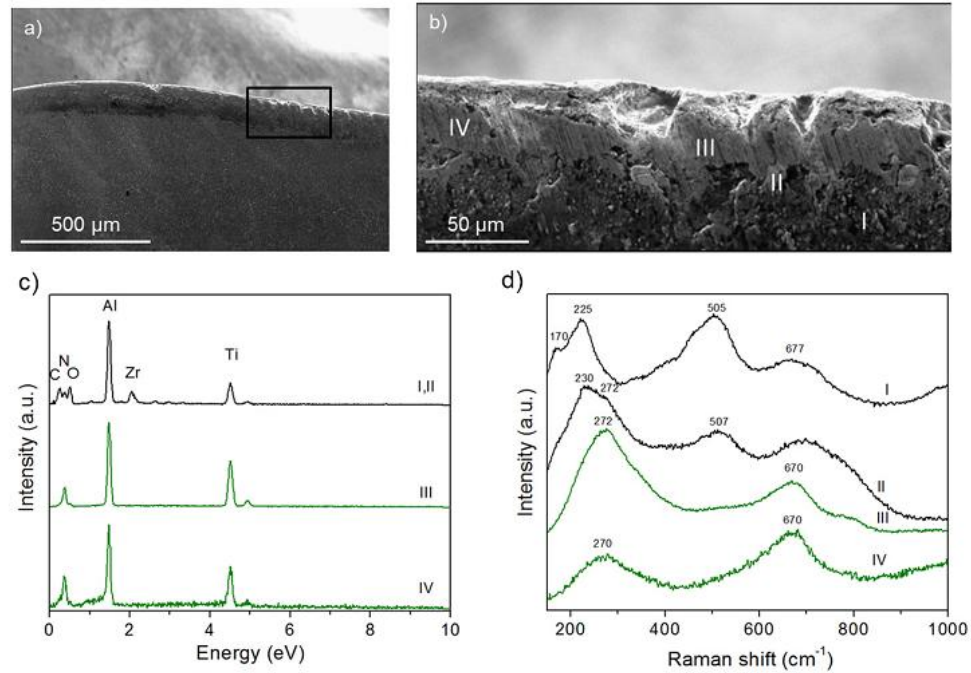
Figure 3.3-11 – SEM images of C3 (a and b), EDX (c), and Raman spectra (d) of indicated zones, in the steady state wear region at approximately 30 m

Figure 3.3-11(b) shows a higher magnification SEM micrograph of the square area in (a). Four different areas have been identified: Zones I and II correspond to the coating layer, as seen by EDX in (c). Zones III and IV showed identical EDX spectra with only titanium, aluminum and nitrogen being identified. The Raman spectroscopy results for Zone I show the ZrN bands, as previously seen for this coating type. In Zone II, the bands associated with ZrN and TiAlN are present. Zones III and IV again showed the TiAlN bands and no characteristics associated with ZrN. Al_2O_3 was not been observed by Raman, possibly because the γ -phase could not be detected by this technique. However, the fact that EDX shows only titanium, aluminum and nitrogen, and not oxygen, indicates that any Al_2O_3 layers have been detached.

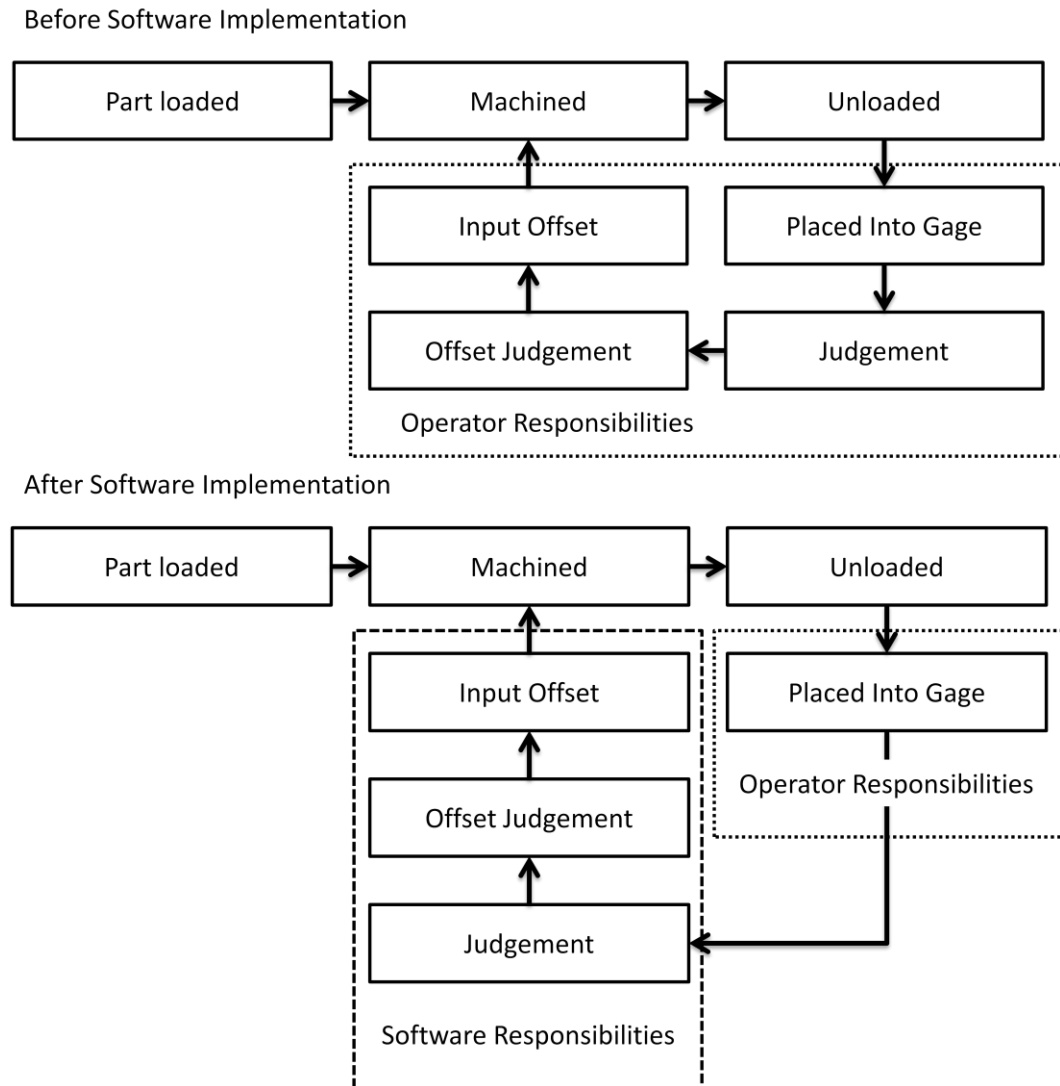
Figure 4.2-6 – Top: Operator responsibilities before software implementation. Bottom: Operator and Software responsibilities after implementation.

A flowchart of the responsibilities of the operator is shown in Figure 4.2-6 along with the planned shift of these responsibilities to the software.

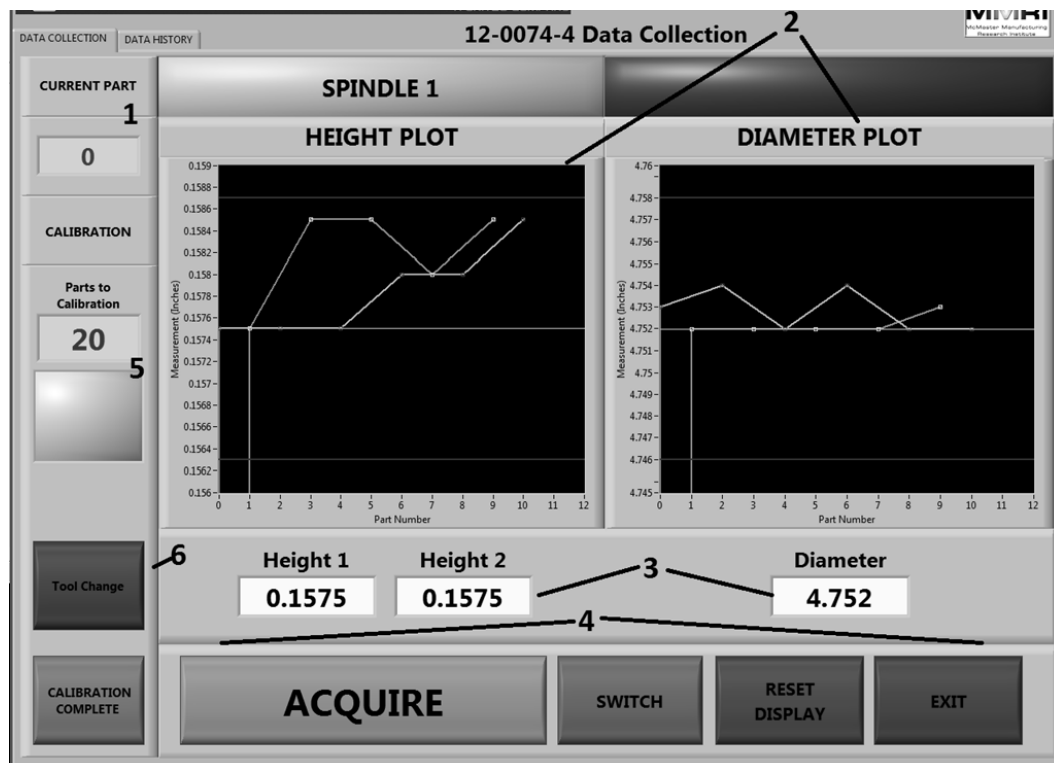
Figure 4.3-1 – Software interface

The interface shown below in Figure 4.3-1 was developed in cooperation with the industry partner. The interface with the operator took some time and effort to develop. The reason for this is that it is critical that interfacing with the software does not significantly increase the amount of time it takes for an operator to process a part. This is discussed in detail in section 4.3.3.

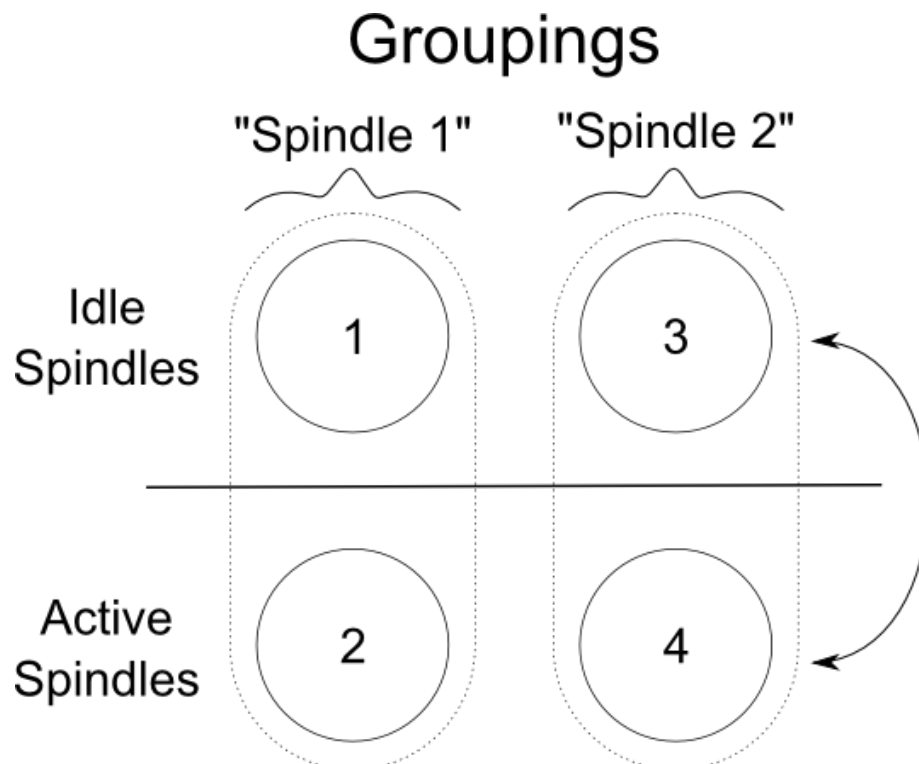
Figure 4.4-1 – Explanation of grouping of four spindles into two groups, and reference convention for the groups

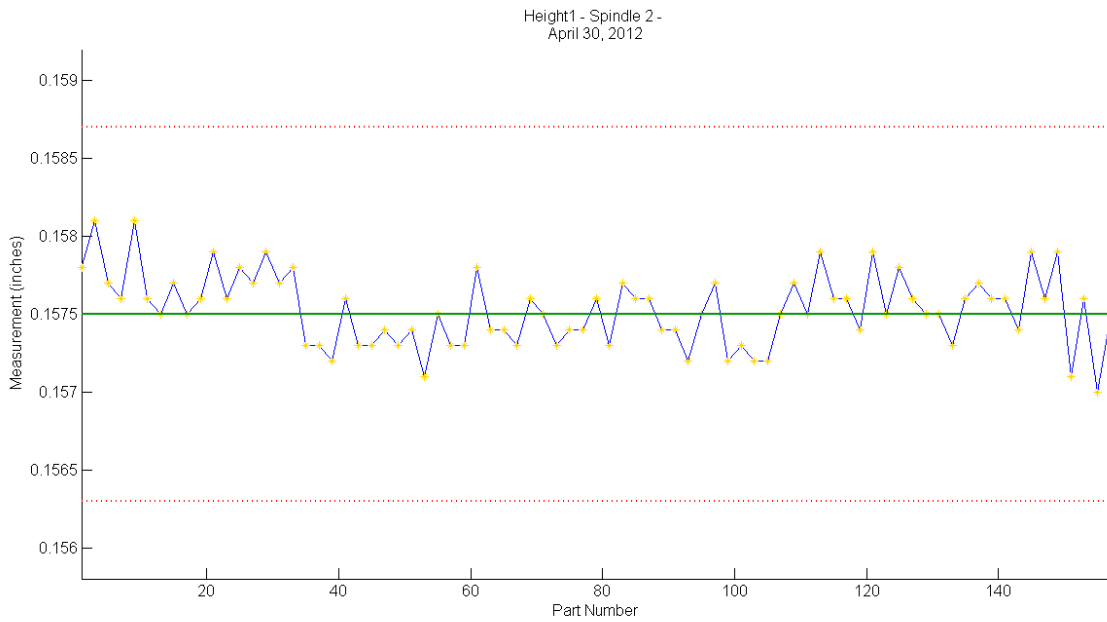
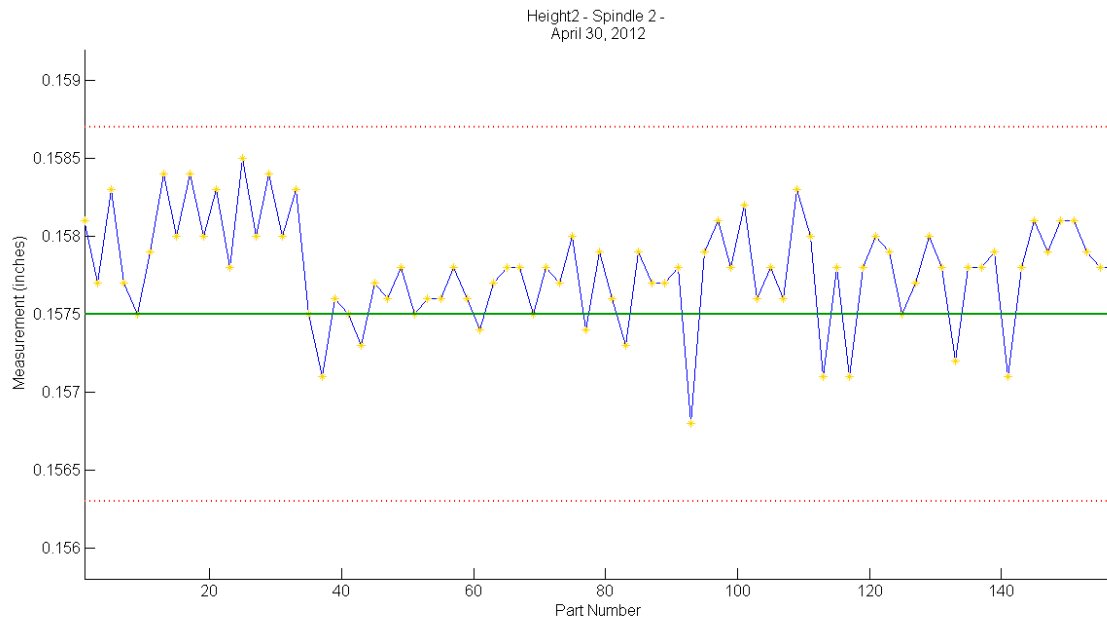
Figure 4.5-13 – Control chart for April 30, 2012 data collection, showing diameter measurements from spindle 1

Figure 4.5-14 – Control chart for April 30, 2012 data collection, showing diameter measurements from spindle 2

Figure 4.5-15 – Control chart for April 30, 2012 data collection, showing height 1 measurements from spindle 1

Figure 4.5-16 – Control chart for April 30, 2012 data collection, showing height 1 measurements from spindle 2

Figure 4.5-17 – Control chart for April 30, 2012 data collection, showing height 2 measurements from spindle 1

Figure 4.5-18 – Control chart for April 30, 2012 data collection, showing height 2 measurements from spindle 2
