**IN PLANE SLIDING SHEAR BEHAVIOUR  
OF  
UNREINFORCED CONCRETE MASONRY  
RETROFITTED WITH  
SURFACE-BONDED FIBREGLASS LAMINATES**

A Report  
Submitted to the School of Graduate Studies  
in Partial Fulfilment of the Requirements  
for the Degree  
Master of Engineering (M.Eng.)

TITLE: In Plane Sliding Shear Behaviour of Unreinforced Concrete Masonry  
Retrofitted with Surface-Bonded Fibreglass Laminates

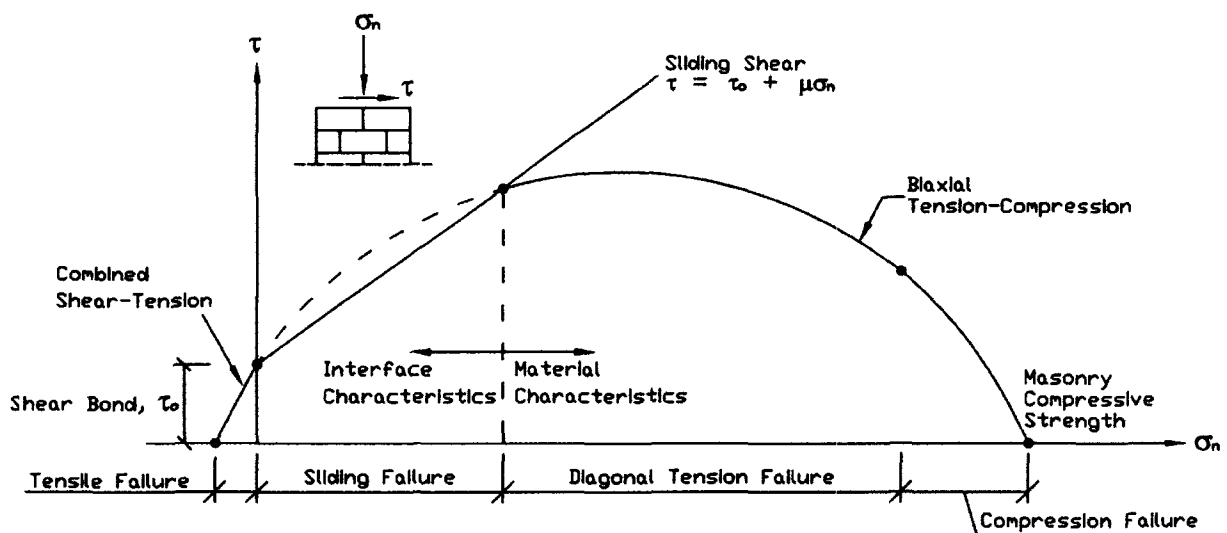
Figure 1.1 – Behaviour of Unreinforced Masonry Under Combined Shear and Normal Stress Along the Mortar Bed Joints [reproduced from Drysdale et al., 1999]

also depends on the tensile strength of the units. However, depending on the combination of vertical and shear forces, stepped diagonal cracking can occur. This stepped diagonal cracking is caused also by slip along one or more of the bed joints. This is most likely to occur near the threshold between sliding failure and diagonal tension failure, as illustrated in Figure 1.1.

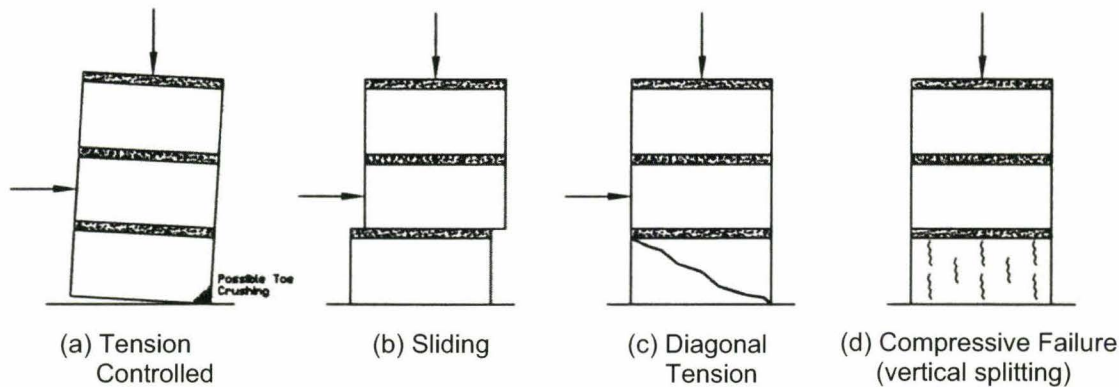
**Figure 1.2** – Failure Modes of Unreinforced Masonry Shear Walls  
[reproduced from Drysdale et al., 1999]

For masonry buildings subjected to lateral loading caused by earthquakes the two dominating failure modes are diagonal tension and shear slip failure (Atkinson et al., 1989). Illustrations of the aforementioned failure modes are found in Figure 1.2.

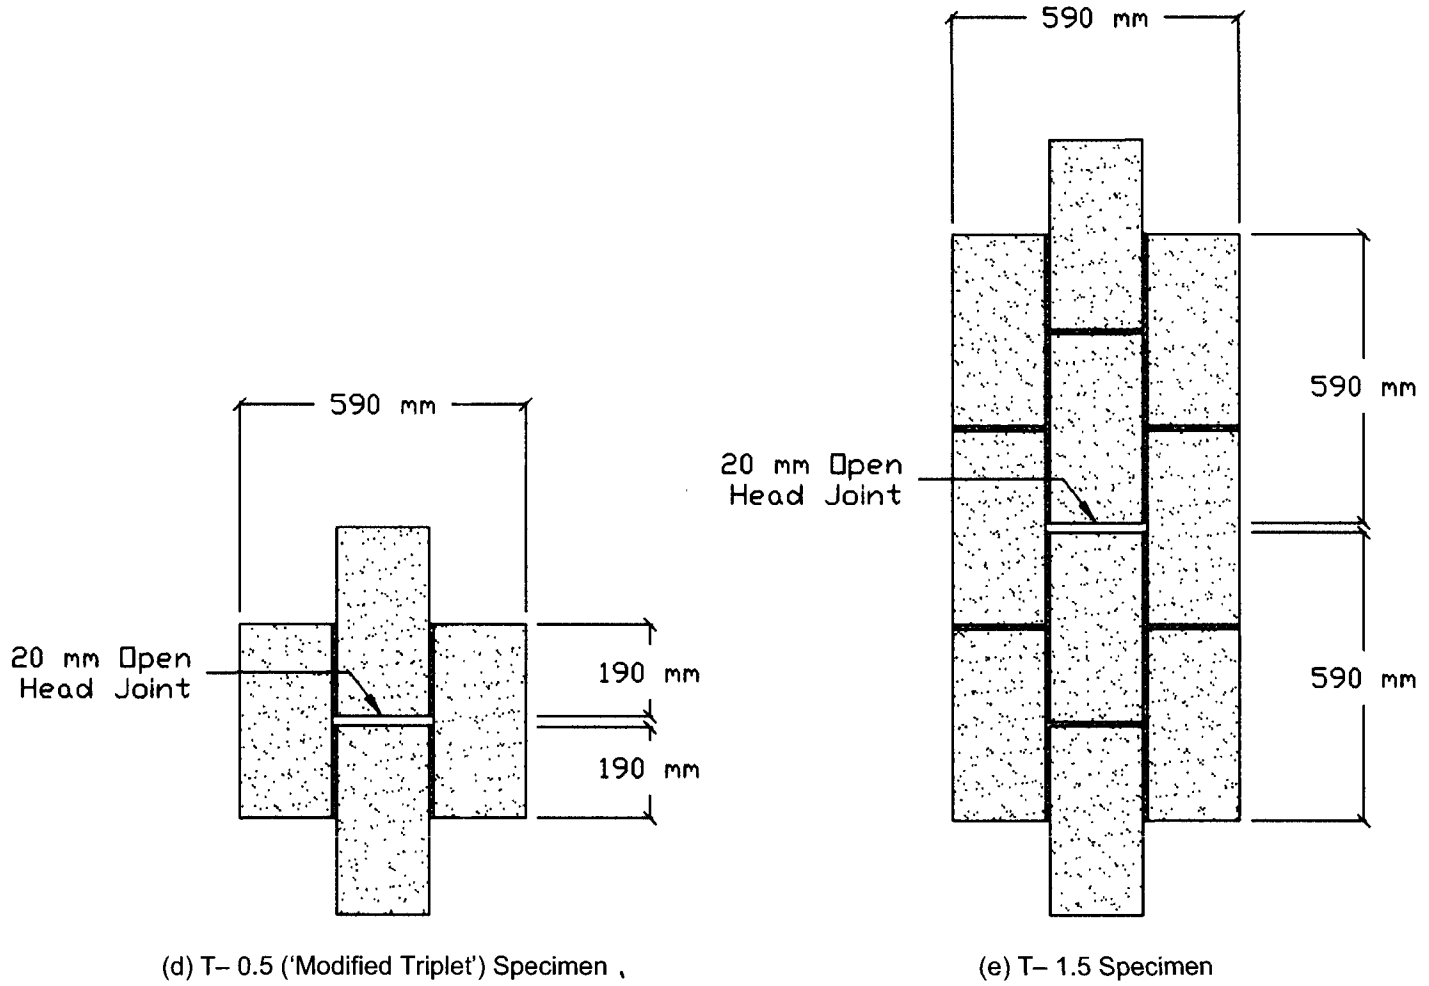
Figure 2.1 – Phase One Test Specimens (Full Stretcher Units Used)

Figure 2.1 (continued) – Phase One Test Specimens (Full Stretcher Units Used)

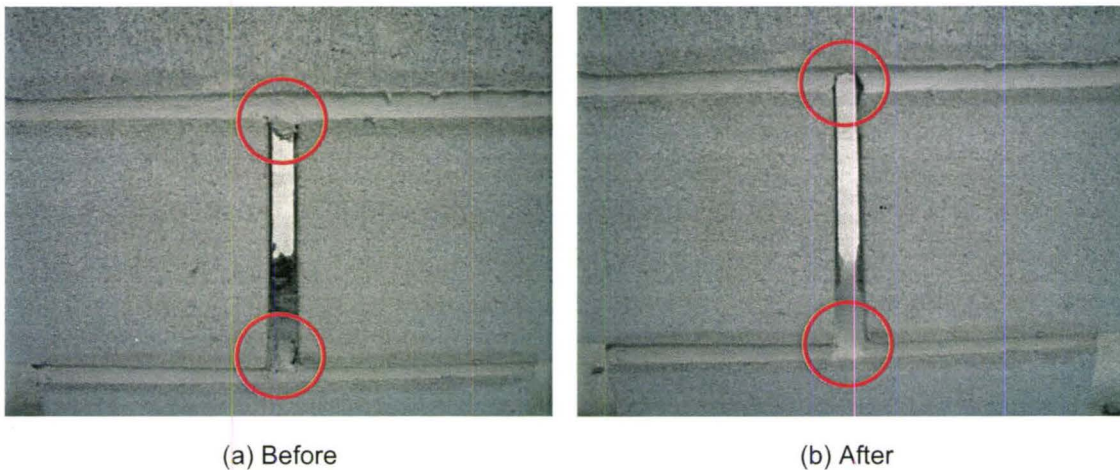
**Figure 2.4 – Excess Mortar Removed from Open Head Joints**

As can be see in Figure 2.4, any excess mortar in the open head joints of the ‘T’ specimens was carefully removed to prevent interference with the slip of the blocks along

the bed joints. This excess mortar in the open head joints was not removed until after the specimens had cured. It was carefully drilled out with a 1/8 inch masonry drill bit. Fortunately none of the specimens were damaged during this process. [It was recognized that this method was not ideal. During the construction of specimens for the later test phases, the excess mortar in the open head joints was removed while the mortar was still fresh.]

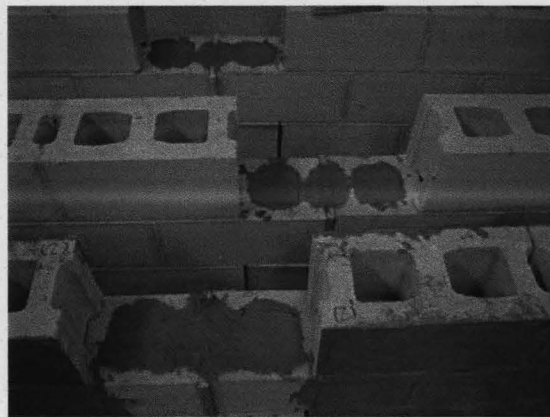
**Figure 2.7 – Grouted End Cells**

Since the specimens were not grouted, there was concern that they might fail in compression at the supports and points of application of the load rather than by shear-slip along the bed joints. This would result in a lower bound strength and diminish the value of the test. Therefore, to help ensure reaching a shear-slip failure along the bed joints, the end cells and fogged ends of blocks at the extreme top and bottom of each specimen were grouted (Figure 2.7) and subsequently wrapped with GFRP. Before the specimens were tested, the epoxy was allowed to cure for at least five days. [The manufacturer, Fyfe Co. (2004), recommends a minimum curing time of 48 hours.] Prior to testing, the top and bottom of each specimen was capped with a thin layer of Hydrostone to ensure full contact with the 12.7 mm ( $\frac{1}{2}$  inch) thick steel loading plates.

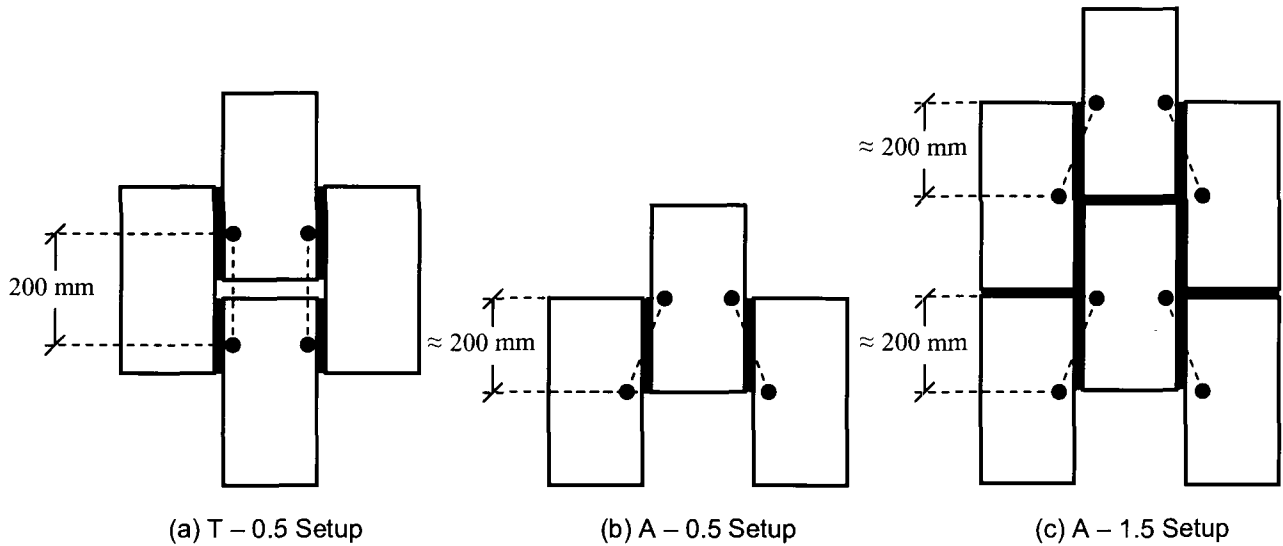
**Figure 2.9** – Phase One Mechanical Displacement Gauge Setup for Smaller Specimens

For all of the aforementioned specimens, displacement readings were only taken along one face. The load was recorded manually from the gauge on the test machine.

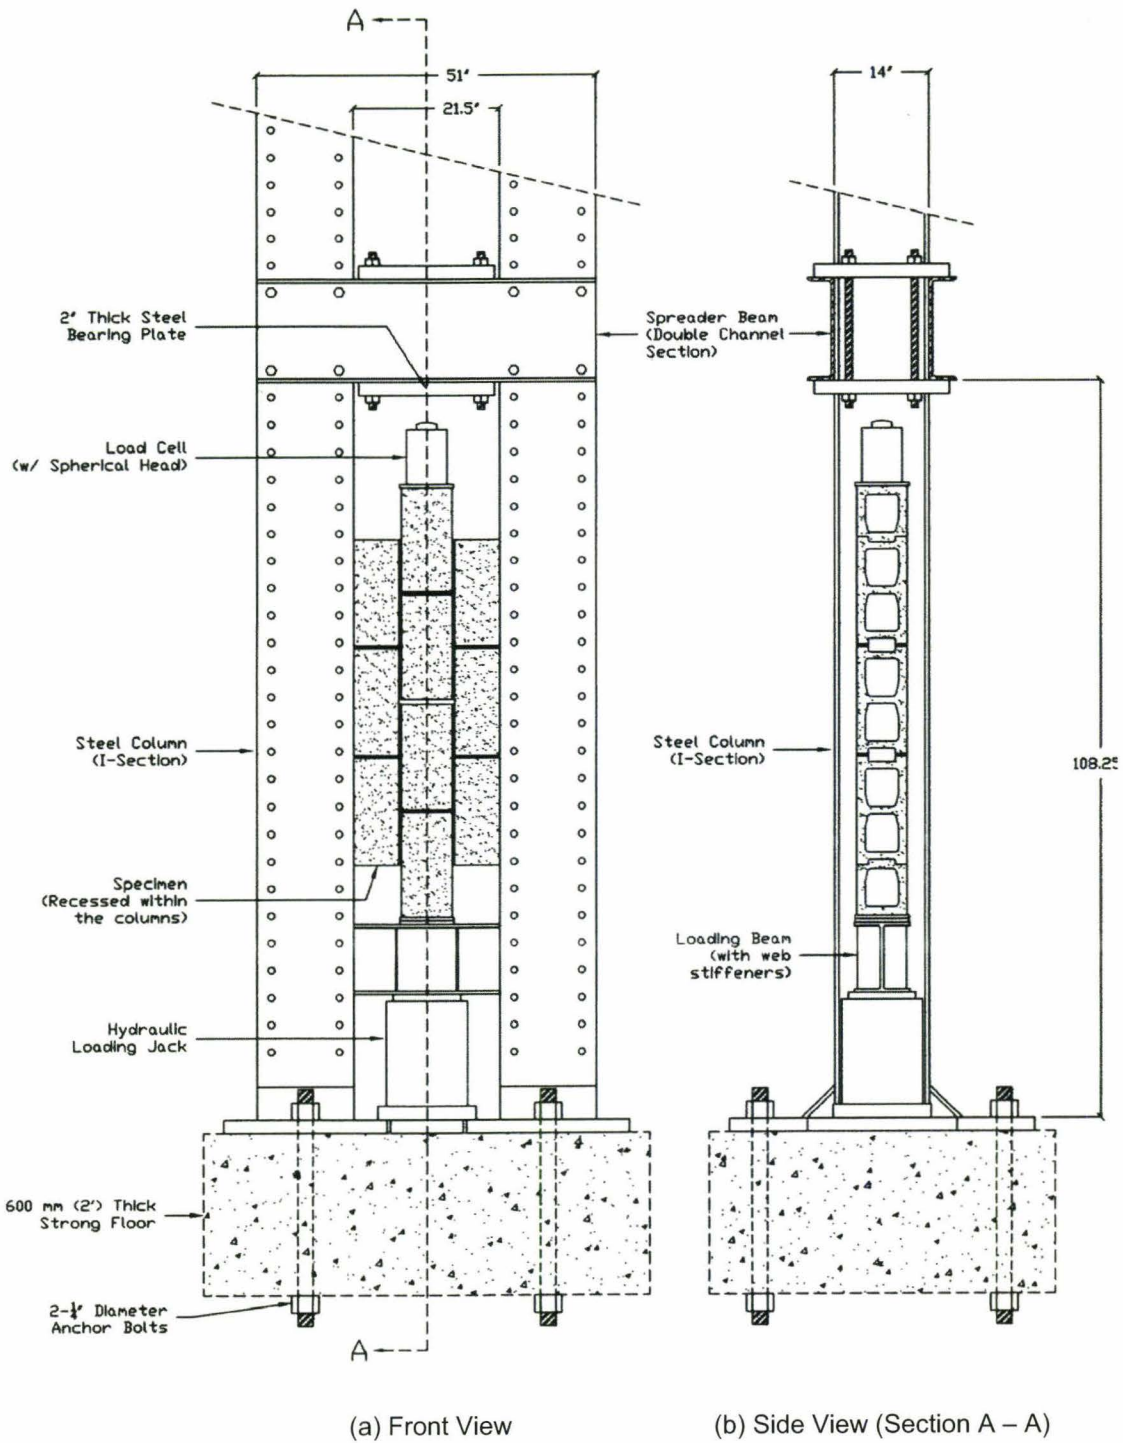
Figure 2.10 – Customized Testing Apparatus

**Larger Specimens.** For the larger specimens (i.e., A-2.5, T-1.5), it was necessary to construct a customized testing apparatus, as shown in Figure 2.10. The apparatus consisted essentially of two steel columns prestressed down onto the 600 mm (2 ft.) thick strong floor of the laboratory, a spreader beam, and a 51 mm (2 inch) thick steel top bearing plate. The load was applied using a hydraulic cylinder, with 1779 kN (400,000 lbs.) maximum capacity. The applied load was monitored using a commercial load cell with a spherical head.

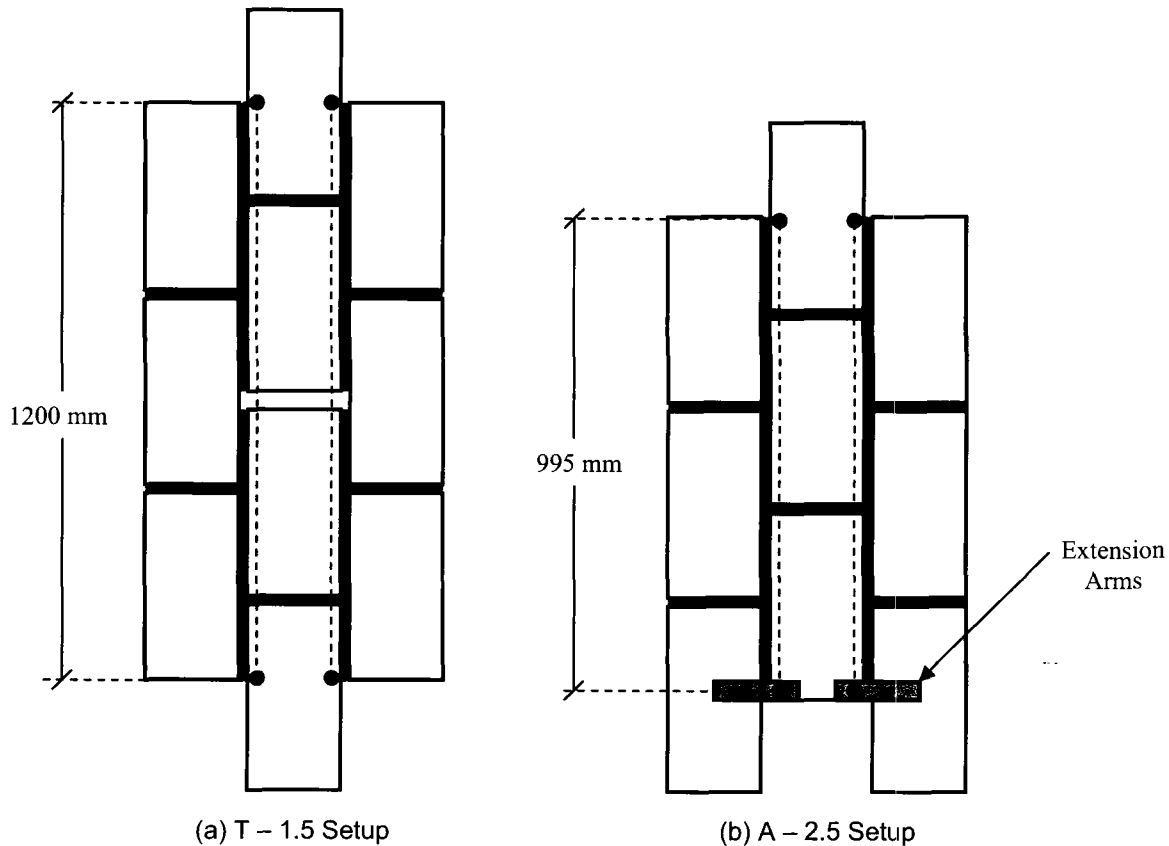
**Figure 2.11 – Phase One LPDT Setup for Larger Specimens**

The relative movement between the blocks along the slip plane was measured using linear potentiometric displacement transducers (LPDTs), with 25 mm stroke, connected to a PC data acquisition system. For the T-1.5 specimens, four LPDTs (two per face) were placed vertically to be parallel to the bed joints and spanned the middle gap, as shown in Figure 2.11(a). For the A-2.5 specimens, using extension arms to cross the bed joint, four LPDTs (two per face) were placed vertically and parallel to the bed joints, as shown in Figure 2.11(b). The extension arms were necessary to allow the LPDTs to be placed vertically. Otherwise they would have been oriented at an angle and not measured the actual slip. For the T-1.5 and A-2.5 specimens, the nominal gauge lengths were 1200 mm and 995 mm, respectively.

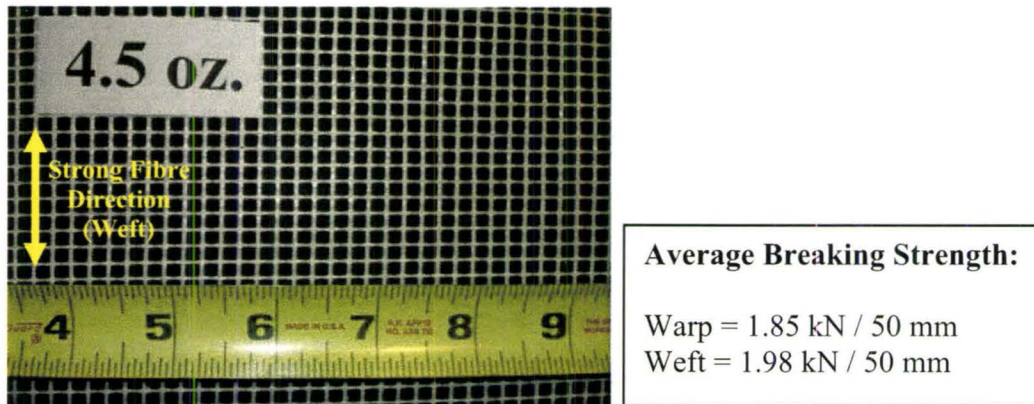
(a) Dry Mesh Weight: 3.9 oz./yd.<sup>2</sup> (4.5 oz./yd.<sup>2</sup> Finish Weight)

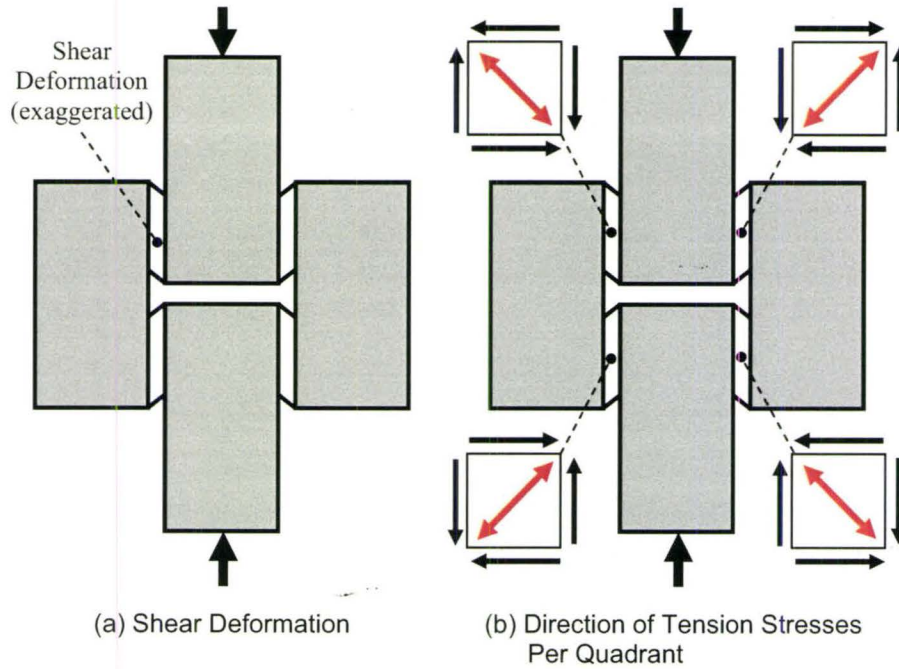
Figure 2.13 – Shear Deformation and Tension Stresses Along the Bed Joints During Testing

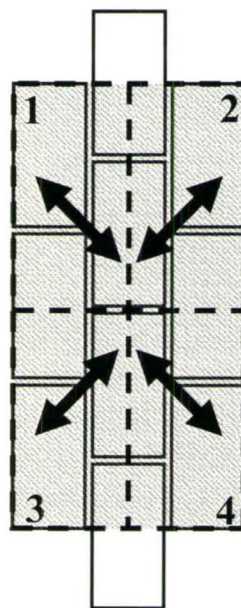
Figure 2.14 – Strong Fibre Direction Per Quadrant

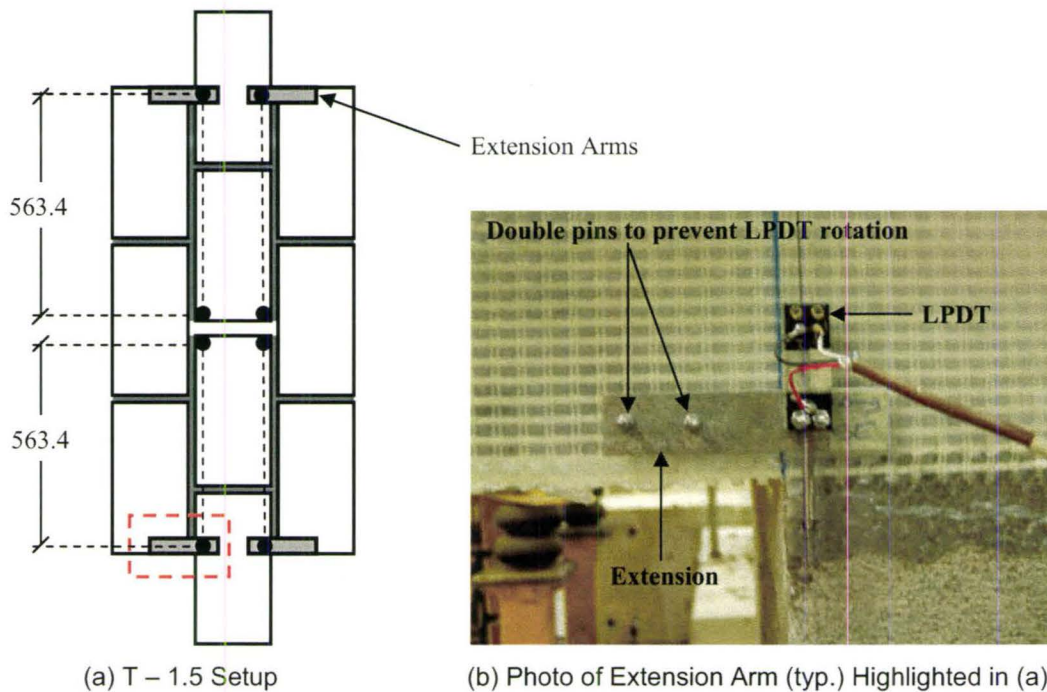
**Figure 2.16 – Phase Three LPDT Setup for All Specimens**

Specimens placed in the test apparatus were positioned and centred as accurately as possible to limit any rotation of the blocks in the direction perpendicular to the plane of the laminate. Another refinement added to the placement of the specimens in the apparatus was to centre and set them on a 1 mm thick, 15 mm wide strip of metal. The strip acted like a point load, ensuring the reaction load acted along the centre of the specimen, within the 15 mm width. With the strip at the bottom and the spherical head of the load cell at the top, the line of action was guaranteed to act close to the centreline of the specimen.

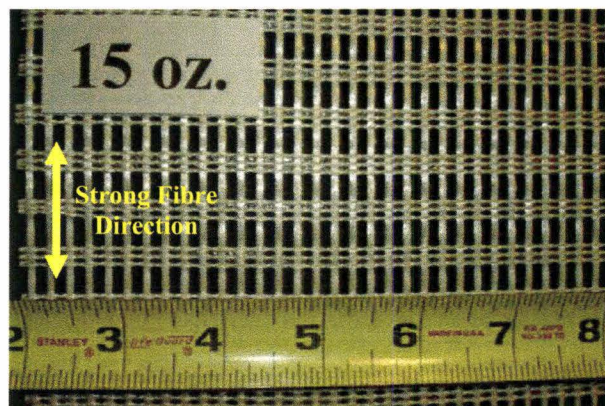
**Figure 2.17** – 15 oz./yd.<sup>2</sup> (Finished Weight) Mesh

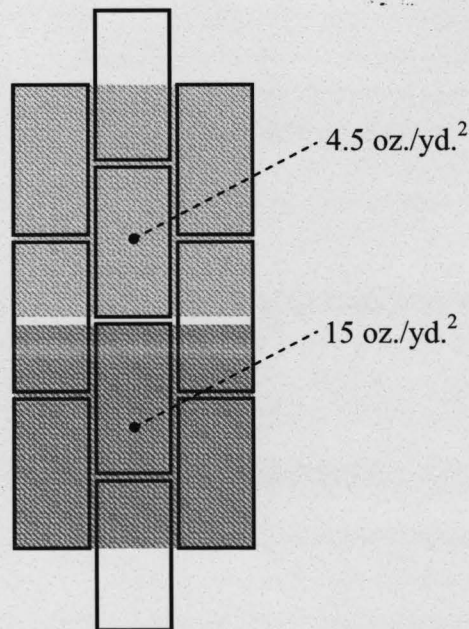
**Figure 2.18 – Phase Two Mesh Reinforcement Scheme**

The T-1.5 specimens were selected for this phase and were tested using the same equipment as used for the larger specimens of Phase One. In order to obtain two sets of data from one specimen, it was decided to apply two different weights of mesh on the same specimen. Half of each specimen would be reinforced with a light weight mesh and the other half would be reinforced with a heavier mesh. As described earlier for the other phases, the reinforcement was placed on both the front and back of the specimen. The mesh weights (finished) selected were: 4.5 oz./yd.<sup>2</sup> and 15 oz./yd.<sup>2</sup>. A photograph of each mesh can be found in Figures 2.12(a) and 2.17, respectively. The meshes were oriented at 0°/90° to the bed joint. The reinforcement scheme is illustrated in Figure 2.18.

The concept was that the slip planes reinforced with the 15 oz./yd.<sup>2</sup> mesh would be stronger and hence not fail before the slip planes reinforced with 4.5 oz./yd.<sup>2</sup> mesh failed. To monitor the displacements along all the slip planes, the same LPDT instrumentation scheme illustrated previously in Figure 2.16 was used. It was assumed that only the slip planes reinforced with the 4.5 oz./yd.<sup>2</sup> mesh would fail, and that insignificant displacements would occur along the slip planes reinforced with the 15 oz./yd.<sup>2</sup> mesh. The specimen would then be repaired, by dry packing the cells along the damaged slip planes with stiff grout, and retested. The cured grout would then ensure failure along the 15 oz. mesh reinforced slip planes.

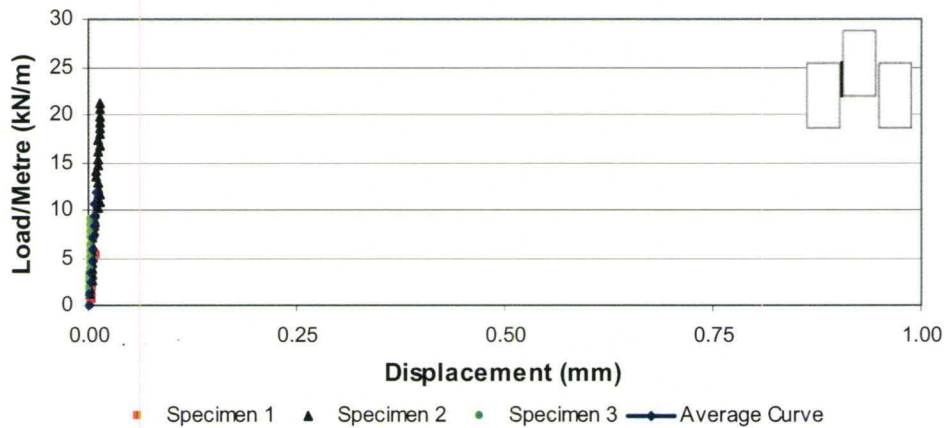
**Figure 3.1 – Specimen AU – 0.5: Load/Metre versus Displacement**

displacement of 0.0087 mm. The amount of scatter of the failure load is evident by the high coefficient of variation (C.O.V.) of 71.9%. The Load/Metre versus Average Displacement plot is provided in Figure 3.1.

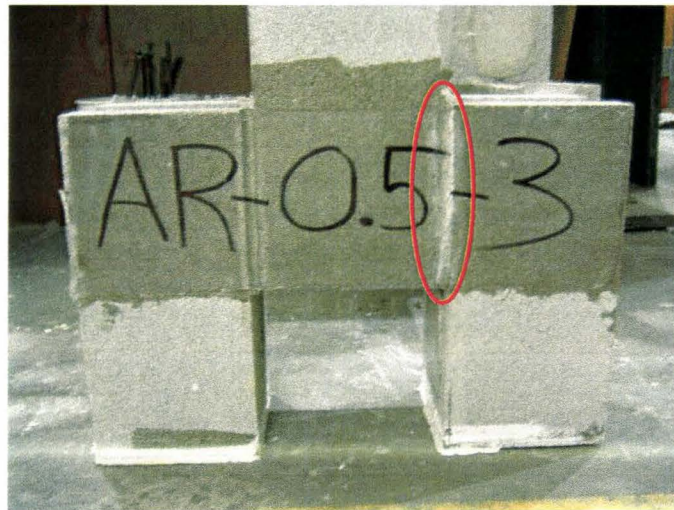
**Figure 3.2** – Typical Damage Along Slip Plane of Reinforced A-0.5 Specimens

During post-cracking, the glass fibres suspended in the epoxy are being deformed but are still intact. After the maximum load was reached, the specimen did not lose all capacity. It continued to support some, albeit decreasing, load, which was accompanied by further cracking and discolouration of the failed bed joint slip plane, as the displacement increased. The post peak response was recorded by stopping the test machine at various levels of displacement and recording the load at that displacement. Eventually, the displacement reached a large enough value where the fibres began to tear.

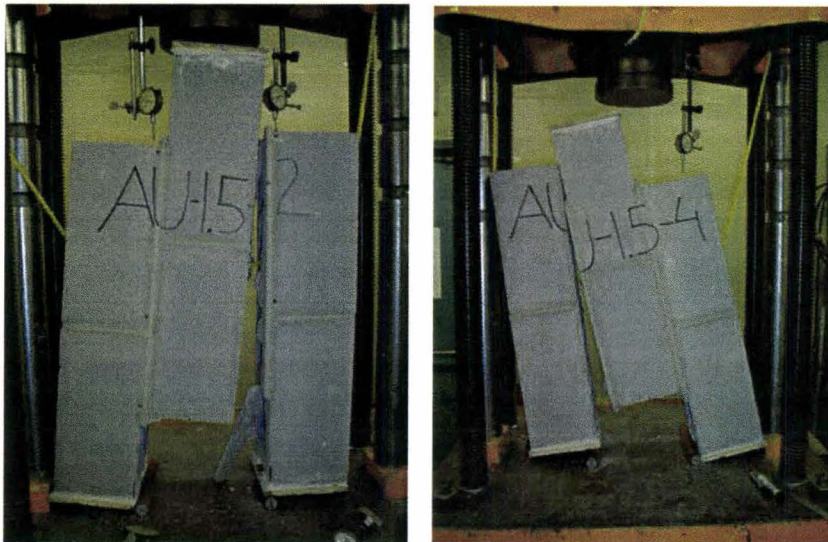
**Figure 3.4 – Typical Failure Mode of AU – 1.5 Specimens**

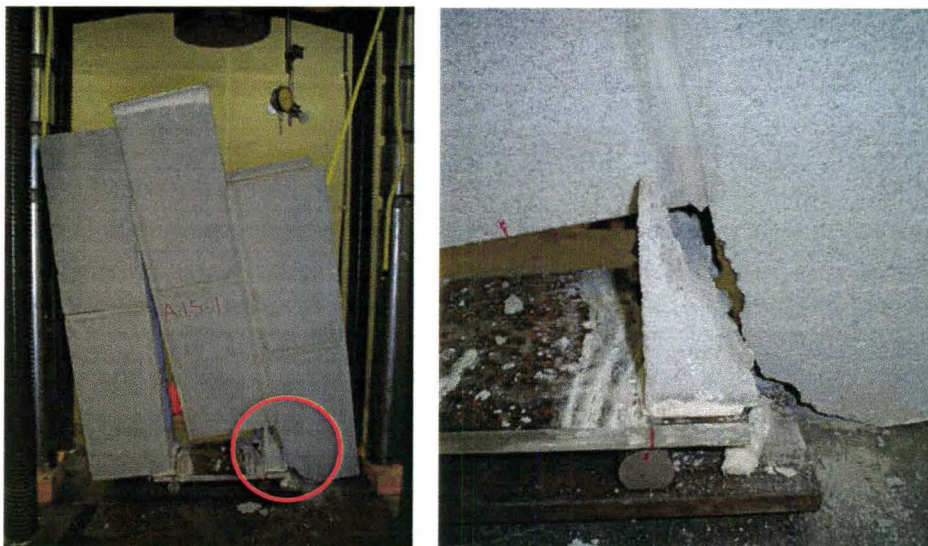
**Figure 3.5 – Block Crushing at Lower Support Point of Specimen AU – 1.5 – 1**

of scatter of the failure load is evident by the C.O.V. of 24.6%. Only the failure of the first specimen was accompanied by crushing of one block at the lower support points, as shown in Figure 3.5. This toe crushing seemed to happen simultaneously with shear slip failure and did not occur in any of the other specimens. The Load/Metre versus Average Displacement plot is provided in Figure 3.6.

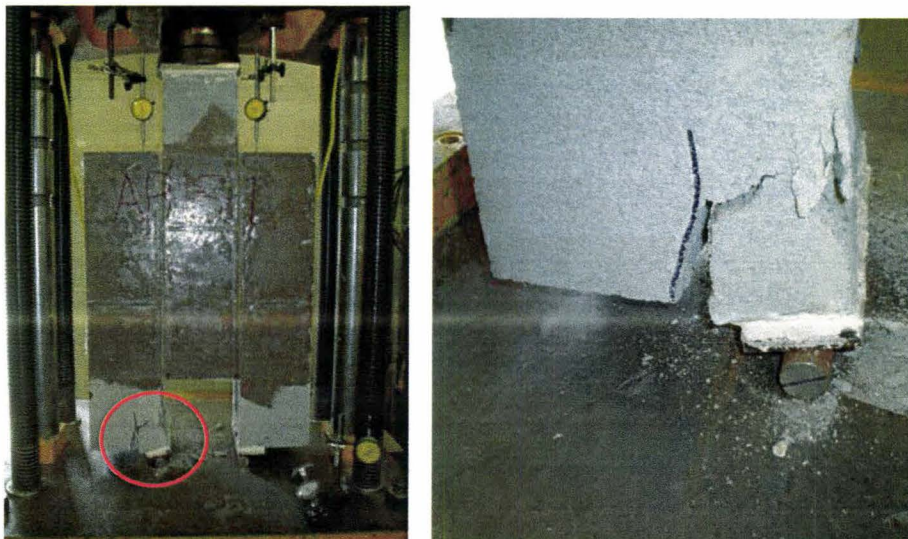
**Figure 3.7** – Block Crushing at Lower Support Point of Specimen AR – 1.5 – 1

The first specimen (AR – 1.5 – 1) failed by crushing of one block at the lower support points, as shown in Figure 3.7, prior to reaching maximum shear-slip resistance. Very limited displacements were recorded up to this point. This also was confirmed by visual observations. The typical near-failure occurrence of fine cracks and white discolouration of the epoxy were not observed along any of the bed joints. Therefore, this test was a lower bound indication of the strength of the specimen. As can be seen in Figure 3.7, the support “feet” of this very first test specimen were not filled with grout and subsequently wrapped with GFRP. This is the reason for the premature failure of this specimen.

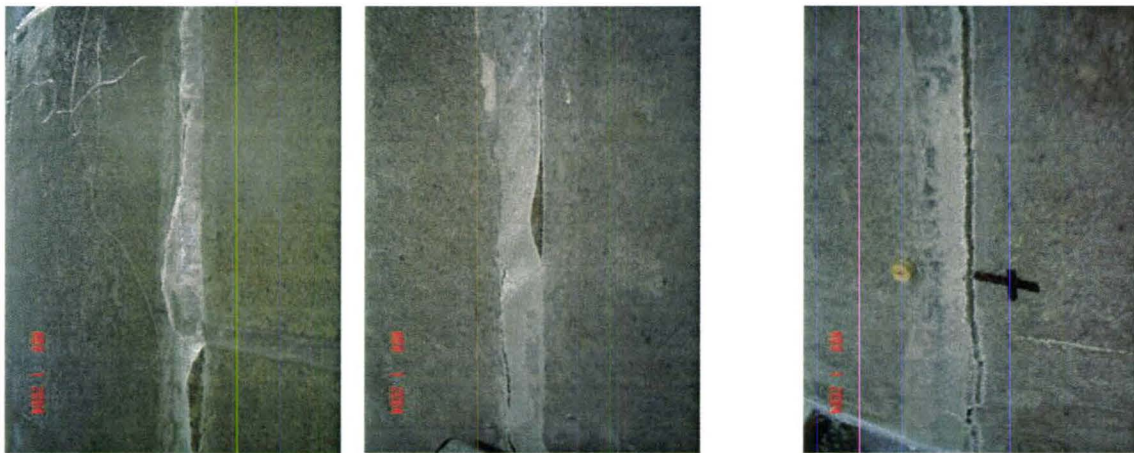
(a) Concave Bed Joints Not Completely Filled with Epoxy      (b) Concave Bed Joints Filled with Epoxy

**Figure 3.8 – Damaged GFRP for Specimen AR – 1.5 – 2**

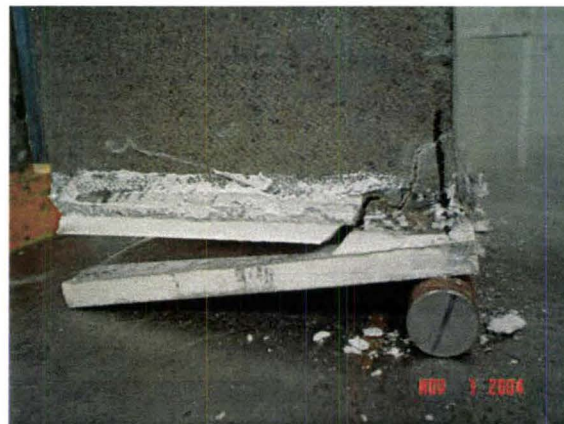
**Figure 3.9 – Block Crushing at Lower Support Point of Specimen AR – 1.5 – 2**

registered on the Tinius Olsen machine steadily decreased as the GFRP continued to tear. Final post-peak failure was caused by crushing of one block at the lower support points, as shown in Figure 3.9. The block crushing was not as severe as for the first specimen, shown in Figure 3.7 and did not limit the maximum load. The failure of the third specimen (AR – 1.5 – 3) was complete tearing of the GFRP along the left bed joint, as shown in Figure 3.10.

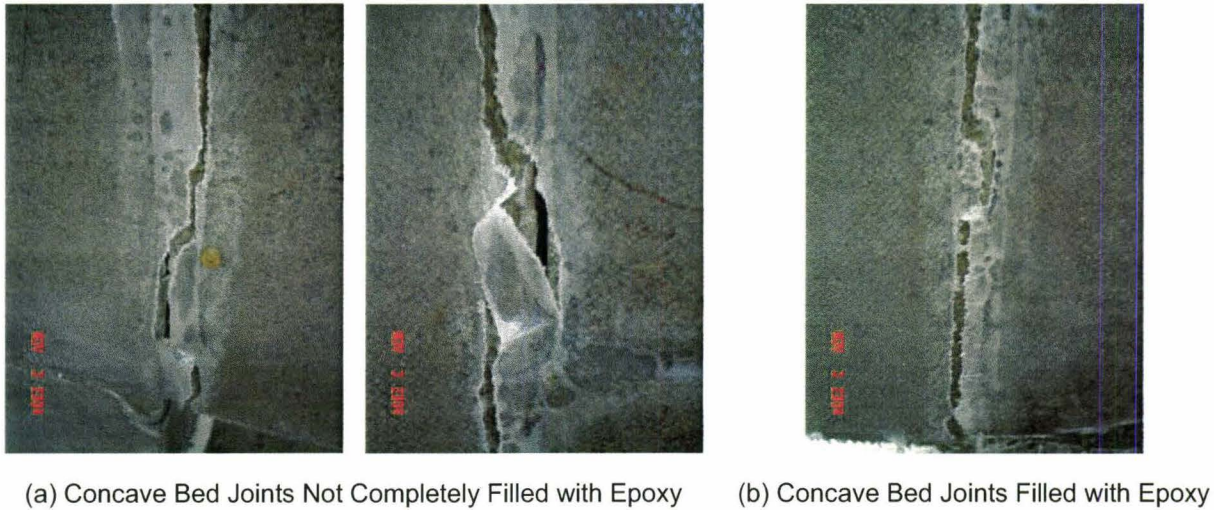
**Figure 3.10** – Damaged GFRP for Specimen AR – 1.5 – 3

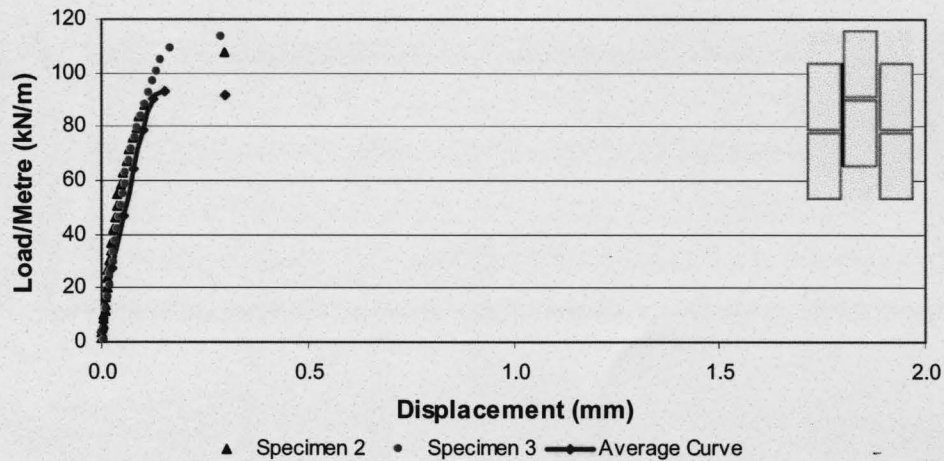
Figure 3.11 – Specimen AR – 1.5: Load/Metre versus Displacement

average ultimate load and the corresponding average displacement increased to 136.0 kN and 0.29 mm, respectively. The Load/Metre versus Average Displacement plot for these latter two specimens is presented in Figure 3.11.

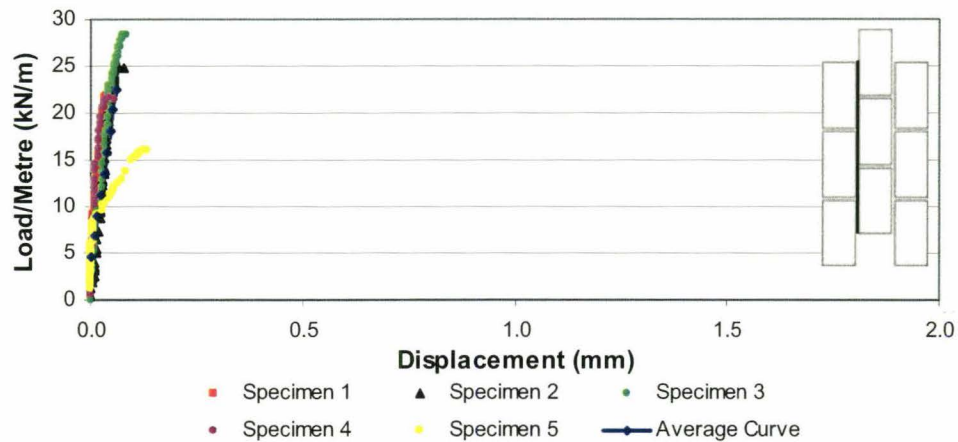
Figure 3.12 – Specimen AU – 2.5: Load/Metre versus Displacement

failure load is evident by the coefficient of variation (C.O.V.) of 20.6%. The Load/Metre versus Average Displacement plot is provided in Figure 3.12.

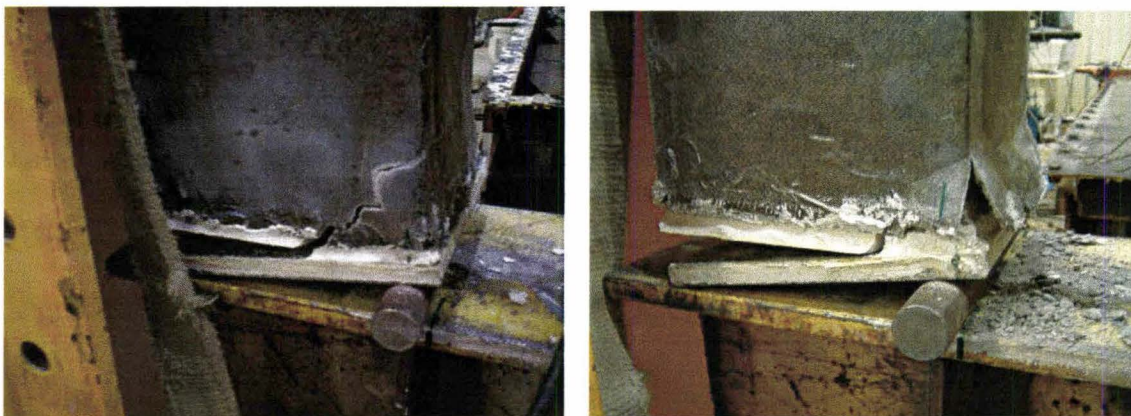
Figure 3.13 – Typical Block Crushing at Lower Support Point of Specimen AR-2.5

The load and displacement data for these specimens were recorded using the data acquisition system described in Chapter 2. All three specimens failed by crushing of one block at the lower support points, as shown in Figure 3.13. This occurred prior to any observable failure in the GFRP. Very limited, or negligible, displacements were recorded up to this point.

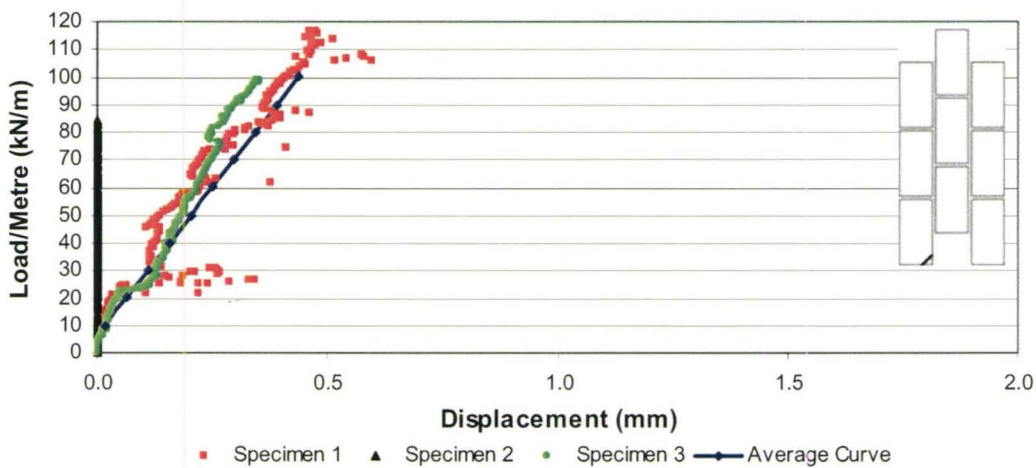
Figure 3.14 – Specimen AR – 2.5: Load/Metre versus Displacement

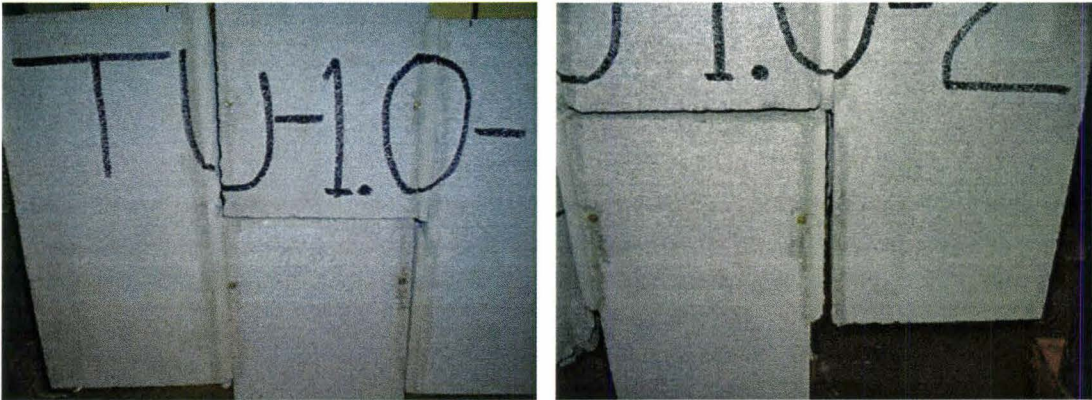
Figure 3.15 – Typical Failure Mode of TU – 0.5 Specimens

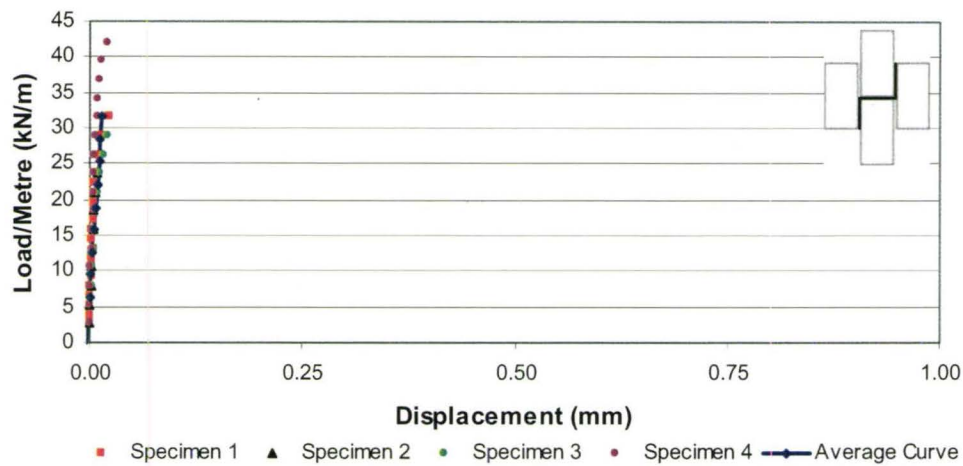
Figure 3.16 – Specimen TU – 0.5: Load/Metre versus Displacement

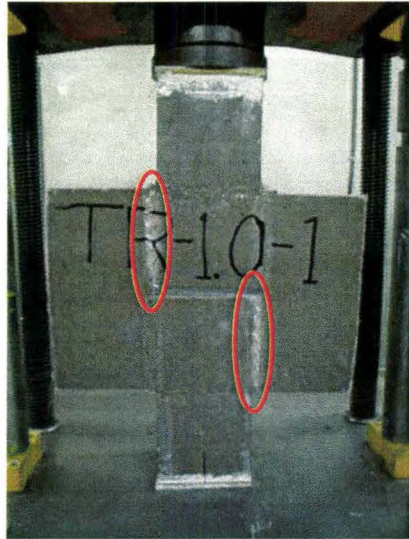
**Figure 3.17** – Typical Damage Along Slip Plane of Reinforced TR-0.5 Specimens

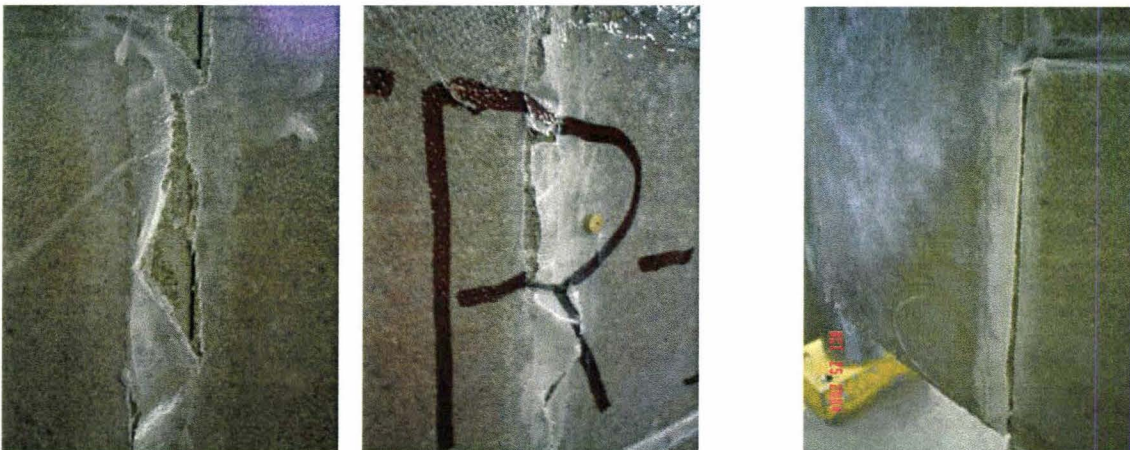
(a) Concave Bed Joints Not Completely Filled with Epoxy

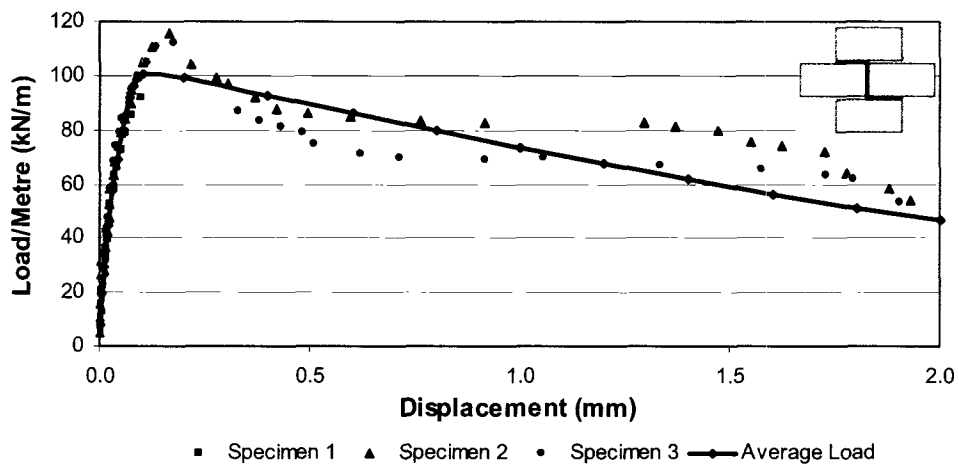
Figure 3.19 – Specimen TR – 0.5: Load/Metre versus Displacement

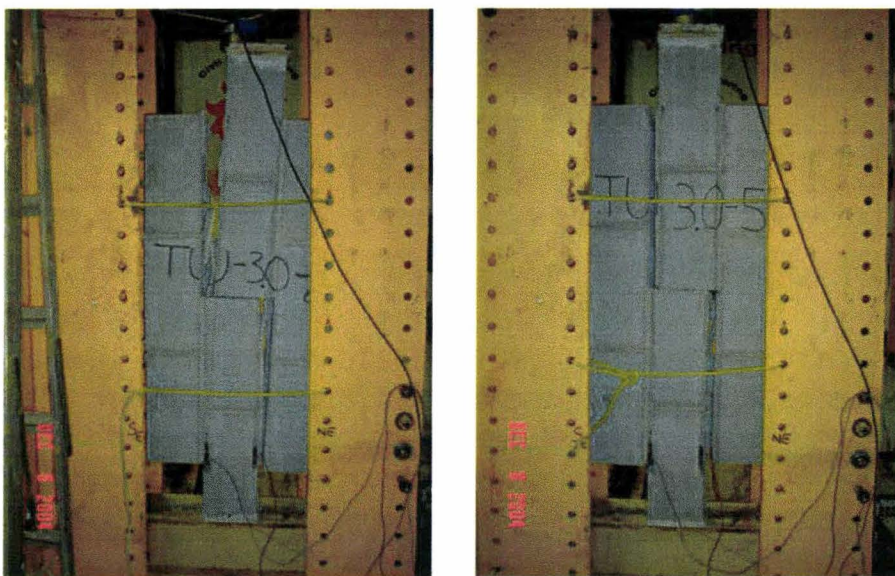
Figure 3.20 – Typical Failure Mode of TU – 1.5 Specimens

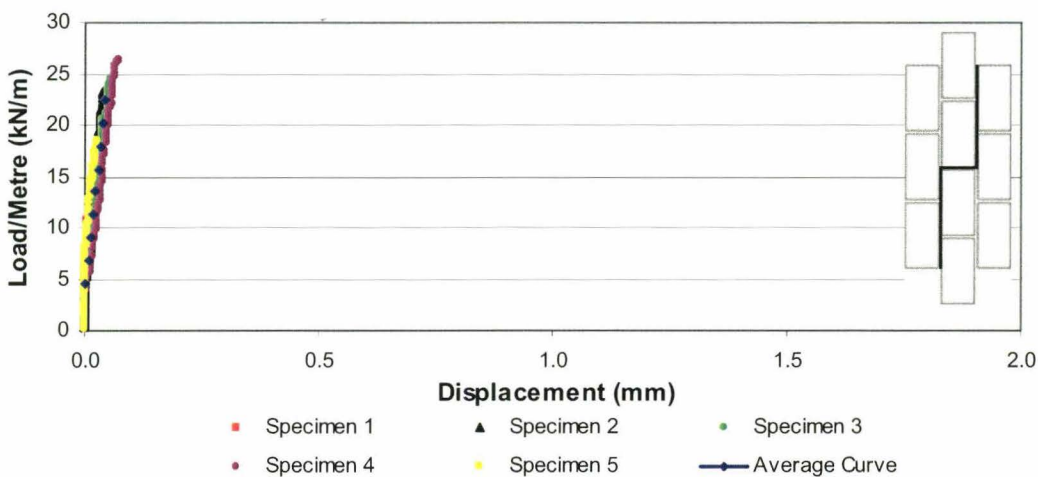
Figure 3.21 – TU – 1.5: Load/Metre versus Displacement

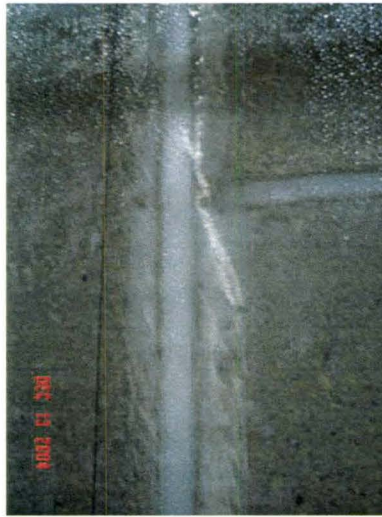
**Figure 3.22** – Minor Damage to GFRP Along Bed Joint (Prior to Full Fabric Tearing)

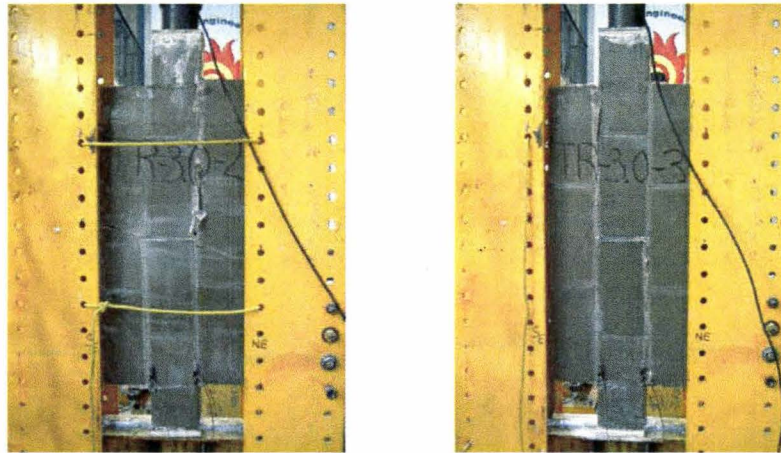
(a) ‘Z’ Crack Plus Middle Block Splitting

(b) ‘Z’ Crack

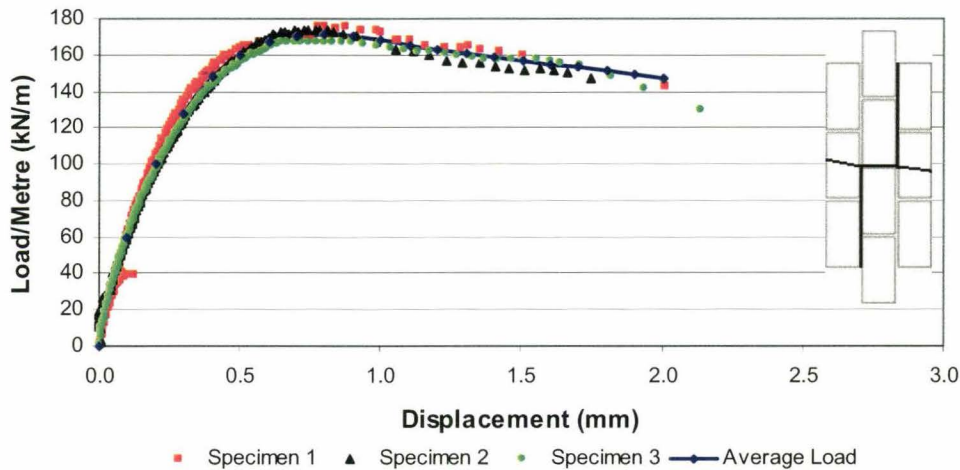
**Figure 3.24** – Specimen TR – 1.5: Load/Metre versus Displacement

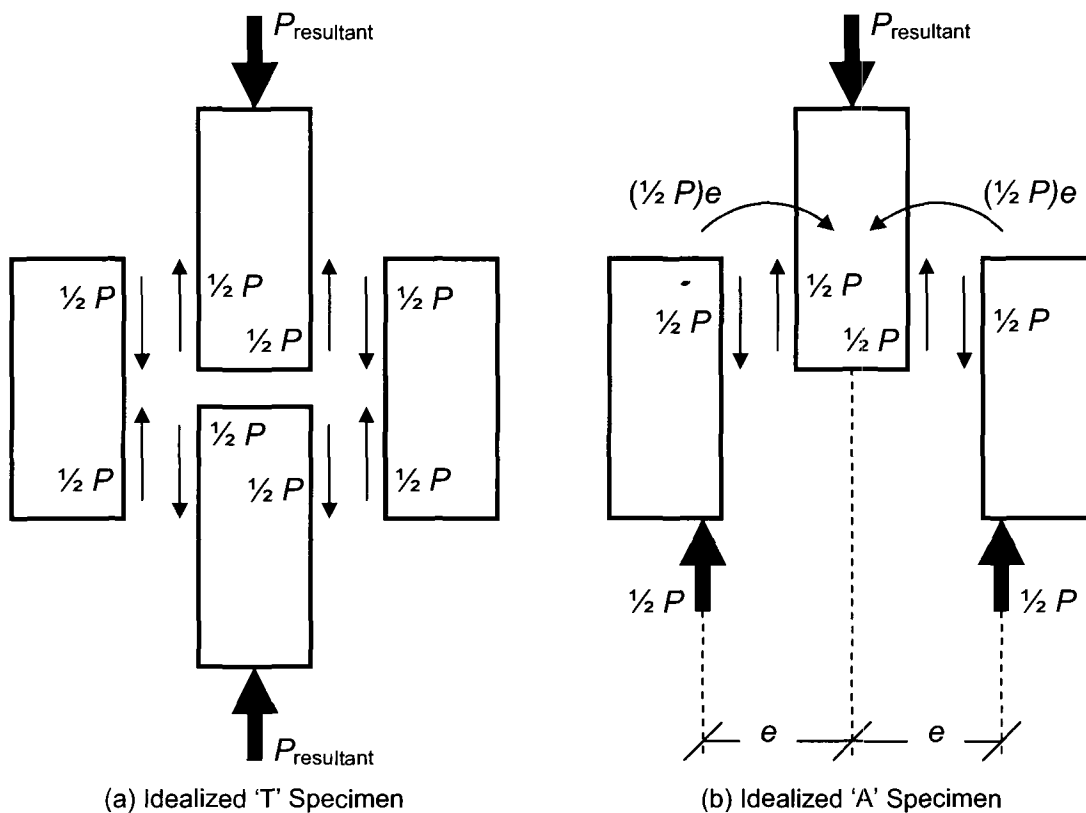
Figure 3.25 – Schematic Diagram of Shear Force Distribution
