**IN PLANE SLIDING SHEAR BEHAVIOUR  
OF  
UNREINFORCED CONCRETE MASONRY  
RETROFITTED WITH  
SURFACE-BONDED FIBREGLASS LAMINATES**

A Report  
Submitted to the School of Graduate Studies  
in Partial Fulfilment of the Requirements  
for the Degree  
Master of Engineering (M.Eng.)

TITLE: In Plane Sliding Shear Behaviour of Unreinforced Concrete Masonry  
Retrofitted with Surface-Bonded Fibreglass Laminates

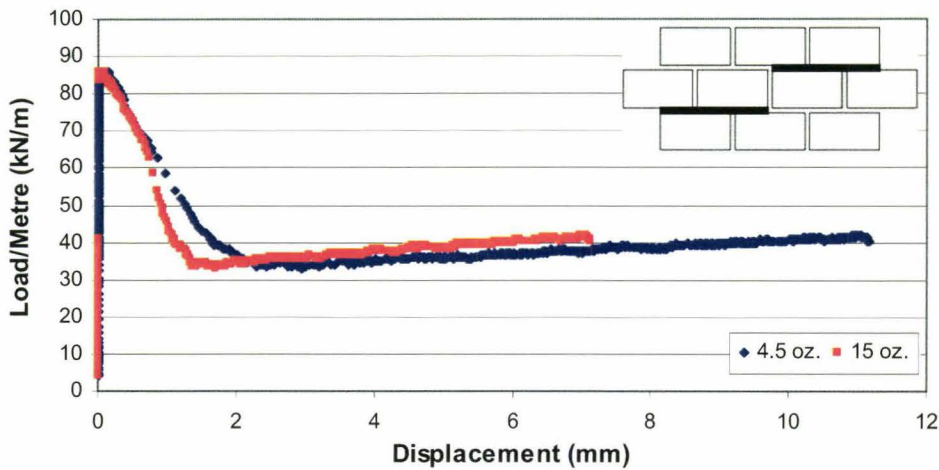
**Figure 3.27** – Load/Metre vs. Average Displacement of Epoxy Applied 4.5 oz./yd.<sup>2</sup> and 15 oz./yd.<sup>2</sup> Mesh at 0°/90° (No applied clamping force)

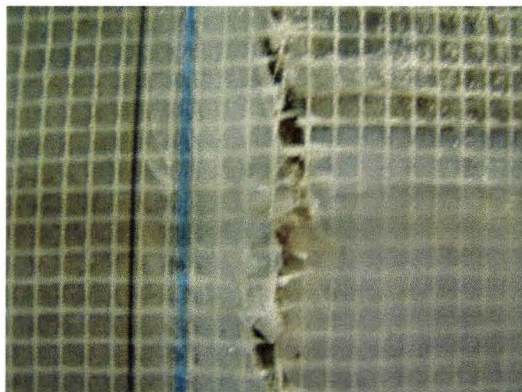
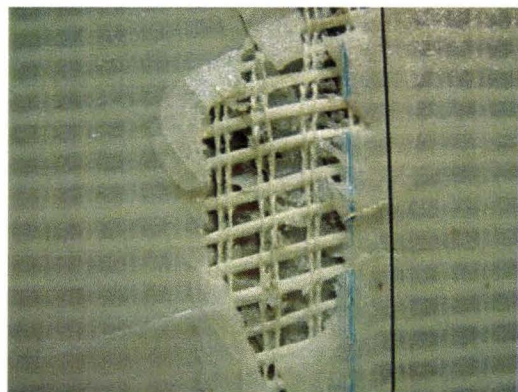
(a) Tearing of 4.5 oz./yd.<sup>2</sup> Mesh

(b) Delamination of 15 oz./yd.<sup>2</sup> Mesh

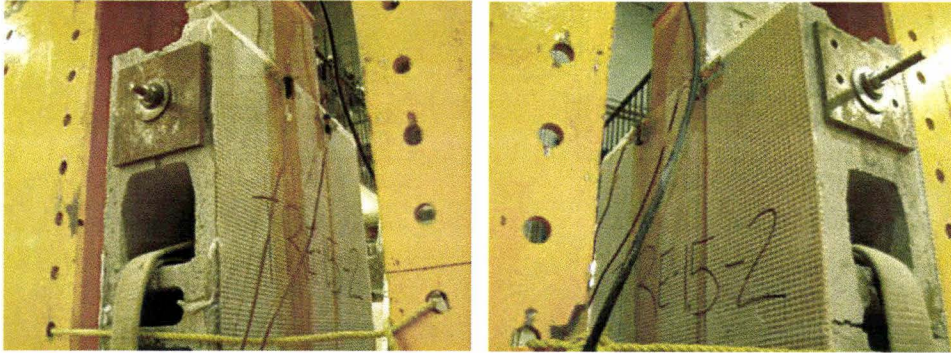
**Figure 3.29** – Clamping Apparatus

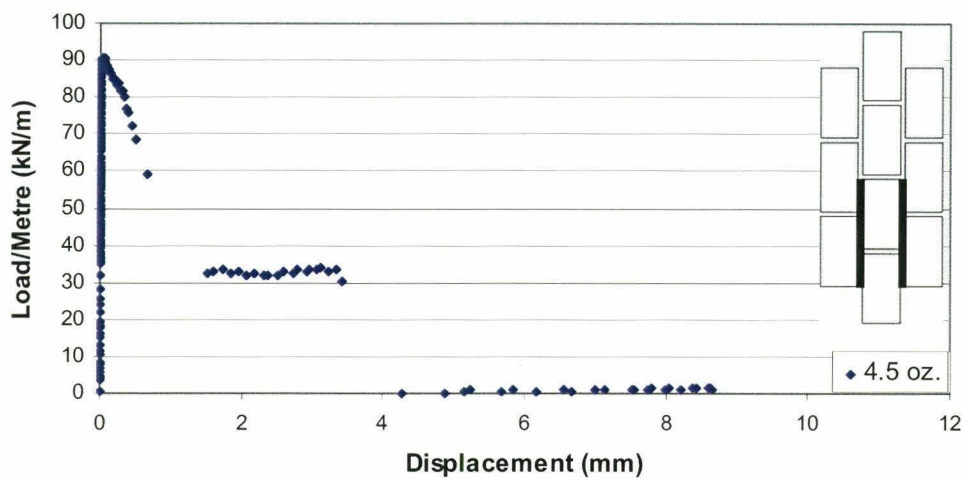
**Figure 3.30** – Load/Metre vs. Average Displacement of Epoxy Applied 4.5 oz./yd.<sup>2</sup> and 15 oz./yd.<sup>2</sup> Mesh at 0/90° (15 oz./yd.<sup>2</sup> mesh reinforced slip planes clamped)

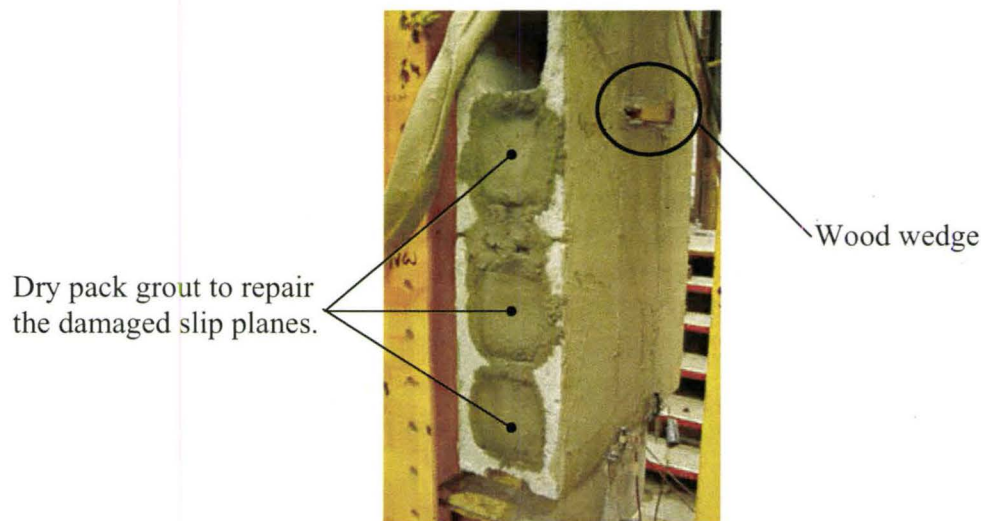
**Figure 3.31 – Repaired Specimen**

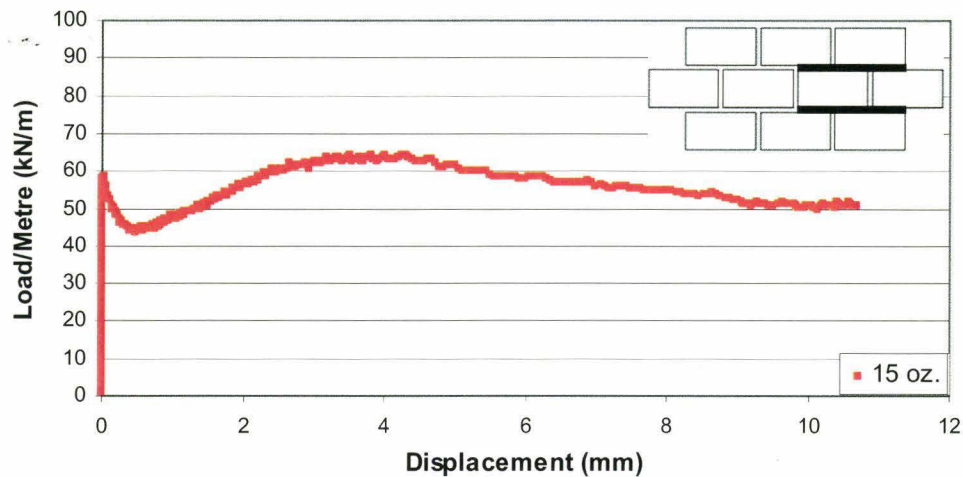
**Figure 3.32** – Load/Metre vs. Average Displacement of Epoxy Applied 4.5 oz./yd.<sup>2</sup> and 15 oz./yd.<sup>2</sup> Mesh at 0/90° (Damaged 4.5 oz./yd.<sup>2</sup> mesh reinforced slip planes repaired)

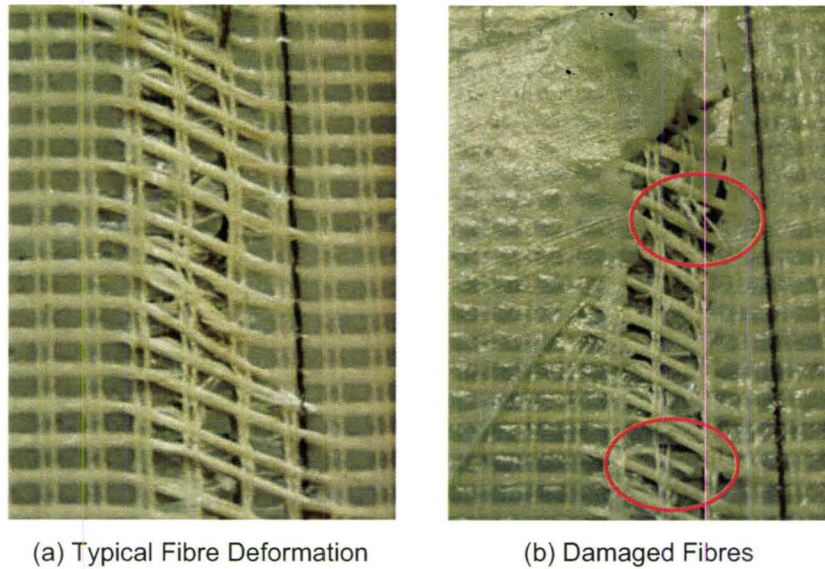
**Figure 3.33** – Damaged Epoxyed 15 oz./yd.<sup>2</sup> Mesh Applied at 0°/90°

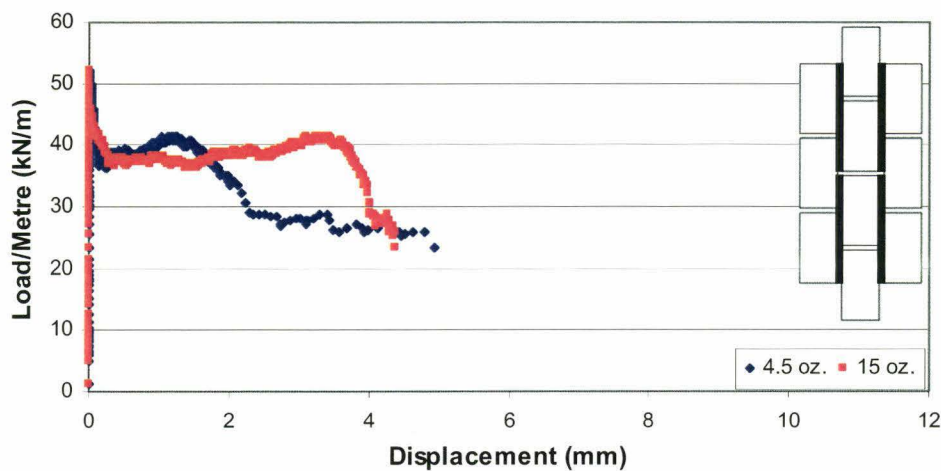
Figure 3.34 – Load/Metre vs. Average Displacement of Mortar Parging Applied 4.5 oz./yd.<sup>2</sup> and 15 oz./yd.<sup>2</sup> Mesh at 0/90° (No applied clamping force)

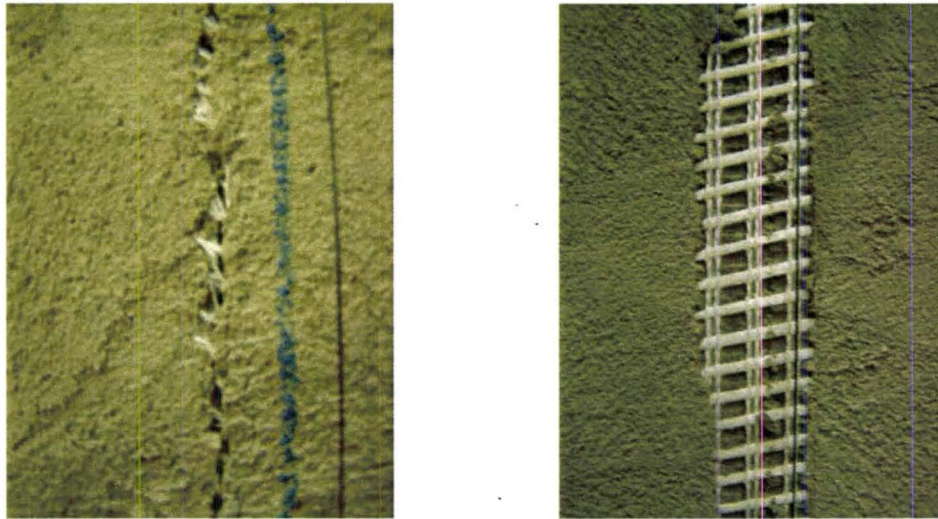
(a) Typical 4.5 oz./yd.<sup>2</sup> Mesh Fibre Damage (b) Typical 15 oz./yd.<sup>2</sup> Mesh Fibre Delamination

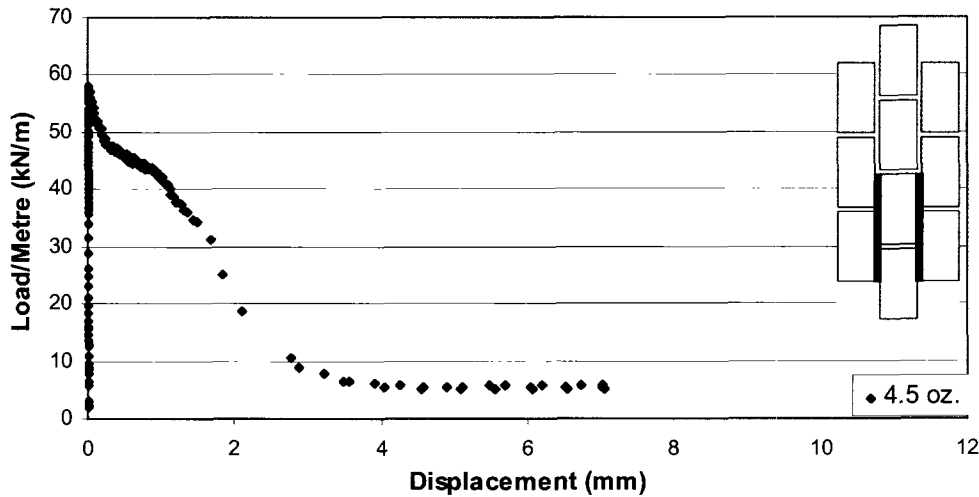
**Figure 3.36** – Load/Metre vs. Average Displacement of Mortar Parging Applied 4.5 oz./yd.<sup>2</sup> and 15 oz./yd.<sup>2</sup> Mesh at 0/90° (15 oz./yd.<sup>2</sup> mesh reinforced slip planes clamped)

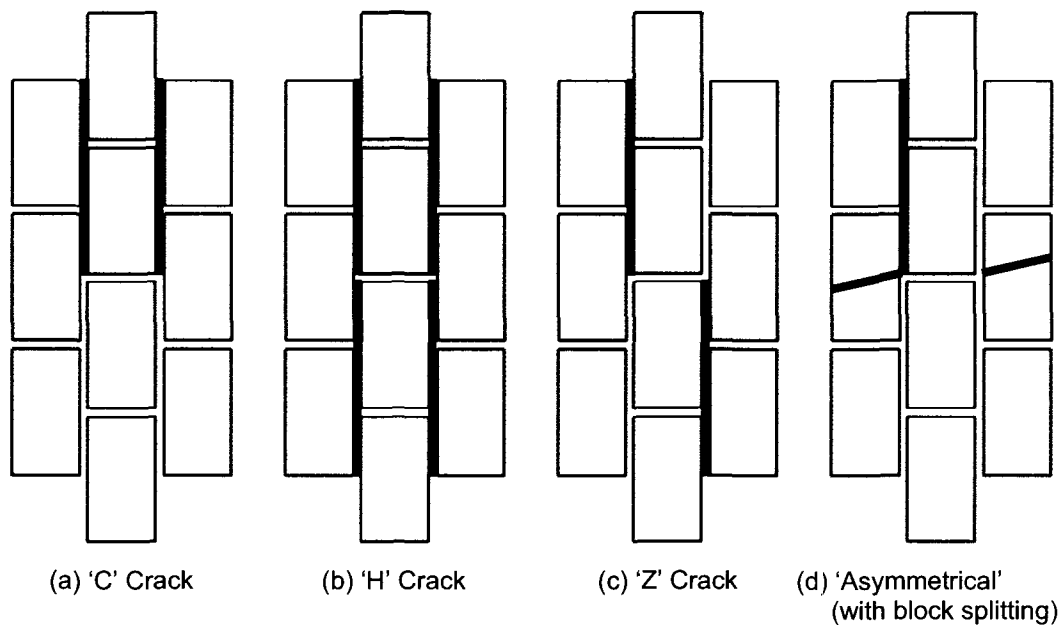
**Figure 4.1 – Typical Phase Three Specimen Crack Patterns**

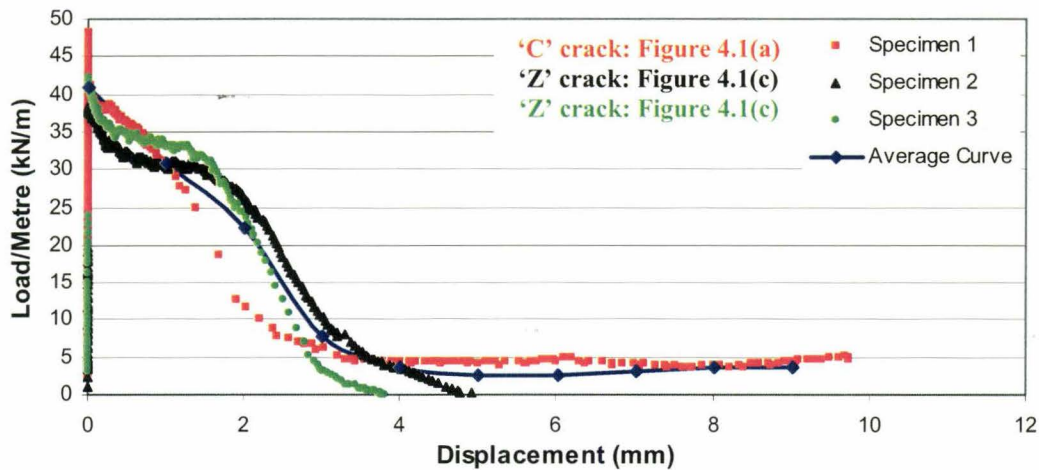
**Figure 4.2** – Load/Metre vs. Average Displacement (4.5 oz./yd.<sup>2</sup> mesh at 0°/90°)

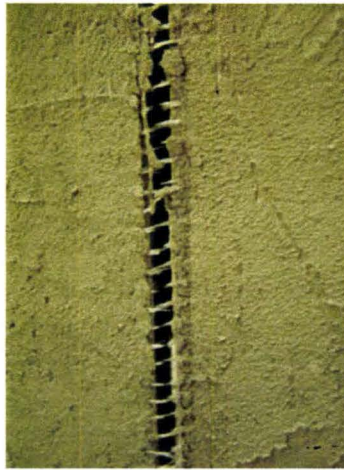
**Figure 4.3** – Typical Fibre Damage (Tearing) of Bed Joints Reinforced with 4.5 oz. Mesh at  $0^{\circ}/90^{\circ}$

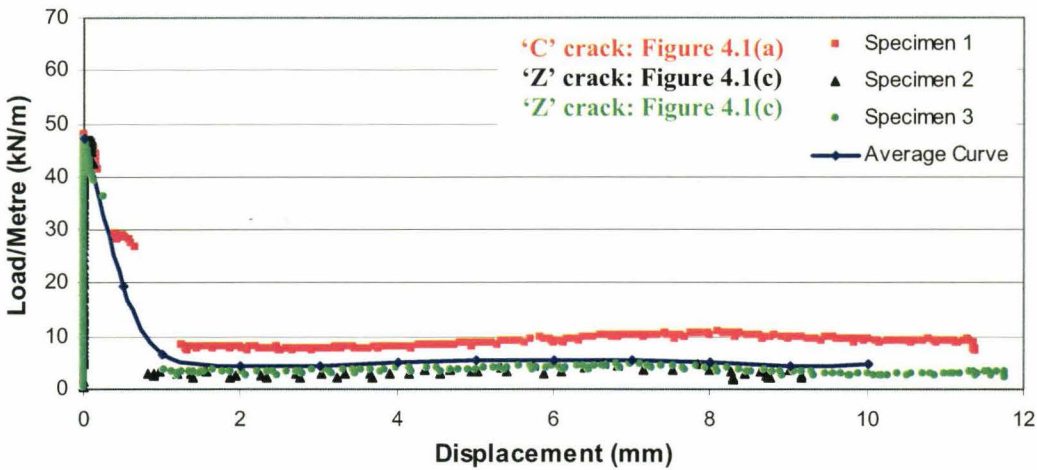
**Figure 4.4** – Load/Metre vs. Average Displacement (4.5 oz./yd.<sup>2</sup> mesh at  $\pm 45^\circ$ )

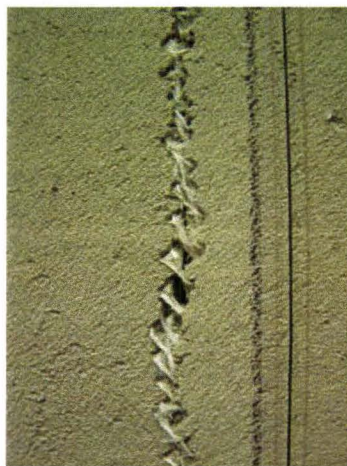
**Figure 4.5** – Typical Fibre Damage (Tearing) of Bed Joints Reinforced with 4.5 oz. Mesh at  $\pm 45^\circ$

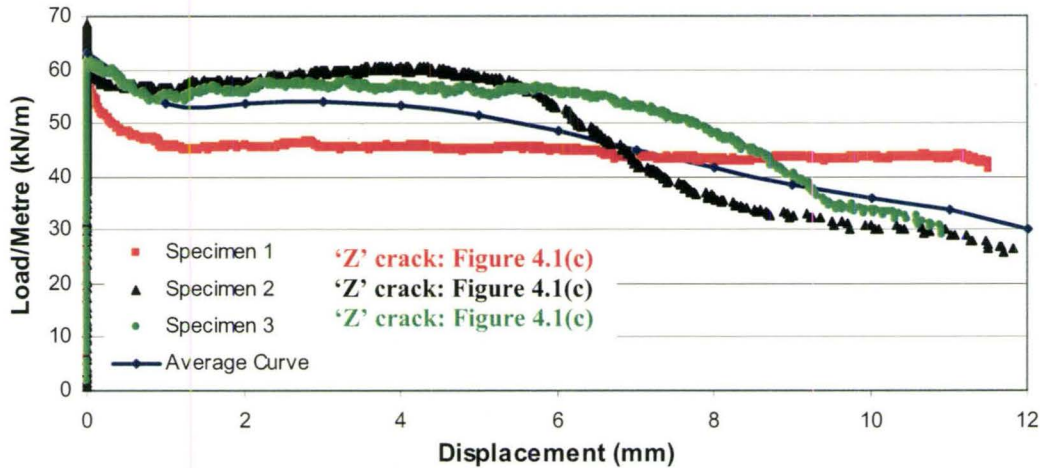
Figure 4.6 – Load/Metre vs. Average Displacement ( 6 oz./yd.<sup>2</sup> mesh at 0°/90°)

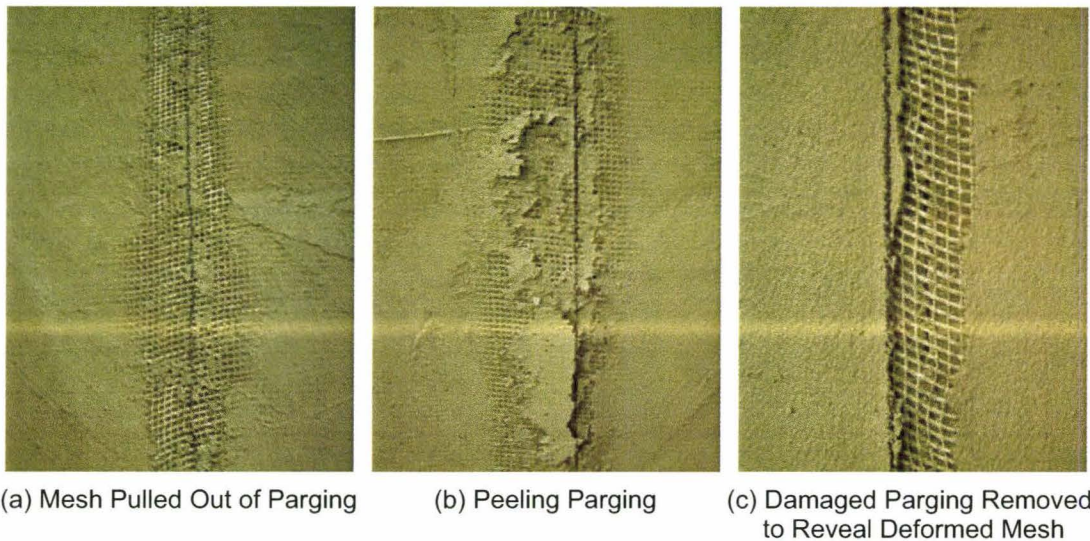
**Figure 4.7** – Typical Damage of Bed Joints Reinforced with 6.0 oz. Mesh at  $0^{\circ}/90^{\circ}$

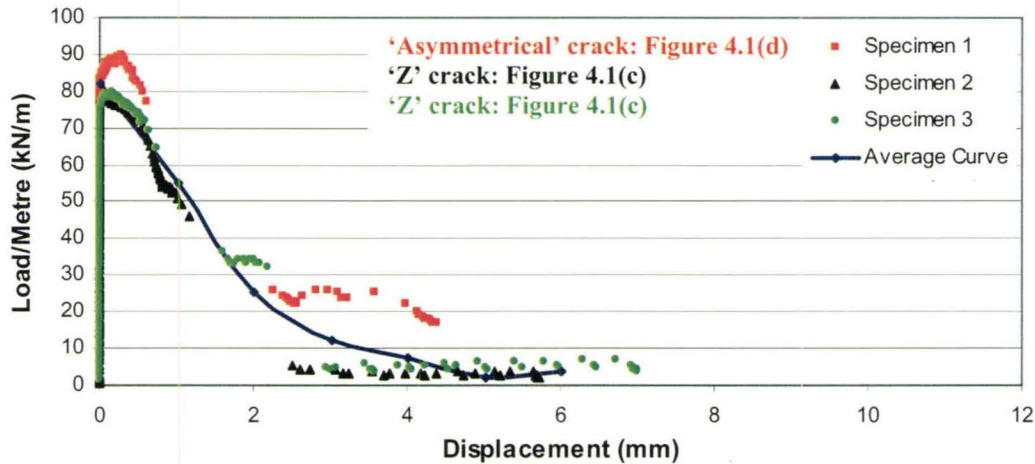
Figure 4.8 – Load/Metre vs. Average Displacement ( 6 oz./yd.<sup>2</sup> mesh at  $\pm 45^\circ$ )

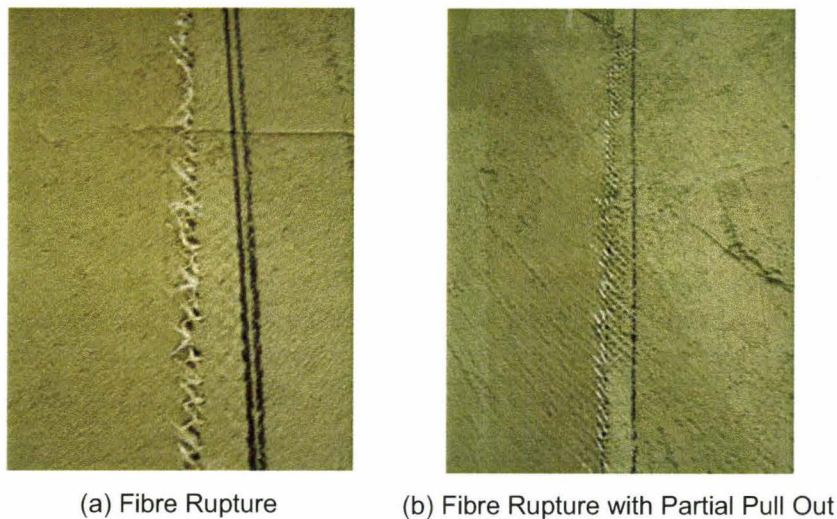
**Figure 4.9** – Typical Torn Fibre Damage of Bed Joints Reinforced with 6.0 oz. Mesh at  $\pm 45^\circ$

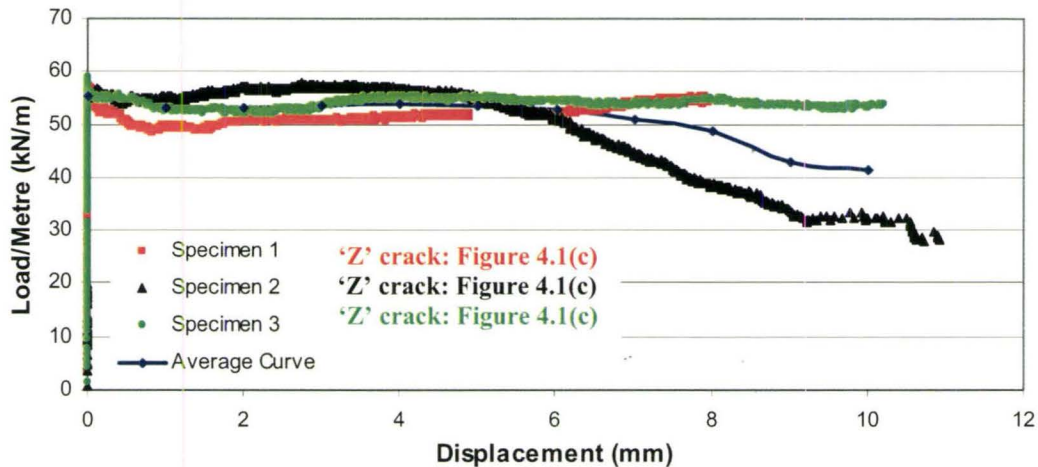
Figure 4.10 – Load/Metre vs. Average Displacement ( 9 oz./yd.<sup>2</sup> mesh at 0°/90°)

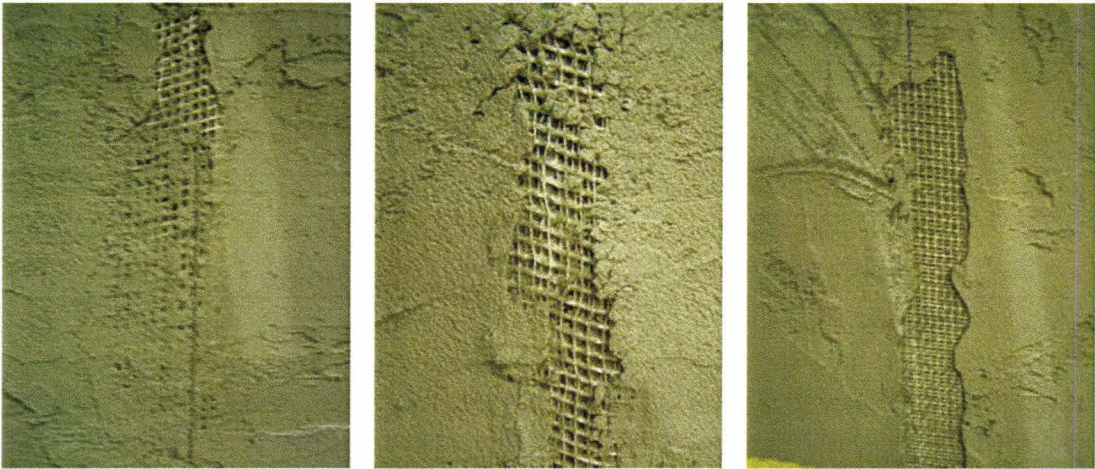
(a) Mesh Pulled Out of Parging (b) Damaged Parging Removed to Reveal Deformed Mesh

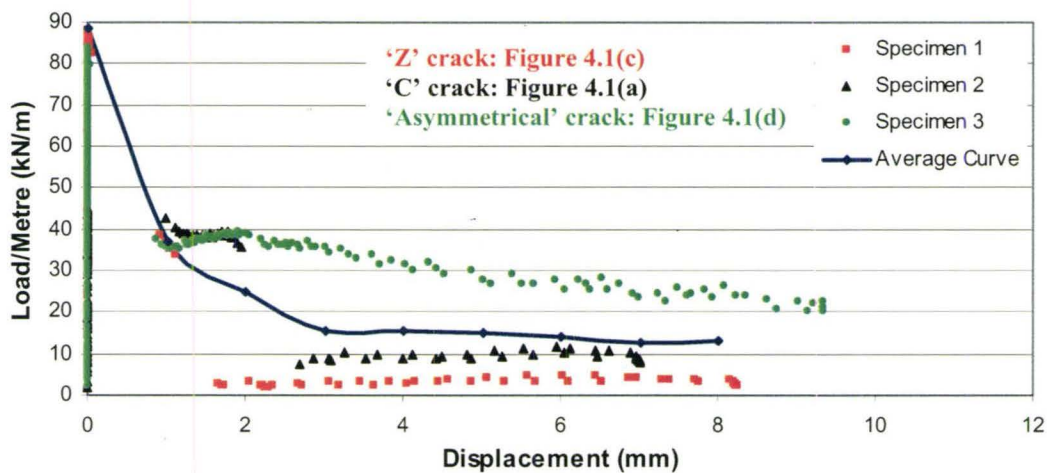
Figure 4.12 – Load/Metre vs. Average Displacement ( 9 oz./yd.<sup>2</sup> mesh at  $\pm 45^{\circ}$ )

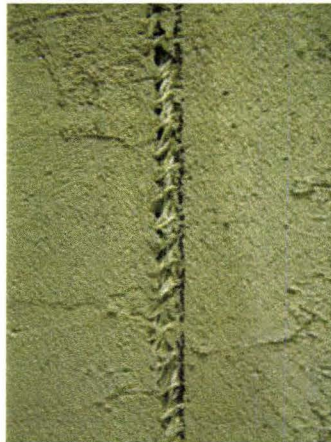
**Figure 4.13** – Typical Fibre Damage (Tearing) of a Bed Joint Reinforced with 9.0 oz. Mesh at  $\pm 45^\circ$

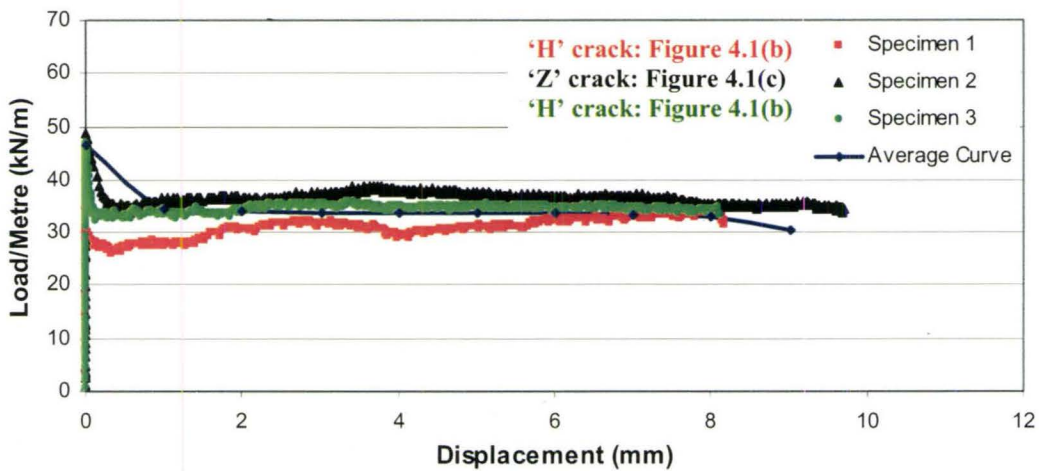
Figure 4.14 – Load/Metre vs. Average Displacement ( 12 oz./yd.<sup>2</sup> mesh at 0°/90°)

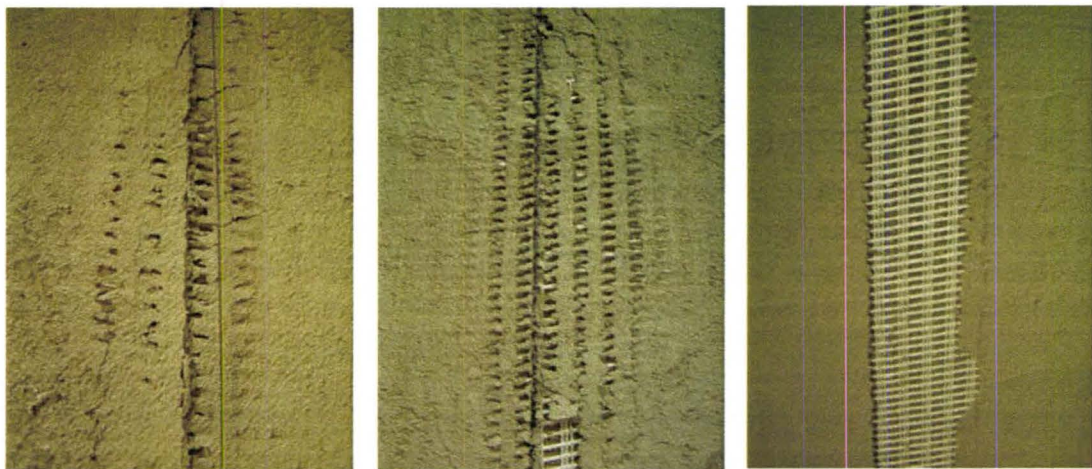
(a) Mesh Pulled Out of Parging (Progressive Damage) (b) Damaged Parging Removed to Reveal Deformed Mesh

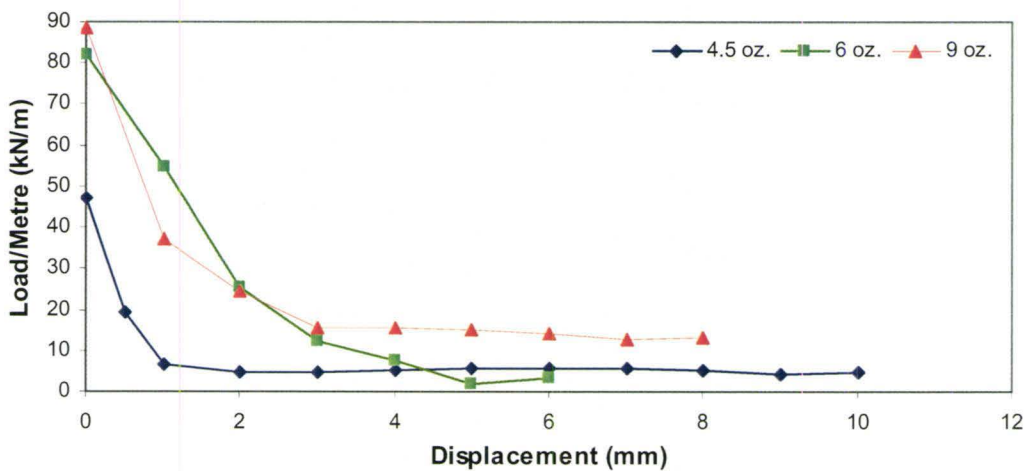
Figure 4.17 – Average Load/Metre vs. Average Displacement Curves for  $\pm 45^{\circ}$  Mesh

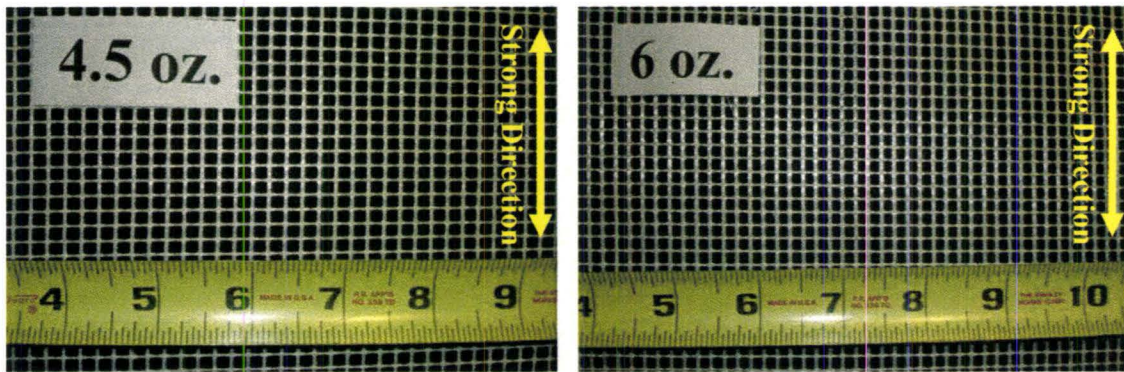
(a) 4.5 oz./yd.<sup>2</sup> (Finished Weight)
