SEISMIC REHABILITATION OF RC STRUCTURAL WALLS

A Thesis

Doctor of Philosophy

McMaster University

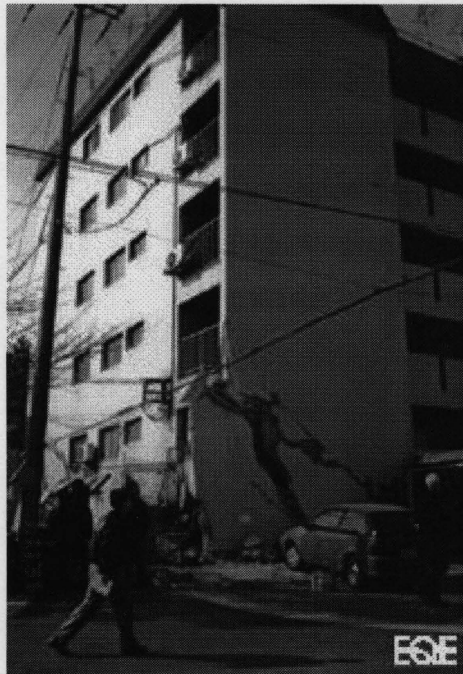
Figure 2. 1 Premature shear failure of Structural wall, during 1995 Kope, earthquake.
(<http://www.hewett.norfolk.sch.uk/curric/NEWGEOG/Tectonic/Earth/Building.htm> (accessed March 2006))

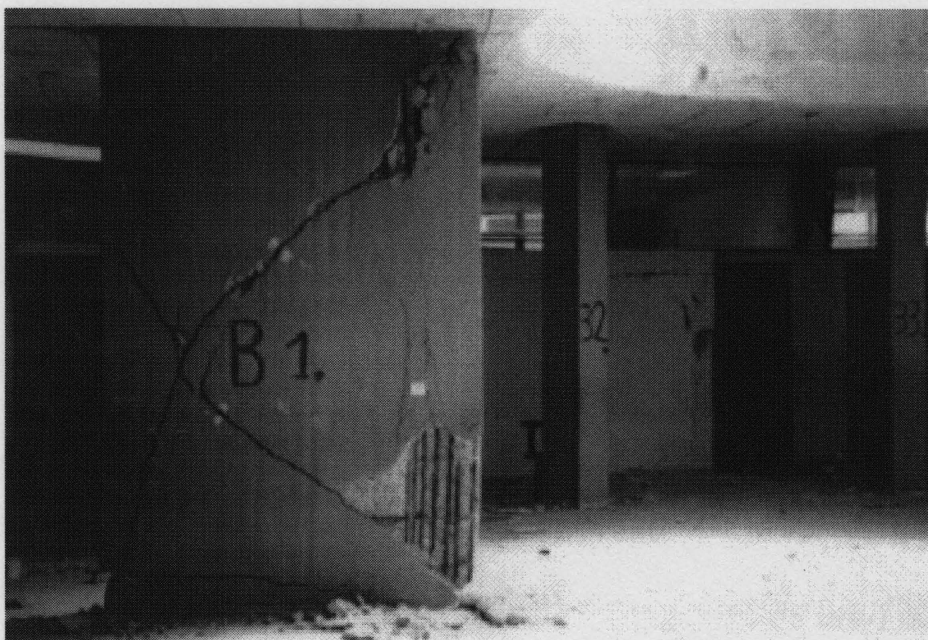
Figure 2. 2 Failure of a structural wall during the 1986 Kalamata earthquake (Lopes 2001).

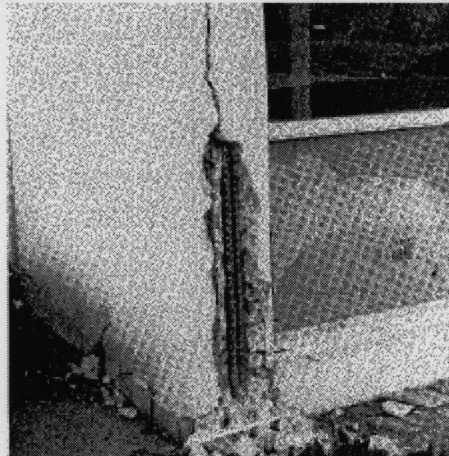
Figure 2. 3 Failure of a structural wall construction joint during the 1971 San Fernando EQ. (Jennings 1971).

Lap splice detailing may present a potential weakness as shown in Figure 2.3. Near horizontal failure planes may develop in plastic hinge zones along intersecting cracks. This may lead to sliding shear failure. Figure 2.5 shows the development of sliding shear failure mechanism of RC structural walls. In the following sections discussion of failure modes of walls are presented.

Failure of a structural wall construction joint during the 1971 San Fernando earthquake was reported by Jennings (1971) as shown in Figure 2.3. The insufficient lap splice length was the main reason for this type of failure. It worth to be noted that this type of failure was observed at the fourth floor of the ten-storey building, which indicates that the lap splice failure is not restricted to the base of the wall or at the connection of the wall with the foundation and the lap splice detailing requires attention at any location they are introduced through the height of the structural walls.

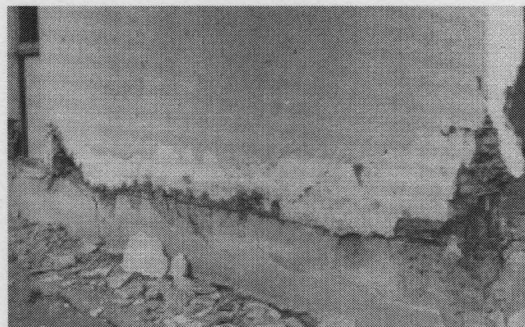
Figure 2. 4 Failure of shear wall observed after the 1985 Chile EQ. (Wyllie et al. 1986).

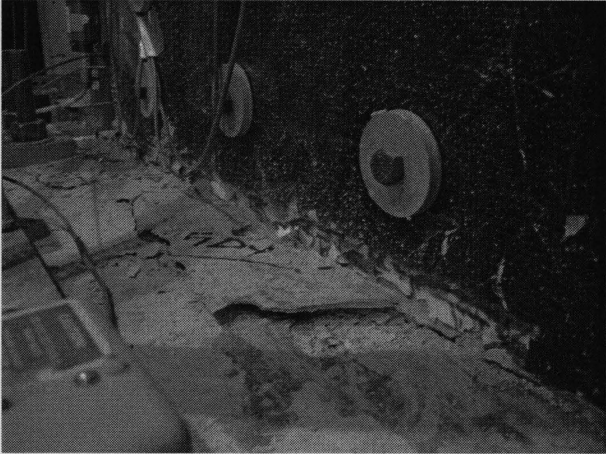
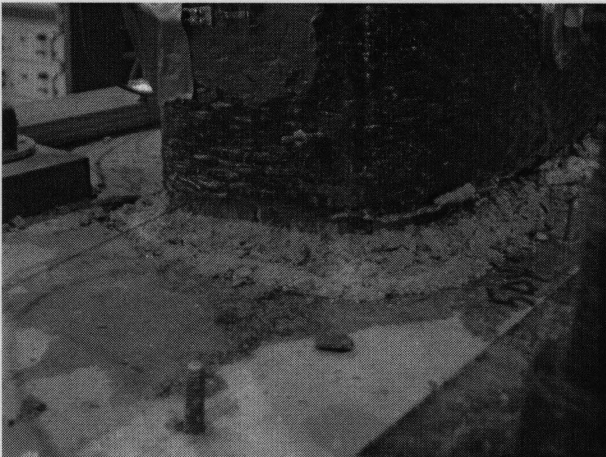
Figure 4- 16 RW3 at failure.

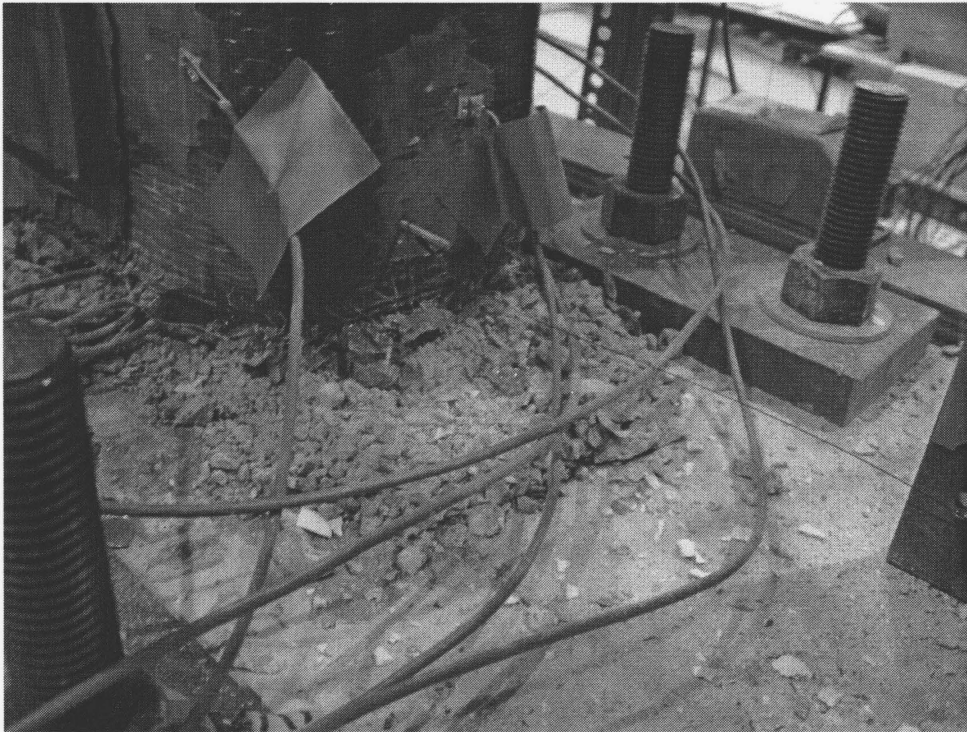
Figure 4- 44 RW6 wall failure.

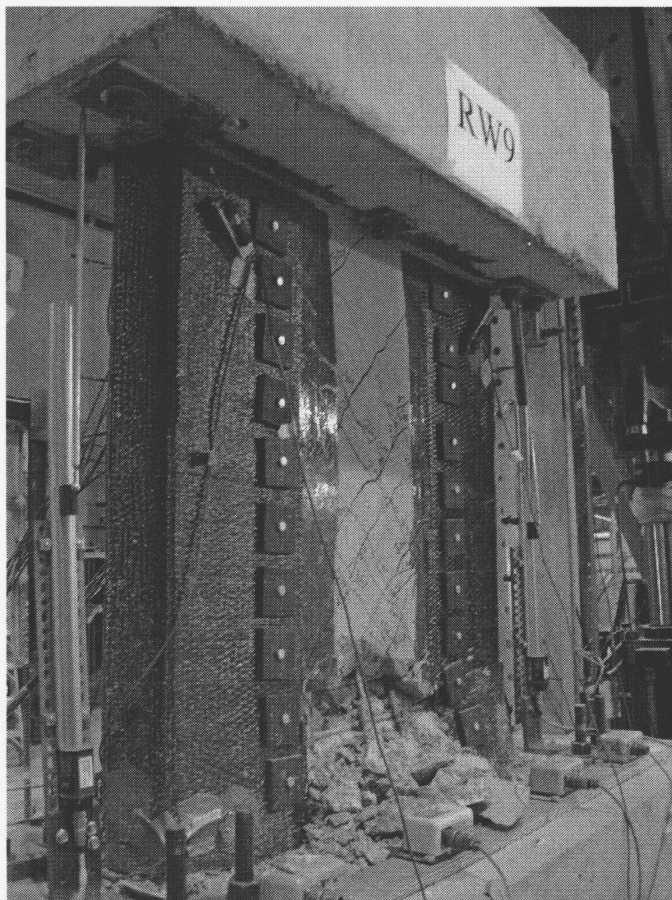
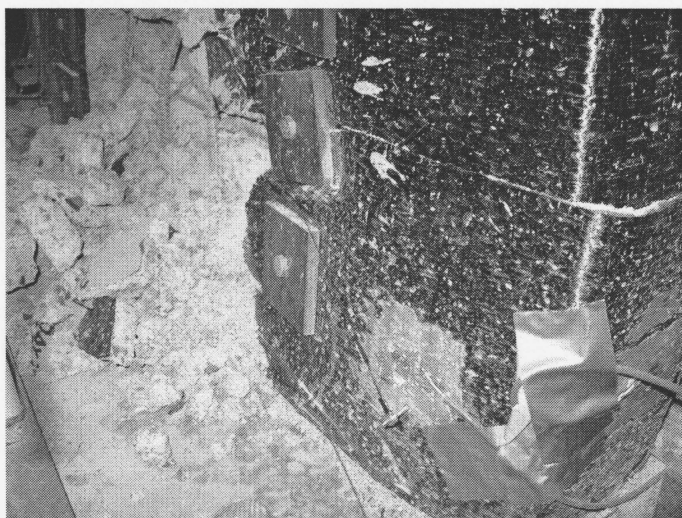
Figure 4- 78 Wall RW9 failure.

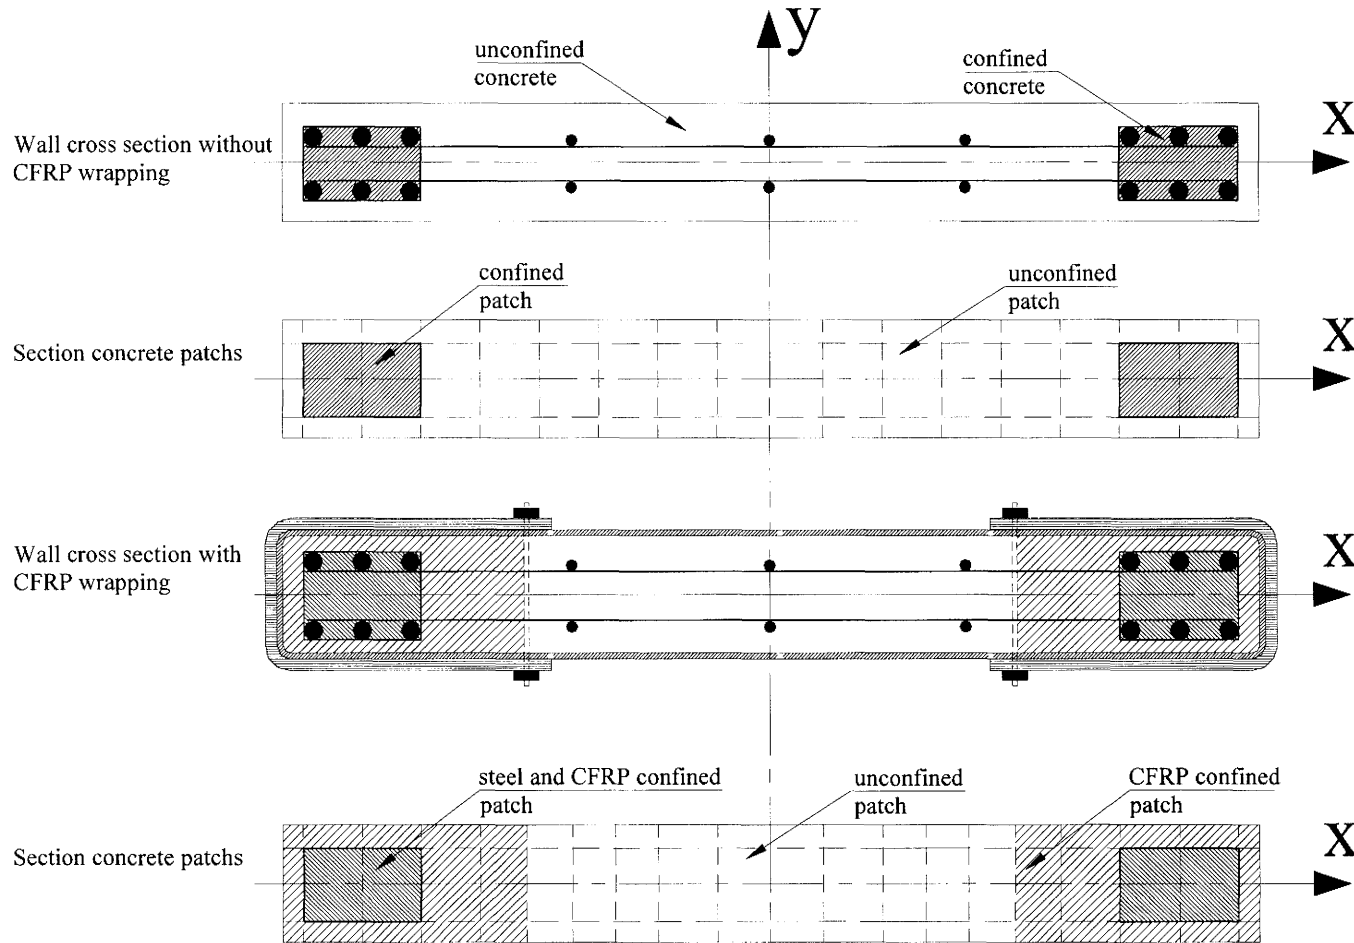
Figure 6. 10 Proposed wall model section meshing

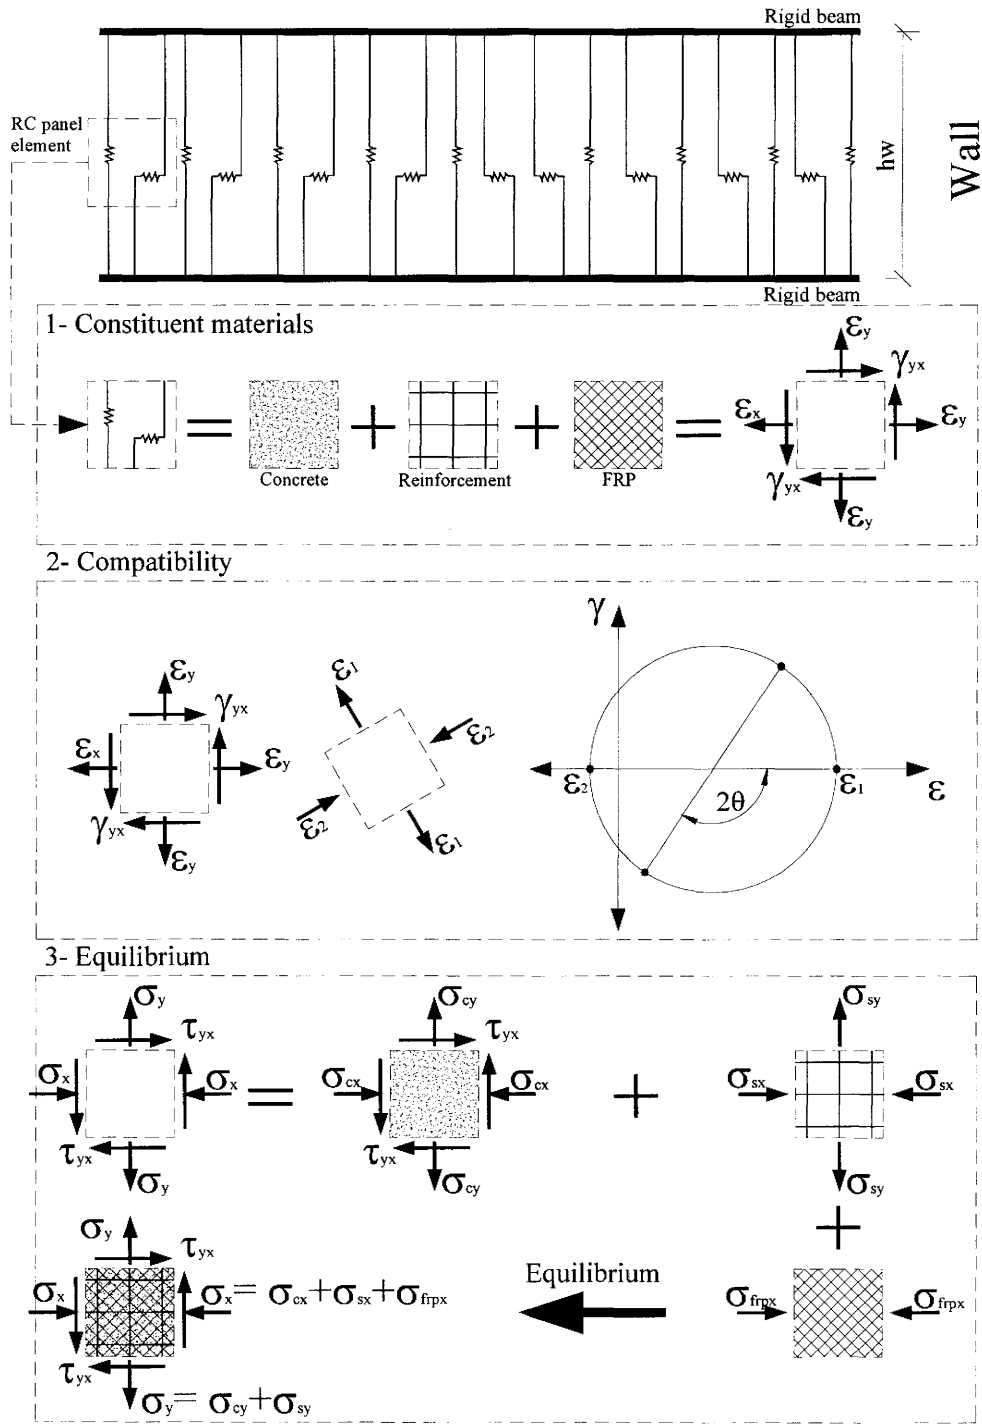
Figure 6.12 Wall hysteretic shear model

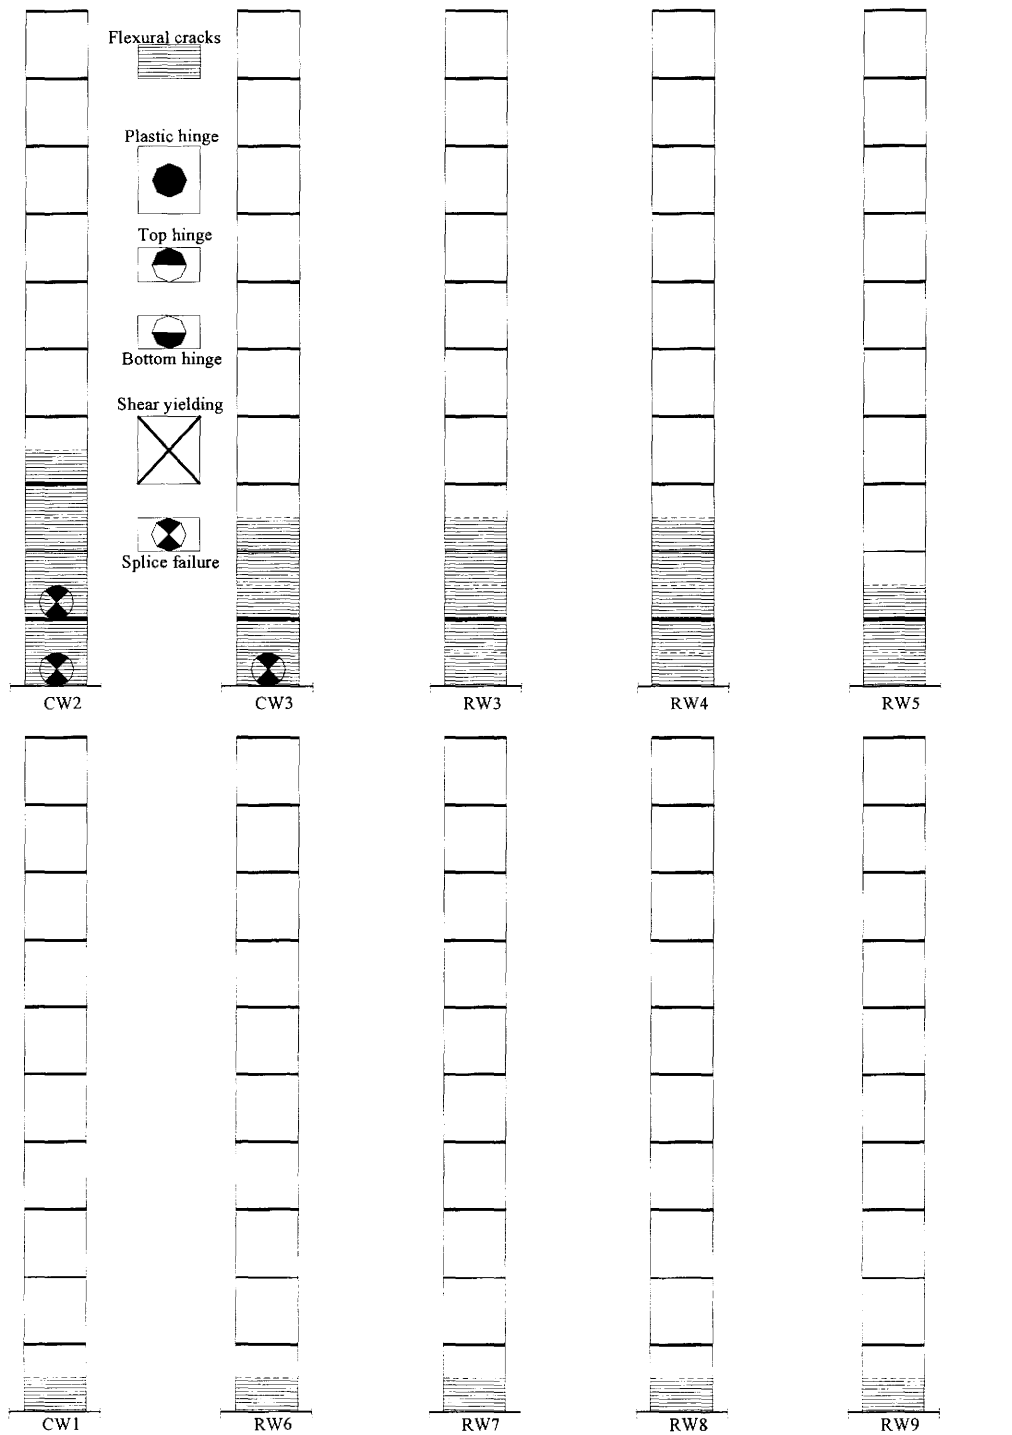
Figure 7.59 Type of damage and location due to El Centro record with PGA= 0.50g
