CORROSION PERFORMANCE OF MIG WELDED CU-LEAN AA7XXX ALLOYS

A Thesis Submitted to the School of Graduate Studies in Partial Fulfillment of the
Requirements for the Degree Master of Applied Science

McMaster University © Copyright by Jacek Dabrowski, February 2015

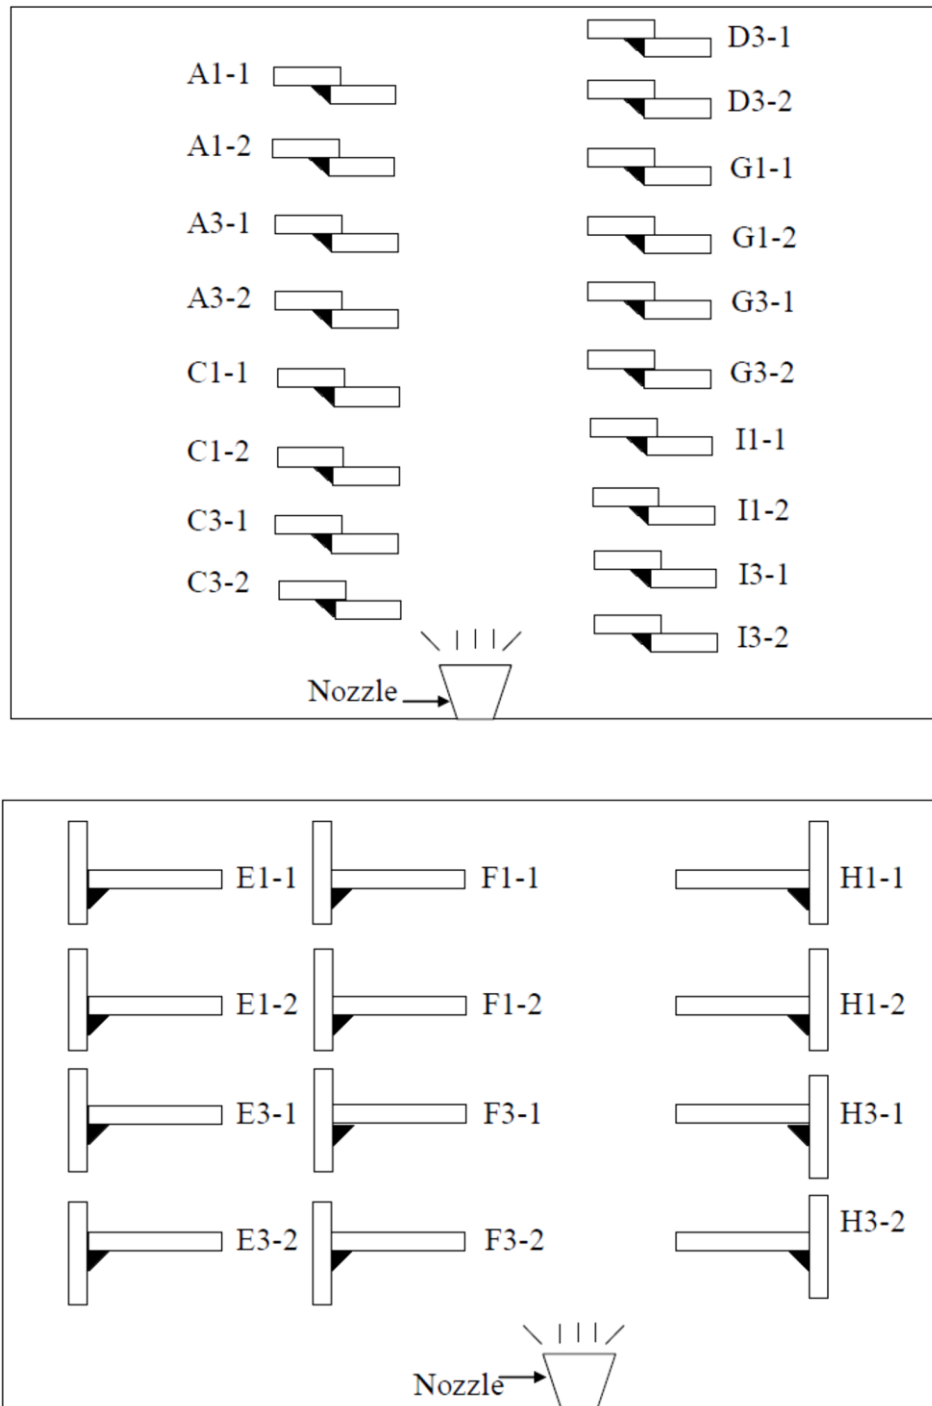
Figure 13: ASTM G85 welded AA7xxx (a) lap-joint and (b) T-joint corrosion chamber rack lay-outs. Internal corrosion chamber dimension necessitated separate exposure of lap-joint and t-joint weld configurations.

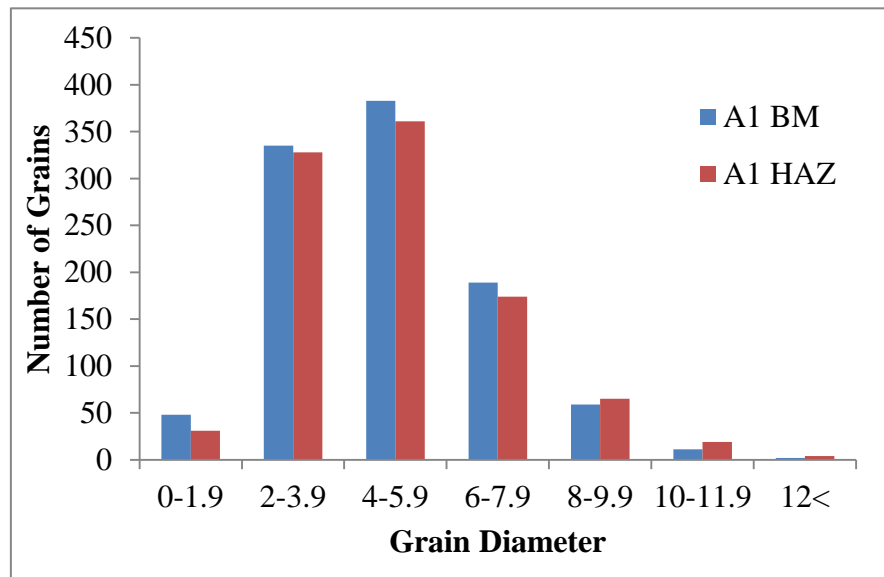
Figure 22: Typical unimodal grain size distribution observed in the unaffected base alloy and HAZ of welded AA7003 and AA7108. Data collected from the fine grained interior of the unaffected base alloy and HAZ of lap-joint configuration A1.

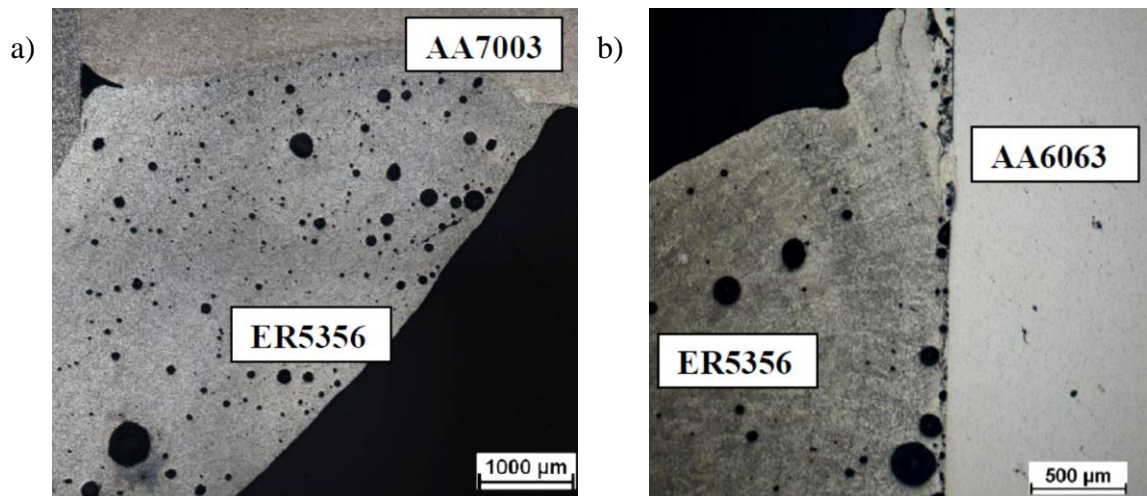
Figure 23: Cross-sectioned weld filler micrographs revealing the presence of (a) scattered porosity and lack of root penetration and (b) linear porosity observed in T-joint configuration H3.

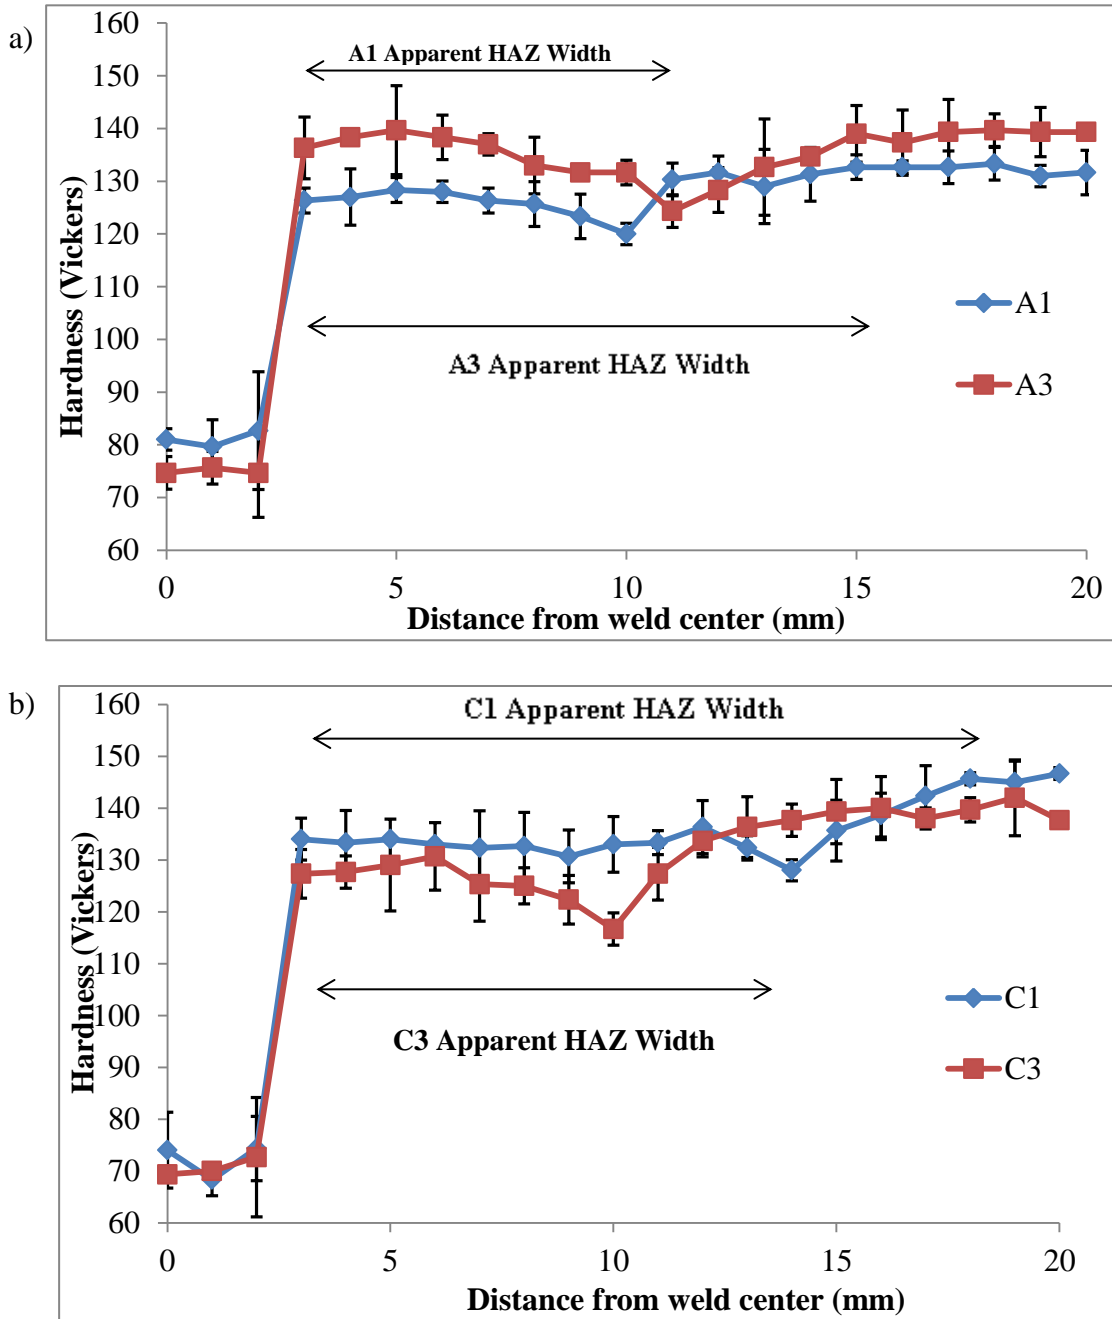
Figure 27: Typical microhardness profiles of welded (a) AA7003 and (b) AA7108 in as-welded T6 and as-welded T6+PB condition. Each error bar was calculated to a 95% confidence interval.

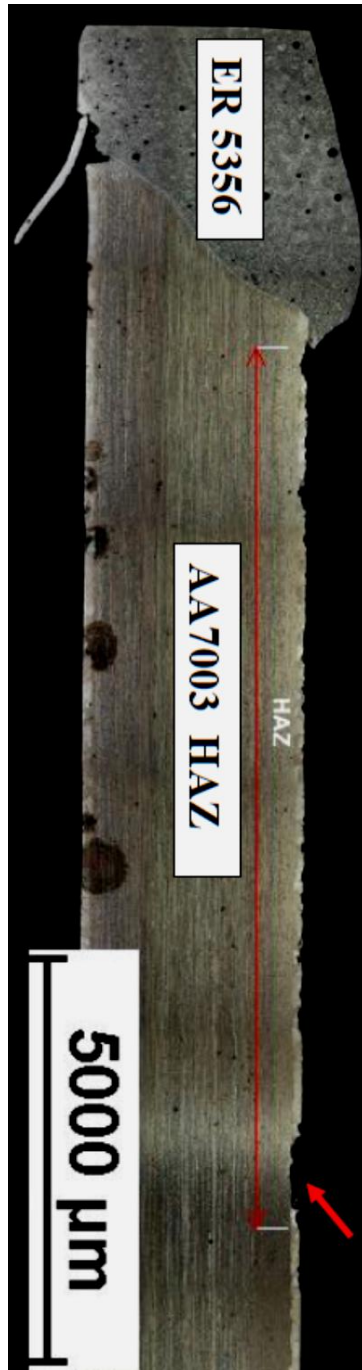
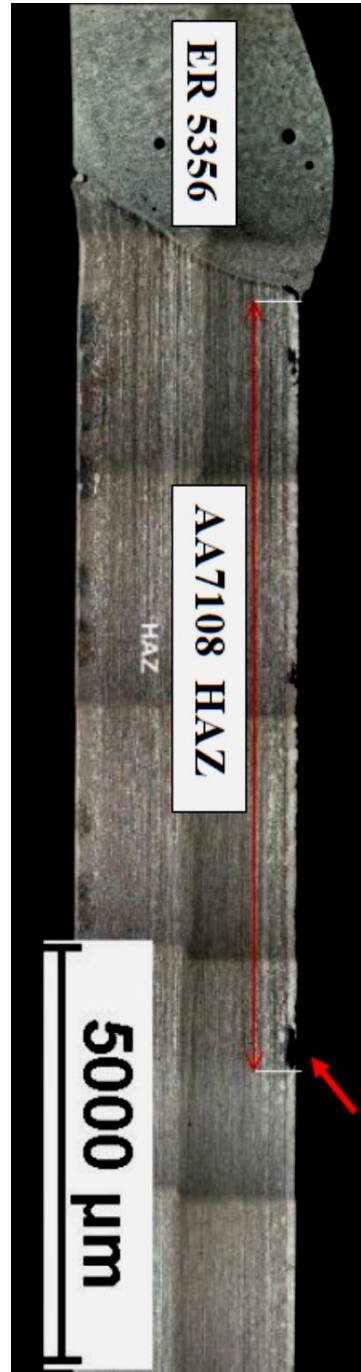
Figures 31 a and b show large-area scanned images of the weld and HAZ of AA7003 and AA7108, respectively. It can be seen from Figure 31 a and b that the corrosion observed in the welded AA7003 and AA7108 was primarily confined to the coarse-grained surface layer with shallow penetration into the fibrous interior grains, with a higher degree of corrosion penetration observed in welded AA7003 – Figure 31 a. Interestingly, the end of the HAZ of both welded AA7003 and AA7108 was denoted by a trench-like pit that is noticeably larger than the pits observed in the interior of the HAZ. This trench-like pit corresponds with the second, thinner attacked region. These larger pits, which indicate the end of the HAZ, are denoted by red arrows in Figures 31 a and b. No corrosion was observed in the weld metal of any of the exposed weld configurations except in the T-joint welded configuration I3 (ER5356/AA7108-T6+PB/≡). Table 8 summarizes the corrosion morphologies observed in the HAZ and unaffected base alloy of duplicate samples of welded AA7003 and AA7108 configurations exposed to ASTM G85-A2.

Figure 31: Large area scans of welded (a) AA7003 (configuration A1) and (b) AA7108 (configuration C1) in the as-welded T6 condition post exposure to ASTM G85-A2

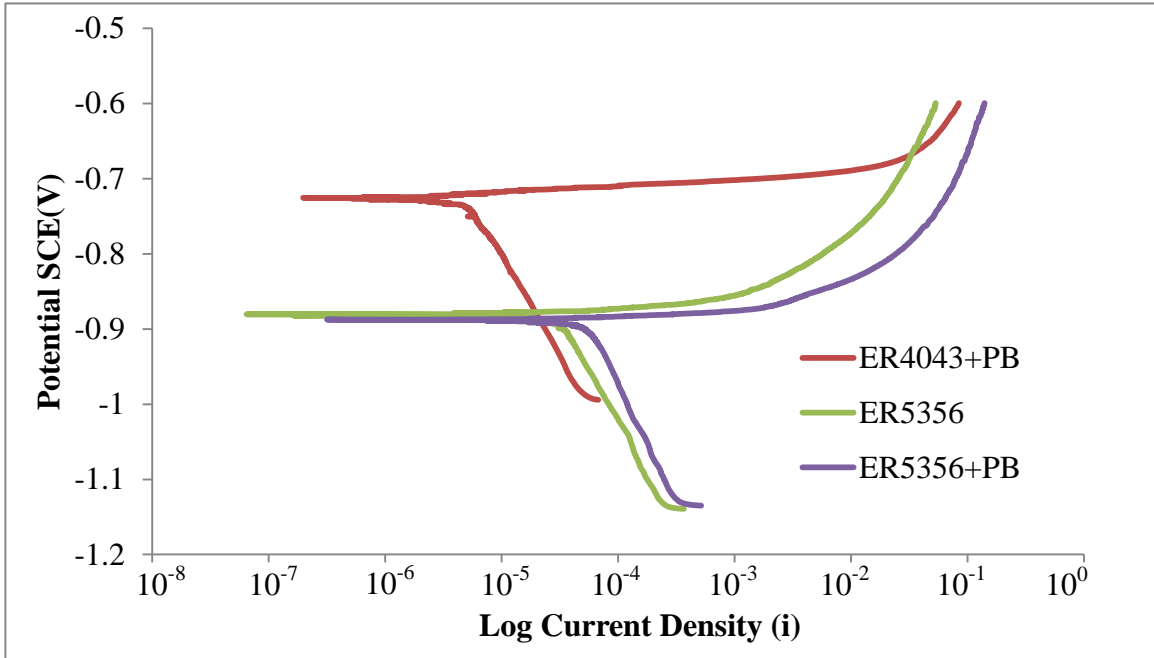
Figure 35: Potentiodynamic polarization scans of filler alloys: ER4043 as-welded T6+PB, ER5356 as-welded T6 and ER5356 as-welded T6+PB.

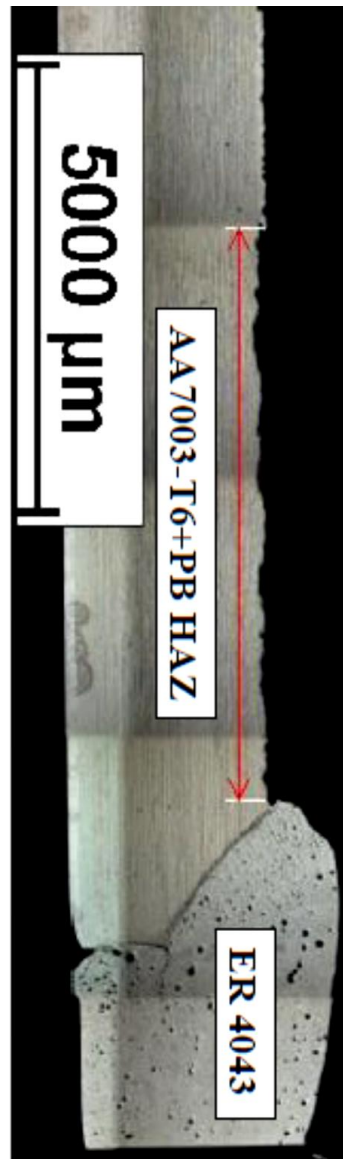
Figure D3 Large area scans of lap-joint welded configuration D (ER4043/AA7003/L) in as-welded T6+PB condition post exposure to ASTM G85-A2.

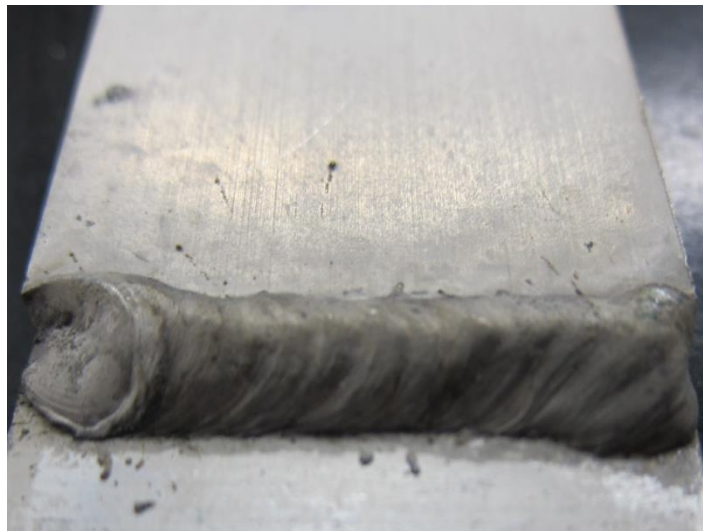
Figure E3 Close-up images of lap-joint welded configuration D (ER5356/AA7003/⊥) in the as-welded T6+PB condition post exposure to GMW-14872.

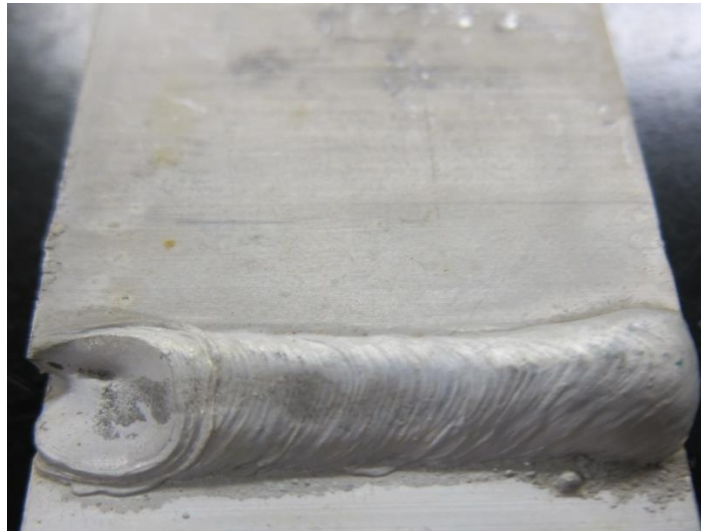
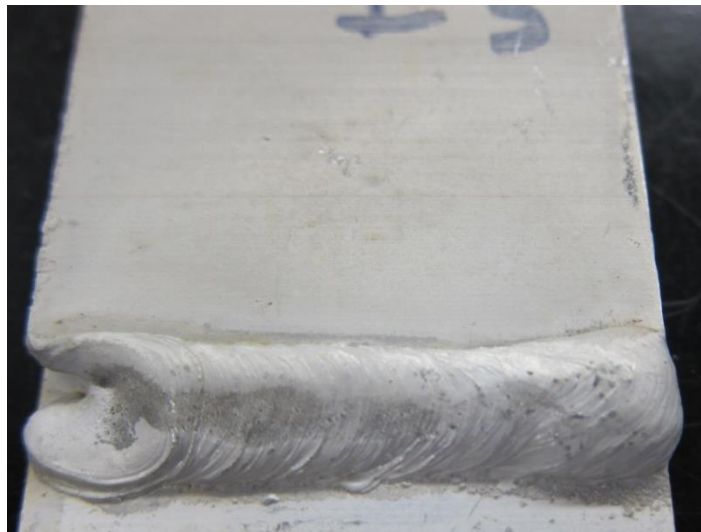
Figure E8 Close-up images of lap-joint welded configuration I (ER5356/AA7108/⇒) in the (a) as-welded T6 condition and (b) as-welded T6+PB condition post exposure to GMW-14872.
