THE LAKE HURON SHORELINE, GRAND BEND TO PORT FRANKS

THE SHORELINE OF LAKE HURON
FROM GRAND BEND TO PORT FRANKS,
AND THE PROBLEMS AT THE MOUTH OF THE AUSABLE RIVER

A 4B6 Research Paper

McMaster University

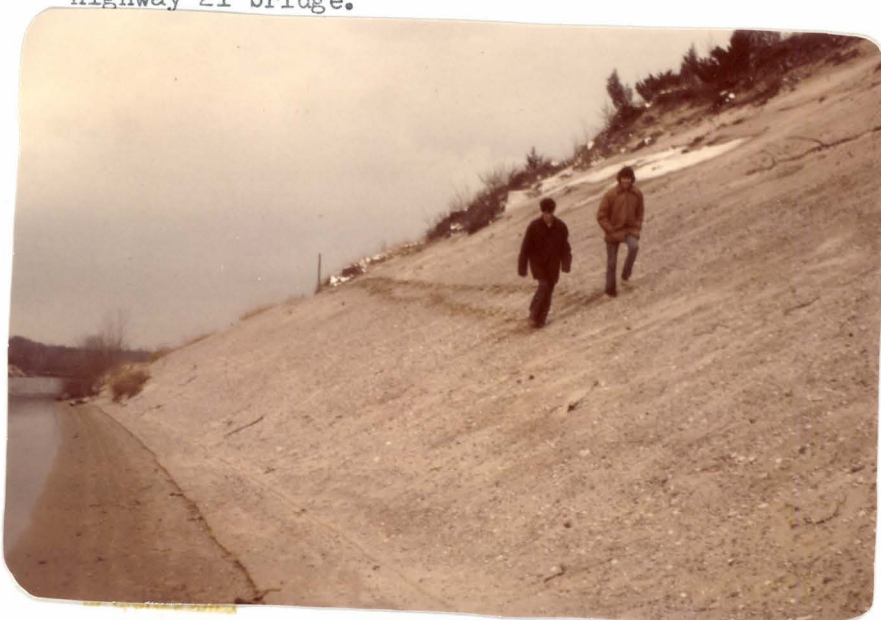
Plate 2.A : The raised shoreline, overlain by wind blown sand on the north bank of The Cut, just downstream from the highway 21 bridge.

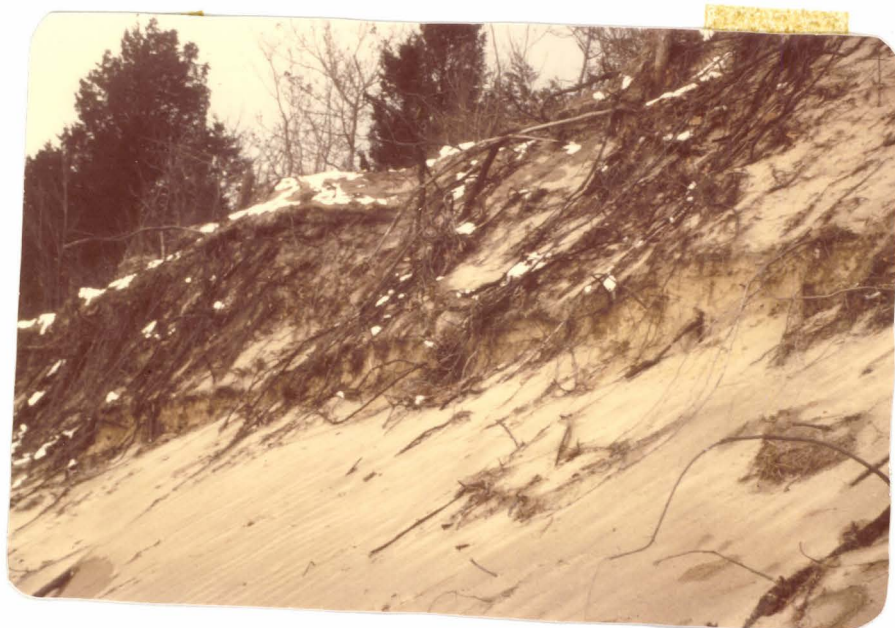
Plate 2.B : The same location as above, showing darker soil horizons in the sand near the top of the dune.

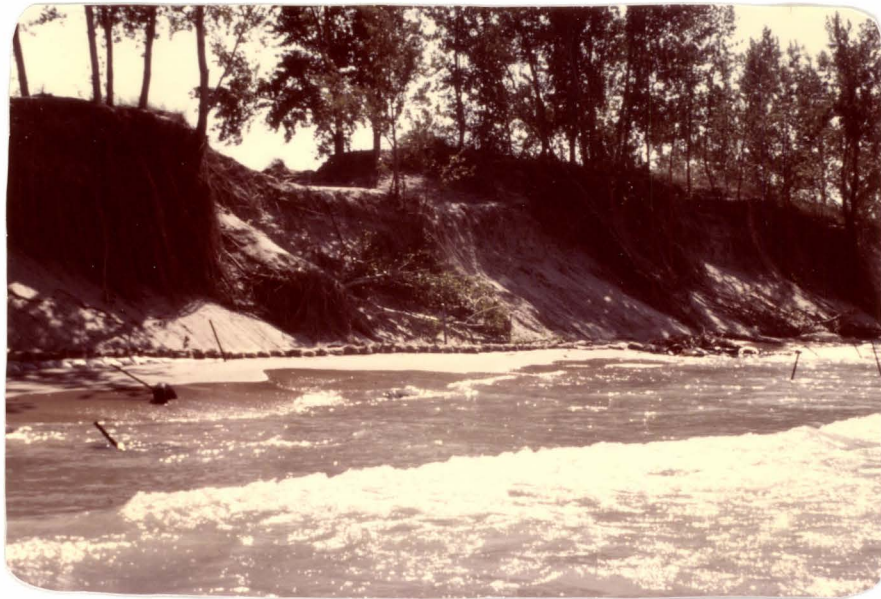
Plate 3.A : The sand dune cliff just north of the mouth of the Ausable River, August, 1972.

Plate 3.A indicates the other type of shore protection attempted on the beach. In discussing the problem with the owner, the author was informed that the purpose of the tires and sand bags was to build up the beach in front of the bluff, and thus provide the best known natural protection against erosion. The owner recognized the problems of breakwalls; that due to the abrupt manner in which they halt the swash, breakwalls increase the backwash and cause the beach to aggrade. He also understood the problem of extreme energy expended on such walls, thus requiring considerable time and labour in their construction. Nevertheless, he too resorted to the timber breakwall, Plate 3.B, during the fall, due to certain inherent weaknesses in his first plan, to save his cottage and its sewage system, which were very close to the edge of the bluff. As a point of interest, he had lost his well sometime prior to August 20th, 1972. All of this information will be considered in reference to the profiles and in later discussion.

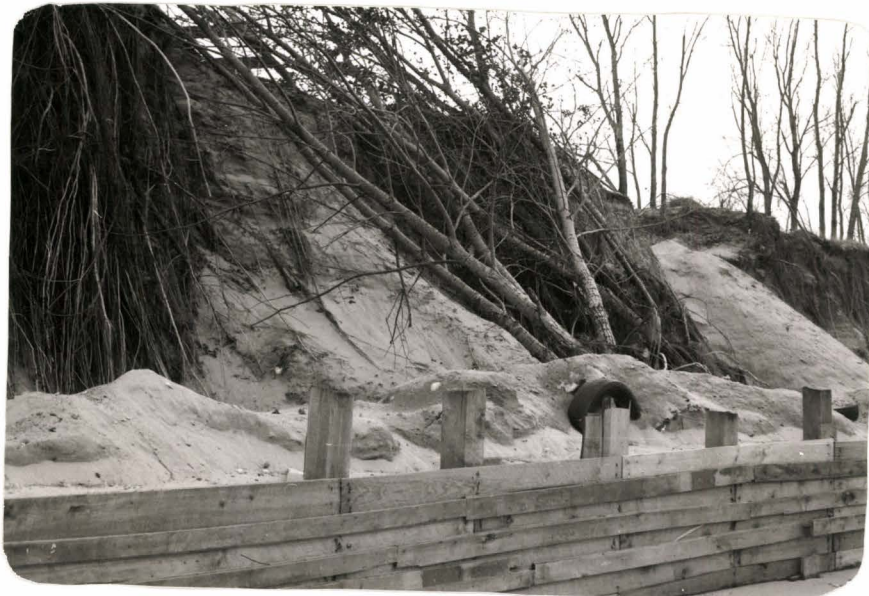
Plate 3.B : The same as above, October, 1972.

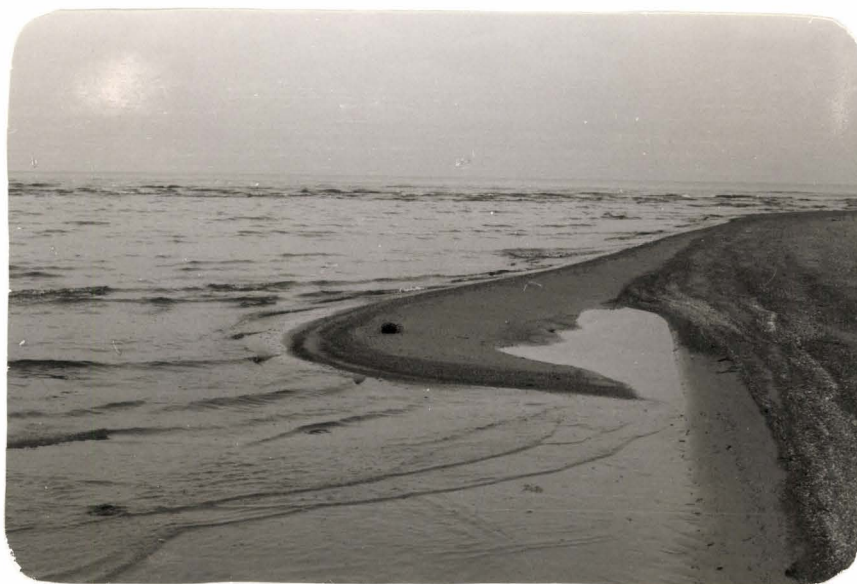
Plate 3.C : A small recurved spit built on the much larger one at the mouth of the Ausable River.

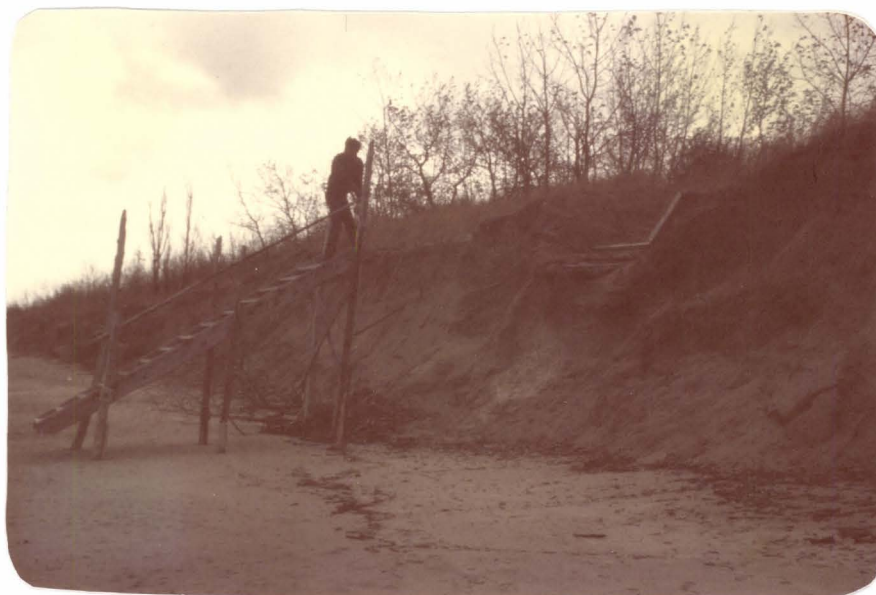
Plate 3.D : Erosion along the beach, to the north of Port Franks, October 30, 1972.

of approximately 25 feet of property, (sand dunes), from the front of their cottage in a one year period. A loss of approximately 40 feet was estimated for the two year period prior to the summer of 1972. Most of the cottages were not in danger however, as they still had a considerable distance of sand dunes in front of them by the end of the fall. Also, the owners felt that, as in the past, the water level would subside and the dunes would be rebuilt, before any real danger was faced. One cottage, see Plate 3.E, that was previously mentioned at profile 180, was possibly in danger of being undermined, particularly with the mild winter just experienced in Southern Ontario.

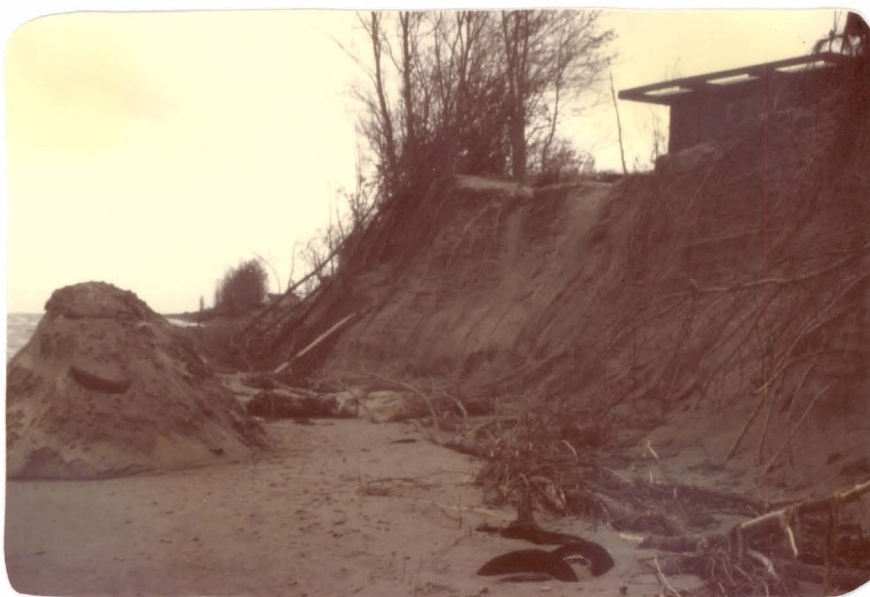
Plate 3.E : Continued erosion at the same site as Plates 3.A and 3.B, prior to the construction of the breakwall.

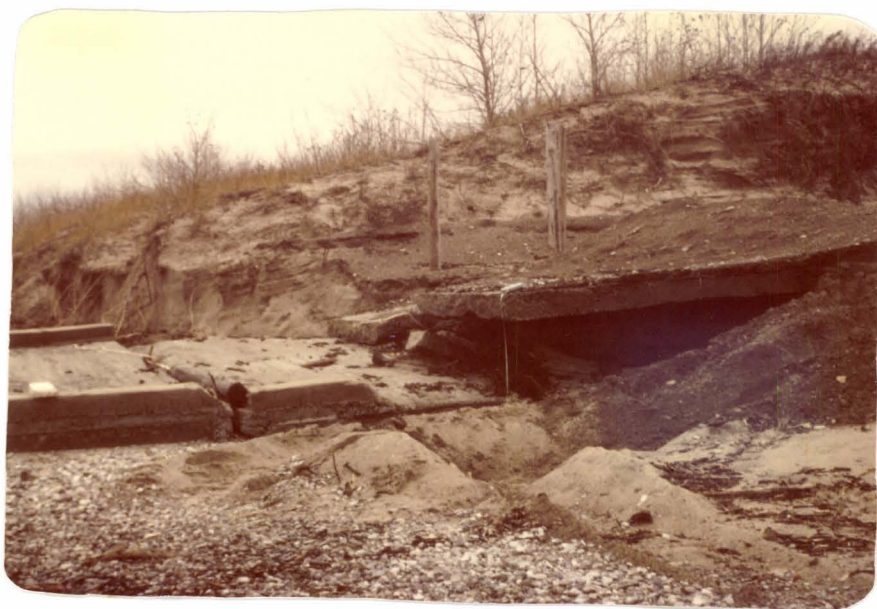
Plate 3.F : Some other effects of the waves attacking the shoreline, in this case the destruction of the boat launching ramp at Burley Camp, in the Pinery.

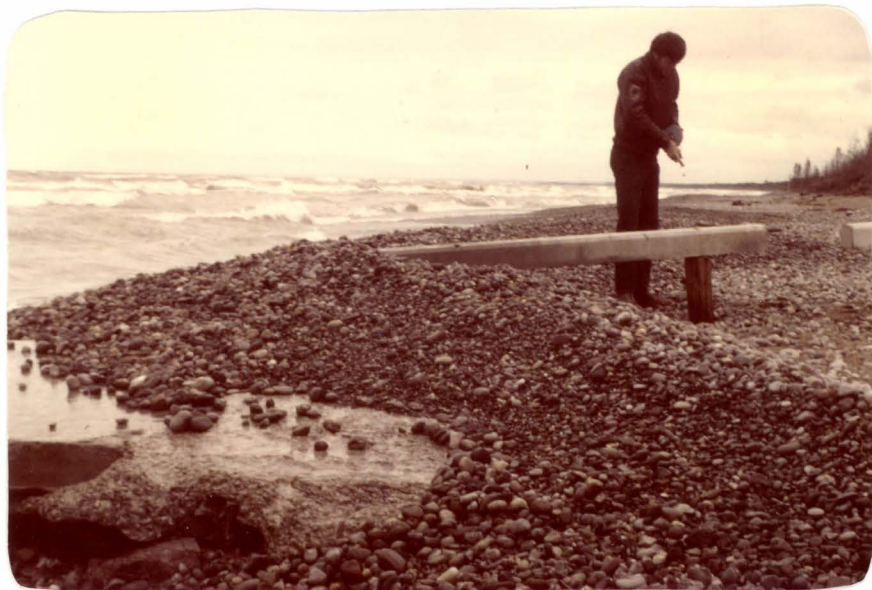
Plate 4.A : This cobble swash bar or berm ridge was observed to have been built by the waves in the photo, the main ridge was approximately 2000 feet long and covered the boat launching ramp at the Dunes Campground in The Pinery.

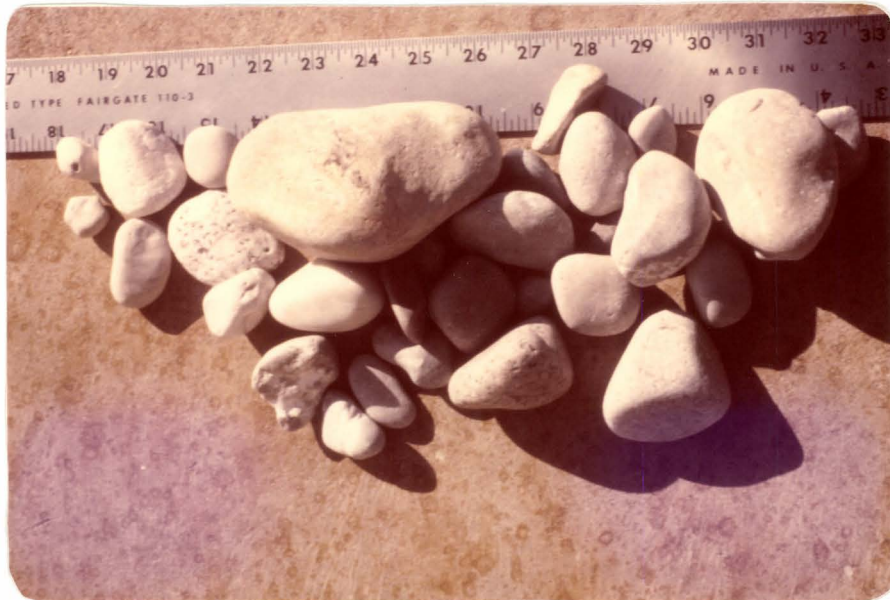
Plate 4.B : Sample 514, from the crest of the ridge of Plate 4.A,
too coarse to sieve.

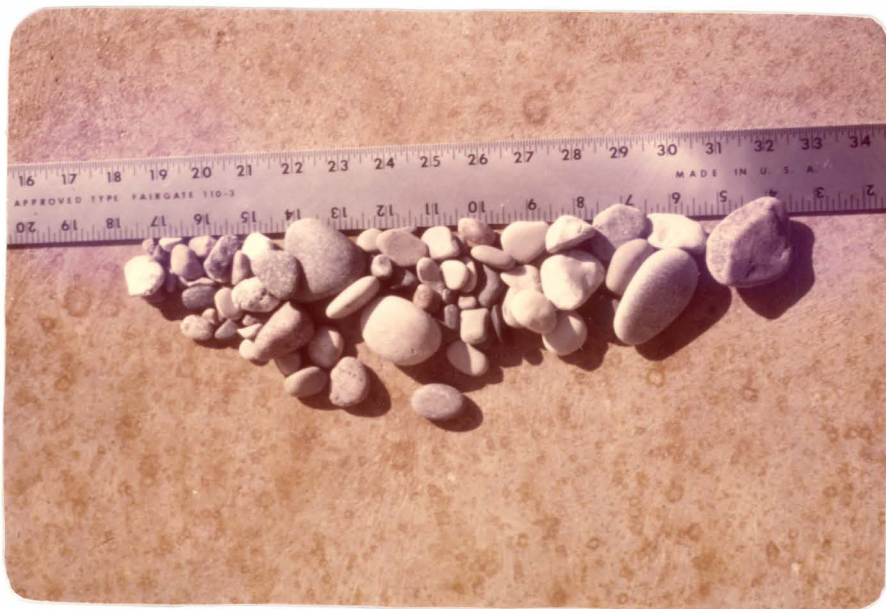
Plate 4.C : Sample 513, from behind the ridge of Plate 4.A.

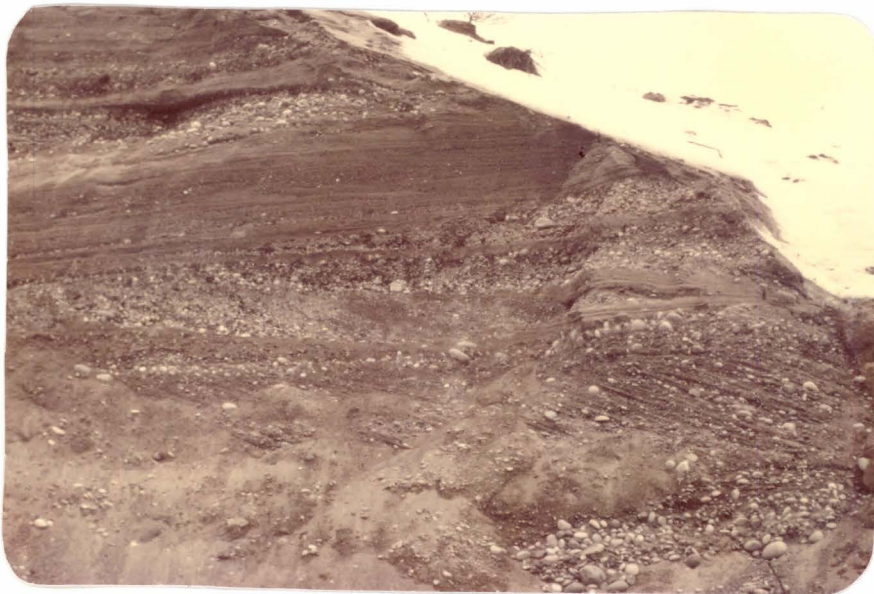
Plat 4.D : Showing some of the bedding features of the raised beaches comprising the bay-mouth bar, at the gravel pit on highway 21 north of the Ausable River.

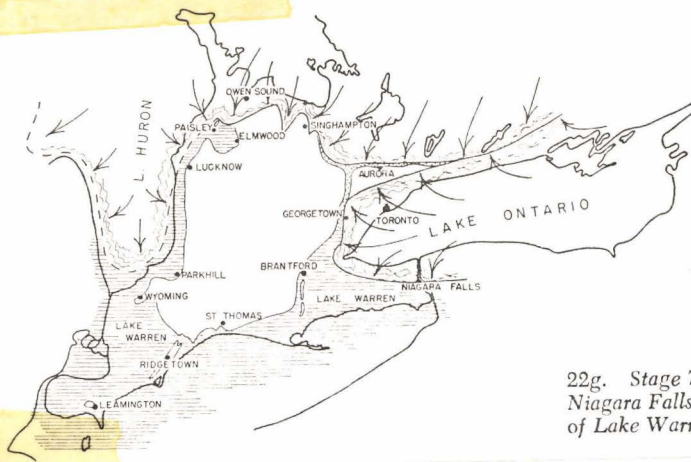
22g. Stage 7: at the Gibraltar and Niagara Falls moraines, or during the life of Lake Warren

Fig. 4.4, The Retreat Of The Wisconsin Glacier And Resultant Lake Stages, from Chapman and Putnam, (1966).

The second objection is based on the Wisconsin glacier recession as presented by Chapman and Putnam (1966), and indicated in Figure 4.4. Again the possibility of growth from the south appears limited. The study area was open to water during the Lake Warren stage, and from this map, there does not seem to be sufficient fetch to build a bar. The time necessary to build such a bar does not seem sufficient either. Stage 8, of Chapman and Putnam (ie. the Schomberg and Peel Pondings) lack the fetch to the south, while the Lake Algonquin stages largely follow the shoreline of the present Lake Huron, and thus also lack sufficient fetch. These latter two stages would be more likely to produce a southward growing bar.

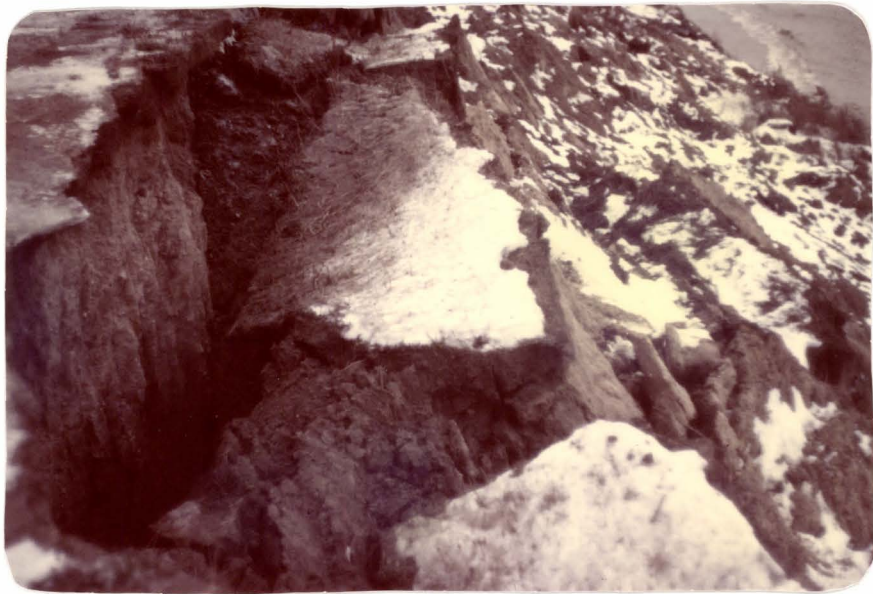
Plate 4.E : The slumps of the boulder clay cliffs to the north of Grand Bend at St. Joseph. These cliffs are probably the source of sediment for the modern beach.

(iii) At present, the boulder-clay cliffs north of Grand Bend appear to be the source area for the modern beach. Not only is the predominant direction of longshore transport in this direction, but the cliffs, although containing a large percentage of clay, do have a considerable percentage by weight, of sand, pebbles, and angular stones. There is sufficient material here to form the beach. It is significant also that the major minerals found in the cliff sample are also those found in the beach samples. This is again true for the raised beach samples taken from The Cut, and the gravel pit on highway #21. The latter point is not too important however, as all glacial tills in this area having a high percentage of clay, possibly contain these same minerals.

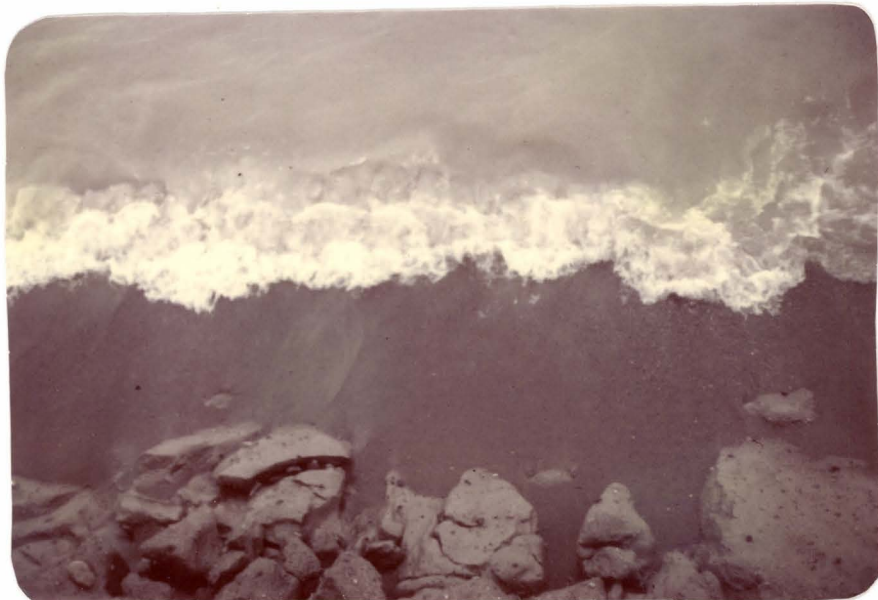
Plate 4.F : The base of the cliffs shown in 4.E.

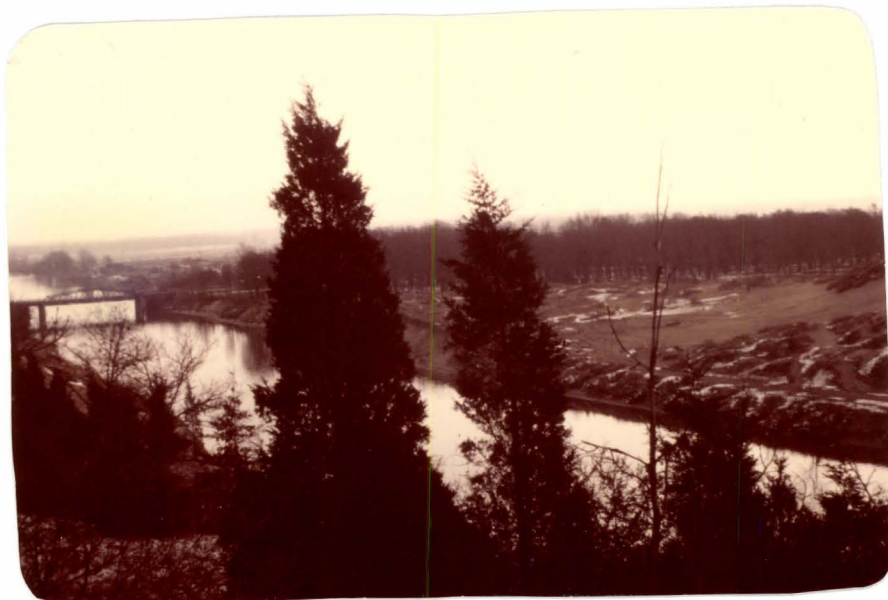
Plate 6.B : The Cut, looking southeast, i.e. upstream, with the highway 21 bridge in the background, and the former Lake Burwell in the distance.

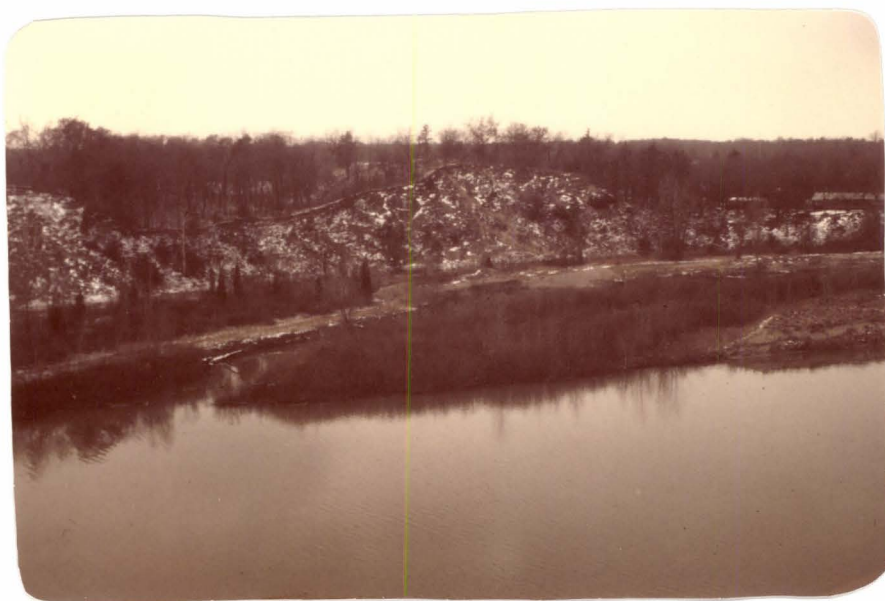
Plate 6.C : The Cut looking southwest and downstream, and showing a portion of meander number 3.

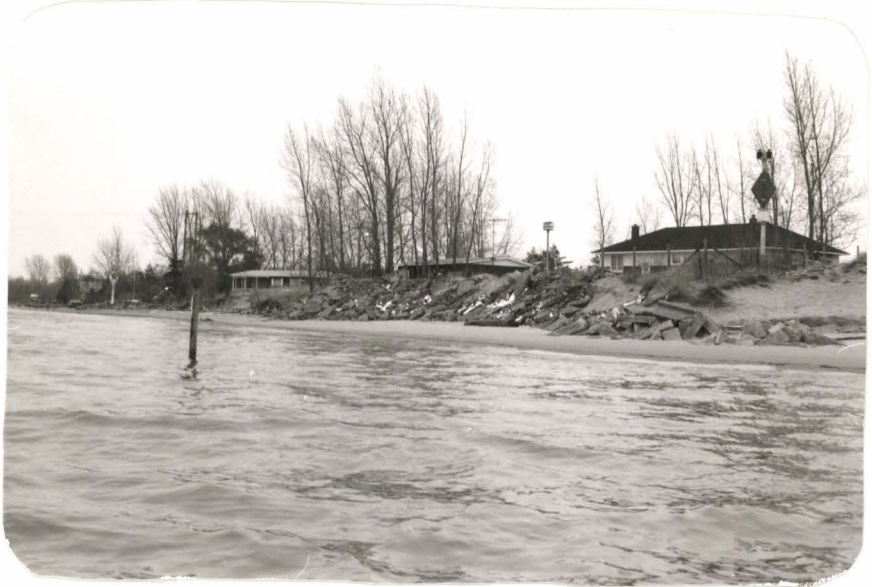
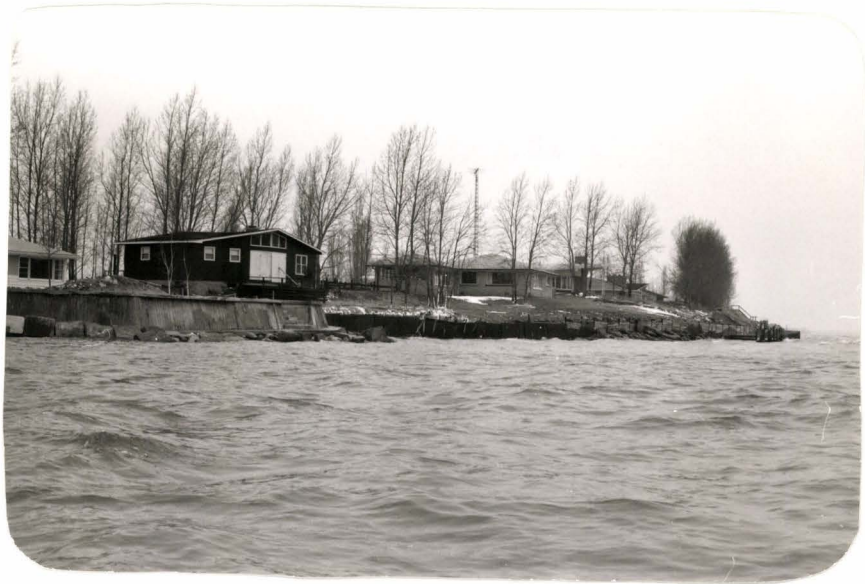
Plate 7.A and 7.B : The south bank of the Ausable River at its mouth at Port Franks, showing the erosion of the bank and shore by the waves.

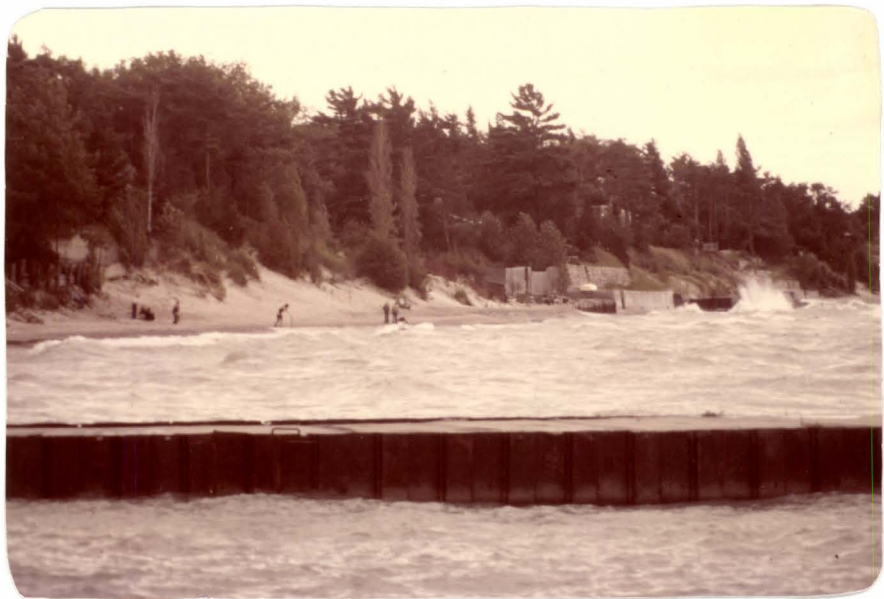
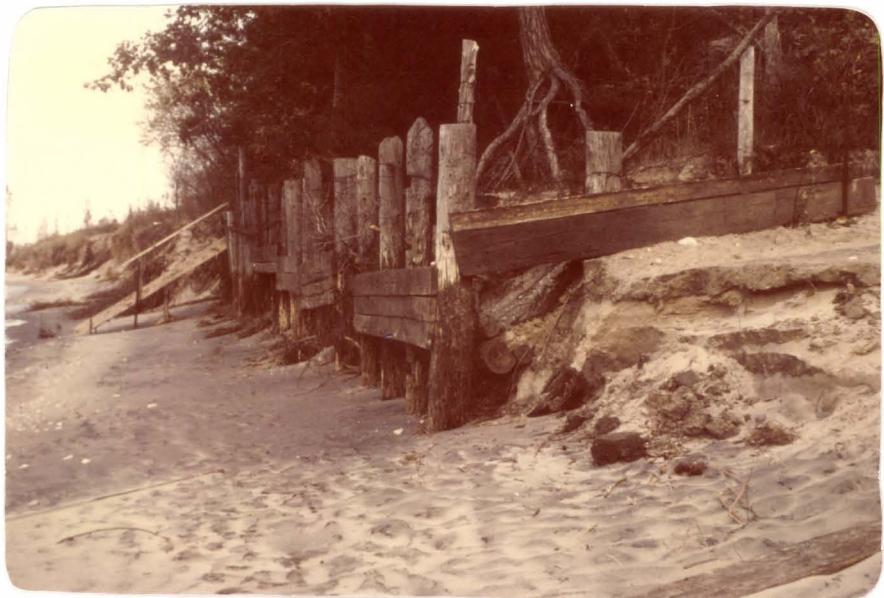
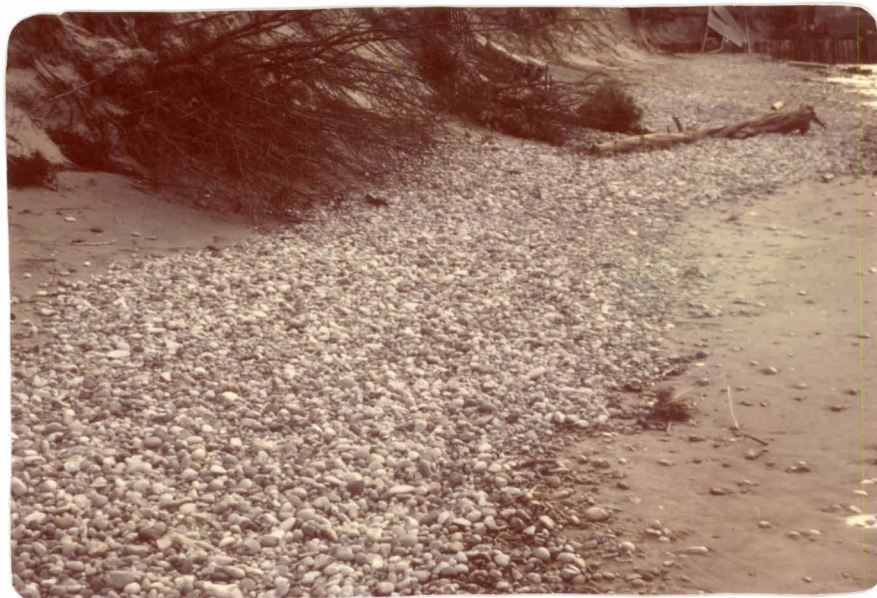
Plate 7. E :

Plates 7.C, 7.D, and 7.E : The Problems associated with the leeward side of the pier at Grand Bend. The coarser material of 7.E indicate that the beach is steeper and apparently being starved for material, to be carried along the beach.
