Cyclic Fatigue Behavior of Friction Stir Welded AZ-Series Magnesium Alloys

A thesis

Master of Applied Science

McMaster University

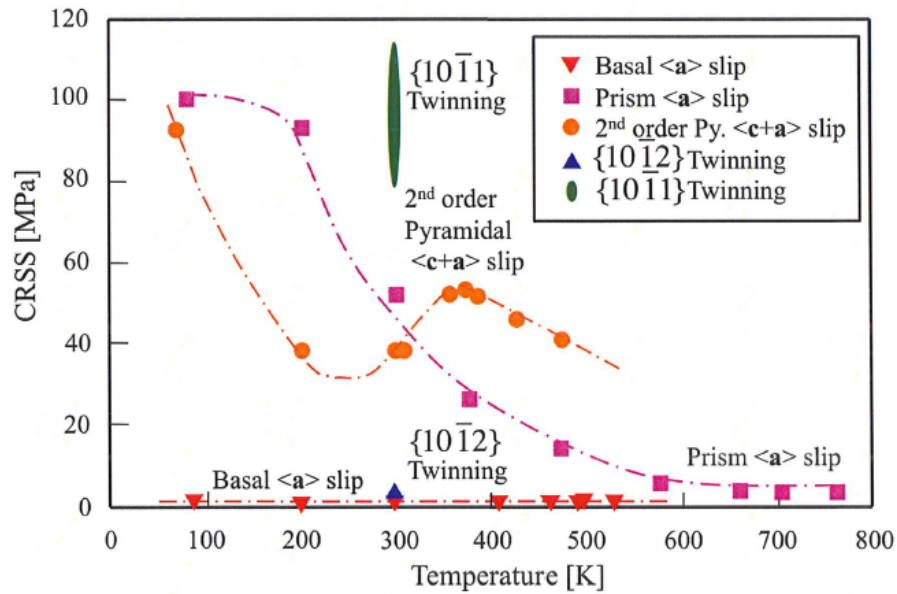
Figure 2.2: CRSS for the common slip systems in magnesium, courtesy of Fumiaki Hiura [4].

From this figure, it is evident that basal slip is the easiest slip system active at room temperature because it has the lowest CRSS value, making it a prevailing deformation mechanism for magnesium. The CRSS of other slip systems, namely prismatic and pyramidal, is almost a hundred-fold larger than basal slip. However, at higher temperatures non-basal slip becomes easier to activate. From Table 2.2 it is apparent that basal slip has only two independent slip systems, which gives rise to the poor ductility and formability of polycrystalline magnesium and magnesium alloys. In fact, if the two most common slips, basal and prismatic, are activated simultaneously, they only offer four independent slip systems between them. When a slip system with a $\langle c + a \rangle$ Burgers vector is operative, this

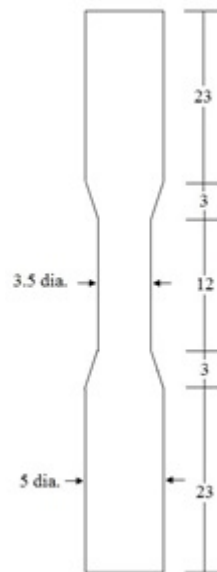
Figure 3.2: Shape and dimensions of the fatigue specimens in millimeters.

E8 standards. The length of the specimens are 58 mm and the diameter of their necks are 3.5 mm. The transition from the grip section to the gage is machined as a gentle curvature to avoid any sharp changes in thickness, to avoid any stress concentrators that would alter the results. All the machining of the specimens was done at Queen's University.

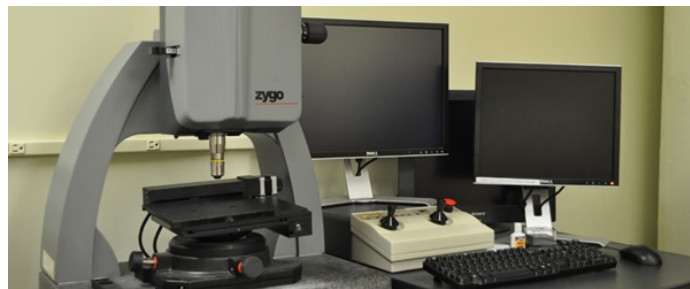
Figure 3.3: The Zygo NewView 5000 surface profiler machine [7].

Master Manufacturing Research Institute (MMRI) facility. The Zygo machine, shown in Fig. 3.3, is a non-contact 3 – *D* surface profiler that scans the specimen with light interferometry to image and measures the topography of the surface. With the specimen orientated horizontally, an area of 6 mm x 0.4 mm, x and y respectively, was observed. Since the Zygo machine uses light to scan the surface, the nature of the cylindrical specimens does not allow light to be reflected back to the detector which skewed the results obtained. To counteract this problem, a filter was available in the program to remove the outer edges and assume a rectangular surface. After the data is collected, a 3-dimensional surface topography image is obtained, as well as the average surface roughness, R_a .

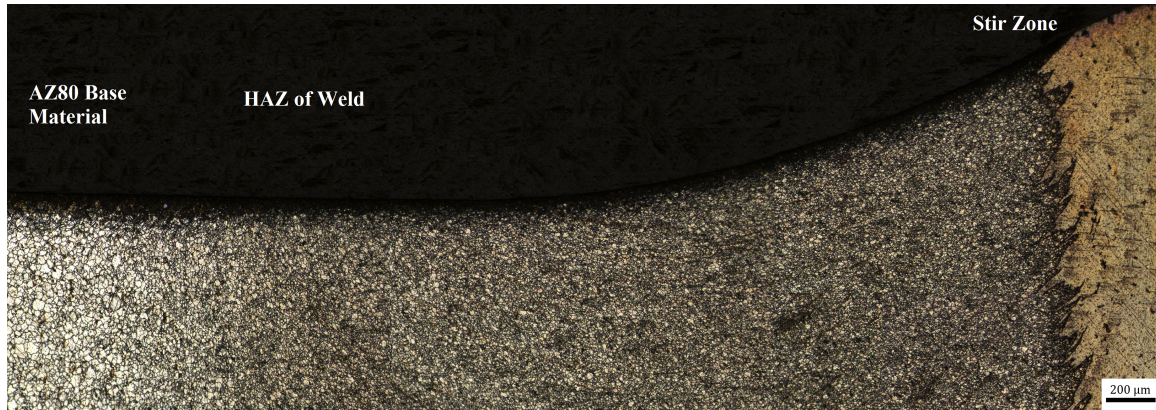
Figure 4.2: Optical Micrograph of AZ80/AZ31 FSW along the fatigue specimen.

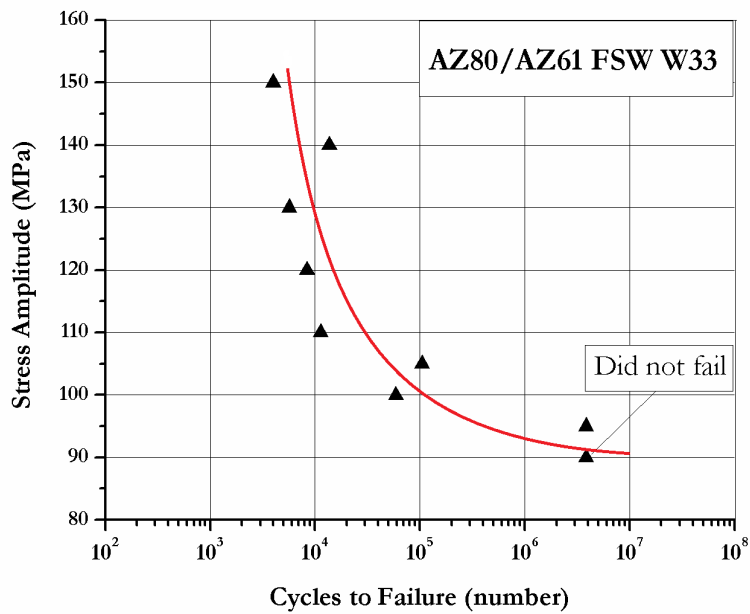
Figure 4.4: S-N curve for weld 33 of FSW magnesium AZ80/AZ61.

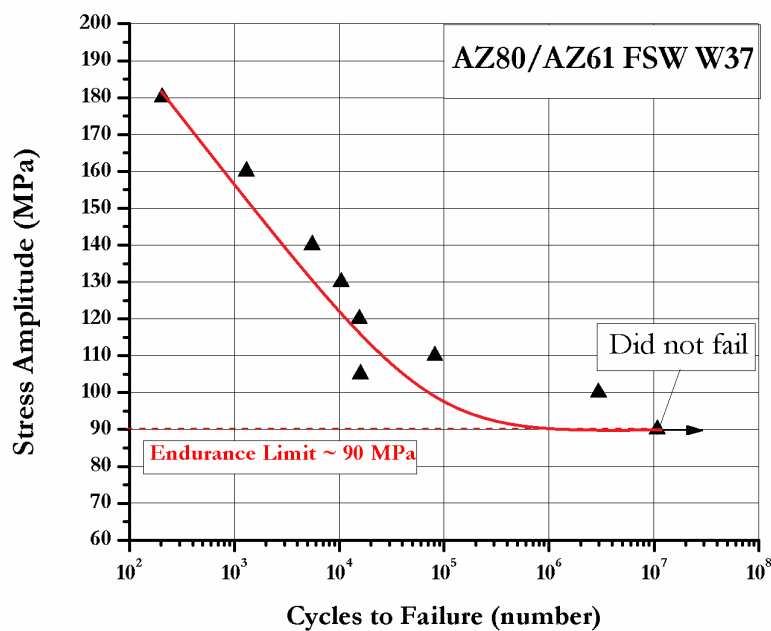
Figure 4.6: S-N curve for weld 37 of FSW magnesium AZ80/AZ61, with the endurance limit shown.

Fig. 4.6 and Fig. 4.7 represent the S-N curves for weld 37 and weld 38, which correspond to the dissimilar welds of AZ80/AZ61 and AZ80/AZ31, respectively. To recall, the

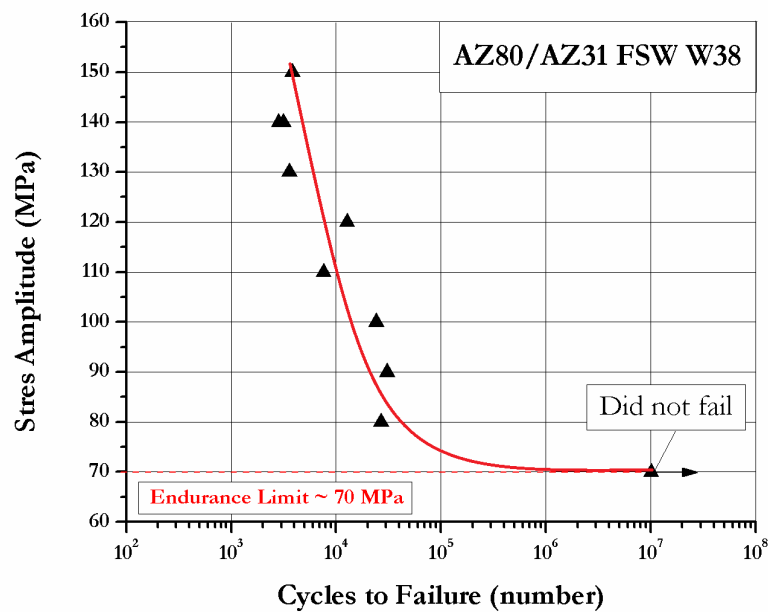
Figure 4.7: S-N curve for weld 38 of FSW magnesium AZ80/AZ31, with the endurance limit shown.

sharp bend occurs around 70 – 80 MPa with an endurance limit of 70 MPa. The specimen tested at this stress amplitude had a fatigue life in excess of 1.006×10^7 before the test was terminated. This result agrees with the previous S-N curve for the AZ80/AZ31 weld which also showed an endurance limit of 70 MPa.

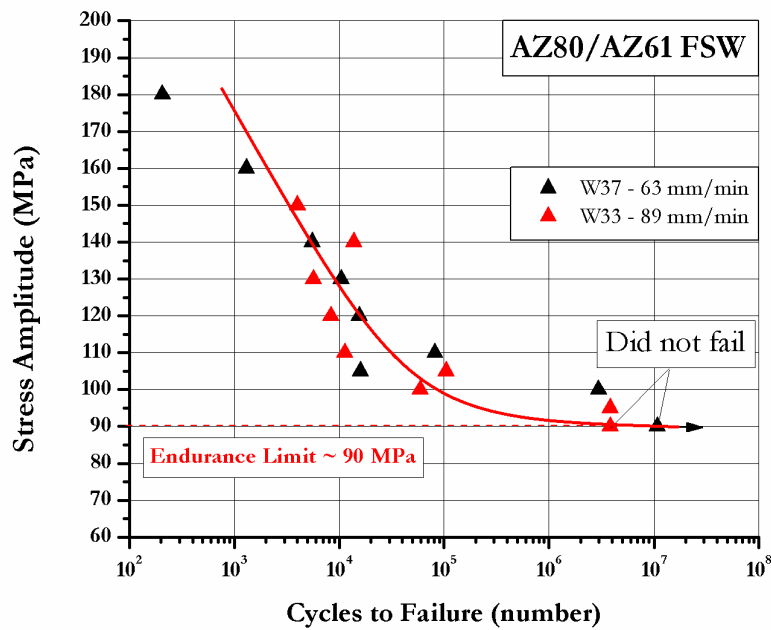
Figure 4.8: S-N curve showing combined fatigue data for the AZ80/AZ61 welds 33 and 37, with the endurance limit shown.

The combined S-N curves for the AZ80/AZ61 weld and AZ80/AZ31 are shown in Fig. 4.8 and Fig. 4.9, respectively. The fatigue data for each set of dissimilar welds show a good correlation with a similar trend observed in each curve. There is also a degree of reproducibility in the fatigue data even though S-N curves tend to have a large scatter in the data. The fatigue data in S-N curves tend to scatter the most at higher stress amplitudes, primarily because at high stresses the sensitivities to specimen preparation is significant. While at lower stress amplitudes, the scatter between the results is reduced. As expected

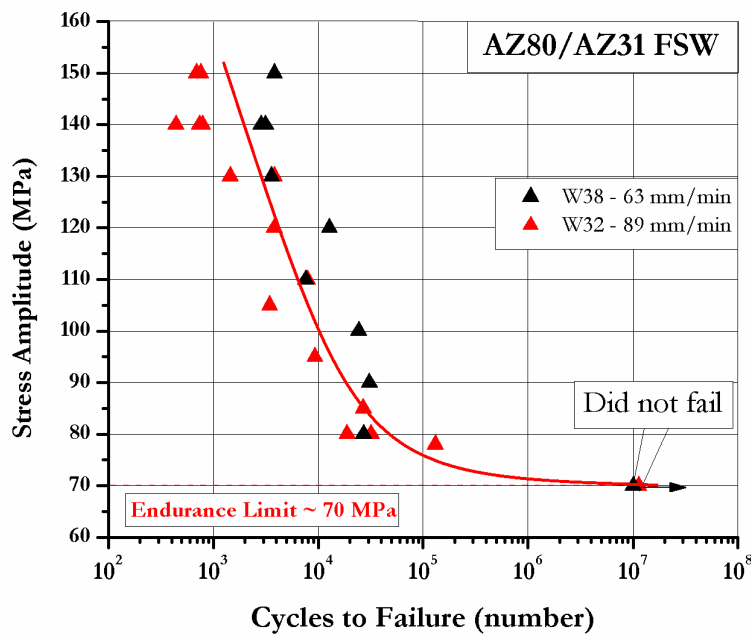
Figure 4.9: S-N curve showing combined fatigue data for the AZ80/AZ31 welds 32 and 38, with the endurance limit shown.

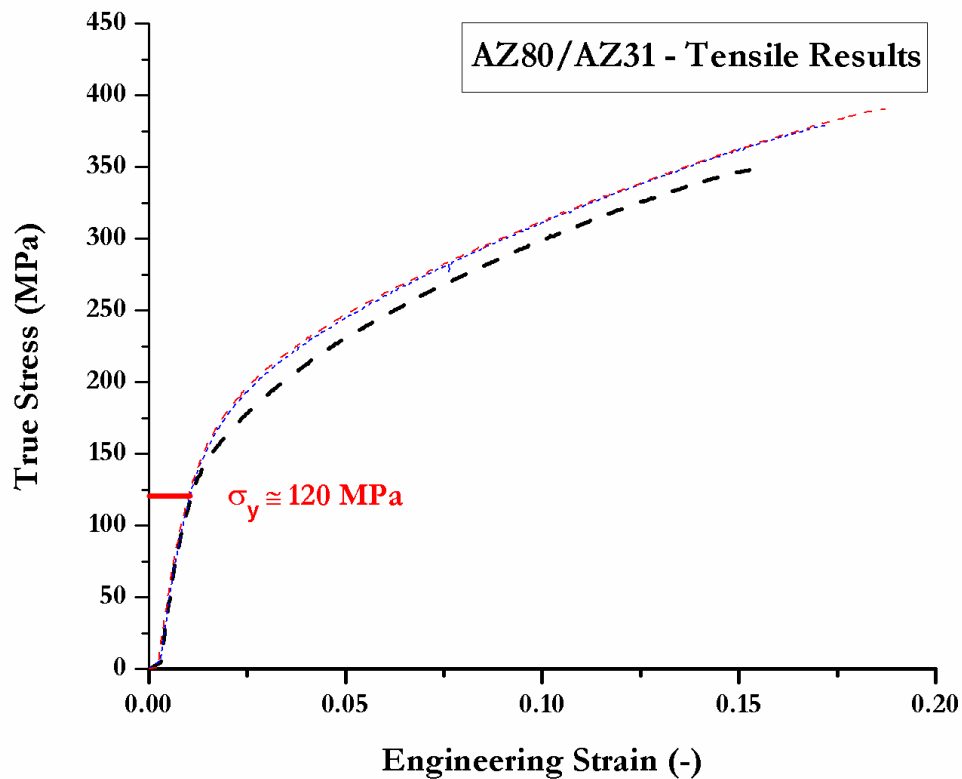
Figure 4.10: Tensile testing curves for weld 32 of FSW magnesium AZ80/AZ31.

From the figure, it is apparent that two of the three curves had almost exact tensile behavior, while the third showed a slightly lower flow stress, but similar yield stress and

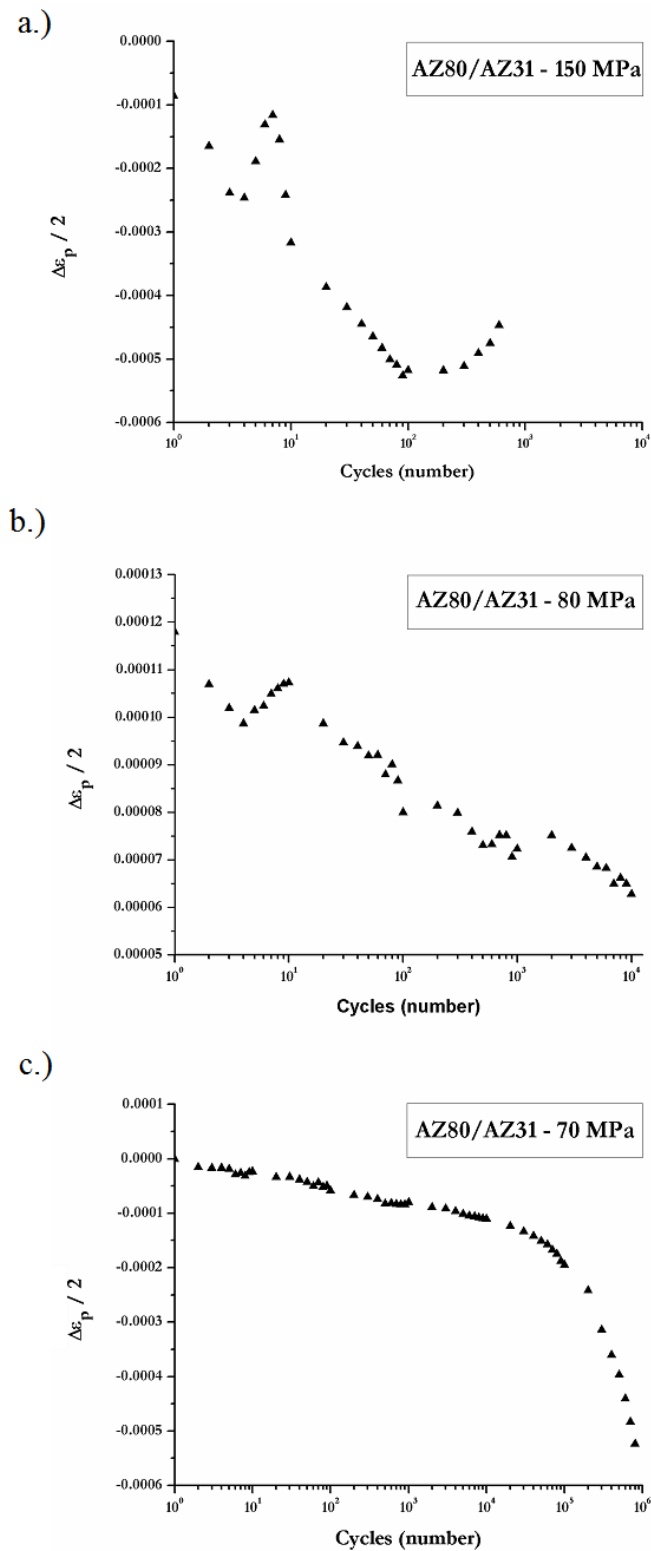
Figure 4.12: Calculated plastic strain vs. number of cycles to failure plot for, a.) 150 MPa stress amplitude, b.) 80 MPa stress amplitude, and c.) 70 MPa stress amplitude.

The fatigue specimen tested at 70 MPa represents the endurance limit of the material because it survived at least 10 million cycles and the specimen did not fail. The applied stress amplitude for this fatigue specimen is also below the experimental yield strength of the material. The first cycle in the hysteresis loop shows a small plastic strain is observed in the material. While this plastic strain is slightly increased at the tenth cycle because of the higher stress amplitude applied. At the mid-life cycle, the plastic strain is minuscule, and

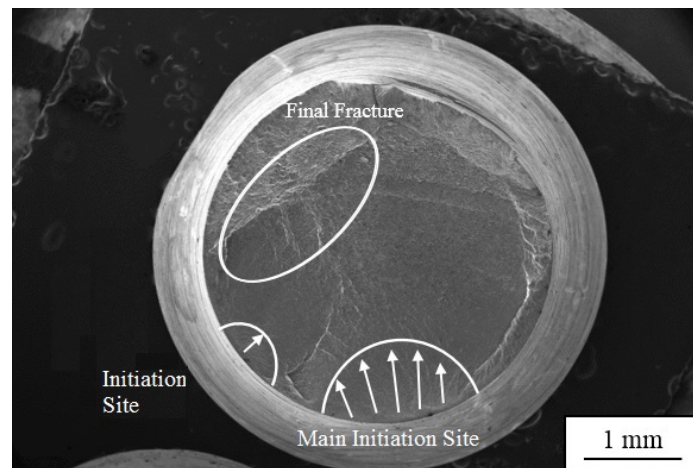
Figure 4.18: Low magnification image of fracture surface for the 80 MPa stress amplitude specimen.

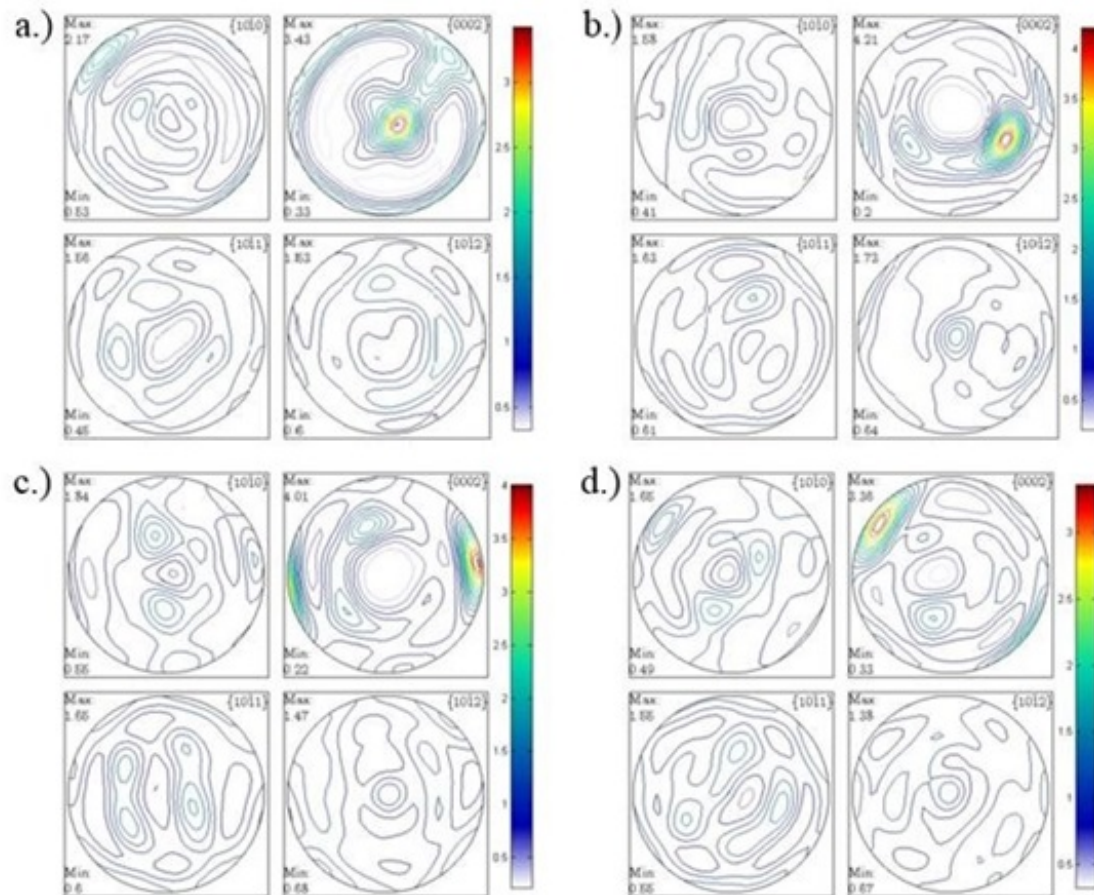
Figure 4.35: The calculated pole figures using MTEX for: a) undeformed specimen, b) specimen deformed to 150 MPa, c) specimen deformed to 80 MPa, and d) specimen deformed to the endurance limit of 70 MPa.

The pole figures obtained through MTEX and GADDS correlate well with each other; however, in GADDS the pole figures obtained do not show data on the outer edges, at low angles of measurements. For the 80 and 70 MPa specimens, there is a strong basal texture shown on the MTEX pole figures but not on the GADDS pole figures. The resulting calculated pole figures for these specimens show a basal texture occurring approximately parallel to the tensile axis. For these specimens, a portion of the basal texture rotates approximately 90° possibly due to the increased fatigue damage applied.
