Investigating Alternative Testing Techniques for
Evaluating the Environmental Stress Cracking
Resistance of Polyethylenes in Contact with Ageing
Fluids

By: William T.J. West, B.Eng.Biosci

A Thesis Submitted to the School of Graduate Studies in Partial Fulfillment of the Requirements
for the Degree Master of Applied Science

McMaster University © Copyright by William T.J. West, April 2017

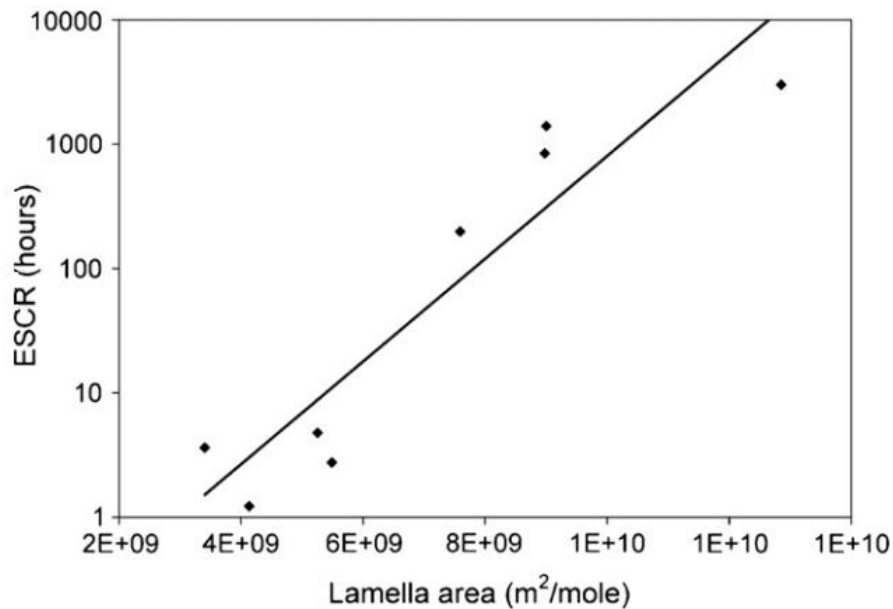
Figure 7: Environment stress cracking resistance improves with larger lamellar surface area. Adapted from [31]

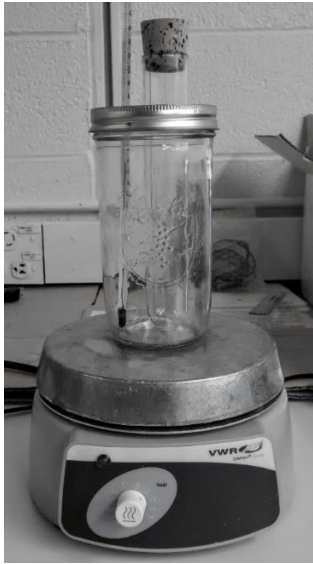
Figure 11: Simplified Mason jar testing configuration.

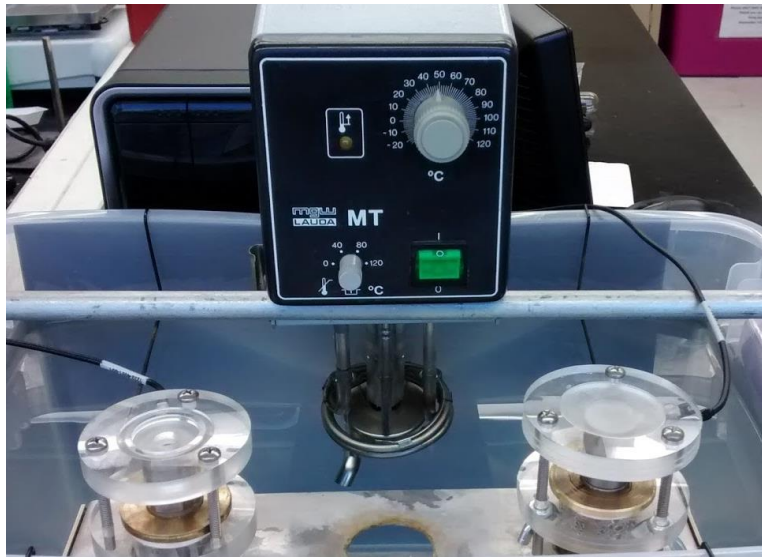
Figure 15: ESCR Test used to identify possible sample derived acoustic activity.

With the newly designed system, a test was performed using two R-30 α sensors: one was clamped to a brass u-channel containing six samples of Grade 1 resin, while the second sensor was clamped to another brass channel containing *no polymer samples* to act as a control. A depiction of the testing apparatus housed within the rectangular tank can be seen below in Figure 15.

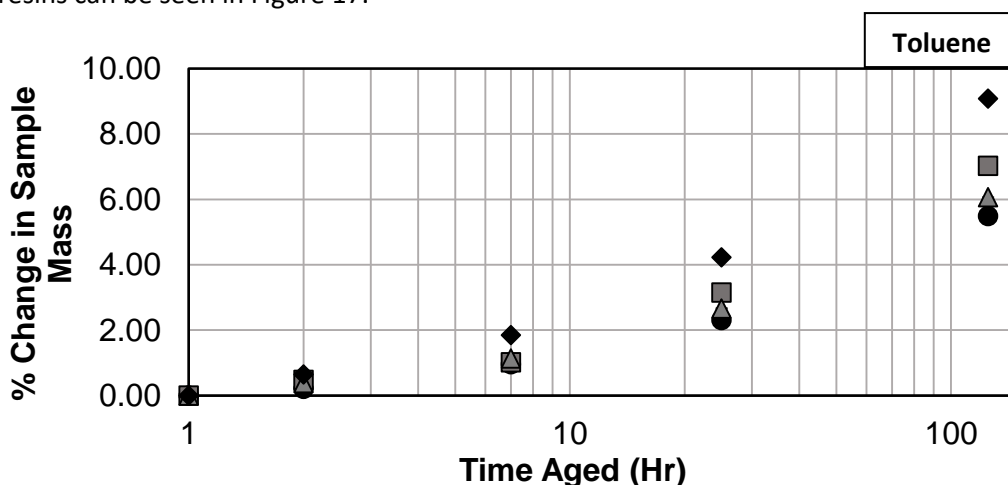
Figure 17: Comparison of relative mass changes for resin Grades 1, 2, 4, and 6 after ageing for 124 hr in solutions of Toluene (**Top**), 10% Igepal (**Middle**) and B100 biodiesel (**Bottom**). The relative standard error for the measurements was $\pm 0.02\%$. ● = Grade 1, ■ = Grade 2, ▲ = Grade 4, and ◆ = Grade 6.

Triplicate mass measurements were obtained with a Mettler AE200 4-point precision balance after thoroughly wiping clean any residual ageing fluid. A summary of the relative mass changes for the studied resins can be seen in Figure 17.

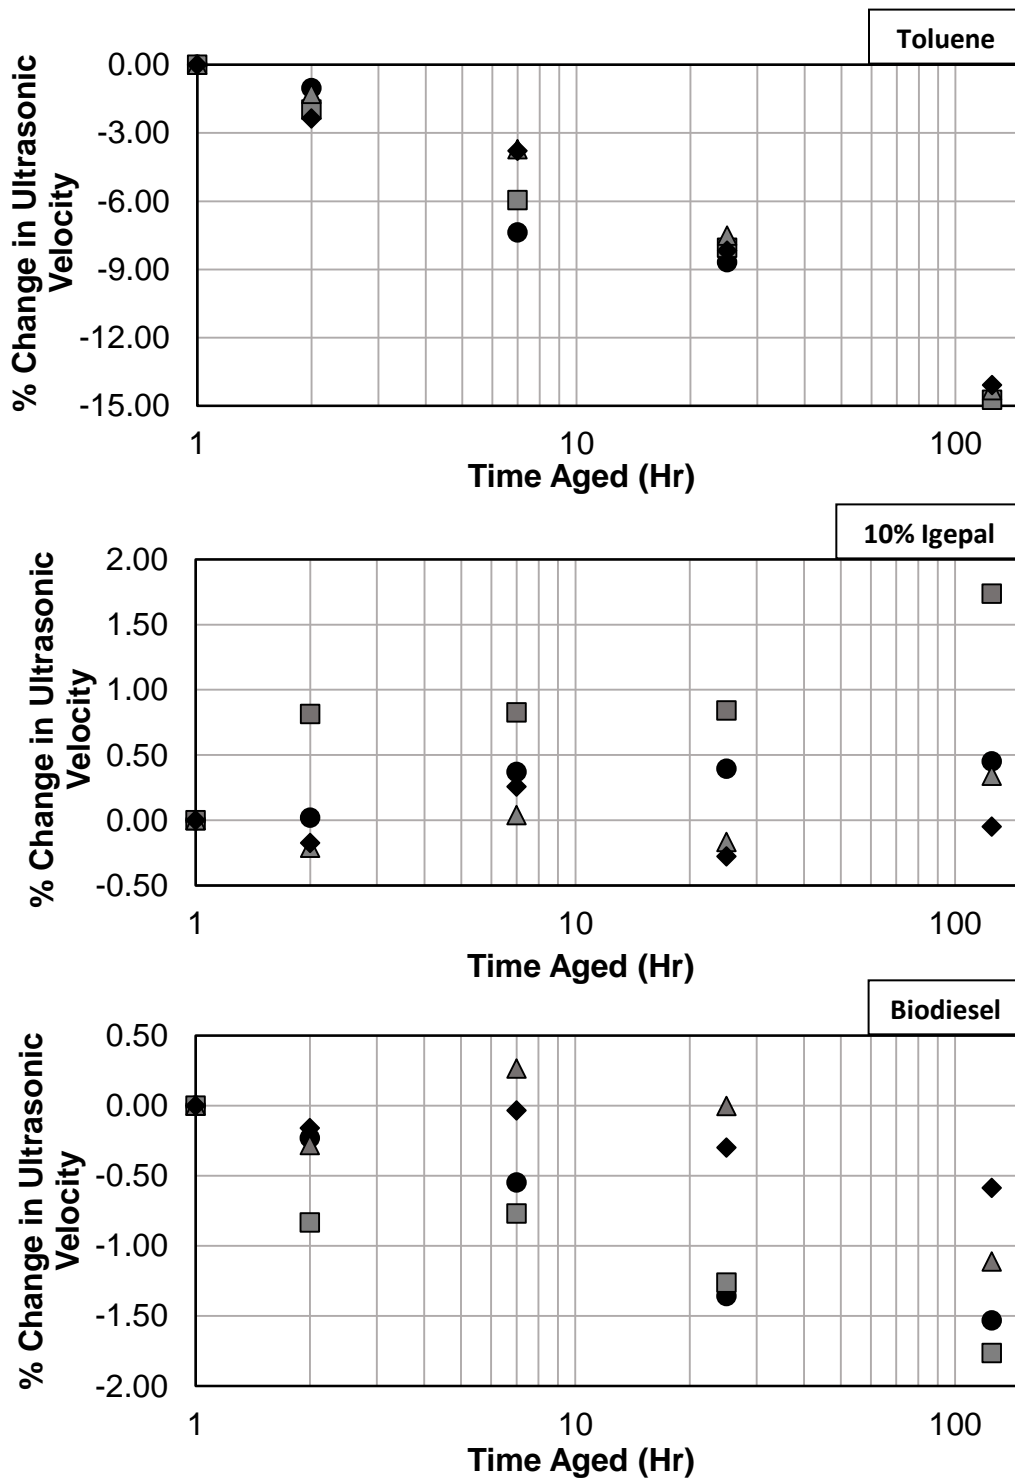
Figure 18: Relative change in ultrasonic velocity for resin Grades 1, 2, 4, and 6 after exposure to either Toluene (Top), 10% Igepal (Middle) or B100 biodiesel (Bottom) after select periods of time. The relative standard error for the measurements was $\pm 0.02\%$. ● = Grade 1, ■ = Grade 2, ▲ = Grade 4, and ◆ = Grade 6.

After each sample was aged, a simple ultrasonic test was conducted using the equipment described previously. The Olympus transducer was clamped to each sample using glycerol as the couplant. Glycerol was decided upon rather than the viscous vacuum grease (Super Lube), as over time the grease was seen to slowly thin out such that the ultrasonic velocity values were seen to increase, due to the lower impedance between the two surfaces (transducer face & polymer surface). Once the sample was clamped in place, five measurements were taken for both ultrasonic velocity and attenuation measurements (reported values were the average of the five samples). The total time for conducting the ultrasonic tests and mass measurements was kept to a maximum of 10 minutes to minimize error/diffusion of absorbed fluid out of each sample. A relative calibration curve (Figure A-1 of Appendix A) was also created using various known thicknesses of HDPE to provide accurate measurements of velocity directly through the LabVIEW code. A comparison of the results of the velocity tests can be seen below in Figure 18.

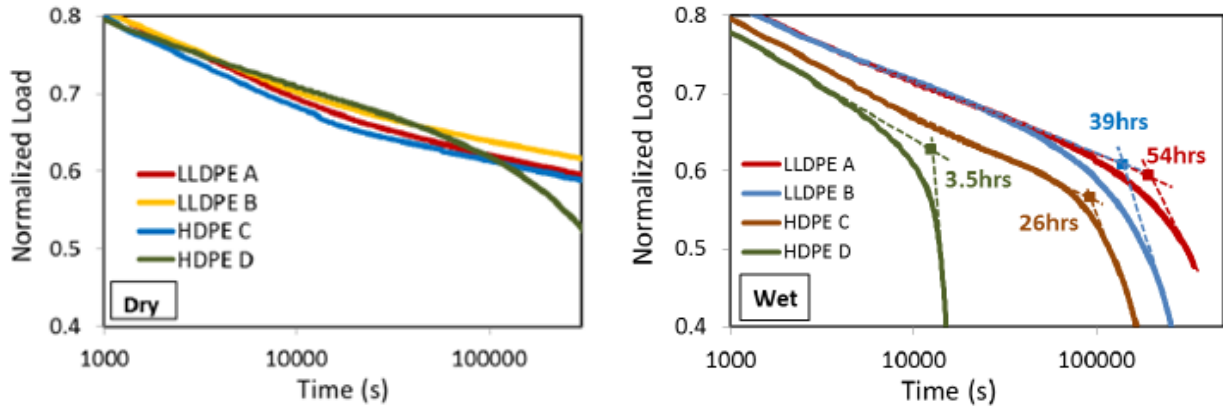
Figure 21: Force response curves from the Plate Test ESCR evaluation technique. Figure adapted from [40]

As seen in Figure 21, the change in load with time for the wet samples indicate the onset and progression of material failure much earlier compared to the dry environment. A rating for ESCR was quantified by extrapolating the linear portions of the force response curves to identify the knee point, where the on-set of ESC theoretically occurs. A comparison of Bell Test vs Plate Test ESCR rankings can be seen below in Figure 22, with significant time savings apparent.

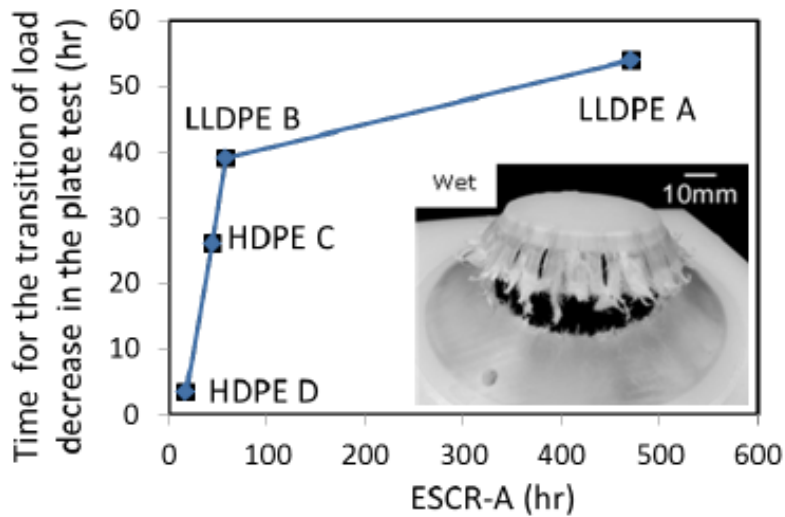
Figure 22: Comparison of ESCR testing times for the Bell Tests and Plate Test. Figure adapted from [40].

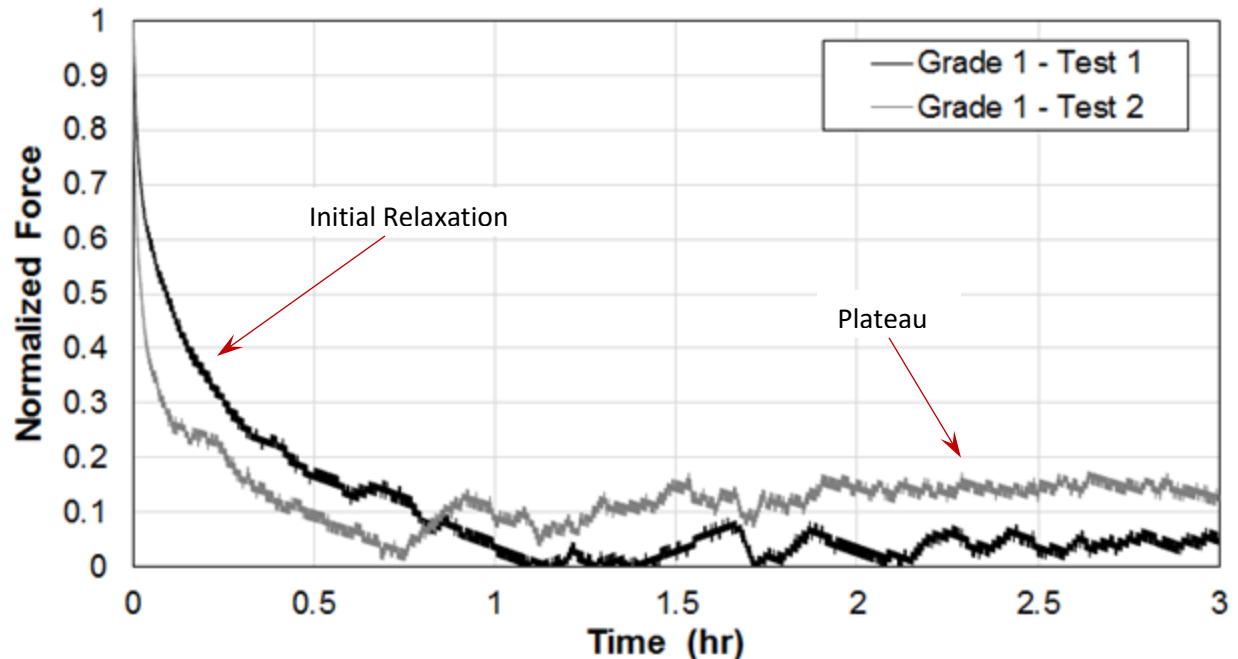
Figure 25: Force profiles obtained from KISTLER Sensor for Grade 1 resin aged in a 10% Igepal solution.

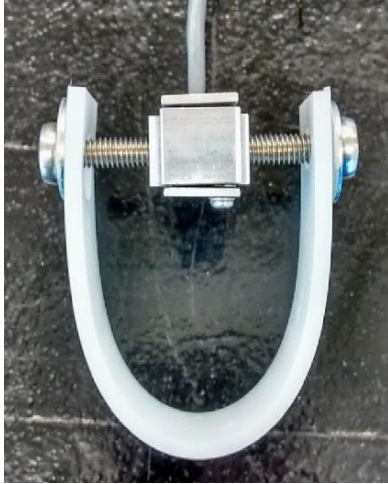
Figure 26: OMEGA sensor with mounted polymer sample.

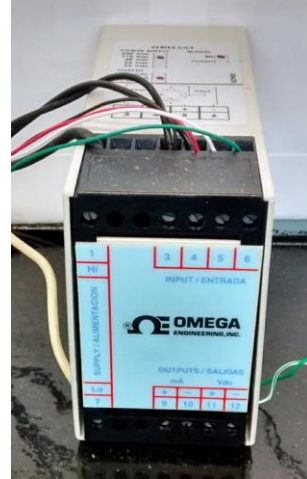
Figure 27: Load cell signal conditioner.

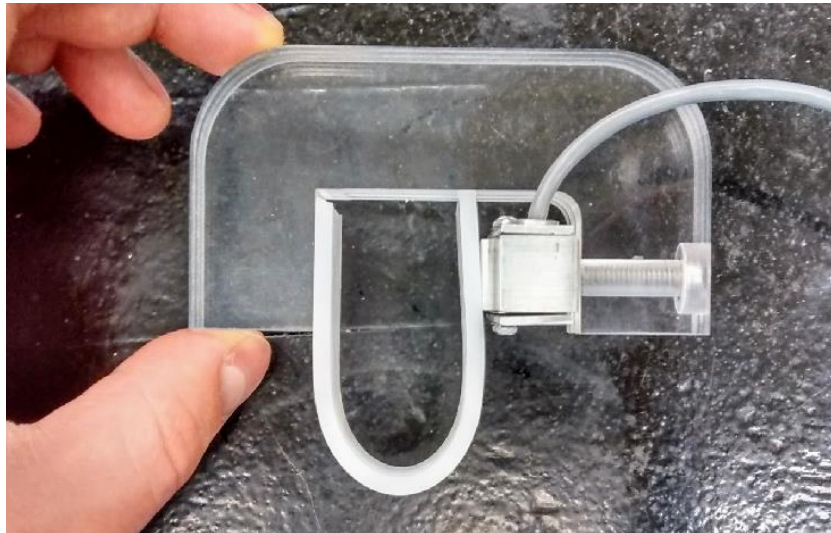
Figure 31: Acrylic sample retaining device with fitted OMEGA sensor to read forces in a compressive manner.

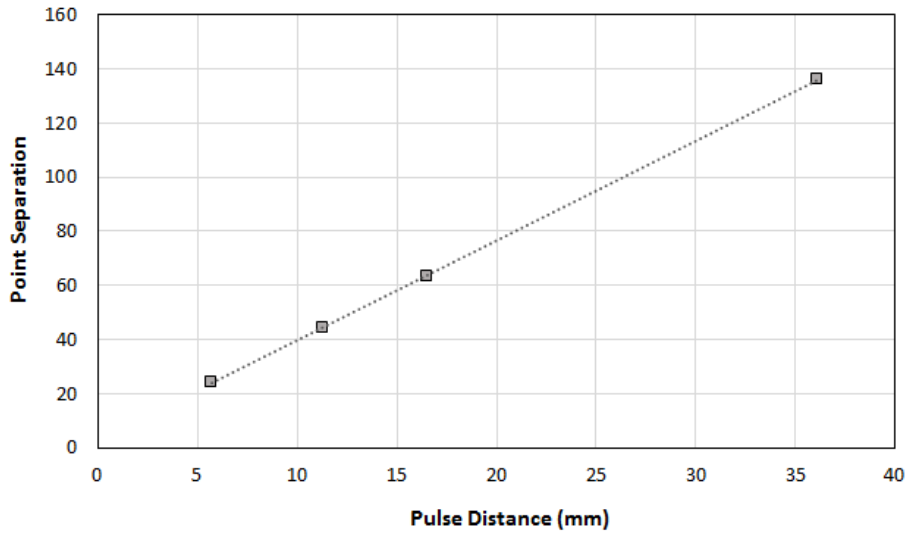
Figure A-1: Calibration curve created for ultrasonic testing with varying thicknesses of HDPE material.
