MATERIALS PATTERNING WITH AN EXCIMER LASER

EDWARD E. GUZZO, B.Sc.

Master of Engineering

M^cMaster University

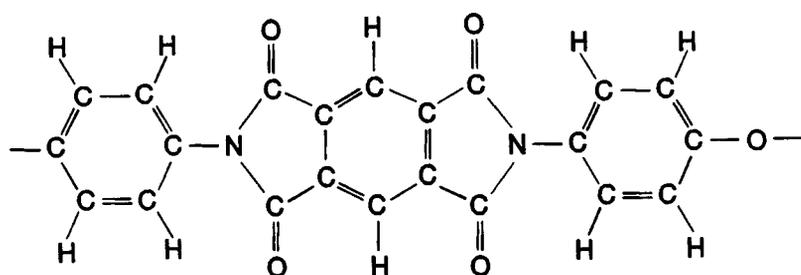
Figure 2.1 The chemical structure of a single monomer of polyimide. This structure is repeated up to 1000 times to form the polyimide molecule. It is also possible that the oxygen atom bonded to the benzene ring (on the right side of the diagram) may be replaced by a CH_2 group in some cases.

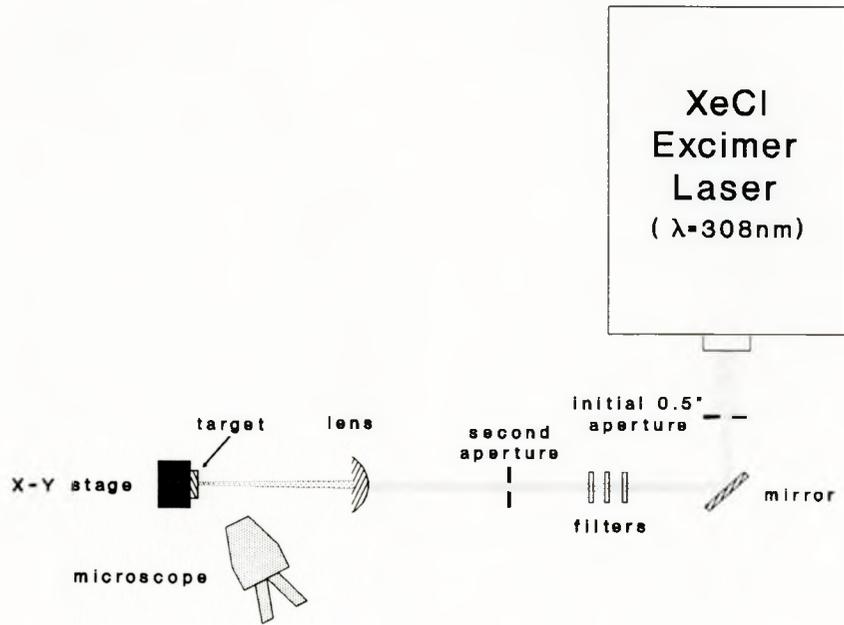
Figure 3.1 Schematic of the experimental apparatus.

The experimental set-up is shown in Figure 3.1. The laser pulses were passed through a 0.5" diameter aperture so that 1" optics could be used. The pulses passed through a series of neutral density filters which allowed their power to be varied. After the filters, a second aperture approximately 1.2 mm in diameter was used to select the uniform central portion of the output. The laser pulse was then focused down using a 1" diameter plano-convex lens with a focal length of 2.5 cm. The lens was mounted on a translation stage so that the sample to lens distance could be altered. By adjusting this distance, the image of the aperture could be properly focused on the sample. A stereoscopic microscope (Seiwa model SKZ-4) was incorporated into the system, permitting *in situ* observation of the ablation.

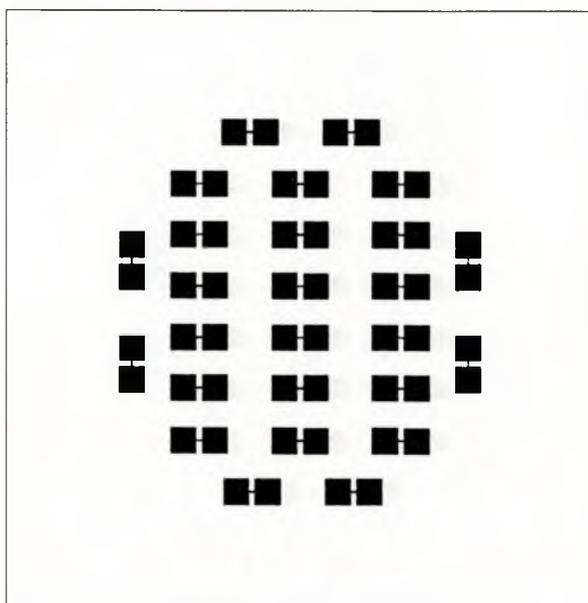
Figure 3.3 Diagram of the mask used during photolithography to pattern the aluminum wires needed for the resistance experiments.

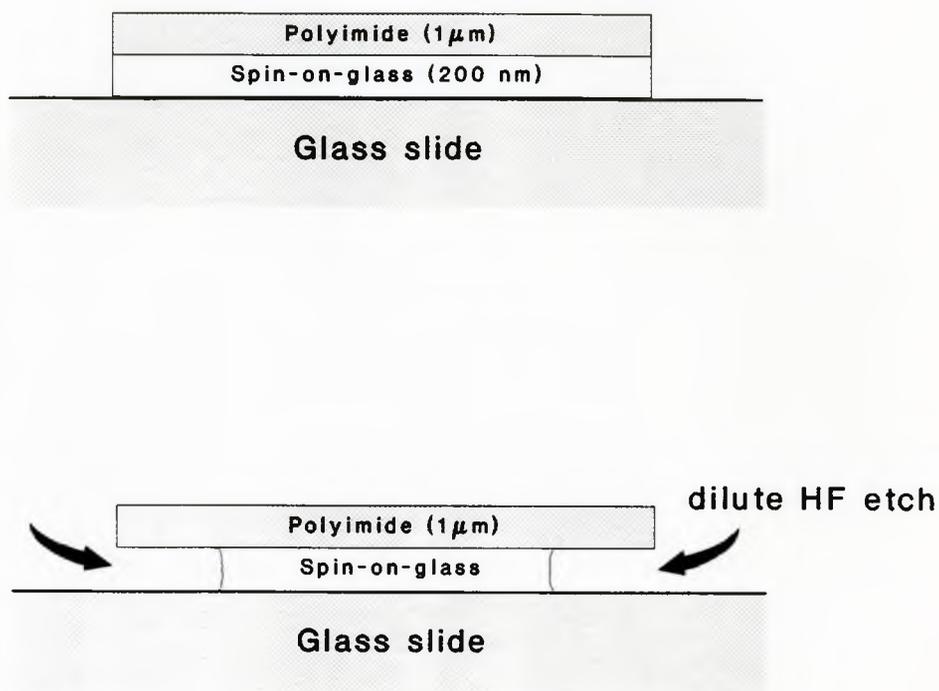
Figure 3.4 Preparation of a free standing polyimide film. The hydrofluoric acid etched the spin-on-glass, but did not attack the polyimide.

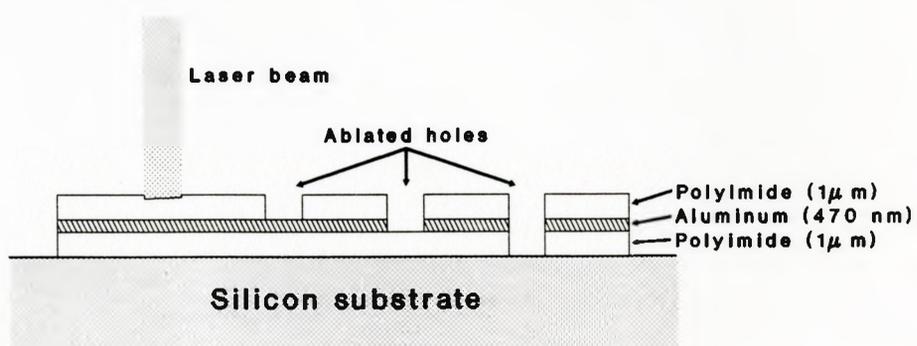
Figure 3.5 Diagram showing selective removal of the metallic and dielectric layers.

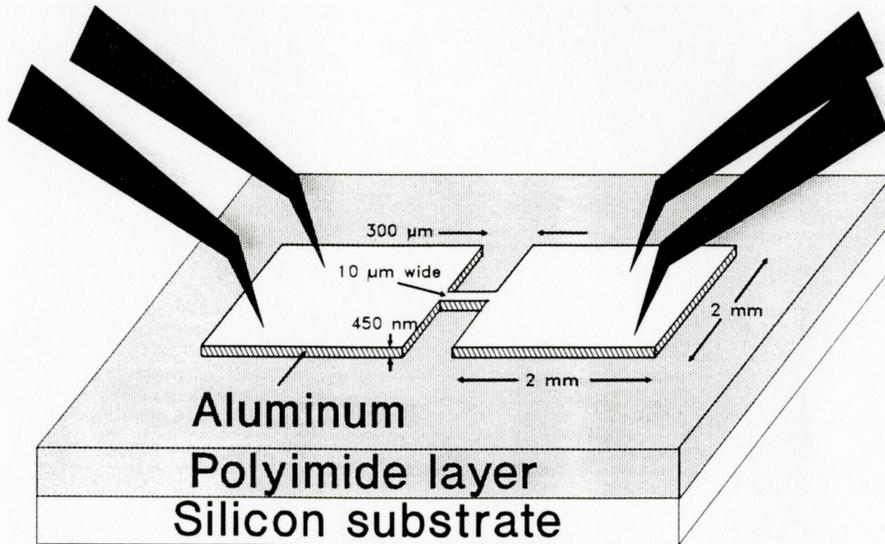
Figure 3.6 Diagram showing the probe tips in contact with a patterned aluminum wire. The wire was irradiated by the laser while its electrical resistance was monitored.

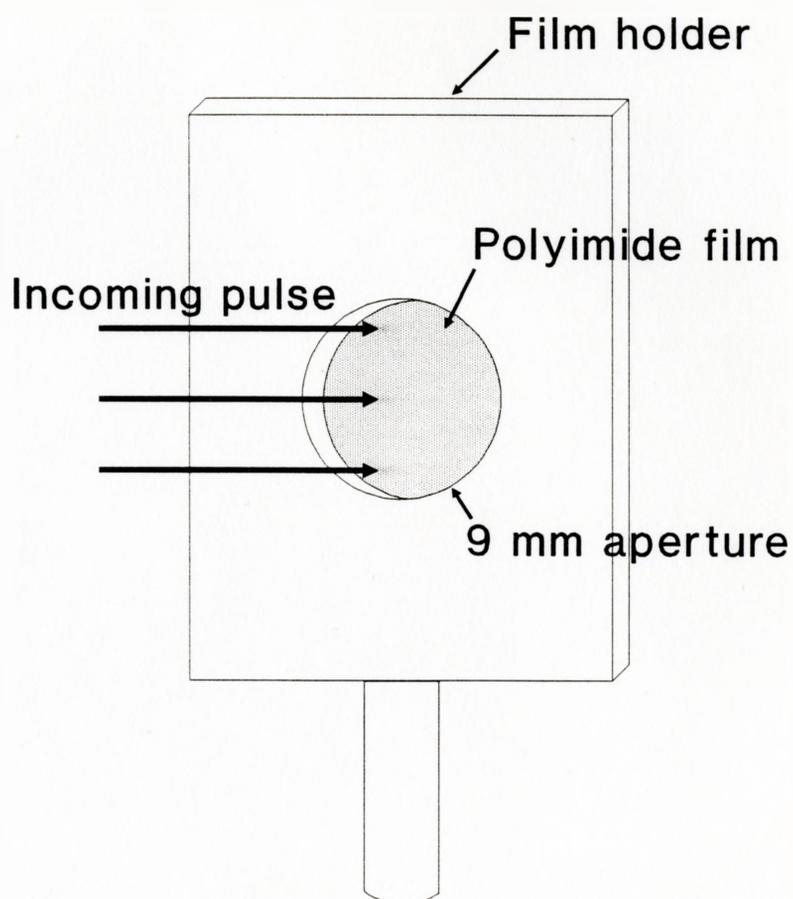
Figure 3.7 Holder for the free standing polyimide film used in the incubation experiment.

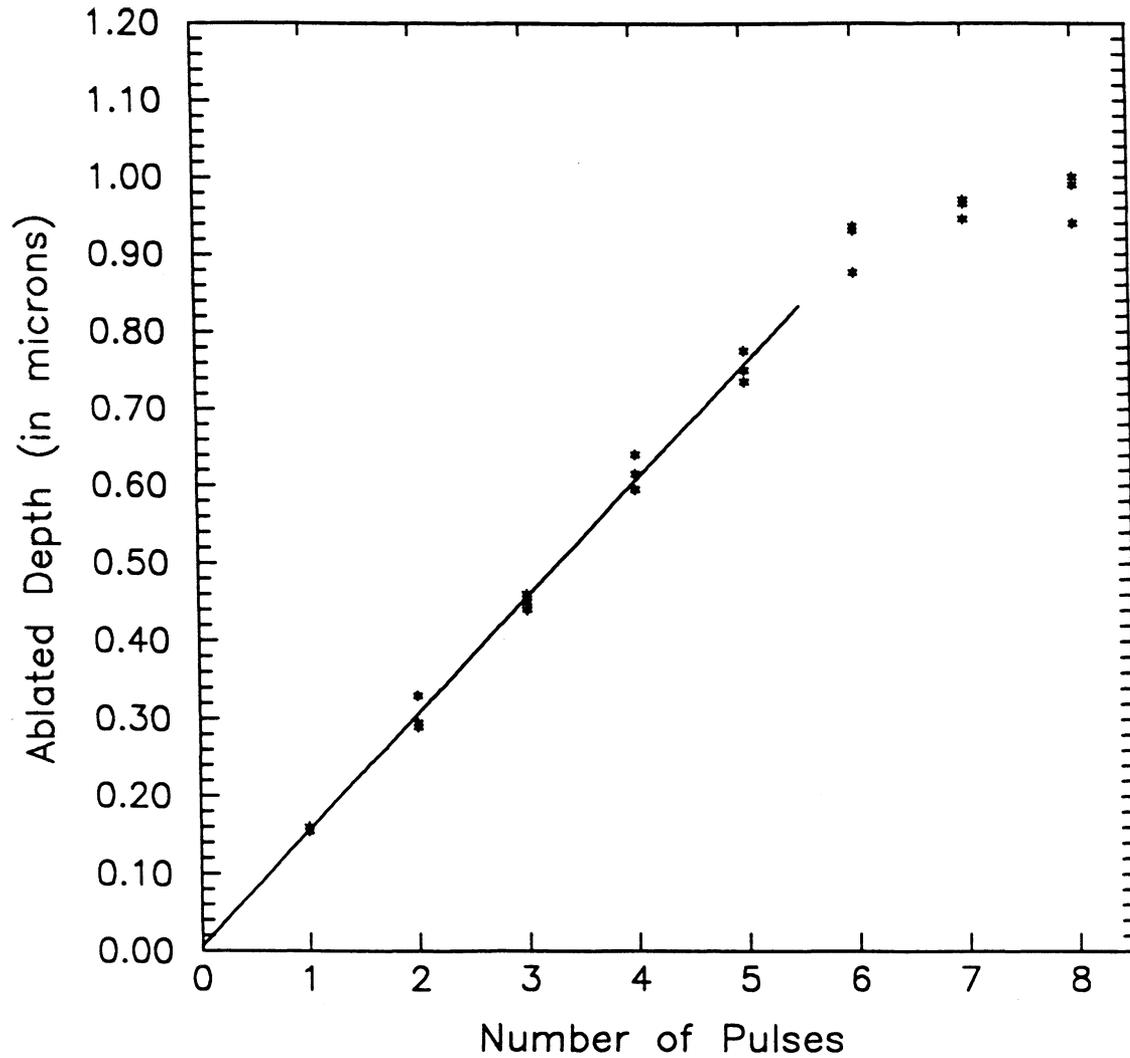
Figure 4.1 Ablated depth versus number of laser pulses for polyimide at an incident fluence of 187 mJ/cm^2 . The random errors present are reflected in the scatter of the data.

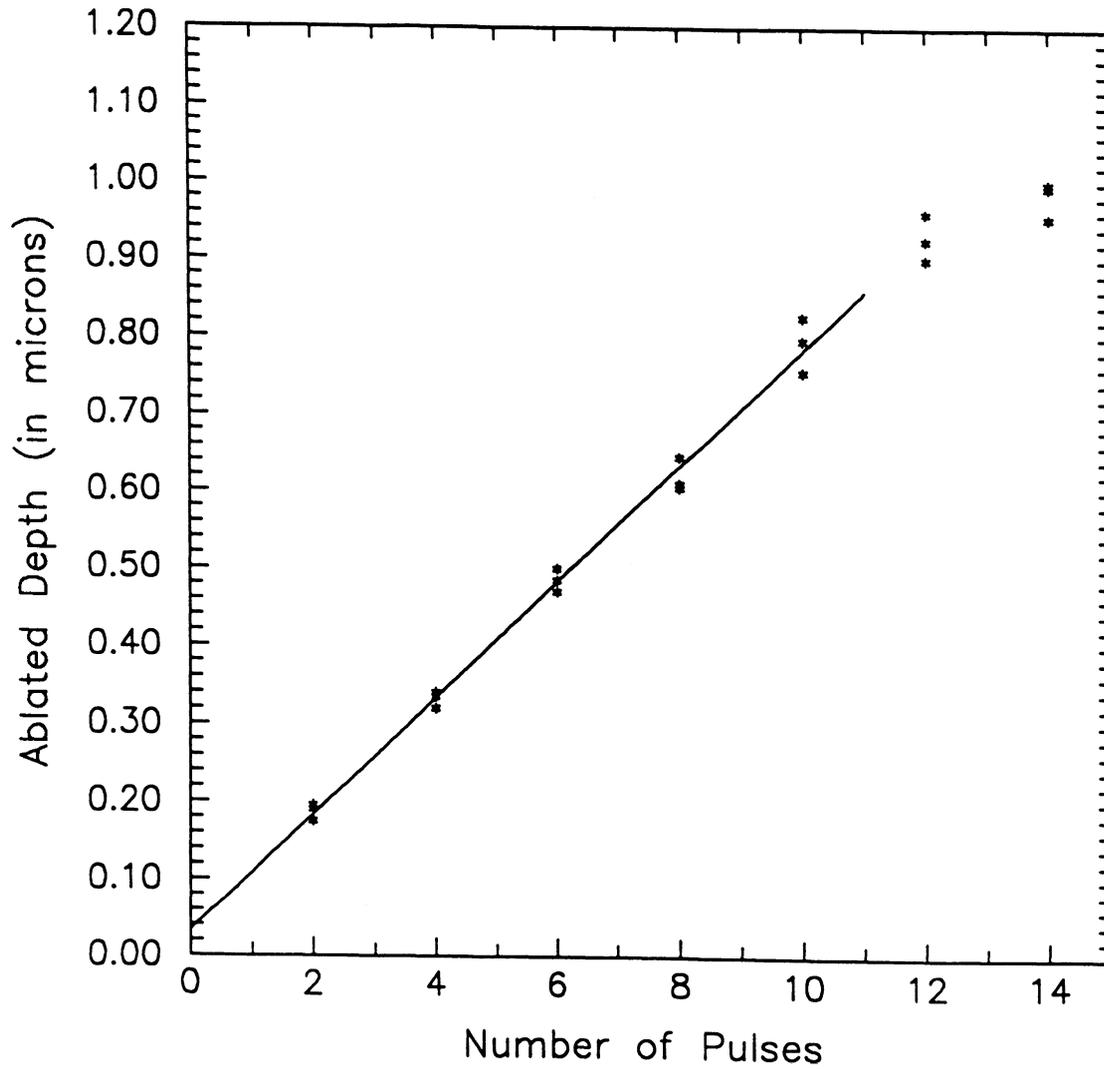
Figure 4.2 Ablated depth versus number of laser pulses for polyimide at an incident fluence of 118 mJ/cm^2 . The random errors present are reflected in the scatter of the data.

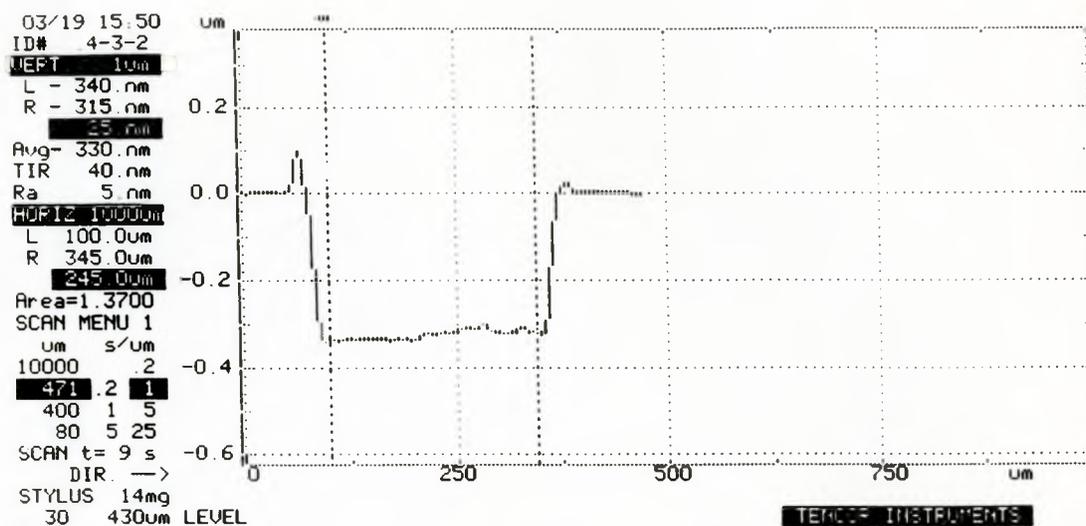
Figure 4.3a Surface profile of a hole made by two incident pulses at a fluence of 187 mJ/cm^2 .

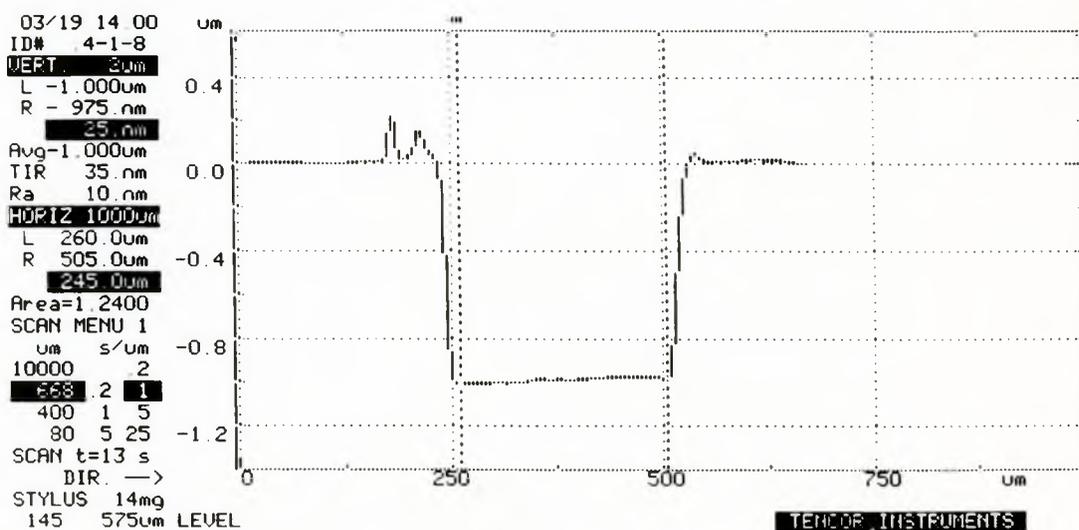
Figure 4.3b Surface profile of a hole made by eight incident pulses at a fluence of 187 mJ/cm^2 .

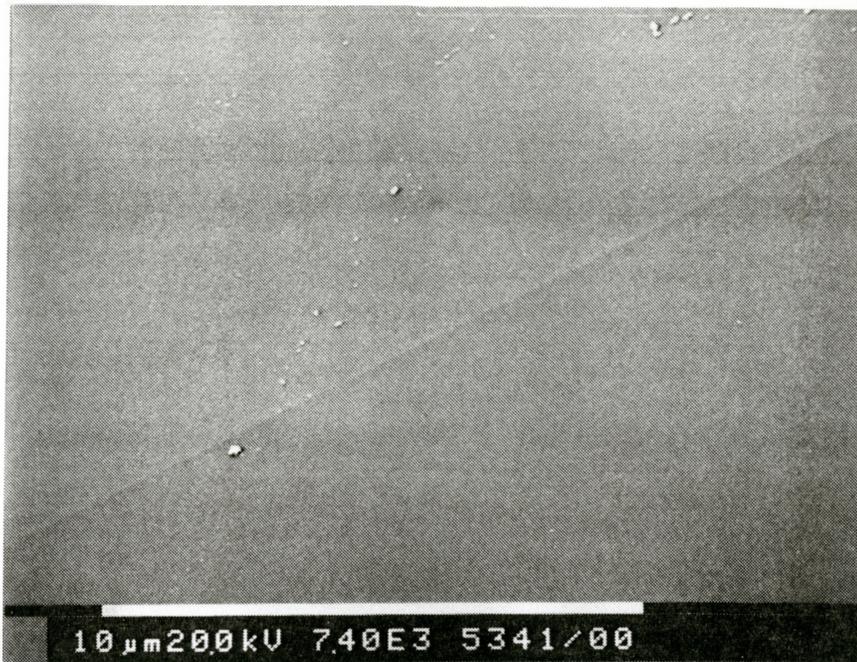
Figure 4.4a SEM image of the polyimide surface prior to irradiation.

In order to observe the ablated holes on a microscopic scale, SEM was performed. Figure 4.4a is a SEM image of the polyimide surface prior to irradiation. The surface is smooth with the exception of a few dust particles. Figure 4.4b is a SEM image of the bottom surface of an ablated hole which partially penetrated the polyimide. This hole was created by 4 pulses at a fluence of 187 mJ/cm^2 . As expected, the surface quality at the bottom of the hole was worse than the surface of the unexposed polyimide.

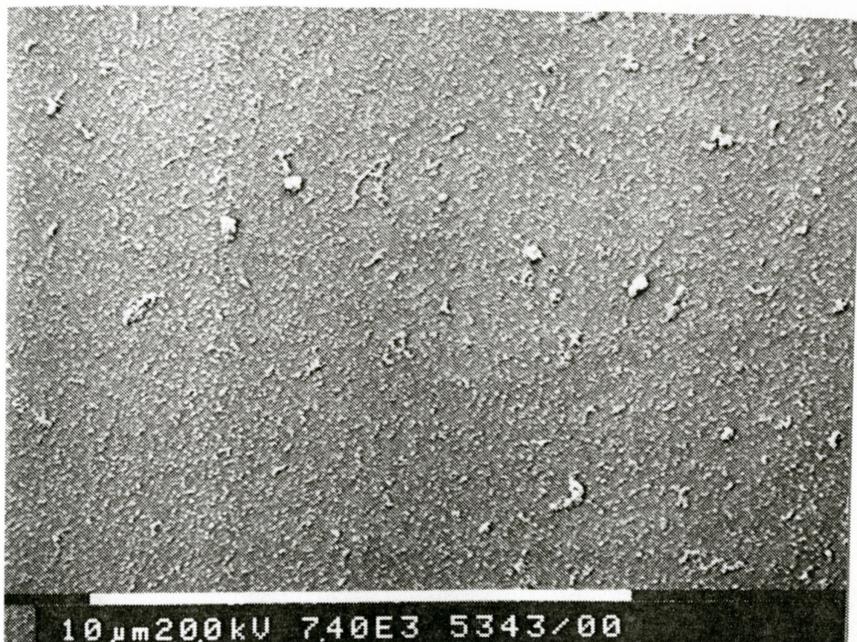
Figure 4.4b SEM image of the bottom of a hole created by four pulses at a fluence of 187 mJ/cm^2 .

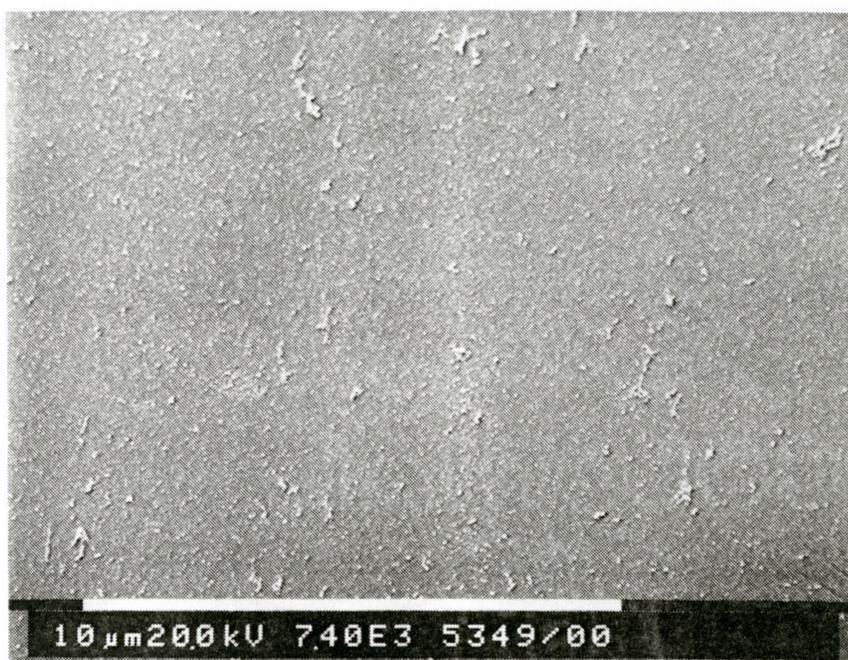
Figure 4.4c SEM image of the underlying silicon surface following ablation of the polyimide layer.

The surface shown is typical of ablated holes which only partially penetrate the layer. Figure 4.4c is a SEM image of a hole which completely penetrated the polyimide. It shows redeposited debris remaining on the silicon surface following ablation. Redeposited debris can be a problem since it forms a soot which does not absorb further UV radiation. As a result, the debris is not removed by subsequent laser pulses and further processing to remove it by other methods is undesirable. There is no evidence in the SEM images that the laser has ablated or damaged the silicon substrate. This was expected since the ablation threshold for silicon is much higher than for polyimide.

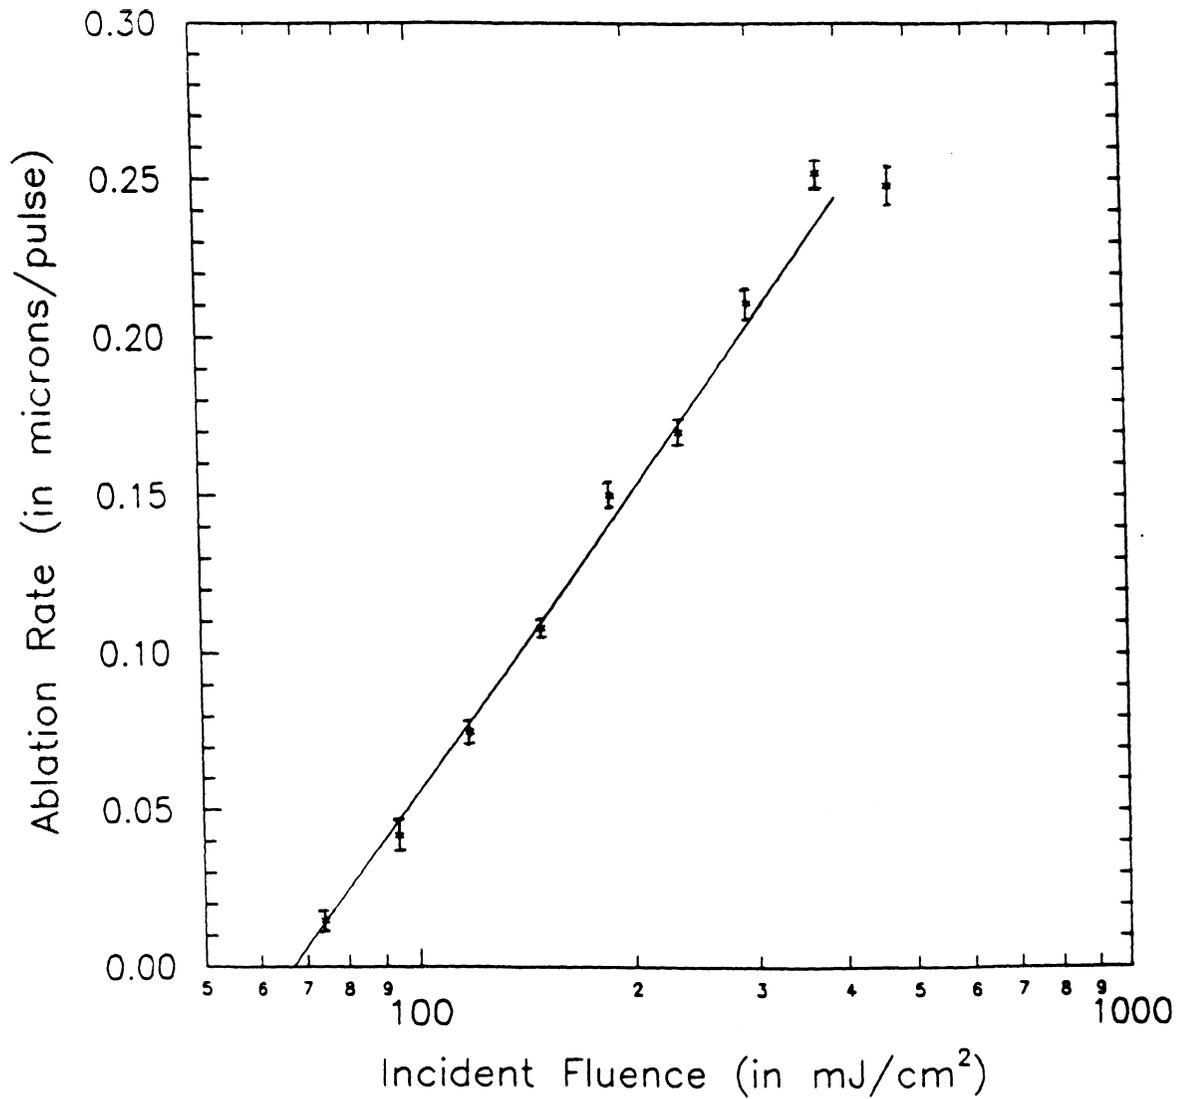
Figure 4.5 The ablation rate of polyimide versus the logarithm of the incident fluence. The x-intercept value of 67 mJ/cm² is the ablation threshold fluence.

At fluences below 67 mJ/cm^2 , the ablation rate is negligible and fluences above this are required for significant material removal. Our experimental threshold value, along with those by other researchers, can be seen in Table 4.1. While our value is in reasonable agreement with the other values, there is some disagreement over the general shape of the ablation rate curve. Results by Brannon *et al*⁶ fit well to Equation 2.4 and the overall shape of their curve is in agreement with our results. However, results by Srinivasan *et al*⁷ did not fit well to Equation 2.4, especially at high incident fluences. Because we were unable to attain the high fluences used by Srinivasan, we could not

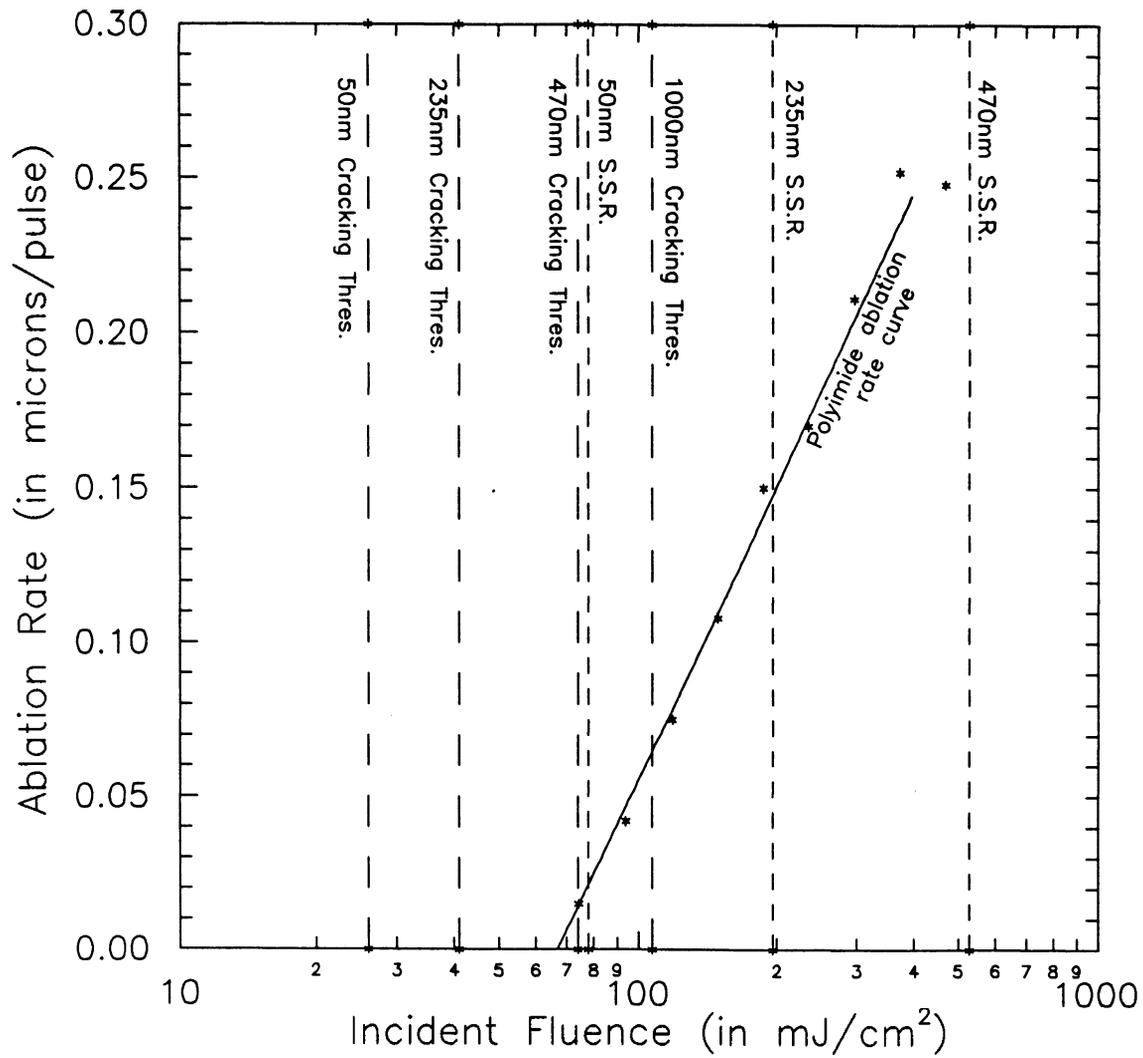
Figure 4.6 Cracking and S.S.R. threshold fluences for various thicknesses of aluminum with the polyimide ablation rate superimposed.

A summary of results for processing aluminum on polyimide can be seen in Figure 4.6. The cracking threshold and the single shot removal (S.S.R.) threshold values for various aluminum film thicknesses are shown. Superimposed is the ablation rate of polyimide taken from Figure 4.5. As defined in section 3.4.2, the cracking threshold is the maximum fluence incident upon the aluminum surface for 1000 pulses without visible cracking occurring. Analysis of Figure 4.6 reveals several results. The cracking thresholds for the 50 nm and 235 nm thick aluminum layers are 26 mJ/cm^2 and 41 mJ/cm^2 respectively. Since these values are less than the polyimide ablation threshold, it would be impossible to ablate polyimide without damaging these aluminum layers if they were exposed to the same incident pulse. This would not be the case for the 470 nm and 1000 nm thick aluminum layers since their cracking threshold is larger than the polyimide ablation threshold. The S.S.R. threshold of the aluminum layers was typically 3 to 5 times larger than their respective cracking thresholds, and in all cases was larger than the polyimide ablation threshold. The removal threshold for the 1000 nm layer could not be determined because it was larger than the maximum attainable fluence of our system. Numerical values for the cracking and removal thresholds which were

The cracking thresholds plotted in Figure 4.6 are the thresholds for 1000 laser

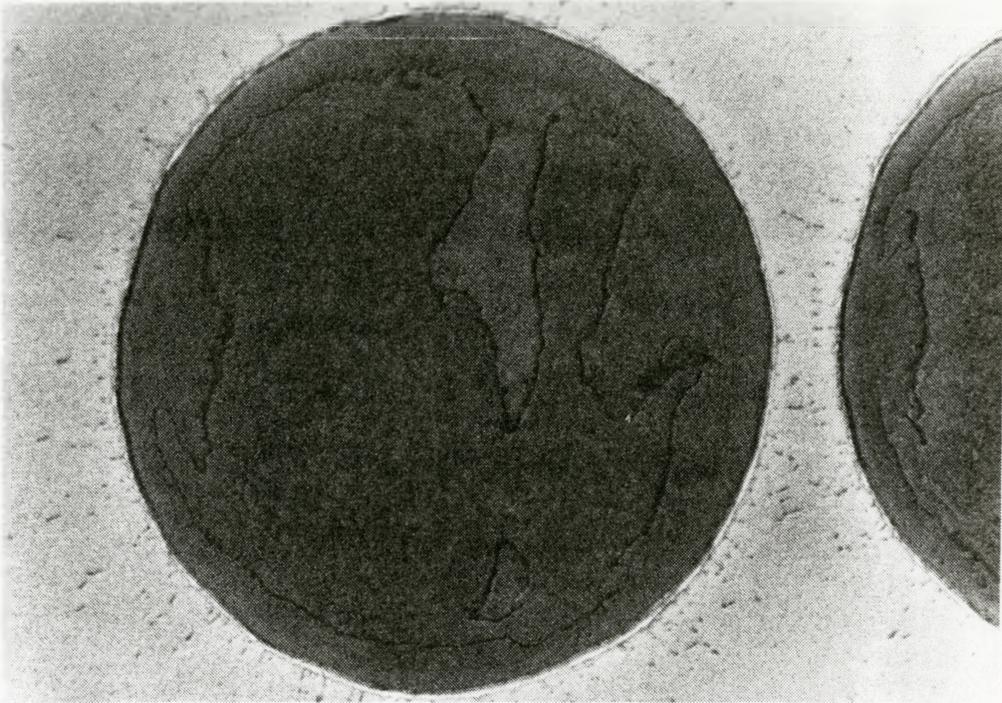
Figure 4.7a Photograph of a hole produced in a 235 nm thick aluminum layer by a single incident pulse at a fluence of 650 mJ/cm^2 .

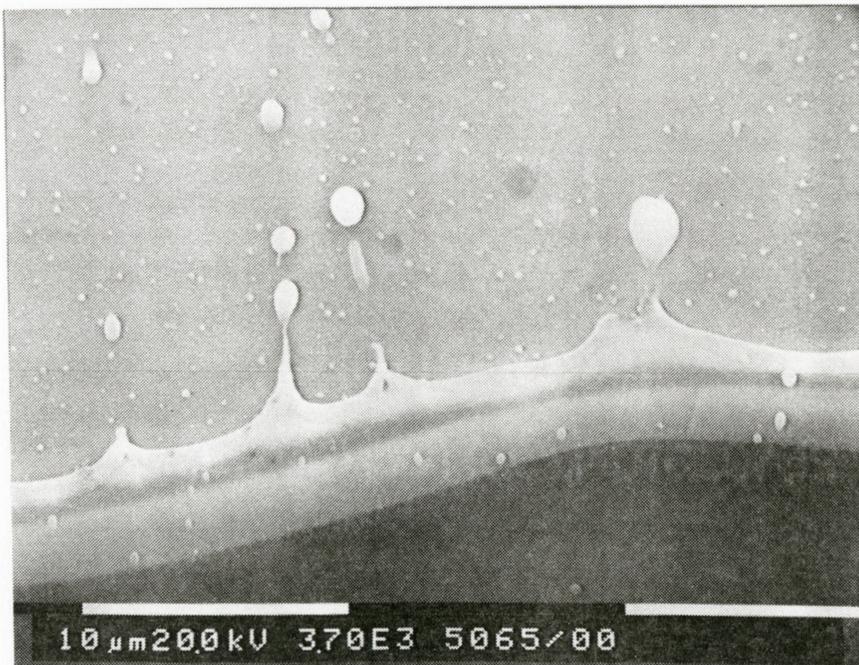
Figure 4.7b SEM image showing the edge quality of the hole in Figure 4.7a.

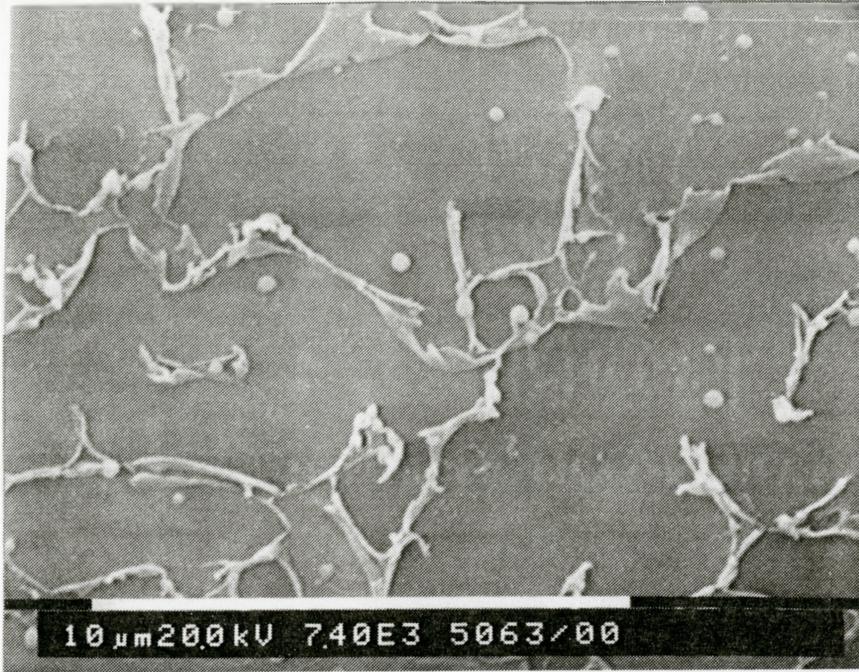
Figure 4.7c SEM image of the damaged region of the hole shown in Figure 4.7a.

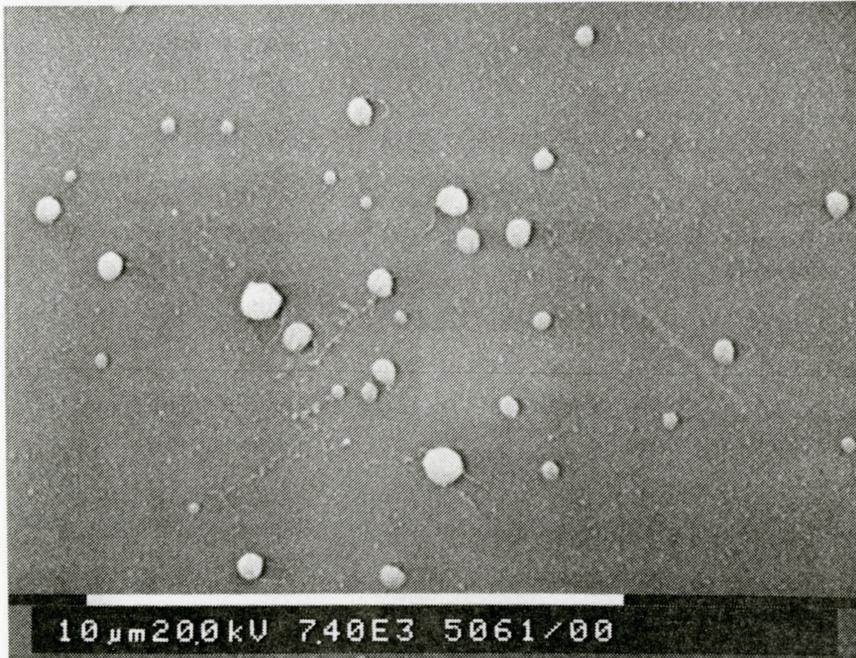
Figure 4.7d SEM image of debris at the bottom of the hole shown in Figure 4.7a.

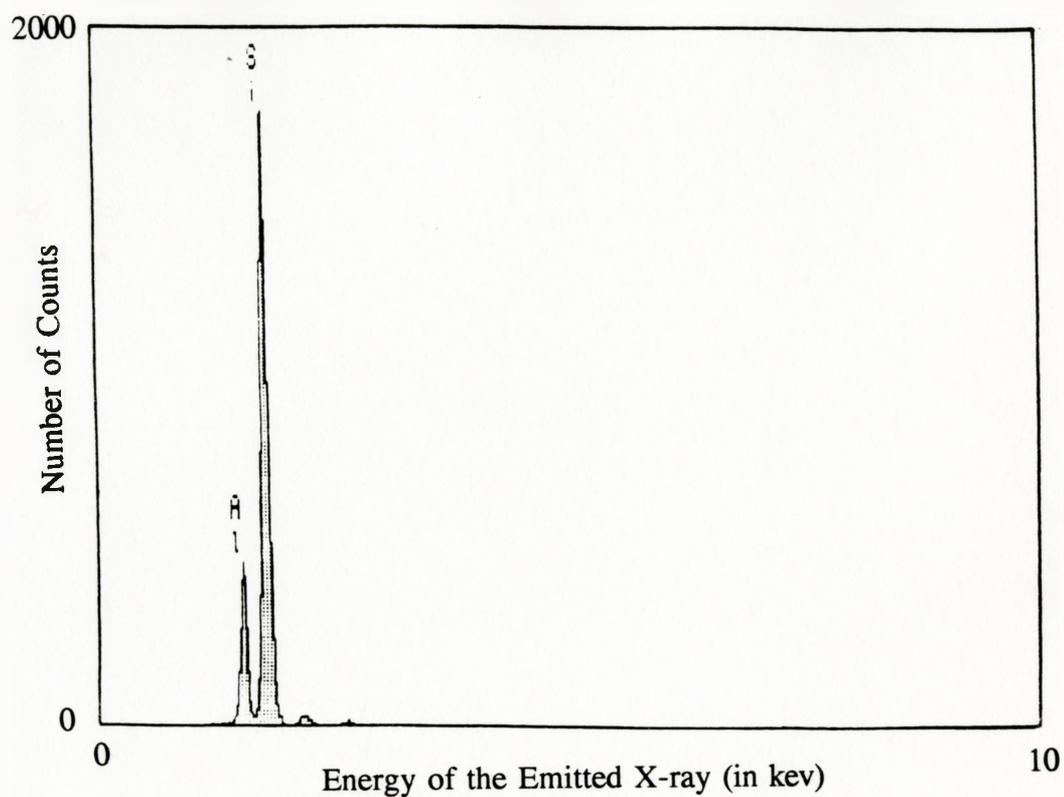
Figure 4.8 EDXS scan showing the composition of the debris at the bottom of the hole shown in Figure 4.7a. The peak indicating the presence of aluminum is located on the extreme left.

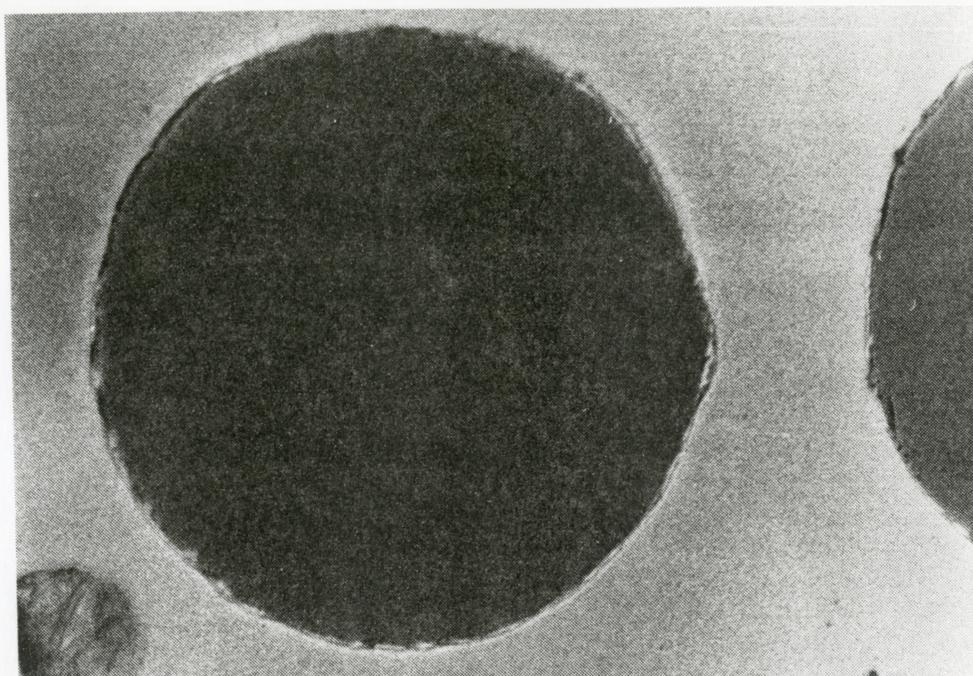
Figure 4.9a Photograph of a hole produced in a 235 nm thick aluminum layer by a single incident pulse at a fluence of 326 mJ/cm².

At lower fluences, the quality of the hole improves. Figure 4.9a shows a hole produced at a fluence of 326 mJ/cm^2 . Since a single pulse at this fluence will produce a temperature rise of approximately 445°C , we expect that the melting of aluminum observed at higher fluences will no longer occur. From this photograph, it appears as though the underlying polyimide is undamaged. Closer inspection with the electron microscope confirmed this. The SEM image in Figure 4.9b shows that the same type of damage which occurred to the polyimide at 650 mJ/cm^2 (Figure 4.7c) did not occur at 326 mJ/cm^2 . In addition, the amount of aluminum redeposited on the polyimide is significantly reduced. Figure 4.9c shows that the edge quality of this hole has also improved. The splattering of molten aluminum previously observed (see Figure 4.7c) is absent and the width of the edge between the hole and the surrounding aluminum is reduced. The debris in the top right portion of the photograph is most likely redeposited aluminum, although this could not be verified by EDXS due to the strong background aluminum signal.

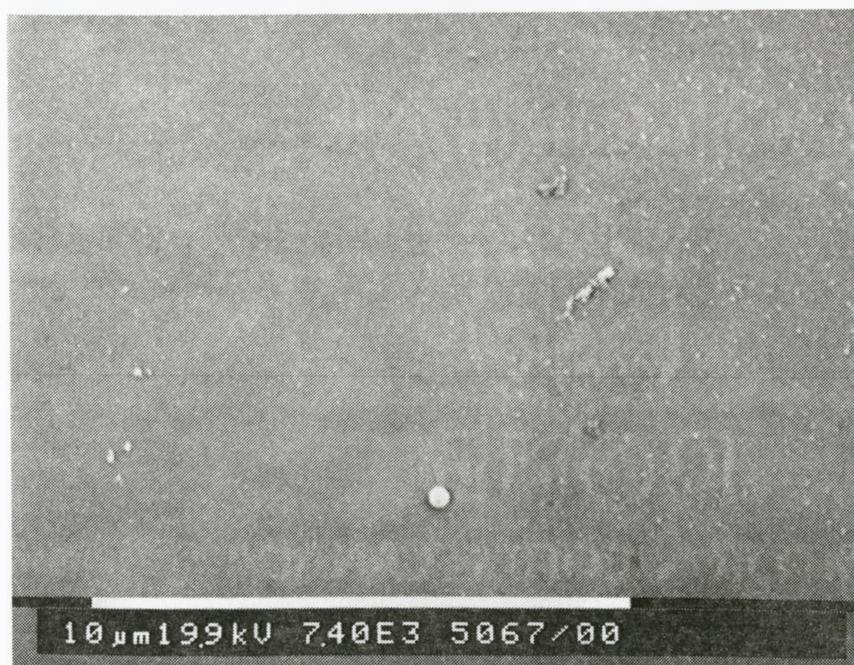
Figure 4.9b SEM image of the bottom of the hole shown in Figure 4.9a.

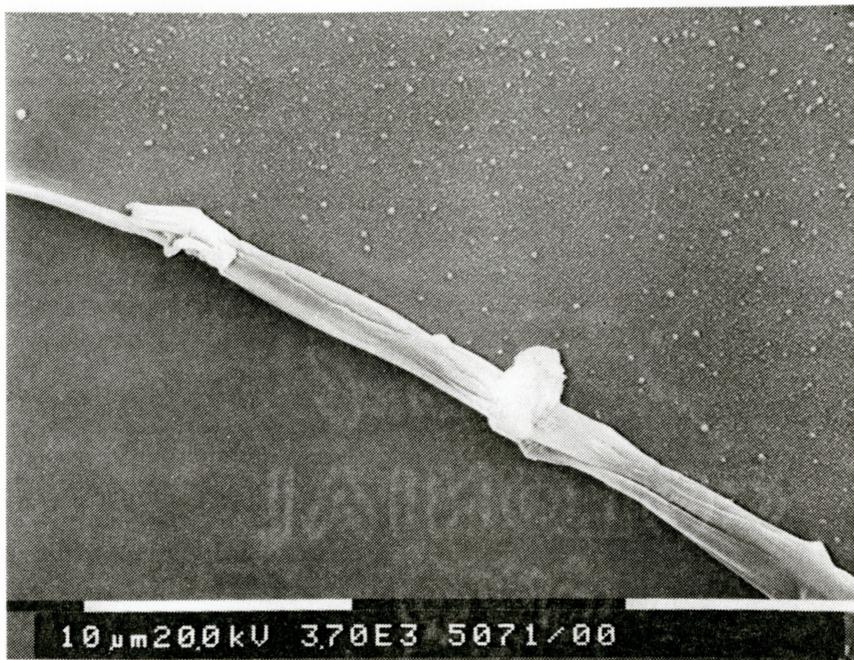
Figure 4.9c SEM image showing the edge quality of the hole in Figure 4.9a.

At yet lower fluences, the quality of the hole deteriorates. Figure 4.10a is a photograph of a hole produced at a fluence of 205 mJ/cm^2 , which is just above the S.S.R. threshold of the material. As can be seen in Figure 4.10b, the aluminum layer around the perimeter of the hole is cracked, wrinkled and uneven. It is important to note that the magnification of this SEM image is less than in Figure 4.9c, so the edge quality is worse than it appears.

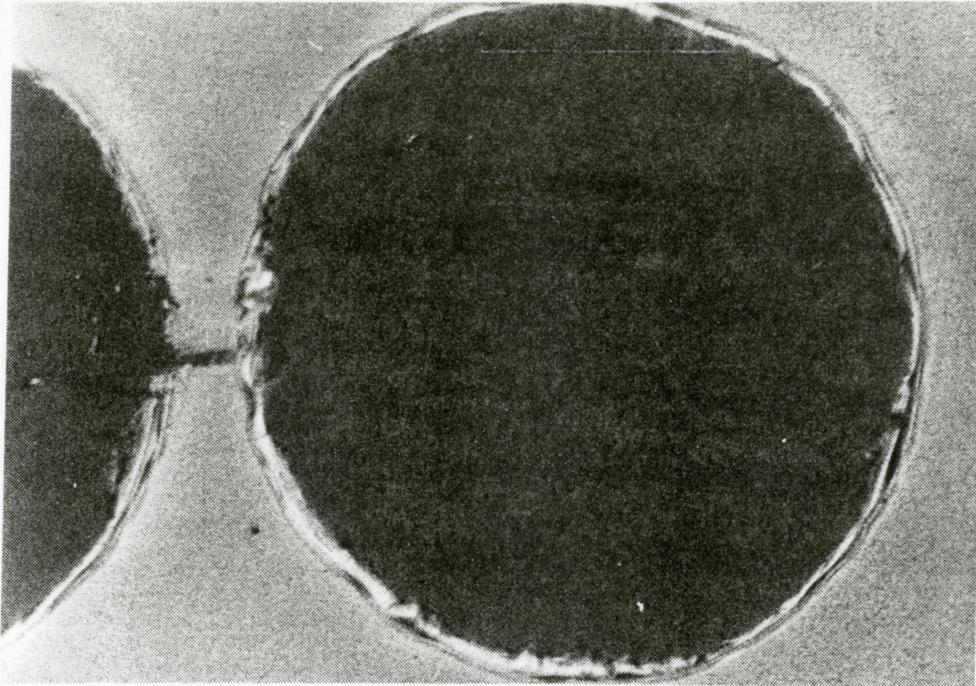
Figure 4.10a Photograph of a hole produced in a 235 nm thick aluminum layer by a single incident pulse whose fluence (205 mJ/cm^2) is just above the S.S.R. threshold.

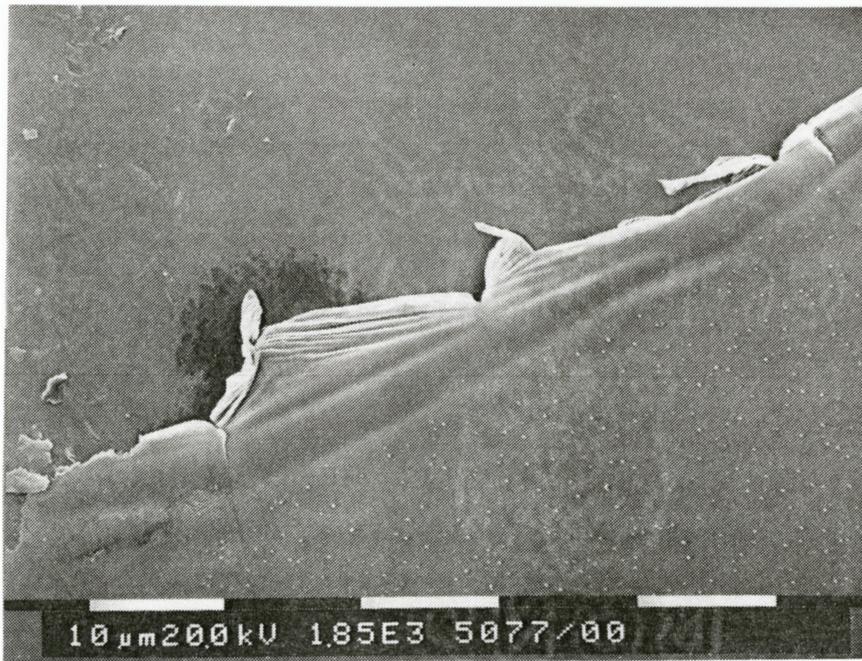
Figure 4.10b SEM image showing the edge quality of the hole in Figure 4.10a.

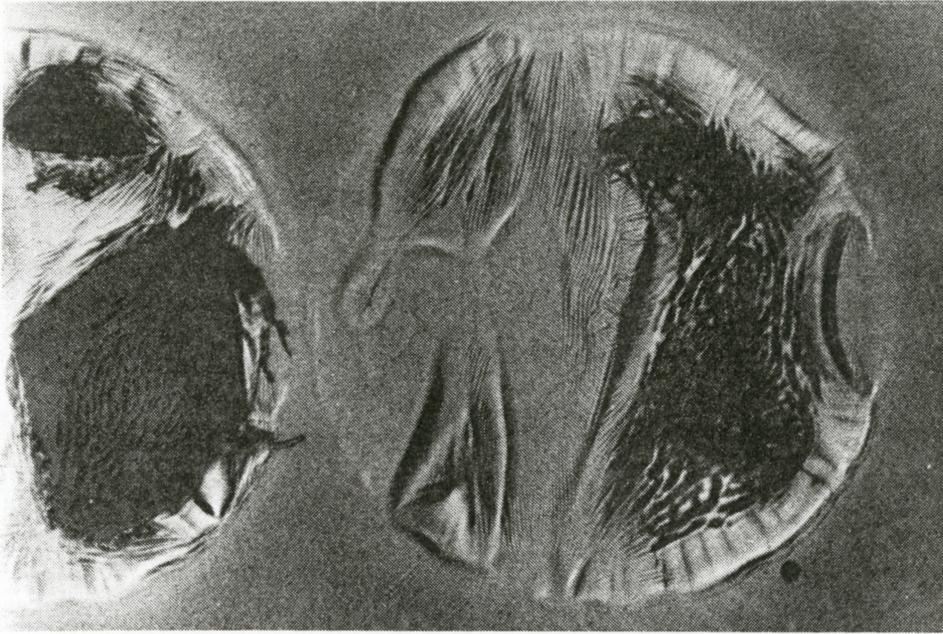
Figure 4.11a Photograph showing heavy damage to a 235 nm thick aluminum layer caused by a single incident pulse at a fluence (163 mJ/cm^2) just below the S.S.R. threshold.

At fluences slightly below the S.S.R. threshold, removal of the aluminum layer ceases and only heavy damage occurs. In Figure 4.11a, we see a section of the aluminum layer which has been exposed to a single pulse at a fluence of 163 mJ/cm^2 . The central portion of the photograph shows the irradiated zone while to the left we see part of a hole from a previous trial. There is intense cracking and partial film removal in the top portion of the irradiated area. SEM images of this heavily damaged region can be seen in Figures 4.11b, 4.11c and 4.11d. Figure 4.11b is a magnification of Figure 4.11a showing cracking of the aluminum layer. The fluence of the incident pulse was too low to completely remove the film, so most of the aluminum was left behind. There are also dark spots on the surface of the aluminum. These spots were present in only a small section of the entire irradiated area and were not observed in any other SEM images. This indicates that the incident laser pulse did not create the spots, although the reason for their existence is unknown. Figure 4.11c shows a region of the sample where the aluminum has been peeled back rather than removed. Cracking and wrinkling of the aluminum surrounding this region has also occurred. This is most likely due to thermal effects. Figure 4.11d is a magnification of the previous photograph showing the debris remaining on the polyimide surface after the aluminum has been peeled back. The physical appearance of the debris indicates that it is most likely polyimide rather than redeposited aluminum. This conclusion was supported by the EDXS analysis seen in Figure 4.12, which shows that the debris does not contain aluminum.

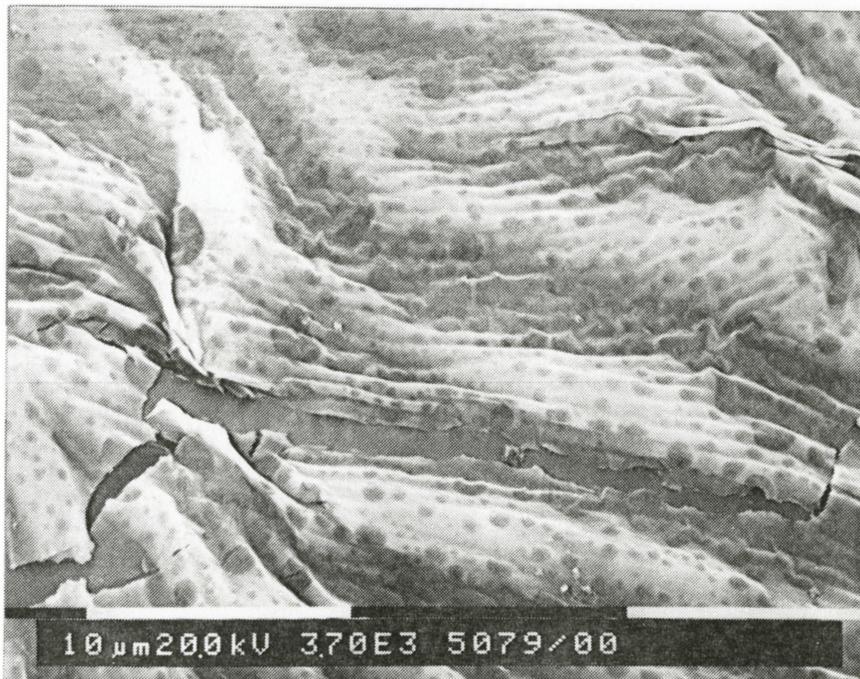
Figure 4.11b SEM image showing cracking and partial removal of the aluminum in the damaged region of Figure 4.11a.

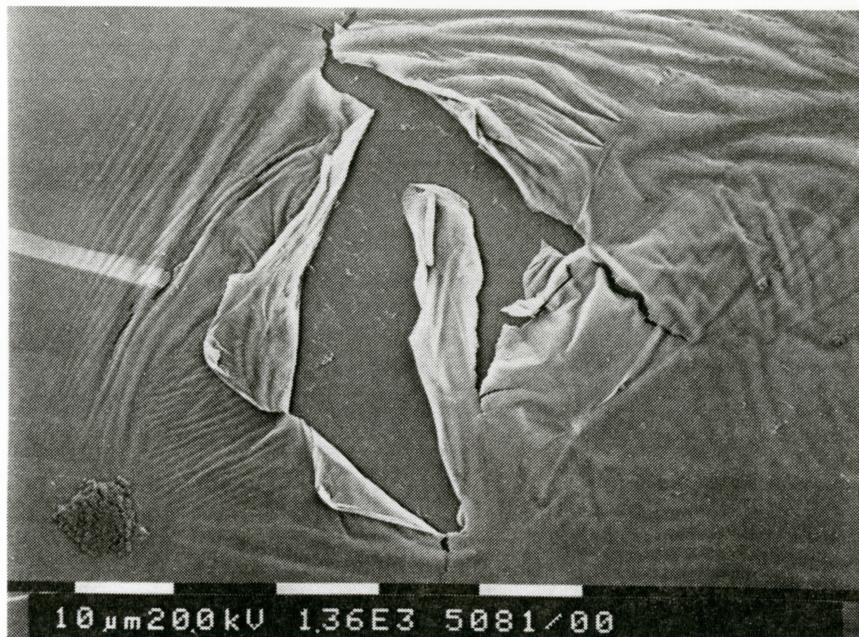
Figure 4.11c SEM image showing a region where the aluminum layer has been peeled back by the incident pulse.

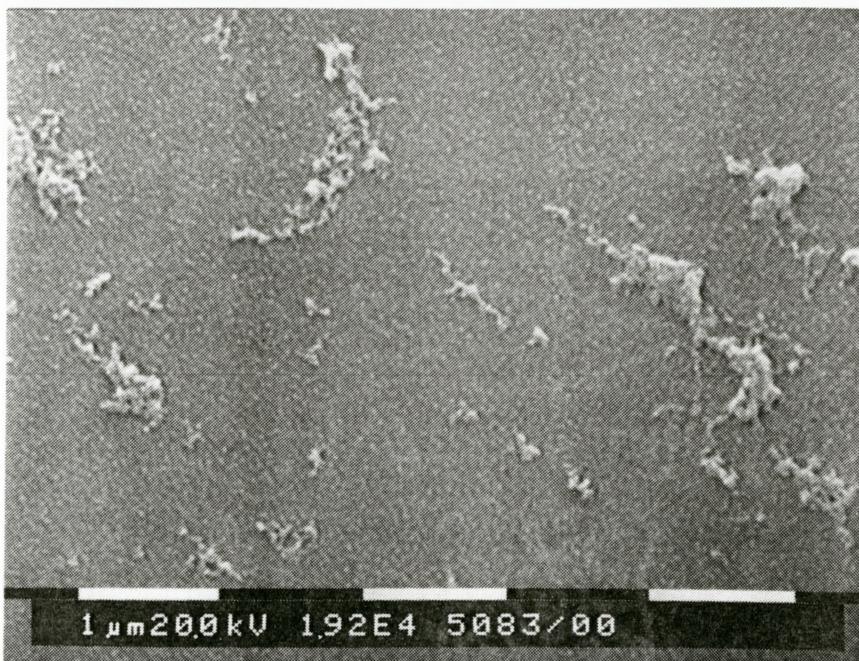
Figure 4.11d Magnification of Figure 4.11c, showing debris on the surface of the underlying polyimide layer.
