MATERIALS PATTERNING WITH AN EXCIMER LASER

EDWARD E. GUZZO, B.Sc.

Master of Engineering

M^cMaster University

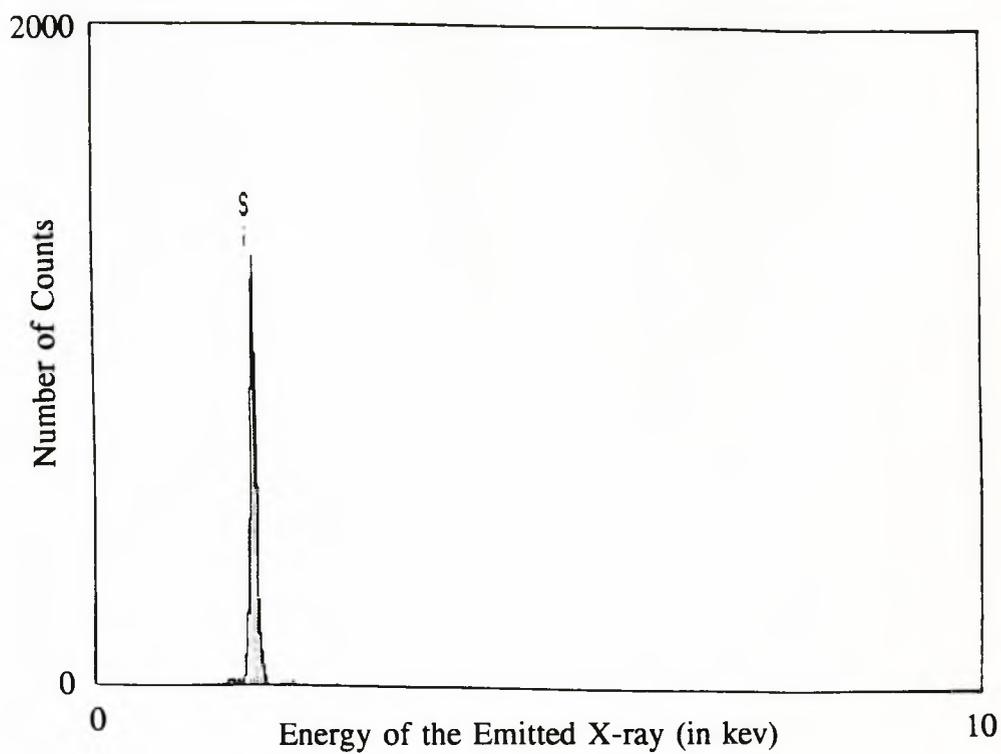
Figure 4.12 EDXS scan of the composition of the debris remaining on the underlying polyimide surface after the aluminum layer has been peeled back. The peak indicating the presence of aluminum (see Figure 4.8) is not present in this scan.

At fluences slightly below the S.S.R. threshold, removal of the aluminum layer ceases and only heavy damage occurs. In Figure 4.11a, we see a section of the aluminum layer which has been exposed to a single pulse at a fluence of 163 mJ/cm^2 . The central portion of the photograph shows the irradiated zone while to the left we see part of a hole from a previous trial. There is intense cracking and partial film removal in the top portion of the irradiated area. SEM images of this heavily damaged region can be seen in Figures 4.11b, 4.11c and 4.11d. Figure 4.11b is a magnification of Figure 4.11a showing cracking of the aluminum layer. The fluence of the incident pulse was too low to completely remove the film, so most of the aluminum was left behind. There are also dark spots on the surface of the aluminum. These spots were present in only a small section of the entire irradiated area and were not observed in any other SEM images. This indicates that the incident laser pulse did not create the spots, although the reason for their existence is unknown. Figure 4.11c shows a region of the sample where the aluminum has been peeled back rather than removed. Cracking and wrinkling of the aluminum surrounding this region has also occurred. This is most likely due to thermal effects. Figure 4.11d is a magnification of the previous photograph showing the debris remaining on the polyimide surface after the aluminum has been peeled back. The physical appearance of the debris indicates that it is most likely polyimide rather than redeposited aluminum. This conclusion was supported by the EDXS analysis seen in Figure 4.12, which shows that the debris does not contain aluminum.

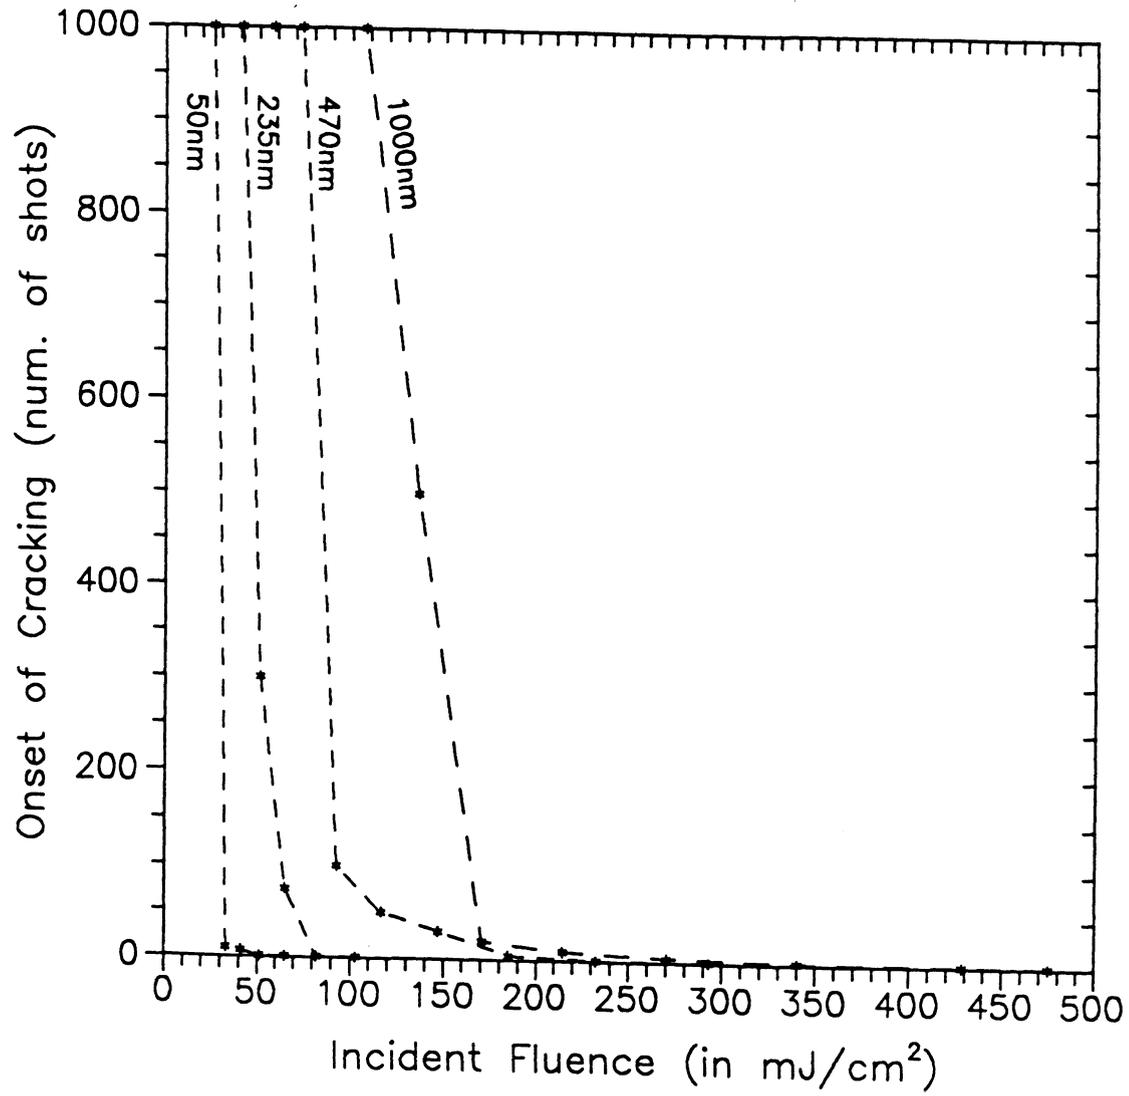
Figure 4.13 The onset of cracking as a function of incident fluence for various thicknesses of aluminum.

pulses. At slightly higher fluences, cracking will occur after a fewer number of pulses. Figure 4.13 shows the number of pulses required to initiate cracking as a function of the incident fluence, with each curve on the graph corresponding to a different aluminum layer thickness. The most obvious feature of this plot is that thicker aluminum layers are less sensitive to small changes in fluence and are therefore more resilient to cracking. For the 50 nm aluminum layer, the cracking threshold was 26 mJ/cm^2 for 1000 laser pulses. If the fluence is raised to 33 mJ/cm^2 , then it only requires 10 laser pulses to cause similar damage. The damage threshold for the 1000 nm aluminum layer was 107 mJ/cm^2 , which is approximately four times larger than the threshold for the 50 nm layer. If we wanted to do similar damage to this layer in only 10 pulses, then the incident fluence would have to be raised to approximately 200 mJ/cm^2 . The damage thresholds for various film thicknesses can be seen in Table 4.3.

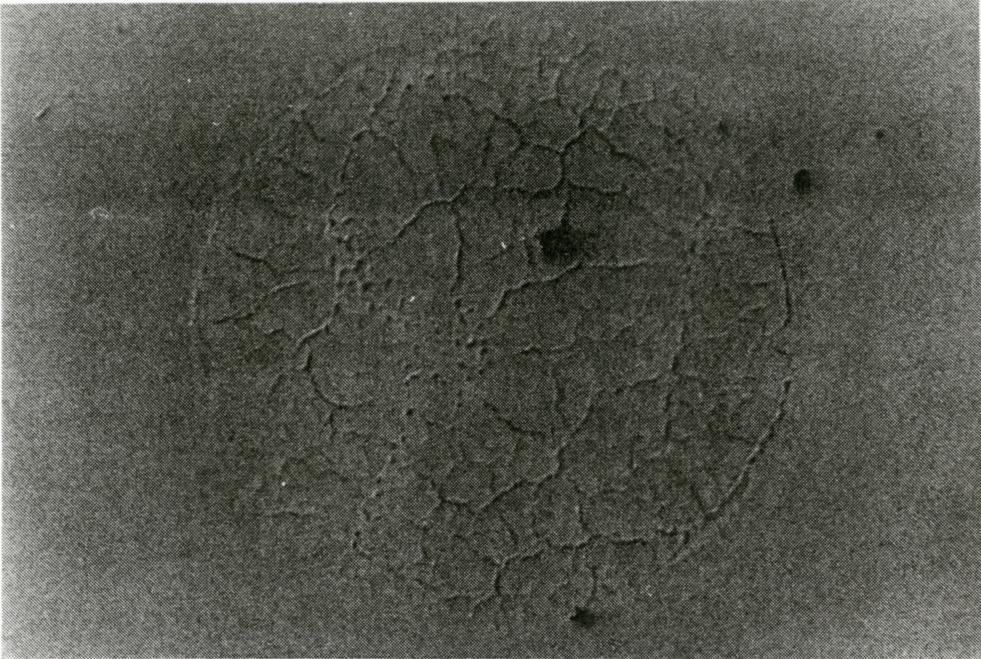
Figure 4.14a Photograph showing cracking of a 470 nm thick aluminum layer caused by two incident pulses at a fluence of 265 mJ/cm².

Figure 4.14a shows cracking of a 470 nm thick layer by two laser pulses at a fluence of 265 mJ/cm^2 . We notice that the cracking is uniform over the entire irradiated region and neither removal nor peeling back of the aluminum has occurred. Figure 4.14b shows the effect of ten similar laser pulses on the same layer. Both the number and the density of cracks has increased. In addition, partial removal and peeling back of the aluminum layer has occurred in parts of the irradiated zone. The size and location of this partially removed region was inconsistent from trial to trial. If further pulses were applied, the size of this region eventually increased to cover the entire irradiated area. These results indicate why aluminum is more effectively removed by a single shot

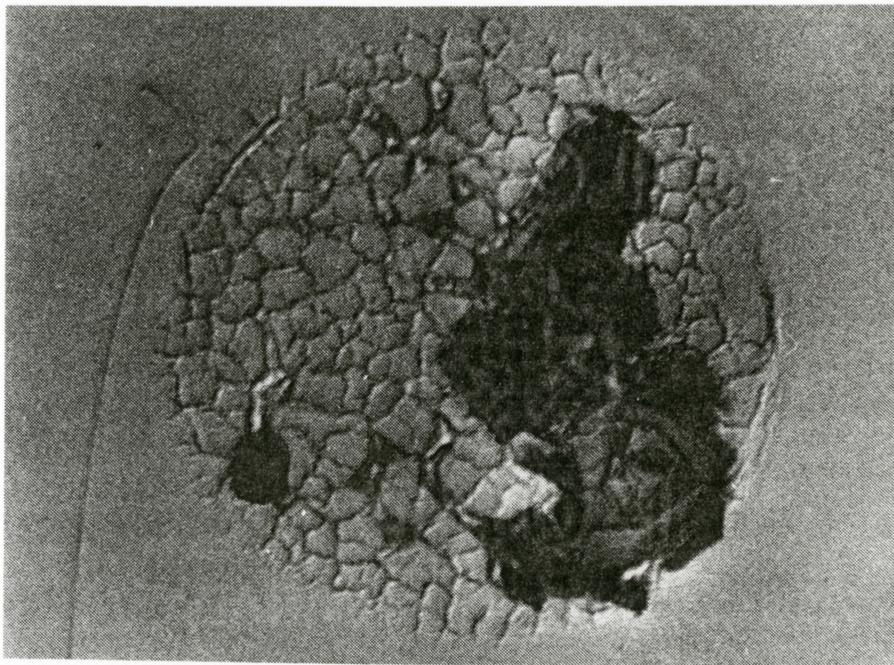
Figure 4.14b Photograph showing cracking of the same layer as above, but caused by ten incident pulses at a fluence of 265 mJ/cm².

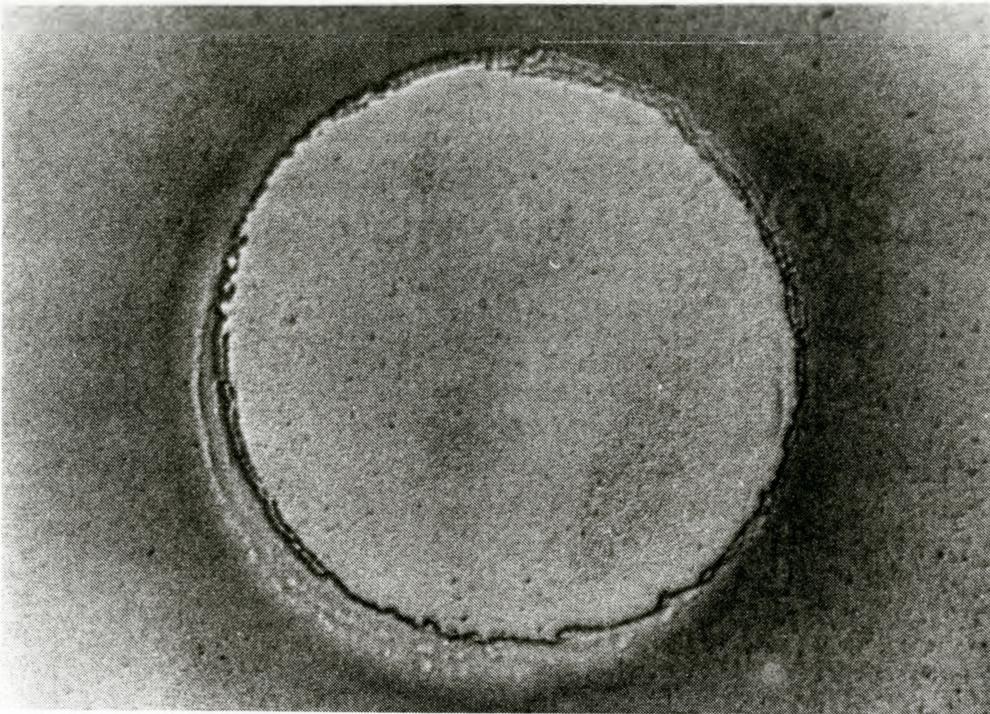
Figure 4.15a Photograph of a hole ablated through the upper polyimide layer of a multilayer.

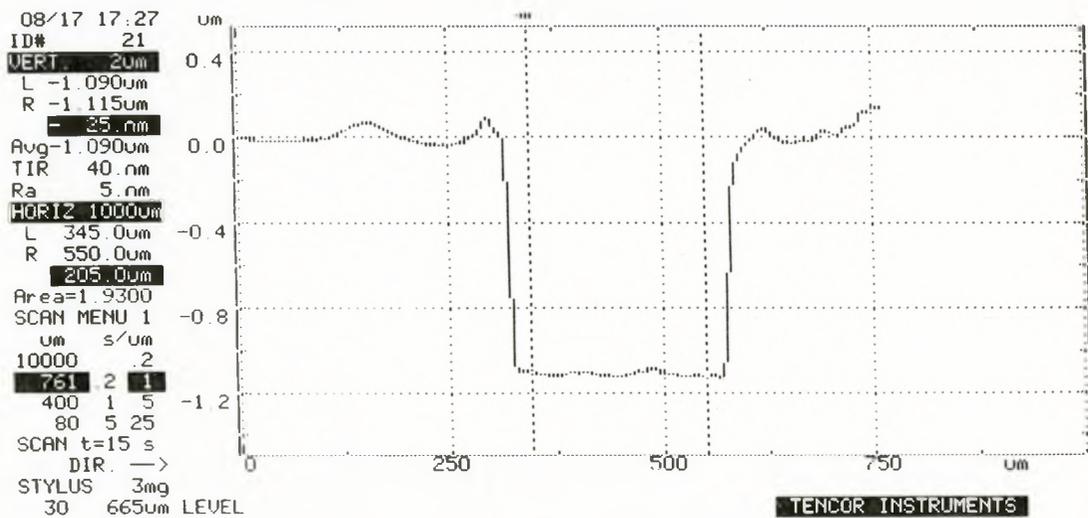
Figure 4.15b Surface profile of the above hole.

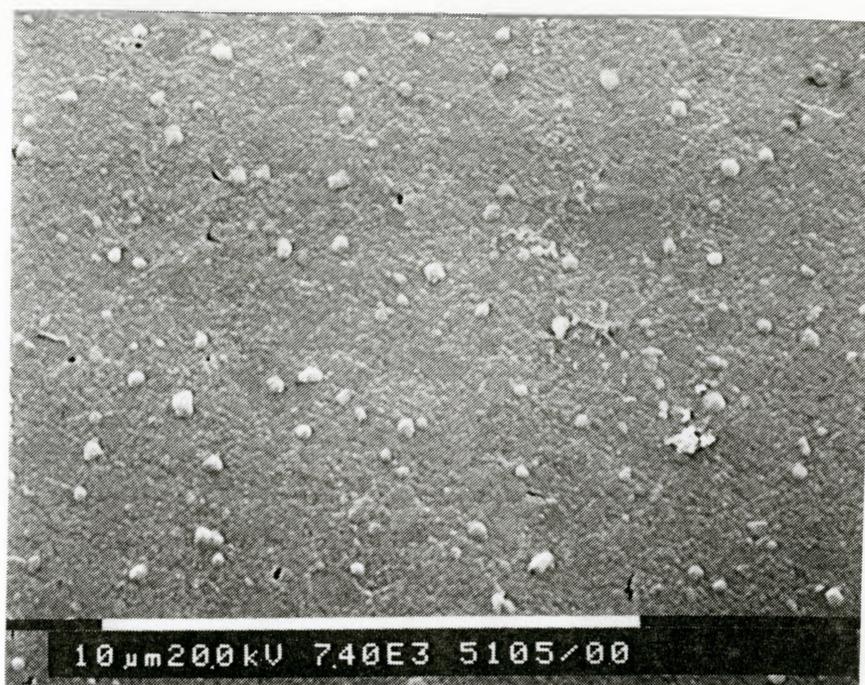
Figure 4.15c SEM image showing the bottom surface of the hole from Figure 4.15a.

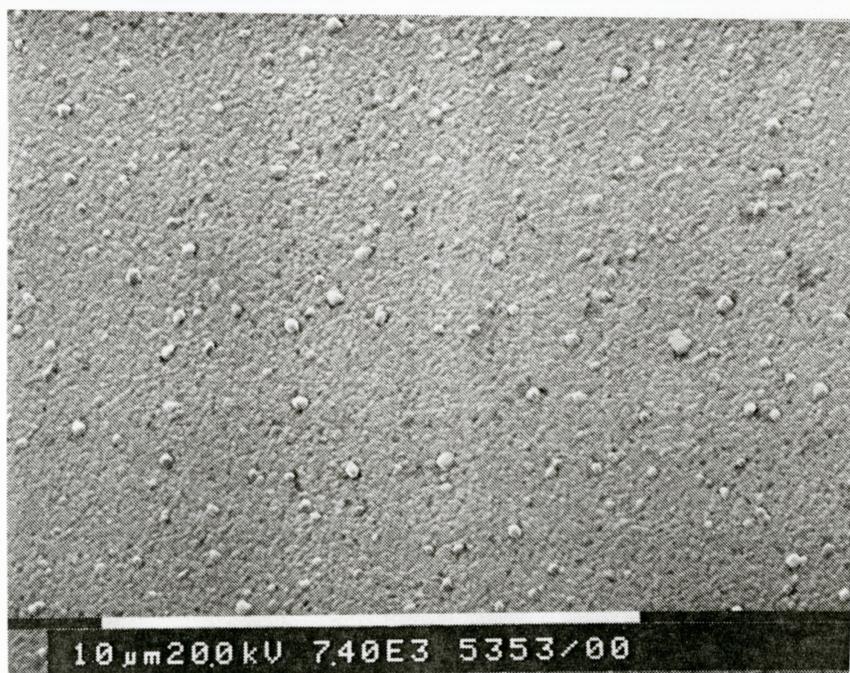
Figure 4.15d SEM image showing the surface of a section of the aluminum layer which has not been exposed to laser light.

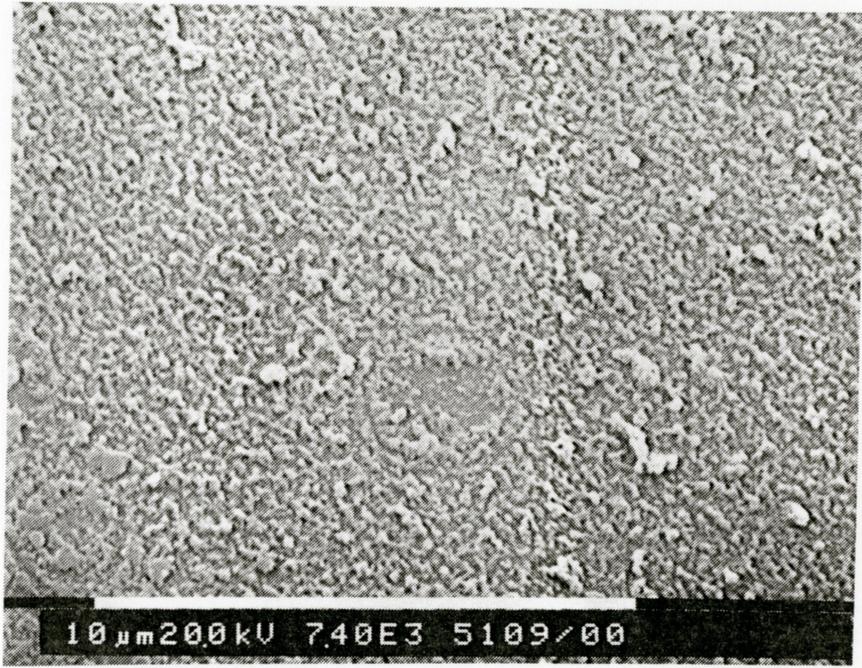
Figure 4.15e SEM image of debris surrounding the hole shown in Figure 4.15a.

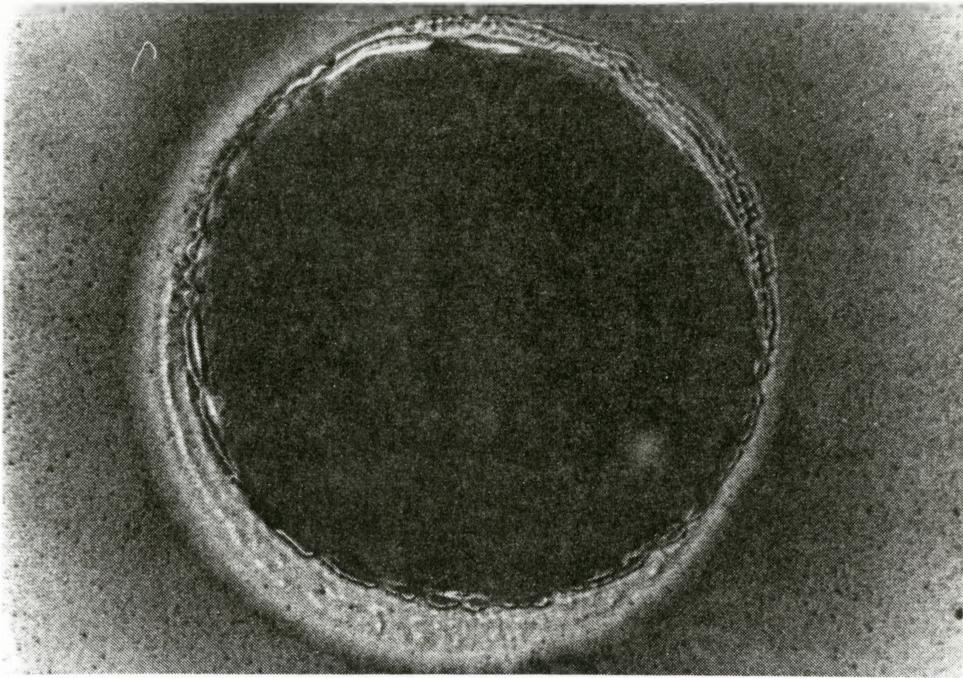
Figure 4.16a Photograph of a hole which penetrates through both the upper polyimide and aluminum layers.

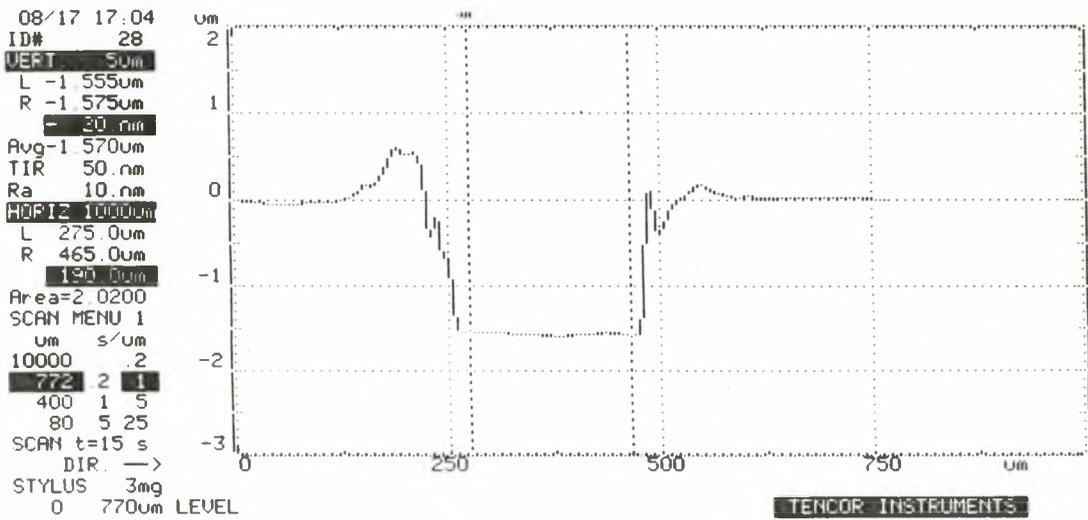
Figure 4.16b Surface profile of the above hole.

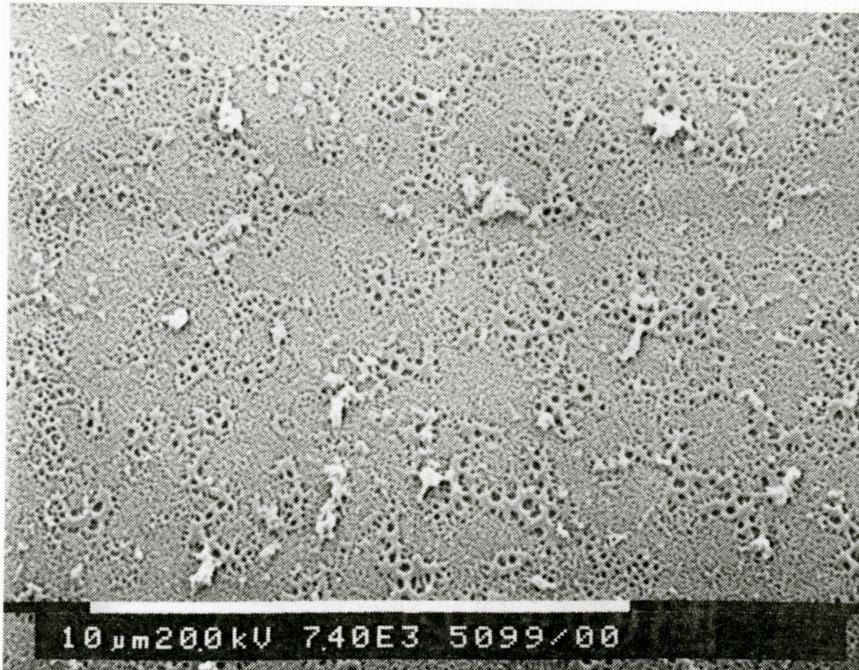
Figure 4.16c SEM image of the bottom of the hole shown in Figure 4.16a.

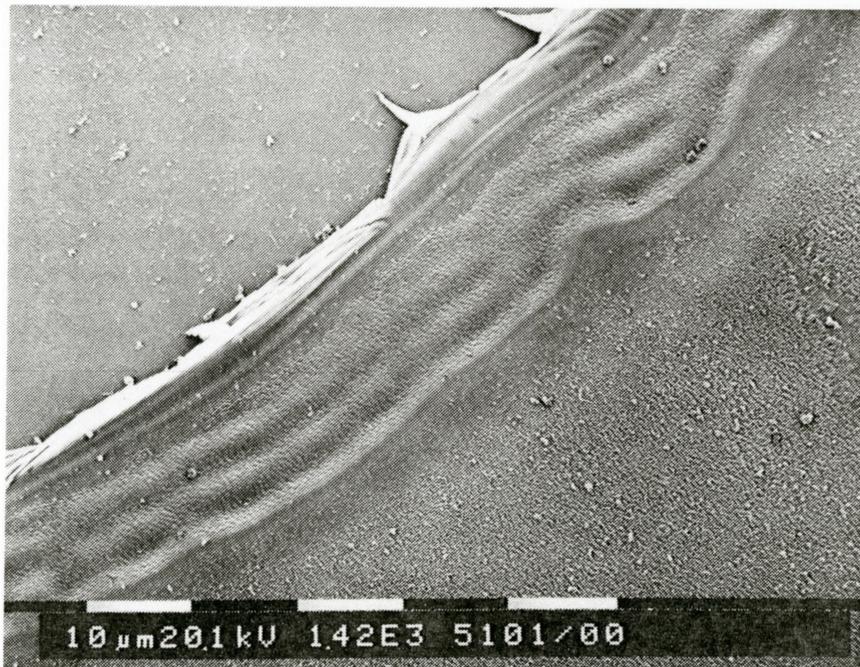
Figure 4.16d SEM image showing the edge quality of the hole in Figure 4.16a.

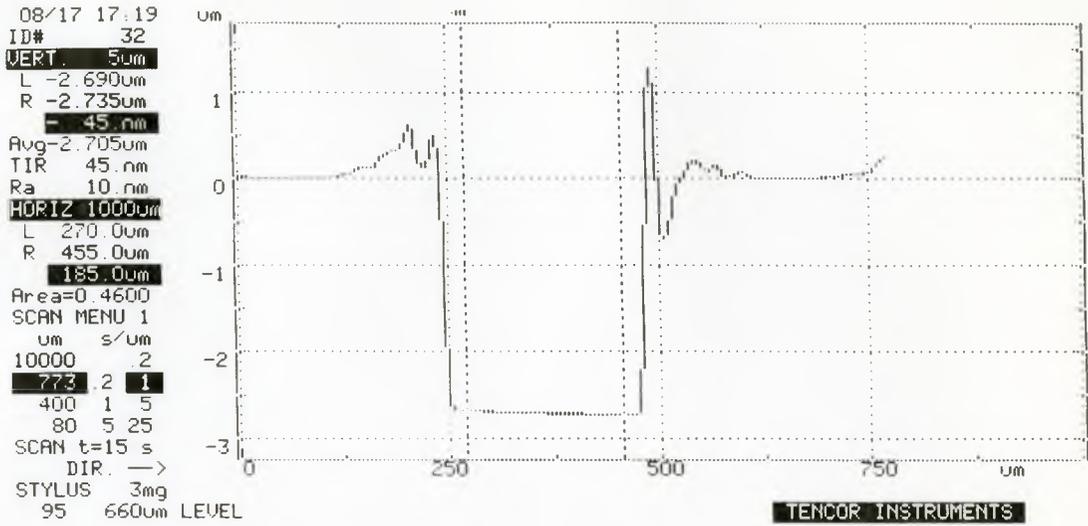
Figure 4.17a Surface profile of the silicon substrate following removal of the multilayer.

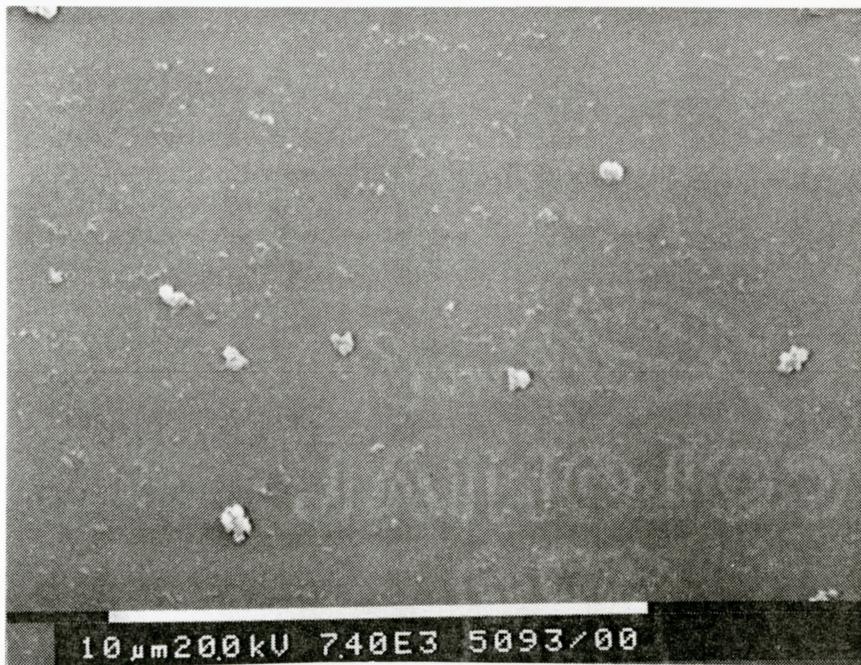
Figure 4.17b SEM image of the silicon surface following removal of the multilayer.

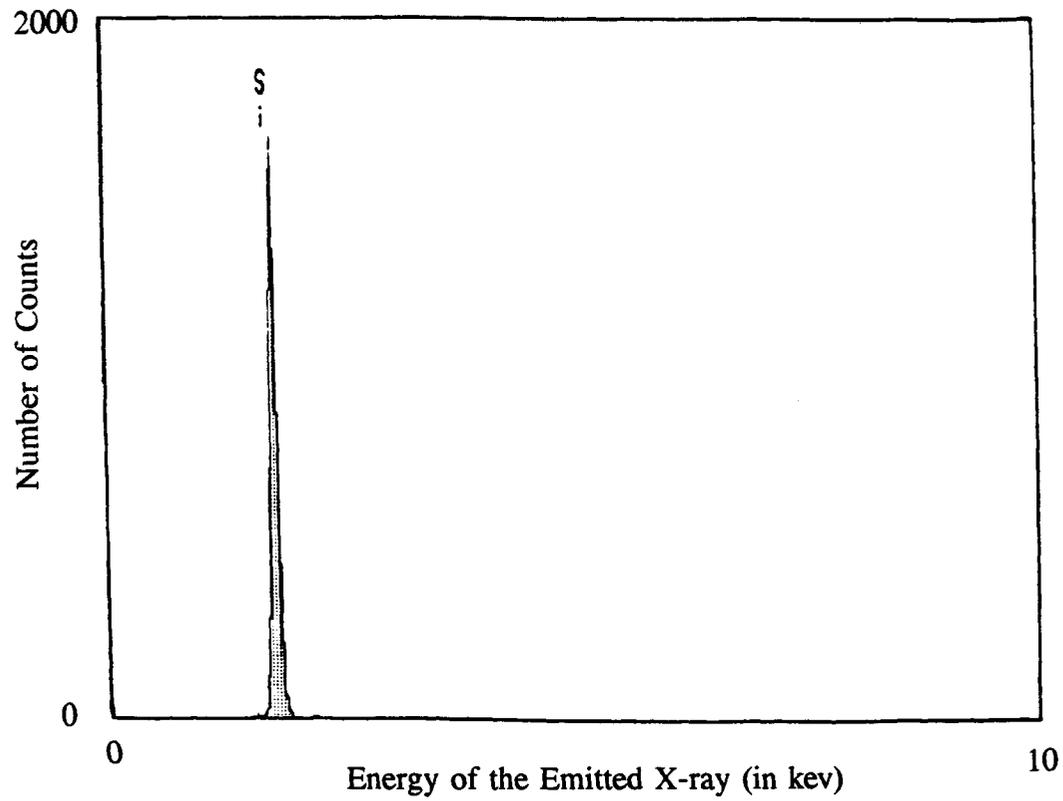
Figure 4.18 EDXS scan showing the composition of the debris remaining on the silicon surface after the multilayer has been removed. The peak indicating the presence of aluminum (see Figure 4.8) is not present.

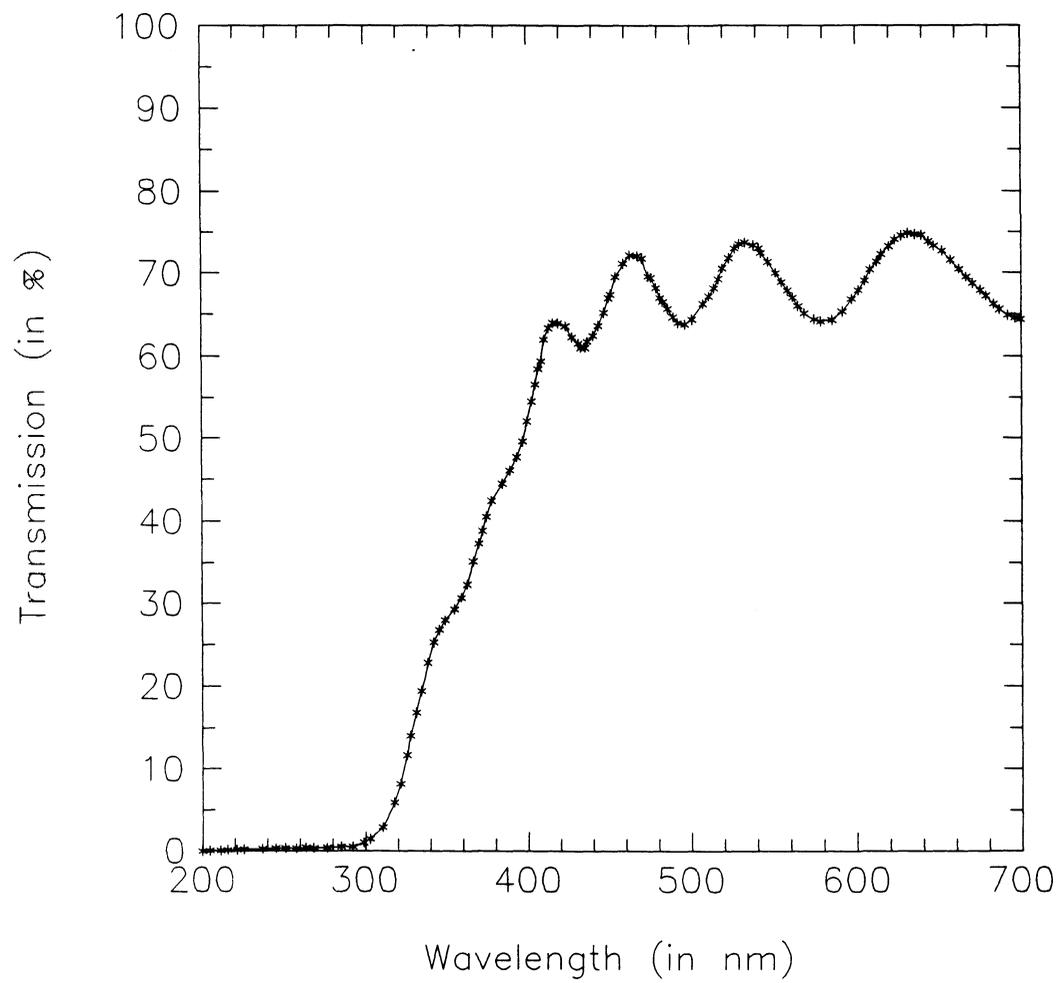
Figure 4.19a Transmission through the free standing polyimide film as a function of wavelength prior to irradiation.

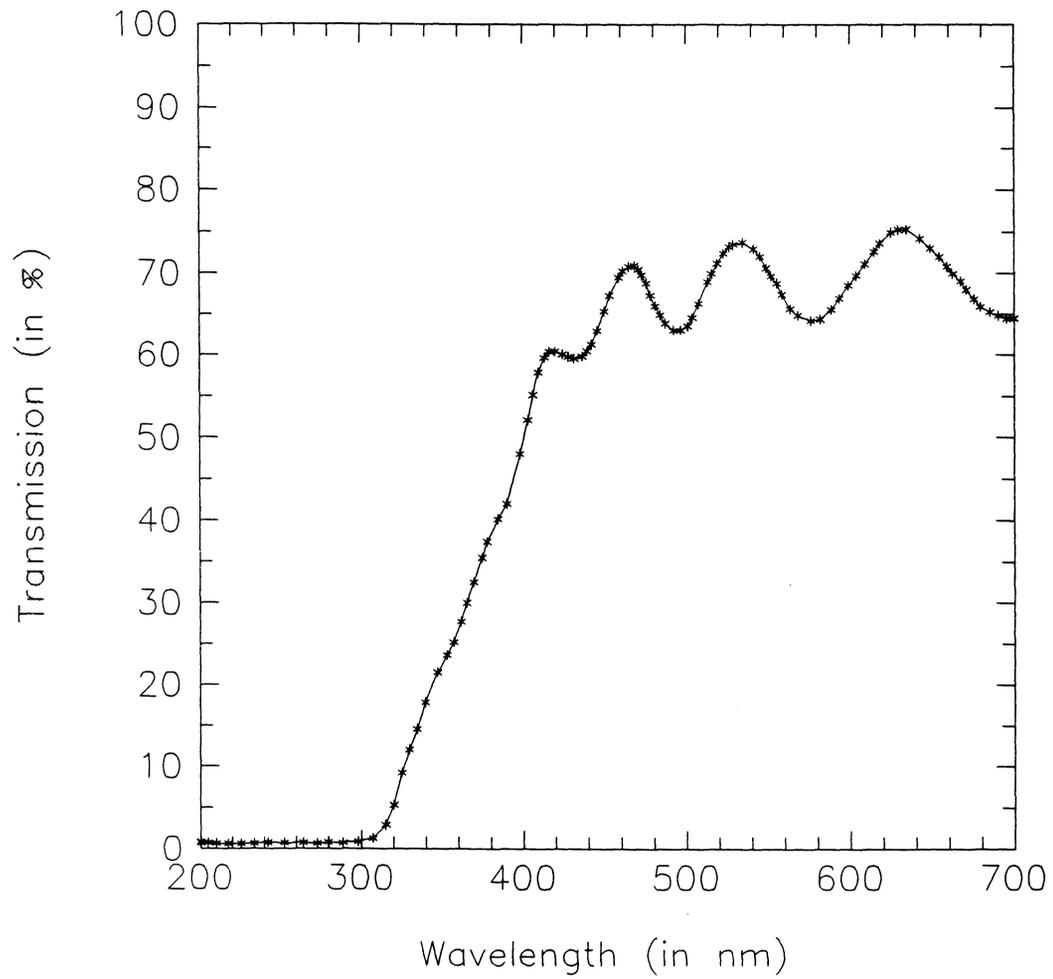
Figure 4.19b Transmission through the same film as a function of wavelength following irradiation.

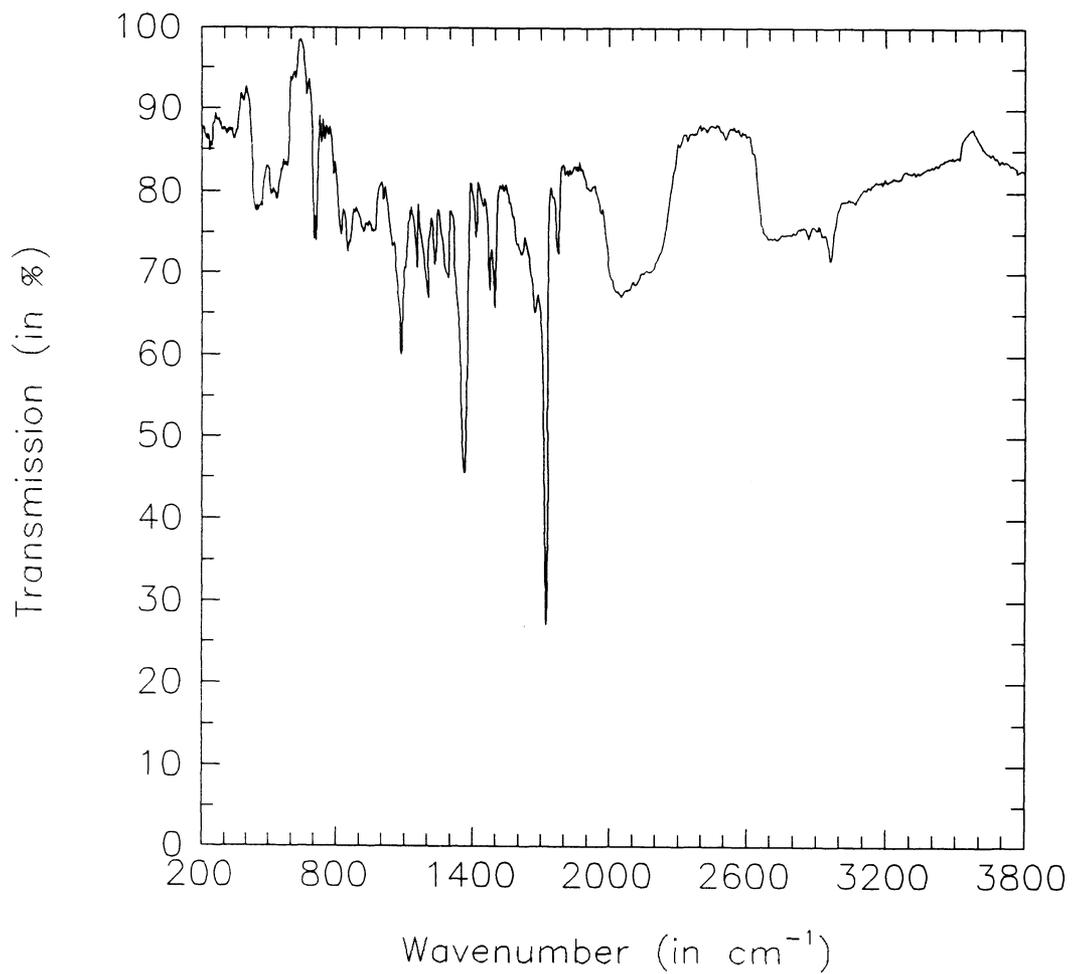
Figure 4.20a Infrared transmission of the film as a function of wavelength prior to irradiation.

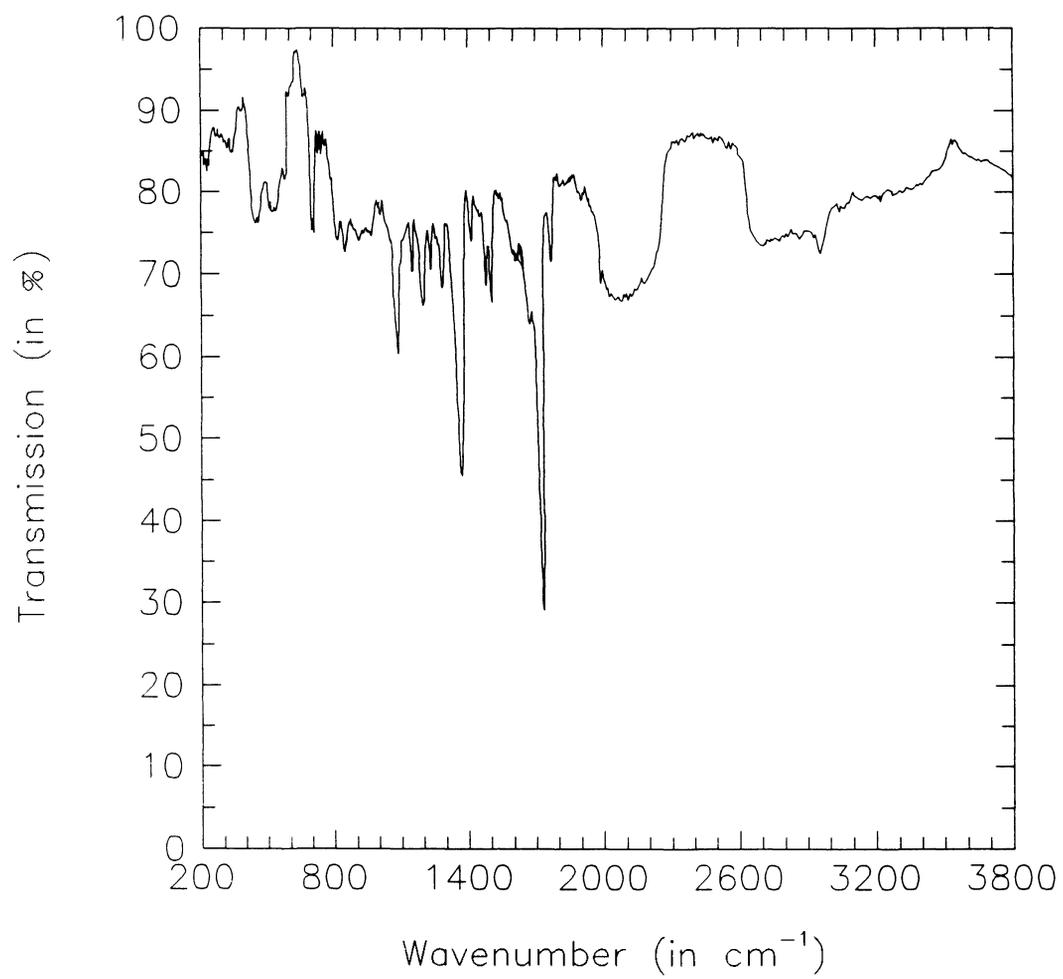
Figure 4.20b Infrared transmission of the same film following irradiation.

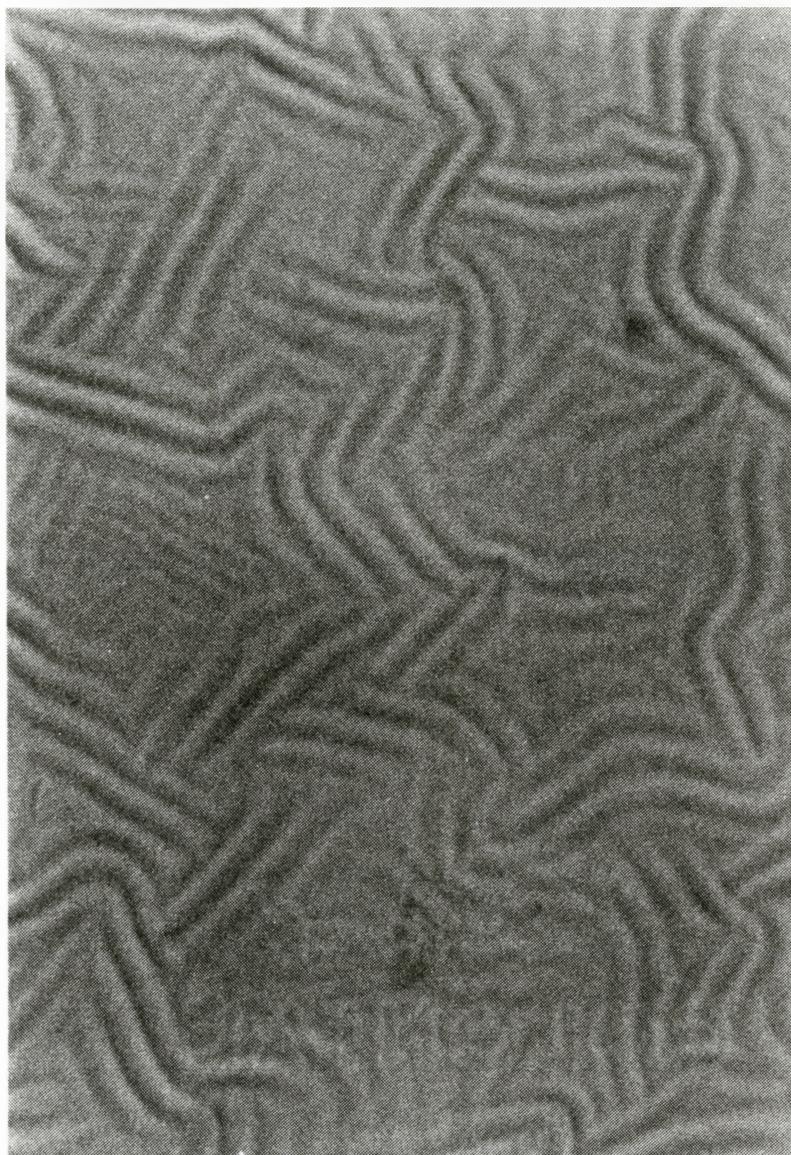
Figure 4.21 Photograph of the free standing film following irradiation.

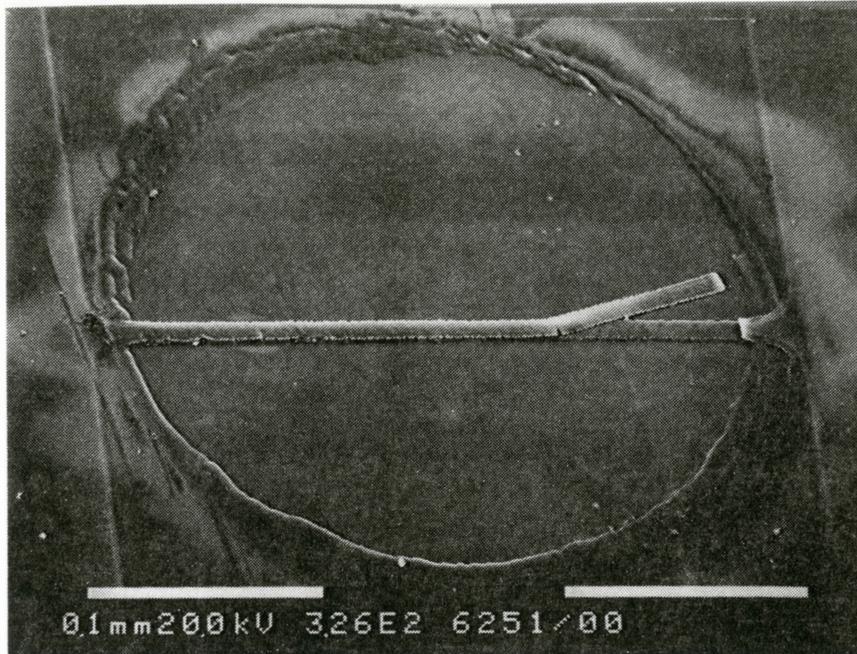
Figure 4.22a SEM image of a 10 micron wide wire irradiated with 40 laser pulses at a fluence of 96 mJ/cm^2 . The surrounding polyimide has been removed, leaving only the section under the wire.

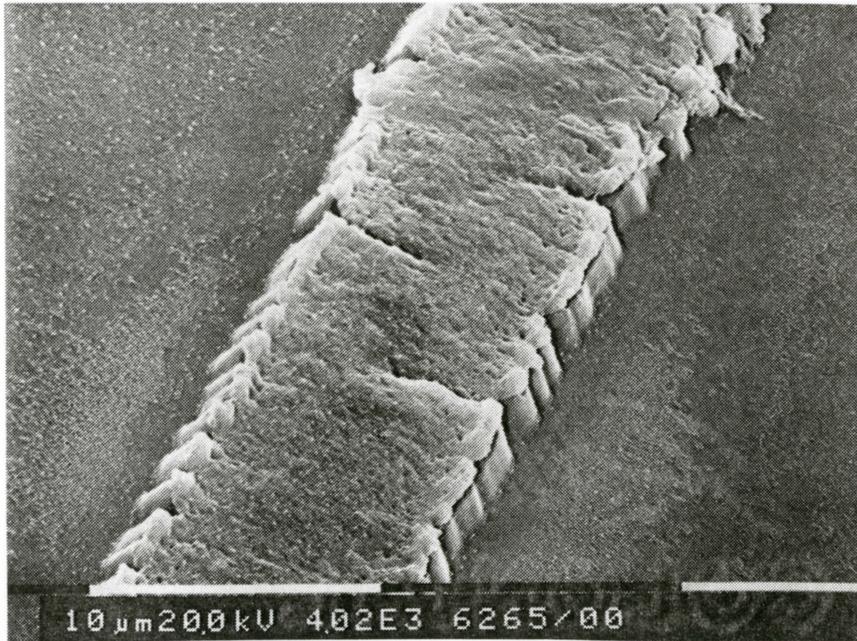
Figure 4.22b Magnification of Figure 4.22a, showing damage to a section of the aluminum wire.

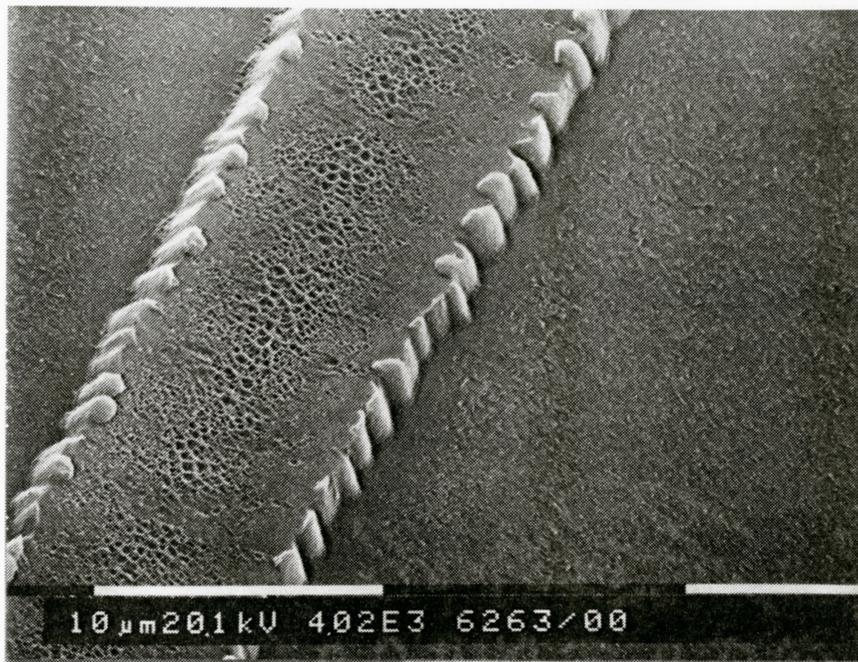
Figure 4.22c Magnification of Figure 4.22a showing the region where the aluminum wire has inadvertently been lifted up in preparation for SEM, thereby revealing the underlying polyimide.

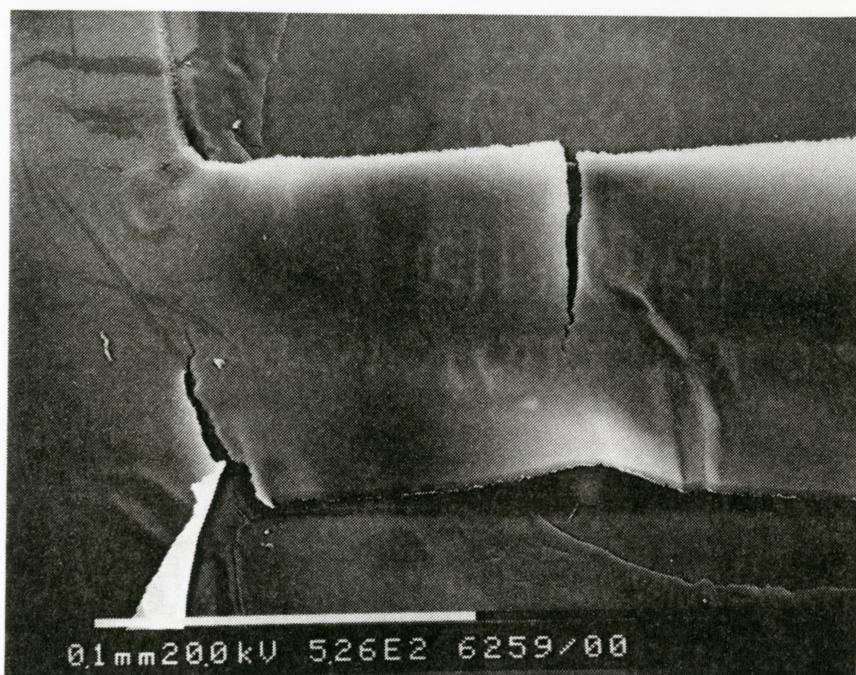
Figure 4.23 SEM image of a 100 micron wide wire exposed to a single laser pulse at a fluence of 121 mJ/cm^2 . The fluence was large enough to damage the wire.

At higher fluences, damage to the wire is expected to occur much sooner. Figure 4.23 is a SEM image of a 100 micron wide wire which was exposed to a single laser

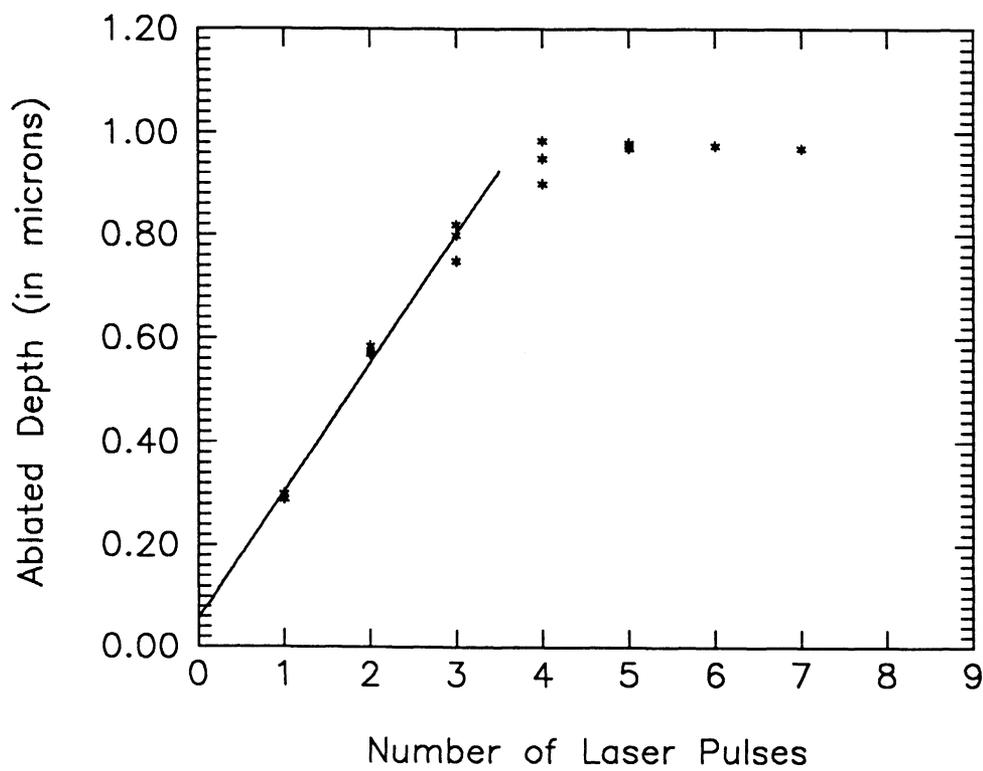
Figure A.1 Ablation performed at an incident fluence of 470 mJ/cm².

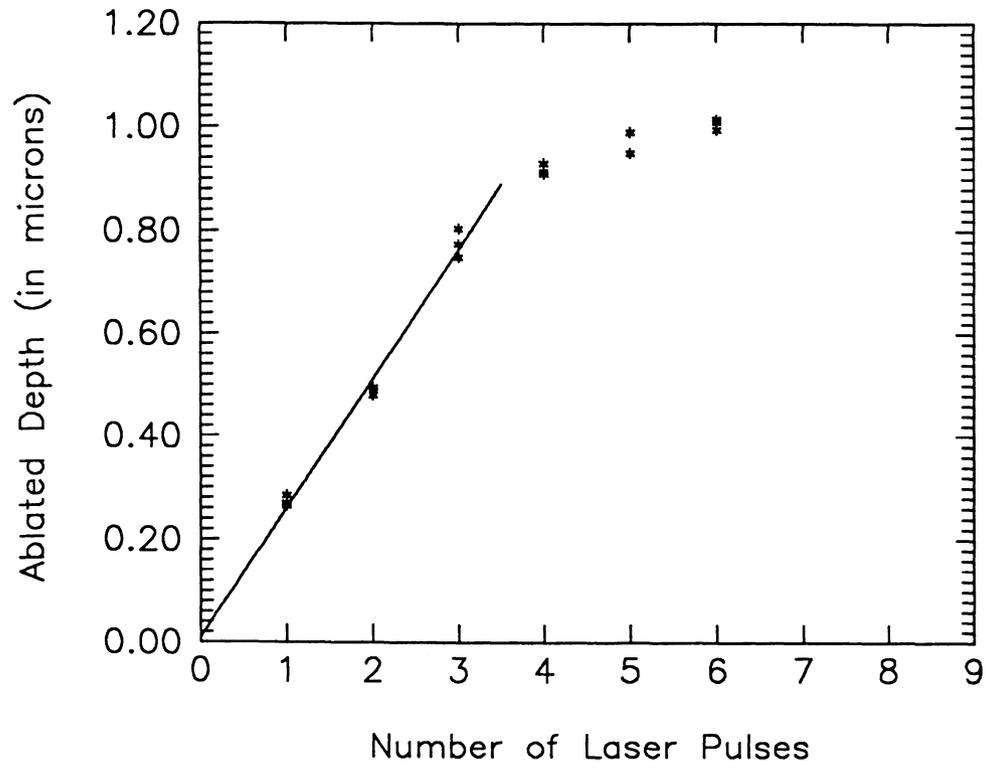
Figure A.2 Ablation performed at an incident fluence of 373 mJ/cm^2 .

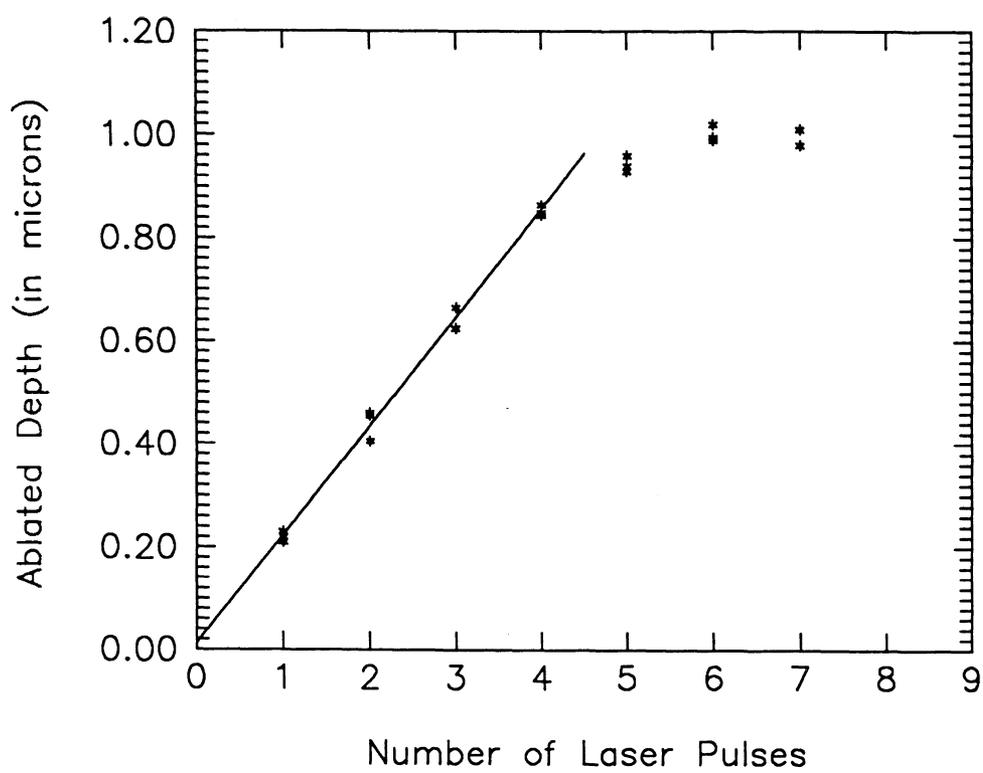
Figure A.3 Ablation performed at an incident fluence of 297 mJ/cm^2 .

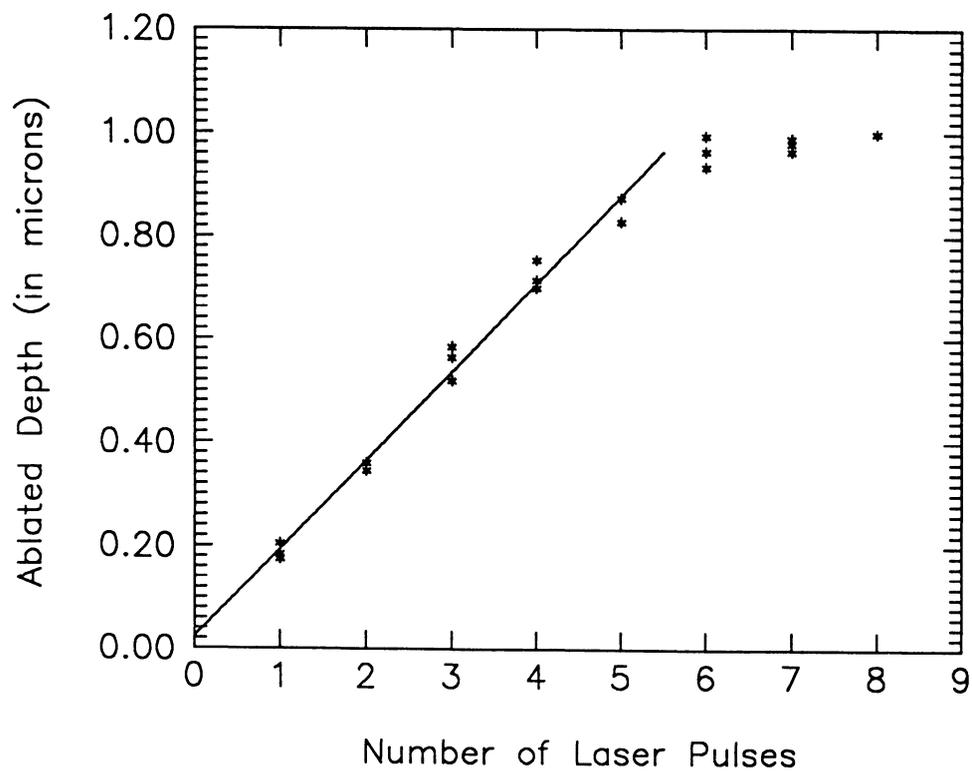
Figure A.4 Ablation performed at an incident fluence of 236 mJ/cm².
