MATERIALS PATTERNING WITH AN EXCIMER LASER

EDWARD E. GUZZO, B.Sc.

Master of Engineering

M^cMaster University

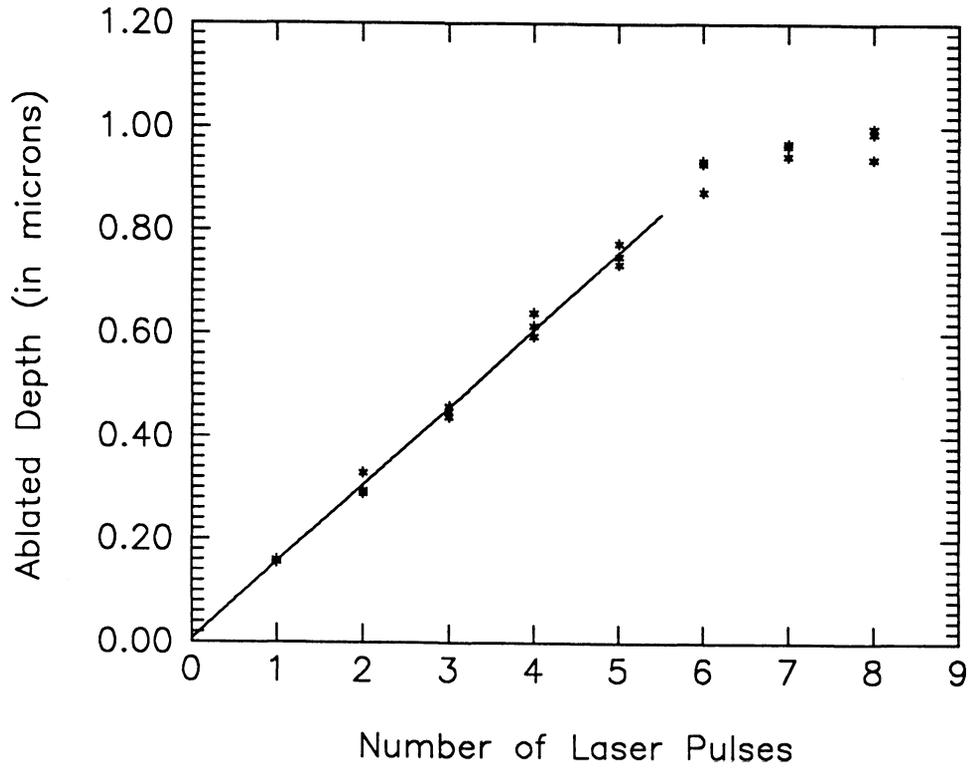
Figure A.5 Ablation performed at an incident fluence of 187 mJ/cm^2 .

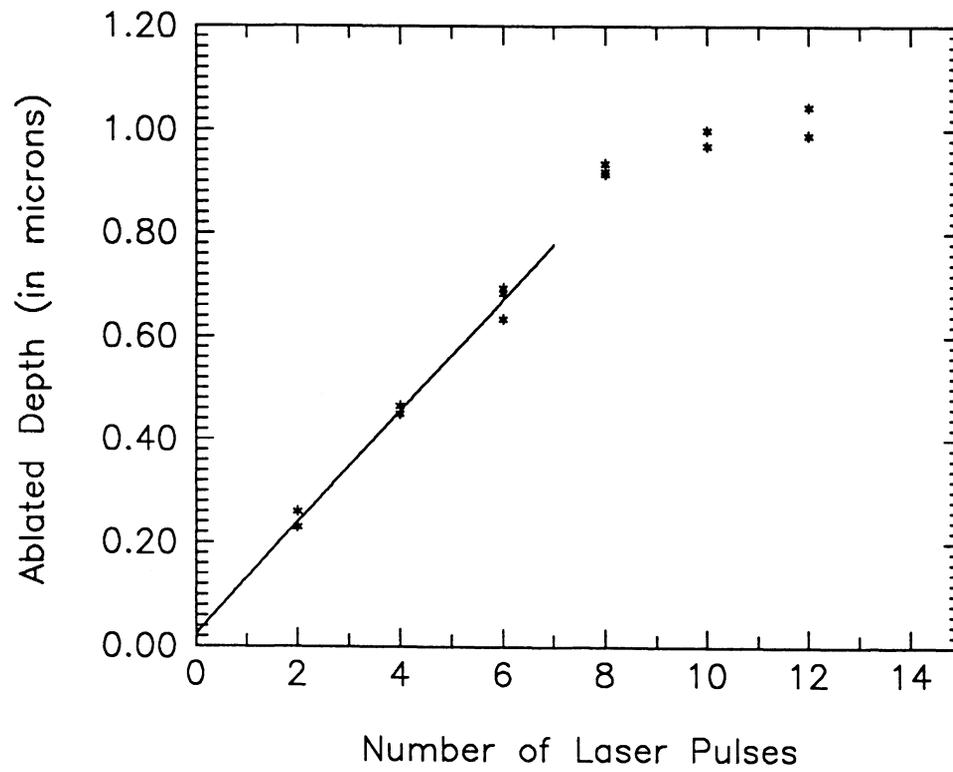
Figure A.6 Ablation performed at an incident fluence of 149 mJ/cm^2 .

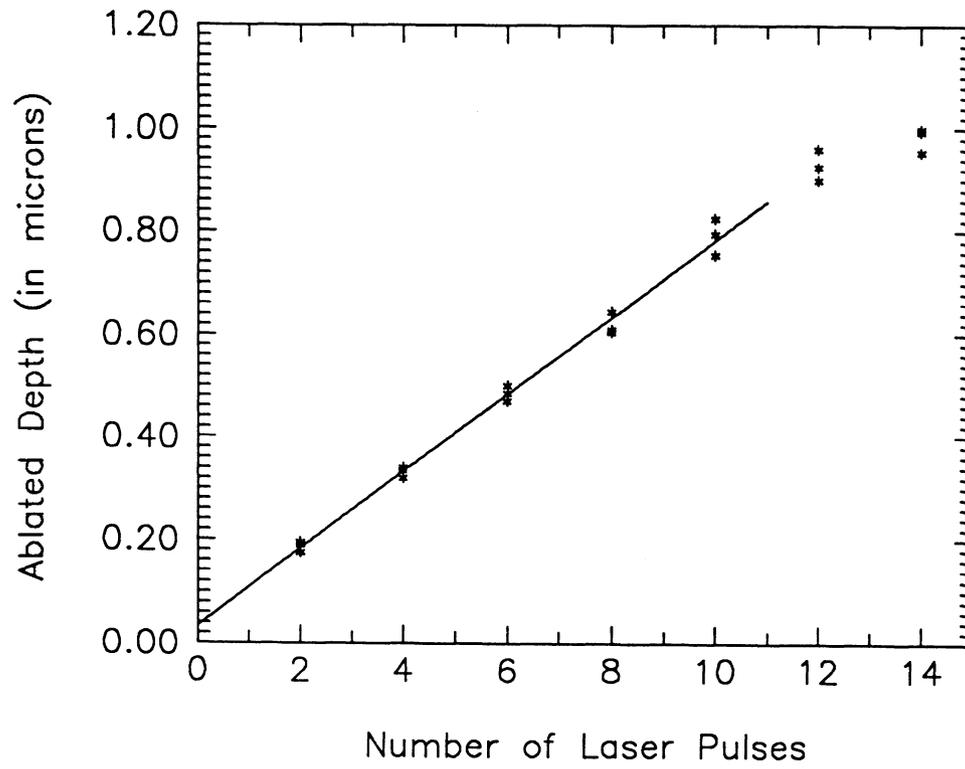
Figure A.7 Ablation performed at an incident fluence of 118 mJ/cm^2 .

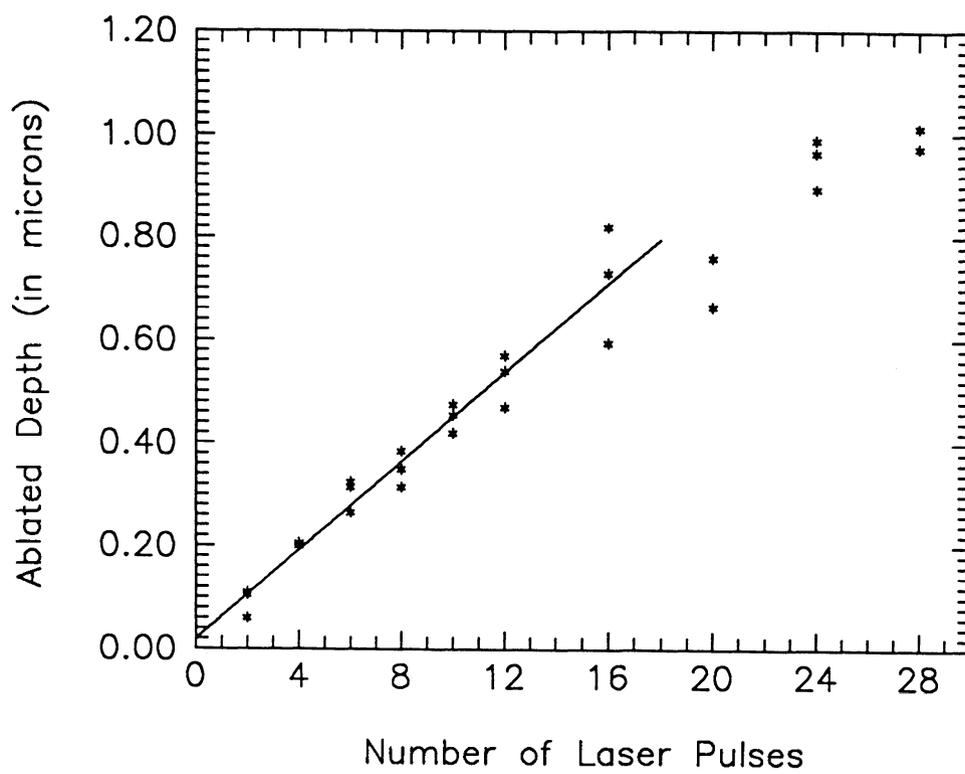
Figure A.8 Ablation performed at an incident fluence of 94 mJ/cm².

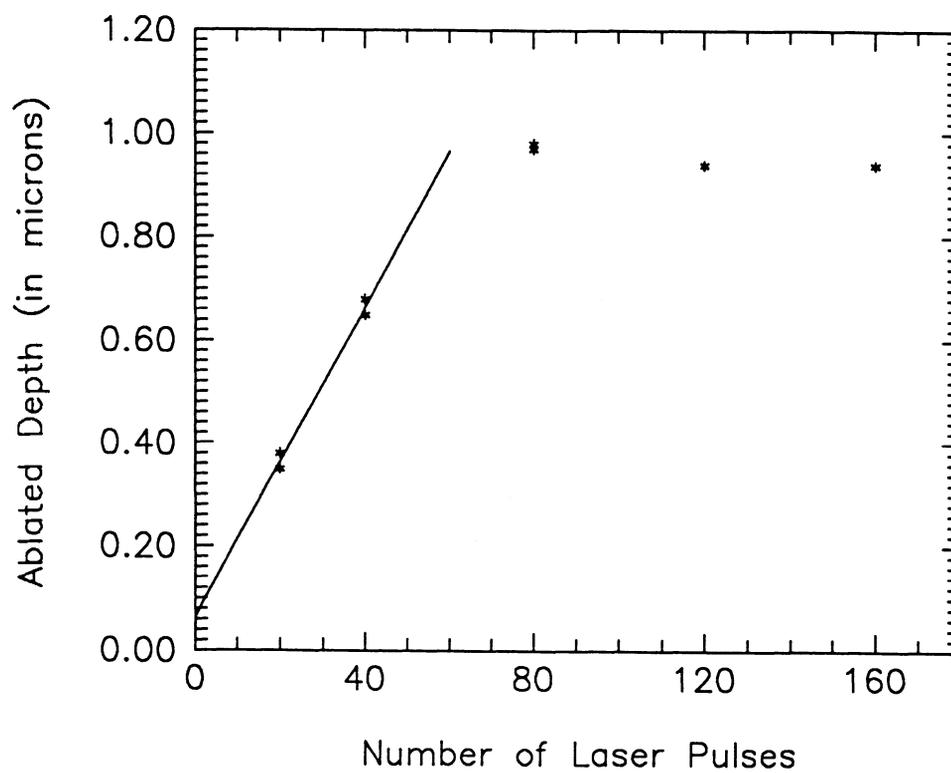
Figure A.9 Ablation performed at an incident fluence of 74 mJ/cm^2 .
