IN-SITU PERFORMANCE OF SU-FREI BRIDGE BEARINGS

Masters of Applied Science Thesis
School of Graduate Studies
McMaster University

© Copyright by Zachary van Galen, April 5, 2023

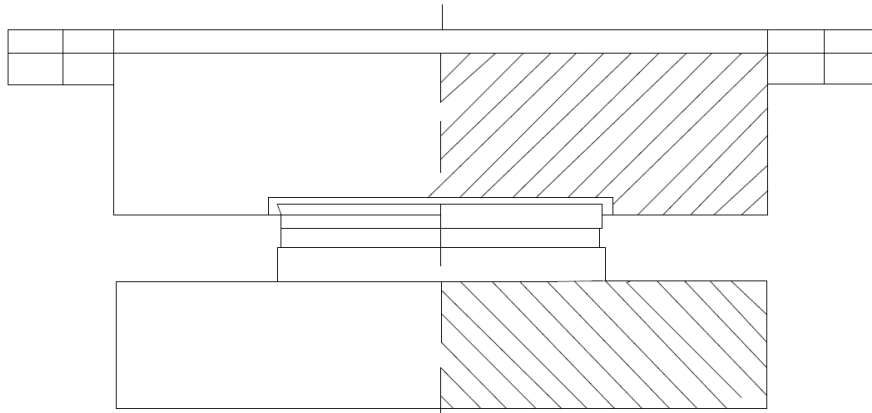
Steel bearings consist of a flat steel plate resting atop a curving one, such that it can tilt freely (Ramberger, 2002). This type of bearing has been in use since the start of the 20th century, and is only able to accommodate rotations: due to frictional forces, any horizontal displacements will result in ‘grinding’ of the plates against one another, which can result in damage. Furthermore, due to the small contact area between the flat and curving plate (only as large an area as is

created by elastic deformation of the plates under contact stresses), the plates must be thicker than those in other bearing types in order to distribute the force concentrations in the contact area. An example of this type of bearing is shown in Figure 1 (Ramberger, 2002).

Figure 1: Steel plate bearing; depiction adapted from Ramberger, 2002.

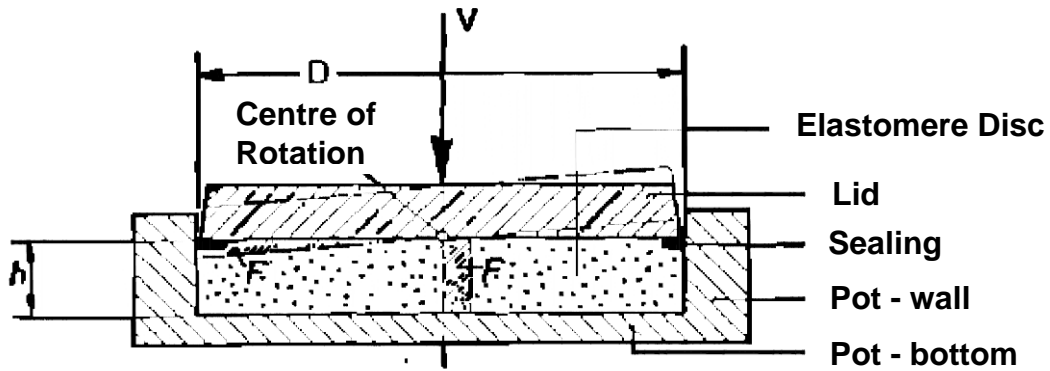
The development of Pot bearings goes back to the 1950s. These bearings consist of a steel pot filled with a rubber disc and capped off with a steel lid. Under large vertical loads the elastomer tends to act like a liquid, allowing the steel lid to smoothly rotate – but like steel bearings, standard pot bearings cannot accommodate horizontal displacements. However, a sliding apparatus may be added to a pot bearing to allow for horizontal displacement, which would consist of a grease-lubricated low-friction disc (often made of polytetrafluoroethylene) and a steel plate over top of the primary bearing apparatus. One major advantage of pot bearings is their high vertical stiffness, which is a result of the confined elastomer being nearly incompressible. An example of the standard type of pot bearing is shown in Figure 2 (Ramberger, 2002).

Figure 2: Pot bearing; depiction adapted from Ramberger, 2002

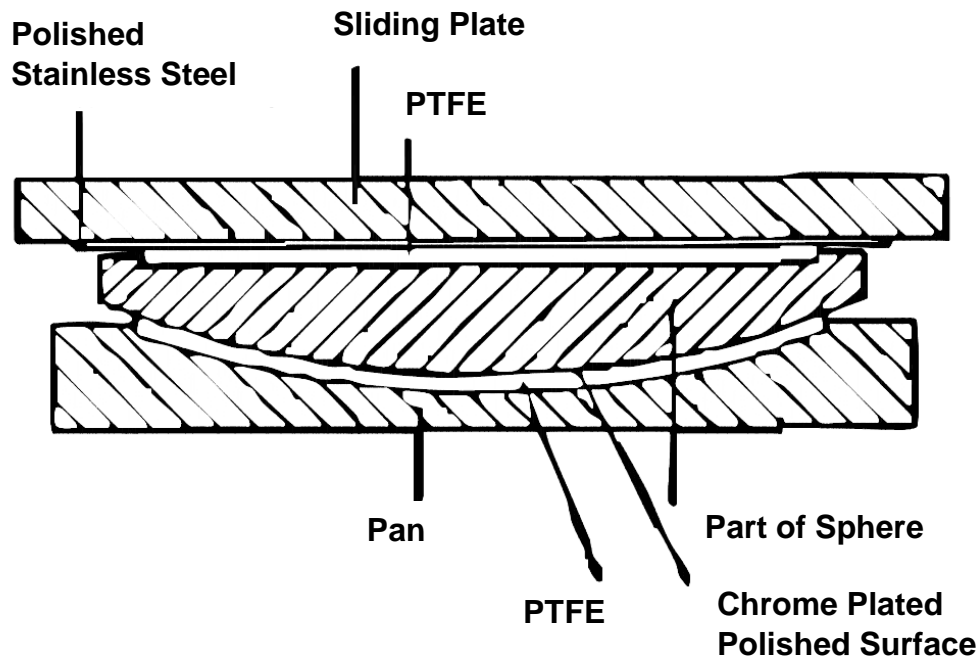
Standard spherical bearings consist of a large steel piece with a flat top and spherically curved bottom located within a steel pan of equal curvature, and a sliding plate above, with each steel element separated by a low-friction sliding layer. Since they include both sliding and rotating elements, they can accommodate both horizontal displacements and rotations – however, the large surface area over which the sliding occurs may cause the bearings to impose reaction moments in response to rotations. An example of this type of bearing is shown in Figure 3 (Ramberger, 2002).

Figure 3: Spherical bearing; depiction adapted from Ramberger, 2002

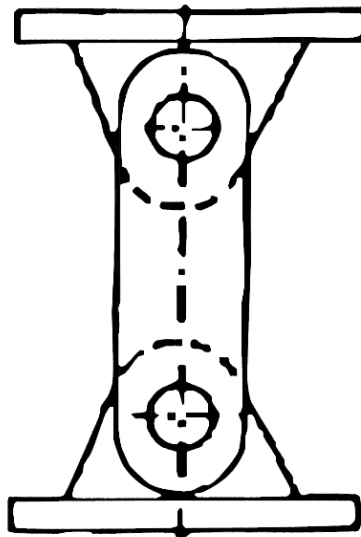
Leaf and link bearings are specialized designs that are employed where it may be necessary for the bearing to transfer tension forces: all previously discussed designs are only able to transfer compression. A leaf bearing consists of an upper and lower plate, each with a number of 'leaves' connected by a pin, allowing rotation in a single direction. Link bearings are similar, but with pendulums introduced between the top and bottom leaves to allow for horizontal displacements as well as rotations in one direction. There are ways to extend this idea to allow omnidirectional rotation and displacement, but these are not commonly used. An example of this type of bearing is shown in Figure 4 (Ramberger, 2002).

Figure 4: Leaf and link bearing; depiction adapted from Ramberger, 2002.

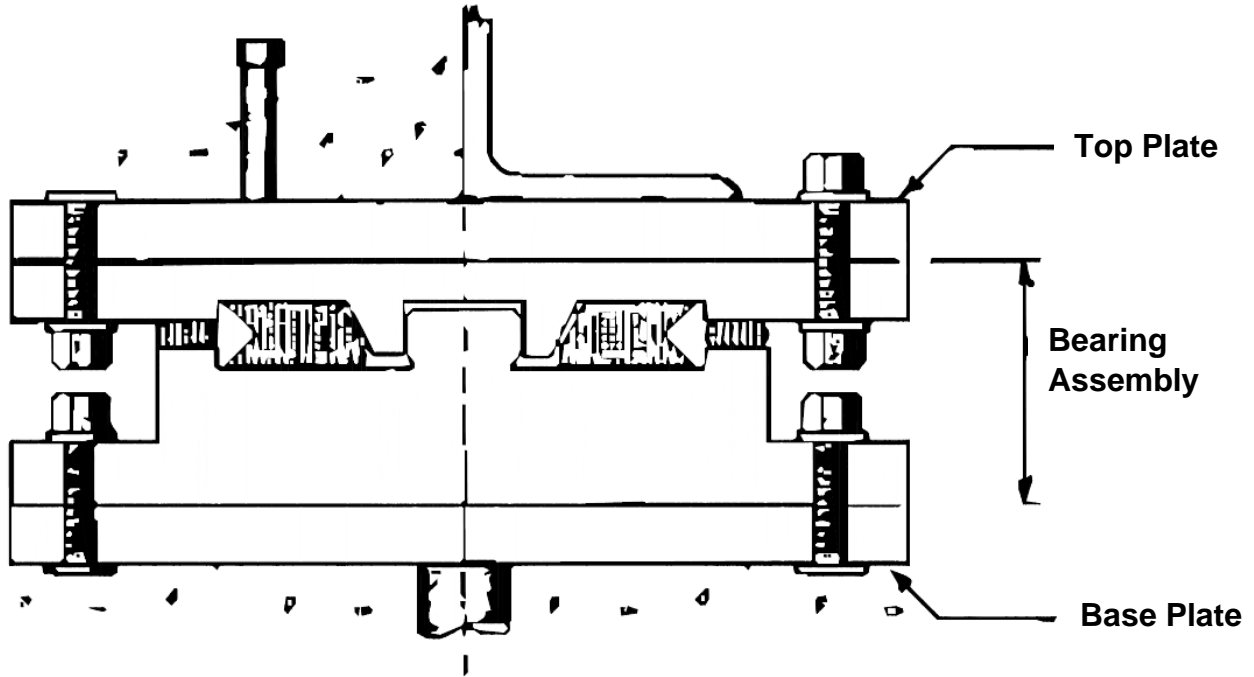
Disc bearings first came into use in the 1960s, and like pot bearings, use an elastomeric disc to transfer the vertical loads. Unlike a pot bearing, the elastomer in a disc bearing is not confined. They accommodate rotations in a similar manner to pot bearings, while transferring vertical forces with the help of a shear-restriction device. In this bearing type, rotations can cause the load axis to shift away from the center of the bearing, which must be considered. An example of this type of bearing is shown in Figure 5 (Ramberger, 2002).

Figure 5: Disc bearing; depiction adapted from Ramberger, 2002

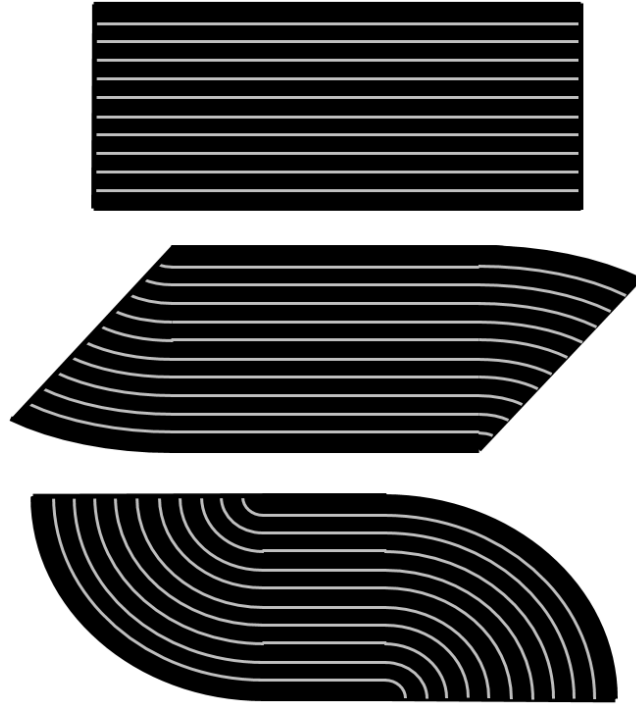
Continued investigations into the hysteretic behavior of FREI confirmed that they remained stable (with acceptable aspect ratio) throughout the previously discussed rollover behavior, including up to the point of failure (De Raaf et al. 2011). It was also observed that at large lateral displacements, the initial stiffness reduction during rollover is reversed as the original vertical side faces of the bearing make contact with the top and bottom supports. This behavior is illustrated in Figure 7, and has been considered a positive feature of SU-FREI as the increased

stiffness occurring after this limits further lateral motion and provides a natural level of maximum displacement the isolator can be designed for.

Figure 7: Rollover behavior of SU-FREI bearing

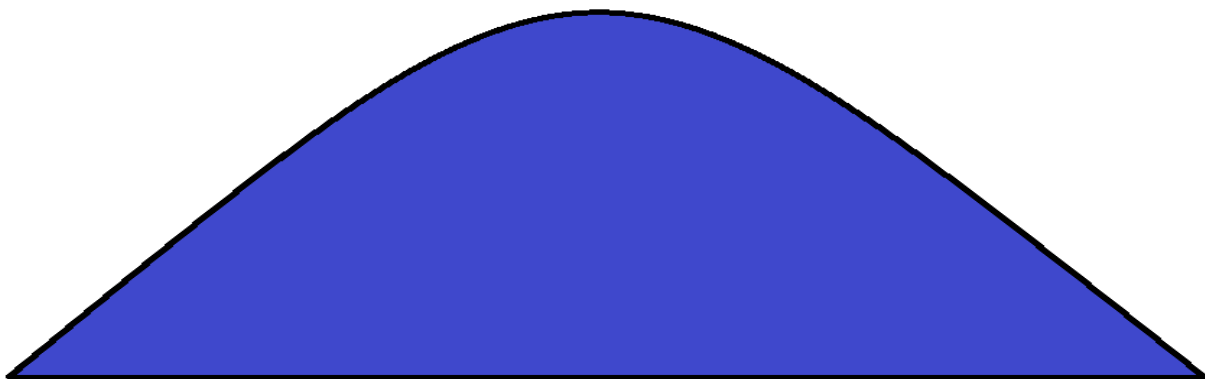
where p_b is a dimensionless parameter. The bending modulus was not directly used to determine the shear strain, however it can produce stresses in the reinforcement which would theoretically have to be added to those produced by compression to determine the full stress distribution. However, in practice, stress in the reinforcement is maximum at the center of the bearings under compression as shown in Figure 8, while bending produces zero stress at the bearing center and maximum stresses at a midpoint between the center and edges as shown in Figure 9.

Figure 8: Stress distribution in reinforcement when the bearing is under compression

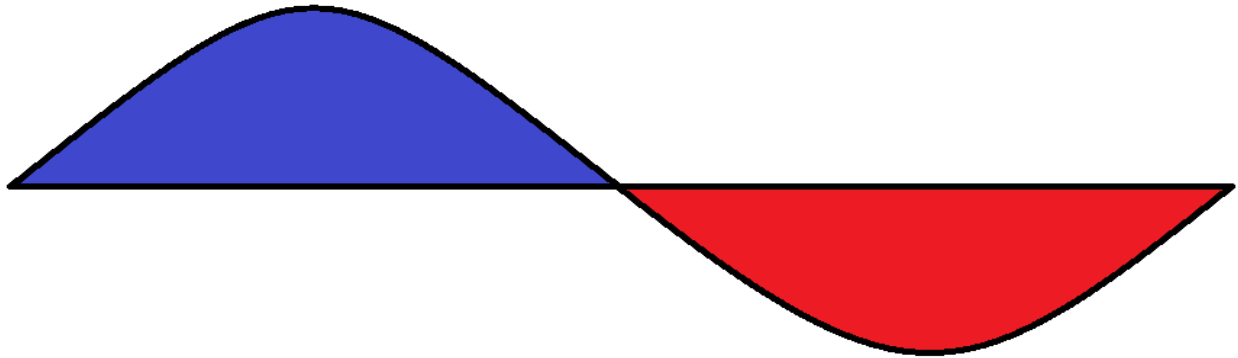
Figure 9: Stress distribution in reinforcement when the bearing is under bending

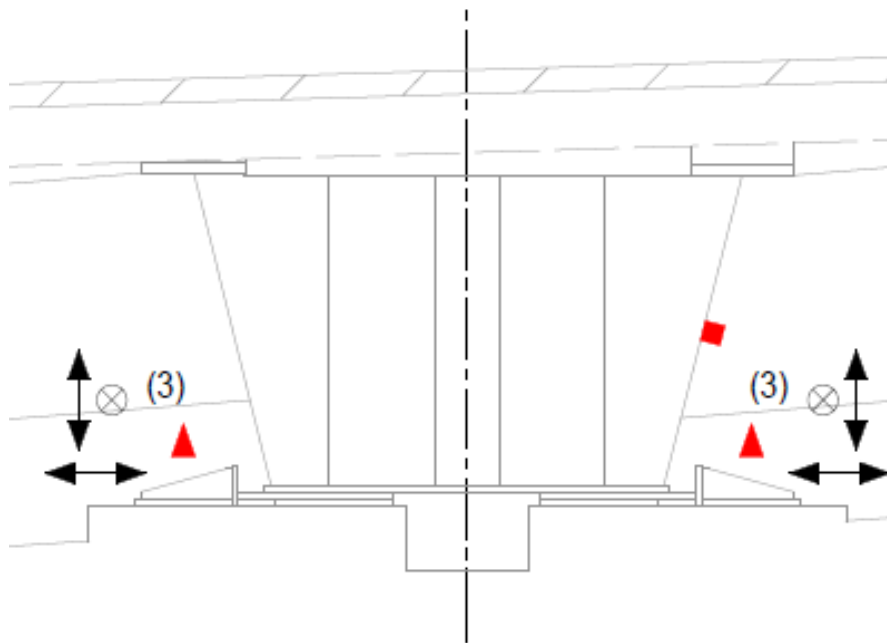
The second site at which FREI bearings were installed was the bridge along the ramp from the 407 Westbound lanes to the 427 Southbound lanes which crosses over Steeles Avenue in Etobicoke, Ontario, as seen in Figure 11 below (Google, n.d.). This bridge was originally constructed in 1990 and consists of a single span supported by 3 steel tub girders. A cross-section of one such girder is shown in Figure 12 below (“407W-to-427S Bridge”, 2020a).

Figure 12: Cross-sectional view of Steeles Avenue bridge girder, including bearing positions

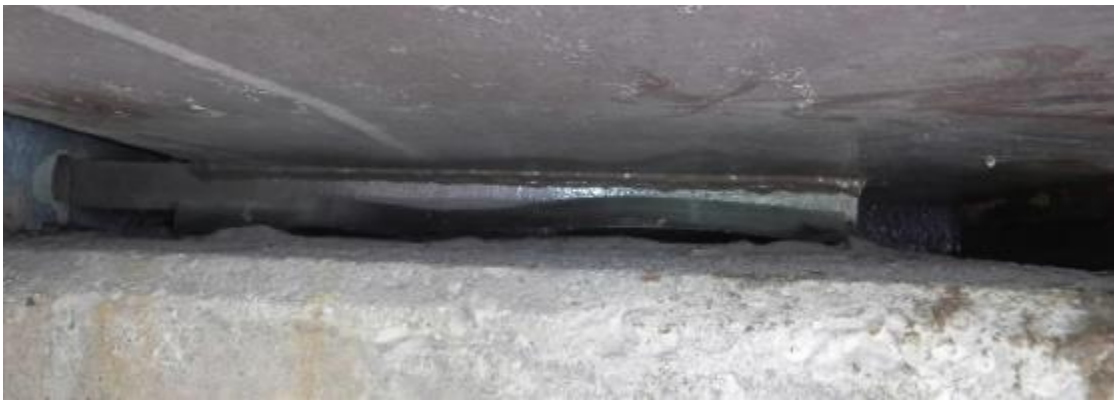
Originally, each girder was resting on a pair of unreinforced elastomeric bearings on the southern abutment – one on the eastern side of each girder, and one on the west. Of the total 6 bearings, all were in poor condition and 4 were recorded as having failed, with large-scale deformations including rubber flowing out from under the shoe plates and a characteristic undulating shape. The condition of the eastern bearing of the western girder is shown in Figure 13 (“407W-to-427S Bridge”, 2020a). It was therefore decided that all 6 of these bearings would be replaced with FREI.

Figure 13: Unreinforced, failed Steeles Avenue bridge bearing

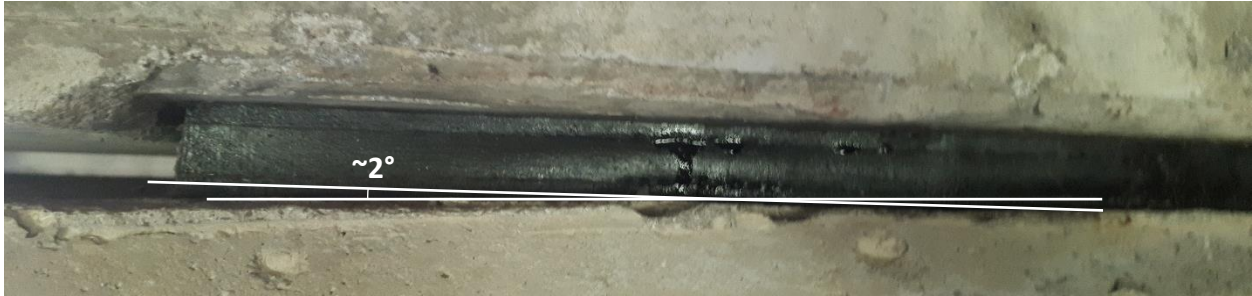
The exception to this was the southernmost FREI bearing on the eastbound bridge, as highlighted in Figure 15 (Google, n.d.). This bearing will be referred to as Bearing #1, in accordance with the numbering in Figure 15. As previously noted, this bearing had produced a loud and unexpected noise during installation, due to an irregularity in the support. While this bearing displayed minimal bulging along most edges, one specific area showed noticeable bulging. At this location, a slick, black, glossy substance was adhering to the surface of the bearing, as shown in Figure 14. It was distributed in a way that appeared that it had, at some point in the past, escaped from the fiber layers and seeped down the surface of the bearing. However, if this was continuing to occur, it was so slow as to make progress unnoticeable to the naked eye. It was also noted that a deformity existed in the lower support at this location, as shown in Figure 14.

Figure 14: Damaged bearing at German Mills. Intersection point of white lines illustrates a change in inclination of the bearing of approximately two degrees, forming a 'bump' directly under the damaged region of the bearing.

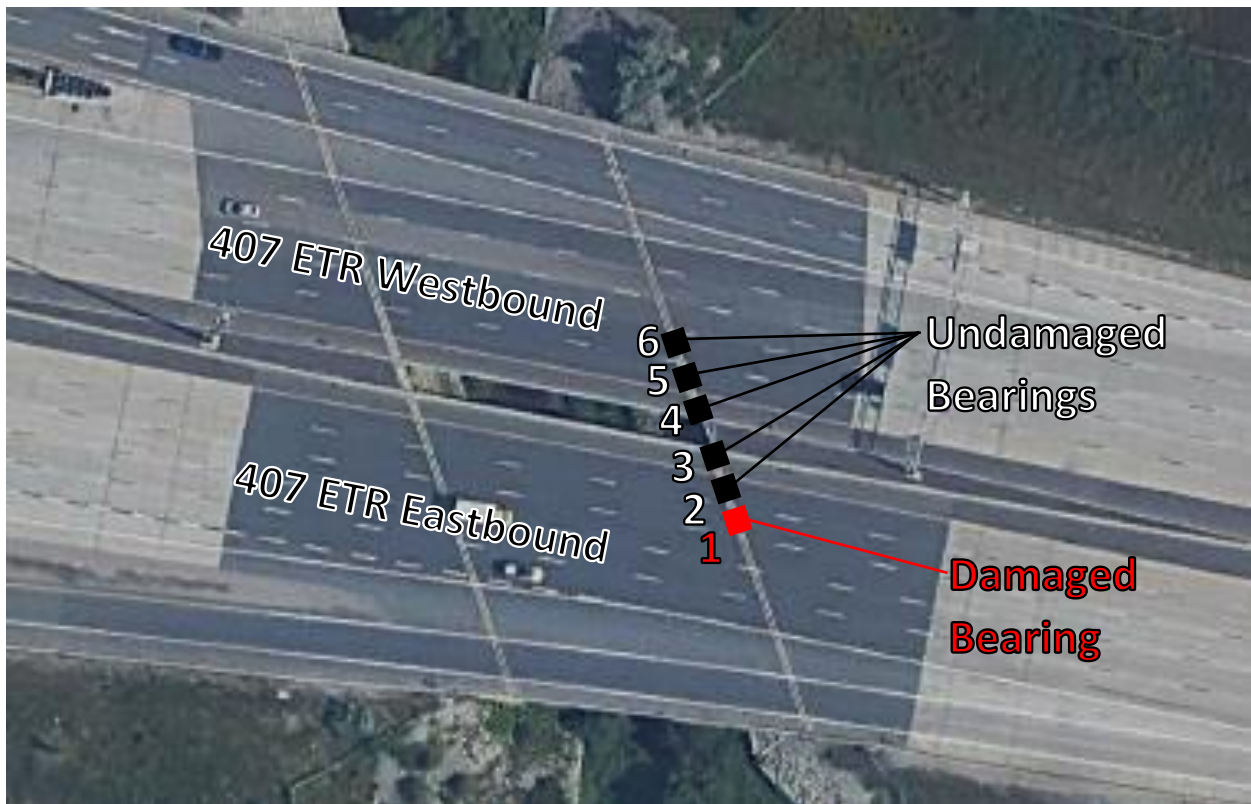
Figure 15: Location of bearings at German Mills Creek site; maps data: Google, Image Landsat/Copernicus

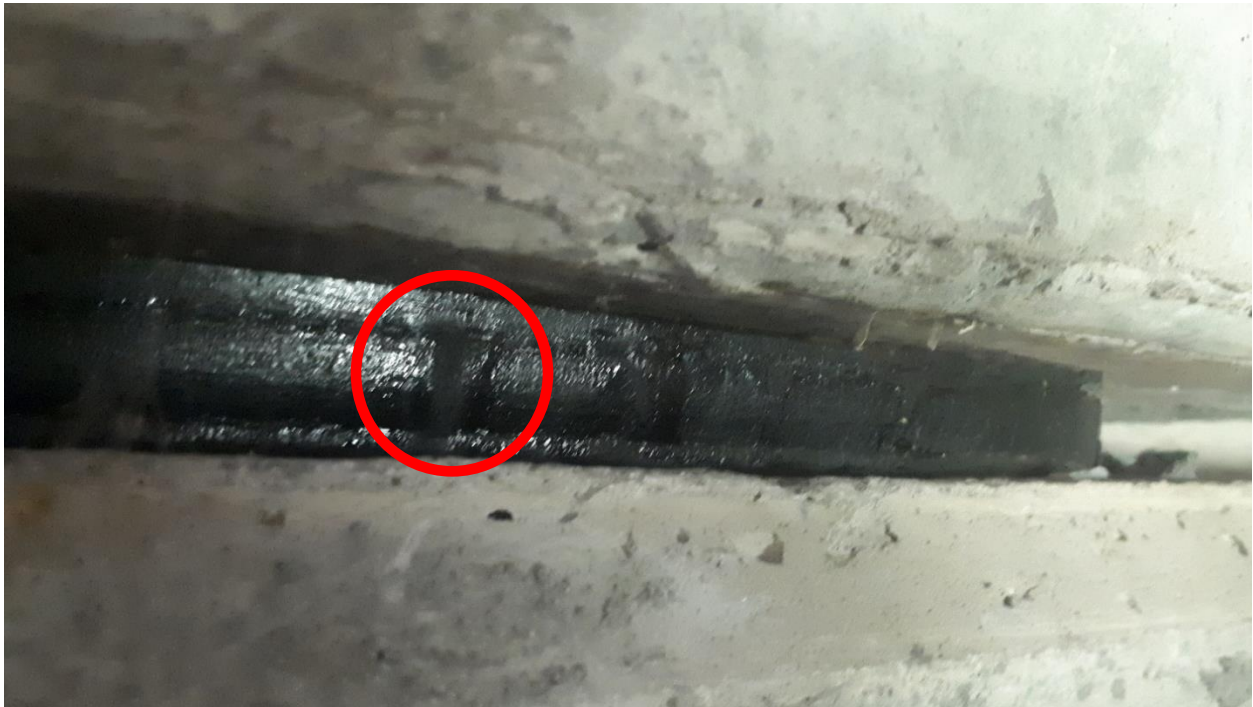
It was found that the previously noted liquid had largely solidified, the material now solid and slightly springy to the touch. However, still-fluid liquid was observed at a second location along the same side of the bearing. A small amount was scraped off onto the tip of a wooden ruler, as shown in Figure 16 and Figure 17. It was observed that the liquid was black in colour, had a low viscosity, and was shiny, with very little odor. Over the next few hours it was absorbed into the tip of the ruler, staining it black.

Figure 16: Bearing 1 at German Mills Creek site with location of liquid recovery marked

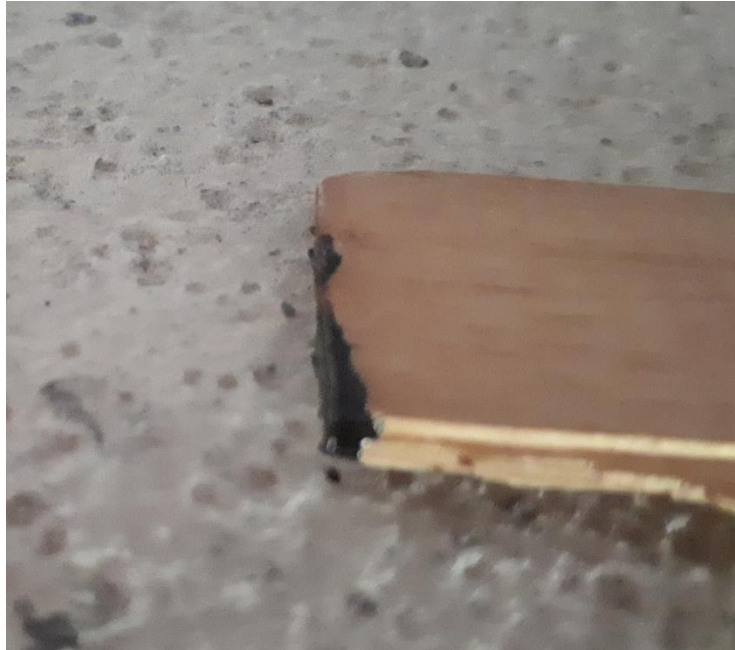
Figure 17: Unidentified black liquid staining tip of ruler

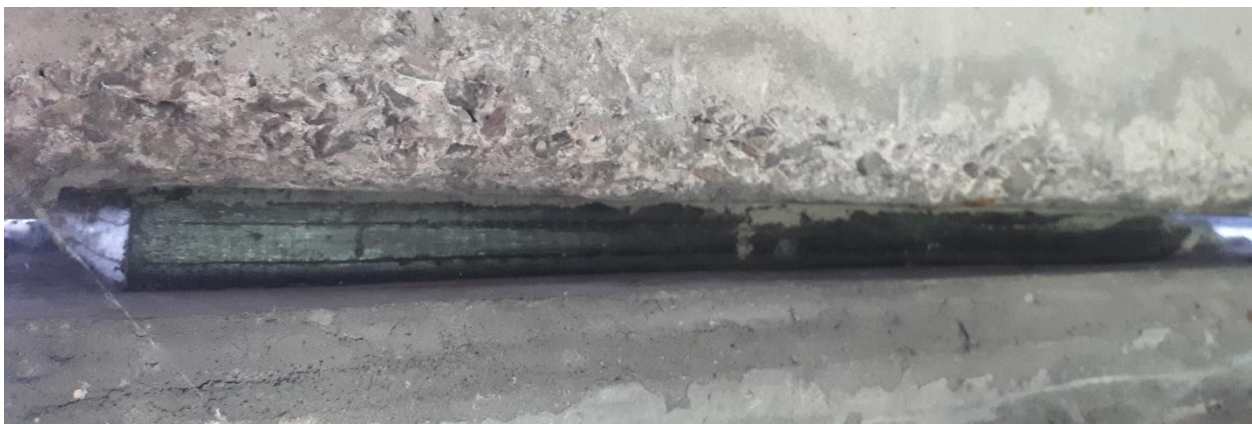
Aside from this single bearing, all other bearings showed no signs of damage or deterioration. An example of such an undamaged bearing, the northernmost bearing on the eastbound bridge is displayed in Figure 18 and Figure 19. As can be seen, the bearing does not have any visible liquid on it. While there is some minor bulging around the sides, it is noticeably less pronounced than that in the damaged bearing.

Figure 18: Undamaged bearing at German Mills Creek; no liquid visible

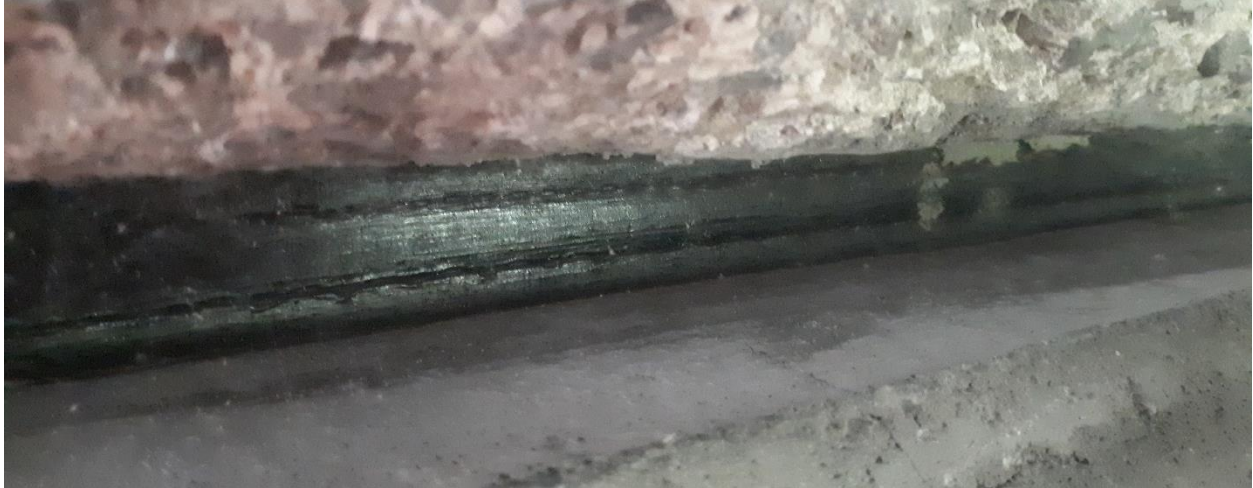
Figure 19: Undamaged bearing at German Mills Creek; slight bulging which is not indicative of damage

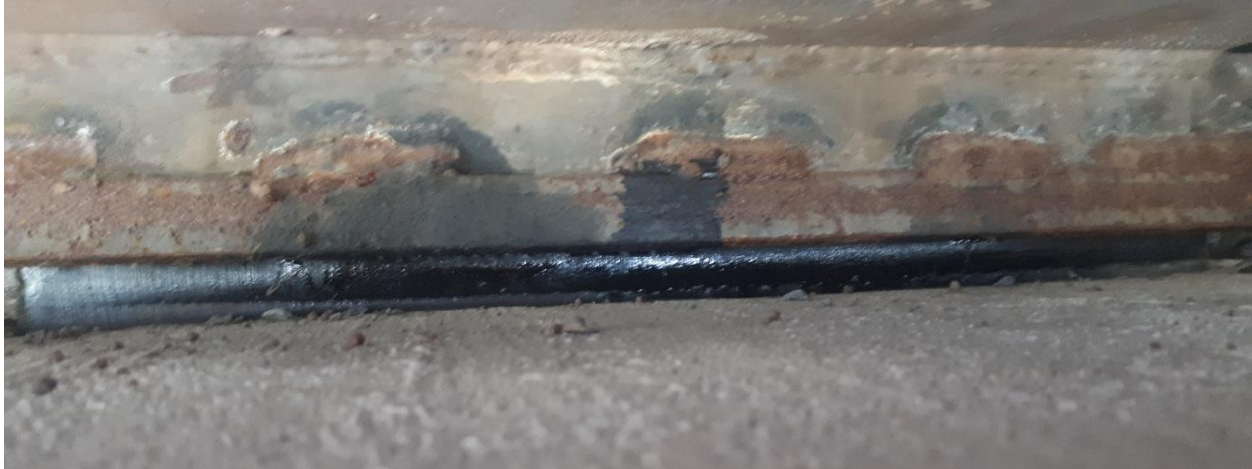
Based on the discrepancy between site visit observations and those recorded in the previous inspection report, a careful review was made of the photos taken during previous rounds of inspection, and inquiries made. It was found that the photos taken during the third and fourth previous inspections showed evidence of the liquid on bearings J1-E, J2-W, and J3-W – all the bearings currently exhibiting leakage. It is postulated that this leakage had been overlooked because it was quite extensive, covering almost the entire face of the bearings to the point where it was difficult to discern the original texture of the material. An example of this, as seen on bearing J2-W, is shown in Figure 21. Notably, while the stain on the left is partially faded, the one on the right is more sharply defined and was not visible in photos taken during previous inspection reports. This indicates that the liquid has appeared at different times on this bearing.

Figure 21: Bearing J2-W with unidentified liquid over the majority of bearing face

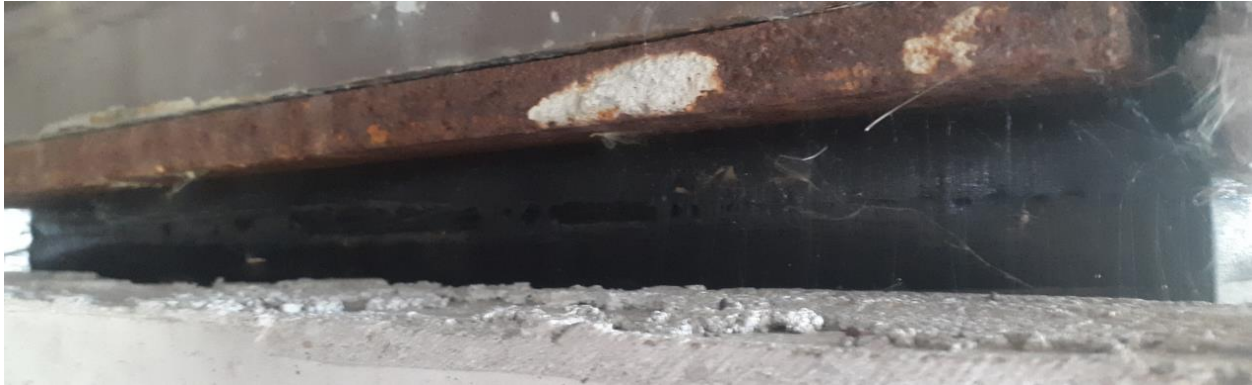
Aside from the leaking, the bearings generally conformed to previous observations – however, additional details were noted during the site visit which were not reflected in the inspection reports. The first of these was the manner in which splitting of bearing J3-W had occurred. The ‘splitting’ of the rubber elastomer mentioned in the inspection reports was observed to be occurring at the locations where the reinforcement had previously been bonded, prior to delamination. This is shown in Figure 22. It appears that where delamination had occurred, a grid of holes had been left in the elastomer where the fibre had torn out of the bulging area, perforating it along that horizontal plane. This defined the line along which splitting which would later occur, as further bulging pulled the elastomer apart and stressed the perforated area beyond its’ capacity in tension.

Figure 22: Bearing J3-W splitting behavior occurring along line of previous delamination

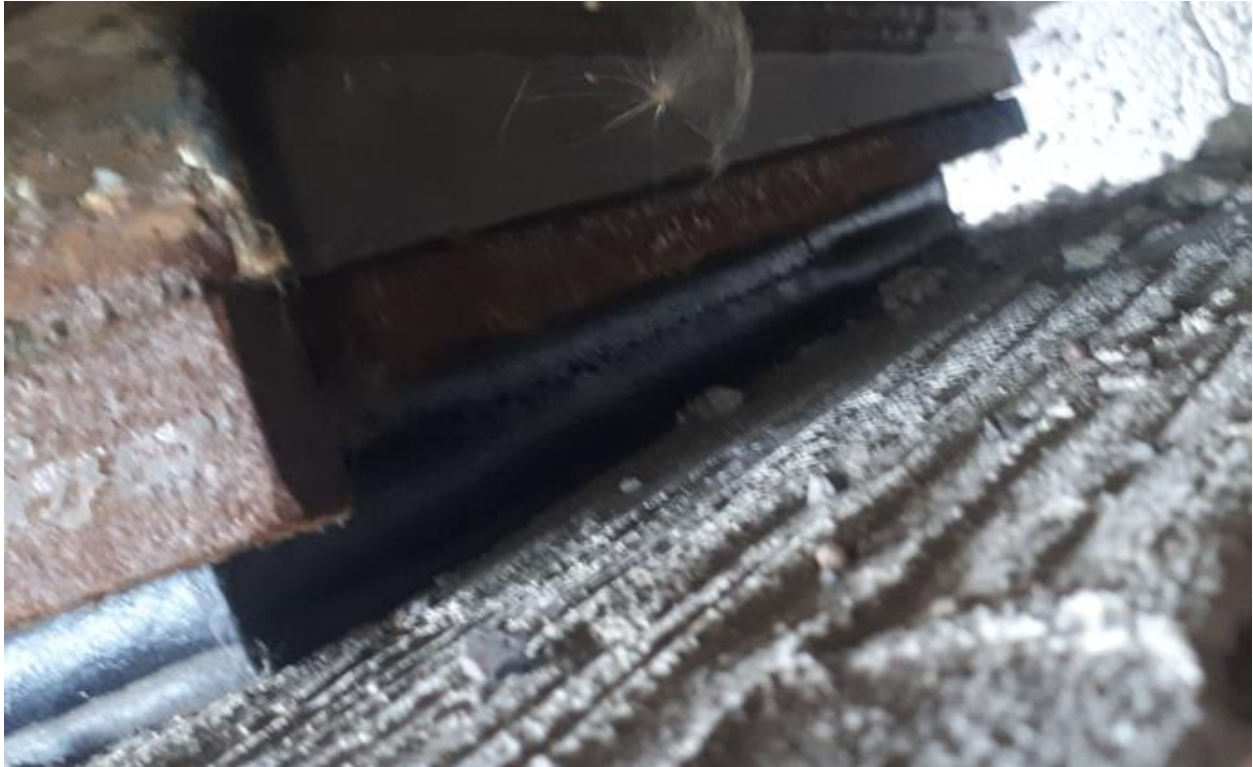
Additionally, bearing J1-W, previously undamaged, was noted to have initial signs of delamination along the western face as shown in Figure 23. This was noteworthy, as it is the first instance of both bearings on a given girder displaying signs of deterioration. It is postulated that as bearing J1-E deteriorated, it became more compressible, causing a majority of the vertical load to be transferred to bearing J1-W and leading to delamination. This would be a reversal of the initial conditions, where bearing J1-E appeared to be under greater vertical load – however, if the compressibility of bearing J1-E was sufficiently impacted by the deterioration it had undergone, it is a plausible outcome.

Figure 23: Limited delamination observed at bearing J1-W

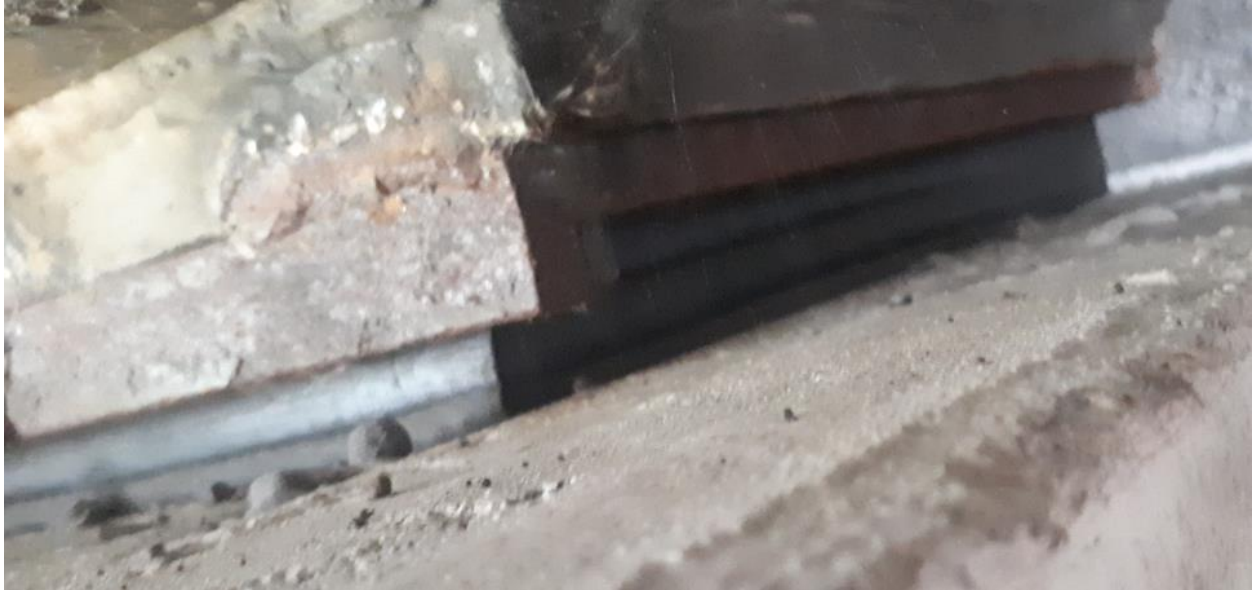
Although four of the bearings exhibited damage at the time of the site visit, two of the bearings remained in good condition. Bearing J3-E, which experienced no deterioration, is displayed in Figure 24. As discussed, there is visible bulging due to compressive stress, but no delamination or other damage has taken place as a result of it. It displays none of the characteristic glistening typically associated with leakage, nor was any staining observed on the supports.

Figure 24: Bulging but undamaged bearing J3-E

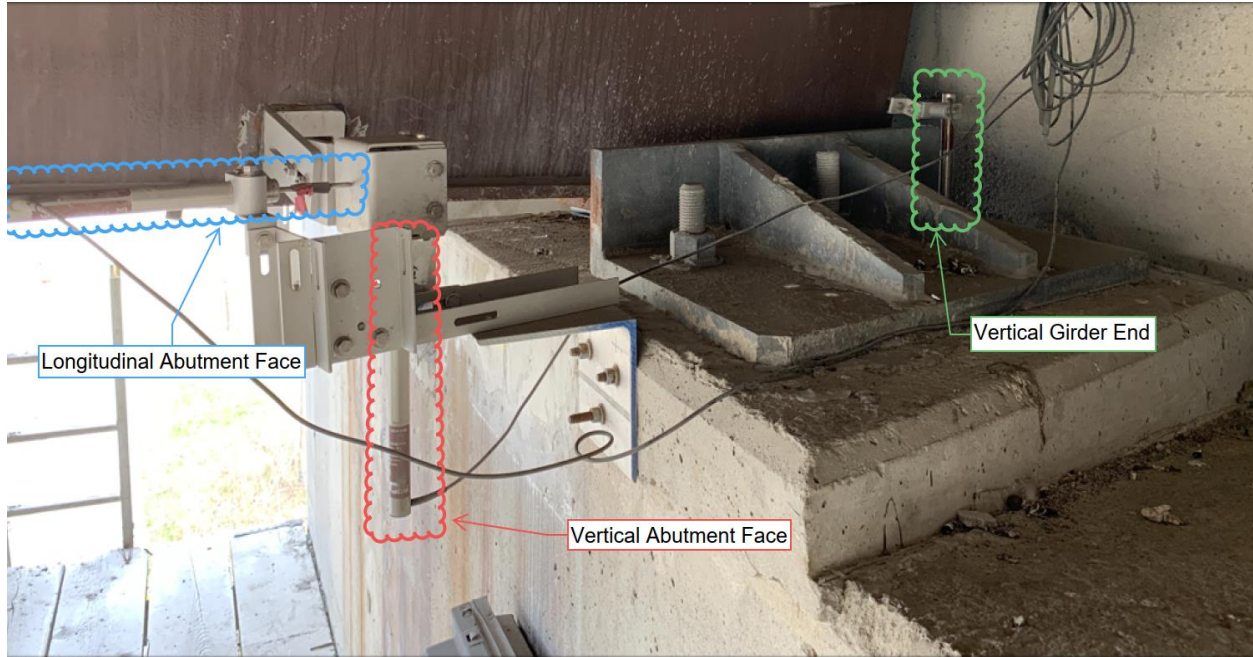
A number of sensors were installed at the Steeles Avenue site, including three Linear Variable Differential Transformer (LVDT) sensors at each of the six bearings, arranged as pictured in Figure 25 (D. MacDonald-Lockhart, Personal Communication, Sept. 15, 2021). The LVDT sensors measure displacement at a single point, in a single direction. Horizontal displacements could be read directly from the longitudinal sensor. Distances between the sensors and the edges of the girder shoe plate were measured and recorded for each sensor. Key measurements for these calculations are displayed in Table 13, where H indicates horizontal distance from the edge of the girder, and L indicates longitudinal distance to the face of the shoe plate, which itself has a length of 440 millimetres (D. MacDonald-Lockhart, Personal Communication, Sept. 15, 2021). For further information on bearing position and sensor layout, refer to Figure 20 in Section 3.2.1.

Figure 25: Sensor locations for Steeles Avenue site bearings (D. MacDonald-Lockhart, Personal Communication, Sept. 15, 2021)

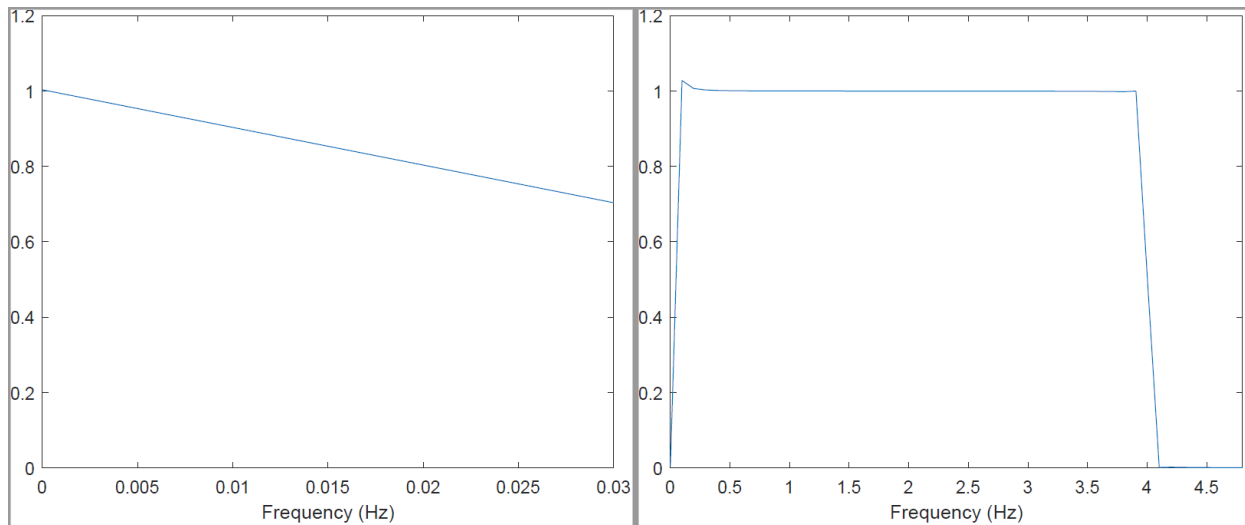
Based on this analysis, low pass and band pass filtering was conducted on the data. It was found that a low pass filter threshold of 0.03 Hz was most effective in capturing the temperature-related motions, while a band pass filter between 0.03 and 4 Hz was able to capture traffic-related induced motions. An examination of several data channels on various days found that more than 90% of all traffic-related motions, in terms of amplitude, are accounted for within that range. These filter functions are displayed in Figure 26. This is also visible on the FFT and PSD plots, where the peaks below 4 Hz rise in excess of a full order of magnitude beyond those which exist beyond 4 Hz, as can be seen in Figure 27 through 32.

Figure 26: Filter functions – low-pass to capture temperature motions (left) and band pass to capture traffic motions (right)

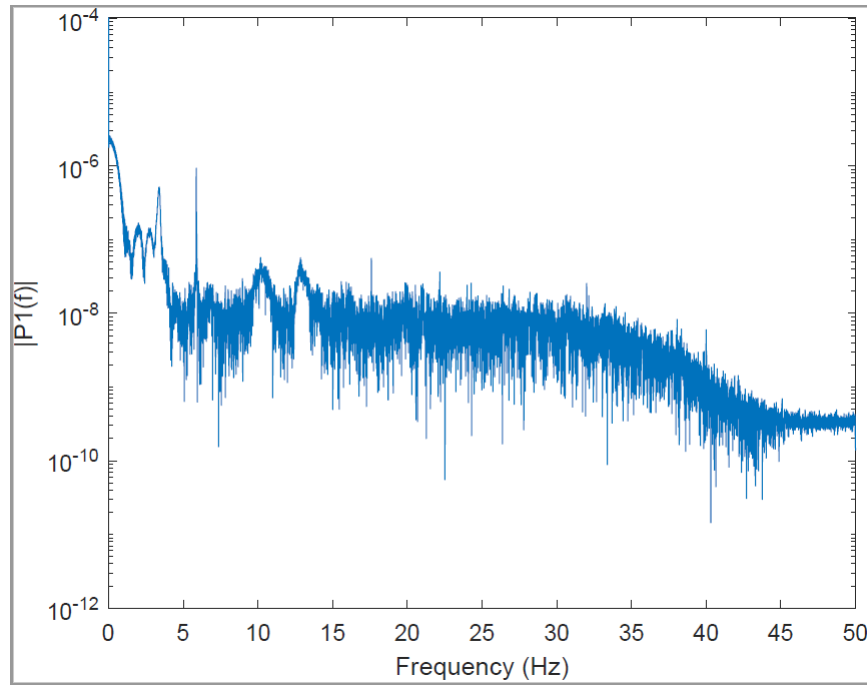
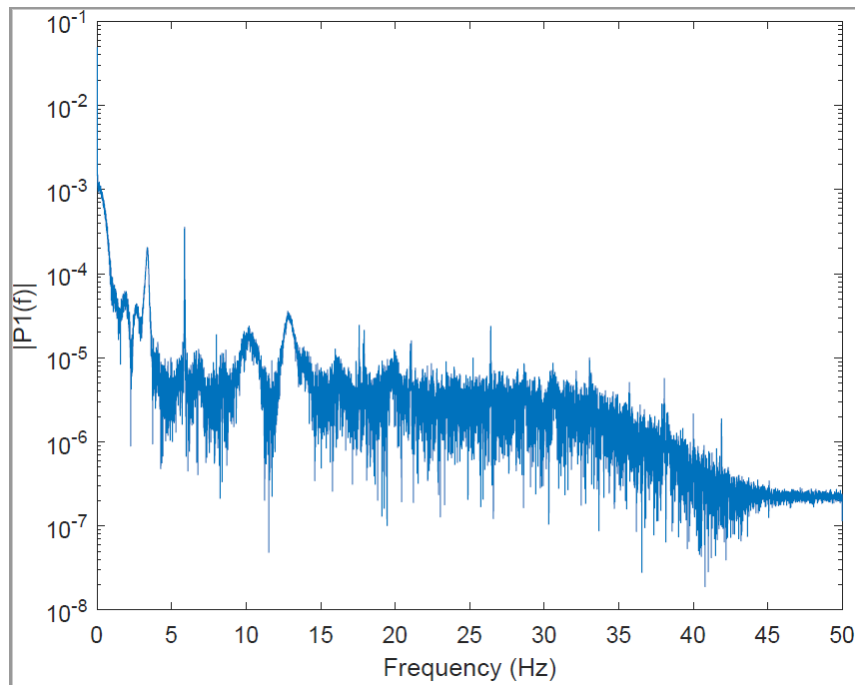
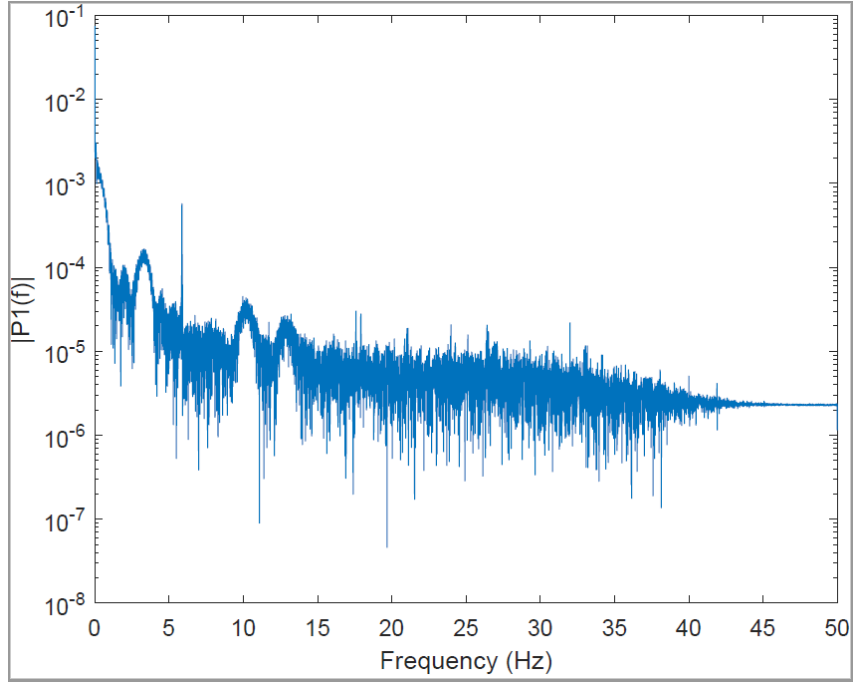
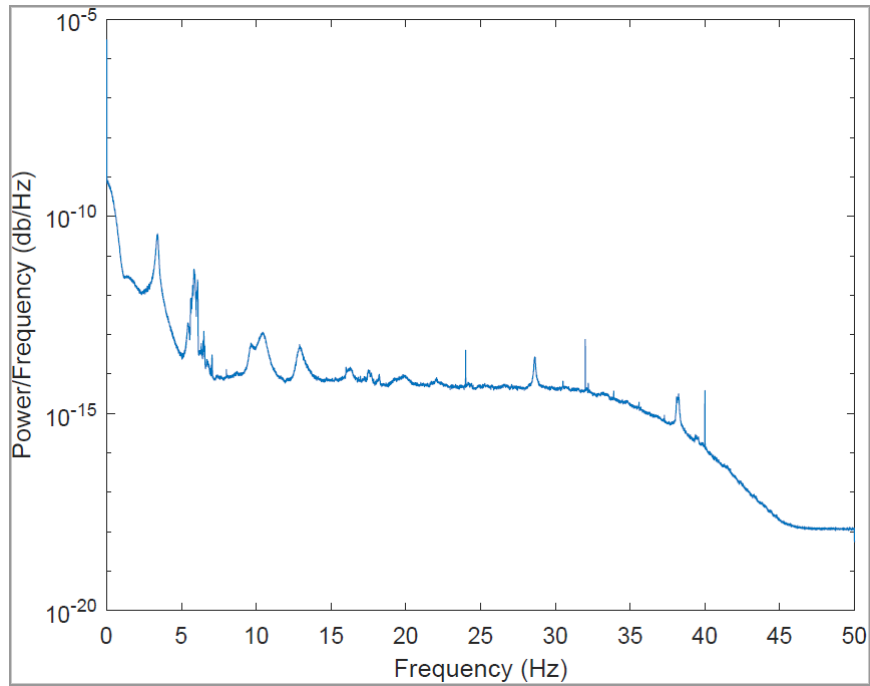
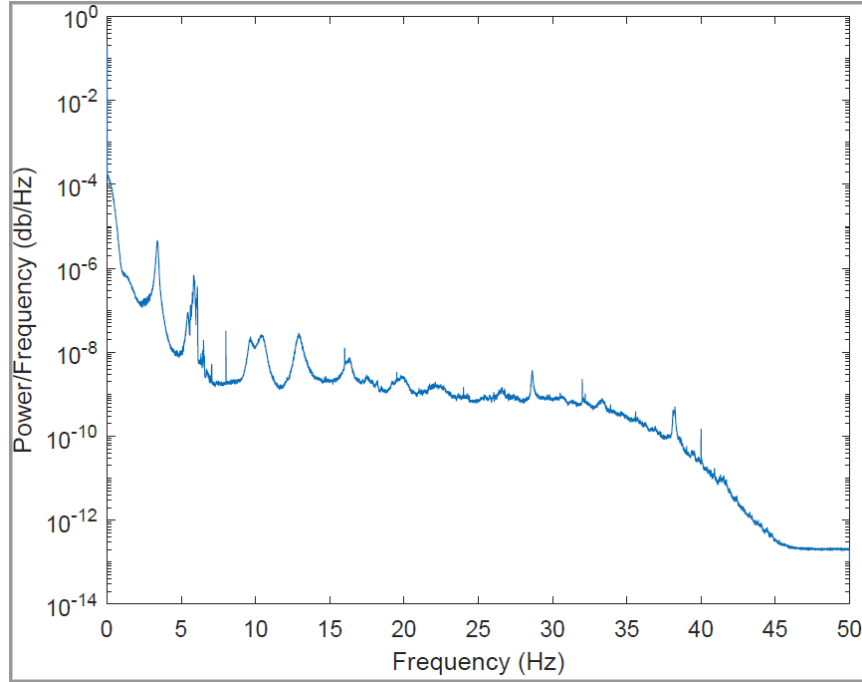
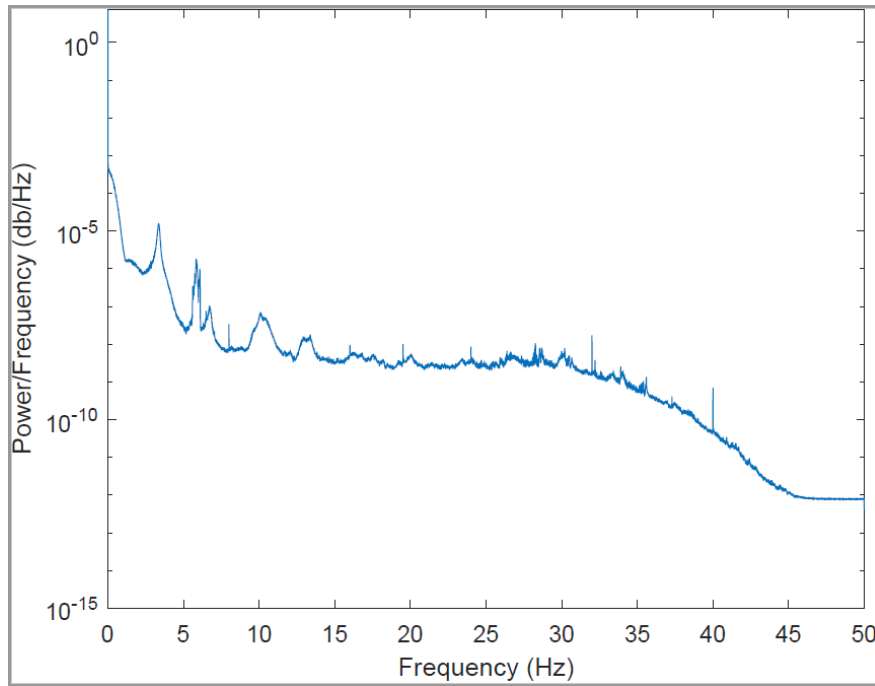
Figure 27: Fast Fourier Transform of rotations at bearing J2-E

Figure 28: Fast Fourier Transform of vertical displacements at bearing J2-E

Figure 29: Fast Fourier Transform of horizontal displacements at bearing J2-E

Figure 30: Power spectral density of rotations at bearing J2-E

Figure 31: Power spectral density of vertical displacements at bearing J2-E

Figure 32: Power spectral density of horizontal displacements at bearing J2-E
