IN-SITU PERFORMANCE OF SU-FREI BRIDGE BEARINGS

Masters of Applied Science Thesis
School of Graduate Studies
McMaster University

© Copyright by Zachary van Galen, April 5, 2023

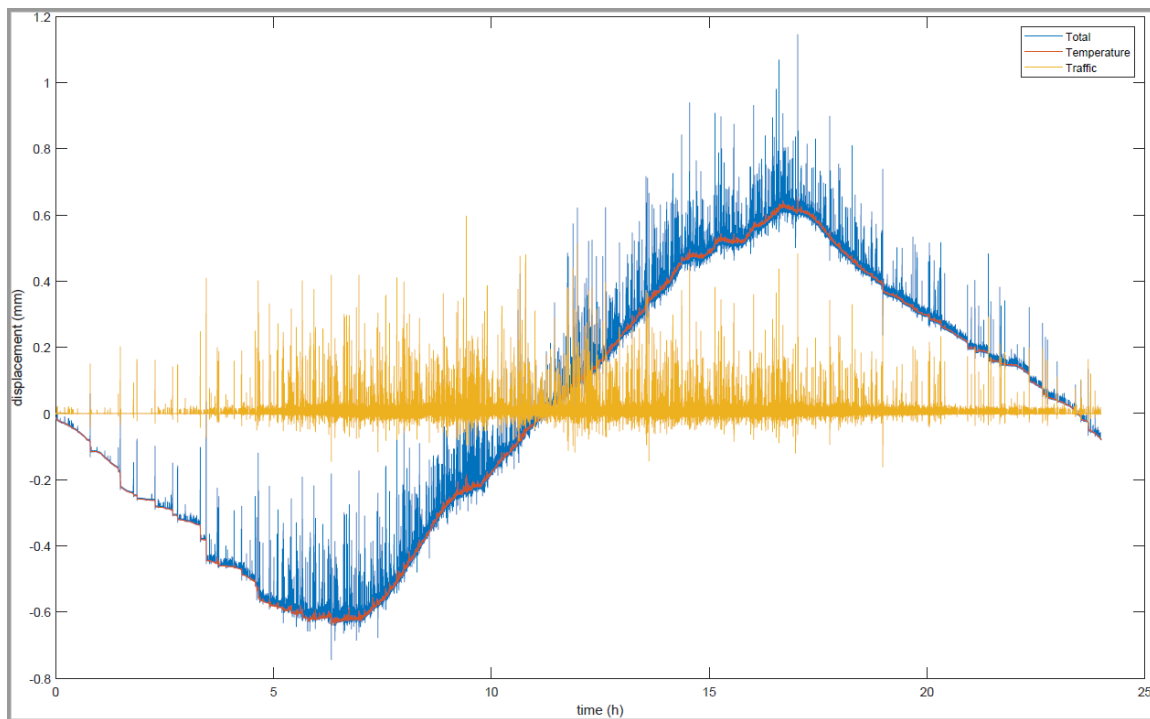
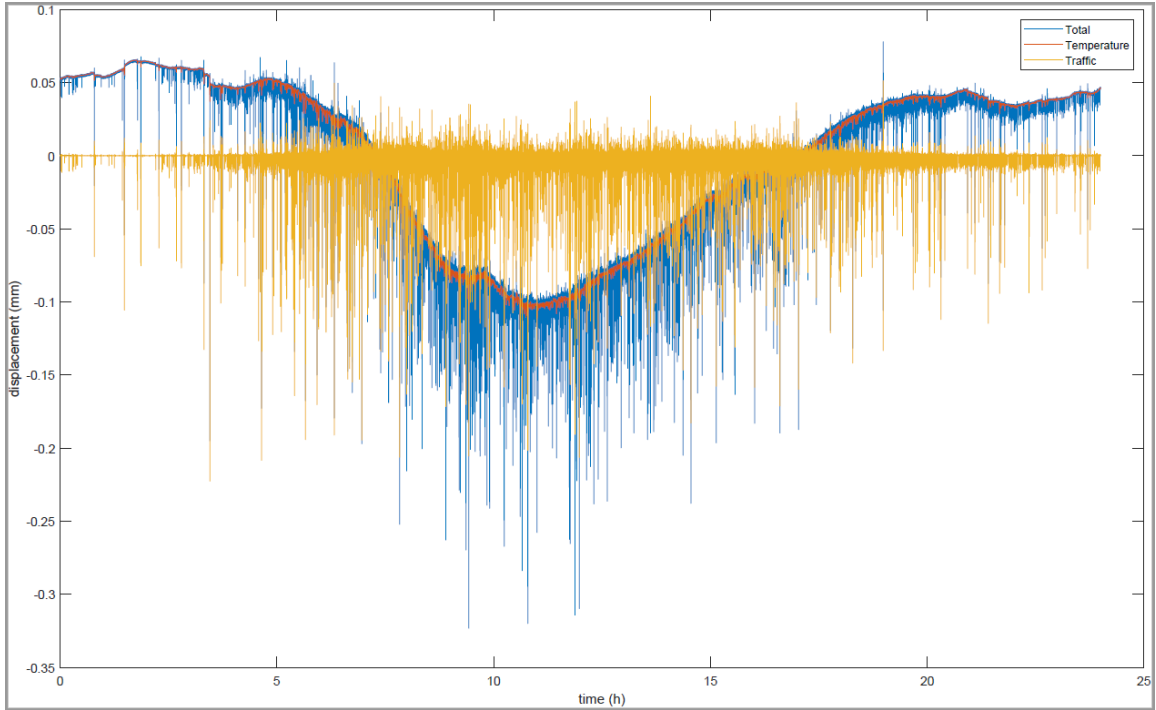
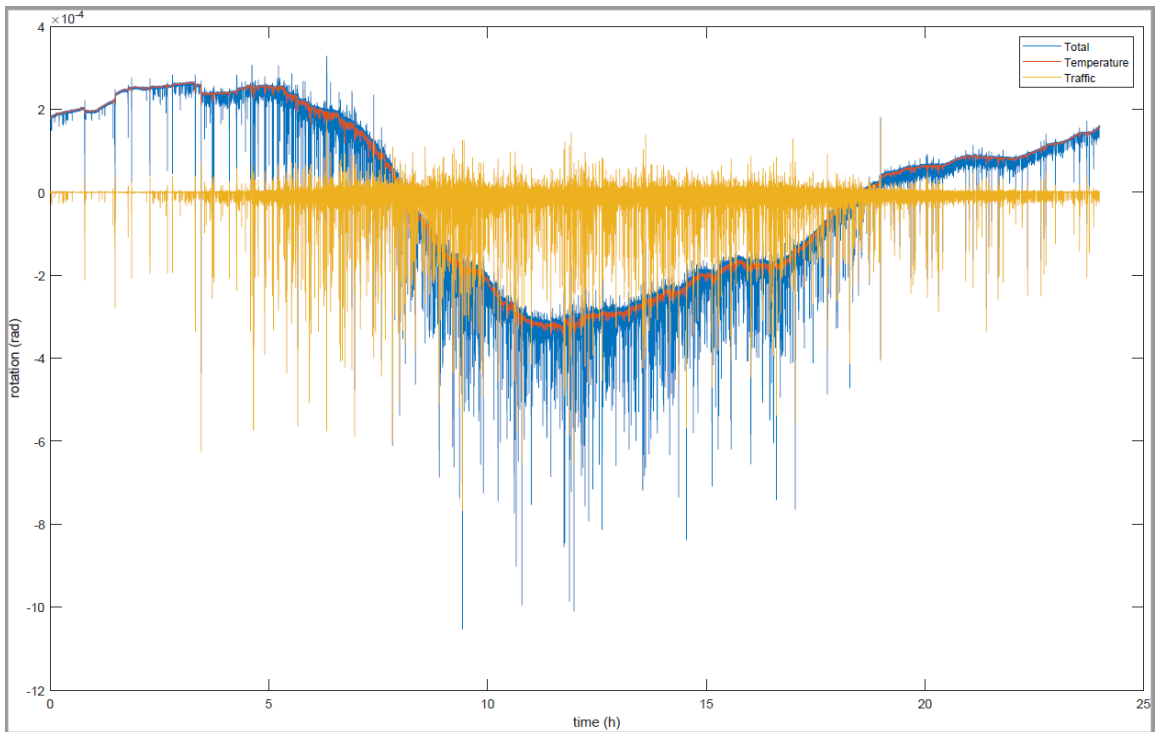
In order to gain insight into the temperature and traffic dependency of various data quantities, an in-depth analysis was run for the continuous data obtained from October 10, 2019. Figures 33 through 35 show the variation in horizontal displacement, vertical displacement, and rotation for bearing J2-E, divided into traffic-related and temperature-related motions using frequency analysis as previously described. As was the case in the trend data section, while the analysis will discuss what was found for bearing J2-E specifically, all graphs examined show similar results (unless otherwise noted).

Figure 33: Horizontal displacement at bearing J2-E on October 10, 2019 – total, temperature, and traffic related motions

Figure 34: Vertical displacement at bearing J2-E on October 10, 2019 – total, temperature, and traffic related motions

Figure 35: Rotation at bearing J2-E on October 10, 2019 – total, temperature, and traffic related motions

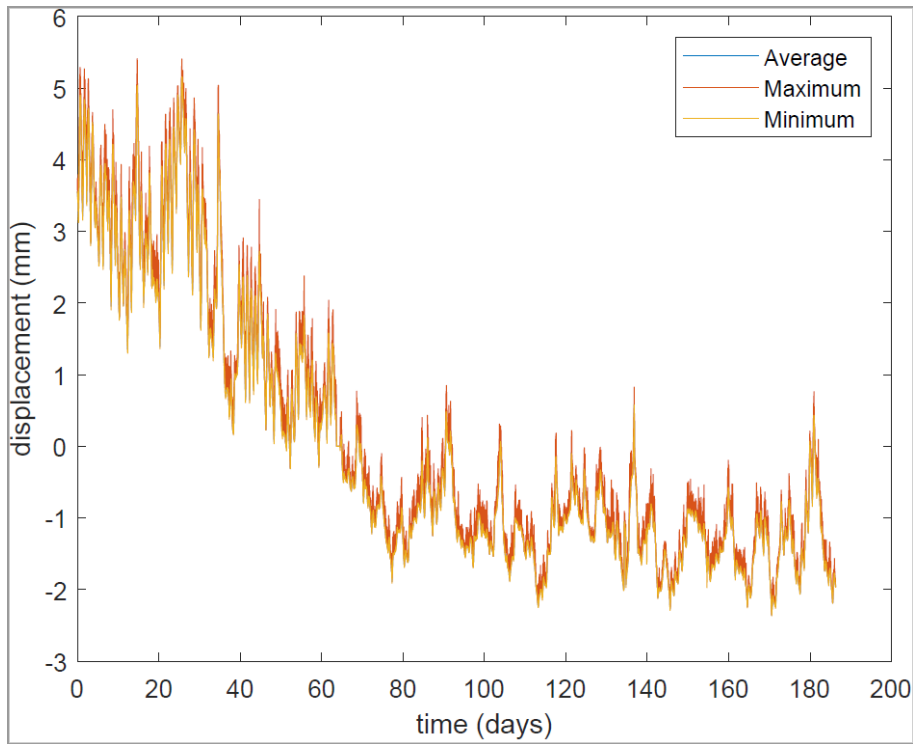
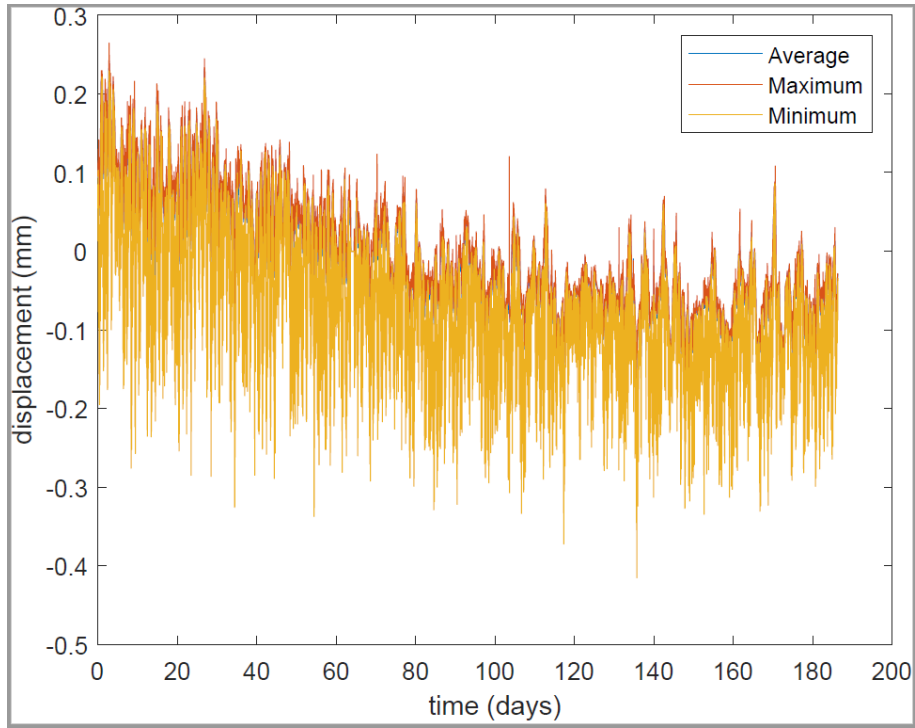
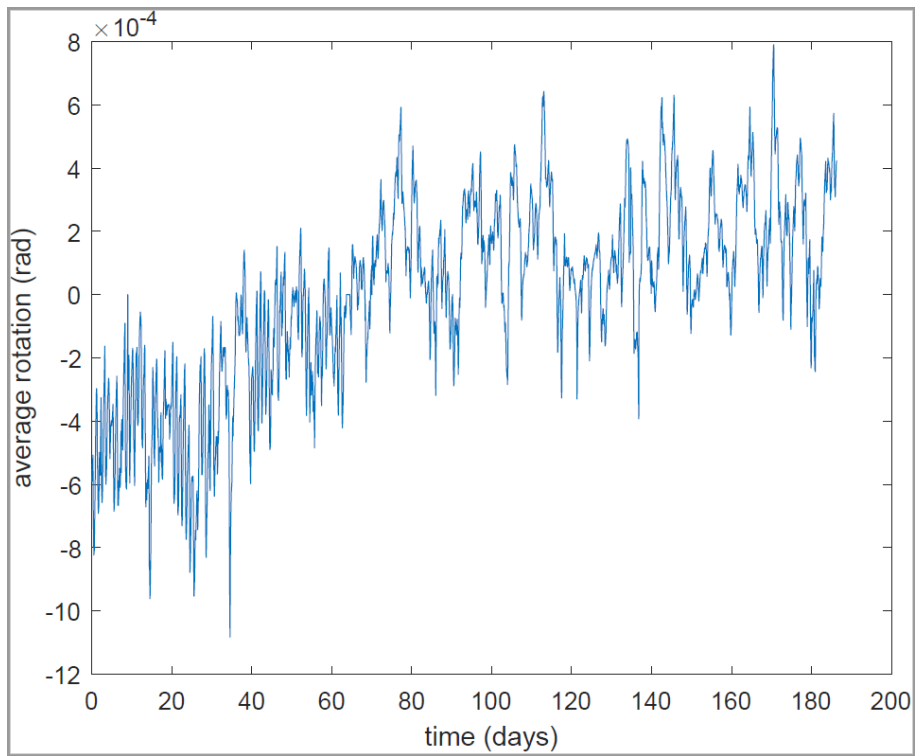
data for all sensors throughout the entire monitoring period, with some additional sensors functioning continuously for other bearings. The full graphs for bearing J1-W are shown in Figures 36 through 38. Graphs for bearing J2-E during this monitoring period are displayed in Appendix A. They are similar to those for bearing J1-W, and all observations made with respect to the bearing J1-W graphs also apply to those for bearing J2-E.

Figure 36: Horizontal displacement at bearing J1-W from August 29, 2019 to February 28, 2020

Figure 37: Vertical displacement at bearing J1-W from August 29, 2019 to February 28, 2020

Figure 38: Average rotation at bearing J1-W from August 29, 2019 to February 28, 2020

It was observed that over the period in question, the two bearings for which full data was available experienced a horizontal displacement range of approximately 7.5 mm, a rotational range of approximately 0.002 radians (with slightly more variance between the bearings than the other quantities), and a vertical displacement range of approximately 0.68 mm. However, it is noted that bearings J1-W and J2-E exhibited no damage as of the final inspection report, while their ‘partner bearings’ were damaged – as such, these readings may be reflective of a relatively under-loaded bearing. For comparison, a set of graphs were selected from among the functioning sensors on visibly overloaded bearings: horizontal displacement from bearing J2-W, and vertical displacement and rotation from bearing J3-W. These are displayed in Figures 39 through 41. As these graphs show, the recorded displacements and rotations of visibly overloaded bearings do not substantially differ from those which are under reduced loading.

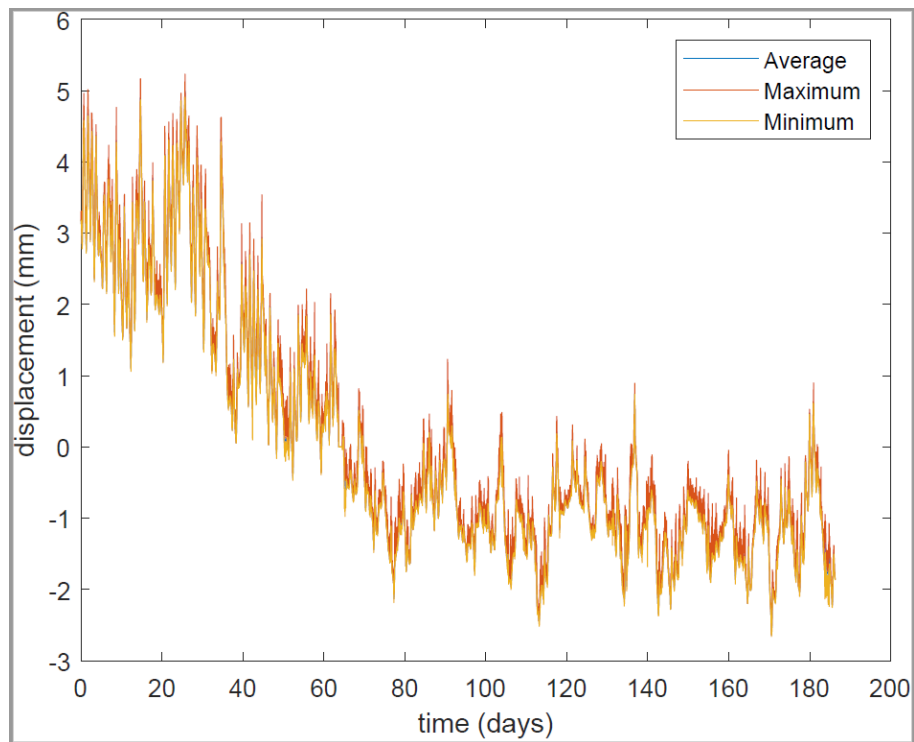
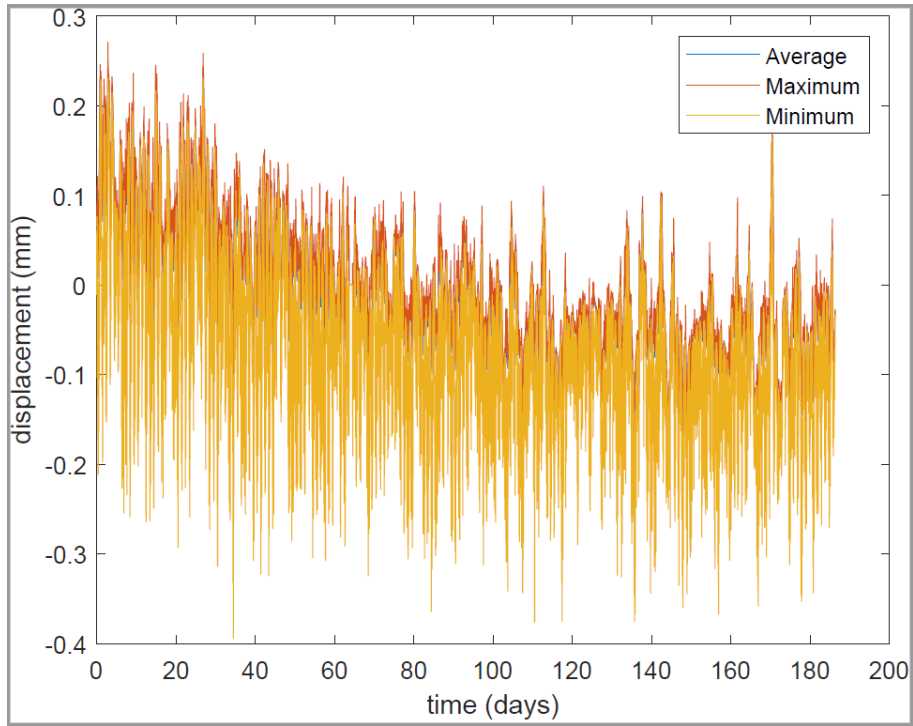
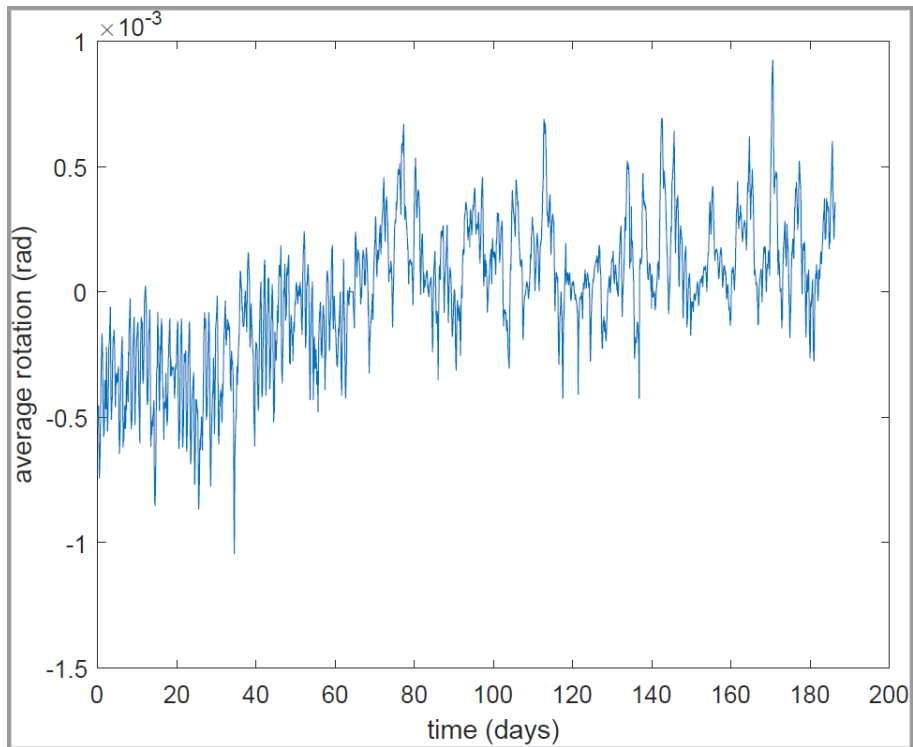
Figure 39: Horizontal displacement at bearing J2-W from August 29, 2019 to February 28, 2020

Figure 40: Vertical displacement at bearing J3-W from August 29, 2019 to February 28, 2020

Figure 41: Average Rotation at bearing J3-W from August 29, 2019 to February 28, 2020

It is noted that all graphs show a gradual trend over the course of the monitoring period: in the positive direction for rotation, and in the negative direction for horizontal and vertical displacement. The time period under consideration shows the transition from summer to winter temperatures, which was postulated to be responsible for the trends observed. A second, longer time period was examined to confirm this, extending from August 28, 2019 to August 28, 2020. Full graphs for bearing J2-E during this monitoring period are displayed in Appendix B - it is noted that fewer sensors were functional over this longer time period, such that only the sensors at bearing J2-E produced usable data throughout the monitoring period. This is the reason it was not used for the prior analysis. It is also noted that all sensors went offline for a short time in June, around day 295. These graphs confirm that the observed trends are seasonal, as a time period covering the transition from winter to summer temperatures shows the opposite trends. An example of this is shown in Figure 42, which displays horizontal displacement at bearing J2-E.

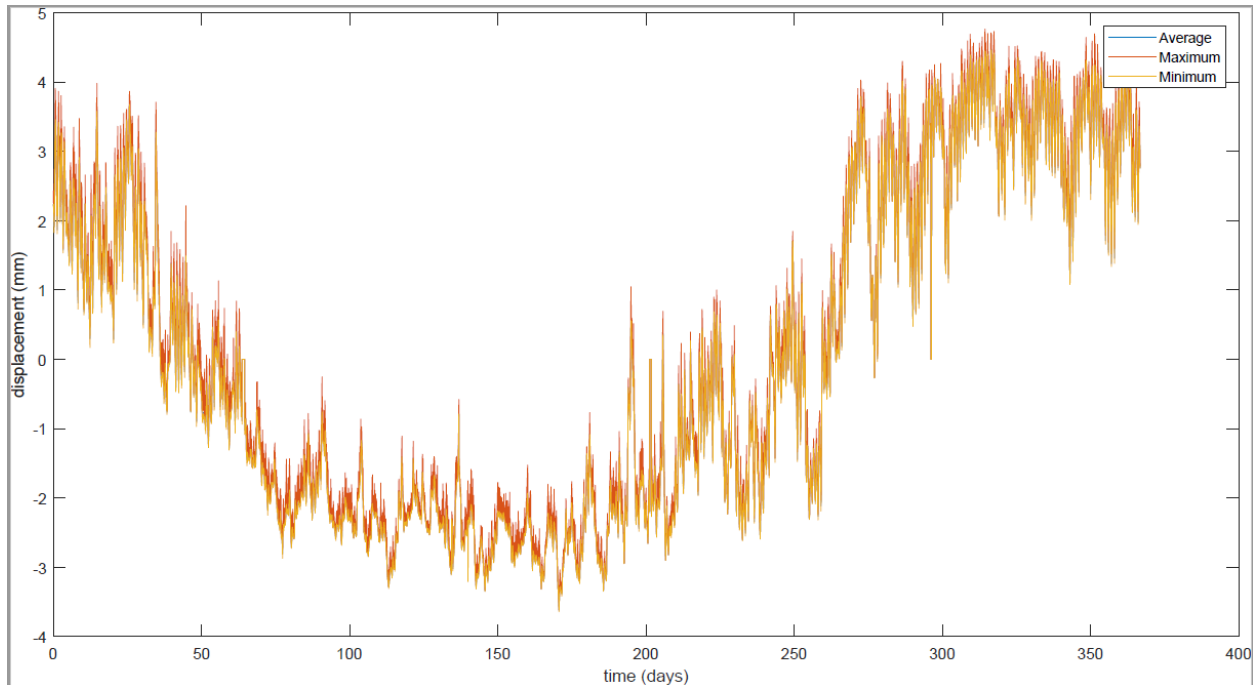
Figure 42: Horizontal displacement at bearing J2-E from August 28, 2019 to August 28, 2020

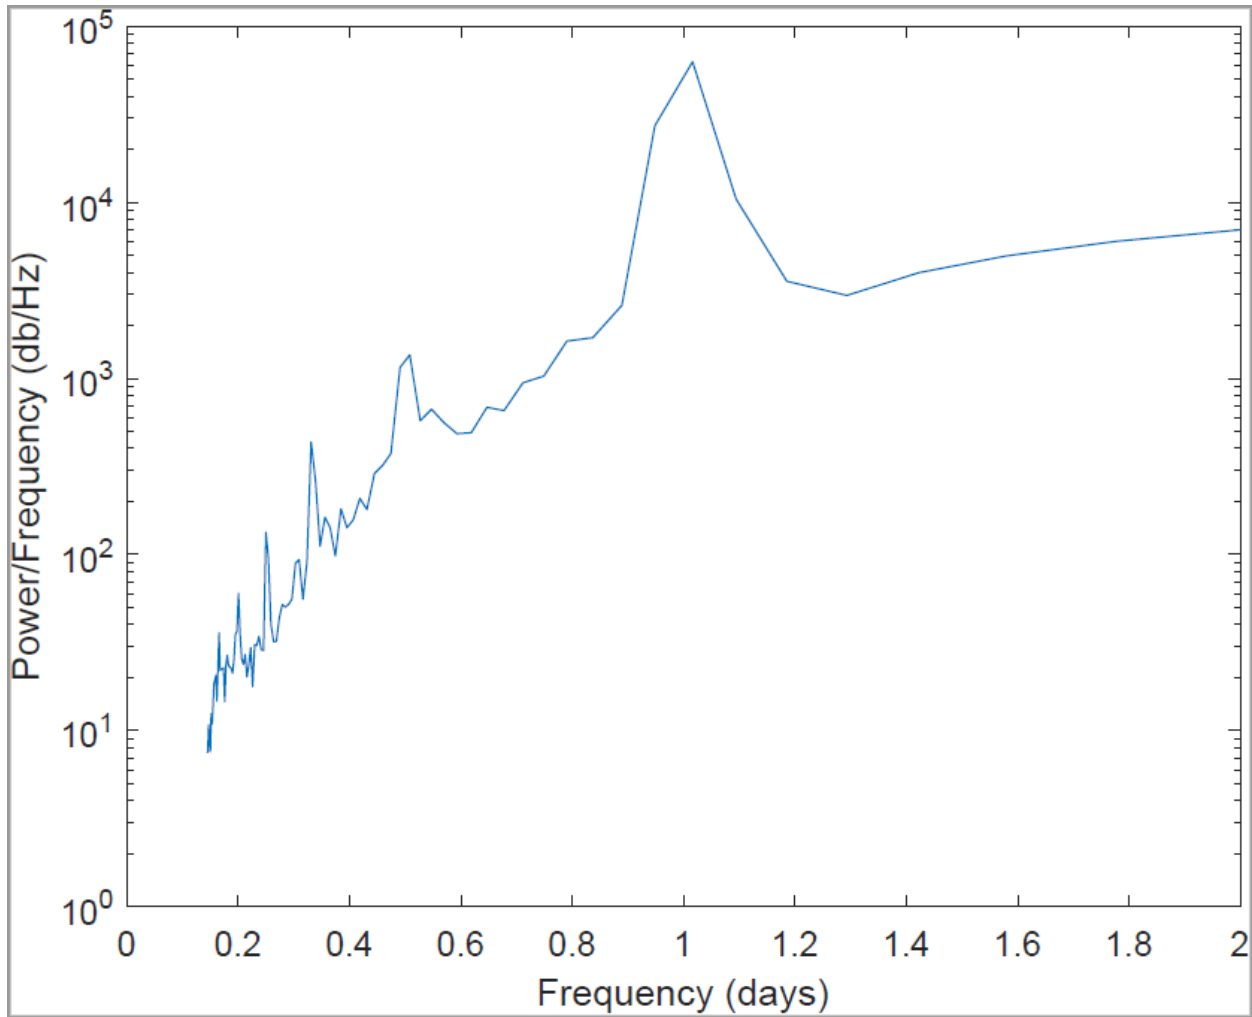
Figure 43: PSD analysis of horizontal displacement at bearing J2-E from August 28, 2019 to August 28, 2020
