A Framework for Accessible Heritage Buildings & Structures Retrofits

Grants and Contributions, Project Number ASC-21/22-010-01-C
Advancing Accessibility Standards Research

By: Professor Samir E Chidiac, PhD PEng FCSCE
Department of Civil Engineering
McMaster University
Hamilton, ON
chidiac@mcmaster.ca

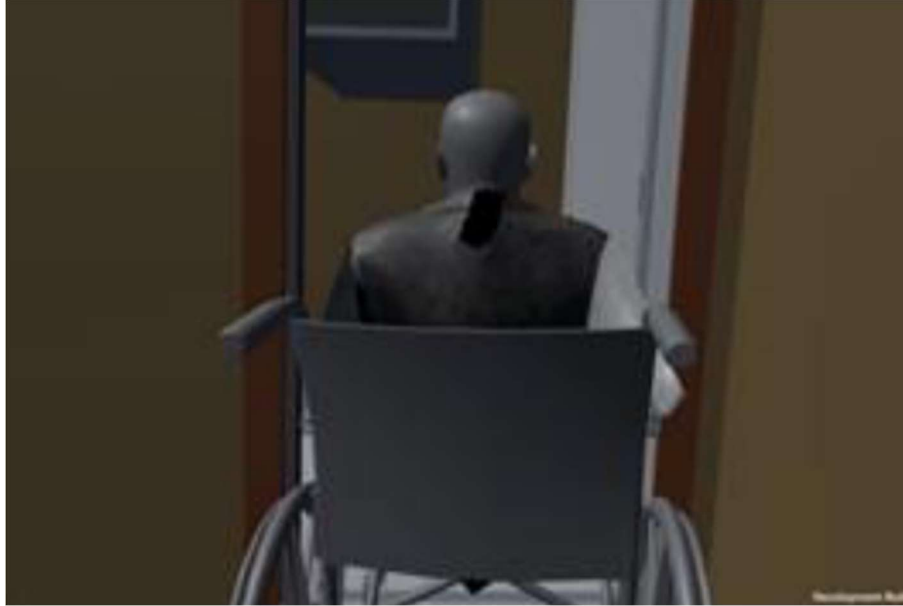
Figure 2.16. The noncompliance bathroom [39].

with limited mobility and wheelchair users based on the requirements of the Americans with Disabilities Act (ADA). The implementation involved several steps, starting with the development of 2D plans using AutoCAD, followed by the creation of a 3D model with tools like Revit, 3Ds MAX, or SketchUp, as seen in Figure 2.13. This model was then enriched with realistic features, e.g., furniture, and imported into the Unity 3D virtual environment for simulation in VR. The testing involved 10 participants using VR headsets and computer screens to navigate through the virtual building, identifying accessibility features and barriers, as shown in an example in Figure 2.14. Test results showed that users preferred the VR environment over traditional computer simulations for identifying accessible (Figure 2.15) and inaccessible spaces (Figure 2.16).

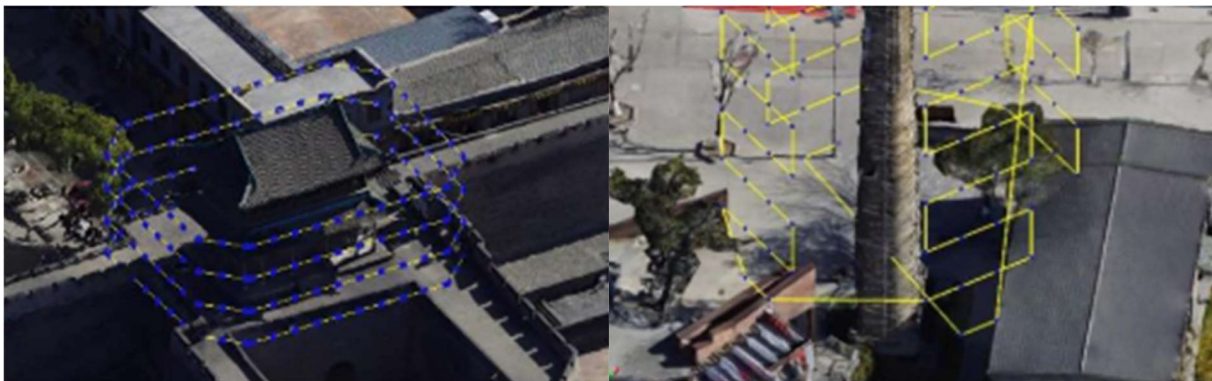
Figure 2.20 UAV path planning to survey the Ancient City of Ping Yao [46]

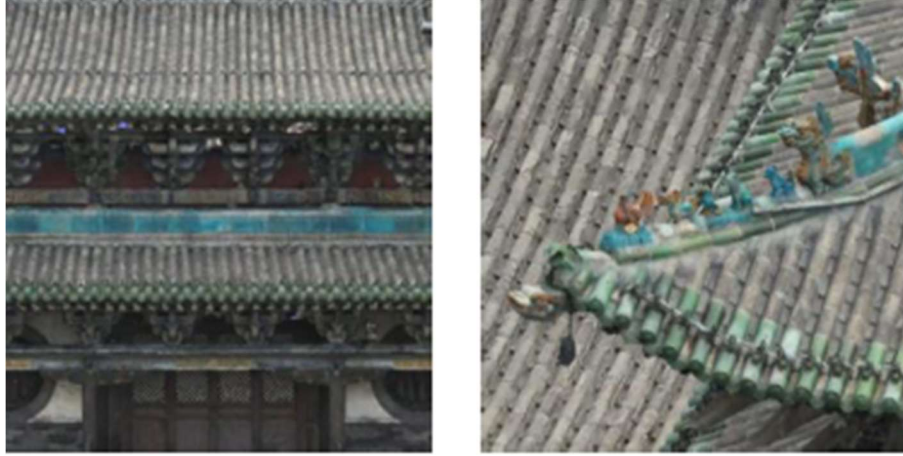
Figure 2.21 (a) 3D baseline reconstruction of the Eaves in the Ancient City of Ping Yao (b) 3D reconstruction of the Eaves in the Ancient City of Ping Yao using UAV [46]

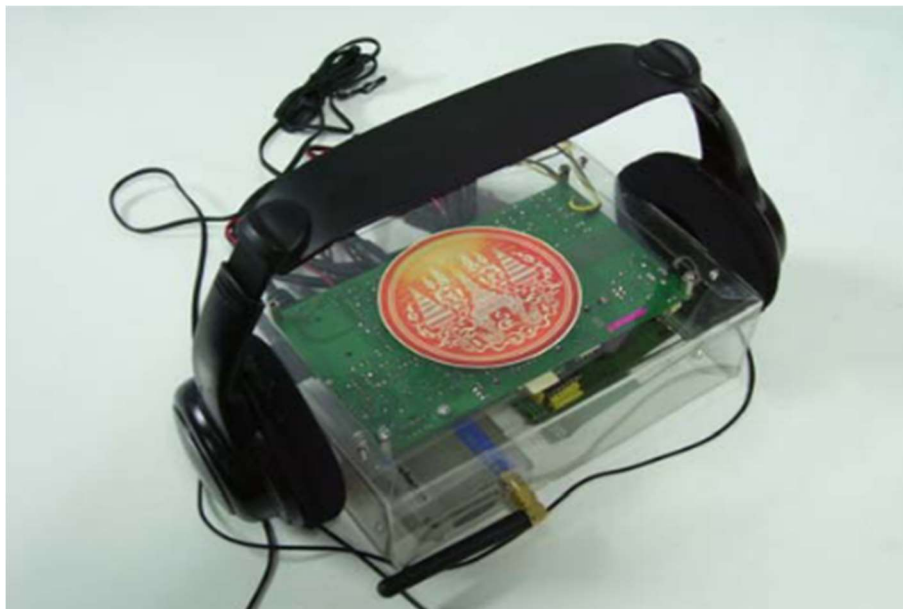
Figure 2.45 Prototype of the navigation device [65]

approximately 6 hours, and provided voice-guided navigation through headphones, Figure 2.45. It was designed to be user-friendly for individuals who are blind, with a navigation cane attached for ease of use (Figure 2.46). In the simulation, a user started at a designated Point A and was directed to a destination Point P. The server calculated the route based on the user's request and updated the route if the routing cost or distance between points changed, thus testing the system's ability to dynamically adjust to new routing information. The results demonstrated the system's potential in guiding users effectively, although it was noted that the prototype's size was larger than ideal [65].

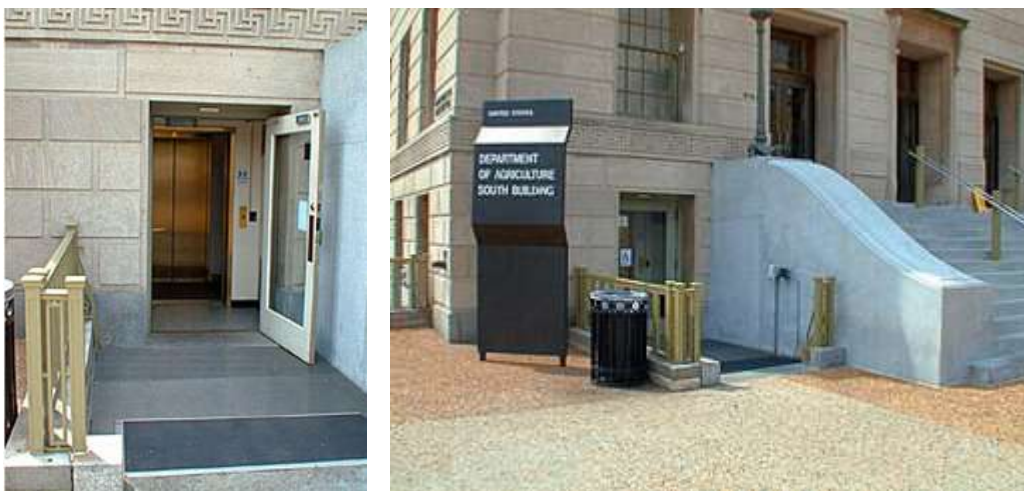
Figure 2.48 The accessible entrance to Agriculture South Building, Washington, DC [69]

To facilitate access to the entrance lobby of the Agriculture South Building in Washington, DC, as depicted in Figure 2.48, an existing window opening on a lower level was extended to accommodate the installation of a door. Additionally, an elevator was integrated to provide direct access to the entrance lobby above [69].

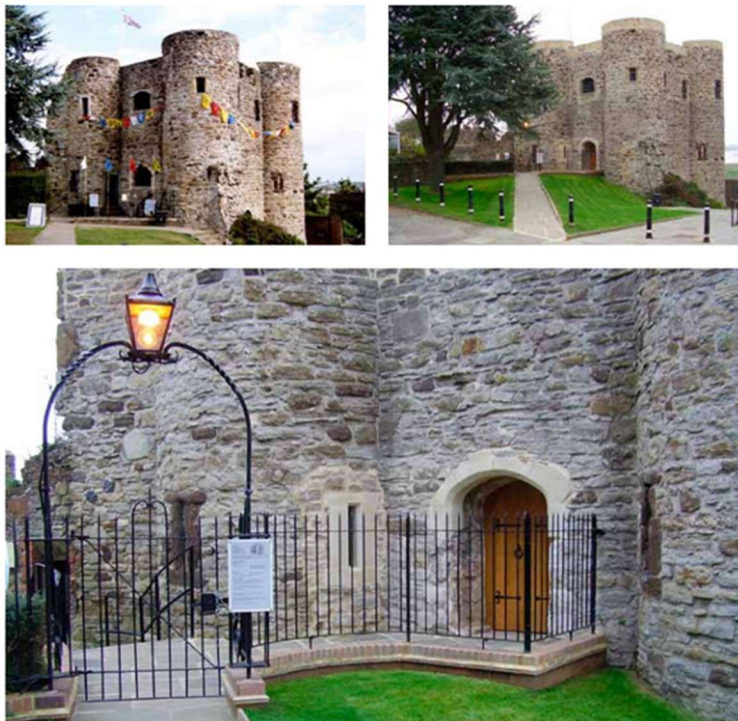
Figure 2.51 Ypres Tower, Rye, UK [71]

Ypres Tower, Rye, UK, is another scheduled monument, depicted in Figure 2.51, where the accessibility was enhanced by developing a gently sloping pathway across the lawn. Additionally, an original medieval doorway was reconstructed to provide level access to the ground floor [71].

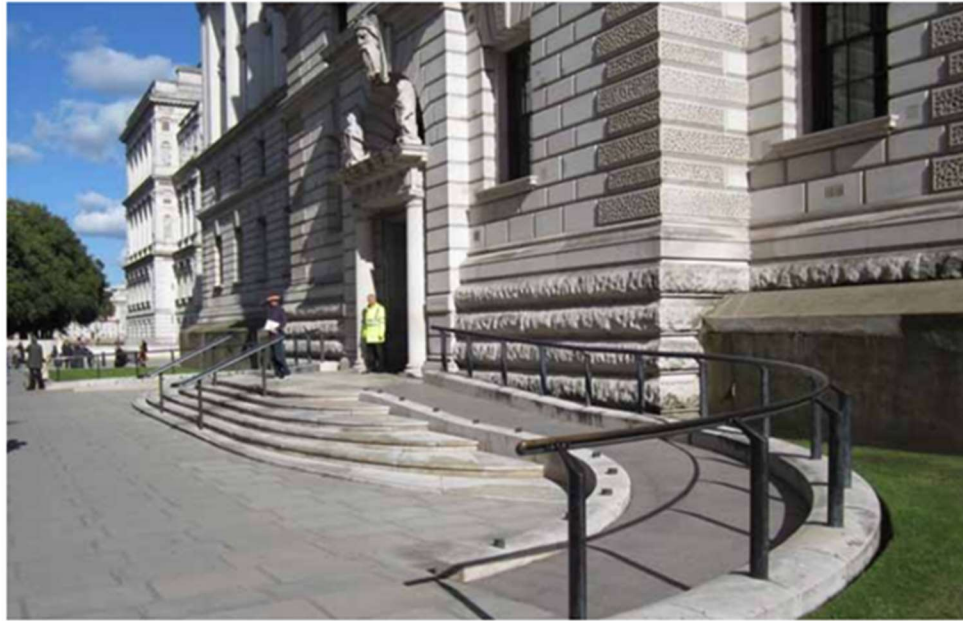
Figure 2.52 The Treasury, London, UK [71]

In the Treasury in London, UK, as illustrated in Figure 2.52, the restored entrance features a symmetrical design of a ramp and steps, balancing between functionality and aesthetic design [71].

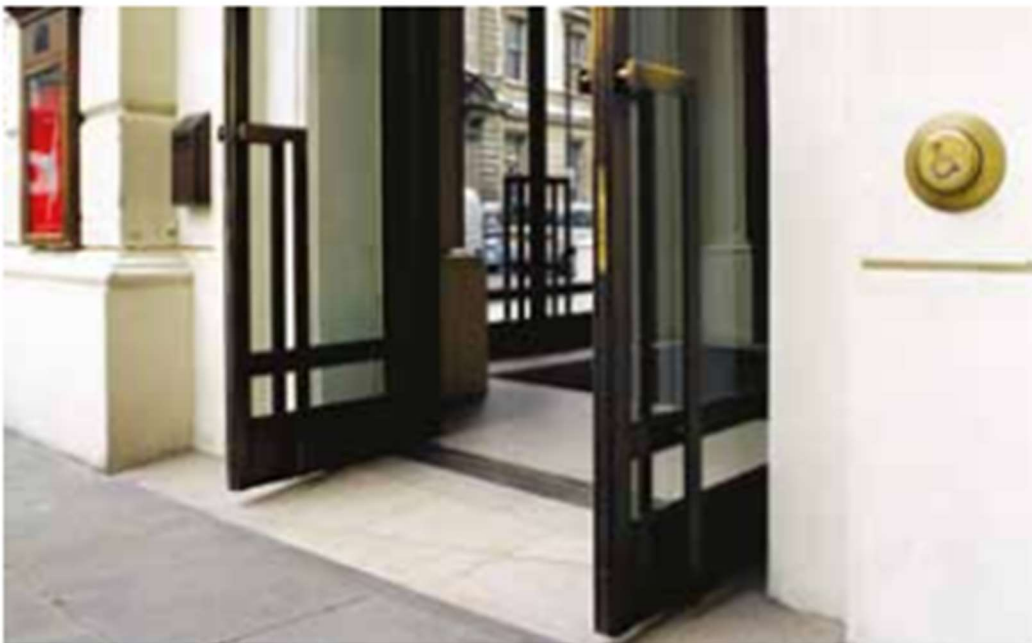
Figure 2.55 The Royal Opera House, London [71]

In the Royal Opera House, London, UK, as illustrated in Figure 2.55, power-assisted doors have been added providing an accessible entrance to the portico. This thoughtful integration ensures an accessible route that enhances ease of entry for all visitors [71].

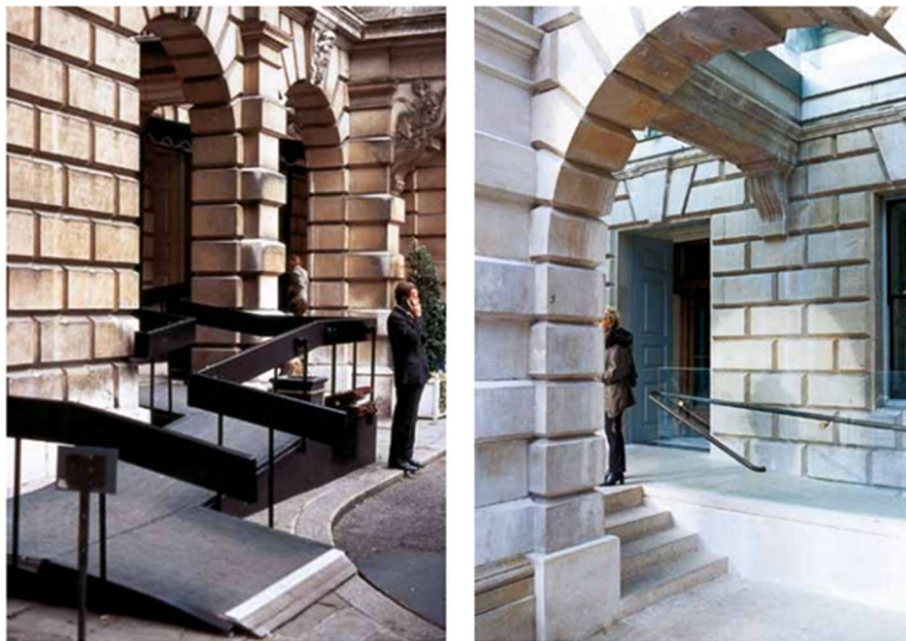
Figure 2.57 The Royal Academy, London, UK [71]

In the Royal Academy, London, UK, shown in Figure 2.57, the transition from temporary ramps (left) to a permanent access solution (right), involved the modification of the building's plinth to align with the elevated levels of the courtyard [71].

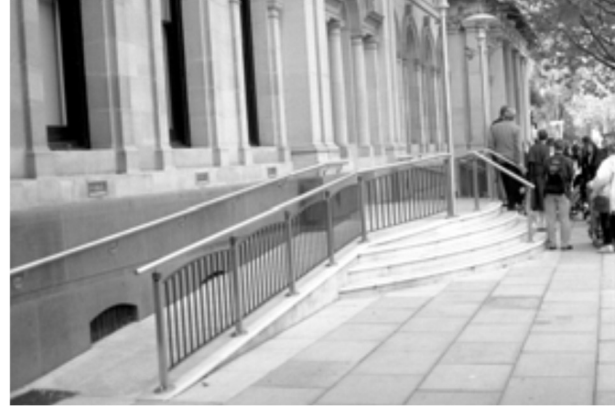
Figure 3.11 Ramp at former Government Offices in Victoria Square, Adelaide, SA, Australia [79]

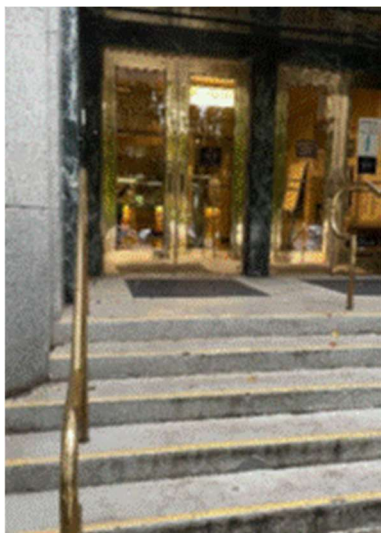
Figure 4.5 Stairs at one of the entrances to Vancouver City Hall

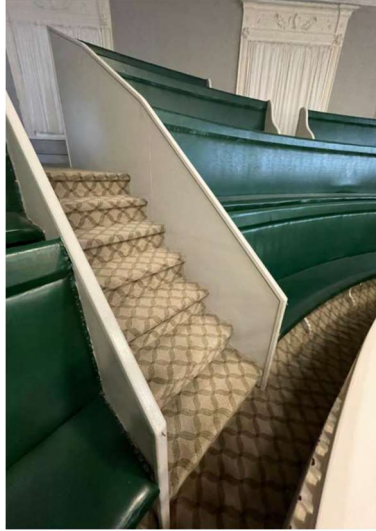
Figure 4.17 Steep steps in the gallery of Province House with inadequate handrails and narrow seats

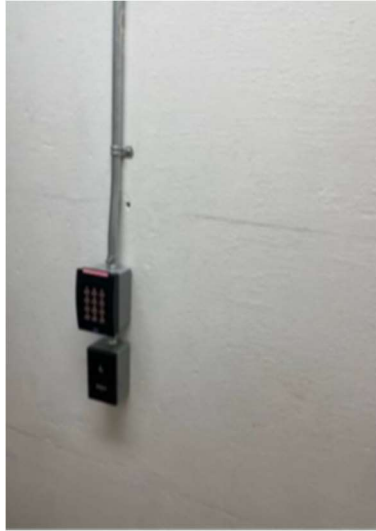
Figure 4.60 Access card reader to access one of the washrooms in Calgary Public Library
