# LAKE LINE

MARCH 1999

# Volunteer-based experimental planting program to restore Cootes Paradise Marsh, an urban coastal wetland of Lake Ontario

PATRICIA CHOW-FRASER

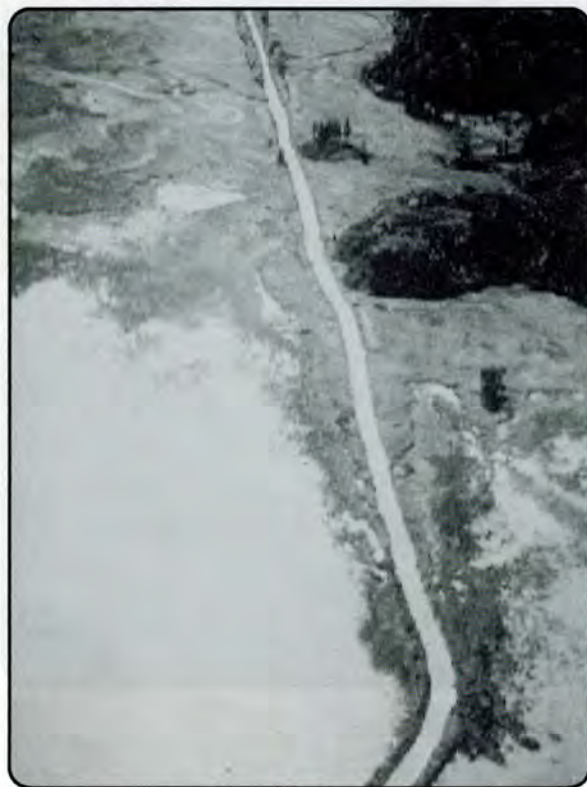
Photo 1. Aerial photo of Cootes Paradise in 1928, showing Desjardins Canal as it curved toward new outflow.

During the first part of the 20th Century, Cootes Paradise was still primarily an emergent marsh (Photo #1) with cattail (*Typha latifolia*) and wild rice (*Zizania*

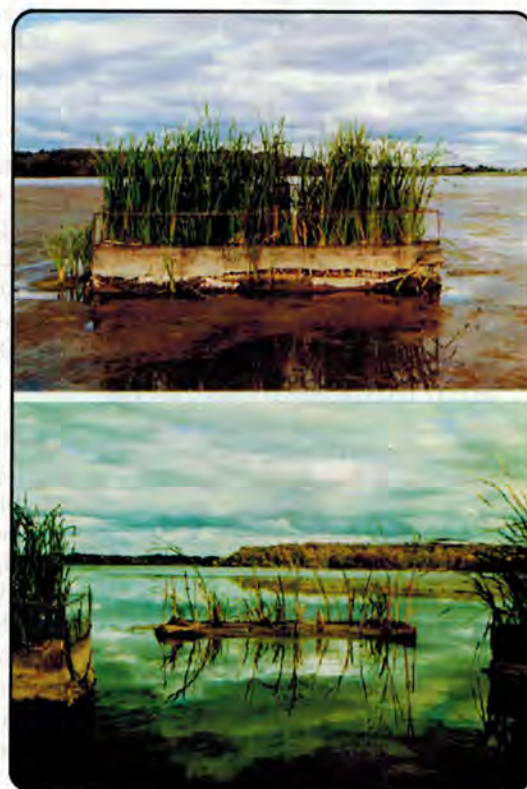
Photo 2. Top: plants protected by exclosure. Bottom: plants unprotected.

transplanted in the exclosures had increased tenfold (Photo 2 top), whereas those that had been transplanted into similar sized plots without any protective fences had become greatly reduced in number (Photo 2 bottom). This pilot study demonstrated that cattail transplantation could be successful in Cootes Paradise as long as exclosures were used.

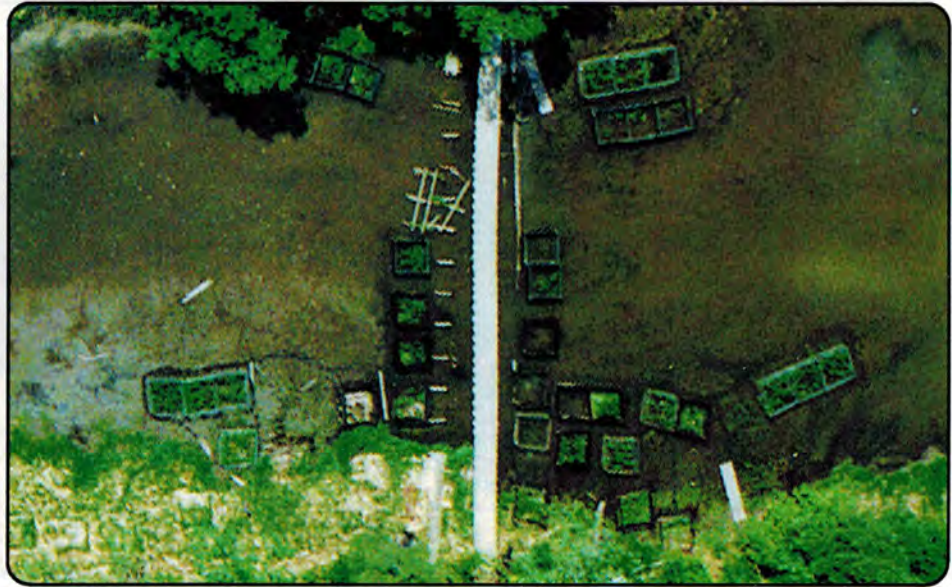
**Photo 5. Overview of planting exclosures at the end of 1994. Exclosures to the south have already been dismantled (bottom left).**

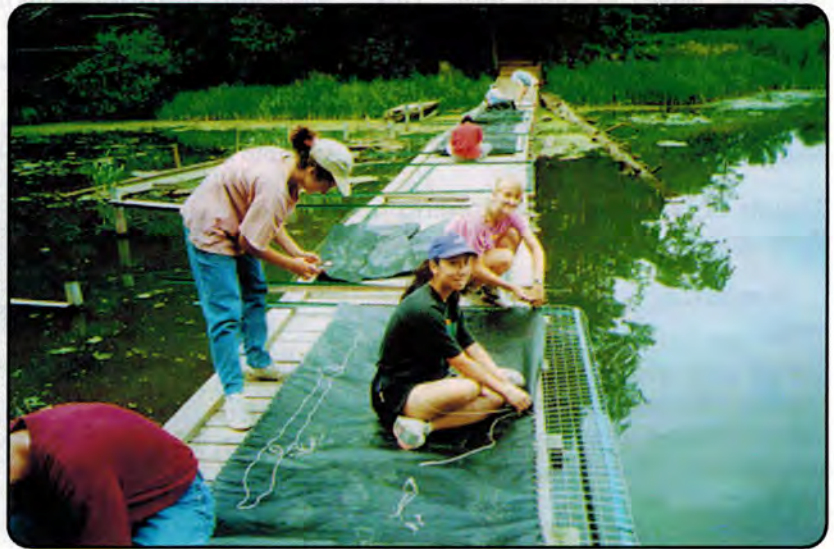
**Photo 6. Volunteers use the boardwalk to construct panels of exclosures in 1994.**

on T-bar frames (Photo #6). The siltscreen was effective in reducing water turbidity by about a third to a half compared with unscreened exclosures. Plants in peat pots were inserted securely into the sediment.

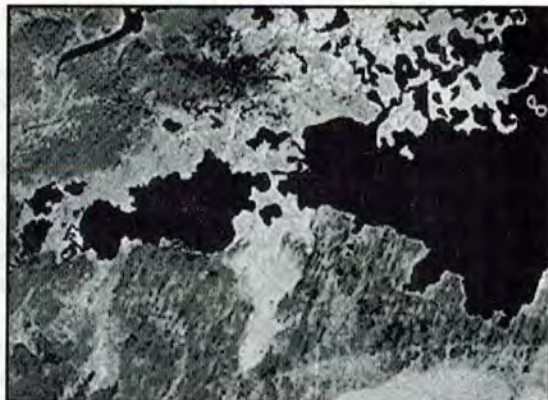
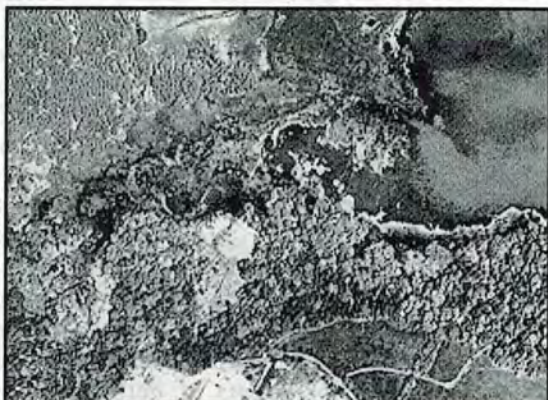
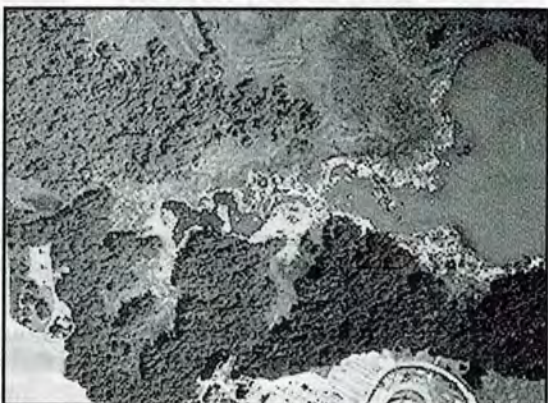
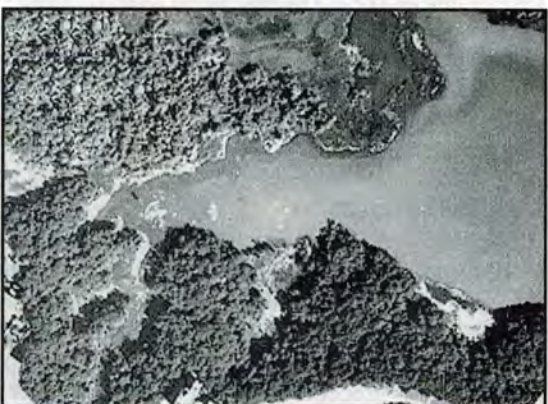
Photos 4a-d, at right: From top:  
(a) Mac Landing, 1950;  
(b) Mac Landing, 1960;  
(c) Mac Landing, 1972;  
(d) Mac Landing, 1978.

1950 to 1978, presumably in response to fluctuating water levels. The 1950 photo shows the adverse effects of several years of high water levels on emergent vegetation in the late 1940s (Photo #4a). By 1960, virtually the entire inlet supported aquatic plants partly because there had been relatively low water levels during this time and partly because a carp removal program conducted in the mid-1950s netted out more than 100,000 carp (Photo #4b). During the early 1970s, some of the emergent plants had retreated, but Mac Landing still had large areas of emergent marsh (Photo #4c). In 1974, exceptionally high water in Cootes Paradise wiped out most of the emergent plants, and even though low water levels returned in 1977 and again in 1988 and 1995, the cattail has not regained its former prominence to this day (Photo #4d).

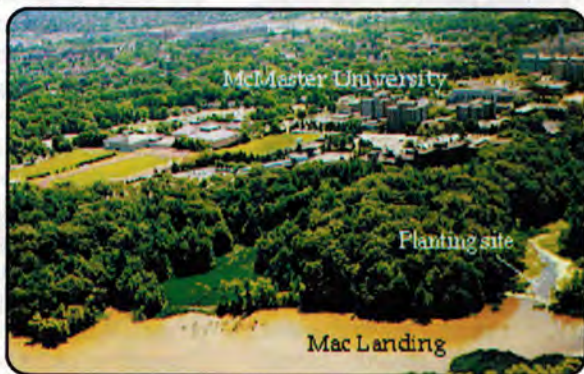
Photo 3. Aerial showing McMaster University in background and planting site in Mac Landing.

The CVPP site was located in one of the inlets on the south shore of Cootes Paradise Marsh known as Mac Landing (Photo #3). The series of aerial photos over Mac Landing illustrate how marsh vegetation expanded and contracted from

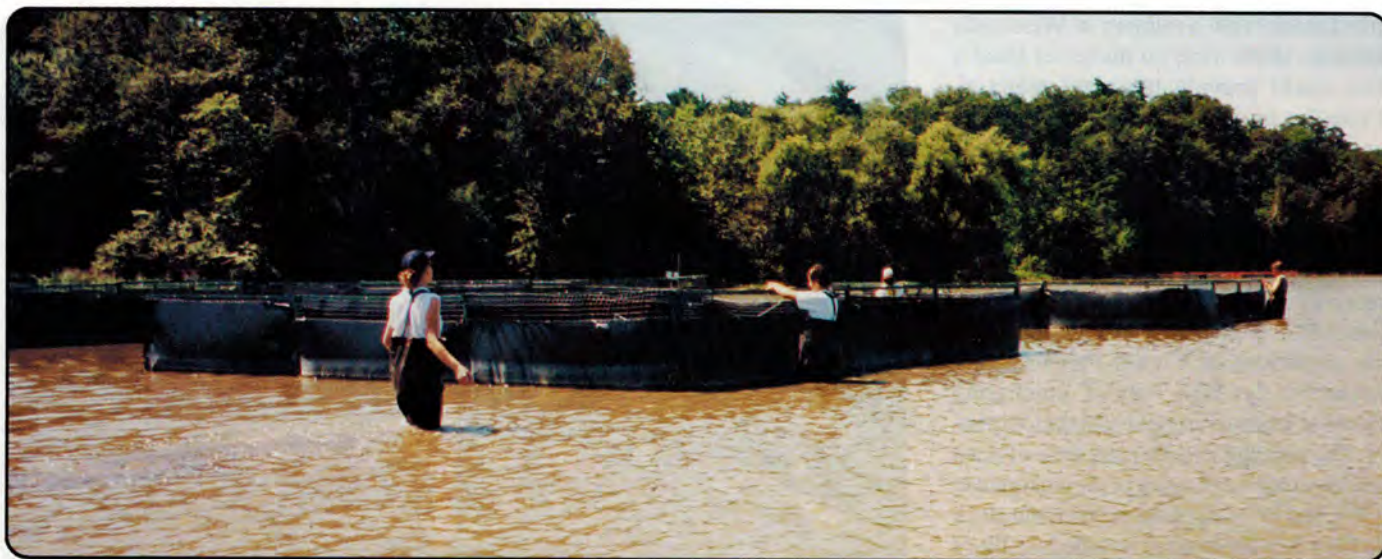
Photo 7. View of submergent-plant enclosures in 1995. All panels were covered with silt screen to help reduce water turbidity.

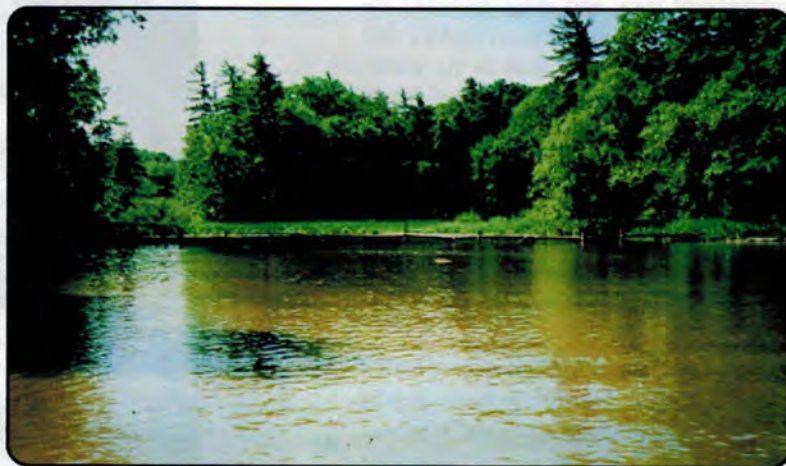
Photo 8.  
View of  
planting  
site  
(board-  
walk in  
back-  
ground)  
in 1993  
before  
program  
commenced.

In 1993, the planting site had been essentially devoid of any emergent vegetation (Photo #8). At least part of the reason for this is because water levels had been extremely high that spring. The September 1993 aerial photo shows the site after the pilot program had been carried out, revealing the barren character of the inlet (Photo #9). Since water levels in 1994 were more favourable for emergent plants, the plants that we had introduced as well as others grew extremely well at the CVPP site. This is evidenced by the expansion of aquatic plants into unvegetated areas in the 1994 aerial photo (Photo #10).

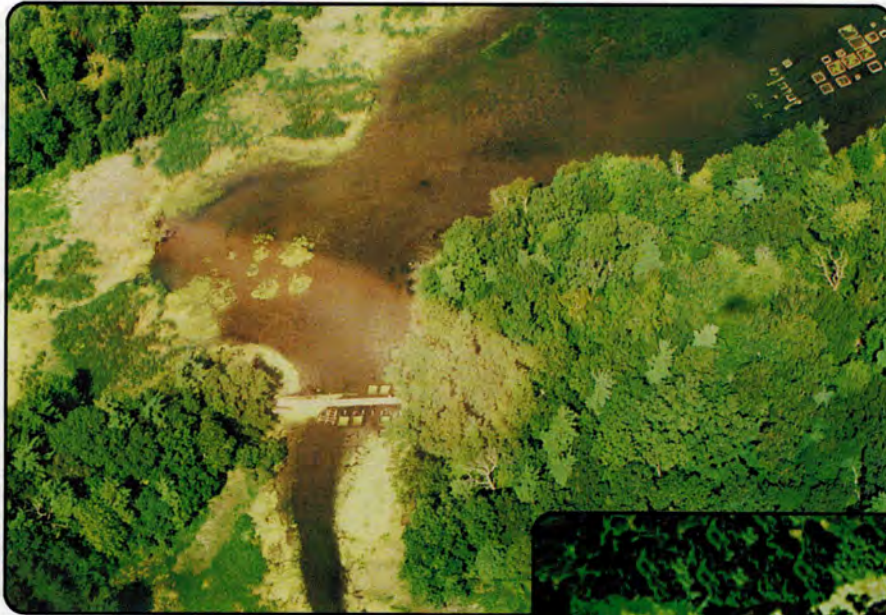
Photo 9 (at left). September, 1993, following installation of first set of exclosures.

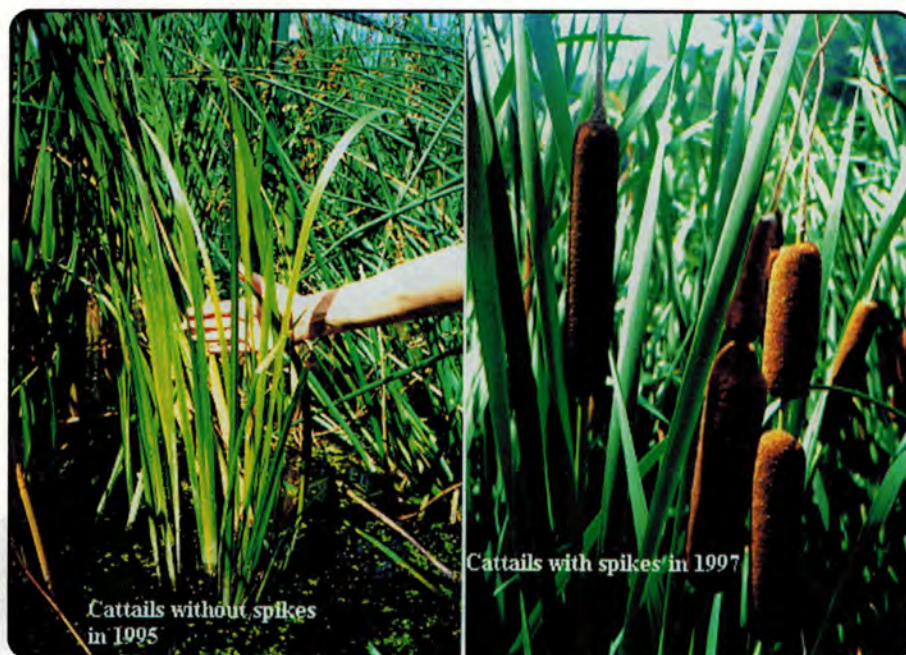
**Photo 11.** At left: Height of plants following one year of growth in exclosures. At right: Ramets of cattails with spikes observed in 1997 survey. Plants were still growing inside exclosures.

Regardless of depth, there were proportionately more of the larger plants in the siltscreen exclosures compared with unscreened exclosures, suggesting that plants were able to grow to a larger size in less turbid water. An alternate explanation is that the siltscreen selected for tall plants since the screen prevented sunlight from reaching the plants until they outgrew the height of the panels. In general, only one or two individuals produced spikes in 1995. Subsequent inspections in 1997, however, showed that many more individuals had mated and produced spikes (Photo #11).

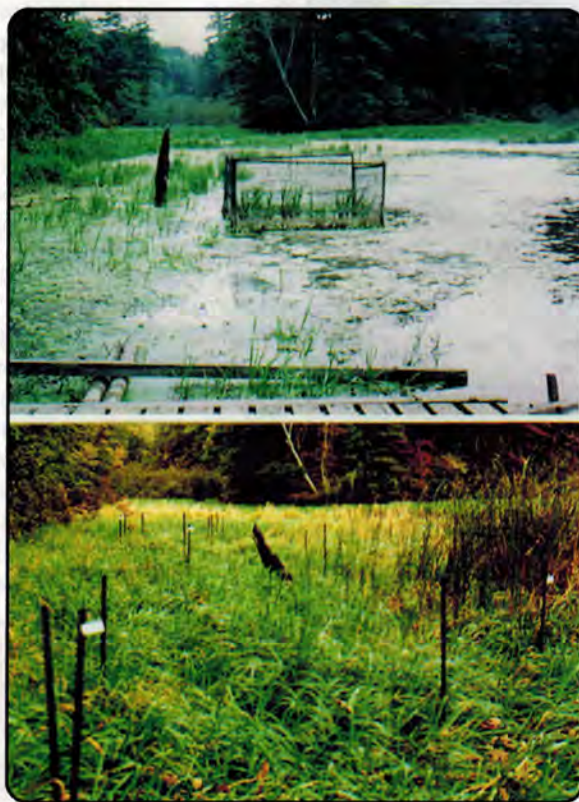
Photo 12. Top: View of CVPP site below boardwalk shortly after beginning of planting in 1993. Bottom: View of site after the monitoring program in 1995; enclosure panels had been removed during spring.

The response of the plants aside, it was much easier to remove the panels in early spring before plants inside the enclosures had started to grow, and when the sediment was still cold and sufficiently firm to walk on. Within weeks of the removal during spring, both cattails and arrowheads emerged among the colonizing manna grass that had begun to overtake the entire area by the end of the previous growing season (compare Photo #12 a and b). In the most recent inspection in July 1998, both arrowheads and cattails could still be found. When panels from the 1994 enclosures were removed during the fall of 1995,

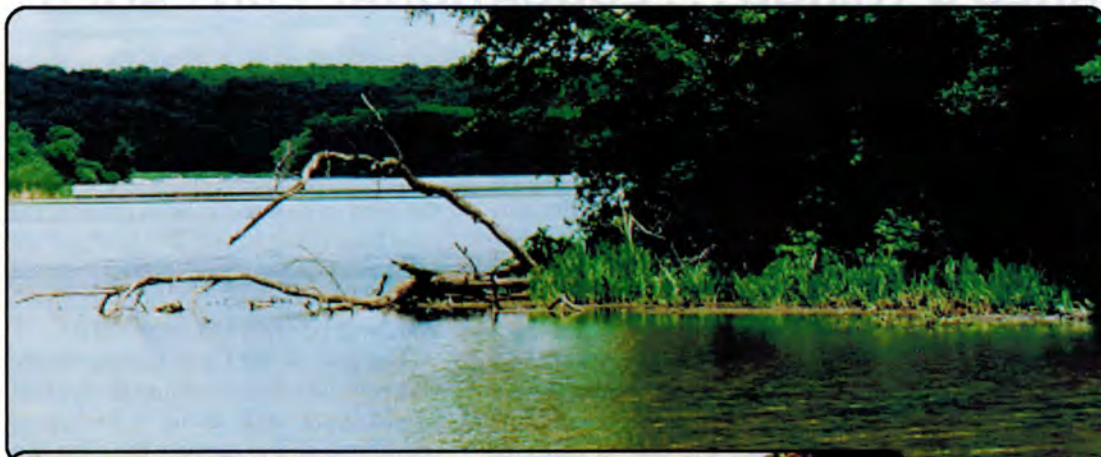
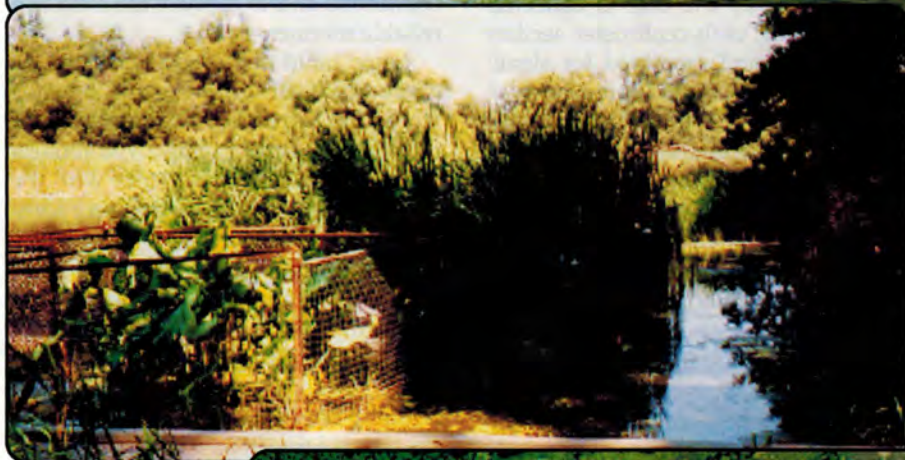
**Photos 15 a, b.**  
Above: View of CVPP site above the boardwalk in 1993, before planting commenced. At left: View of same area after planting program had finished. Photo taken in September 1995.

The short-term success of the planting program is confirmed by the tremendous growth of transplants a year following the planting program (Photos #15a and #15b). The best evidence of the long-term success of our planting program is shown in the 1997 aerial photo (Photo #16). Despite relatively high water levels that year, most of the plants that had been transferred continued to grow there and even expanded beyond the enclosure walls. There is now established populations of at least two species of cattails (*T. latifolia* and *T. angustifolia*), softstem bulrush, and arrowheads. However, swampdock, which grew well in the 1995 and 1996 seasons, has become very scarce, as have all of the remaining taxa that we planted. Since these species did not survive in the long-term and were also problematic to keep in greenhouse cultures, they should probably be dropped from future large-scale planting programs. The July 1997 photo also shows a resurgence in growth of the cattail beds outside the planting site in Mac Landing and this may be attributed to successful exclusion of carp through the Cootes Paradise Fishway several months earlier.

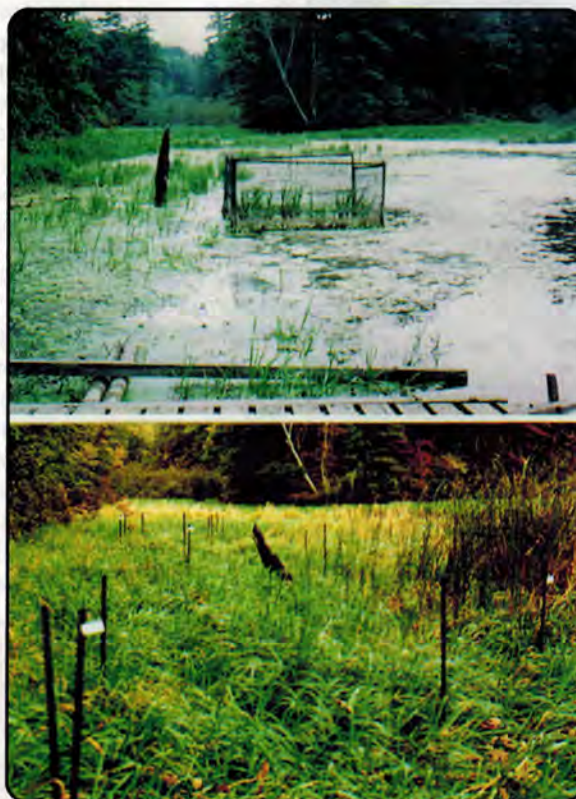
Photo 12. Top: View of CVPP site below boardwalk shortly after beginning of planting in 1993. Bottom: View of site after the monitoring program in 1995; enclosure panels had been removed during spring.

The response of the plants aside, it was much easier to remove the panels in early spring before plants inside the enclosures had started to grow, and when the sediment was still cold and sufficiently firm to walk on. Within weeks of the removal during spring, both cattails and arrowheads emerged among the colonizing manna grass that had begun to overtake the entire area by the end of the previous growing season (compare Photo #12 a and b). In the most recent inspection in July 1998, both arrowheads and cattails could still be found. When panels from the 1994 enclosures were removed during the fall of 1995,
