BEHAVIOUR OF PARTIALLY GROUTED
NOMINALLY REINFORCED MASONRY
SHEAR WALLS
UNDER DYNAMIC LOADING

A Thesis

Master of Applied Science

McMaster University

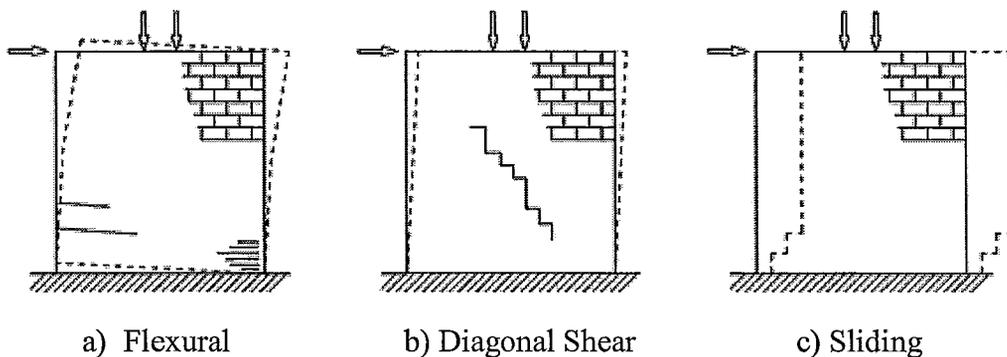
Figure 1.1: Types of failures

The result of the varied parameters in experimental programs subjected to axial and lateral loads identified three types of failure modes; flexural, shear and sliding [Drysdale et al. (2005) and Voon (2007)]. The failures are shown in Figure 1.1.

This type of failure mechanism is characterized by diagonal tension and compression cracking. It is undesirable for walls to fail in shear as it is a brittle type of failure, occurring without warning. The stiffness degradation of walls failing in shear is relatively large compared to that of walls failing in flexure (Drysdale et al. 2005).

Flexural failure is characterized by the yielding of the vertical reinforcement, crushing of masonry near the wall toe and bed-joint cracking. Generally, this is the preferred failure mode, particularly under seismic loads, as the type of failure is ductile with the ability to effectively dissipate energy. A cantilever wall failing in flexure can withstand large inelastic deformations without significant loss of stiffness and strength. Shing et al. (1989) investigated the effect of applied axial load on the behaviour of reinforced masonry shear walls. From the test results, it was concluded that the applied axial load can change the behaviour of walls from a mixed flexure/shear to a more brittle shear failure mode. Although the applied axial load has the effect of increasing the flexural capacity and stiffness, the ductility is decreased due to the delayed yielding of tensile reinforcement and crushing of masonry.

Sliding failure is characterized by the movement of parts of the wall or the whole wall over a mortar bed joint or its base. It is resisted by the dowel action of the vertical reinforcement and by friction due to axial load. This type of failure may occur when there is a low friction coefficient between the wall and its base or when there is inadequate dowel resistance from vertical steel reinforcement (e.g. unreinforced masonry shear walls). Equation 1.11 is used to determine sliding shear strength (Drysdale et al. 2005).

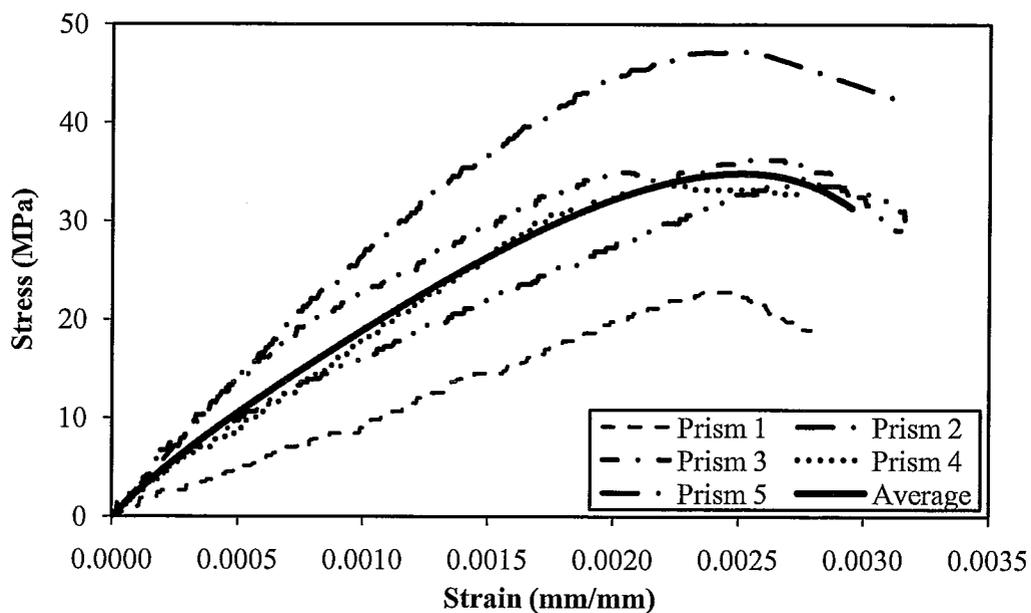
Figure 2.12: UngROUTED stress-strain curves

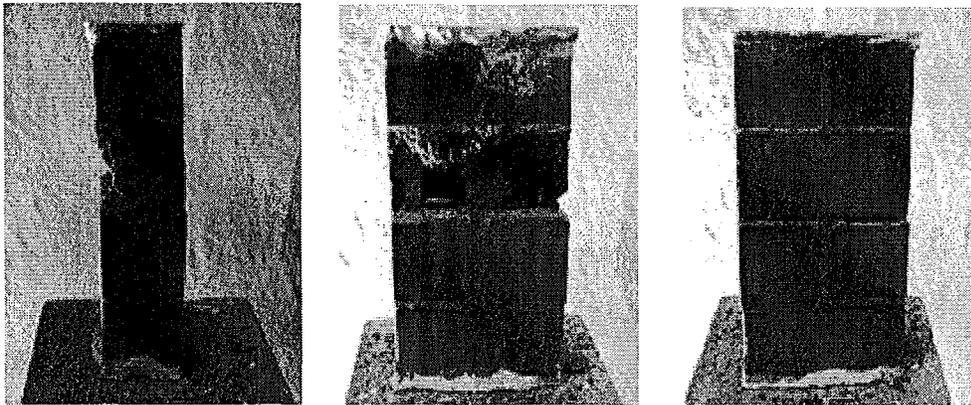
Figure 2.13: Eccentric failure of specimen 1

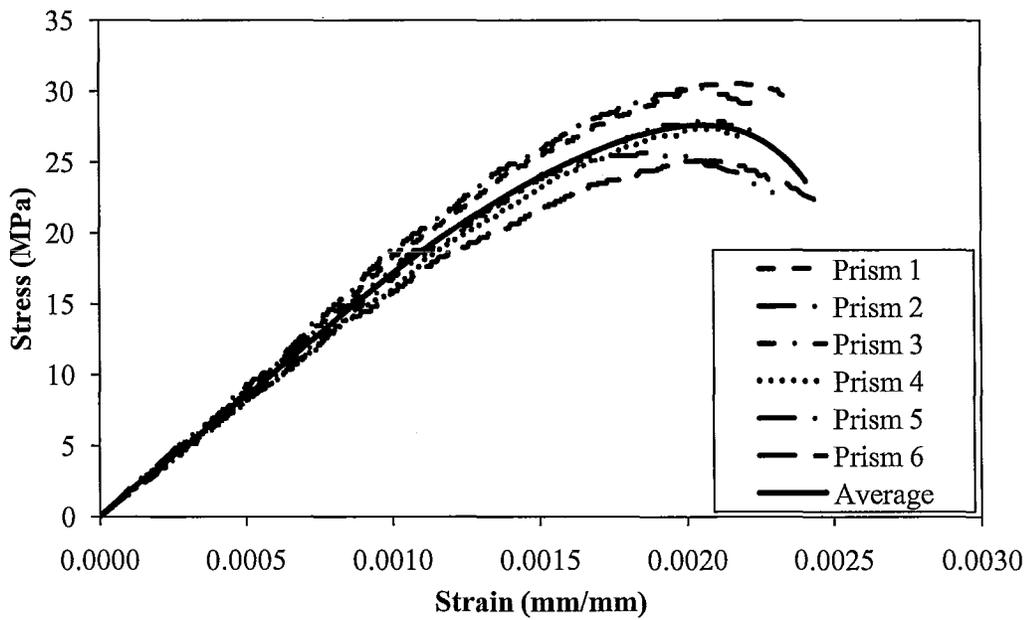
Figure 2.14: Grouted stress-strain curves

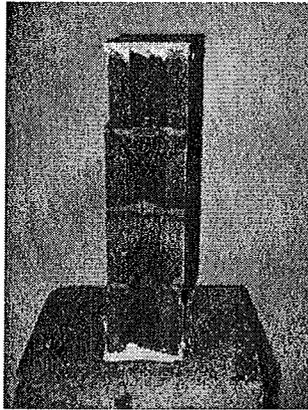
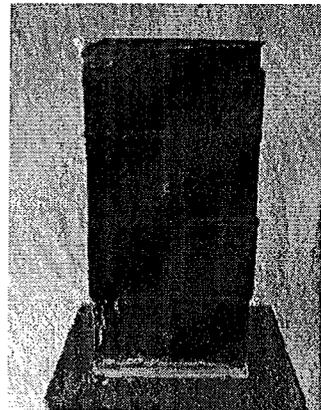
a) Specimen 4: conical failure

b) Specimen 5: shear failure

Figure 2.15: Failure of grouted specimens

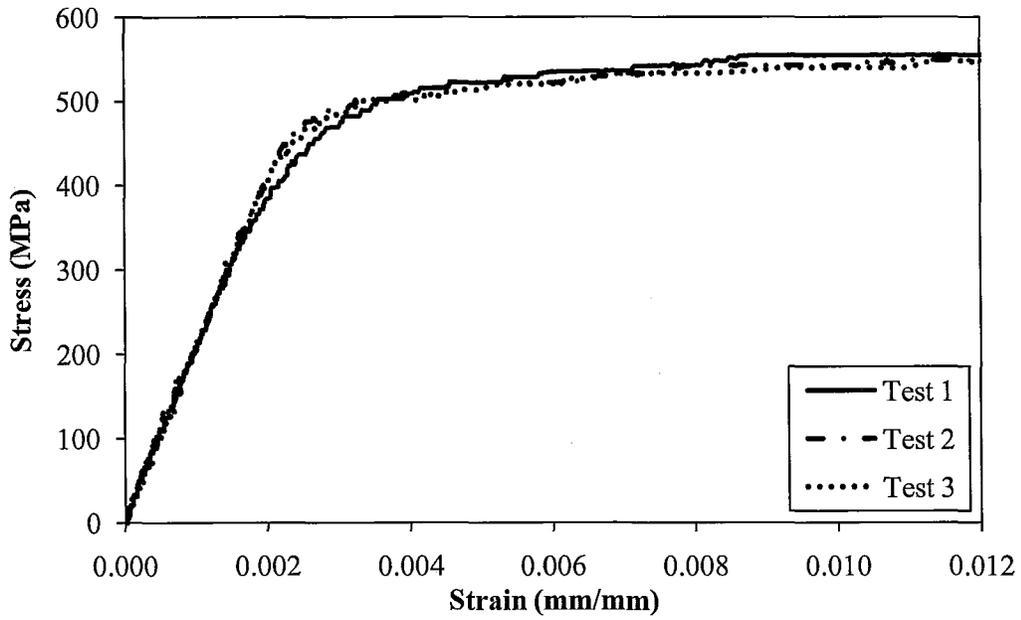
Figure 2.17: Stress-strain curves for $\text{Ø}=4.76$ mm wire reinforcement

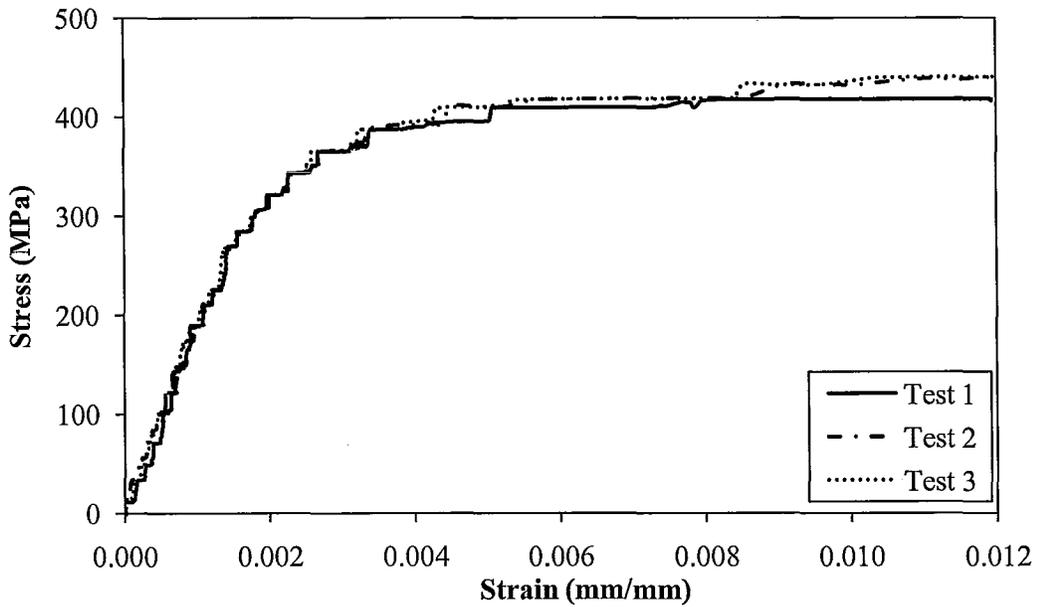
Figure 2.18: Stress-strain curves for $\text{Ø}=3.66$ mm wire reinforcement

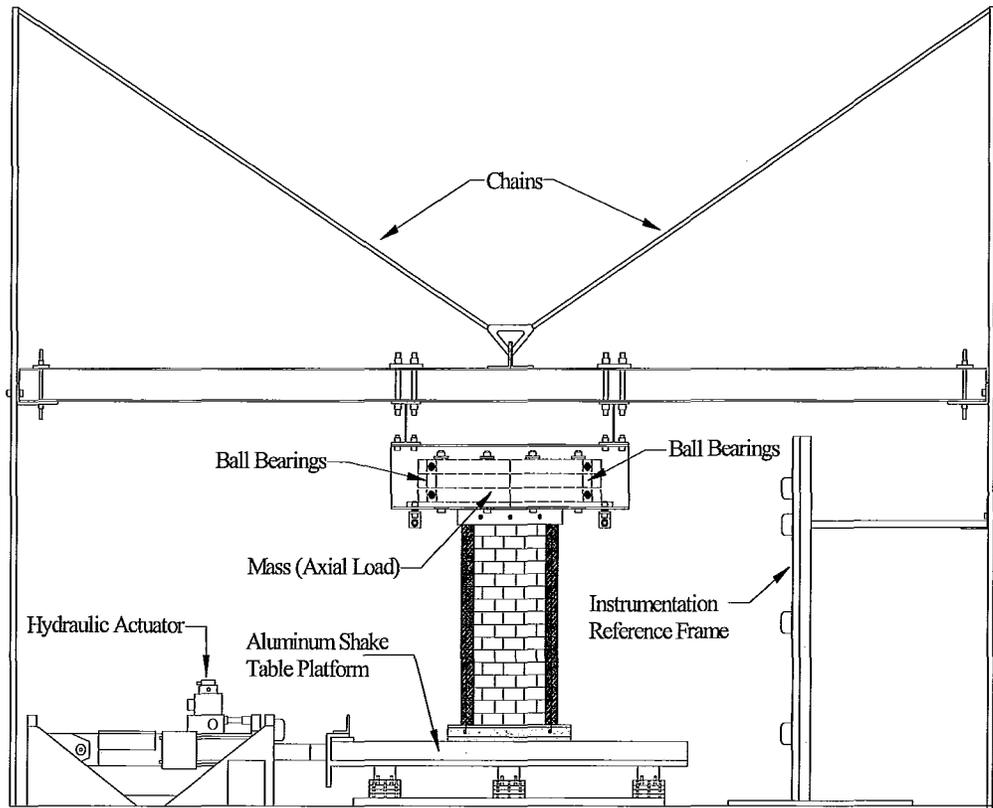
Figure 2.19: Front view of test setup

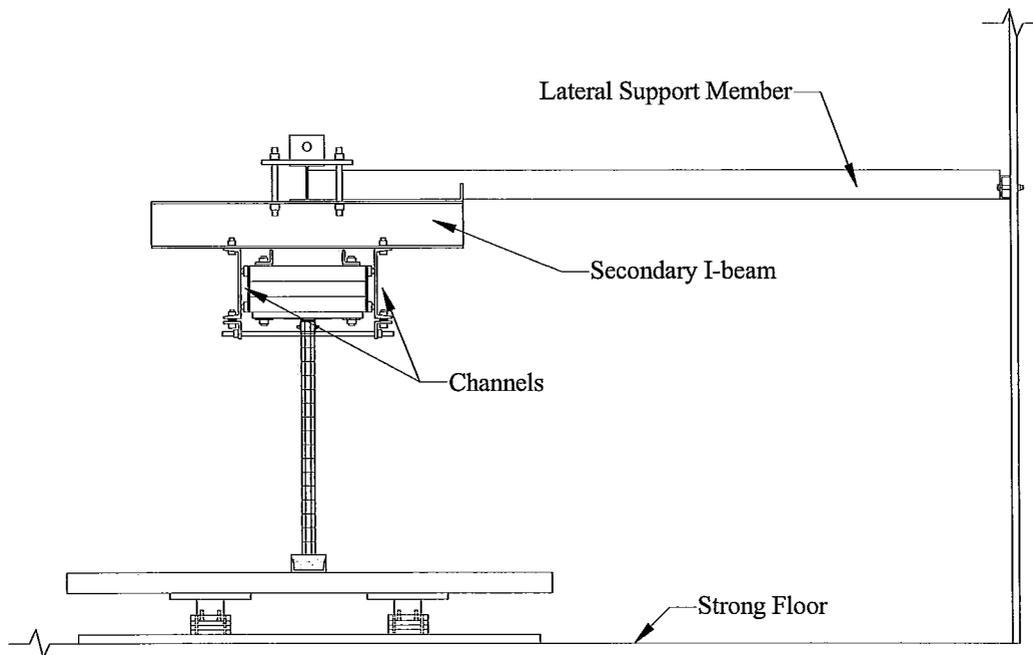
Figure 2.21: Side view of test setup

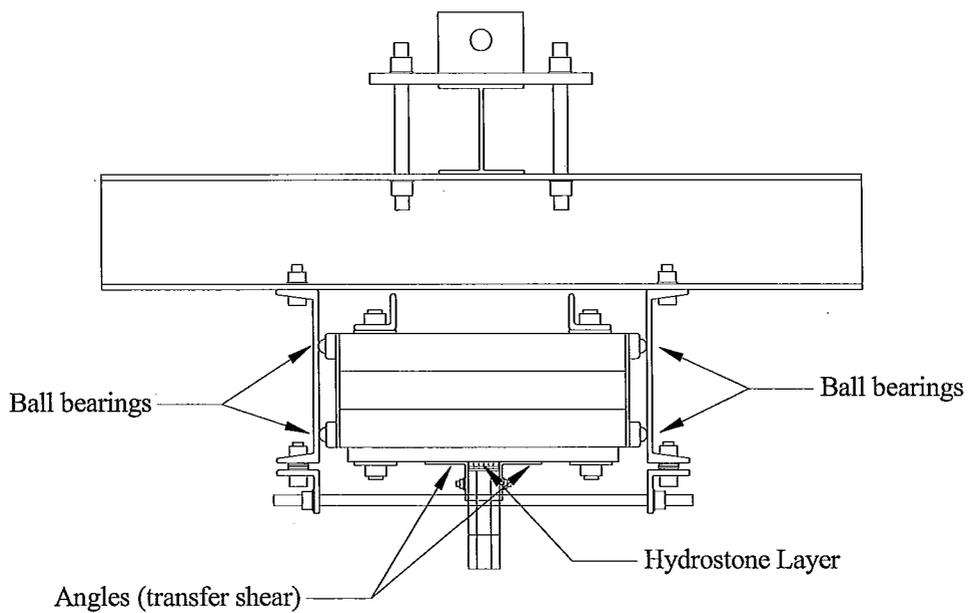
Figure 2.22: Close-up side view

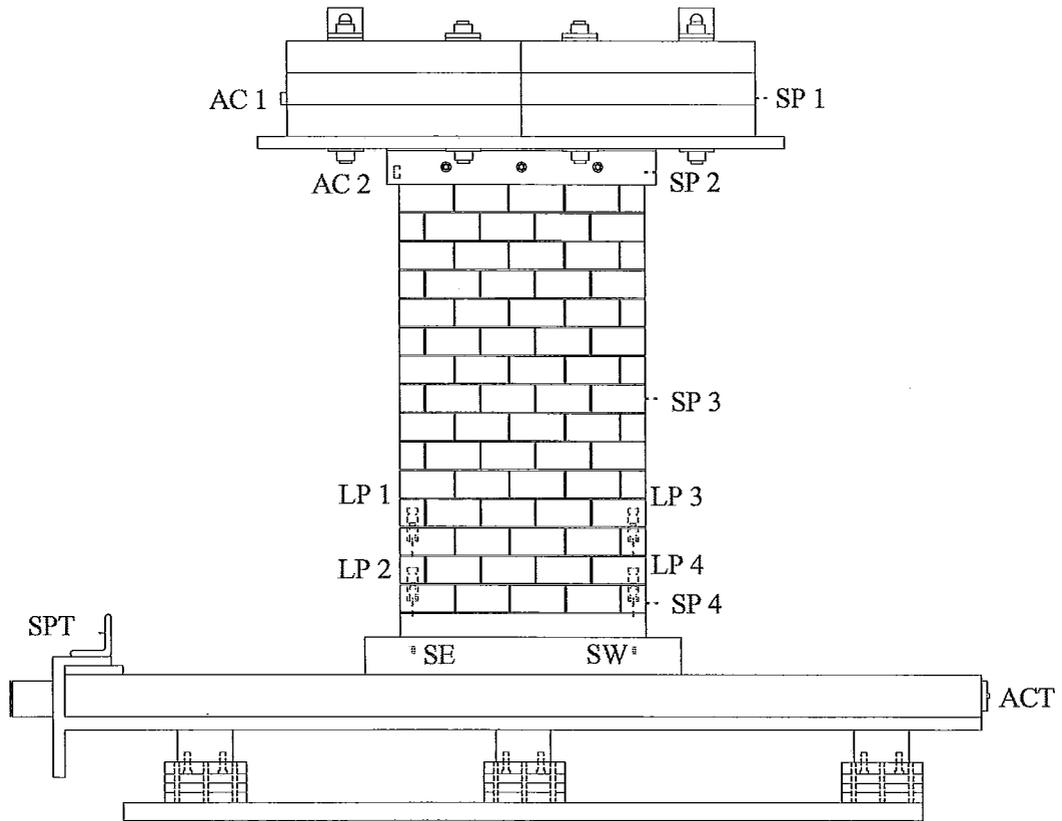
Figure 2.25: Instrumentation setup

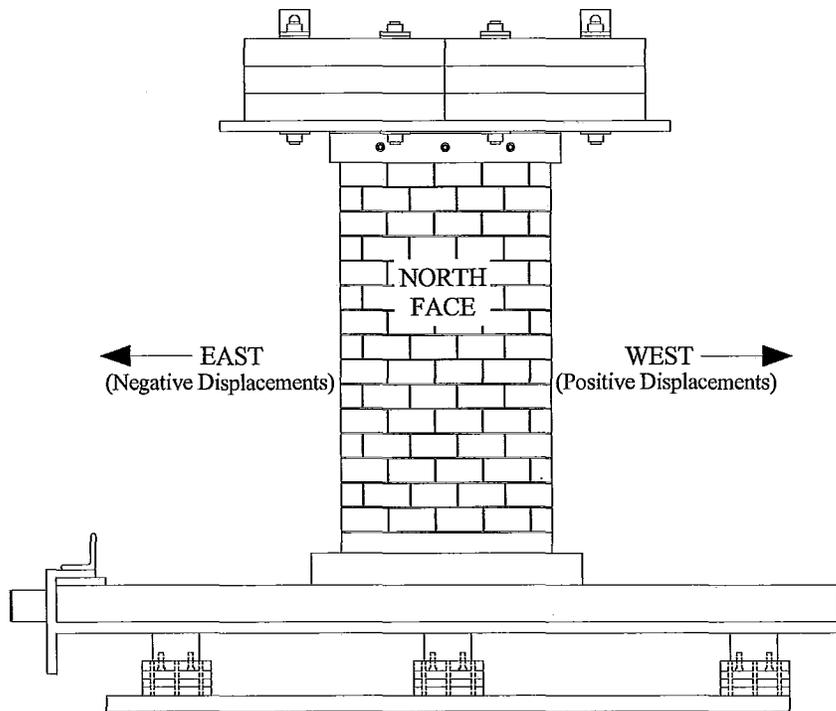
Figure 3.1: Orientation of the wall with depicted east (negative) and west (positive) directions

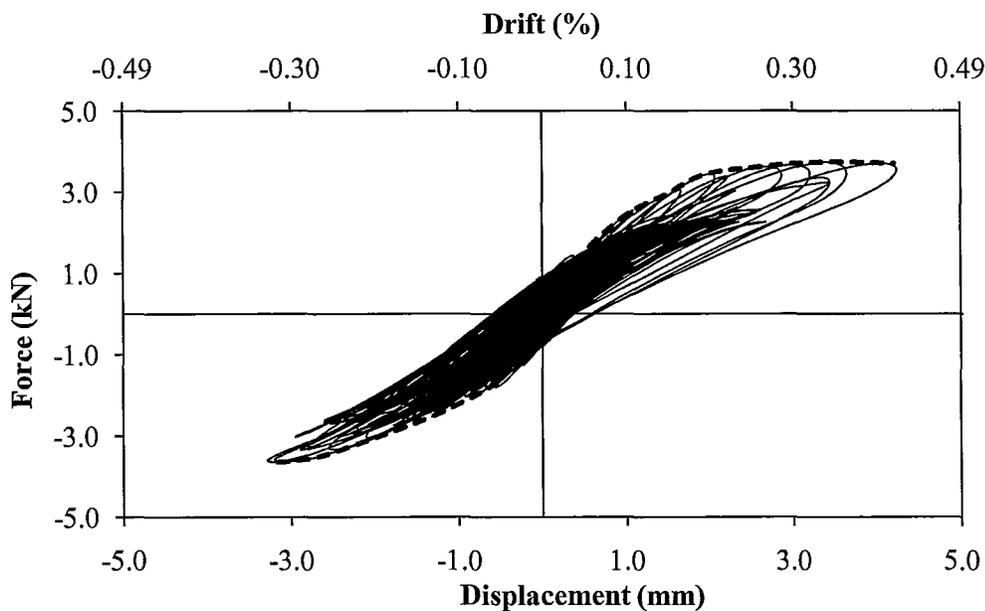
Figure 3.3: Wall IA hysteresis plot of all runs

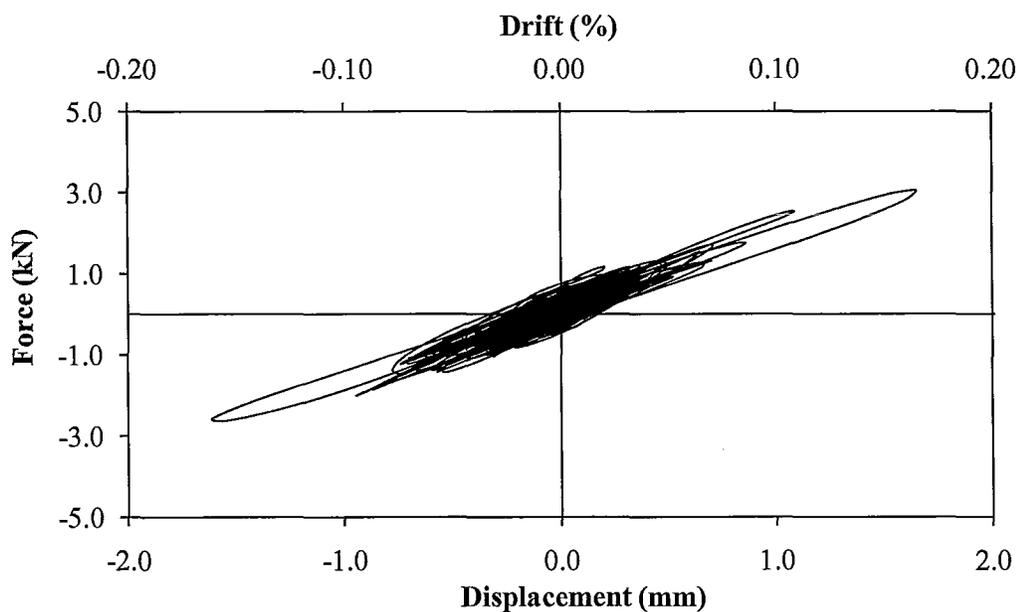
Figure 3.4: Wall IA Run E hysteresis showing energy dissipation and change of stiffness

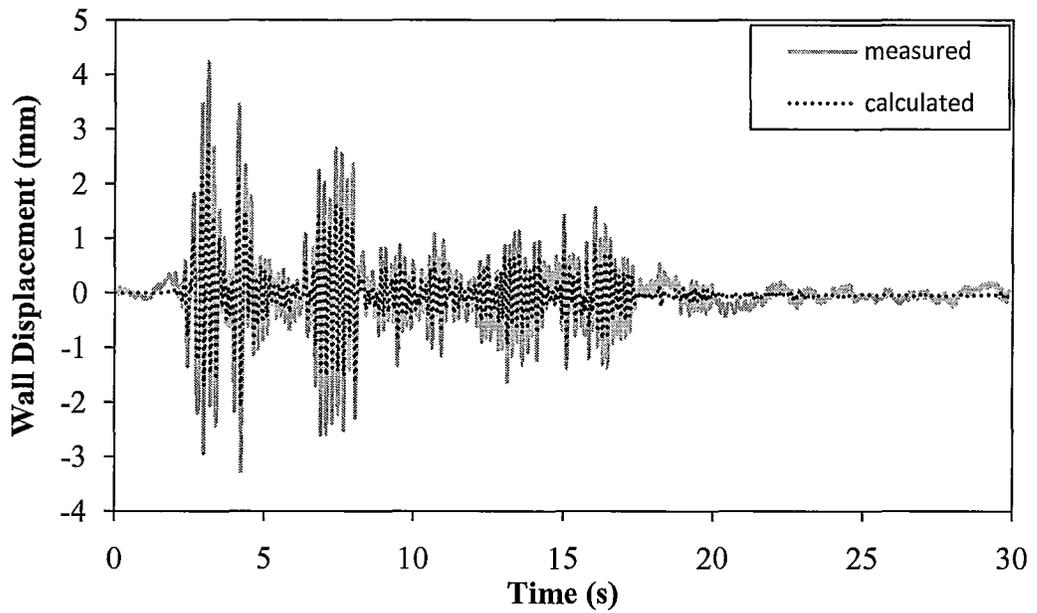
Figure 3.7: Time-history comparison between measured and calculated displacement due to the rocking of Wall IA

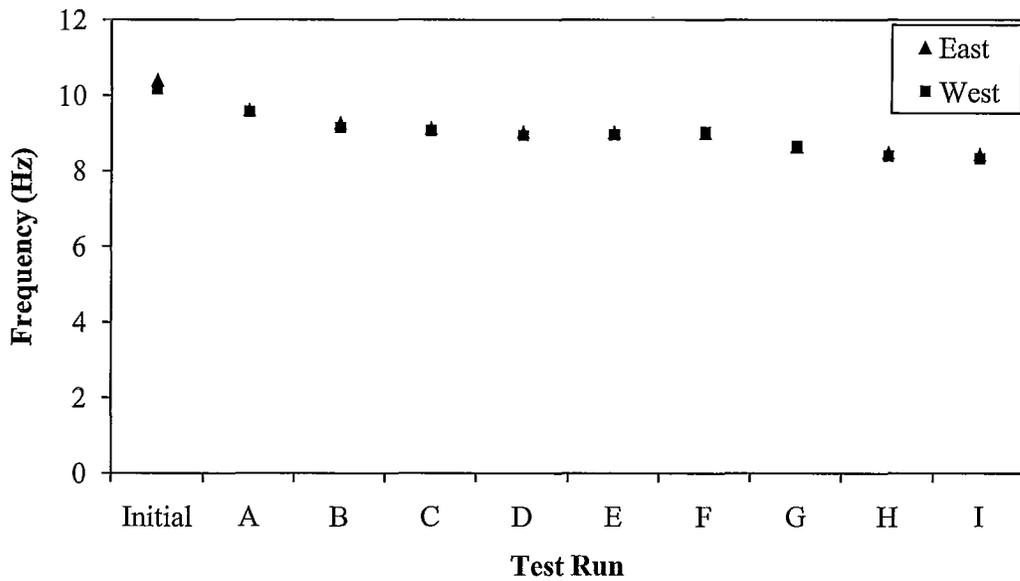
Figure 3.8: Hammer tap test frequency of Wall IA

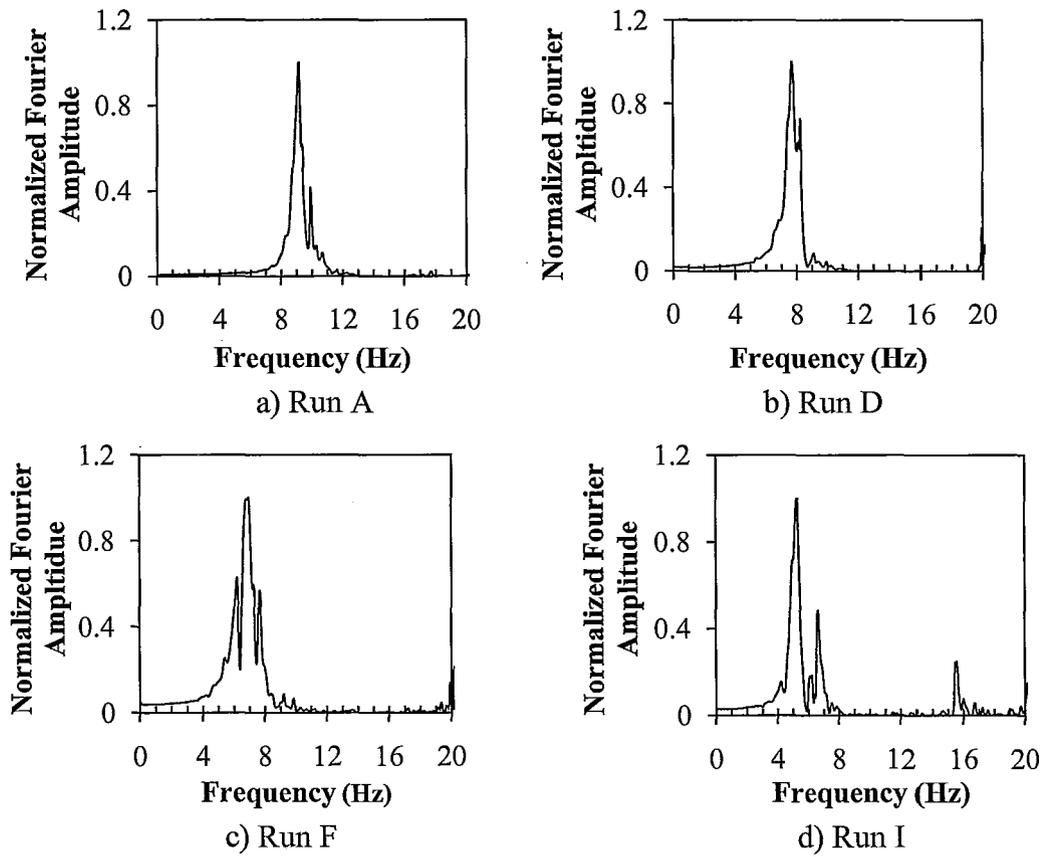
Figure 3.9: Frequency of Wall IA during several runs calculated by the FFT

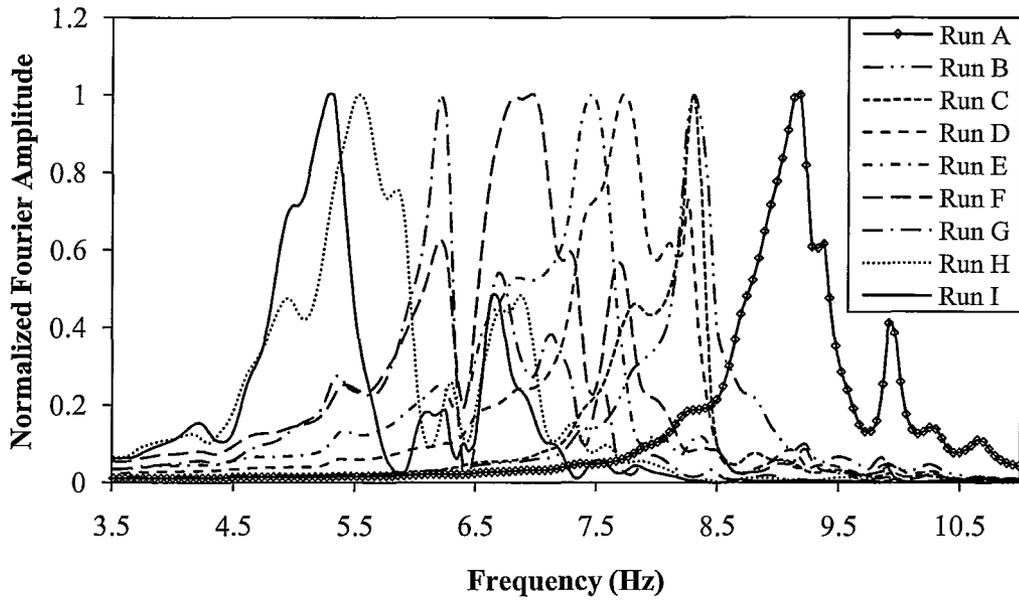
Figure 3.10: Frequency of Wall IA with all runs superimposed on the same graph calculated by the FFT

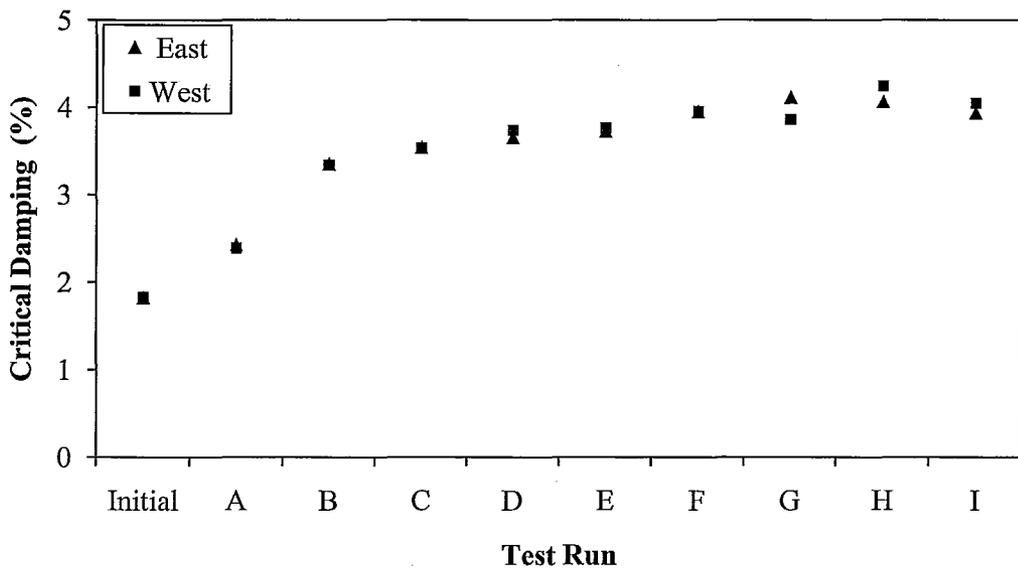
Figure 3.11: Critical damping of Wall IA runs calculated from the hammer tap test

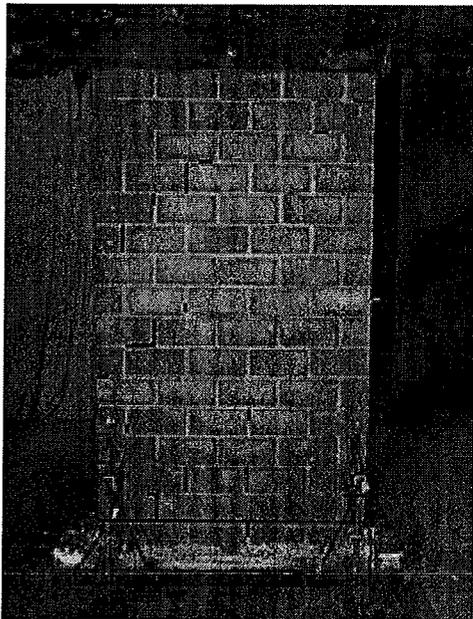
d) Run I

Figure 3.14: Crack propagation of Wall IB for selected runs

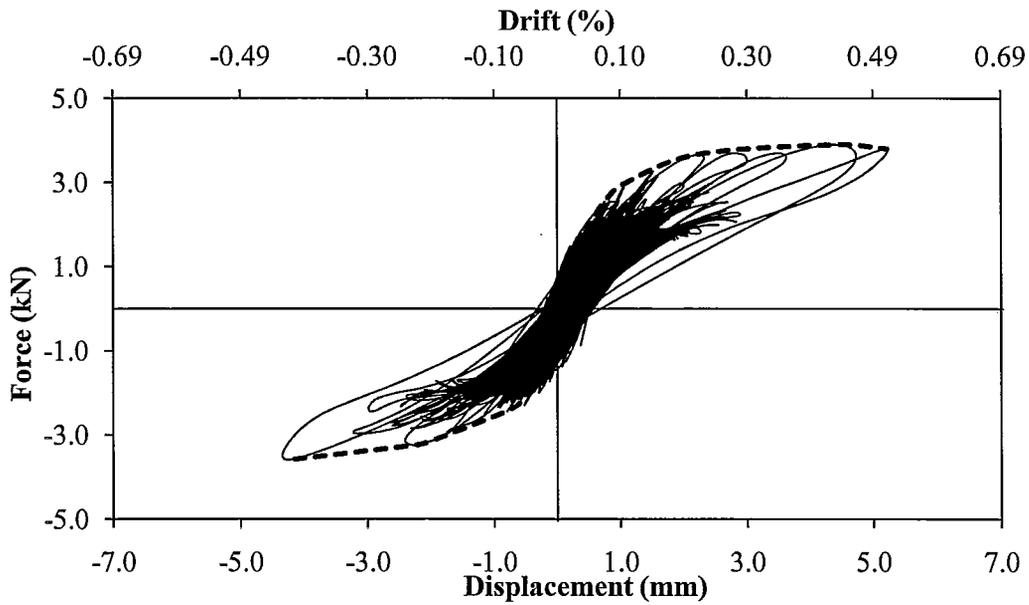
Figure 3.15: Wall IB hysteresis plot of all runs

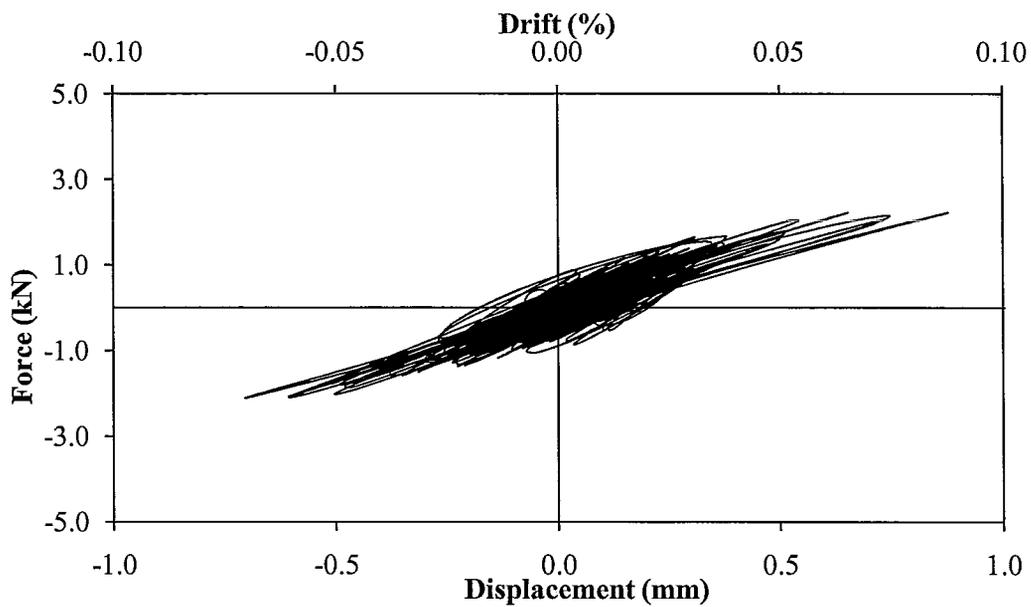
Figure 3.16: Wall IB Run D hysteresis showing change of stiffness

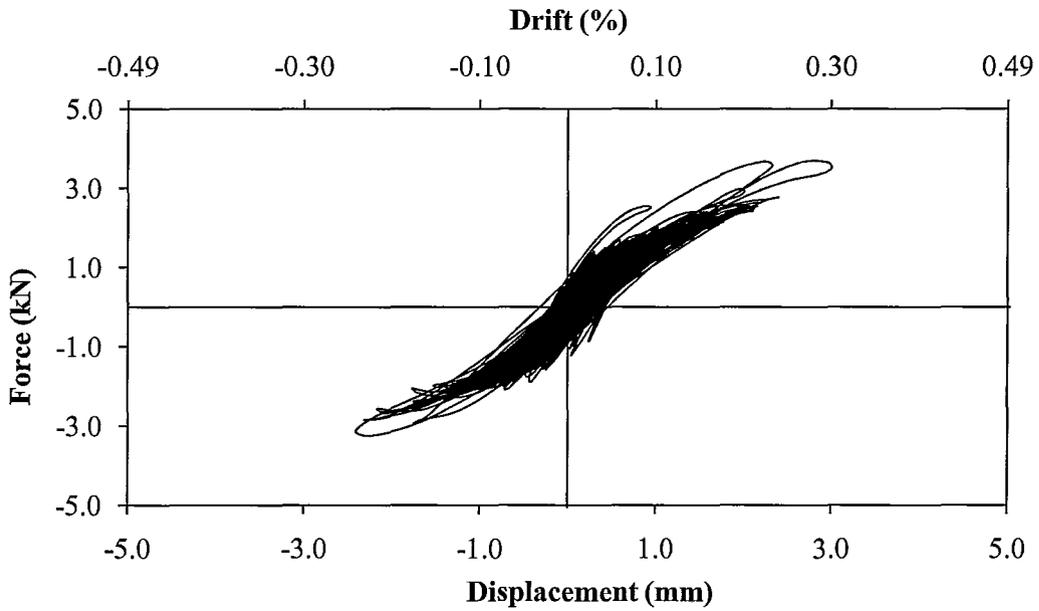
Figure 3.17: Wall IB Run H hysteresis showing energy dissipation

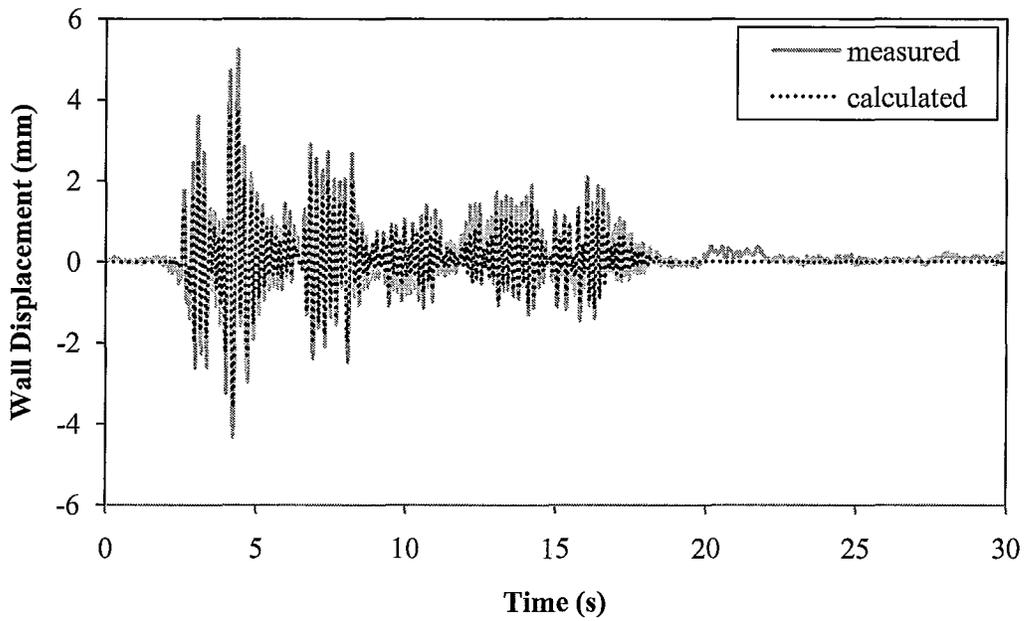
Figure 3.20: Time-history comparison between measured and calculated displacements due to the rocking of Wall IB

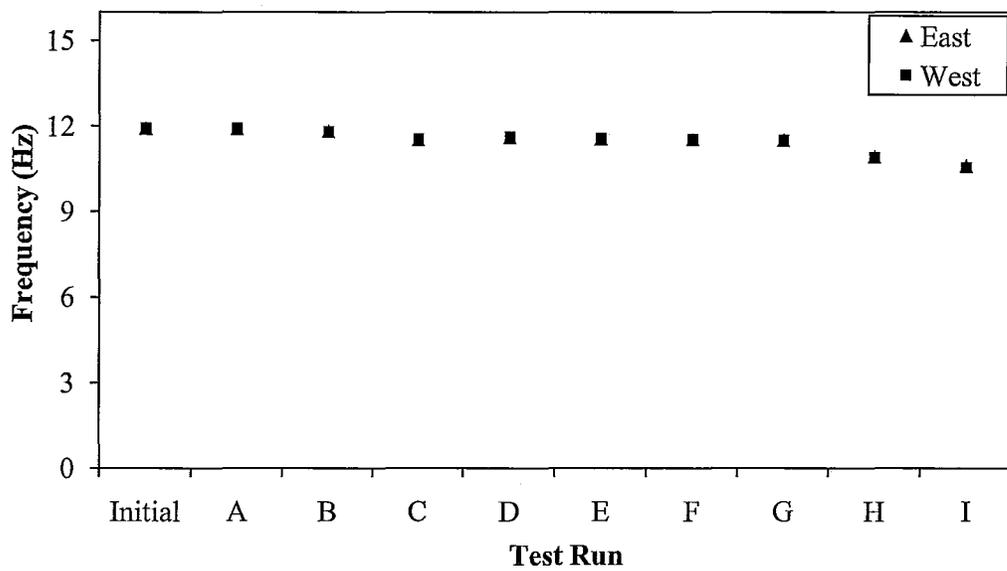
Figure 3.21: Hammer tap test frequency of Wall IB

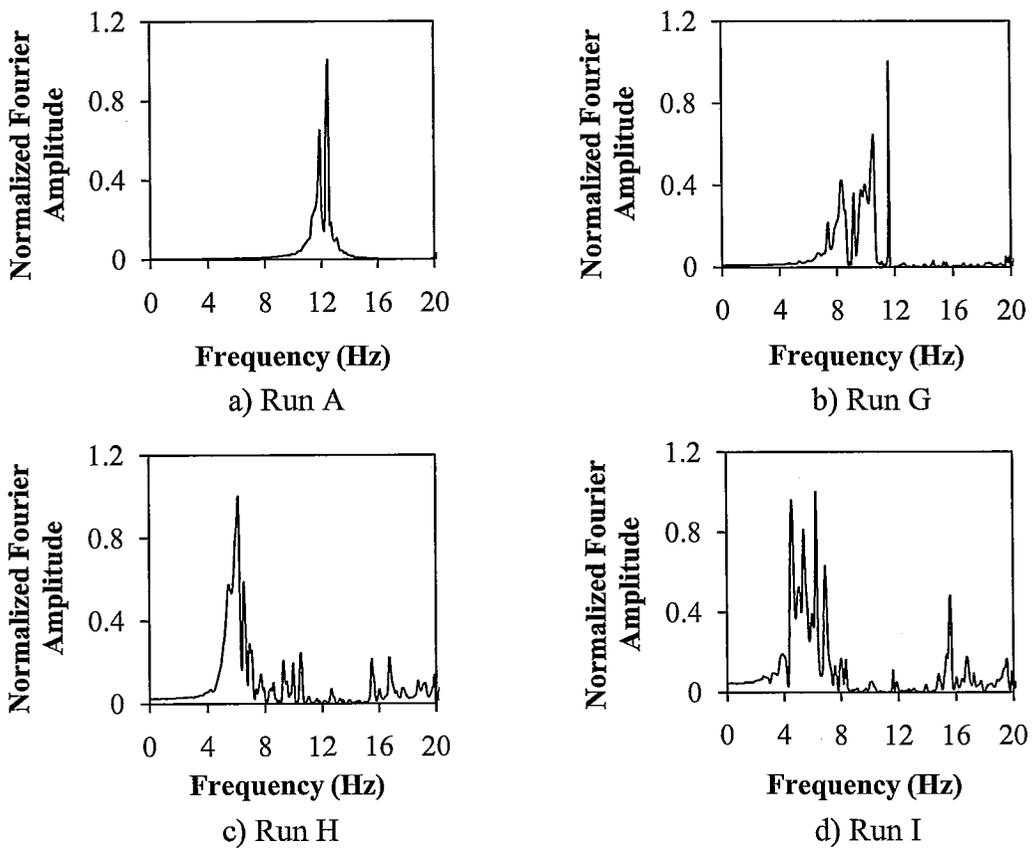
Figure 3.22: Frequency of Wall IB during several runs calculated by the FFT

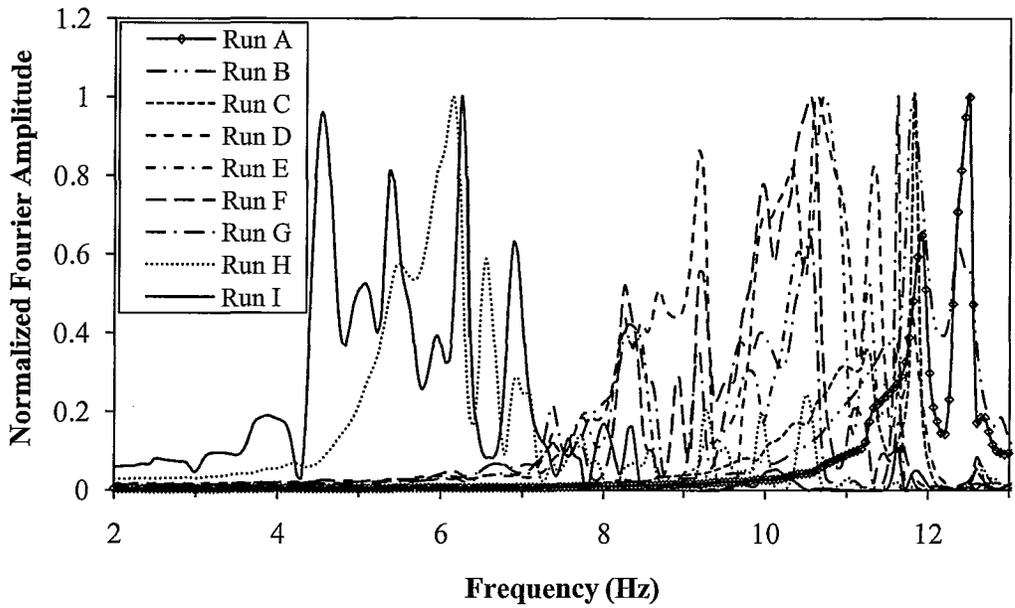
Figure 3.23: Frequency of Wall IB with all runs superimposed on the same graph calculated by the FFT

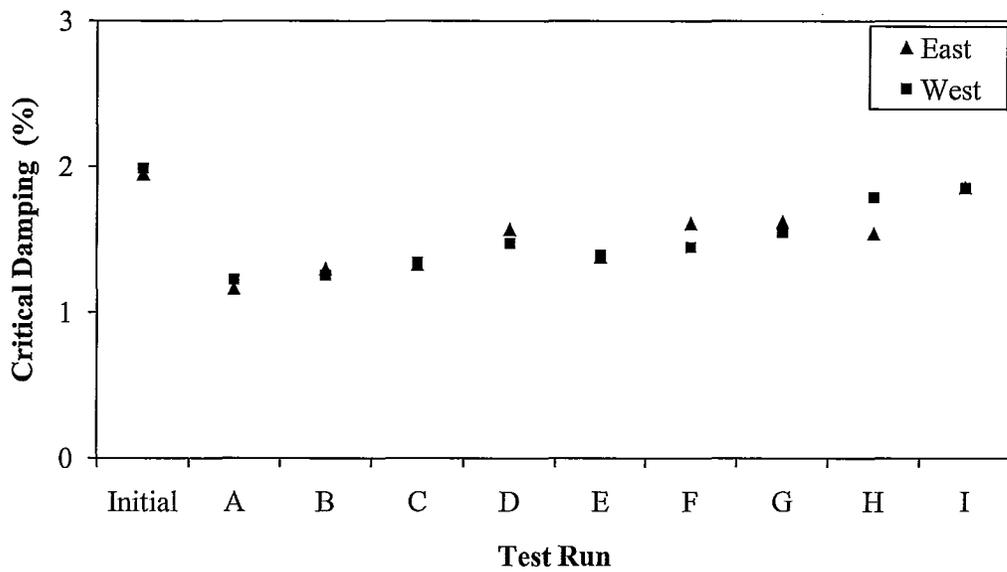
Figure 3.24: Critical damping of Wall IB runs calculated from the hammer tap test

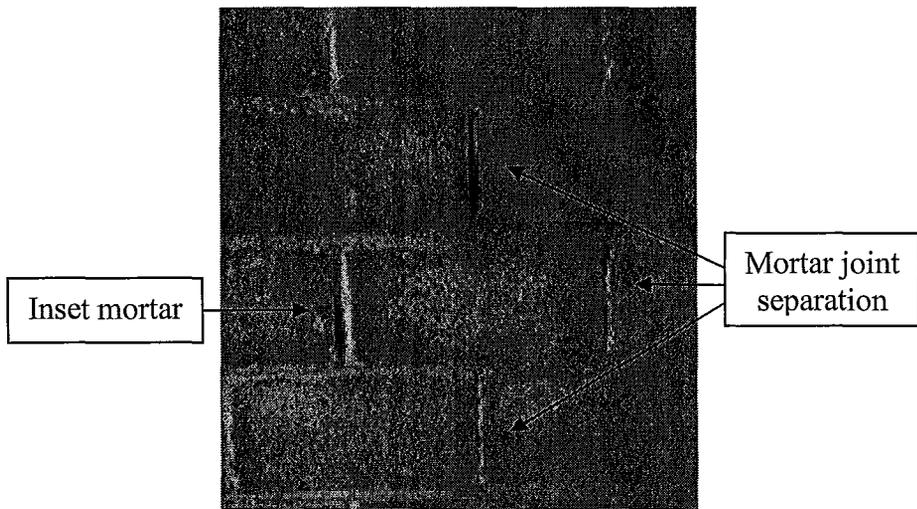
Figure 3.25: Inset and separated mortar joints on the South face

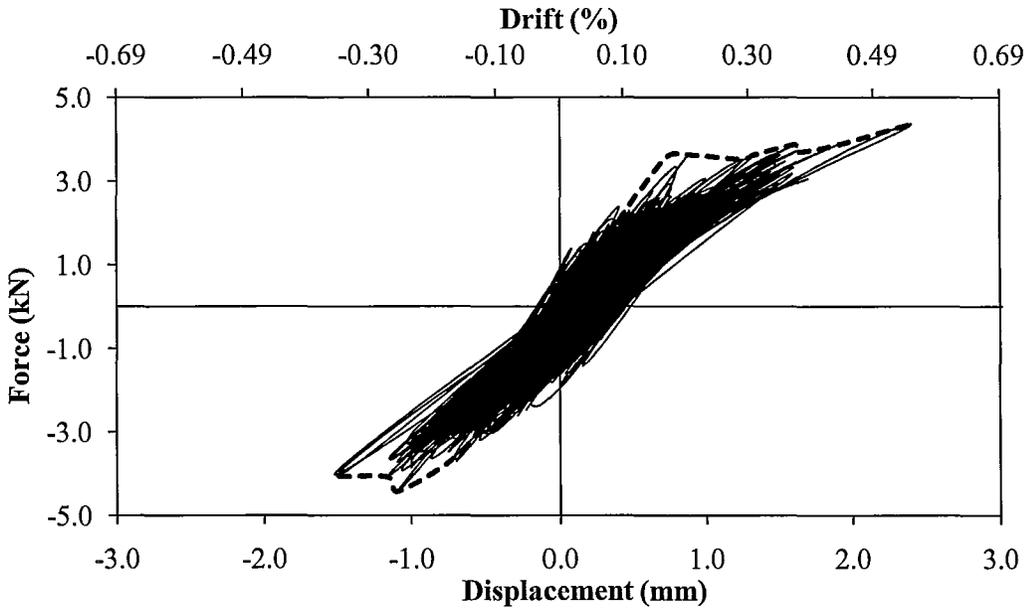
Figure 3.27: Wall IIA hysteresis plot of all runs

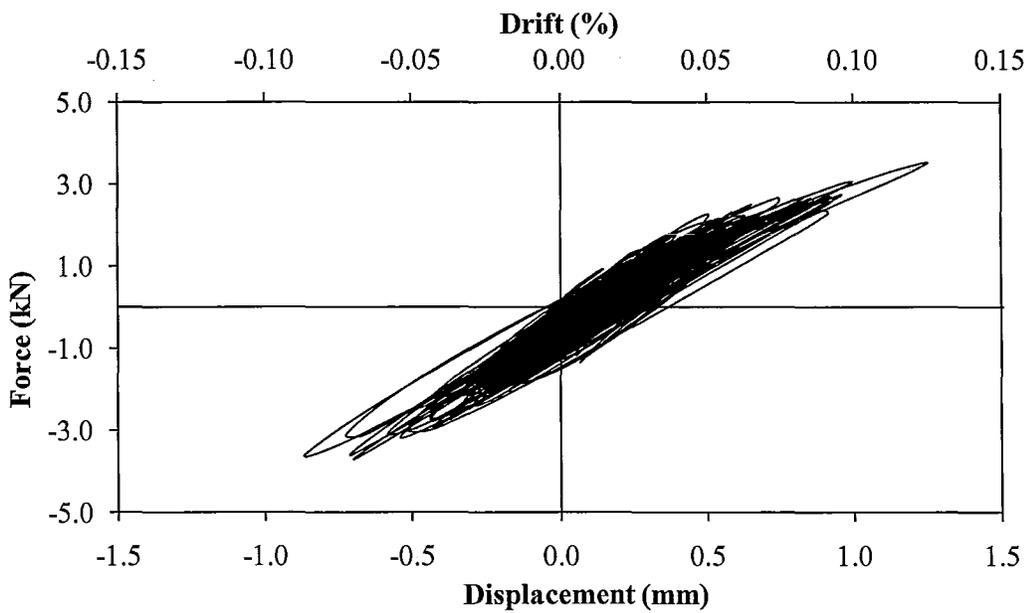
Figure 3.28: Wall IIA Run F hysteresis showing change of stiffness

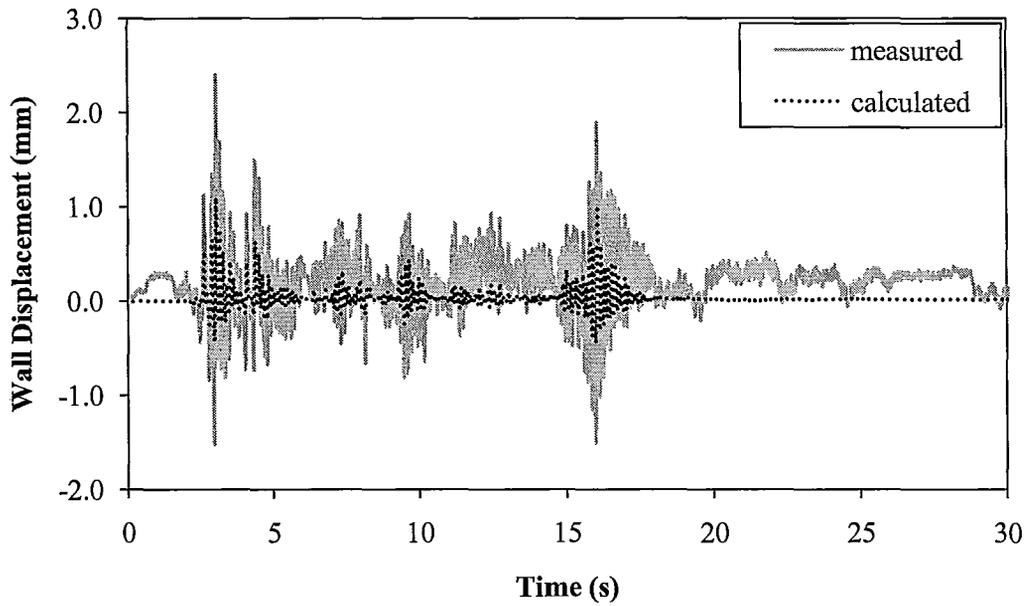
Figure 3.31: Time-history comparison between measured and calculated displacements due to the rocking of Wall IIA

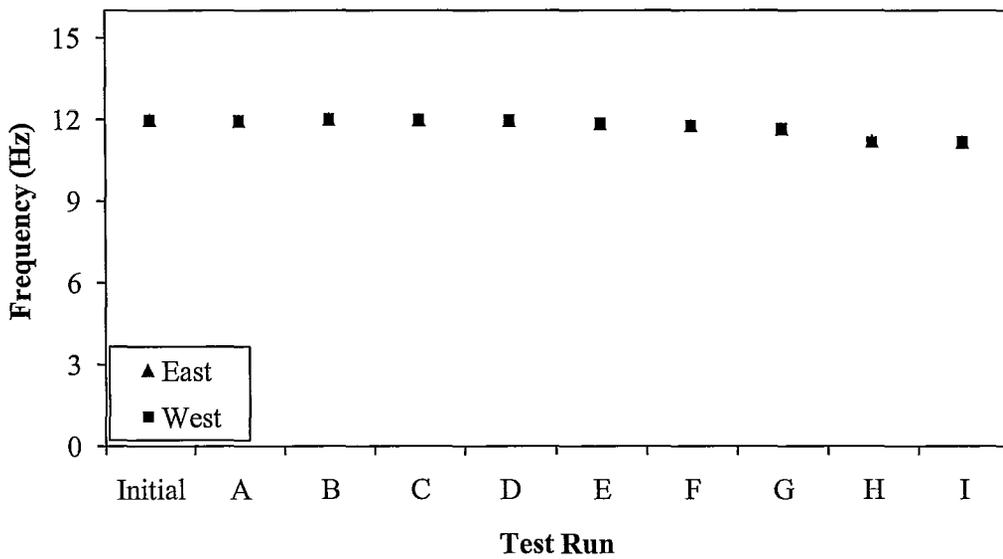
Figure 3.32: Hammer tap test frequency of Wall IIA

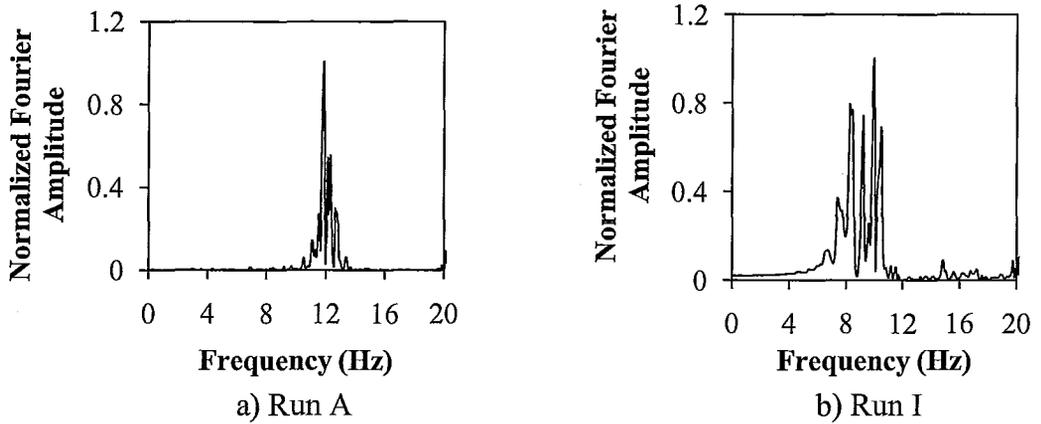
Figure 3.33: Frequency of Wall IIA during several runs calculated by the FFT

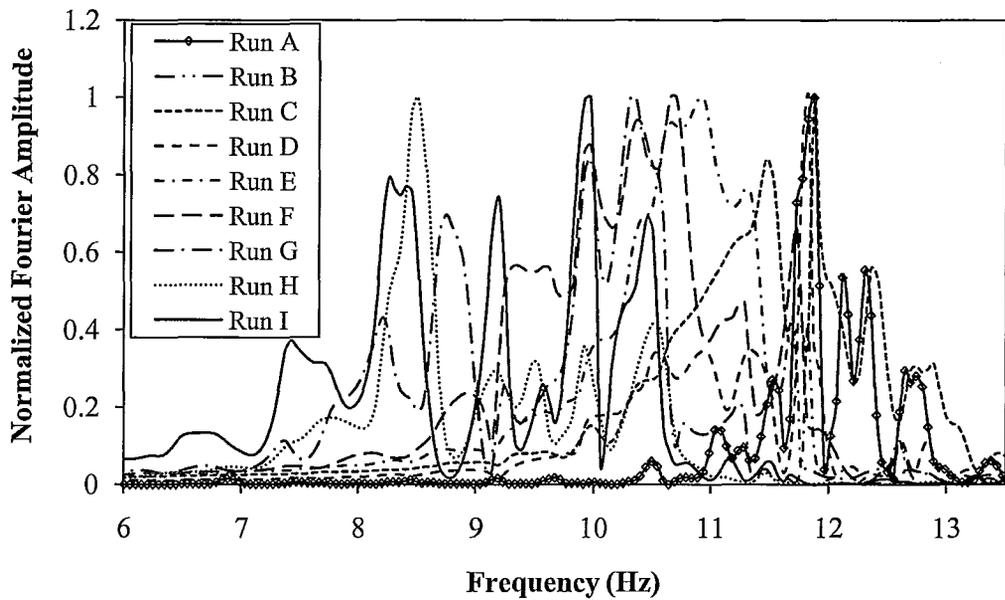
Figure 3.34: Frequency of Wall IIA with all runs superimposed on the same graph calculated by the FFT

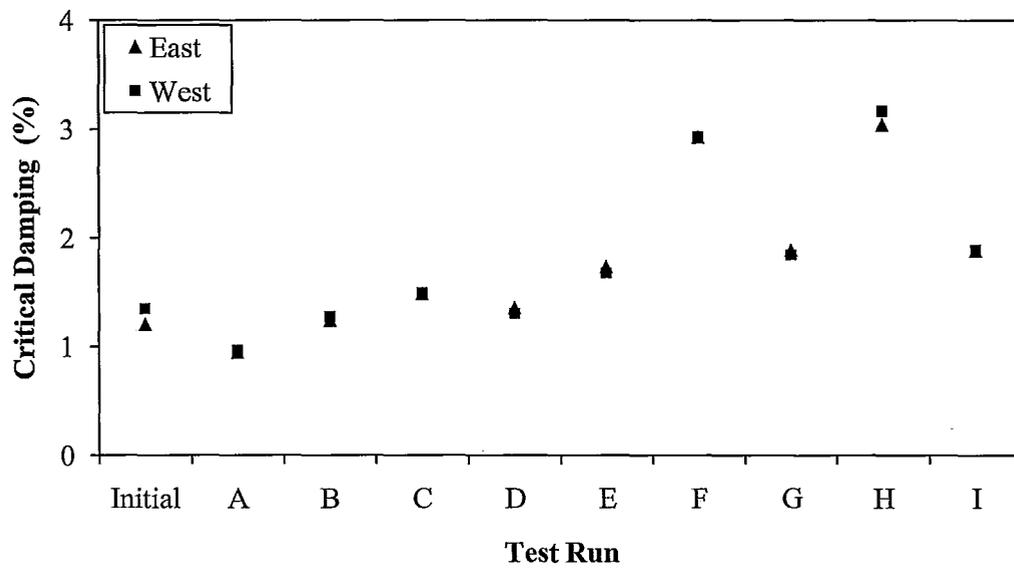
Figure 3.35: Critical damping of Wall IIA runs calculated from the hammer tap test

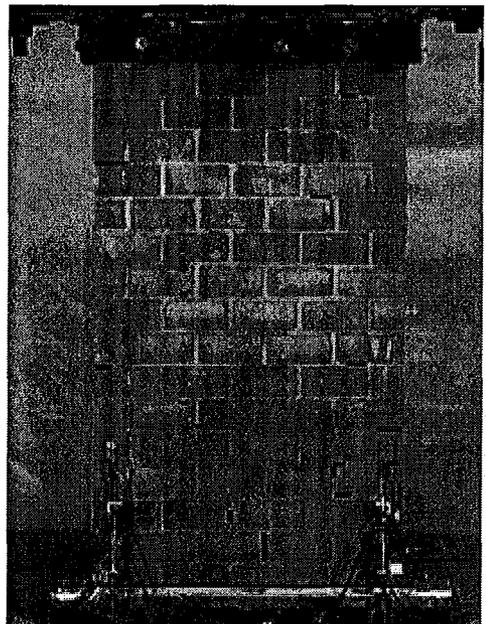
d) Run I

Figure 3.36: Crack propagation of Wall IIB for selected ru
