BEHAVIOUR OF PARTIALLY GROUTED
NOMINALLY REINFORCED MASONRY
SHEAR WALLS
UNDER DYNAMIC LOADING

A Thesis

Master of Applied Science

McMaster University

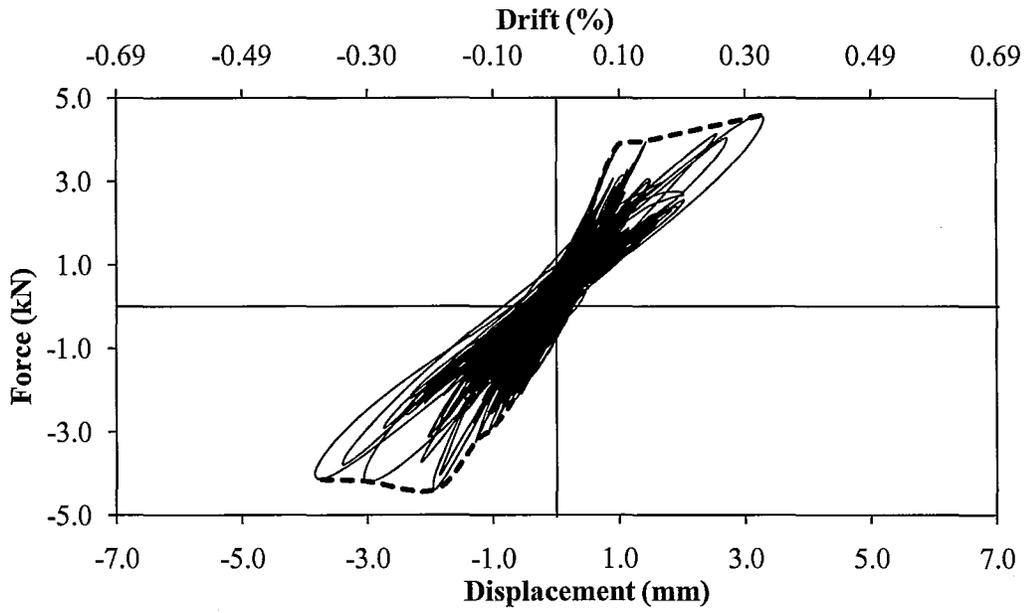
Figure 3.37: Wall IIB hysteresis plot of all runs

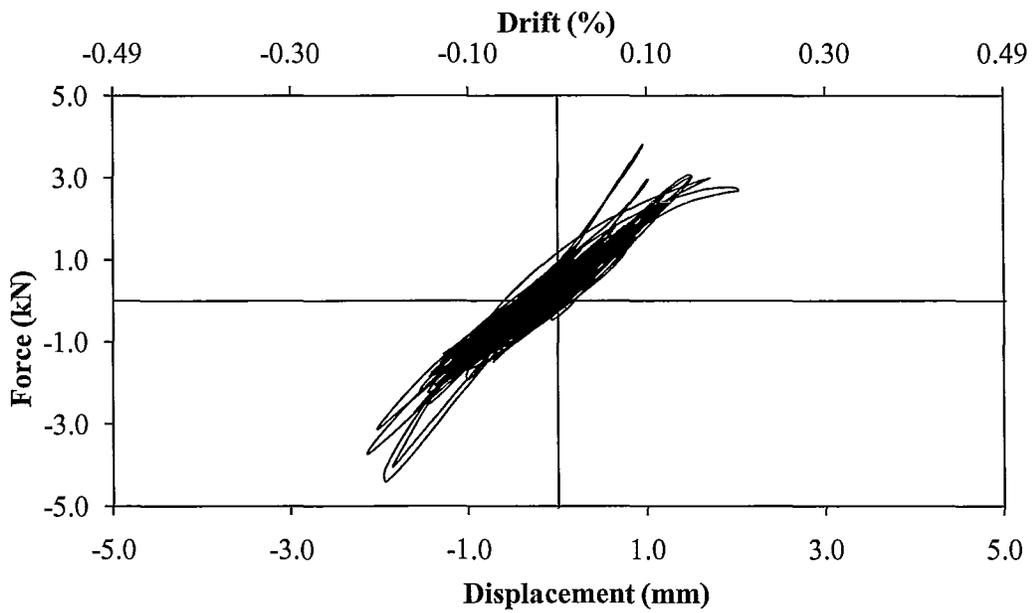
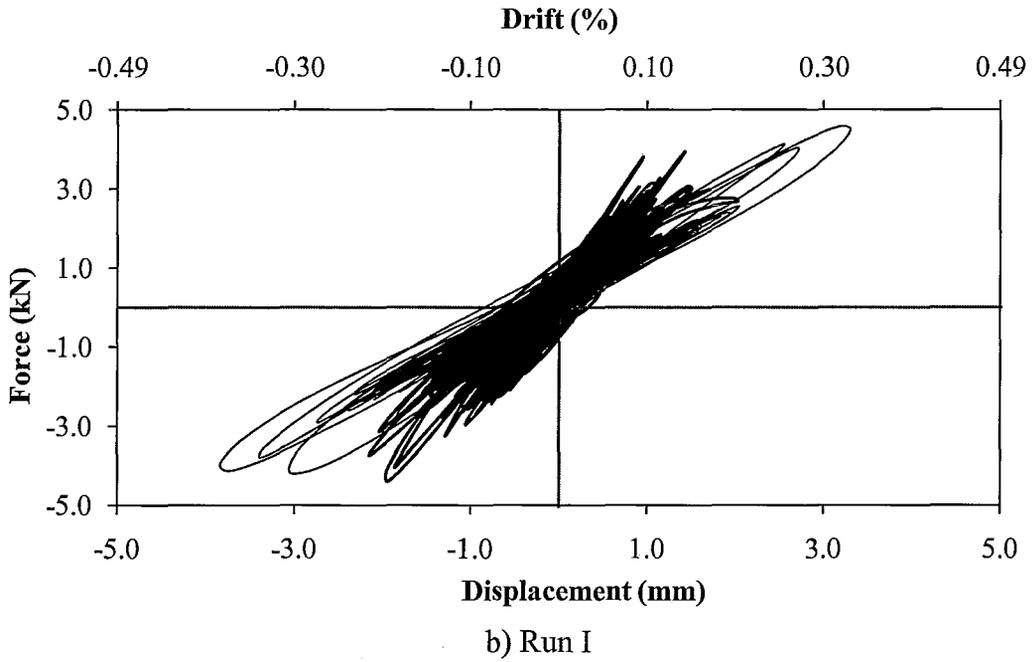
a) Run H

Figure 3.38: Wall IIB Run H and I showing change of stiffness and energy dissipation

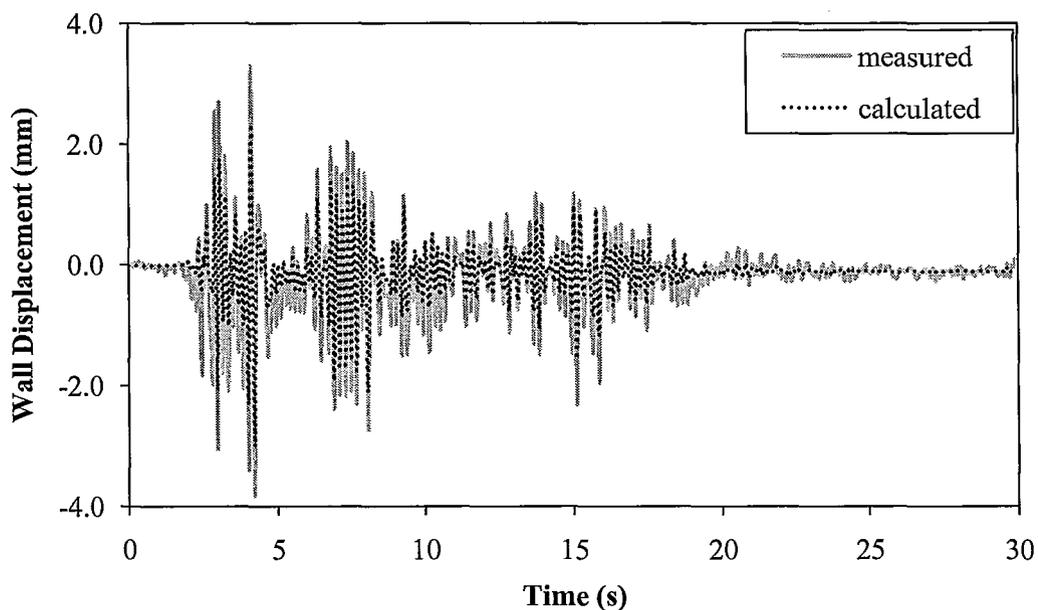
Figure 3.41: Time-history comparison between measured and calculated displacements due to the rocking of Wall IIB

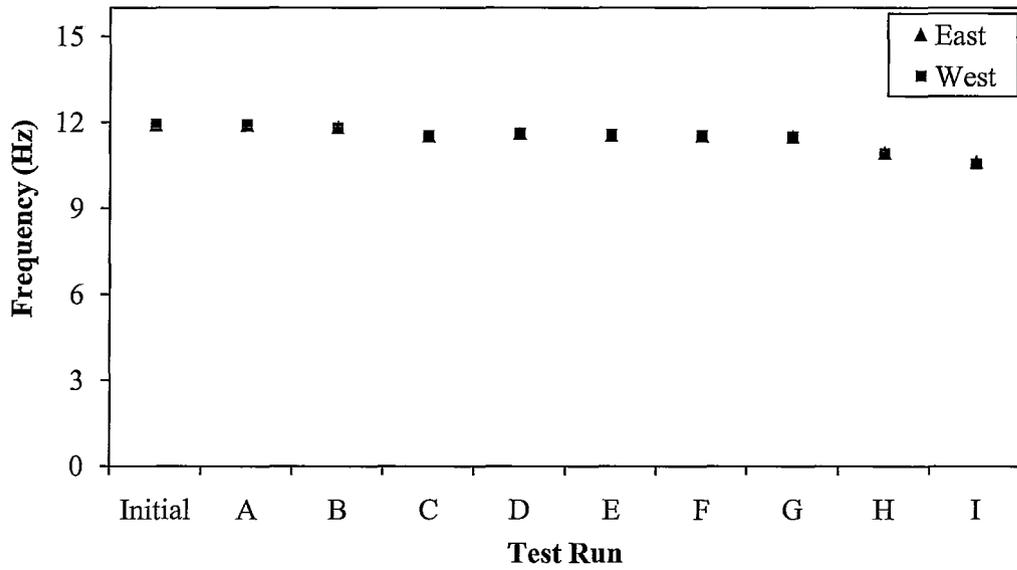
Figure 3.42: Hammer tap test frequency of Wall IIB

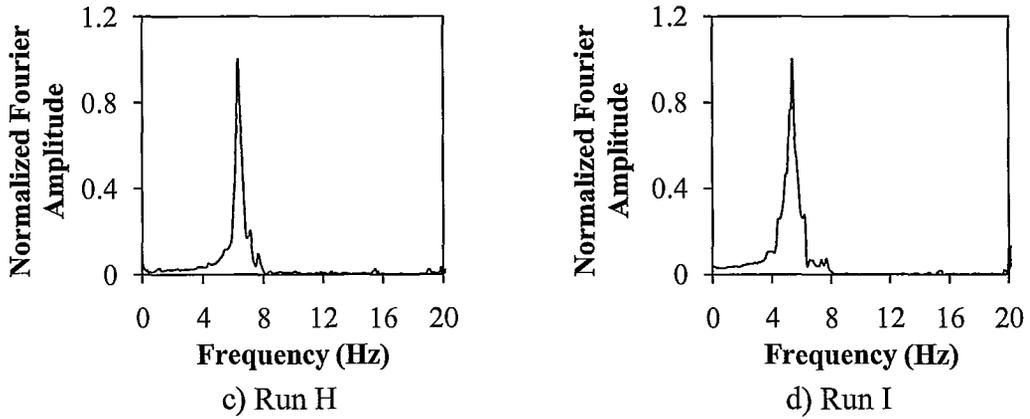
Figure 3.43: Frequency of Wall IIB during several runs calculated by the FFT

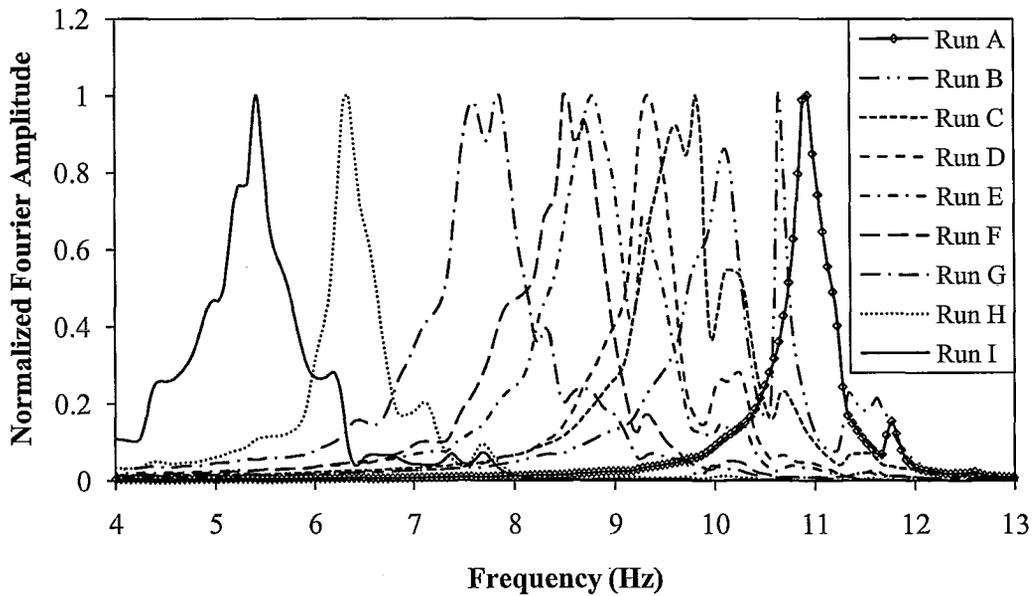
Figure 3.44: Frequency of Wall IIB with all runs superimposed on the same graph calculated by the FFT

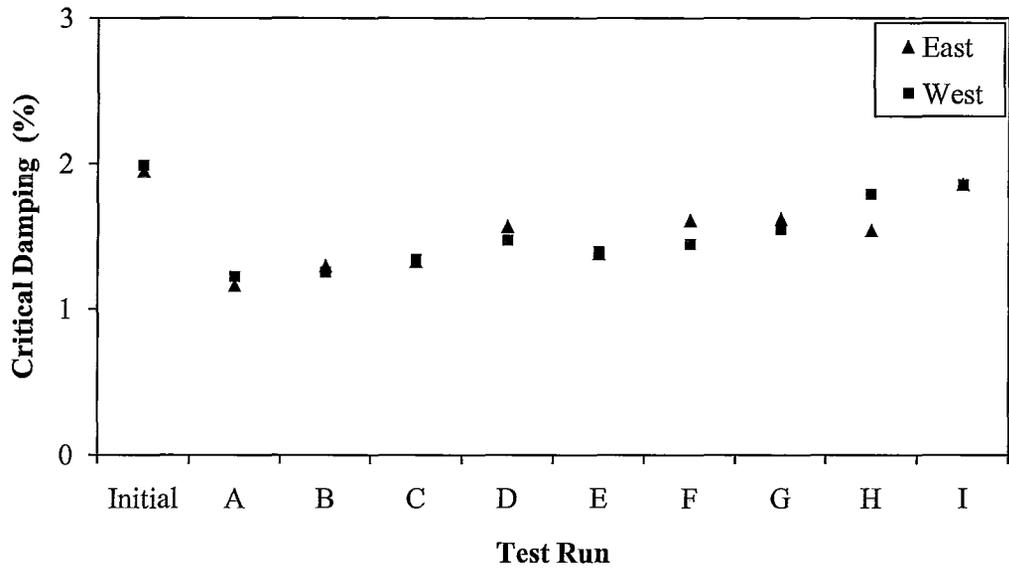
Figure 3.45: Critical damping of Wall IIB runs calculated from the hammer tap test

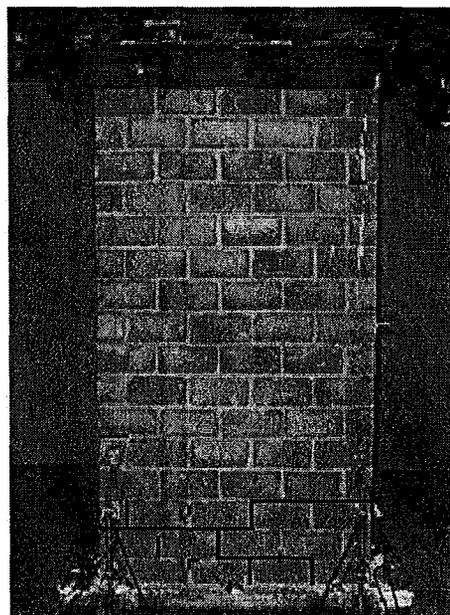
e) Run I

Figure 3.46: Crack propagation of Wall IIIA for selected runs

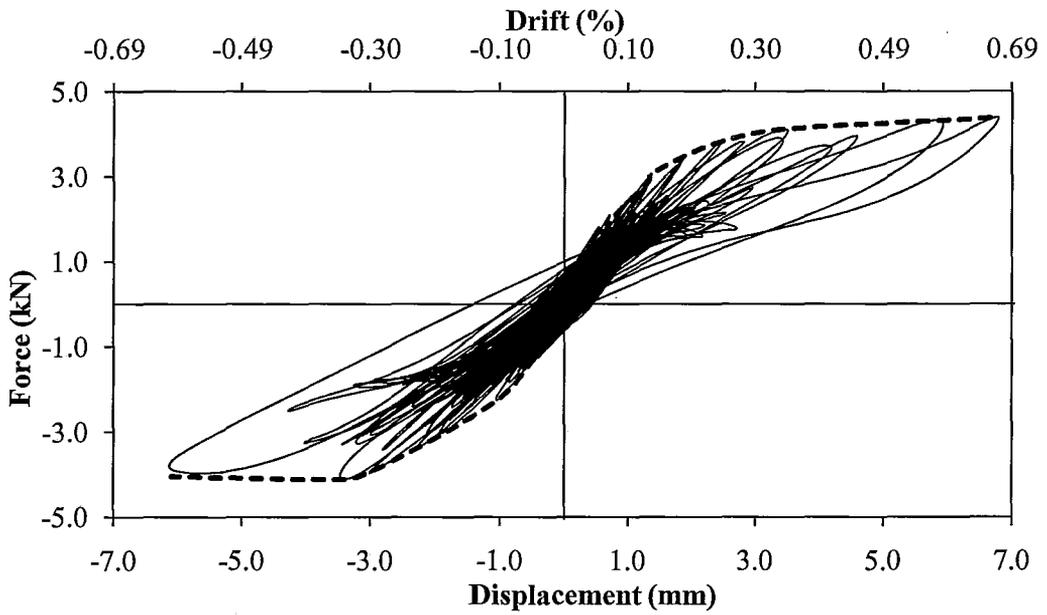
Figure 3.47: Wall IIIA hysteresis plot of all runs

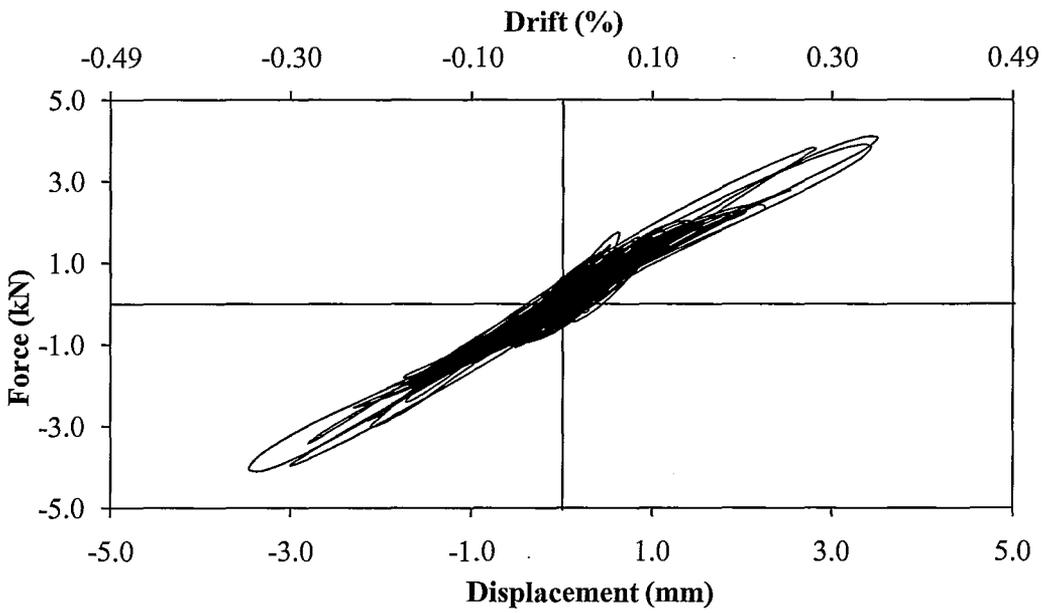
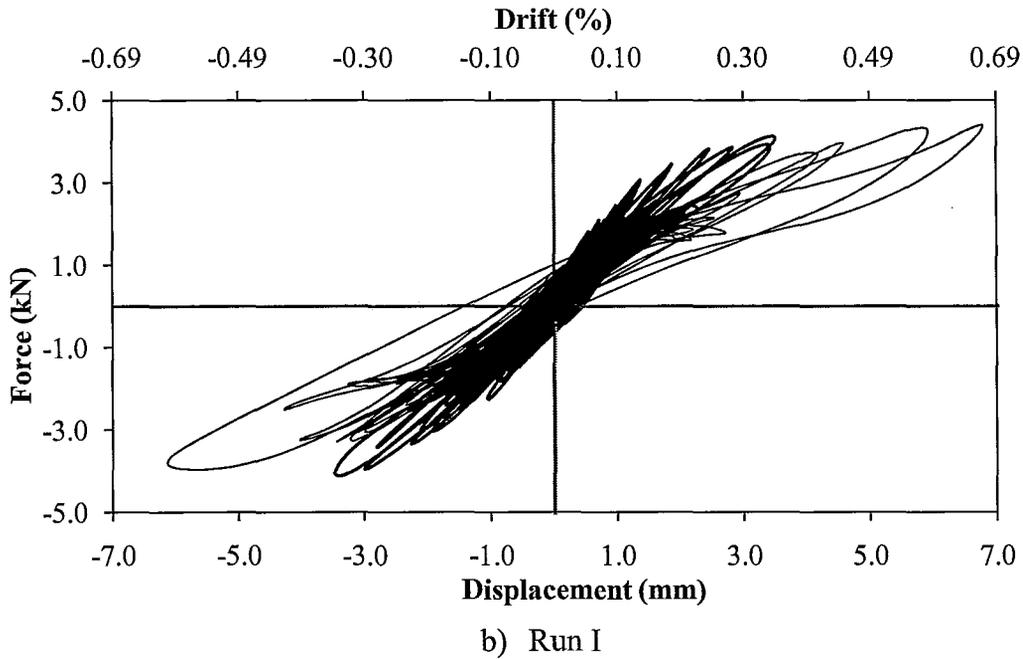
a) Run H

Figure 3.48: Wall IIIA Run H and I showing change of stiffness and energy dissipation

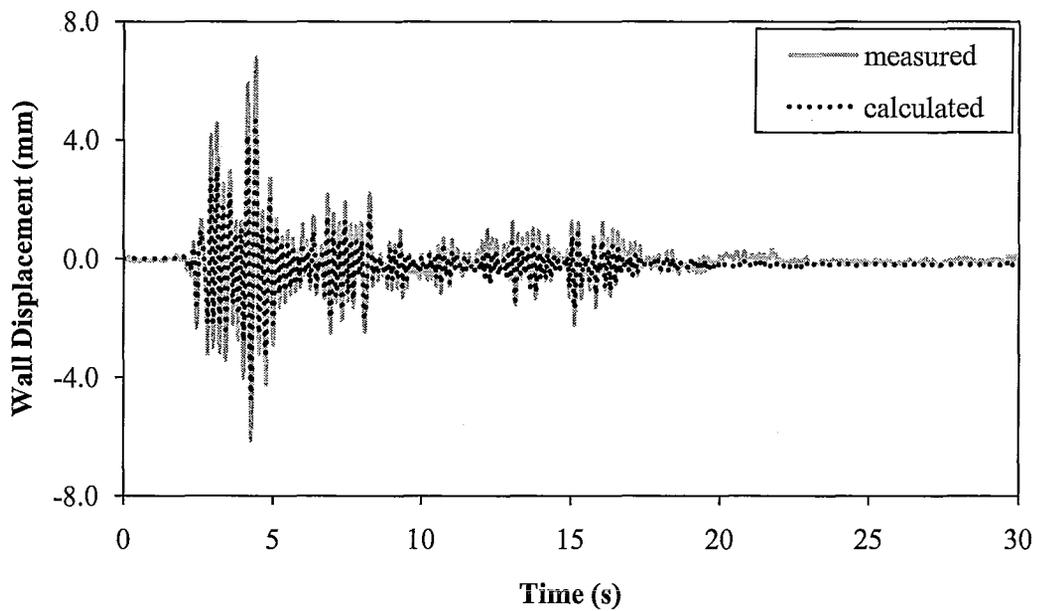
Figure 3.51: Time-history comparison between measured and calculated displacements due to the rocking of Wall IIIA

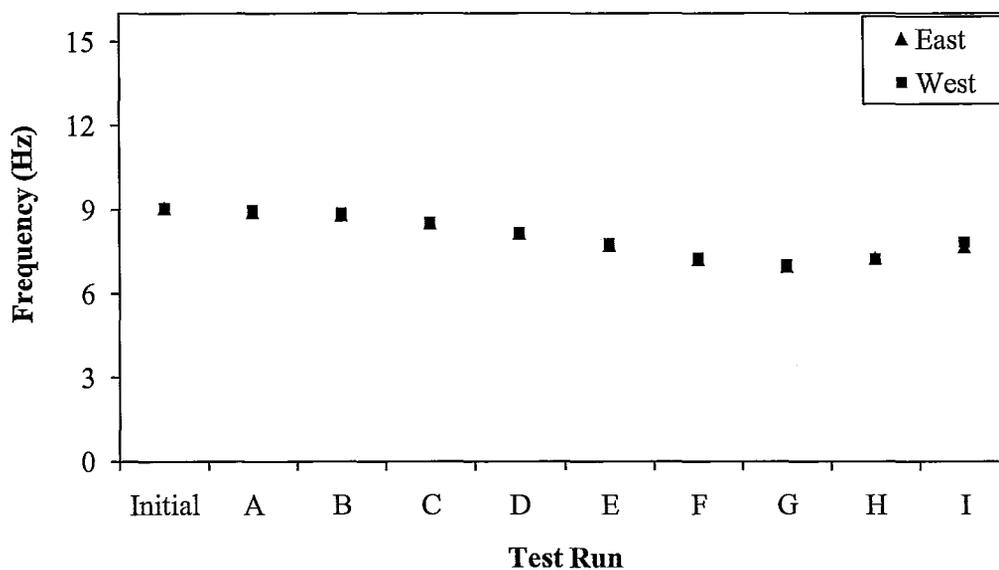
Figure 3.52: Hammer tap test frequency of Wall IIIA

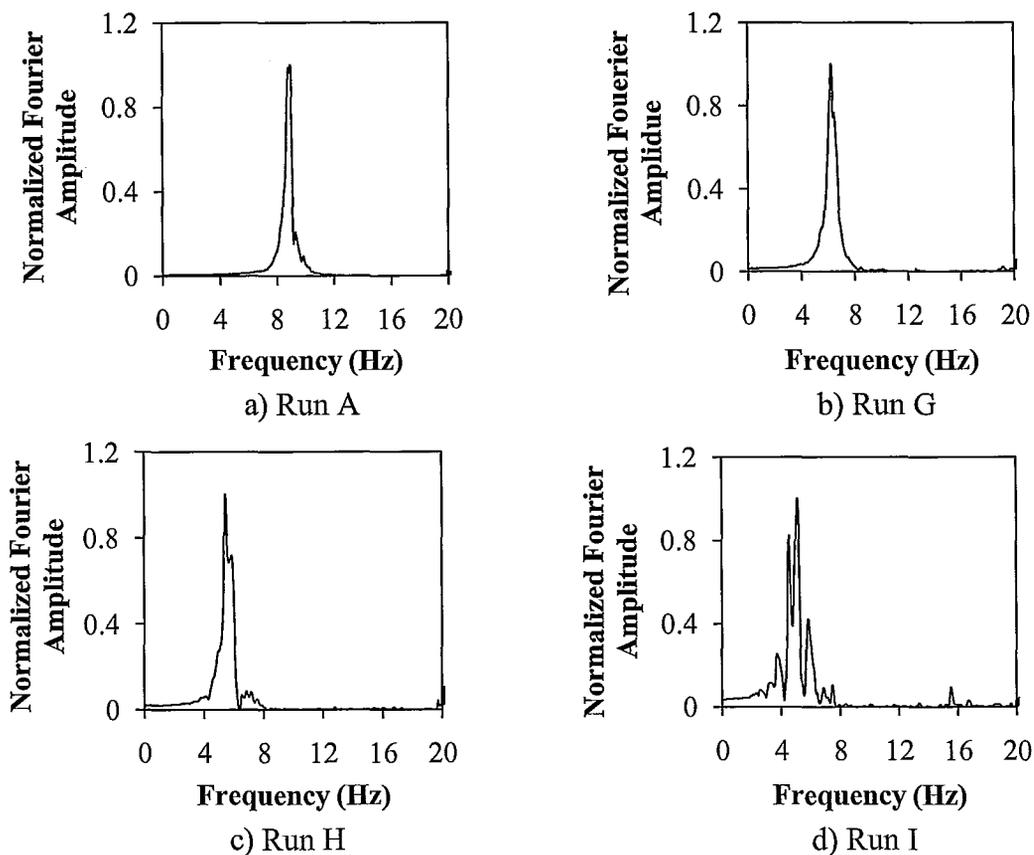
Figure 3.53: Frequency of Wall IIIA during several runs calculated by the FFT

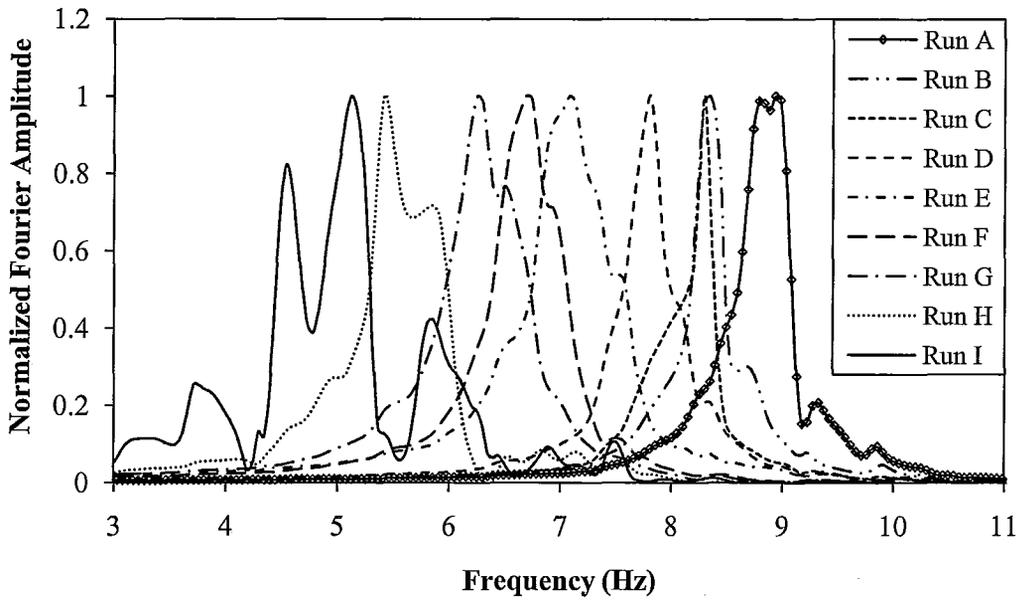
Figure 3.54: Frequency of Wall IIIA with all runs superimposed on the same graph calculated by the FFT

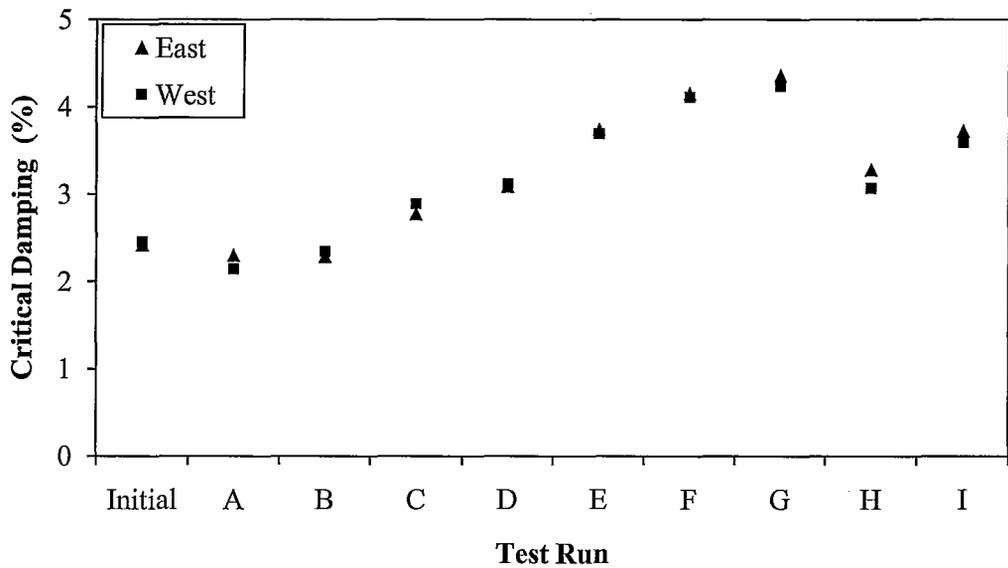
Figure 3.55: Critical damping of Wall IIIA runs calculated from the hammer tap test

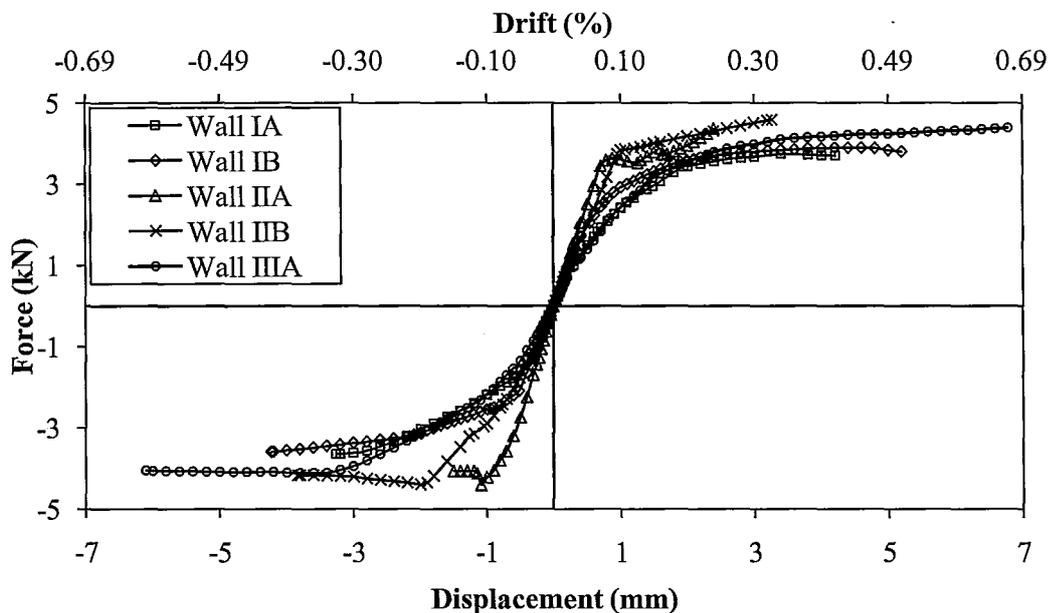
Figure 4.1: Hysteresis envelopes of all walls

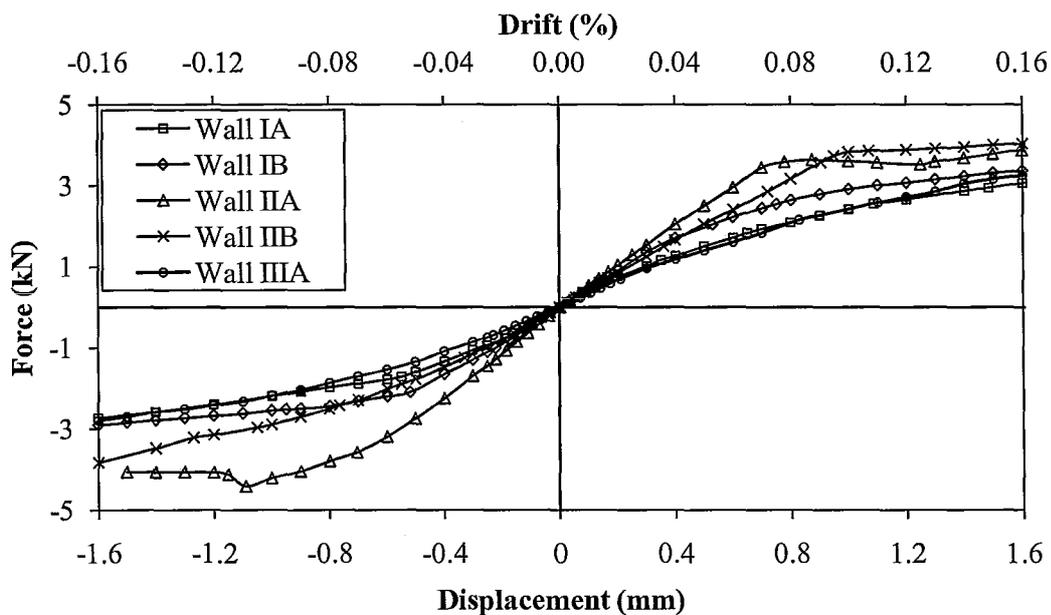
Figure 4.2: Initial hysteresis envelopes at low level drifts

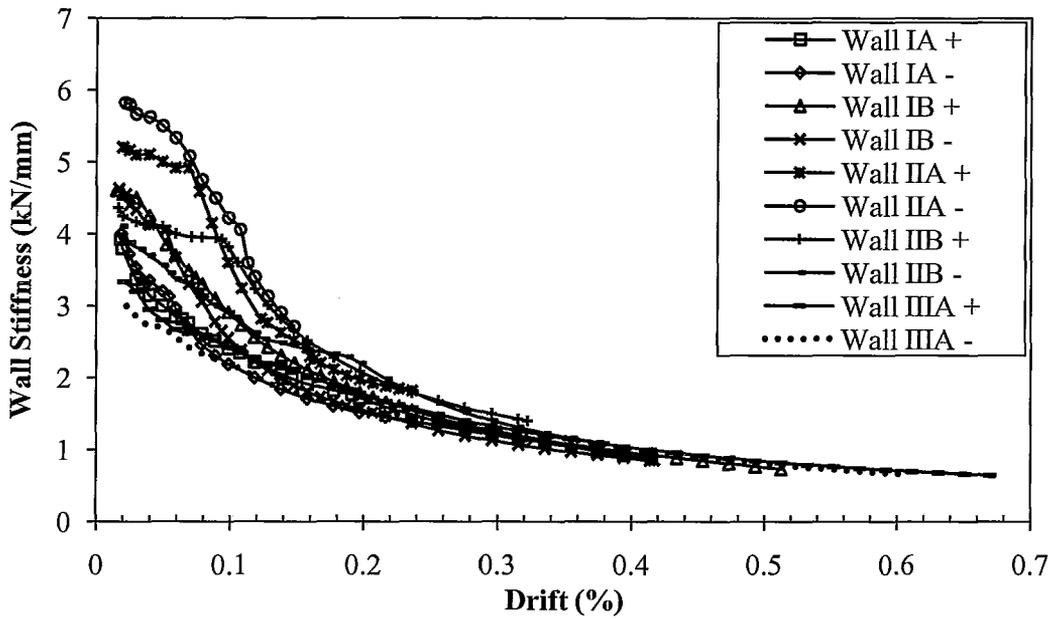
Figure 4.3: Secant stiffness versus drift

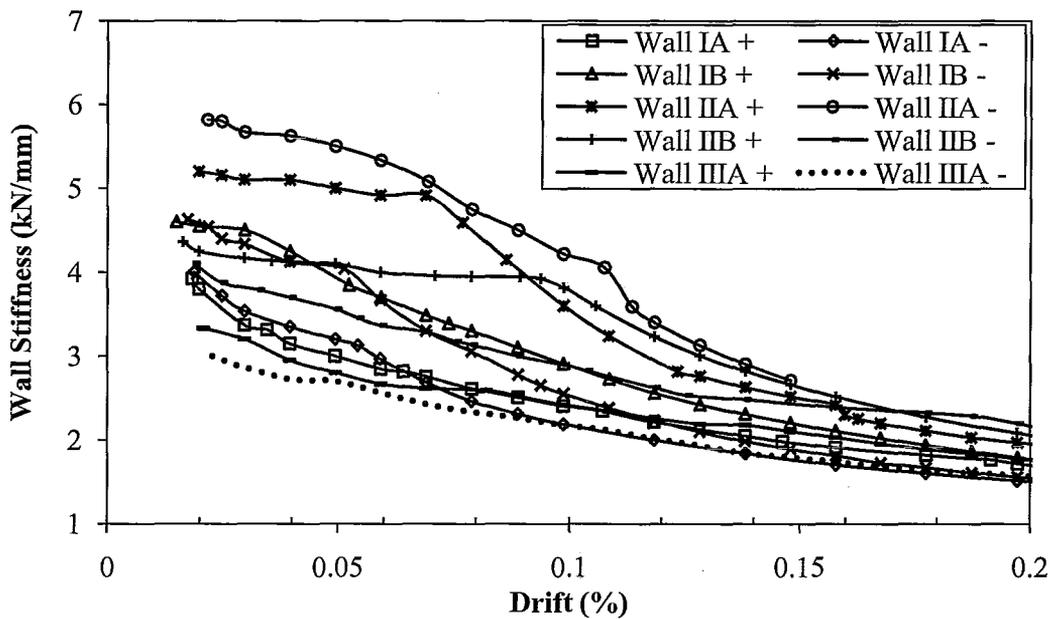
Figure 4.4: Secant stiffness at low level drifts

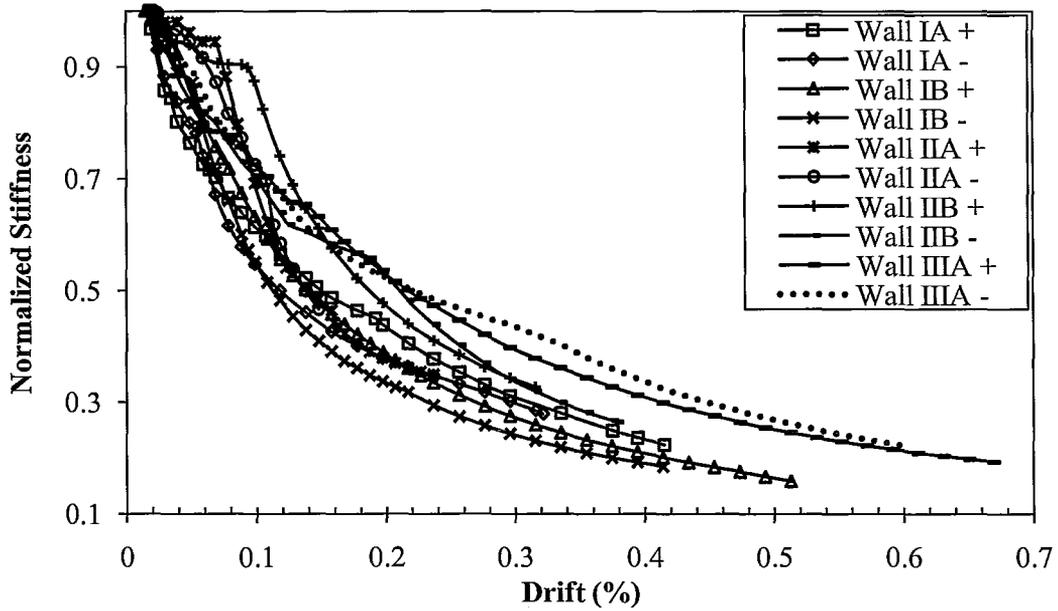
Figure 4.5: Normalized secant stiffness versus drift

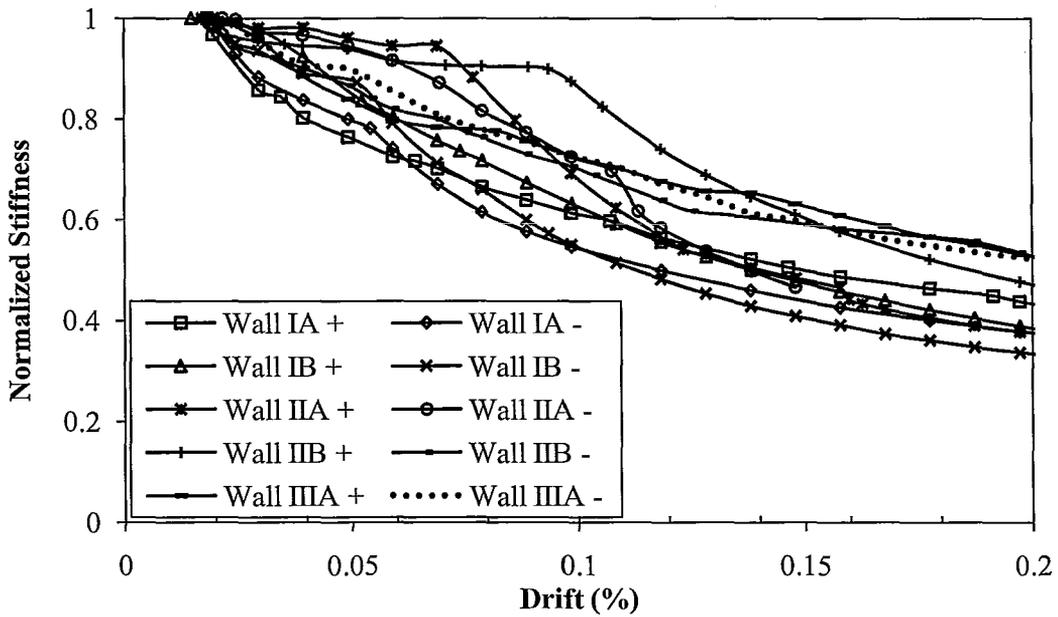
Figure 4.6: Normalized secant stiffness at low level drifts

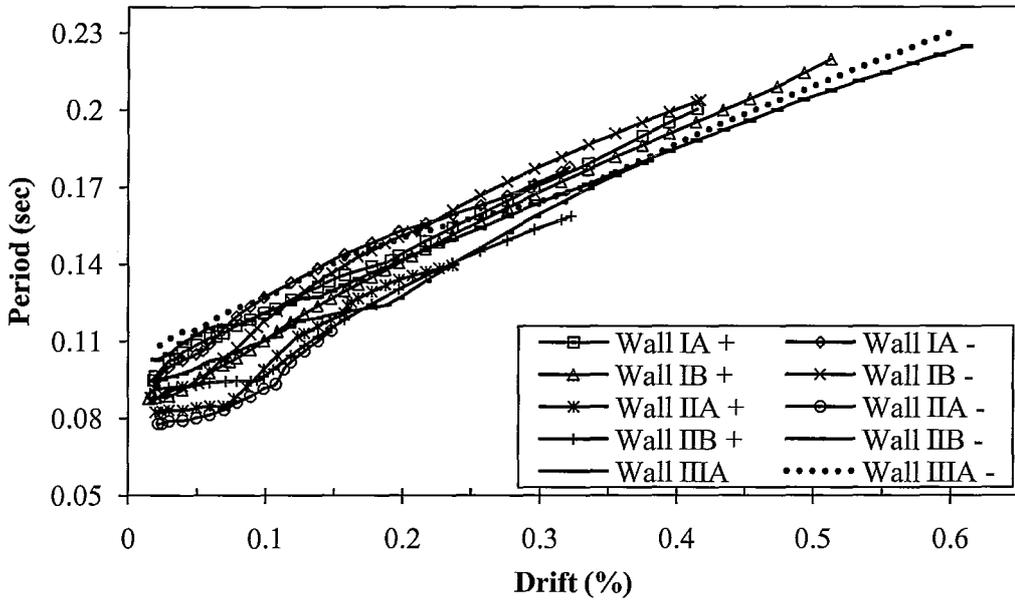
Figure 4.7: Period versus drift

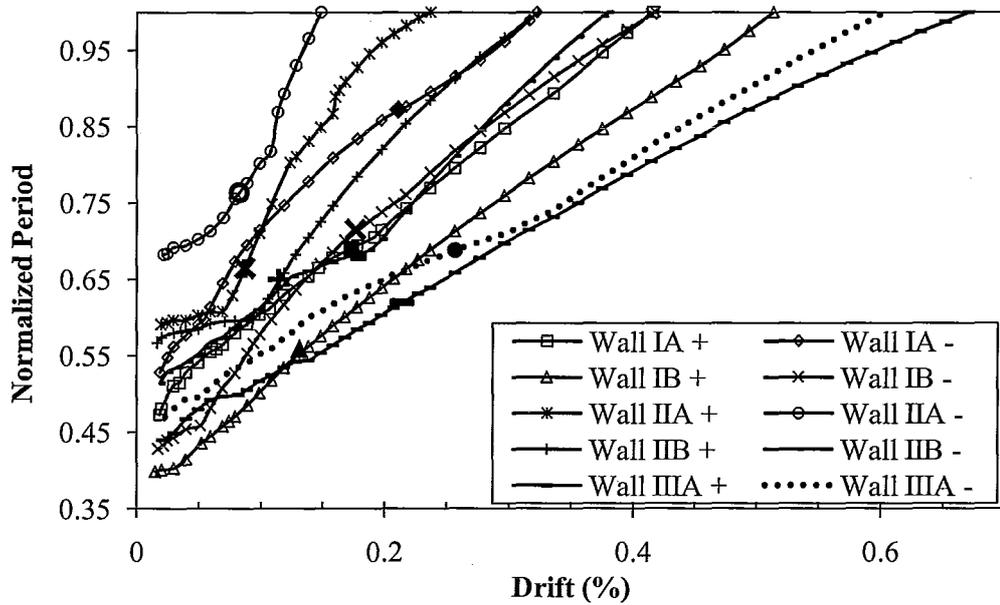
Figure 4.8: Normalized period versus drift
