**Behaviour of a Reduced-Scale Fully Grouted Reinforced
Concrete Block Masonry Building**

Jordan Marc Vandervelde

A Thesis

Master of Applied Science

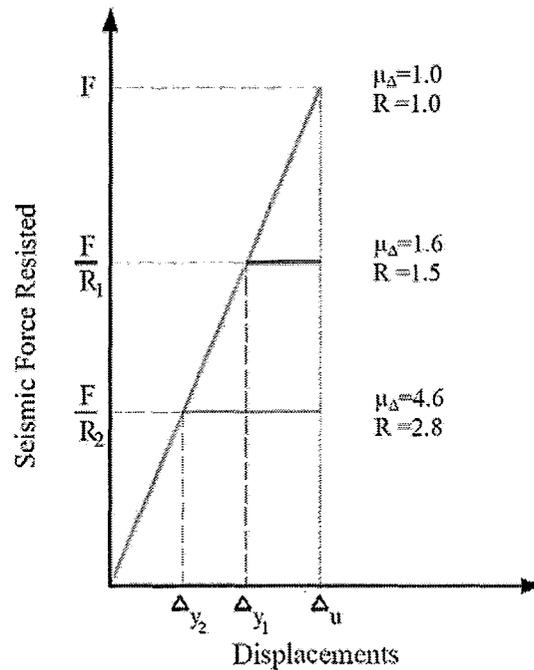
Figure 1.1: Seismic Reduction Factors Based on Equal Energy (Shedid, 2006)

As suggested previously, certain detailing is required to allow for load reduction factors to be used. As shown in Figure 1.1, the required strength for the more ductile structure is significantly less than the elastic strength requirement. This reduction in elastic demand is accounted for with force reduction factors. Therefore, the structure need only be designed for a strength of V_p , which is only V_e/R , where R is the reduction factor, if the appropriate level of ductility can be provided. The National Building Code of Canada (NBCC, 2010), referencing the detailing requirements found in the Canadian masonry design standard, CSA S304.1 (2004), allows a maximum load reduction factor of

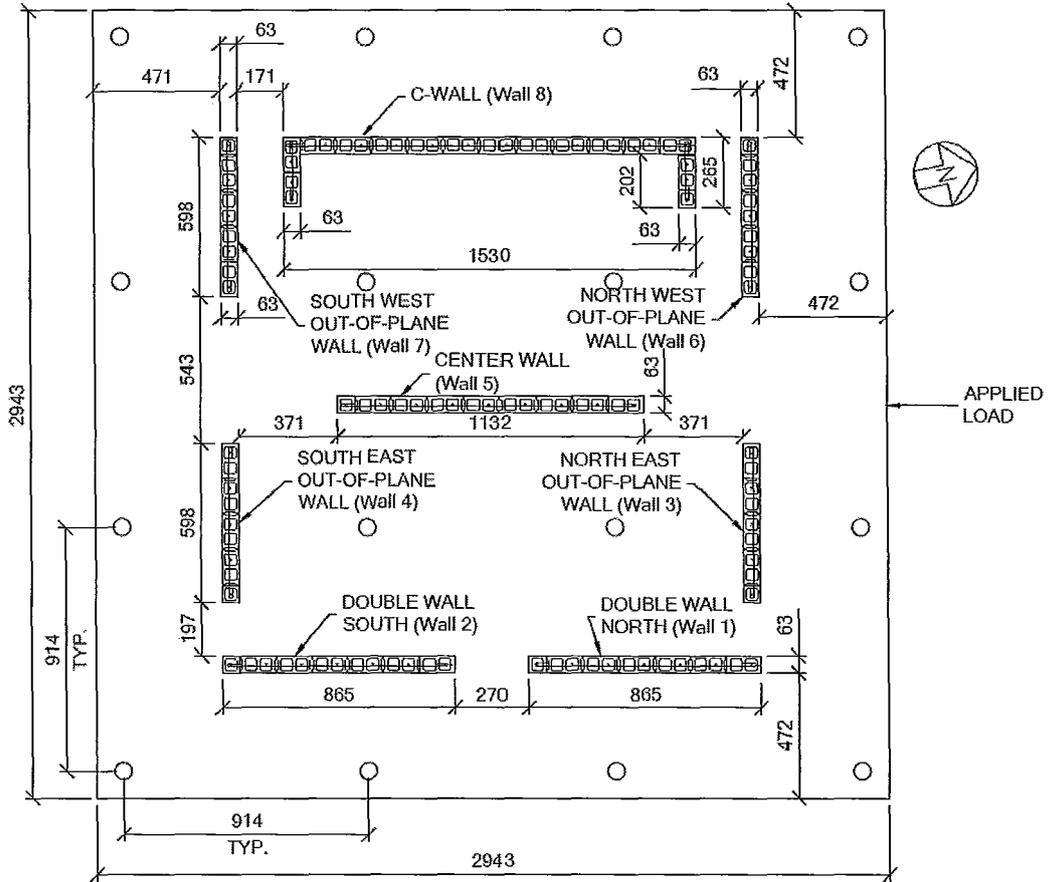
Figure 2.4: Final Layout of Experimental Building

Given the laboratory area available for this test program, the building size was limited to 2.5 m by 2.5 m. For the first test in this program a slightly smaller size of 2 m by 2 m was chosen so as not to push the limits of the test setup with the first trial. The layout of the structure also was designed to be torsionally unbalanced in the plane of loading to include the effects of torsion on reinforced masonry structures. On the other hand, the building was designed to be balanced in the plane orthogonal to the loading plane so as to simplify the analysis of the torsional response. The full building layout can be seen in Figure 2.4.

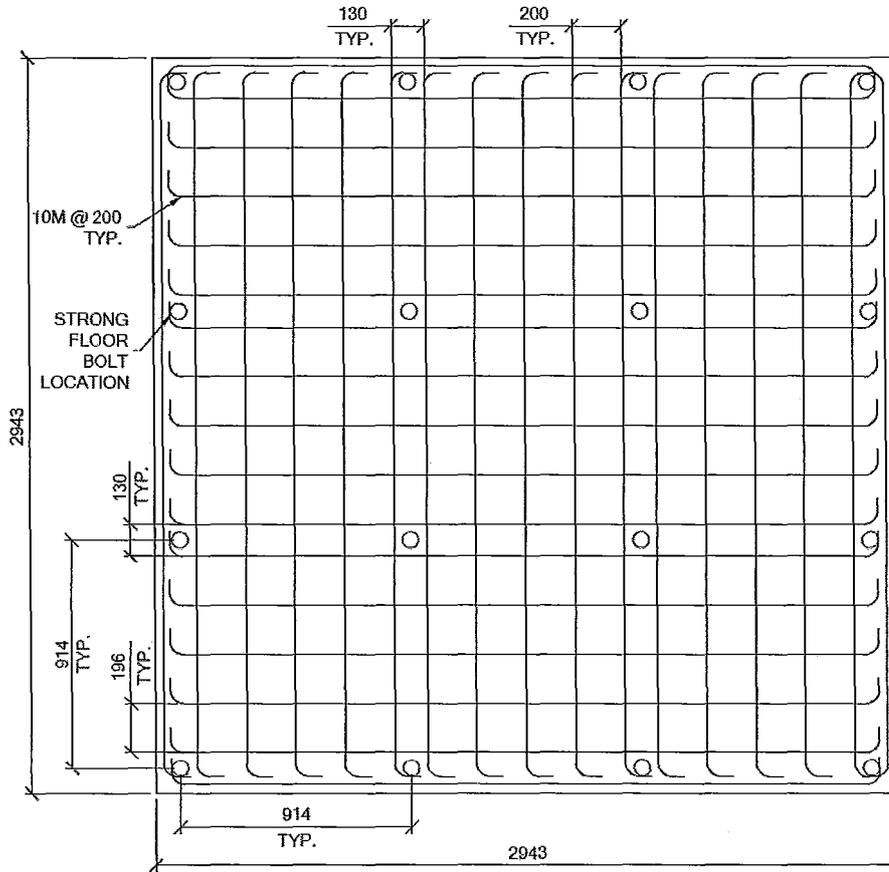
Figure 2.5: Reinforcing Bar Locations in the Foundation Slab

The foundation for the structure was designed to not only fit into the test rig but also to provide a stable base for the structure. The foundation slab was designed to be 150 mm thick with top and bottom layers of No. 10 reinforcing bars spaced at 200 mm horizontally. This reinforcement was chosen based on a rough calculation of the moment that would be developed in the base due to the strongest wall. The calculated moment required No. 10 bars spaced at 400 mm to resist the loading but a spacing of 200 mm was chosen to avoid any possibility of foundation flexibility and also to accommodate the bolt grid in the strong floor of the laboratory. Orthogonal bars were added to resist any moment developed by the torsional response of the structure. Figure 2.5 shows the layout of the foundation slab reinforcement and how it fits in with the grid of bolt holes in the laboratory floor.

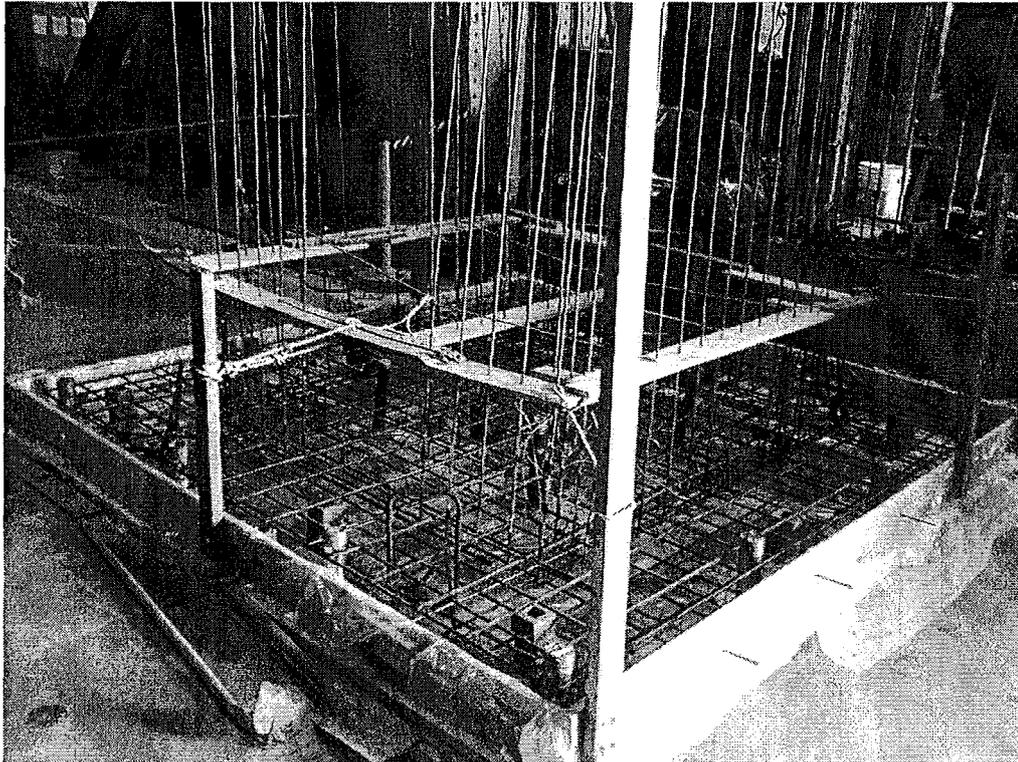
Figure 2.6 shows the vertical bars terminating in a 90 degree bend in the bottom of the foundation slab where they were tied to the slab reinforcing bars to help hold them in place during the pouring of the slab concrete. These bars extended up to over the entire height of the building to avoid any need for splicing of the vertical reinforcing bars. In effect, the foundation slab was over designed so that it would not become a factor in terms of deflections or vertical bar pullout.

Figure 2.6: Photograph of Reinforcement Prior to Placing the Slab Concrete

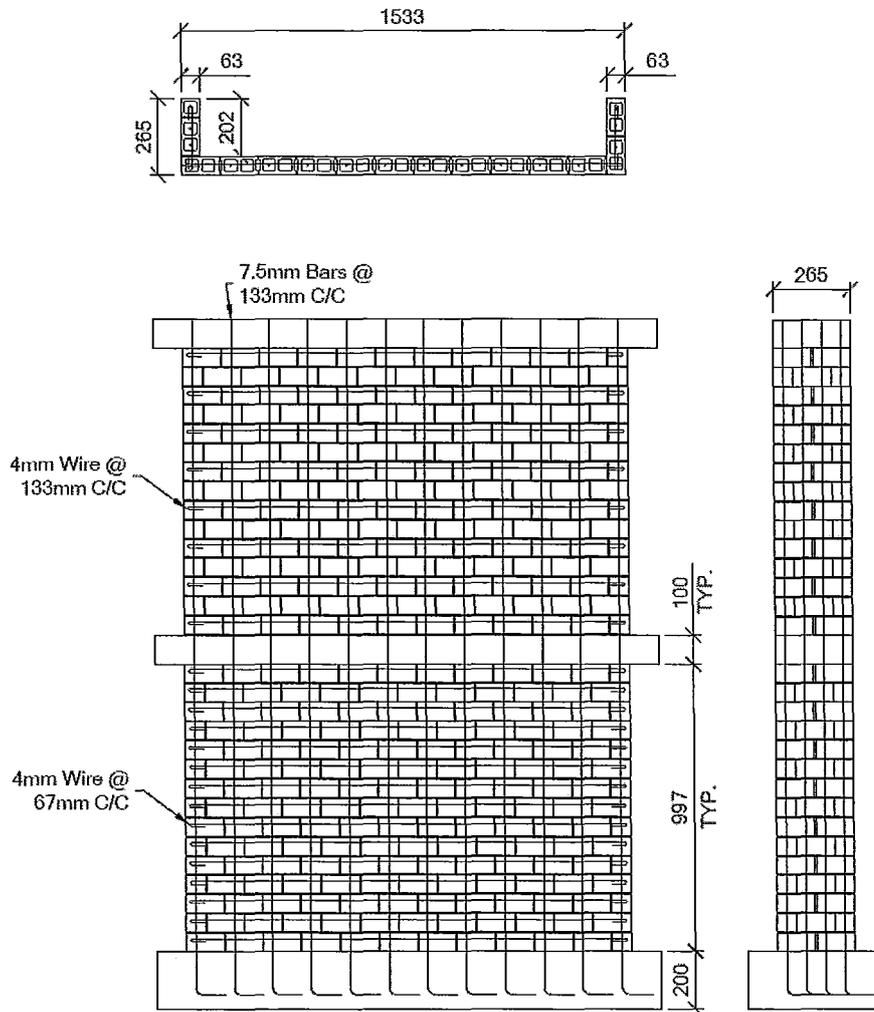
gathered from the prisms and tensile tests of the vertical reinforcing bars. In this regard, the masonry strength was taken as 22.94 MPa while the steel properties used were yield strength of 540 MPa at 0.0027 strain. The layout and elevation of this particular wall are shown in Figure 2.8.

Figure 2.8: Plan Side and End Views of C-Wall (Wall 8).

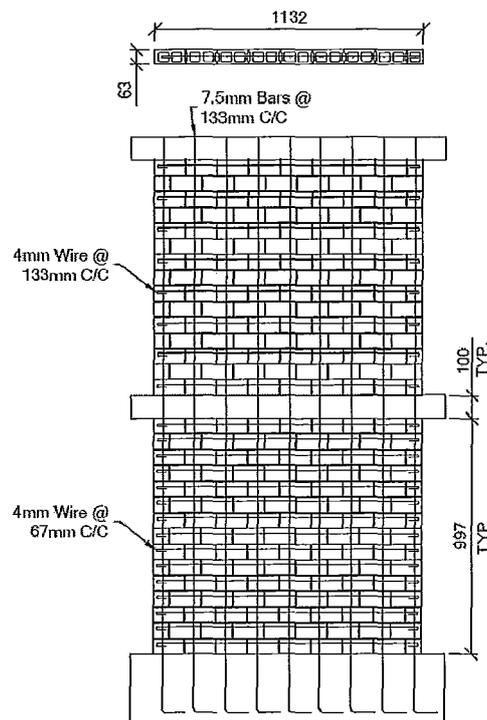
The wall measured 1132 mm long and was reinforced with vertical D7 bars in every other cell. It had an aspect ratio of 1.94 and a vertical reinforcing ratio of 0.57%. This wall had a calculated ultimate moment capacity of 114.4 kN-m corresponding to a required lateral load of 52.2 kN. Assuming elastic behaviour, the calculated yield moment for this wall was found to be 70.4 kN-m.

Figure 2.10: Plan and Elevation of Centre Wall (Wall 5).

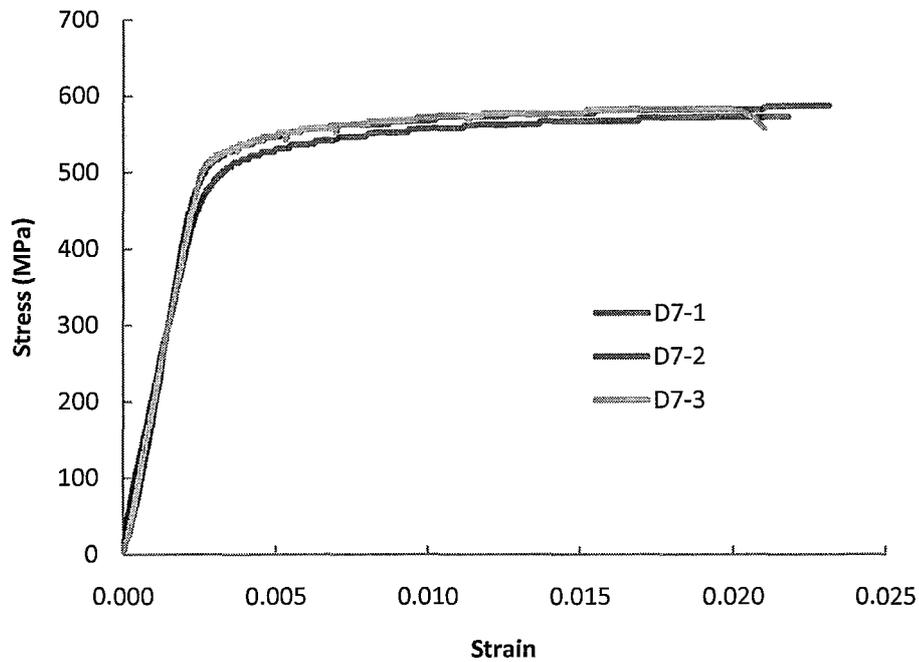
From Figure 2.17 it can be seen that there is no definite yield point for this steel. It reaches approximately 8 times the yield strain at fracture. Unfortunately, as discussed in Section 2.9 on test procedure, this limited straining property has specific implications for the method required to test the structure.

Figure 2.17: Stress Strain Relationship for D7 Reinforcing Bars

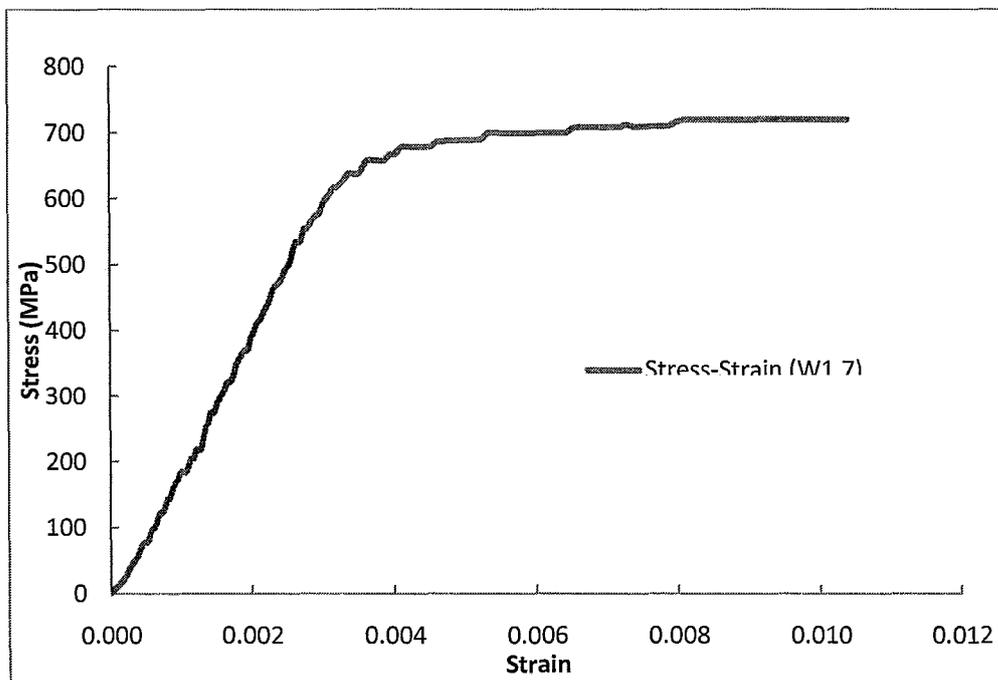
Figure 2.18: Stress-Strain Relationship for the W1.7 Wire Reinforcing

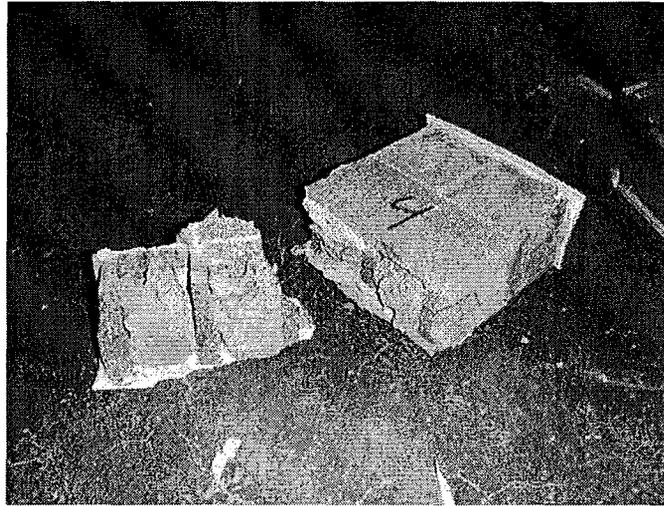
It also can be seen that the prism strength for the fourth phase of construction is much lower than the others. The photograph in Figure 2.19 shows that this reduction in strength is due to incomplete grouting of the specimens. This happened during the last phase of construction where some of the grout was spilled during its placement causing very little to be left for the filling of the prisms. As such, only a small amount of stiff grout was left to grout the prisms. Even with vigorous rodding, voids still remained in the grout of the prisms.

Figure 2.19: Void in Prism from Fourth Stage of Grouting

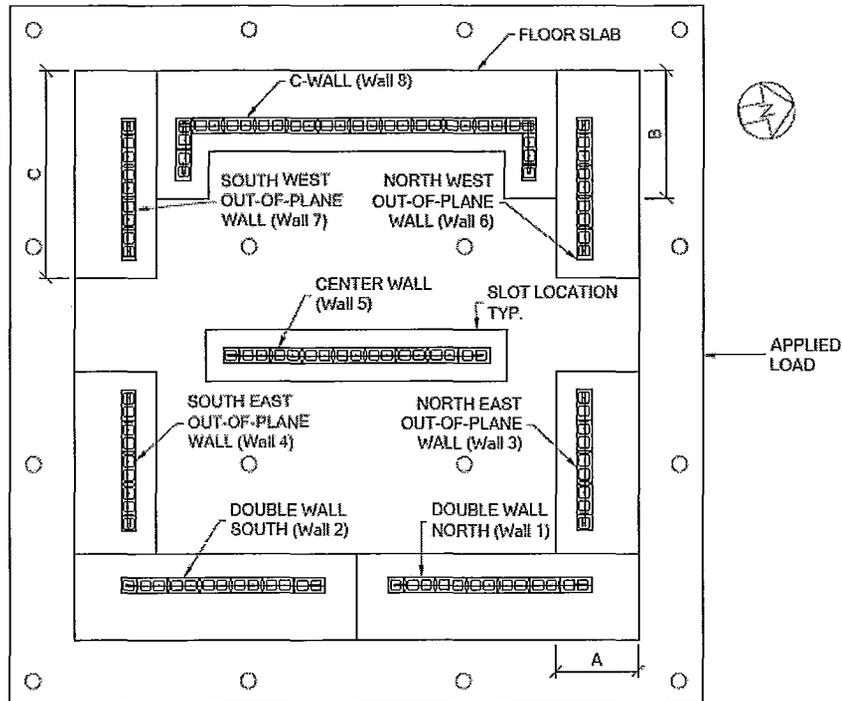
Figure 3.1: Wall and Slot Layout

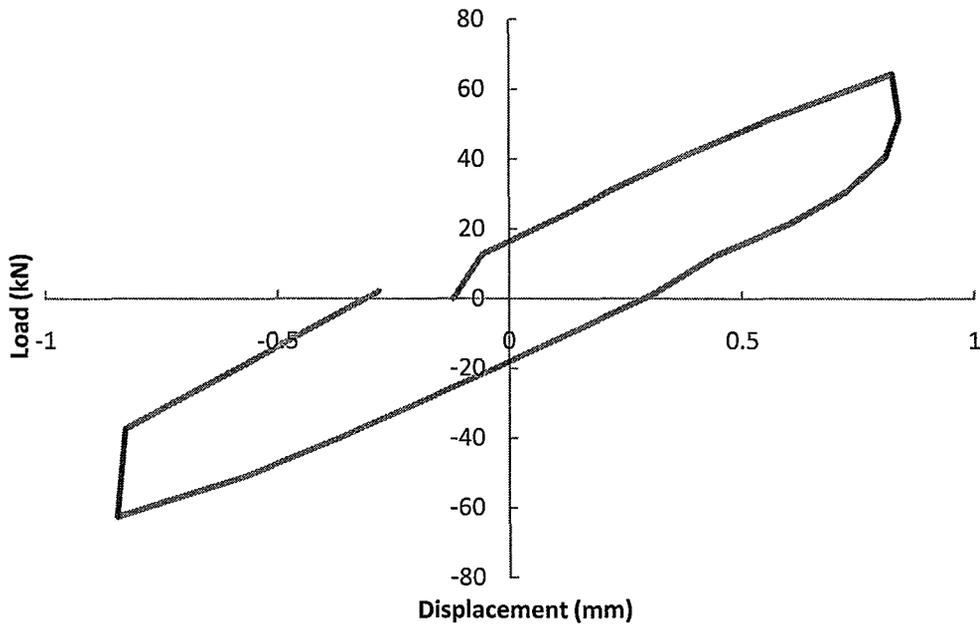
Wall (Wall 8) remained uncracked at this juncture of testing. Figure 3.3 shows the load-displacement response of the structure for this cycle.

Figure 3.3: Load-Displacement Plot for 40% of Yield Loading Cycle

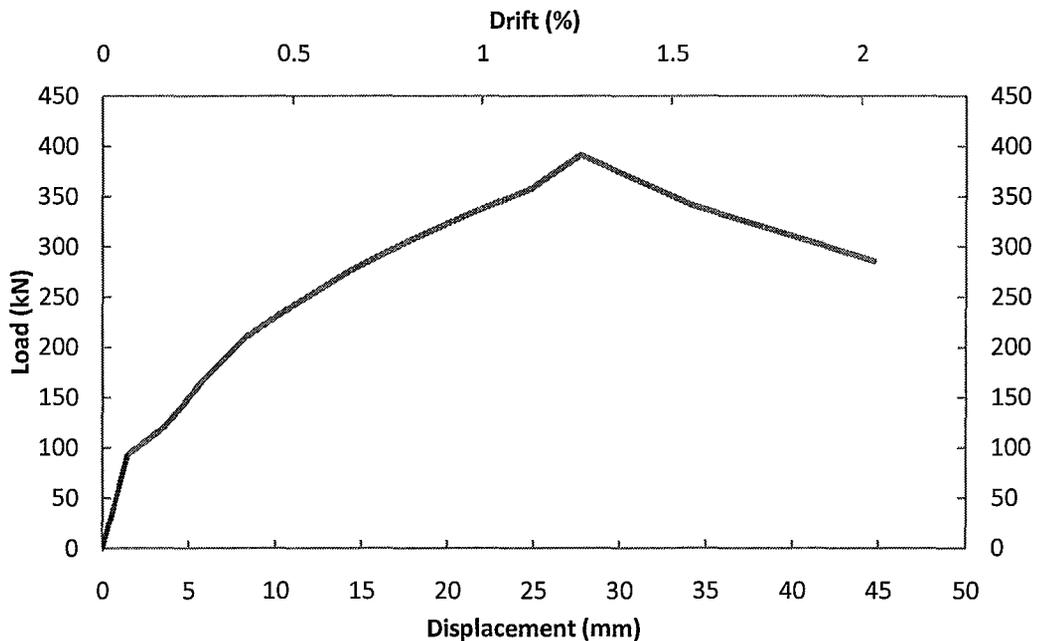
Figure 3.4 is the resulting pushover curve of the building plotted as the total applied lateral load versus the corresponding top of building displacement in the direction of the applied load at the geometric centroid of the structure.

Figure 3.4: Pushover Curve for the Shear Wall Structure

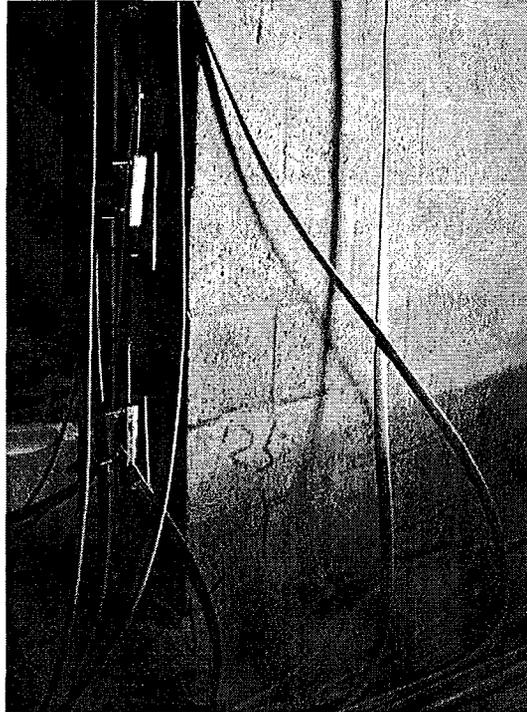
Examination of the structure after reaching 0.17% drift showed that the existing cracks had propagated. The cracking of the bed joints in the out-of-plane walls had lengthened as was the case with the flexural cracks of the in-plane walls. There was no visual evidence of flexural cracking of the C-Wall (Wall 8). Figure 3.5 shows the cracking pattern of the Centre Wall (Wall 5) at this loading level.

Figure 3.5: Flexural Cracking in Centre Wall (Wall 5) at 0.17% Drift

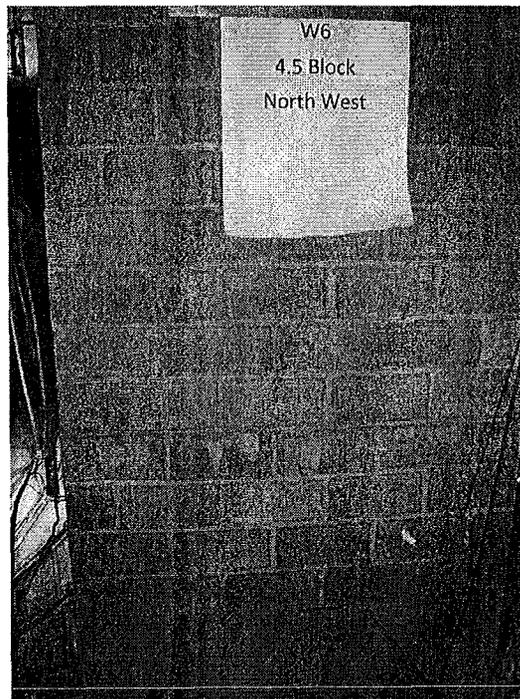
Figure 3.6: Cracking on North West Out-of-Plane Wall (Wall 6)

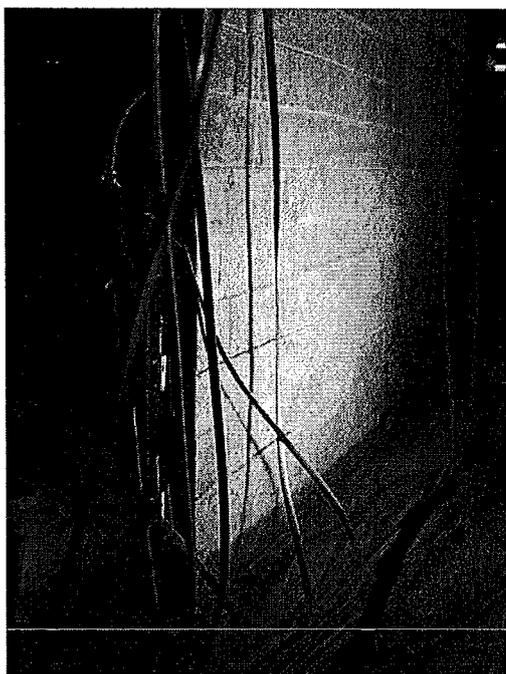
Figure 3.10: Cracking on Centre Wall (Wall 5)

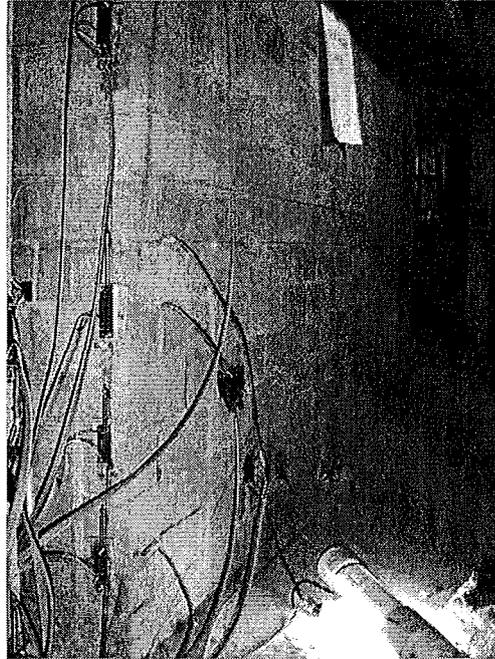
Figure 3.11: Cracking on C-Wall (Wall 8)

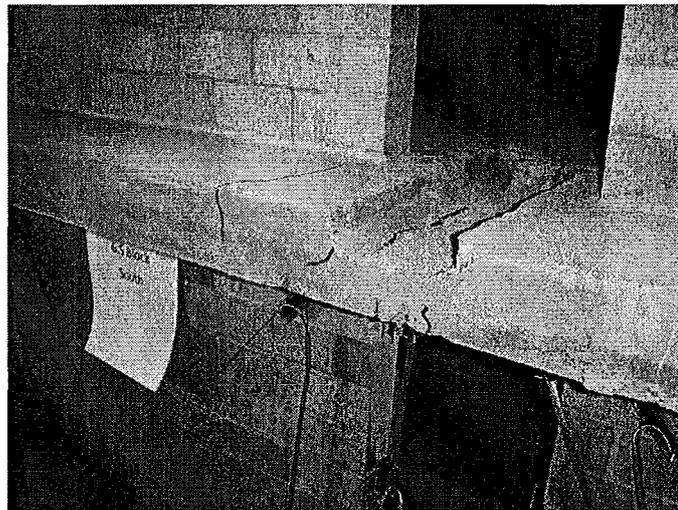
Figure 3.12: Cracking of the First Story Slab between Portions of the Double Wall (Walls 1 and 2)

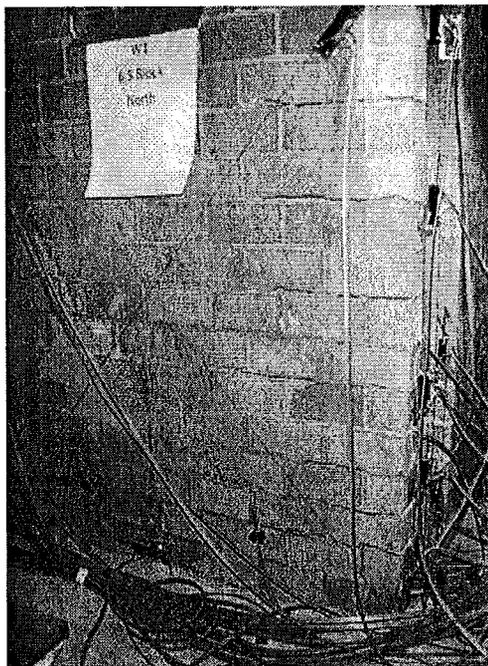
Figure 3.14: Cracking on North Portion of the Double Wall (Wall 1)

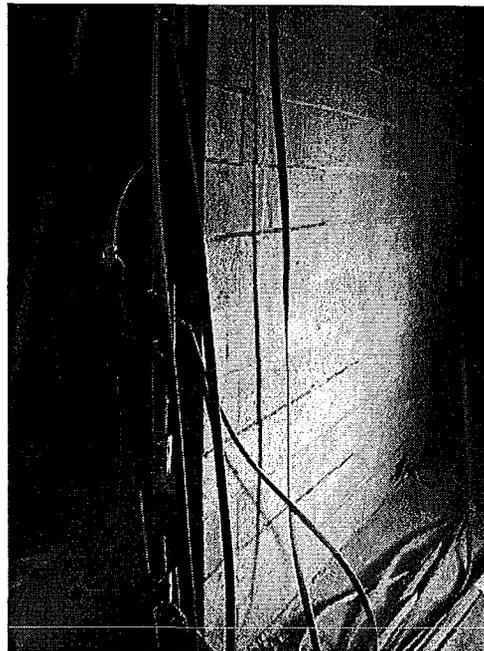
Figure 3.16: Cracking on Centre Wall (Wall 5)

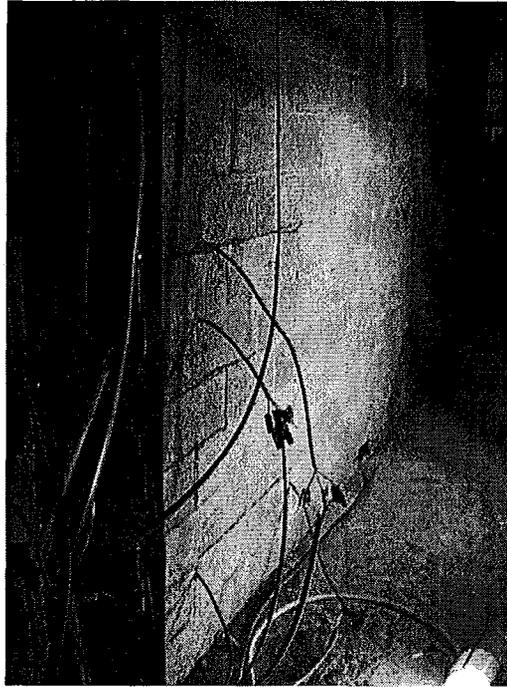
Figure 3.17: Cracking on C-Wall (Wall 8)

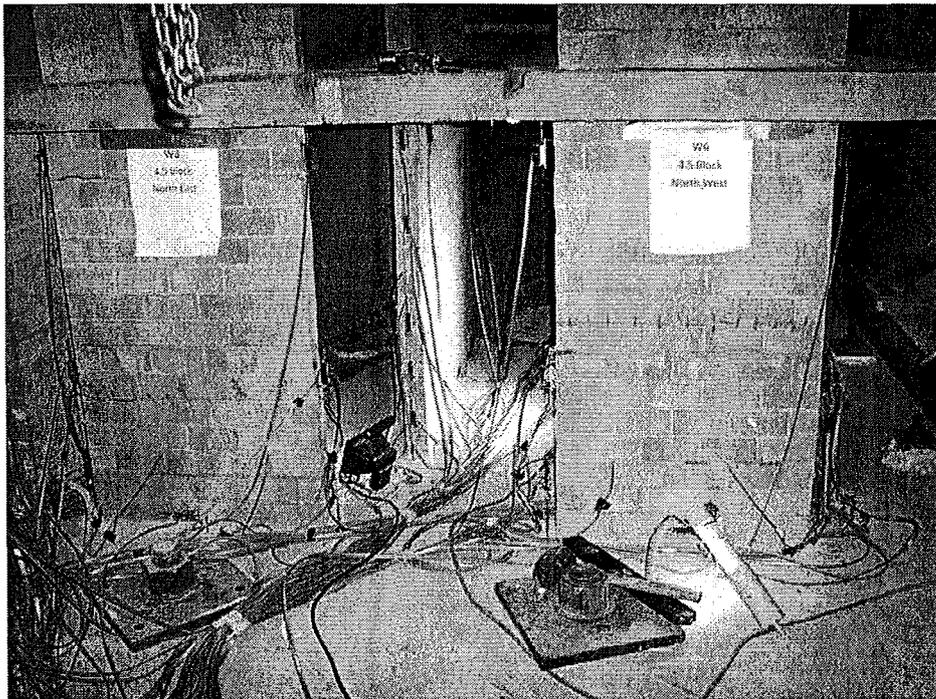
Further cracking of the out-of-plane walls took place spanning the entire length of the walls. Some of these cracks started to propagate upward through head joints. Figures 3.18 to 3.23 illustrate the cracking pattern following this push increment which is marked in pink with hatching.

Figure 3.18: Cracking on North East and West Out-of-Plane Walls (Walls 3 and 6)

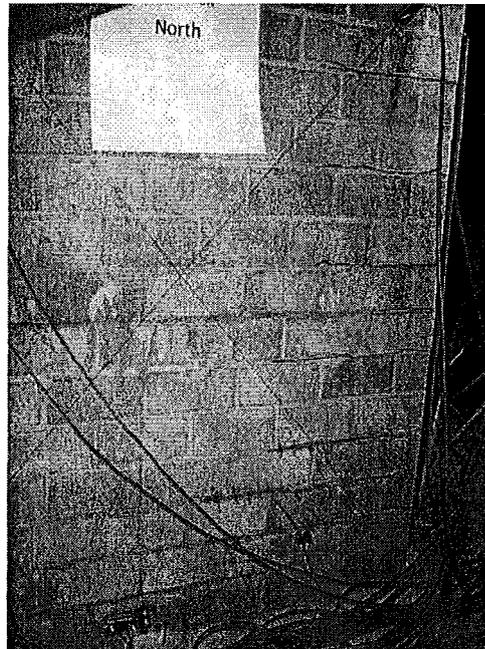
Figure 3.19: Cracking on North Portion of the Double Wall (Wall 1)

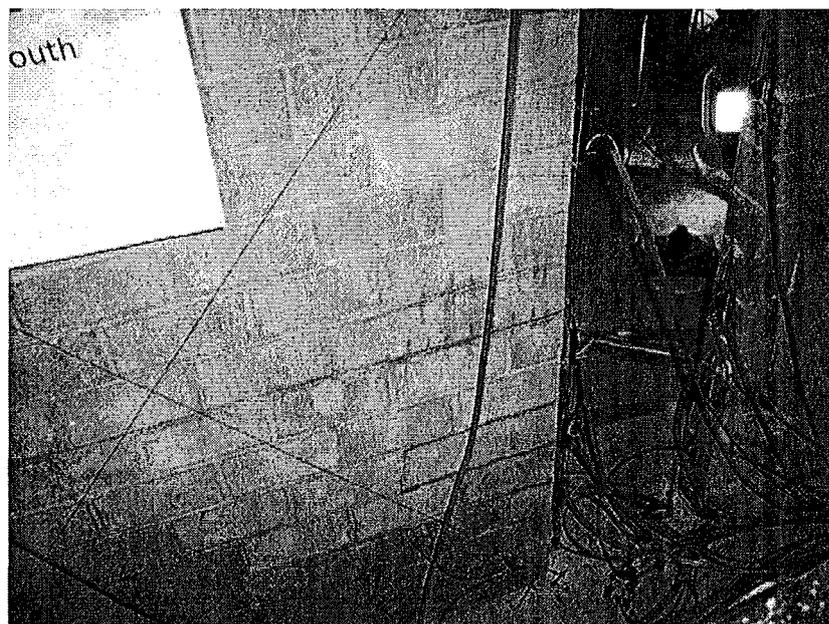
Figure 3.20: Cracking on South Portion of the Double Wall (Wall 2)

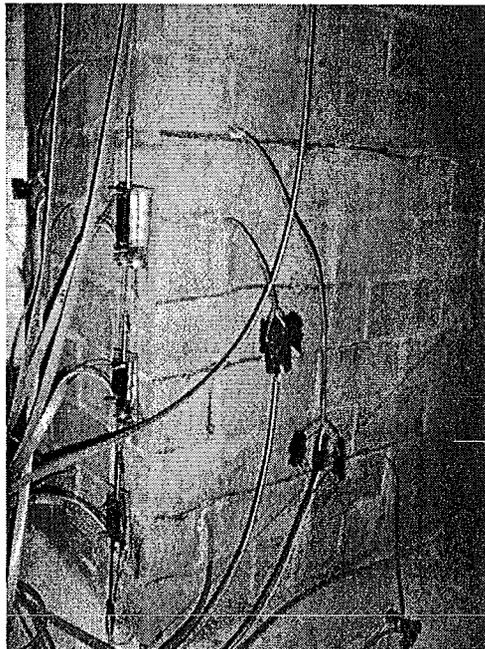
Figure 3.22: Cracking on C-Wall (Wall 8)

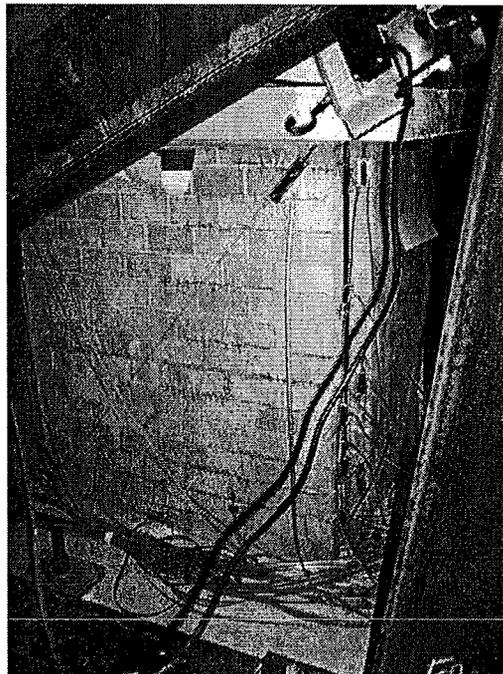
Figure 3.24: Cracking on North Portion of the Double Wall (Wall 1)

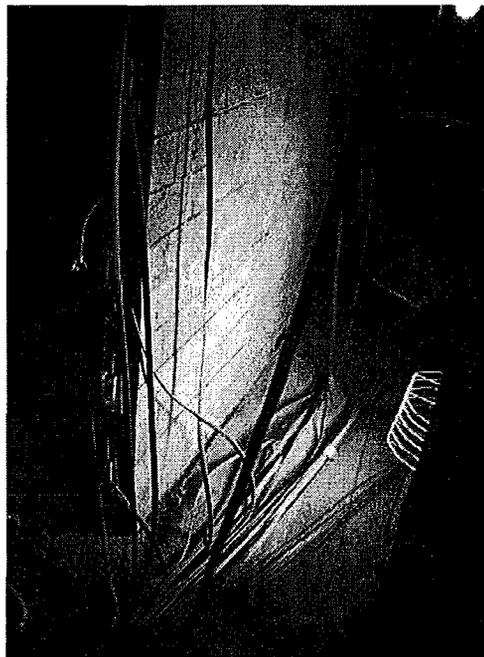
Figure 3.26: Cracking on Centre Wall (Wall 5)

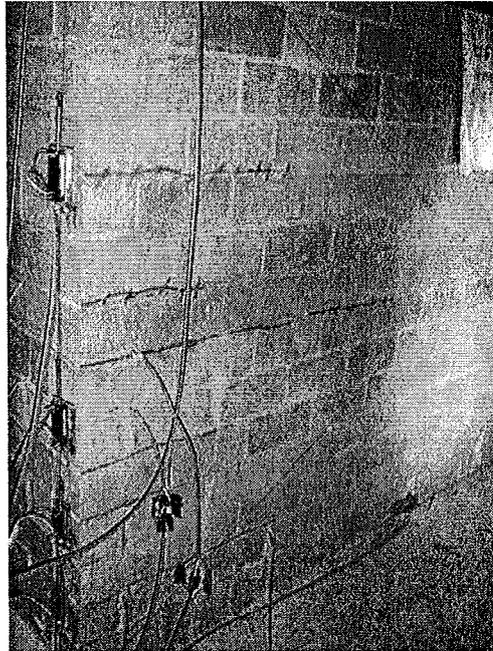
Figure 3.27: Cracking on C-Wall (Wall 8)

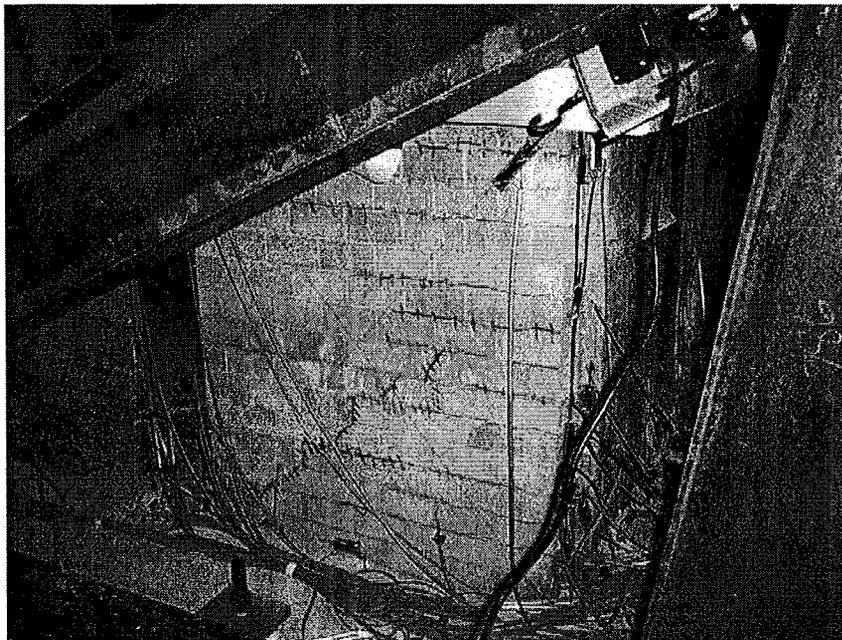
Figure 3.30: Cracking on North Portion of the Double Wall (Wall 1)

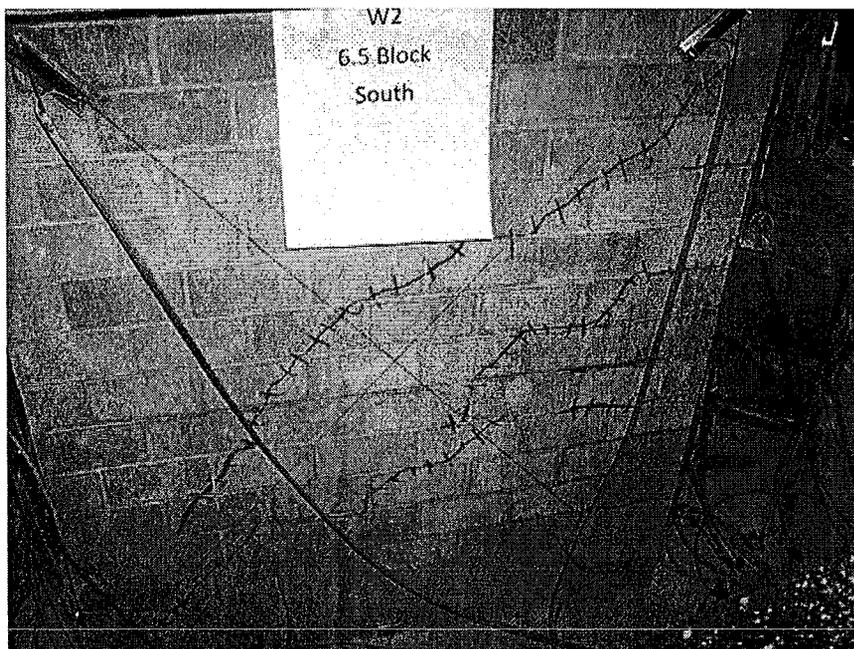
Figure 3.31: Cracking on South Portion of the Double Wall (Wall 2)

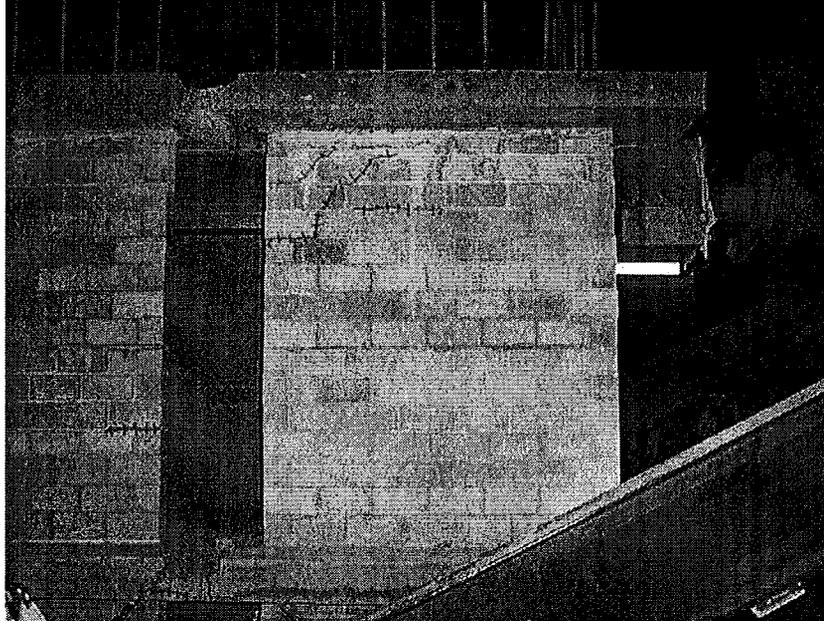
Figure 3.32: Cracking in Second Story of the Double Wall (Walls 1 and 2) and First Floor Slab

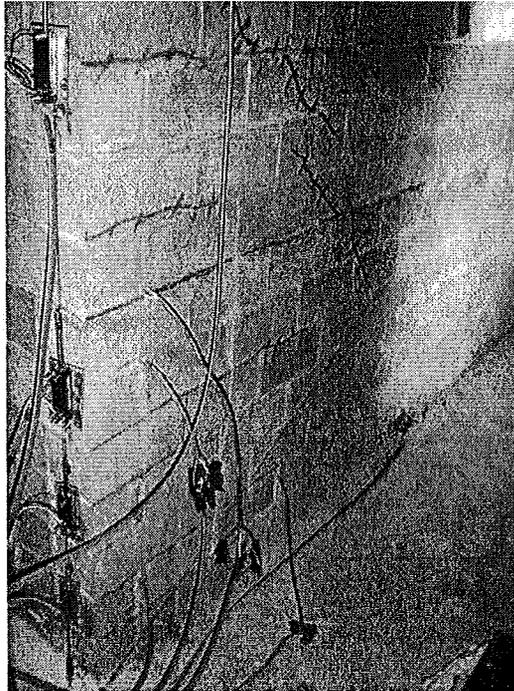
Figure 3.34: Cracking on C-Wall (Wall 8)

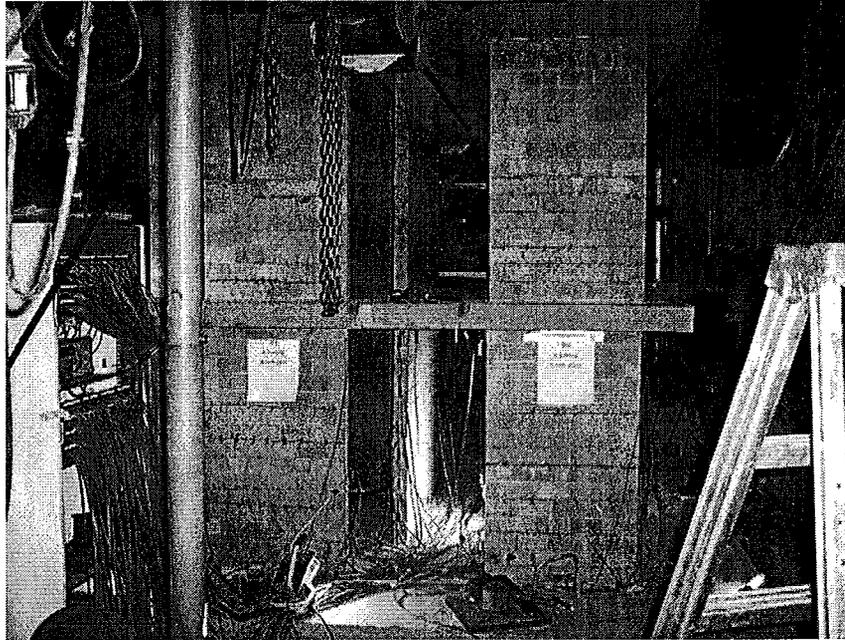
The loading reached 335 kN at a drift level of 0.96%. More significant shear cracking reached the second story of the in-plane walls at this load level. Cracks spread or lengthened on the first story of both the in-plane and out-of-plane walls. For this loading level, the visible cracks were marked in purple with X's and are contained in Figures 3.35 to 3.39.

Figure 3.35: Cracking on North East and North West Out-of-Plane (Walls 3 and 6)

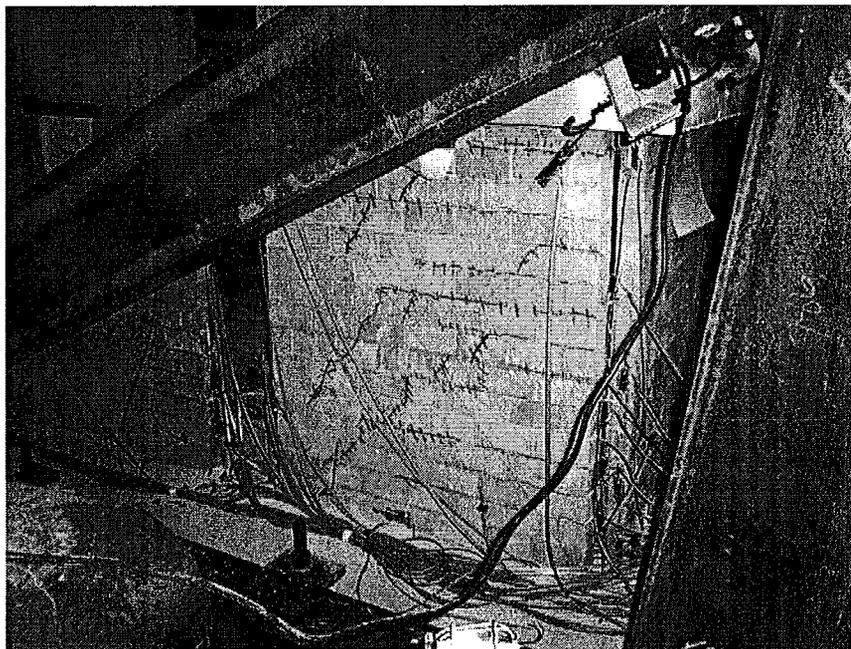
Figure 3.36: Cracking on North Portion of the Double Wall (Wall 1)

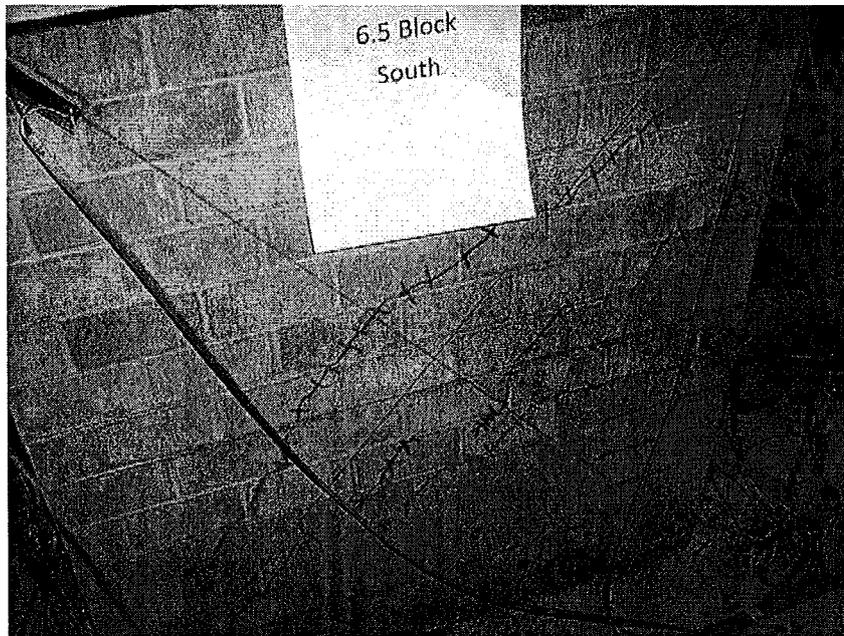
Figure 3.37: Cracking on South Portion of the Double Wall (Walls 2)

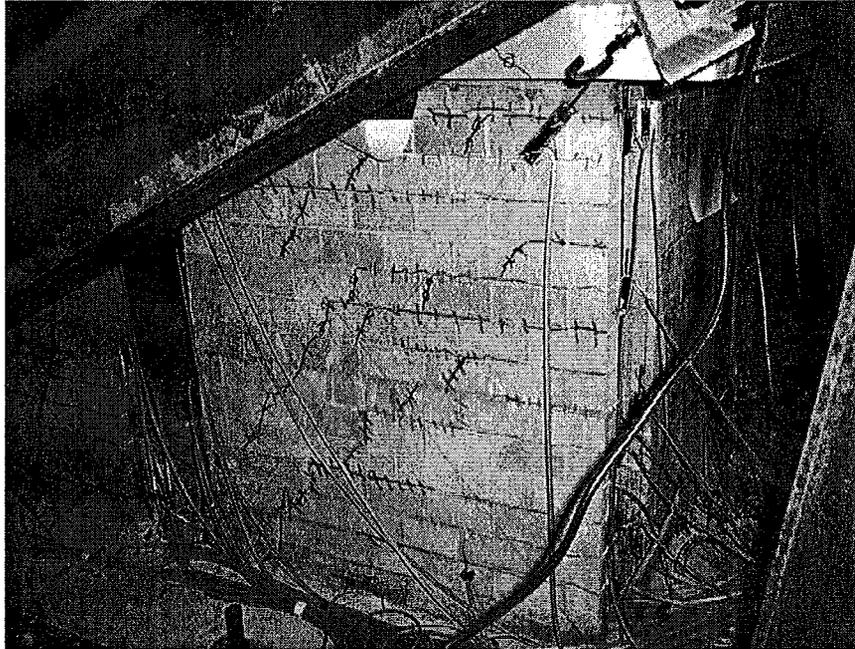
Figure 3.42: Cracking on North Portion of the Double Wall (Wall 1)

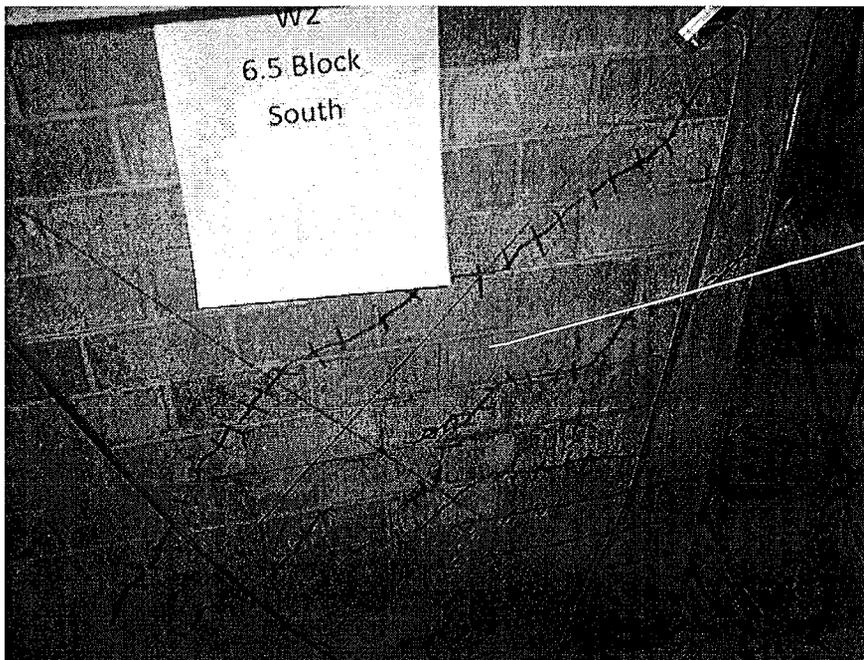
Figure 3.43: Cracking on South Portion of the Double Wall (Wall 2)

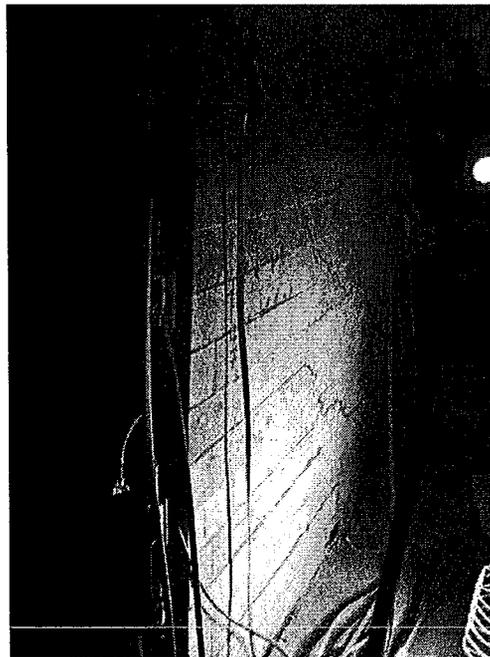
Figure 3.45: Cracking in Centre Wall (Wall 5)

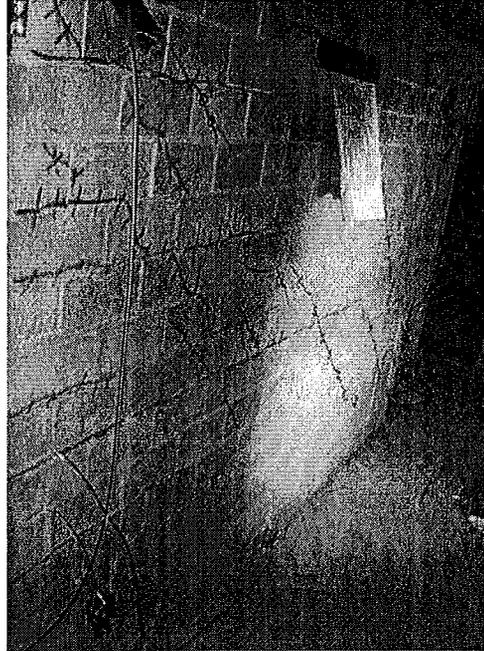
Figure 3.46: Cracking on C-Wall (Wall 8)

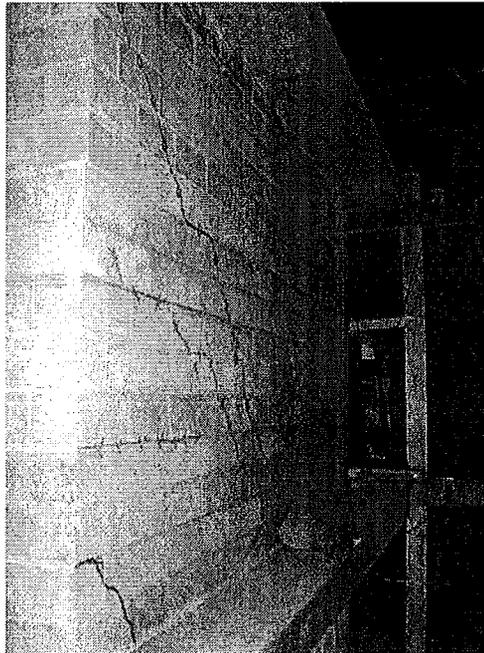
Figure 3.47: Cracking on Second Story of C-Wall (Wall 8)

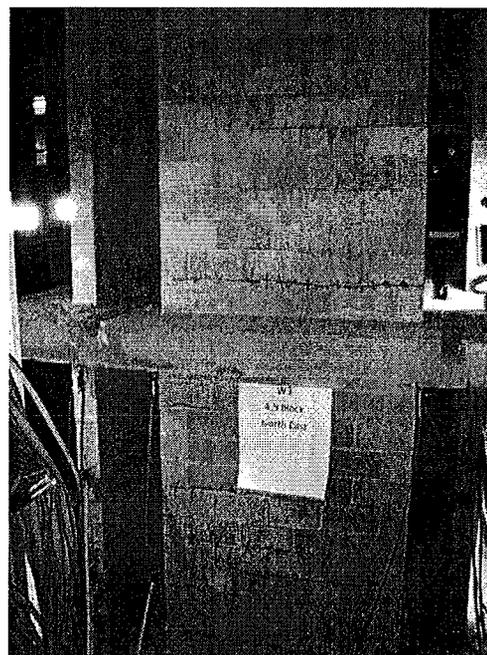
Figure 3.49: Cracking on North East Out-of-Plane Wall (Wall 3)

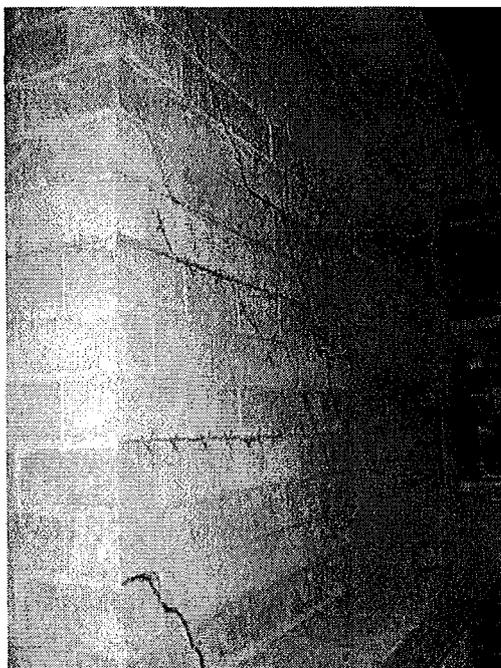
Figure 3.54: Cracking on Second Story of C-Wall (Wall 8)

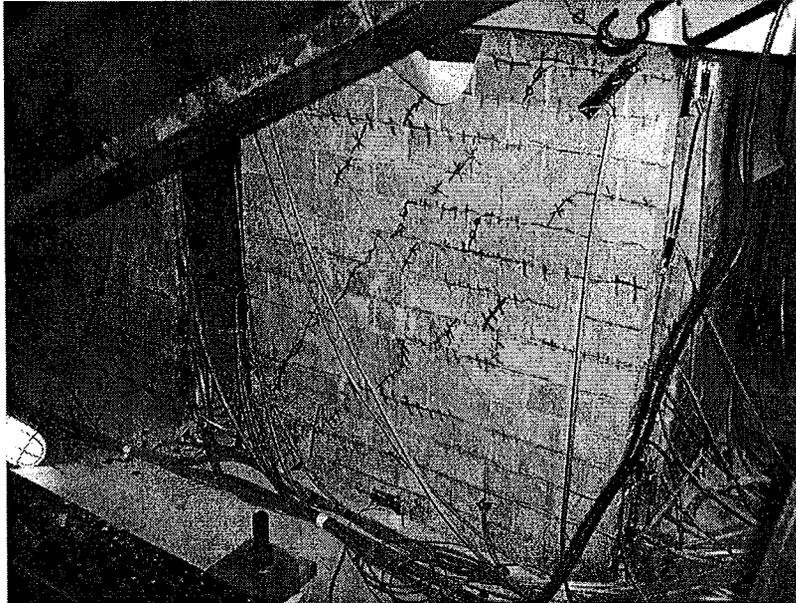
When the building was pushed through another increment, bars ruptured in so many locations that it was impossible to determine the sequence of rupture. The load steadily decreased as the displacement increased and bars ruptured. Upon completion of this push displacement increment, the loading had decreased to 295 kN and was steadily declining without further displacement input. Since the loading had fallen below 80% of the peak value ($0.8 \times 396 \text{ kN} = 317 \text{ kN}$), the test was stopped as per the predetermined test termination point. The test was completed at a drift level of 2.03%. Figures 3.55 through 3.62 illustrate the cracking patterns observed at the final stage of the pushover test. The visible cracks were marked in purple with circles.

Figure 3.55: Cracking in North Portion of the Double Wall (Wall 1)

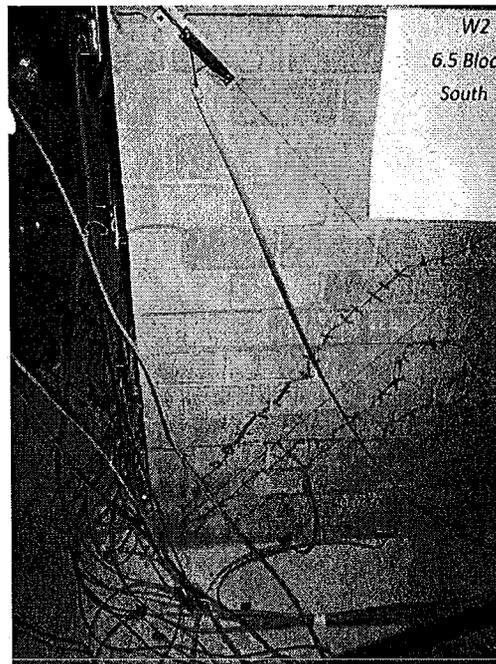
Figure 3.56: Cracking in South Portion of the Double Wall (Wall 2)
