**Behaviour of a Reduced-Scale Fully Grouted Reinforced
Concrete Block Masonry Building**

Jordan Marc Vandervelde

A Thesis

Master of Applied Science

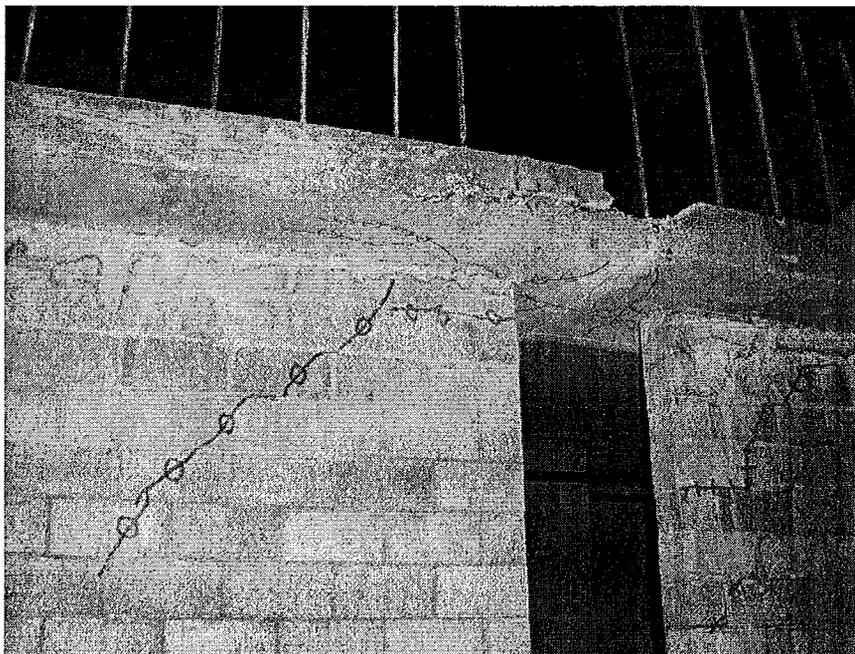
Figure 3.58: Cracking in Second Story of the South Portion of the Double Wall (Wall 2)

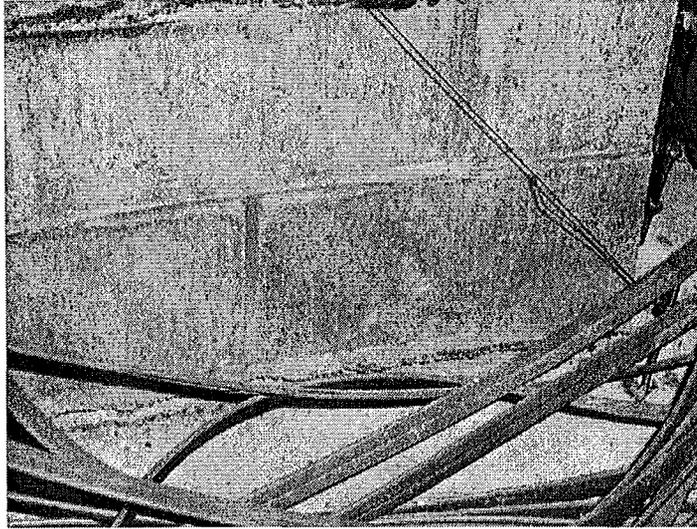
Figure 3.59: Uplift on North Portion of the Double Wall (Wall 1)

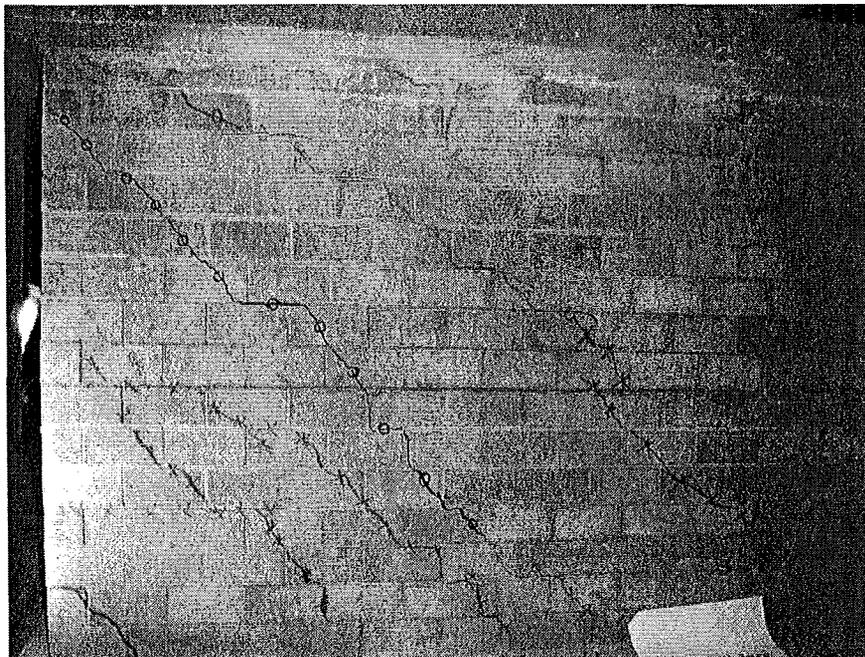
Figure 3.60: Cracking in Second Story of C-Wall (Wall 8)

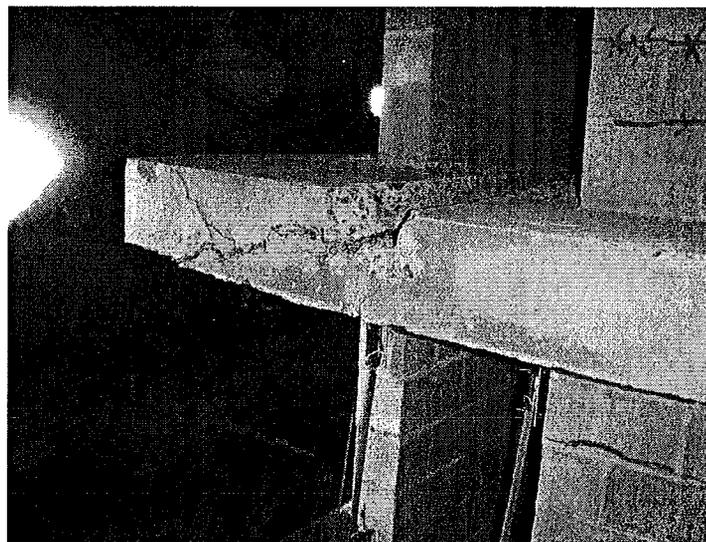
Figure 3.62: Slab Failure Between the North Portion of the Double Wall (Walls 1 and 2) and the North East Out-of-Plane Wall (Wall 3)

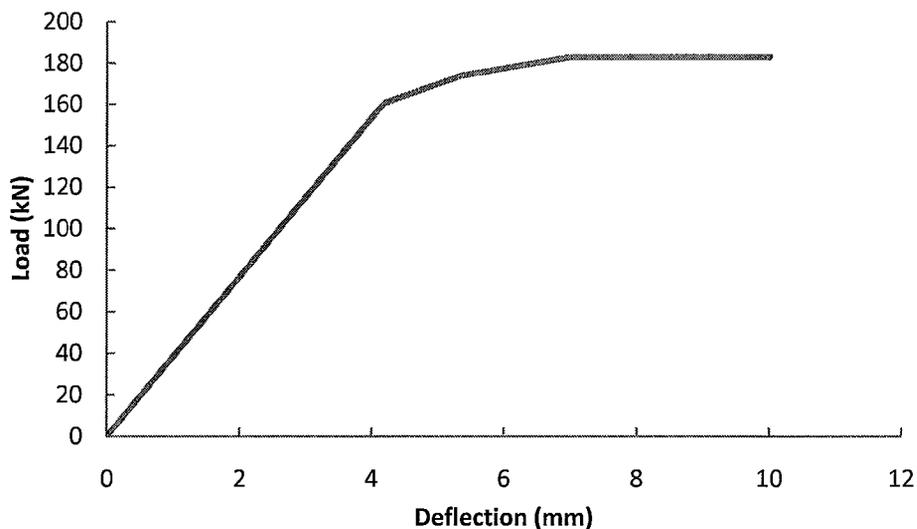
perfect elastic-plastic responses. Since the initial intent of the test program was to limit inter wall coupling via section reduction, the initial assessment of the strength and stiffness of the structure was found as an algebraic sum of the strengths of the in-plane walls. The out-of-plane walls were intended to resist torsion as the in-plane walls reached plastic conditions. A related idealization that was made was that the building was assumed to deflect in the plane of loading without twisting. Therefore, for analytical purposes, the walls were all assumed to undergo the same in-plane displacement. Figure 4.1 shows the total load displacement curve for this simplified analysis.

Figure 4.1: Preliminary Idealized Elastic-Plastic Building Behaviour

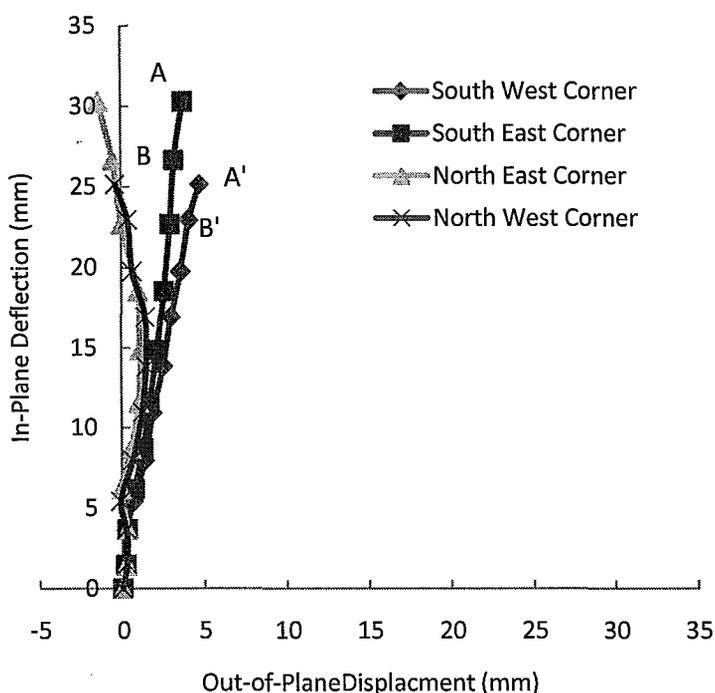
building twisted, the South West corner, which was nearest to the stiff C-Wall (Wall 8) deflected less in its plane relative to the South East Corner but moved more in the lateral direction. As can be seen, the North Corners nearest to the lateral restraint provided by the actuator had similar in-plane deflections but lower out-of-plane movement.

Figure 4.4: Movement of Slab Corners

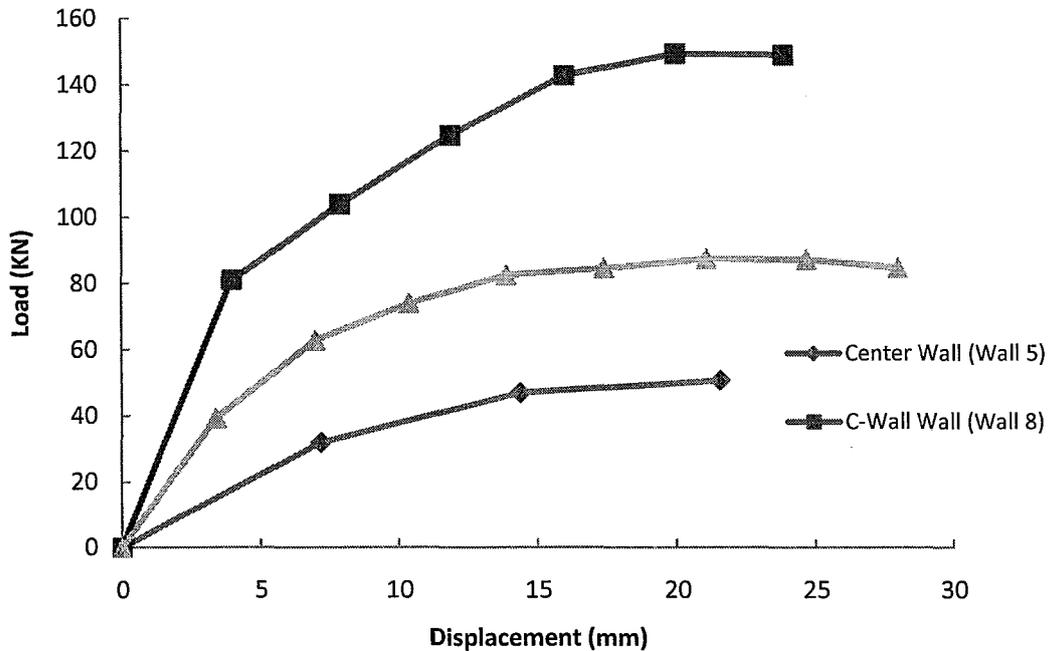
(2010). His testing documented the behaviour of all the in-plane walls found in this building. Naturally, no coupling with out-of-plane walls is included in these load resistance values. This documentation is presented in Figure 4.7.

Figure 4.7: Load-displacement Curves for In-Plane Walls (Wierzbicki, 2010)

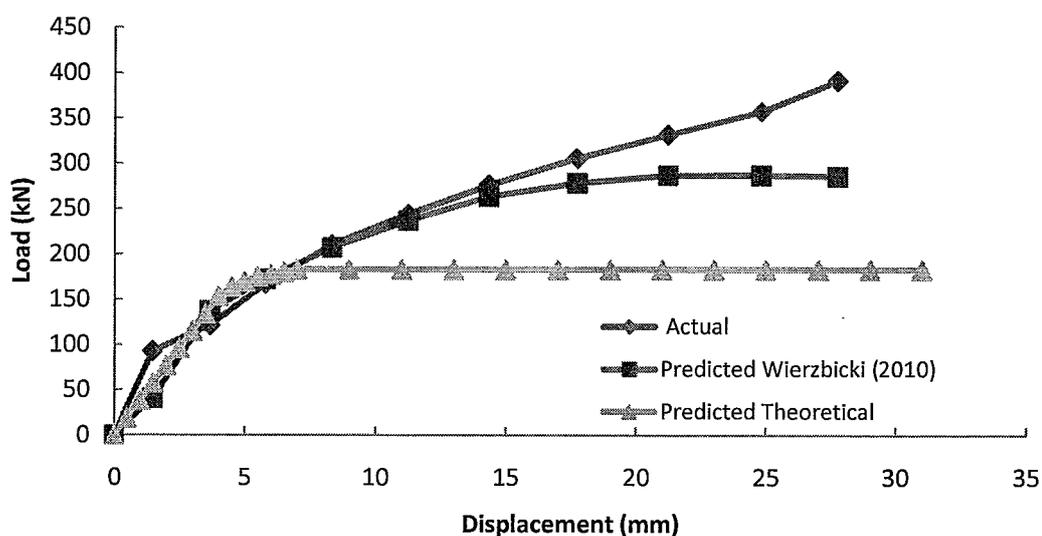
loading based on the observed data taken from Wierzbicki (2010) as well as the preliminary simplified theoretical estimation as presented in Section 4.1.

Figure 4.8: Actual Building Response as Plotted versus Predictions

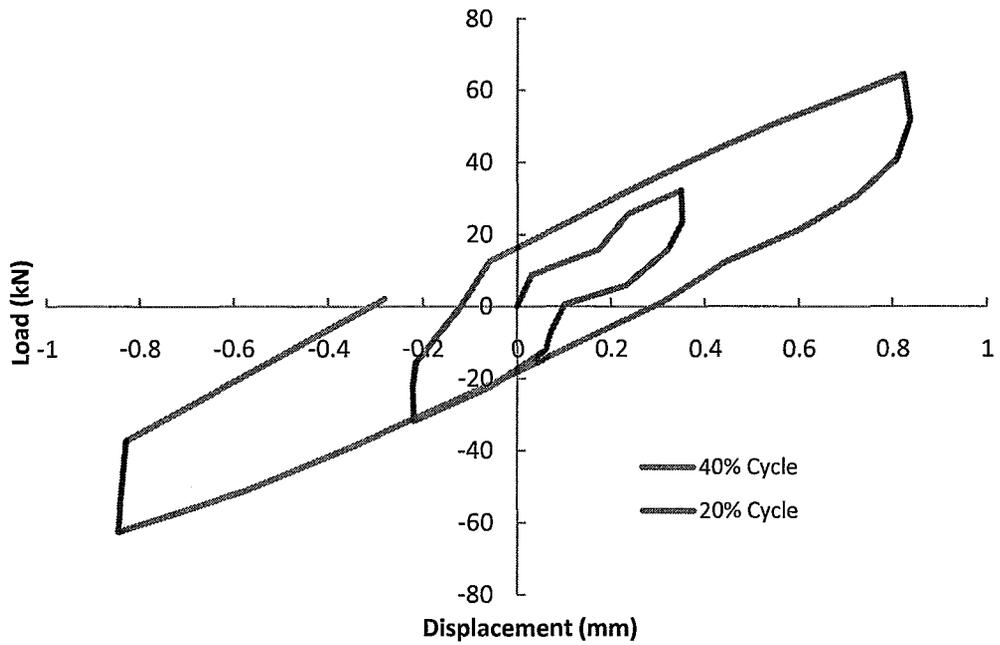
Figure 4.9: Load Displacement Cycles of $0.2\Delta y$ and $0.4\Delta y$

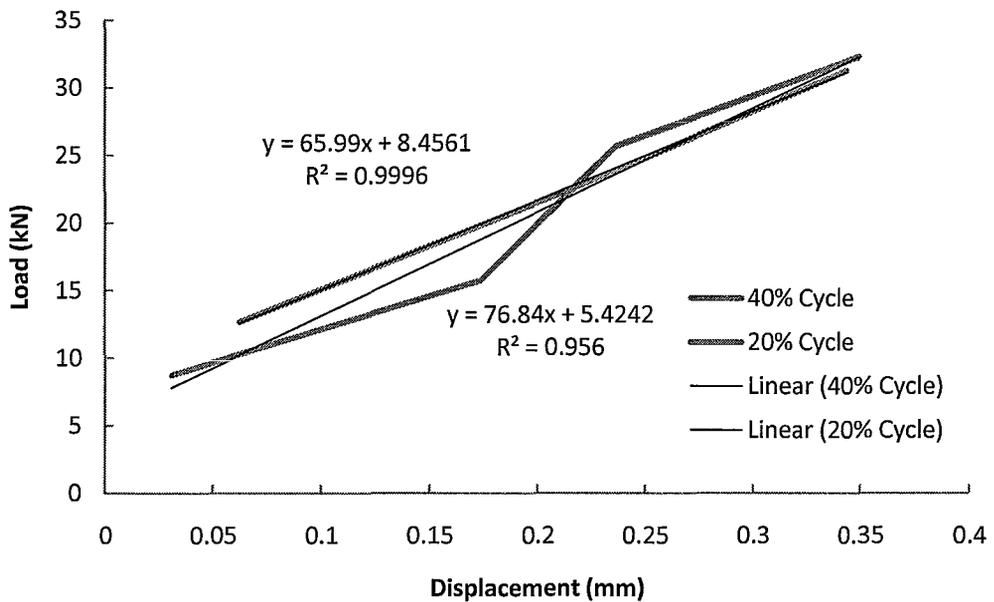
As noted in Chapter 3, the stiffness of each of the cycles in both push and pull directions appear to be very similar indicating good consistency. Figure 4.10 shows the trend lines established for each cycle.

Figure 4.10: Pre-Yield Building Stiffness

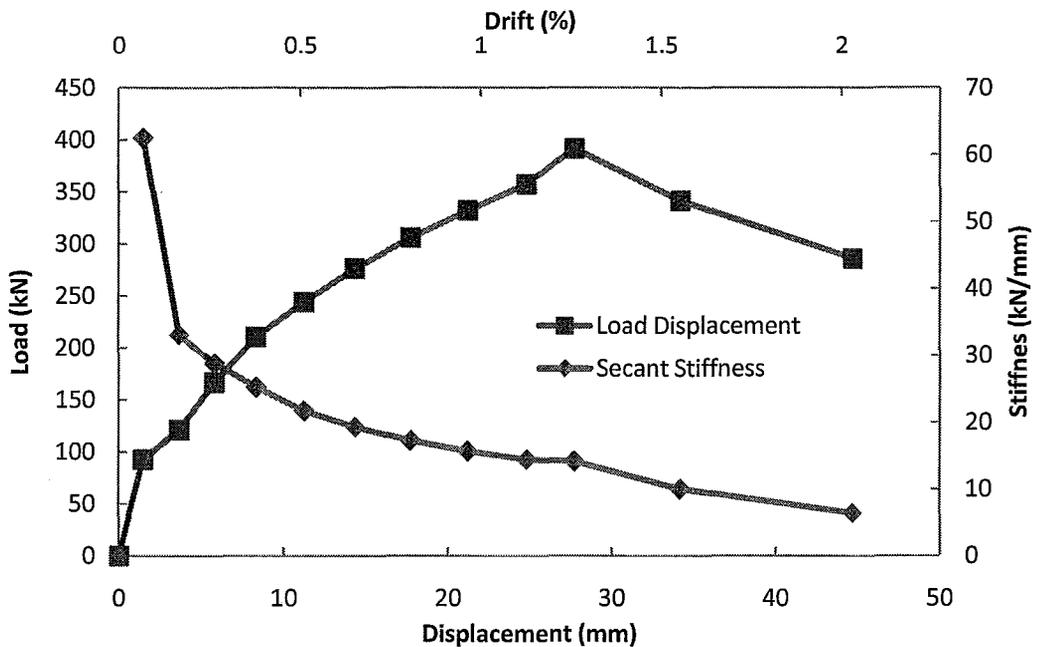
As mentioned earlier, the building softened as it entered into the plastic state. Figure 4.11 shows the secant stiffness degradation as the building progressed into the plastic state during the final push to failure test. The building stiffness reduced from 63 kN/mm at the loading onset to 14.1 kN/mm at peak load.

Figure 4.11: Building Secant Stiffness Degradation

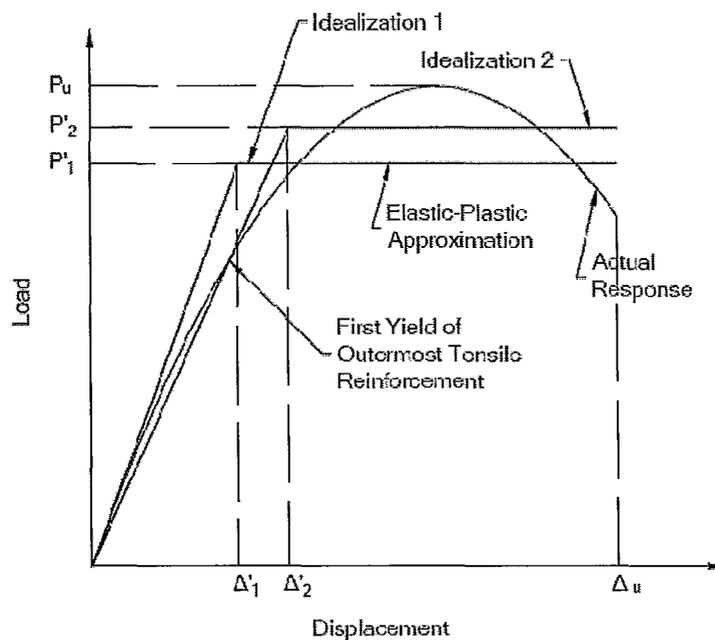
Figure 4.12: Elastic-Plastic Idealization for Reinforced Masonry Shear Walls

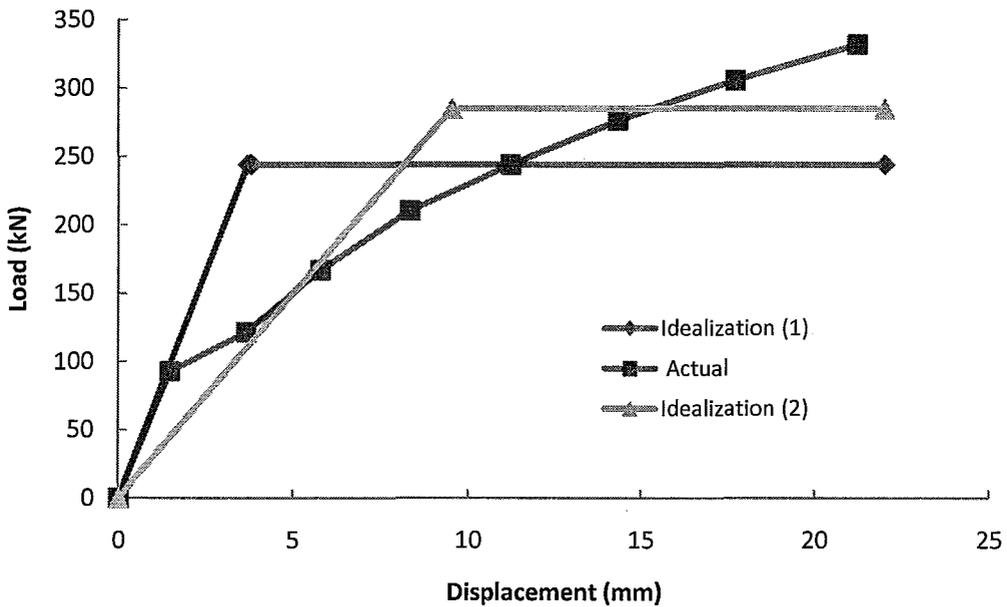
idealization is also shown where the slope of the elastic part is established by the point of initial yield at a load of 164 kN.

Figure 4.13: Idealized Elasto-Plastic Building Response

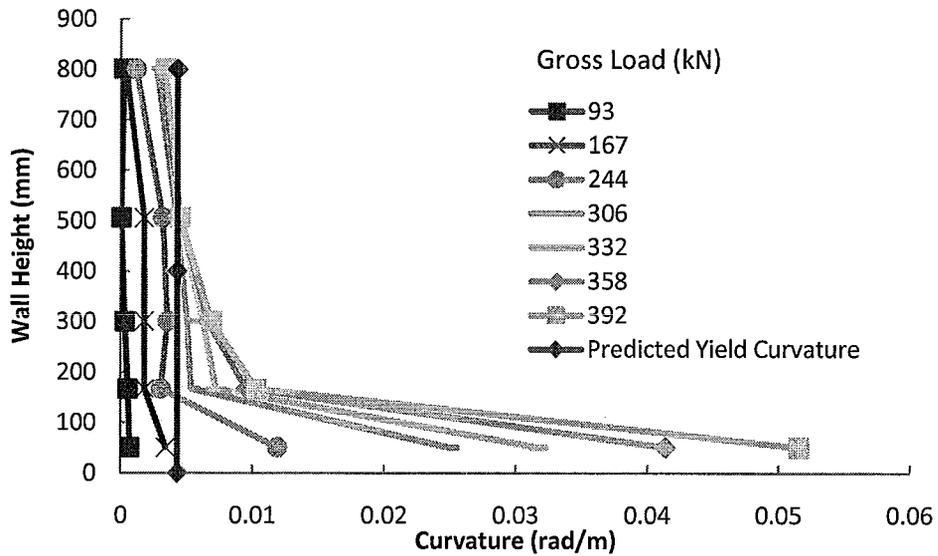
Figure 4.15: Average Curvature Profile: North Portion of the Double Wall (Wall 1)

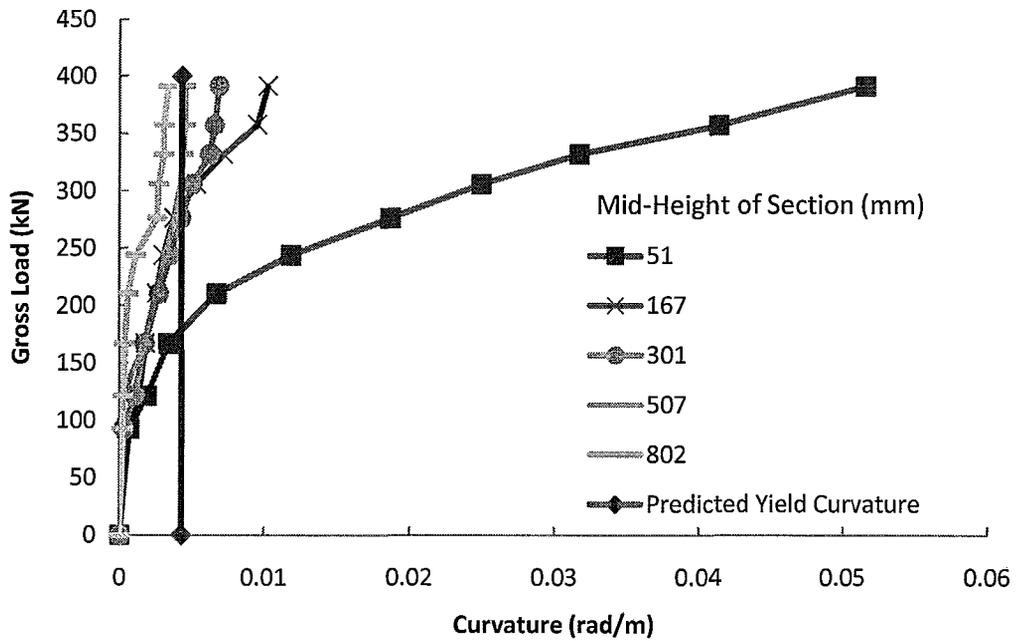
Figure 4.16: Average Curvature vs. Gross Load: North Portion of the Double Wall (Wall 1)

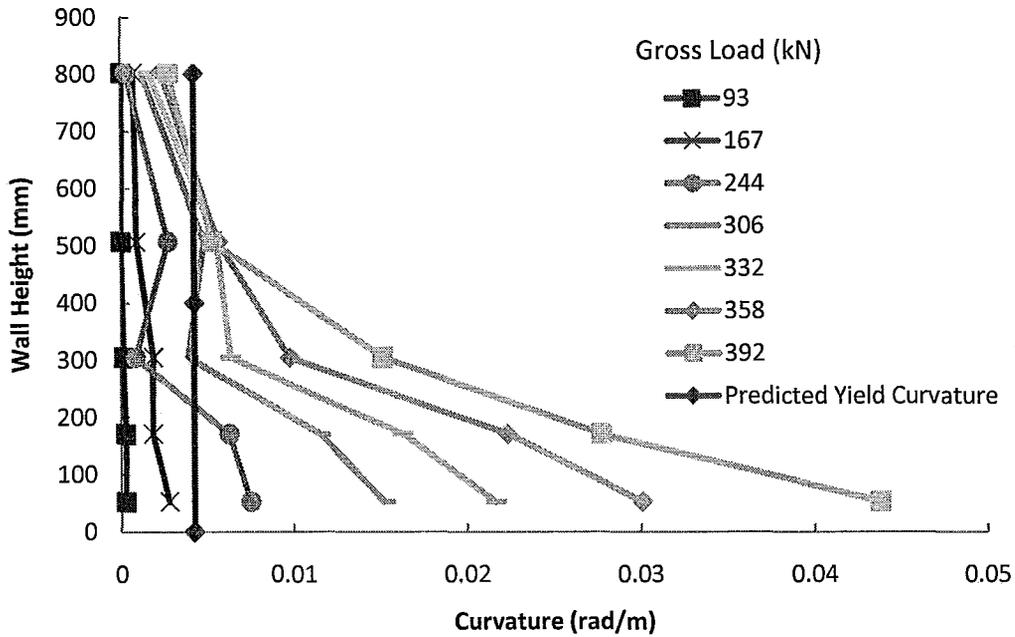
Figure 4.18: Average Curvature Profile: South Portion of the Double Wall (Wall 2)

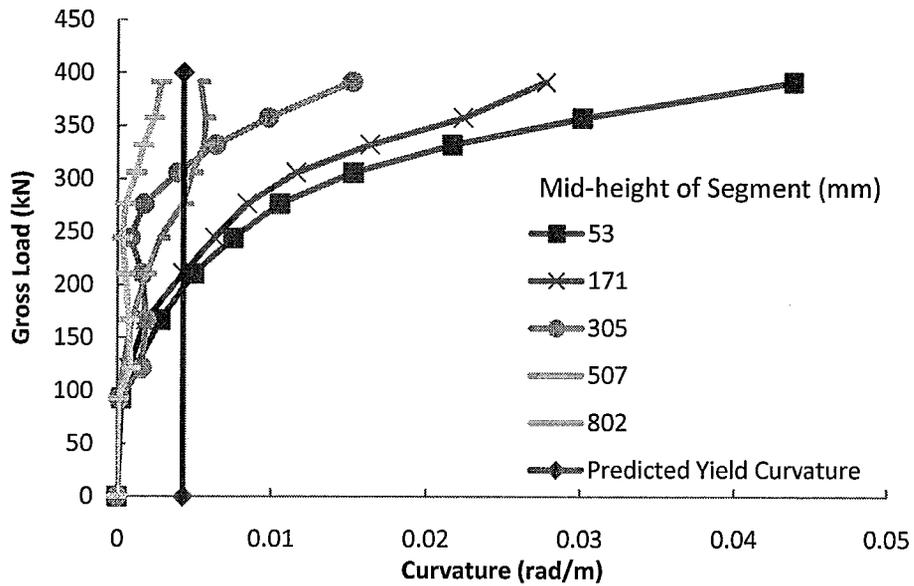
Figure 4.19: Average Curvature vs. Gross Load: South Portion of the Double Wall (Wall 2)

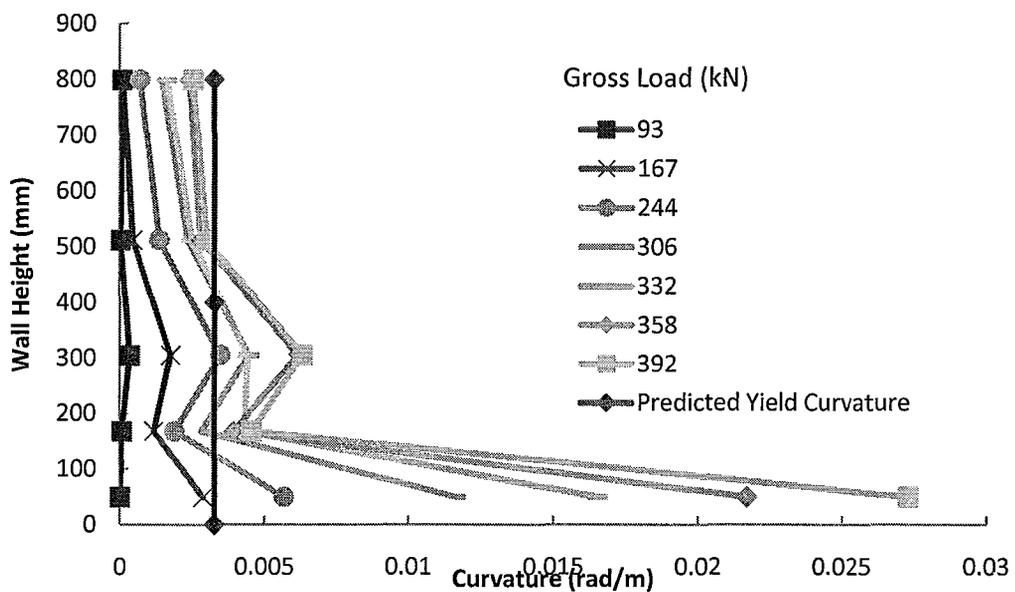
Figure 4.23: Average Curvature Profile: Centre Wall (Wall 5)

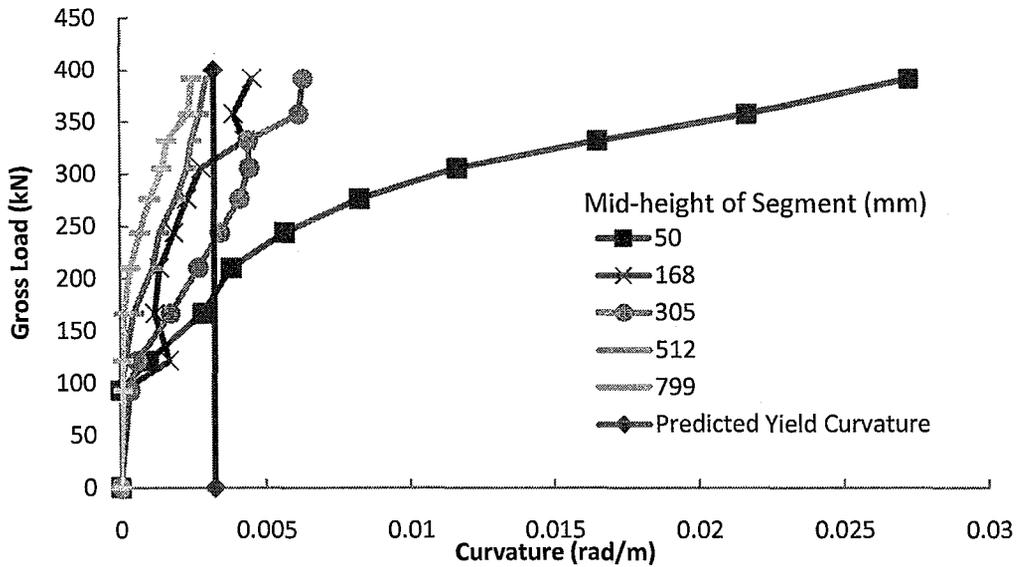
Figure 4.24: Average Curvature vs. Gross Load: Centre Wall (Wall 5)

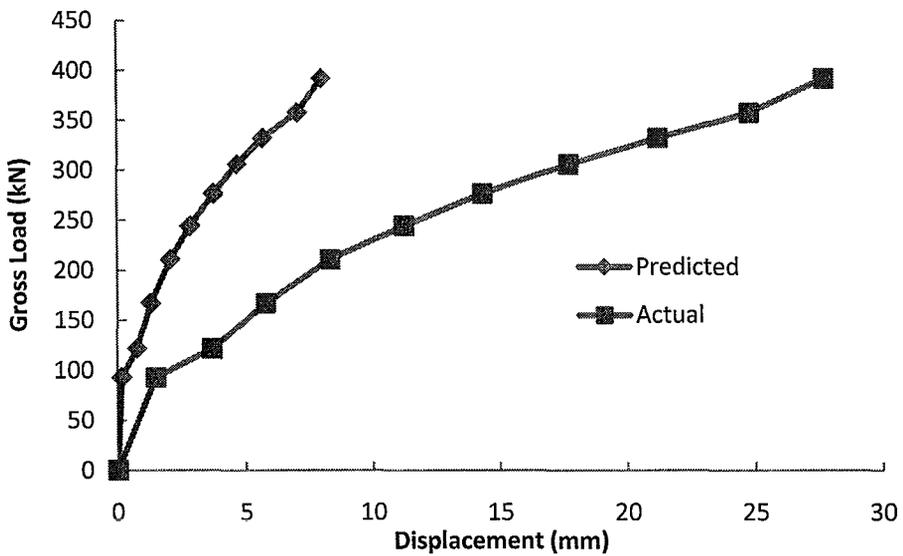
Figure 4.25: Predicted Displacement Based on Measured Average Curvature for Wall 5

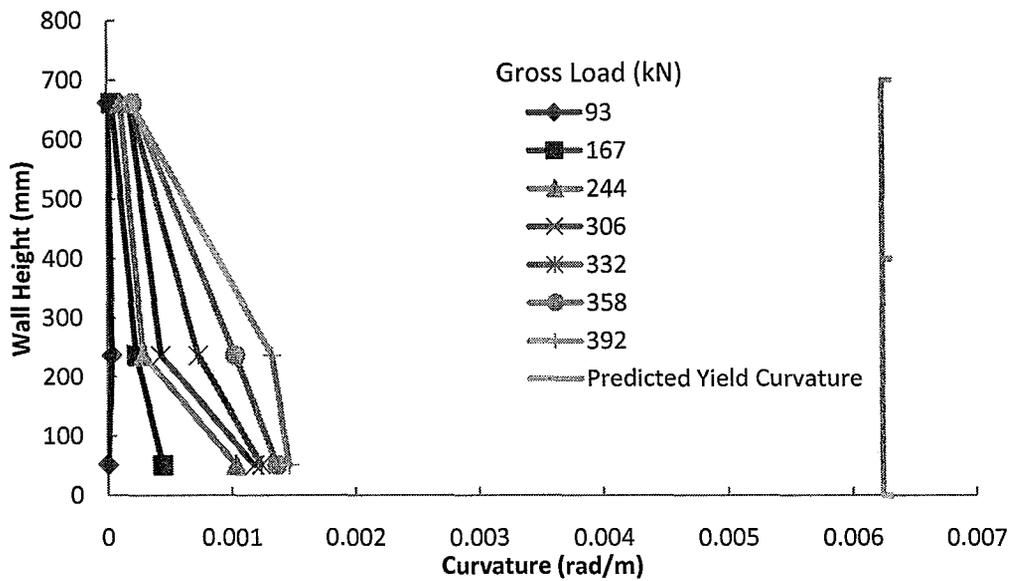
Figure 4.26: Average Curvature Profile: South East Out-of-Plane Wall (Wall 4)

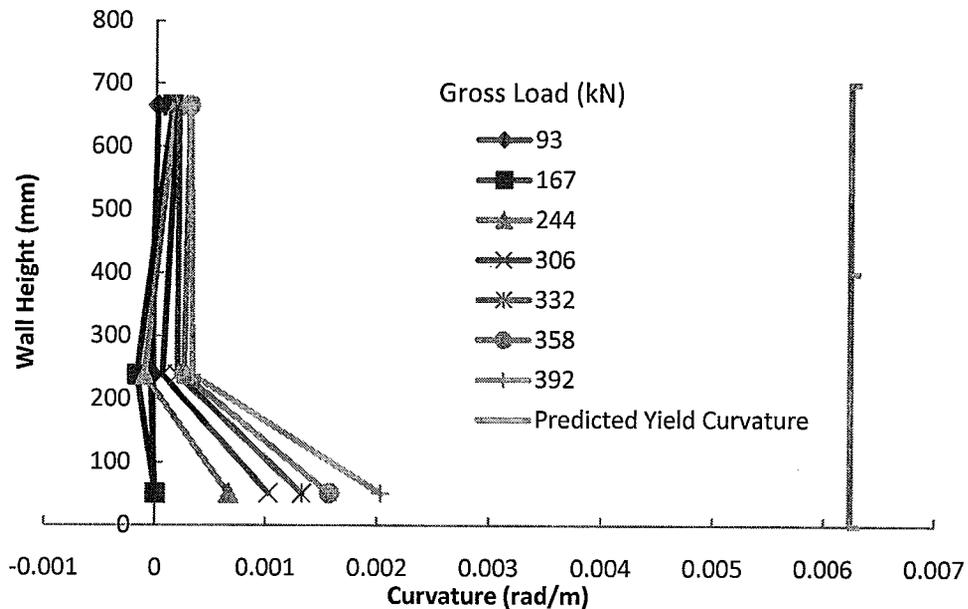
Figure 4.27: Average Curvature Profile: South West Out-of-Plane Wall (Wall 7)

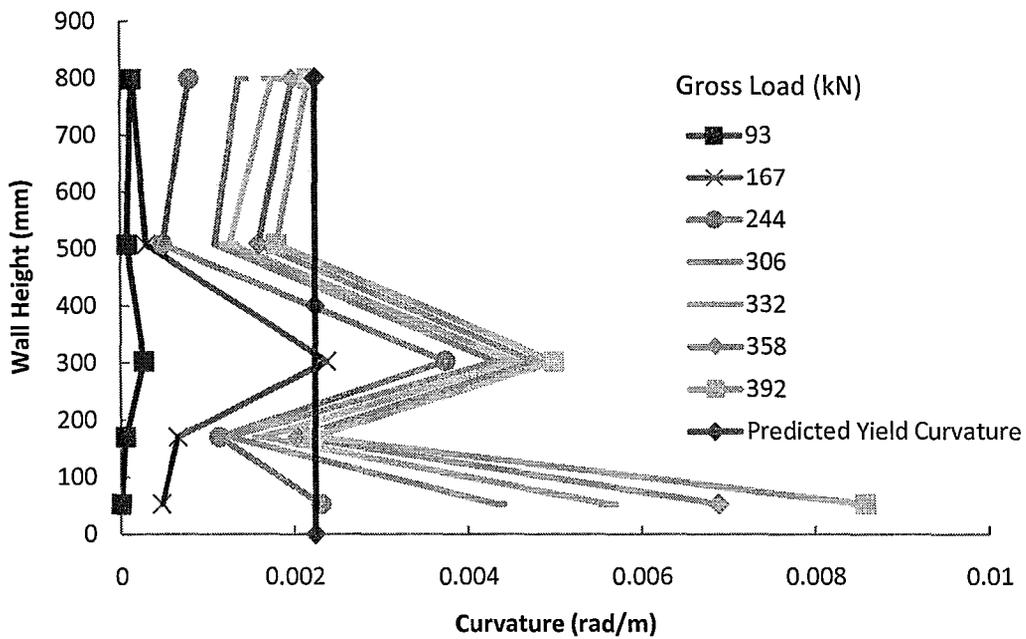
Figure 4.28: Average Curvature Profile: C-Wall (Wall 8)

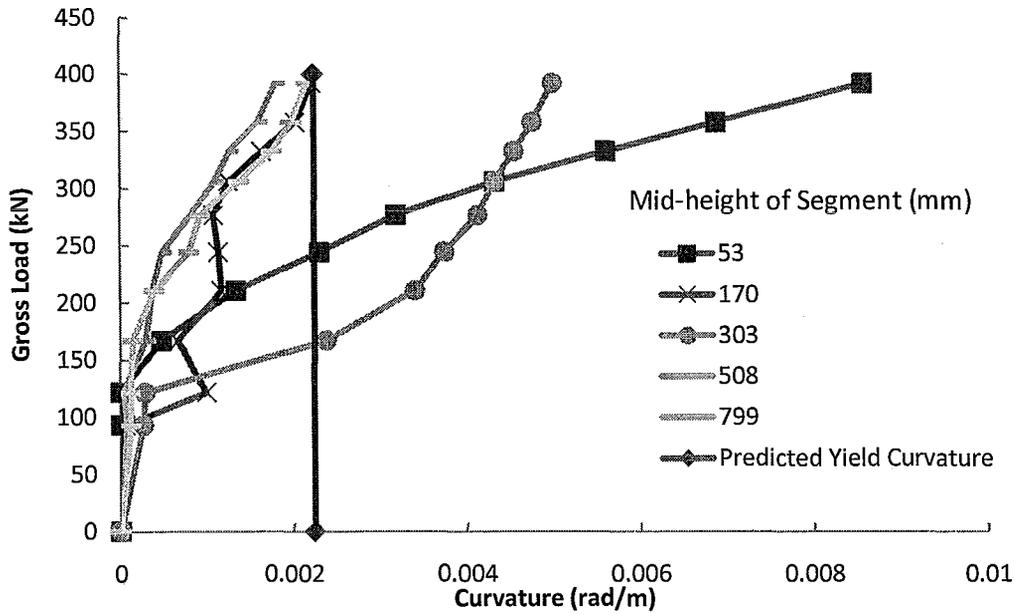
Figure 4.29: Average Curvature vs. Gross Load: C-Wall (Wall 8)

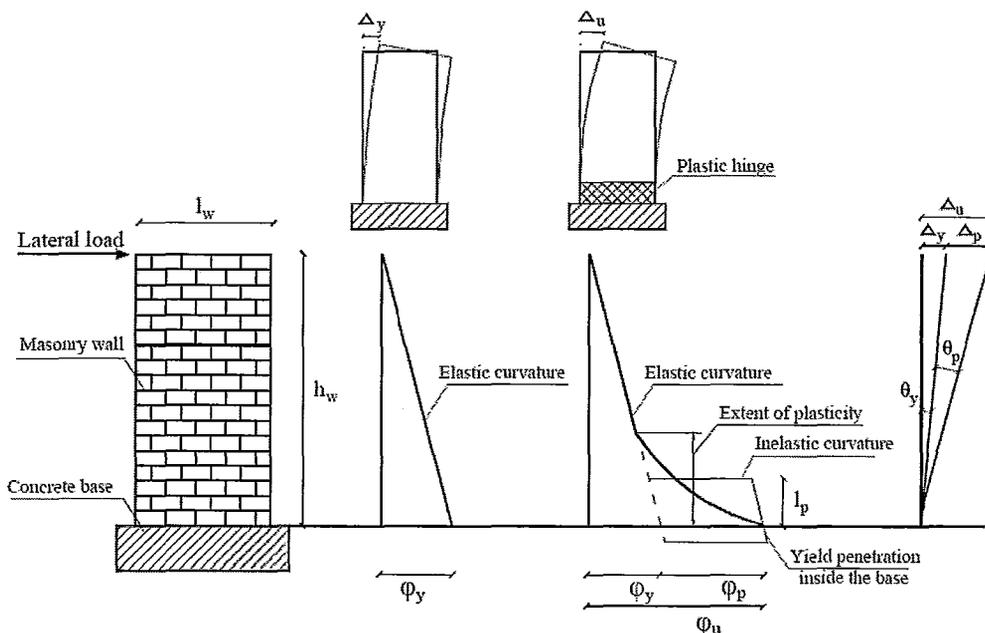
Figure D.1: Curvature and Deflection Relationship of a Reinforced Cantilever Masonry Shear Wall (Shedid, 2006)
