**THE COLLAPSE  
OF  
THE DOFASCO NO. 2 ORE BRIDGE  
MARCH 28th 1995  
HAMILTON ONTARIO**

TIMOTHY VERHEY, B.Eng.

A Project

Master of Engineering

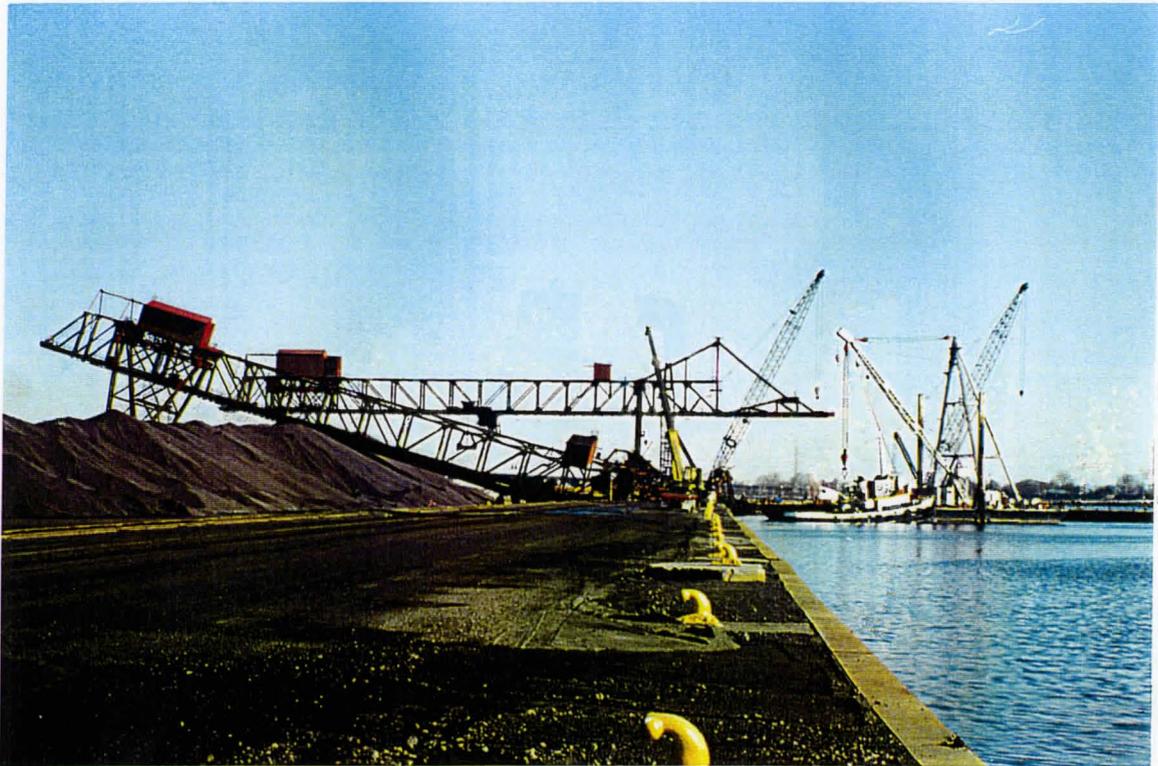
**FIGURE 6: View of the collapsed No.2 Ore Bridge (looking north).**

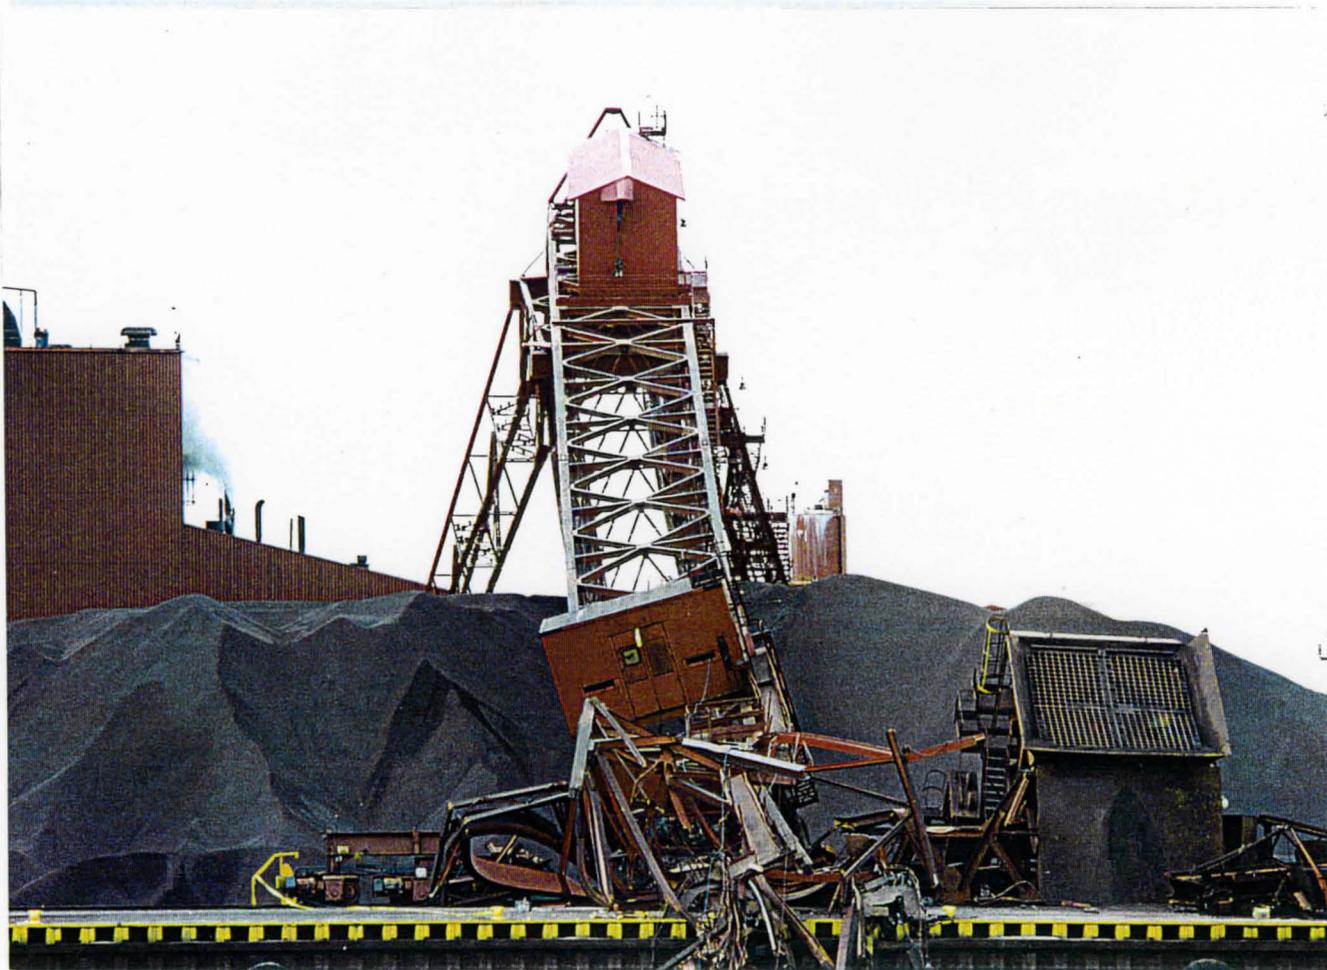
**FIGURE 7:** View of the collapsed No.2 Ore Bridge (looking west).  
(Dofasco, 1995)

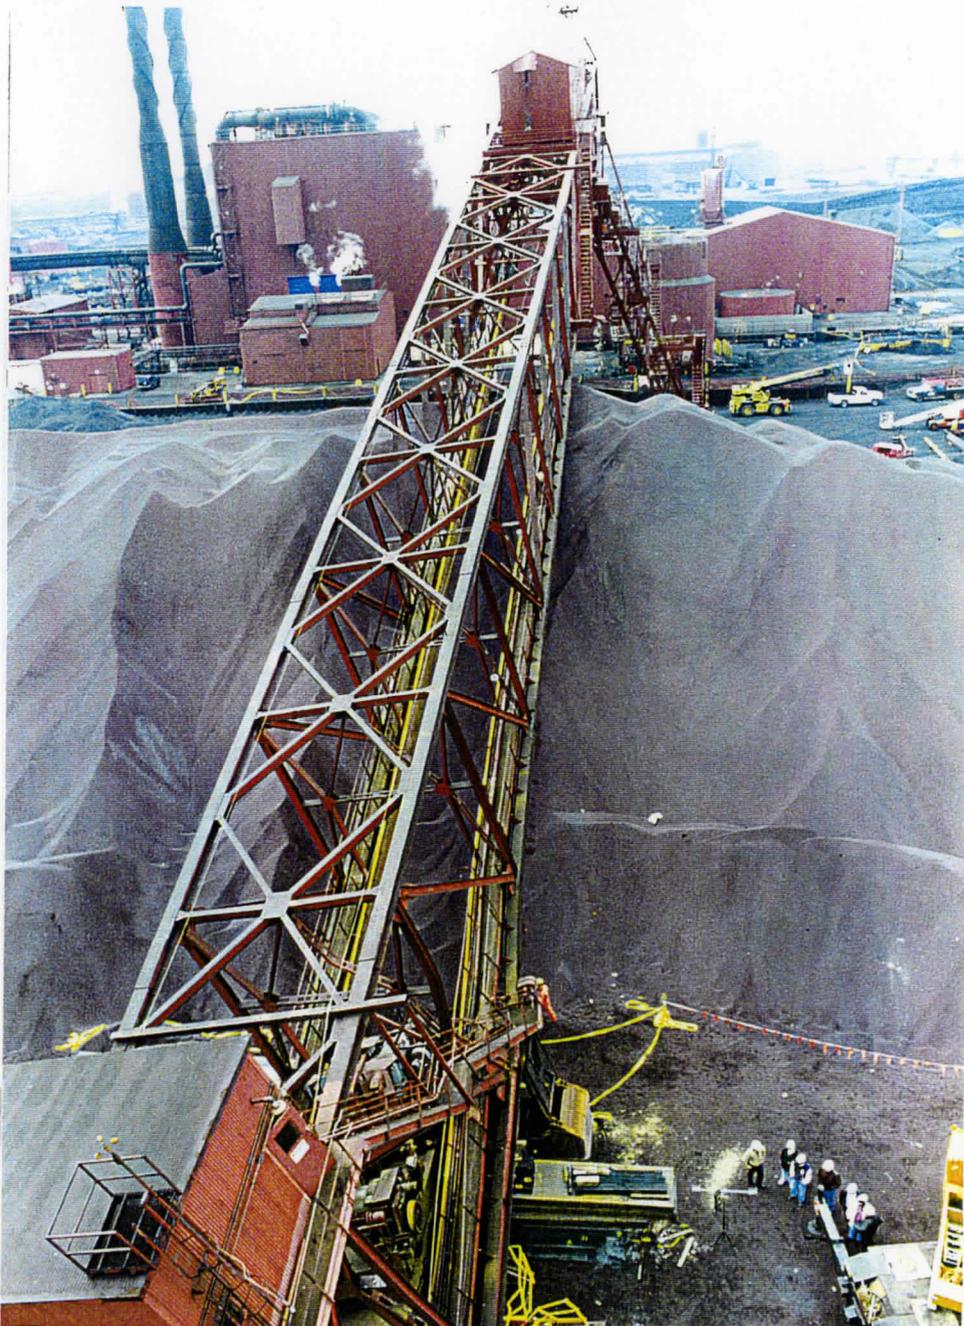
**FIGURE 8:** Aerial view of the collapsed No.2 Ore Bridge (looking west).  
(Dofasco, 1995)

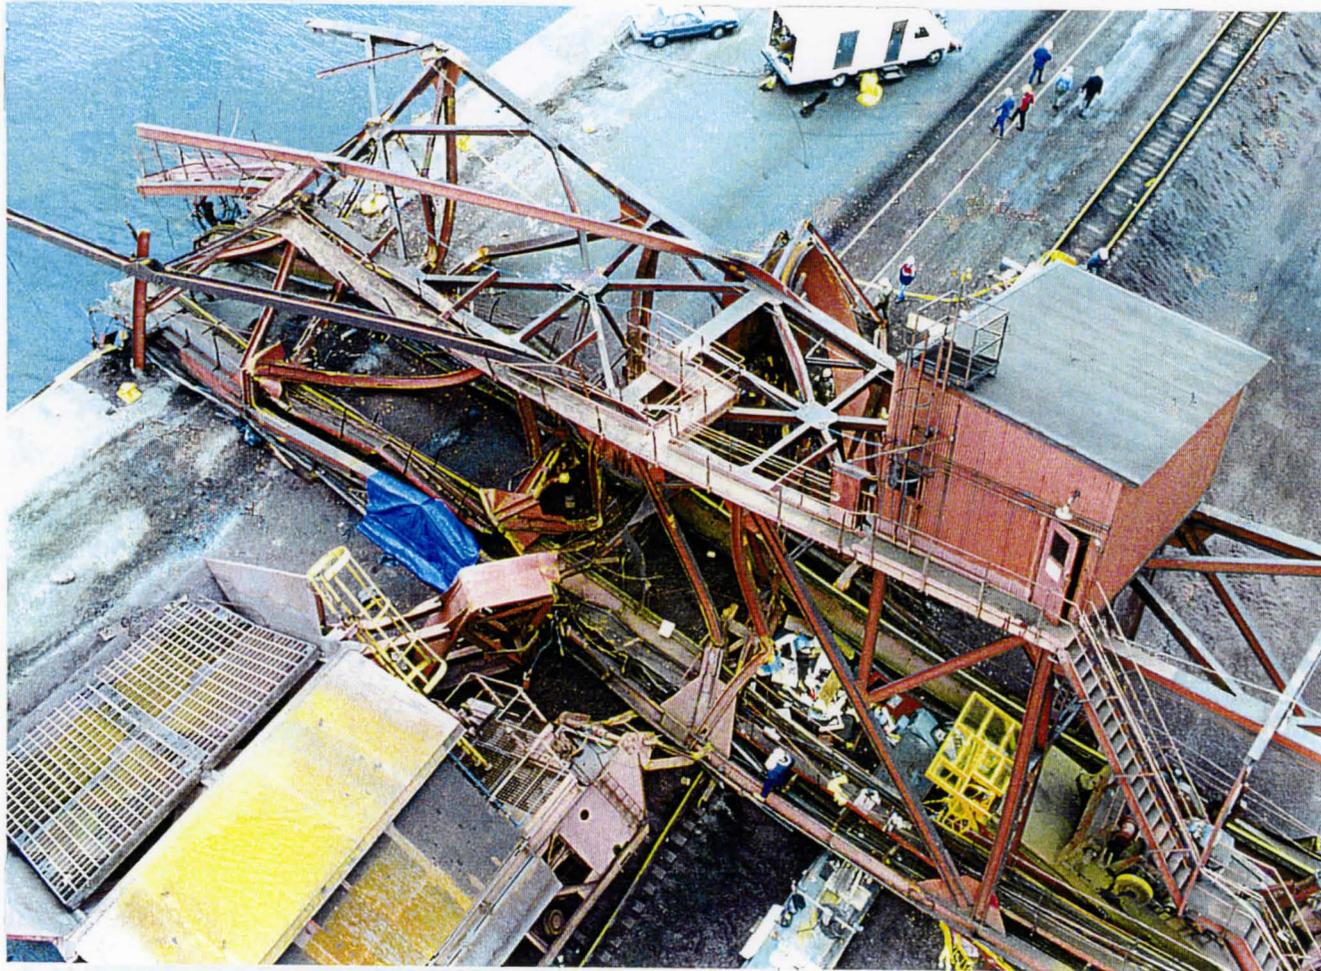
**FIGURE 9:** Aerial view of the collapsed No.2 Ore Bridge in the vicinity of the Shear Leg (looking south). (Dofasco, 1995)

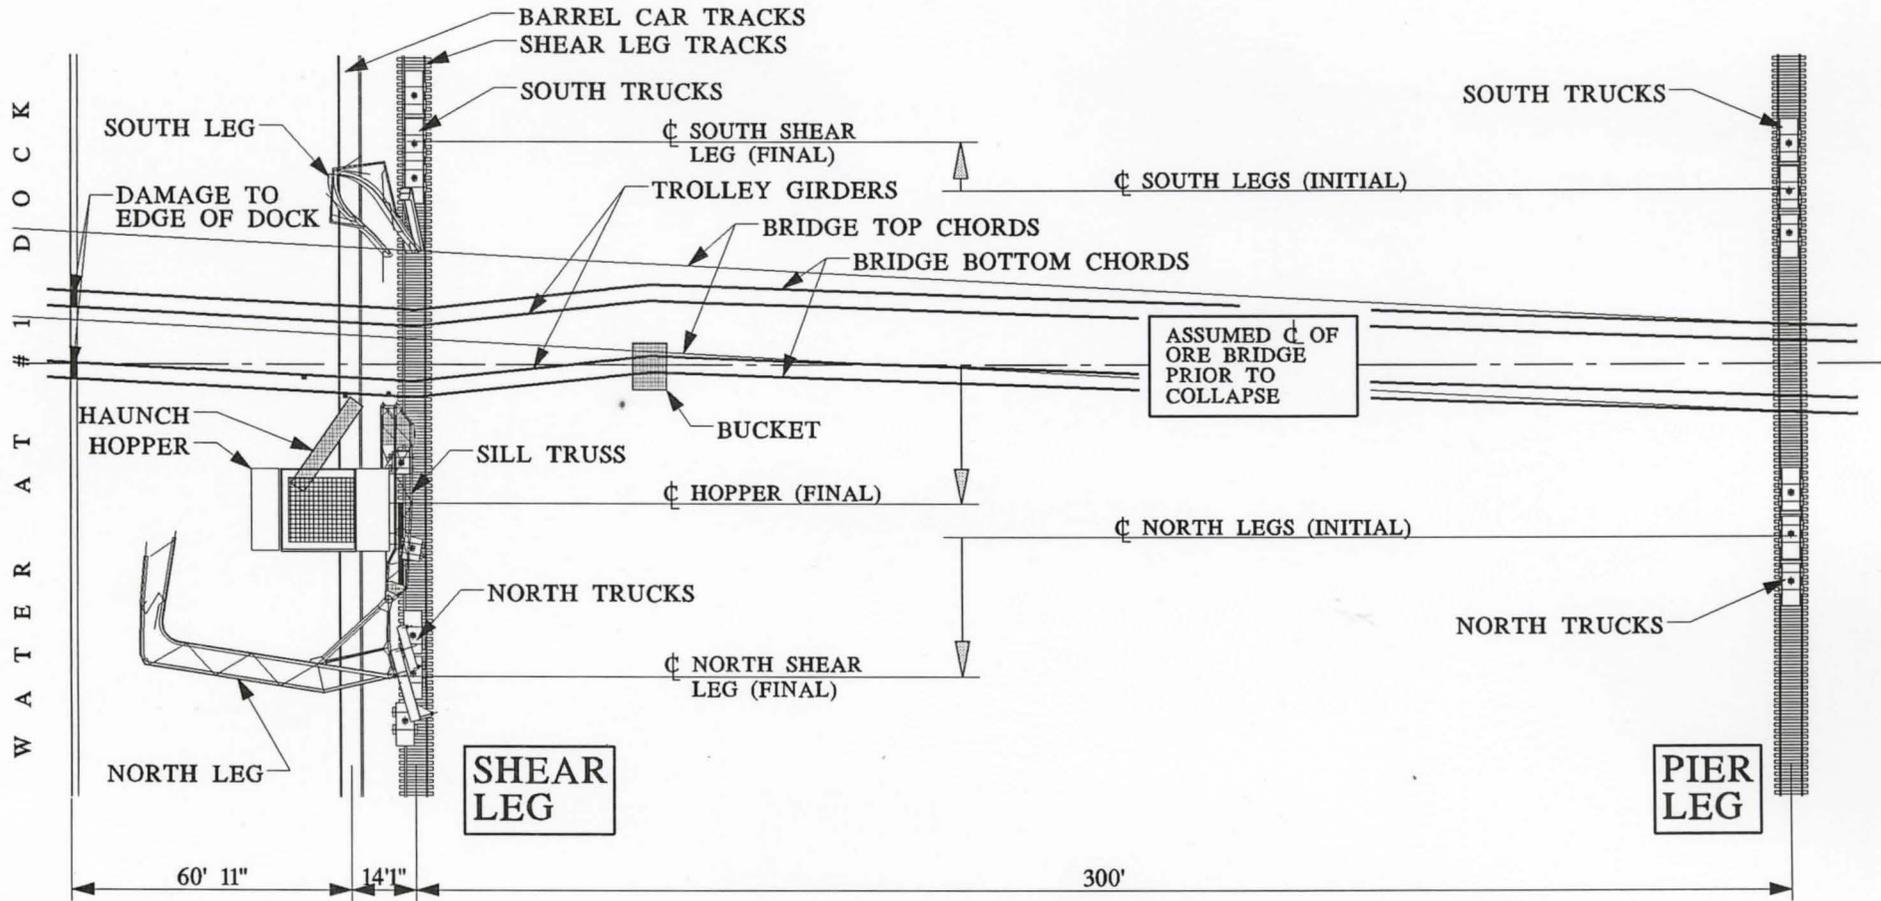
FIGURE 13: Plan view of collapsed No.2 Ore Bridge.

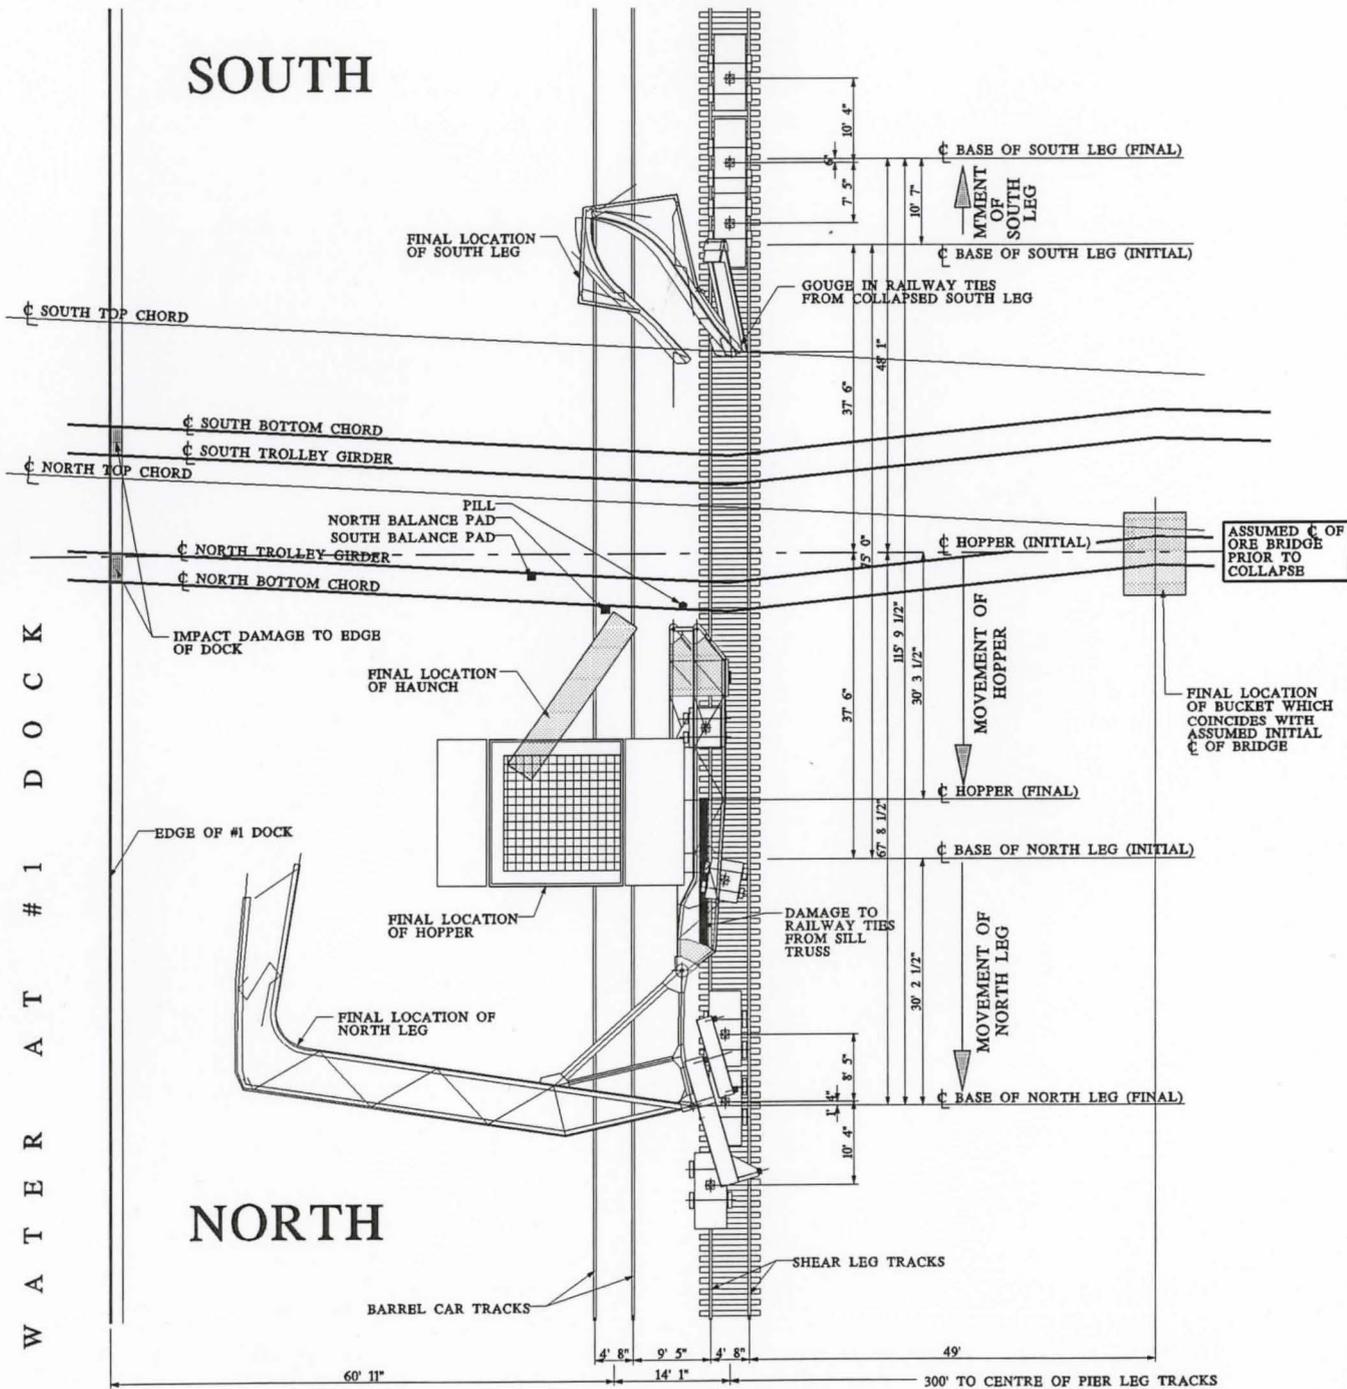
FIGURE 14: Detailed plan view of collapsed No.2 Ore Bridge in vicinity of Shear Leg.

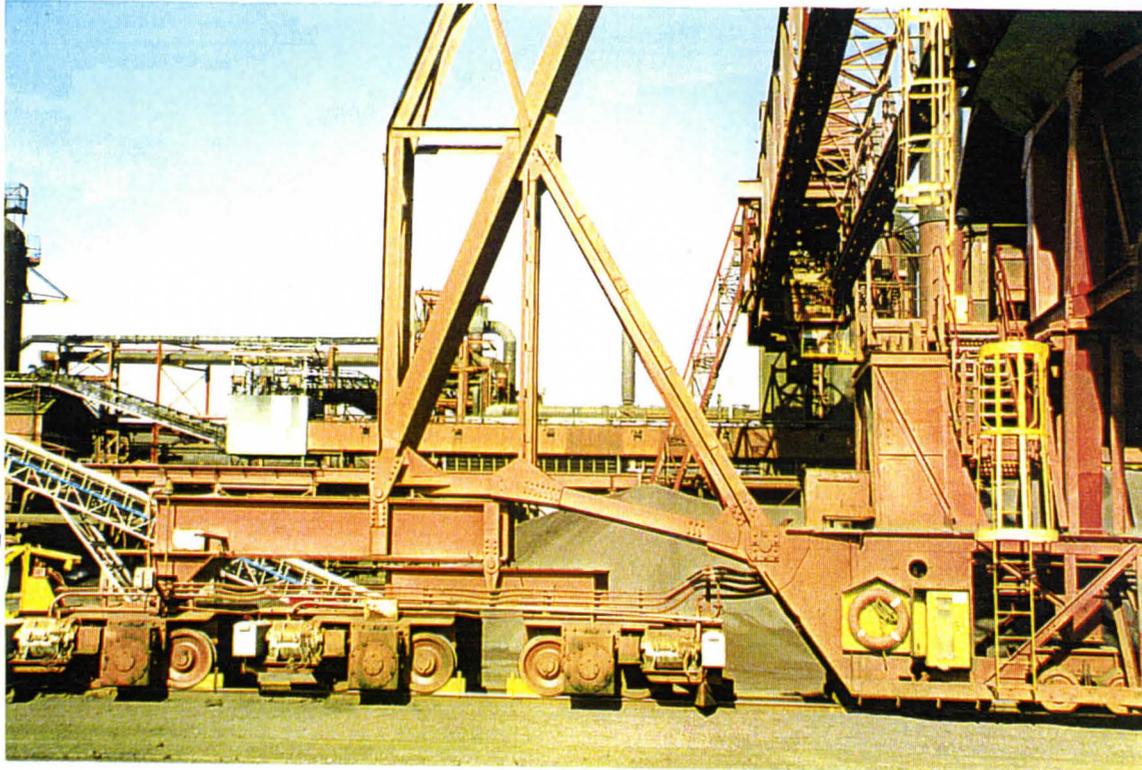
From Figure 25 it is obvious that the tie-brace is not pinned where it changes direction at the intersection of the vertical brace, because of the fixity of the connecting plates. As a result, the tie-brace was modelled as a continuous member at that location which indicated the stresses under the 1990 loadings just about reached the allowable limit, because of local bending stresses in the connection, Figure 57.

**FIGURE 25: View of base of South Leg of No.1 Ore Bridge Shear Leg.**

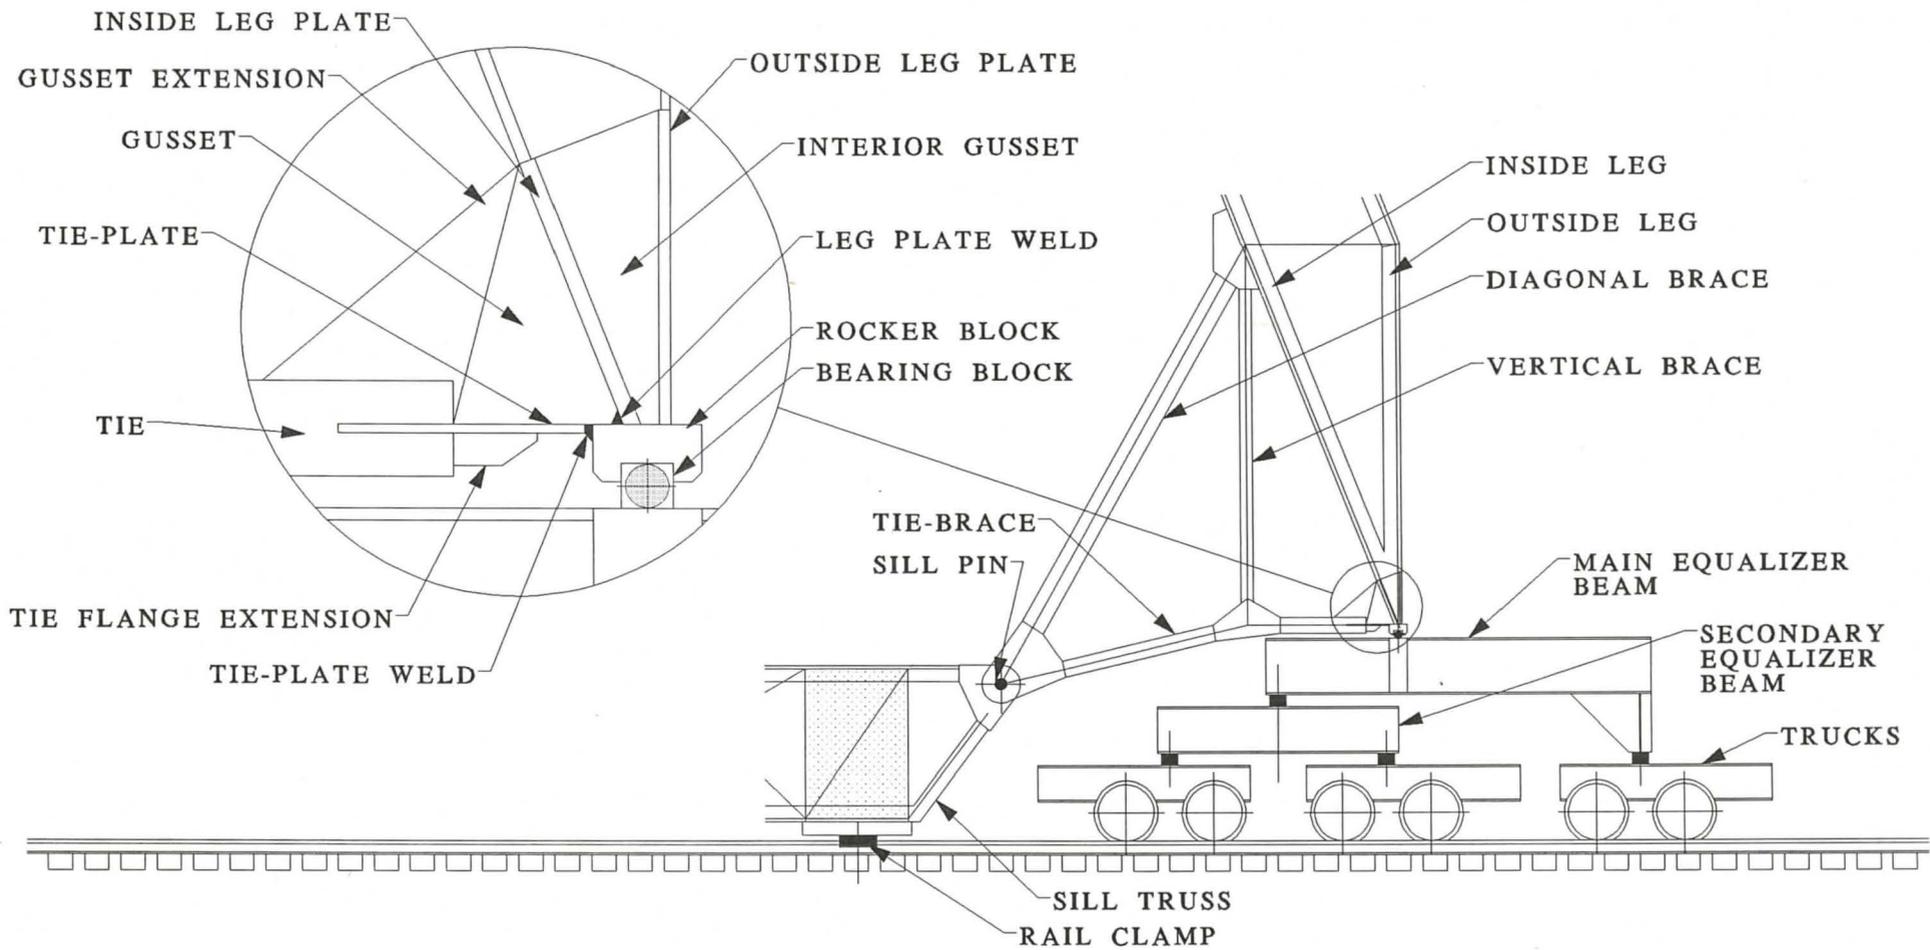
**FIGURE 26: Detail view of base of South Leg of No.2 Ore Bridge Shear Leg (looking east).**

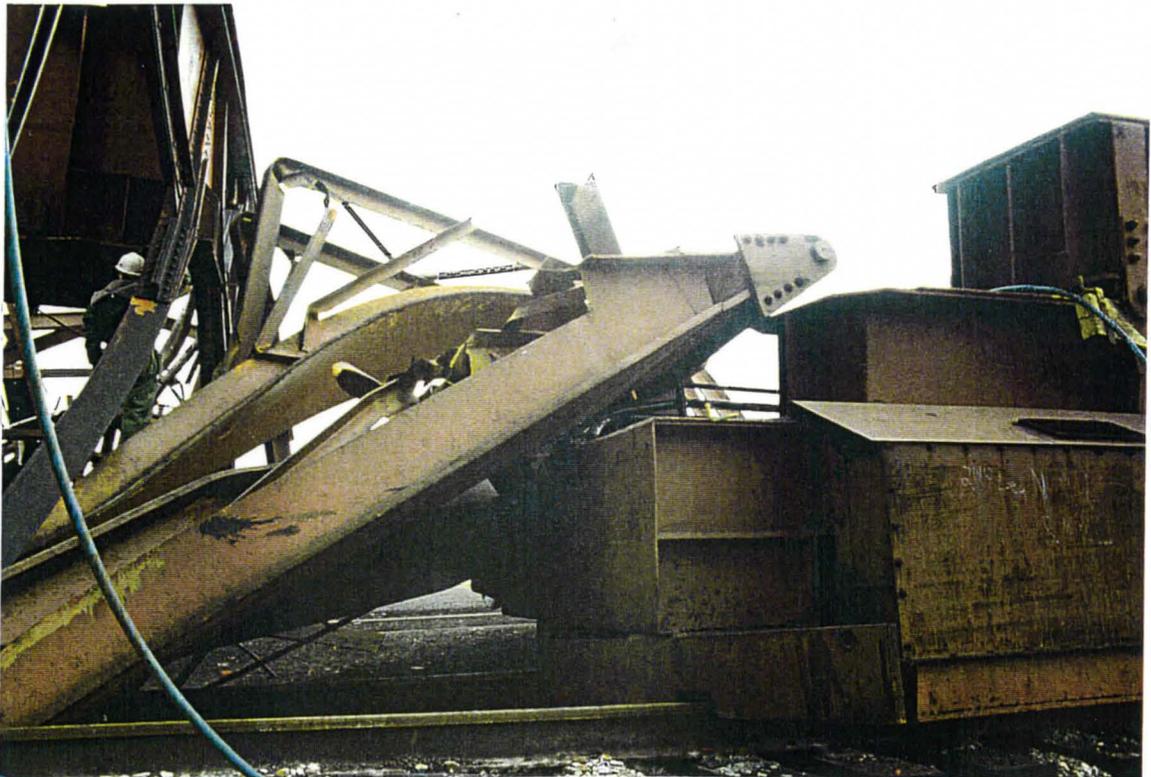
**FIGURE 37:** Collapsed lower portion of South Leg of Shear Leg partially resting on south drive truck (looking east).

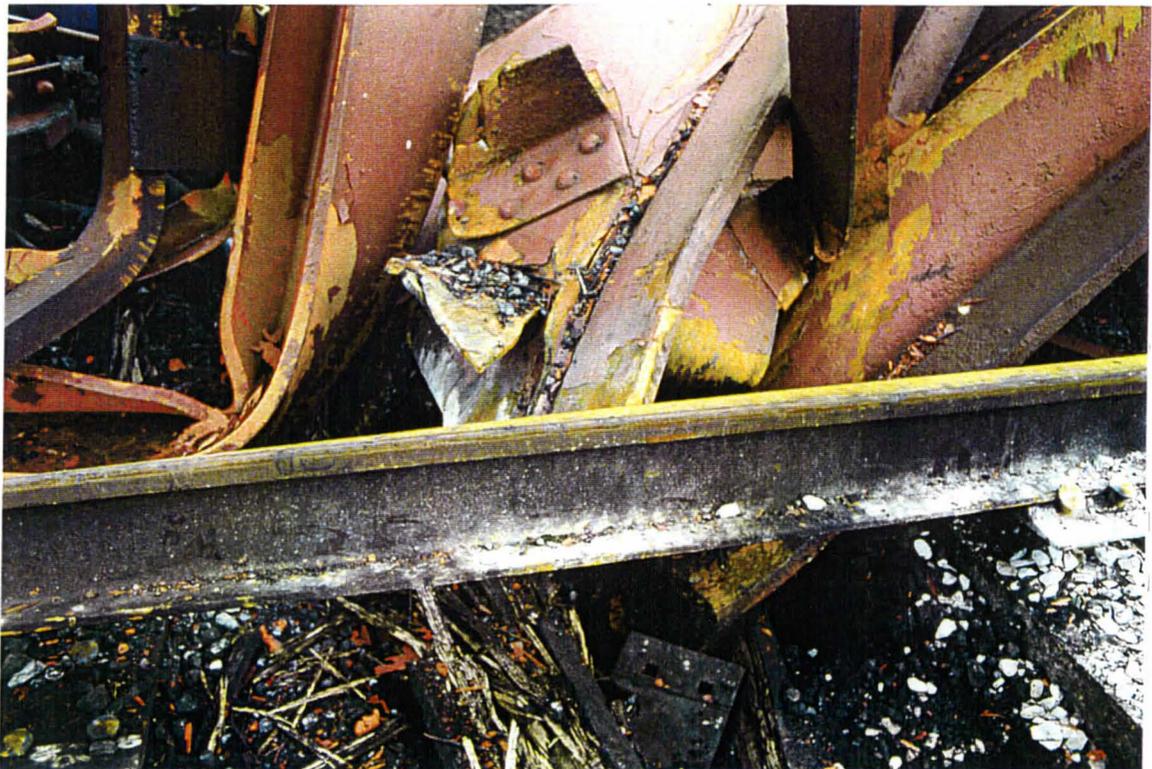
**FIGURE 38:** South Leg of Shear Leg where it was driven into the railway ties and ballast.

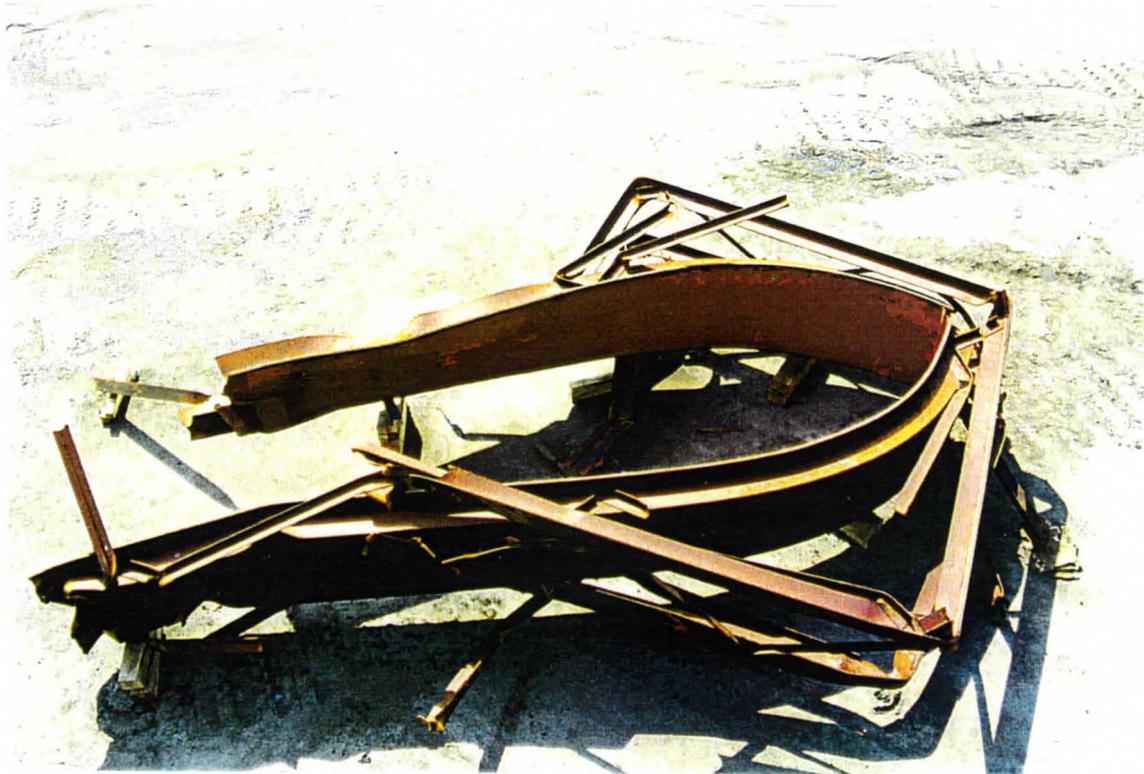
**FIGURE 42:** Aerial view of collapsed South Leg of Shear Leg.

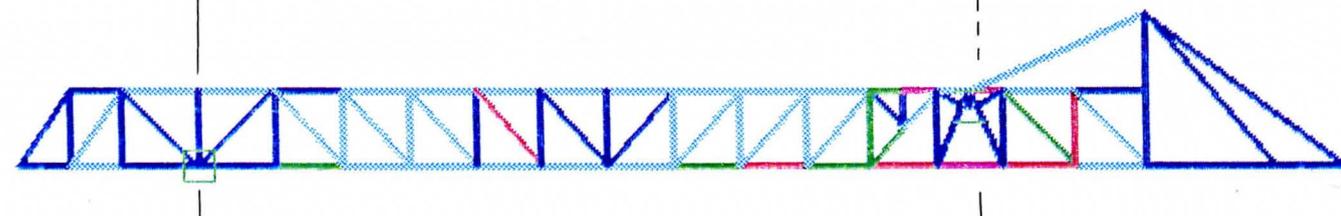
Fig. 49b No.2 Ore Bridge - Apron Extended (1968)

The apron was extended in 1968 and the result is recorded in Figure 49b. Because the trolley can now travel further to the east, it increases the effect of the trolley load on the main span. Several of the members now exceed their allowable stresses, but only by 3 or 4 percent. The results are not inconsistent with those of H&P on their drawings, where stresses reaching or slightly exceeding their allowable are tabulated. (Dofasco, 1995)

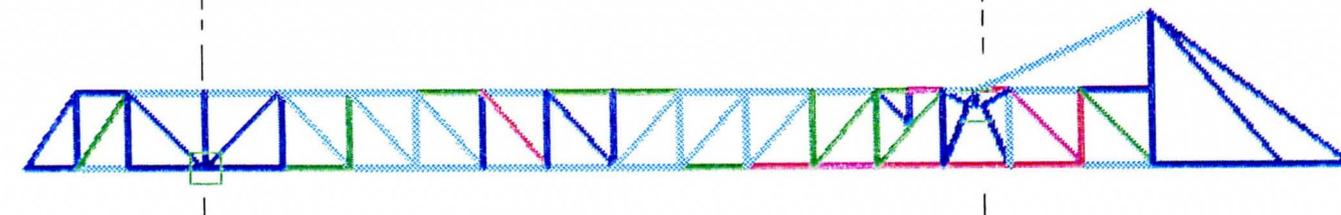
Fig. 49c No.2 Ore Bridge - Final Configuration (1995)

As a result of the recent increase in the recognised dead weight of the main span and the trolley and the increase around 1975 of the lifted trolley payload to 17.5 Tons, more members become overstressed, even with a reduction of the trolley impact factor from 30% to 25%, Figure 49c. Several members now exhibit stresses beyond the allowable of up to 15%, especially around the Shear Leg, which should have triggered consideration of reinforcing. There was no record however, indicating the members were ever reinforced.

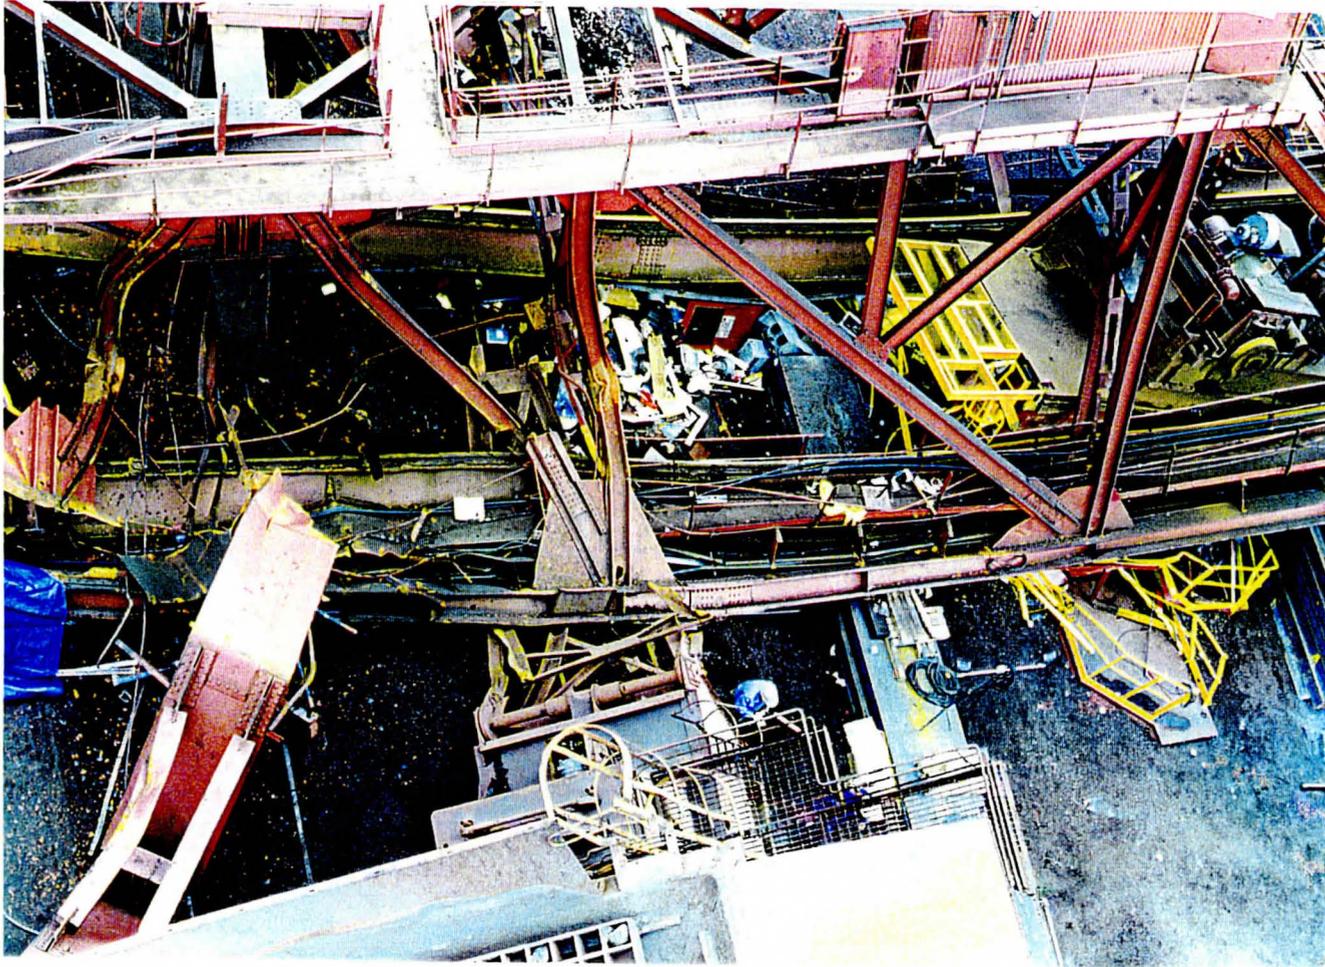
The members in the main span around the Shear Leg are recorded in Figure 50, looking towards the south, following the collapse. Figure 51 was taken along the north side bottom chord of the main span looking east, while Figure 52 records the south side of the main span in the area of the Shear Leg support.

The damage to these members is consistent with the impact of the east end of the main span on the dock, combined with the twisting of the main span towards the south. The twist in the main span was enhanced when the underside of the bottom chord on the north side impacted the bucket, Figure 53.

**FIGURE 50:** Aerial view of main span members in the vicinity of the Shear Leg (looking south). (Dofasco, 1995)

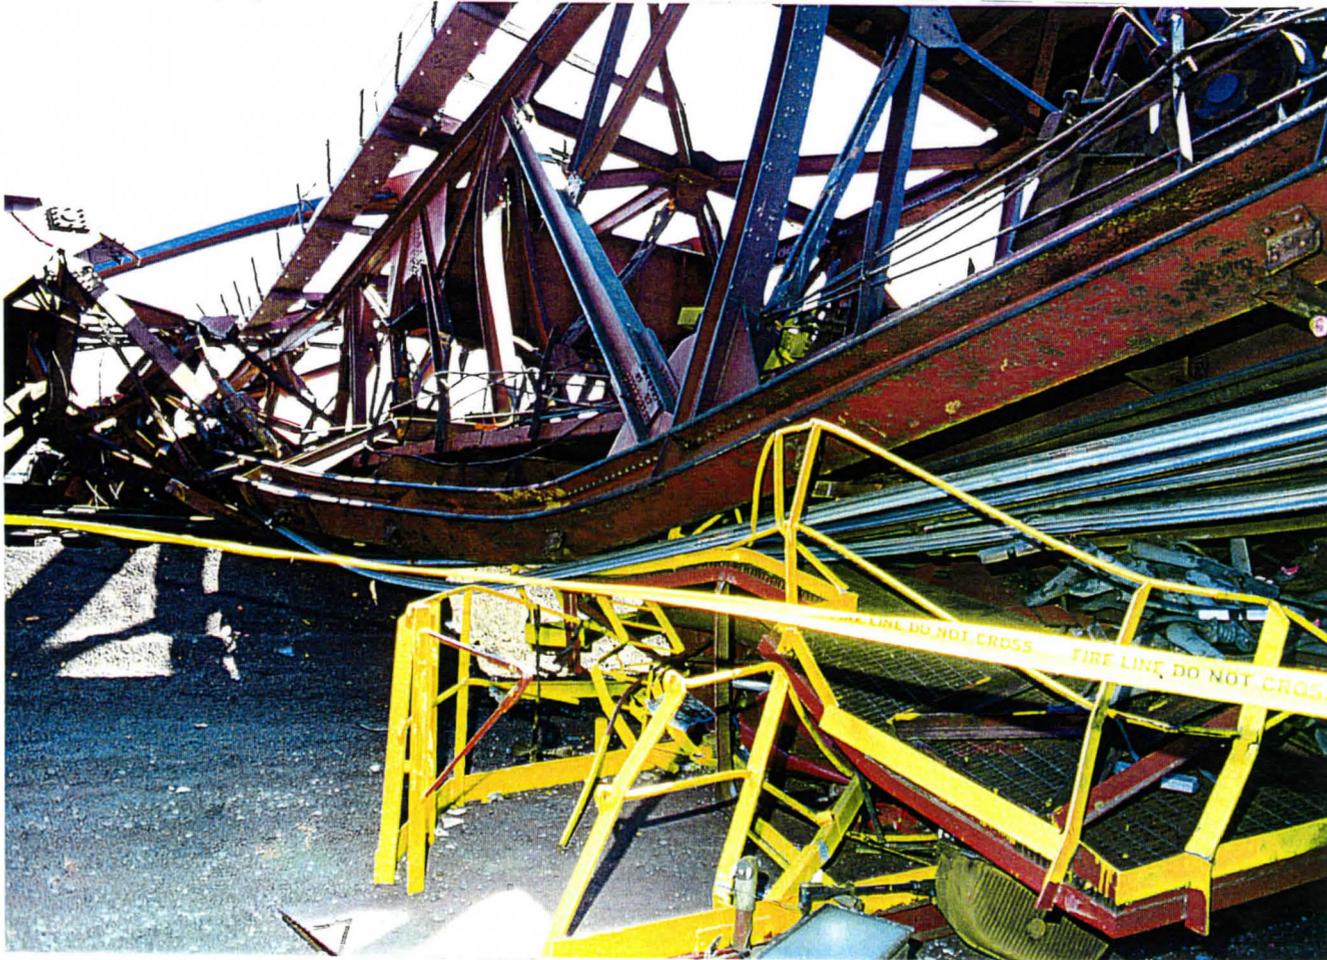
**FIGURE 51:** View of the north bottom chord of the Main Span where it impacted the ground during the collapse. (Dofasco, 1995)

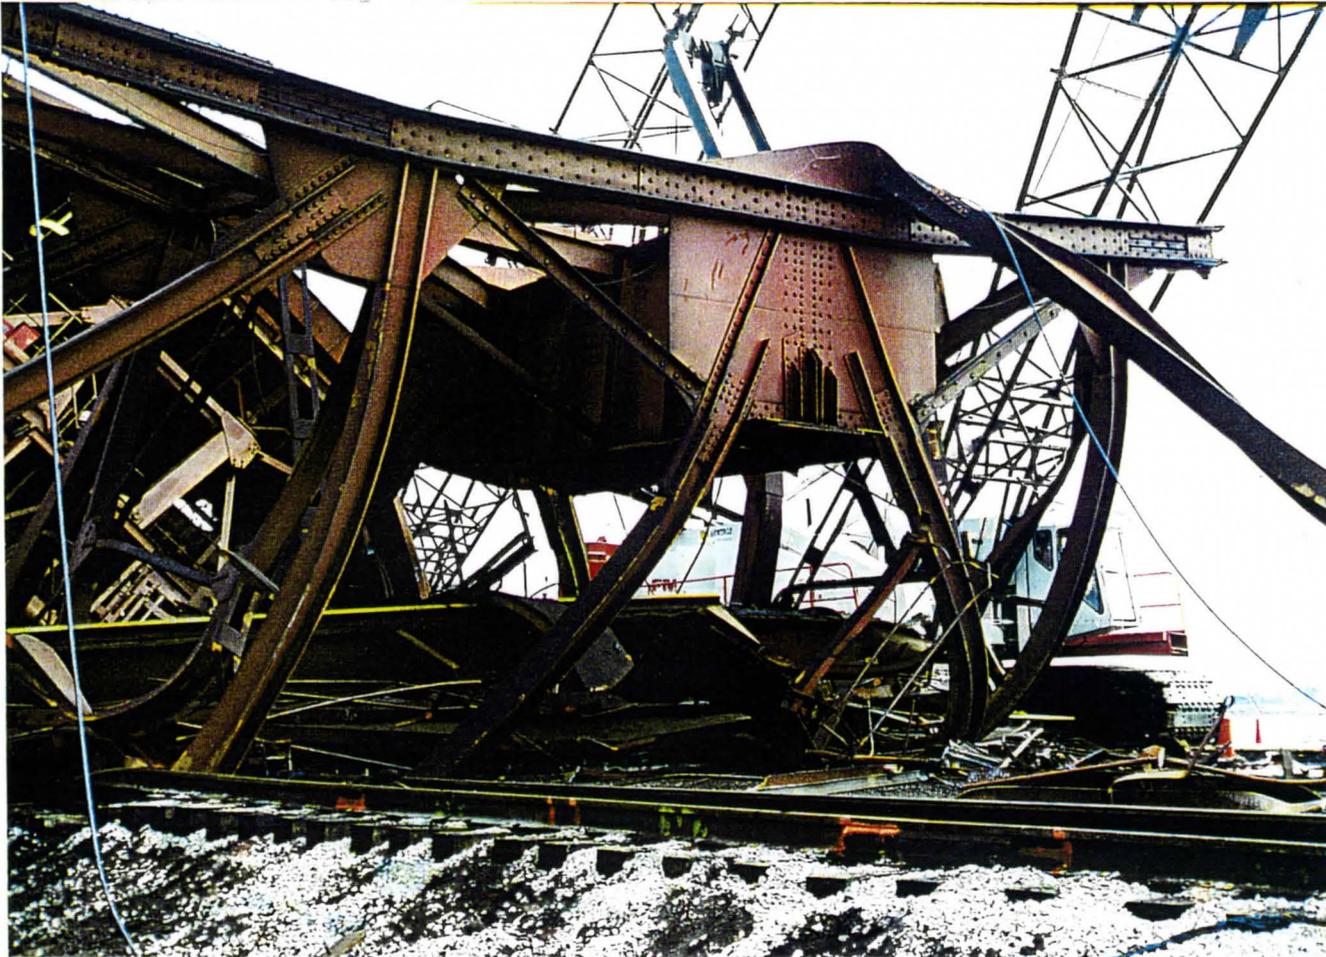
**FIGURE 52:** View of the south side of the Main Span in the vicinity of the Shear Leg (looking north). (Dofasco, 1995)

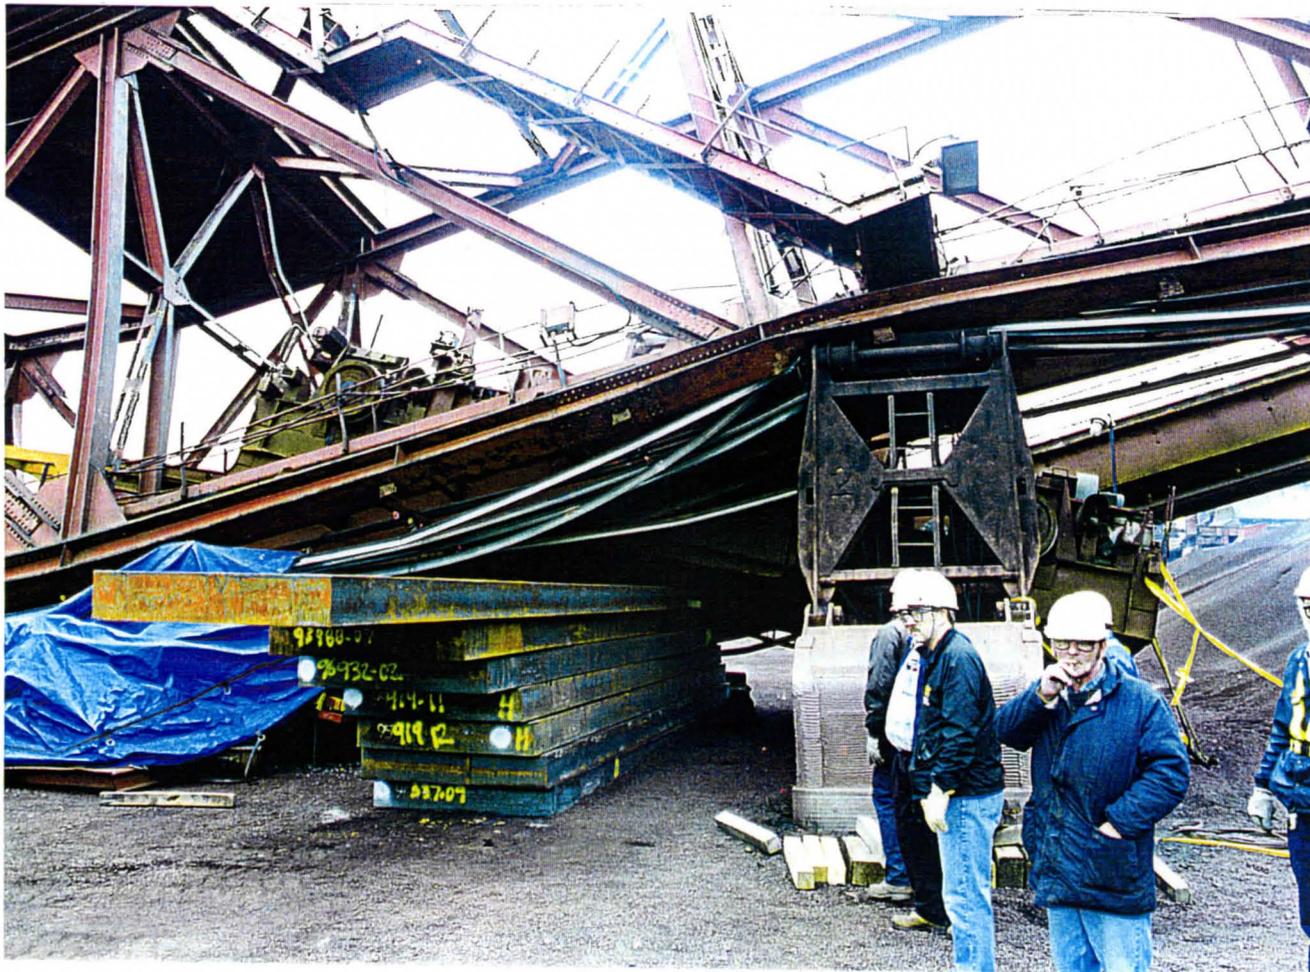
**FIGURE 53:** View of the north side of the Main Span where it impacted the bucket (looking south). (Dofasco, 1995)

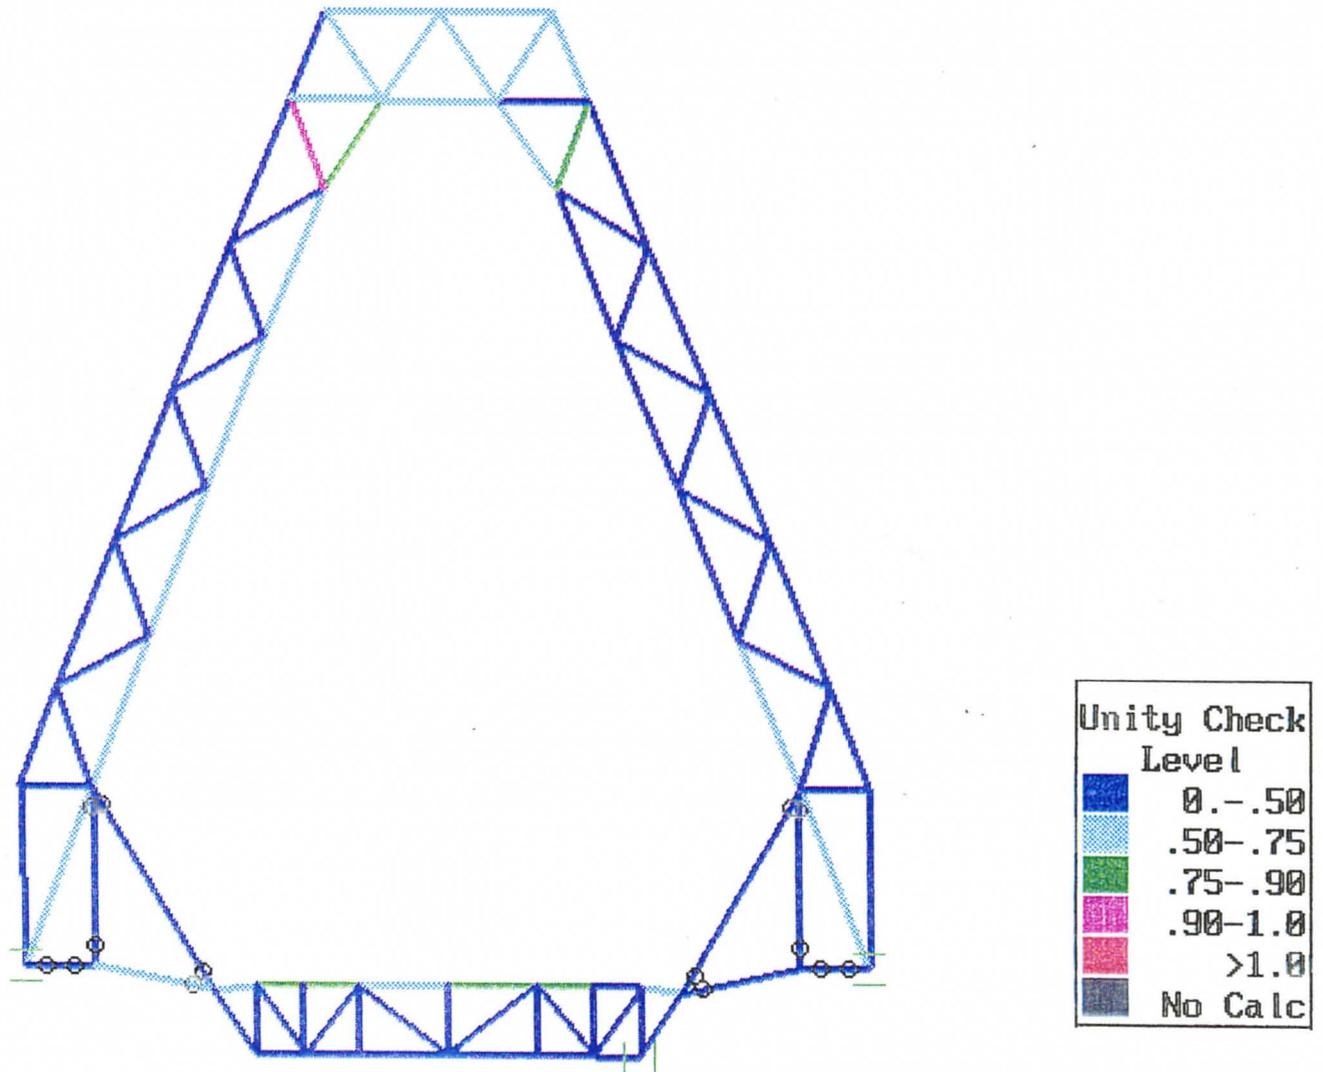
The original gravity loads on the main span were transferred directly into the Shear Leg and combined in the manner described on the H&P drawings. The impact factor from the trolley was reduced to 15%. As well, the horizontal load on the pill resulting from skewing the main span was combined with the trolley fully loaded, but not including impact, which is reasonable. The maximum results from RISA-2D, for these loadings, are shown in Figure 54. None of the Shear Leg members is overstressed.

The Shear Leg was originally analysed by H&P as a pin-jointed two-dimensional framework. In Figure 54 the tie members connecting the sill truss to the bottom of the north and south legs are shown with small circles at their ends. The circles indicate the ends of those members were assumed to be pinned in the computer program, for structural analysis and design purposes.

**FIGURE 54:** Results of a two-dimensional structural design check of the Shear Leg of the No.2 Ore Bridge as originally designed (1952).
