**THE COLLAPSE  
OF  
THE DOFASCO NO. 2 ORE BRIDGE  
MARCH 28th 1995  
HAMILTON ONTARIO**

TIMOTHY VERHEY, B.Eng.

A Project

Master of Engineering

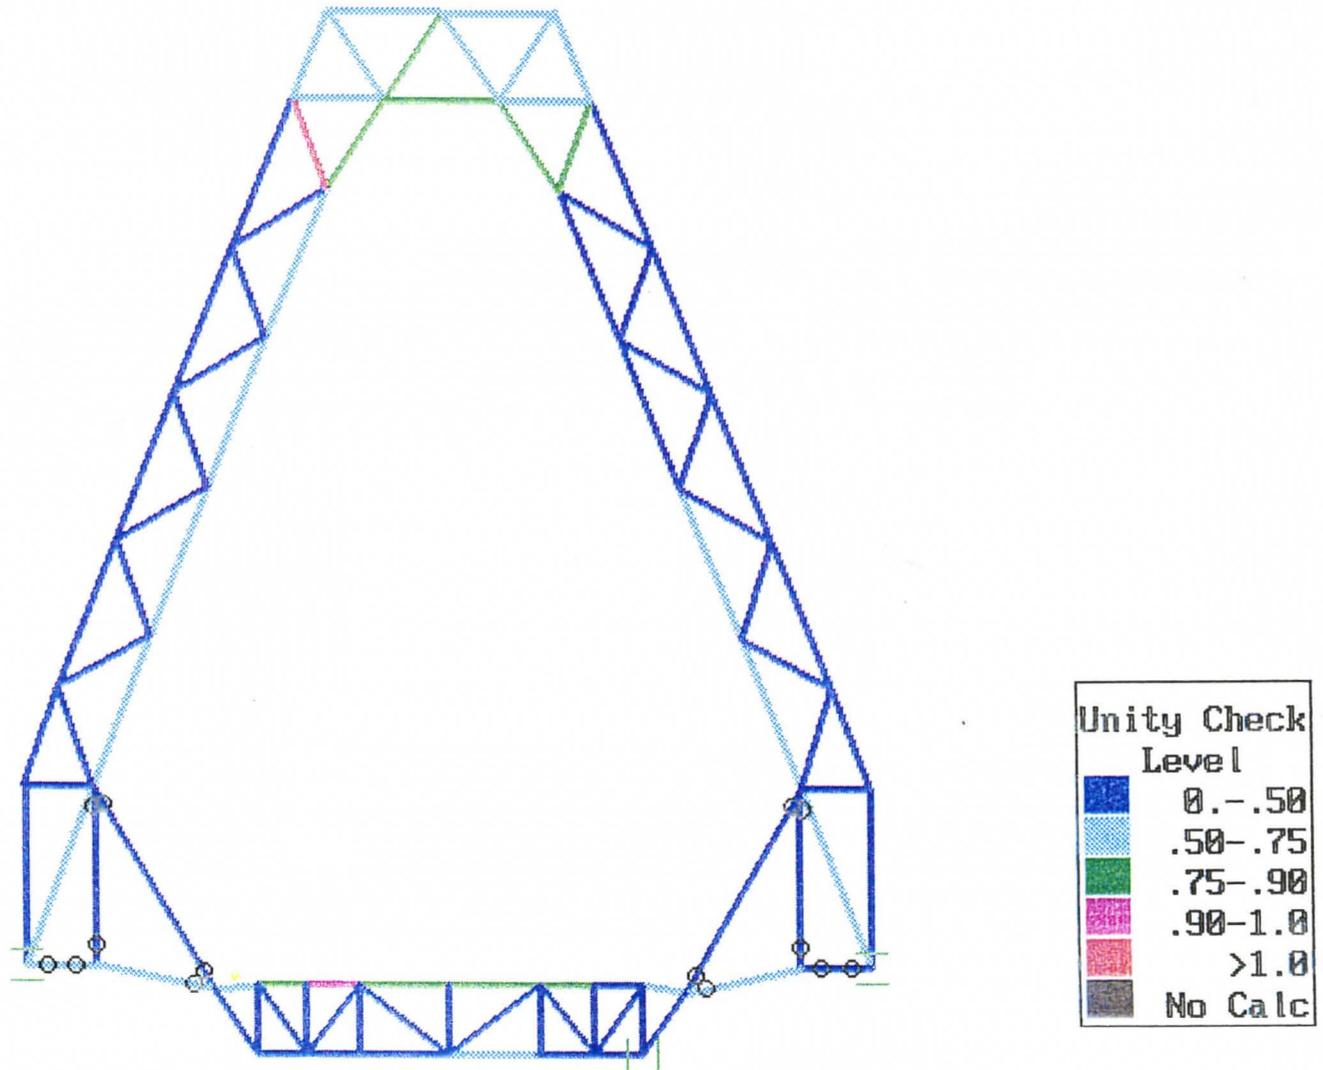
In 1990 the trolley was upgraded which, combined with the 1975 increase in the payload to 17.5 Tons, recognition that the dead weight of the main span was greater than originally assumed, and a 5 psf wind blowing, did produce an overstress, Figure 55. On the leeward side of the Shear Leg, the diagonal "T" members at the top of the leg, directly underneath the haunch, were overloaded by approximately 5%, which is not unlike the findings reported at the time by H&P. (Dofasco, 1995)

**FIGURE 55:** Results of a two-dimensional structural design check of the Shear Leg of the No.2 Ore Bridge with the payload and dead-weights increased (1990).

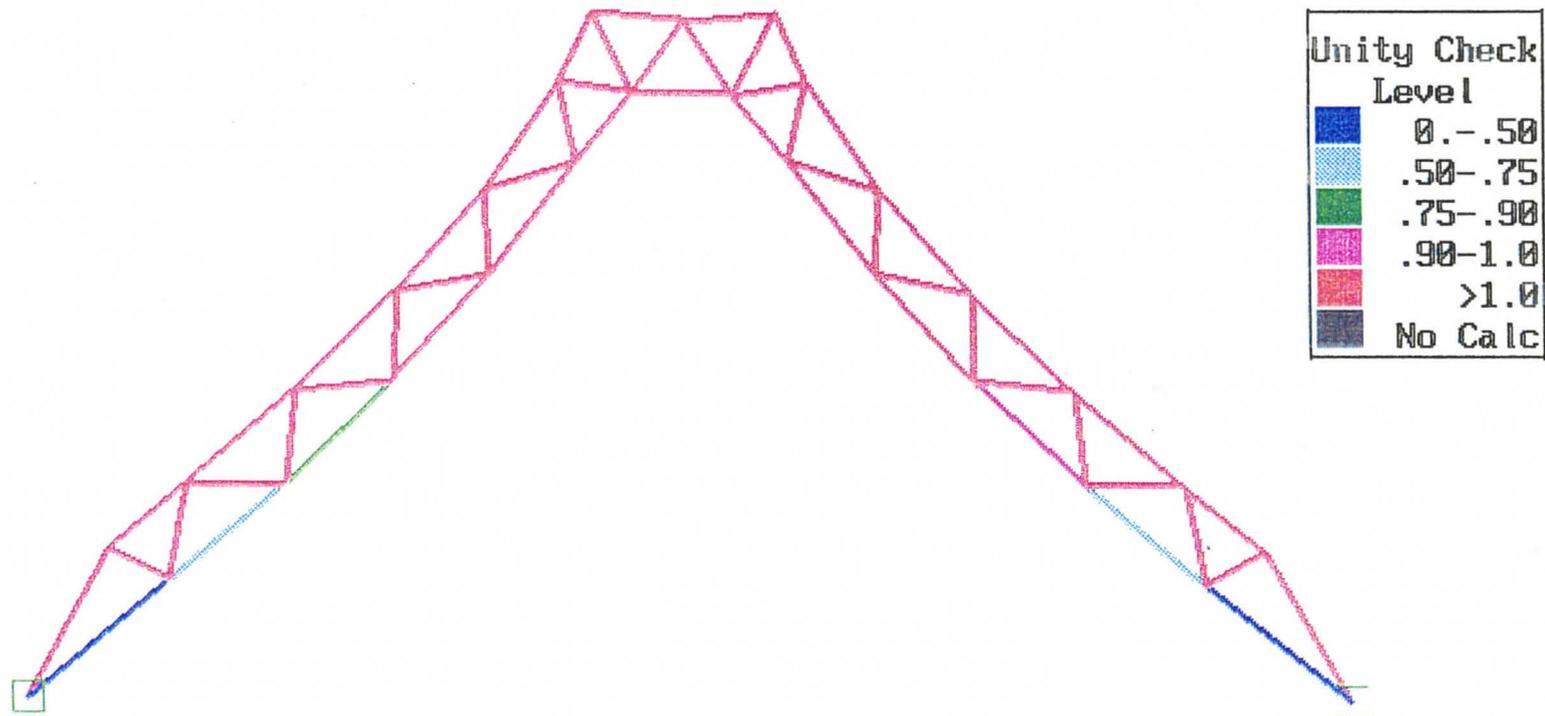
Because the Shear Leg is in structural terms a portal frame or tied arch, the tie-brace is a critical member. It carries the tension force which prevents the north and south legs from spreading. Without the tie-brace and the sill truss, the Shear Leg will spread. Considering the 1990 loadings from the main span and trolley, if the tie-brace and the sill truss are removed, virtually every member in the Shear Leg is overstressed to failure, Figure 56.

Once the fractures intersected, the tie-plate was in two pieces and incapable of carrying any tensile force. The connection linking the bottom of the north and south legs of the Shear Leg was thus effectively lost, allowing the legs to start spreading (as depicted in Figure 56), and the collapse of the No.2 Ore Bridge to begin.

**FIGURE 56:** Results of a two-dimensional structural design check of the Shear Leg of the No.2 Ore Bridge with the Tension Tie removed.

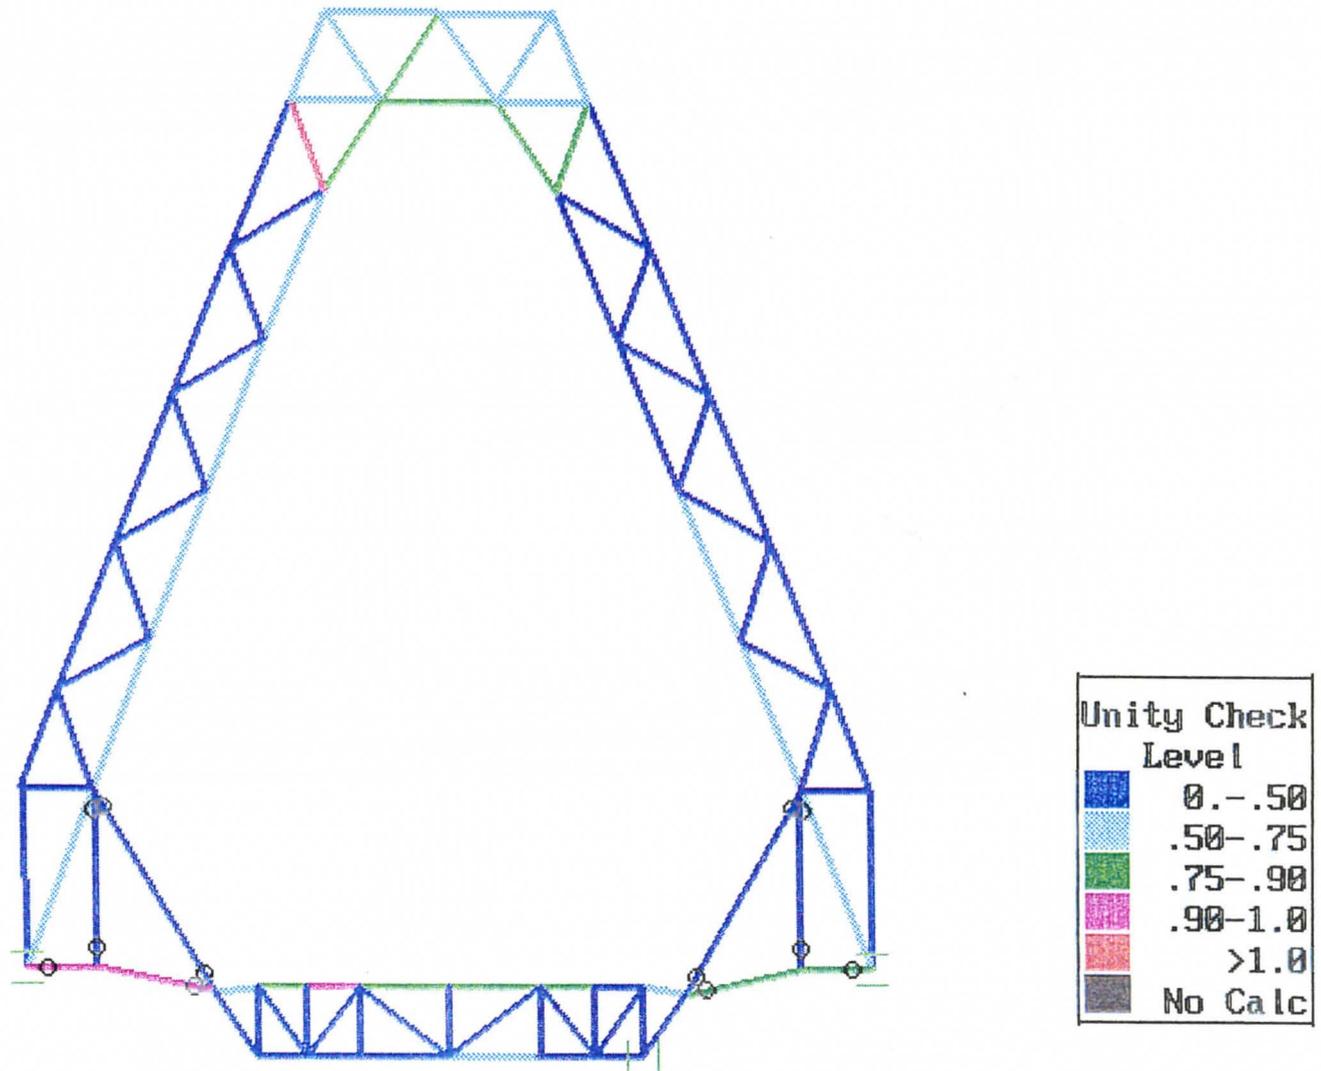
From Figure 25 it is obvious that the tie-brace is not pinned where it changes direction at the intersection of the vertical brace, because of the fixity of the connecting plates. As a result, the tie-brace was modelled as a continuous member at that location which indicated the stresses under the 1990 loadings just about reached the allowable limit, because of local bending stresses in the connection, Figure 57.

**FIGURE 57:** Results of a two-dimensional structural design check of the Shear Leg of the No.2 Ore Bridge with a continuous Tension Tie (1990).

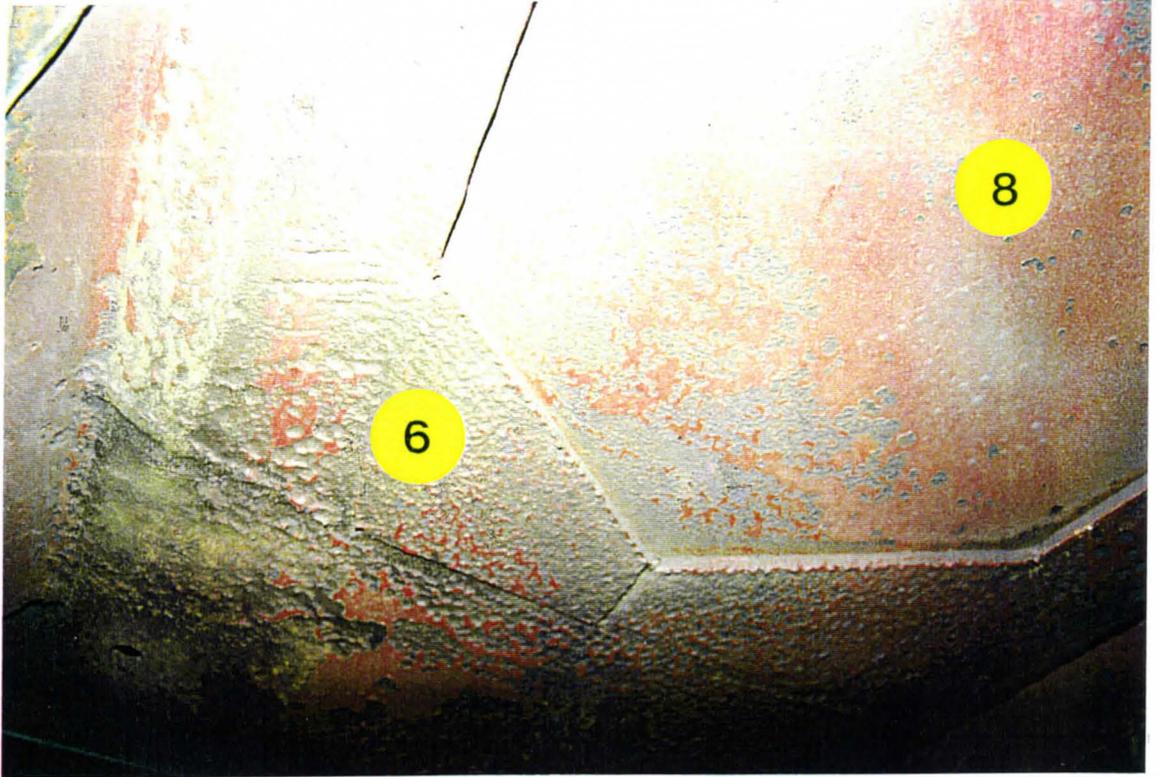
**FIGURE 69:** View of underside of south tie-plate showing additional reinforcing plates. (See text for notes)

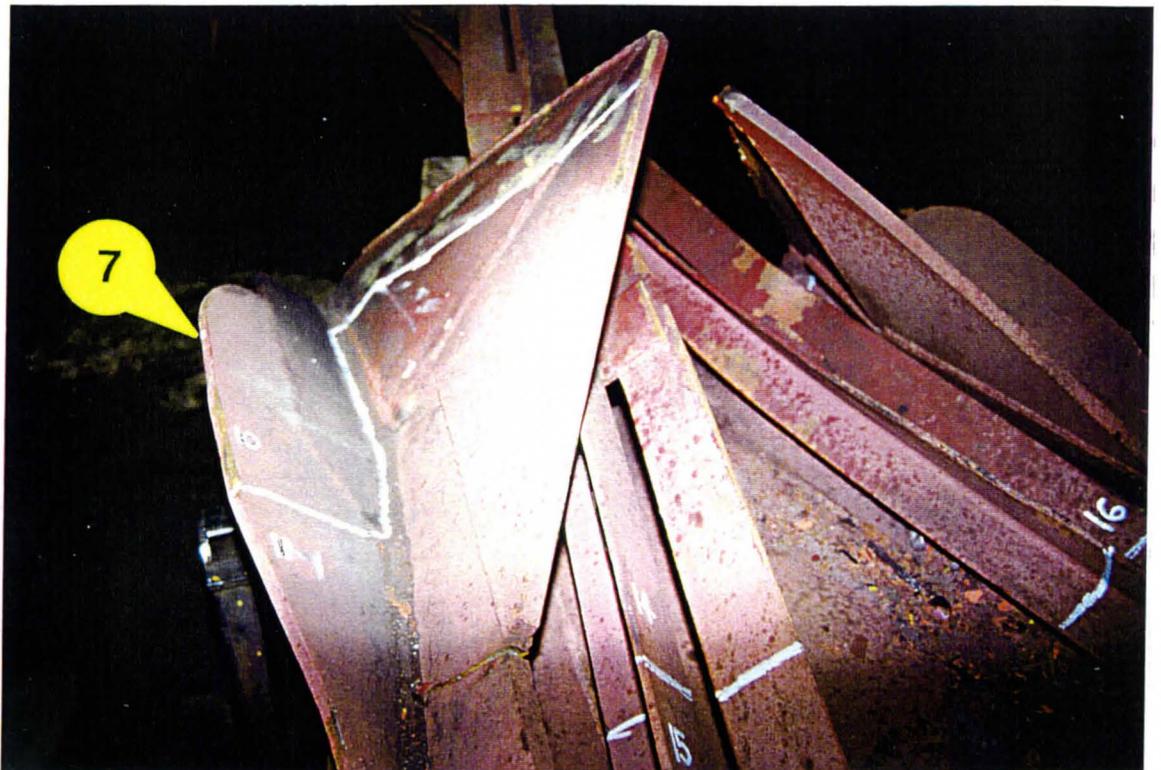
**FIGURE 70:** View of additional reinforcing plates which were added to the edges of the tie-plate. (See text for note)

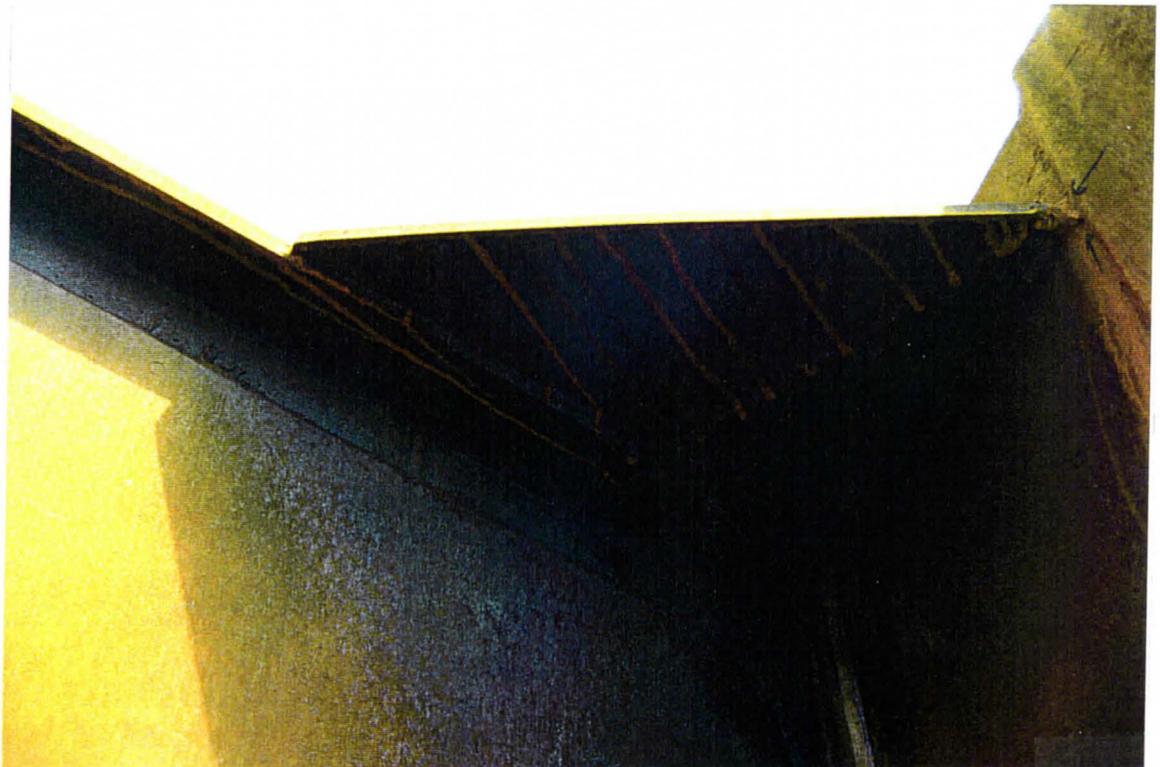
**FIGURE 72:** Closeup view of the gusset extension at the west side of the base of the North Leg of the Shear Leg of the No.2 Ore Bridge.

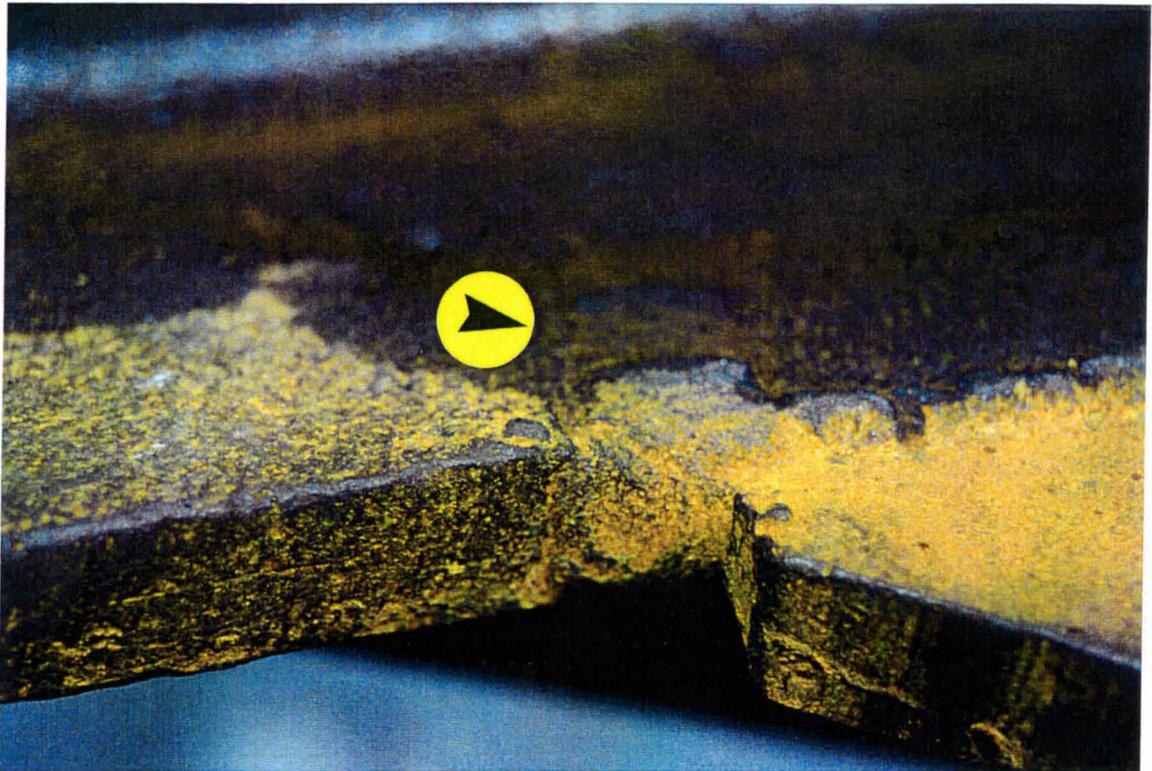
**FIGURE 75:** Closeup view of a weld repair in the east tie-brace flange.

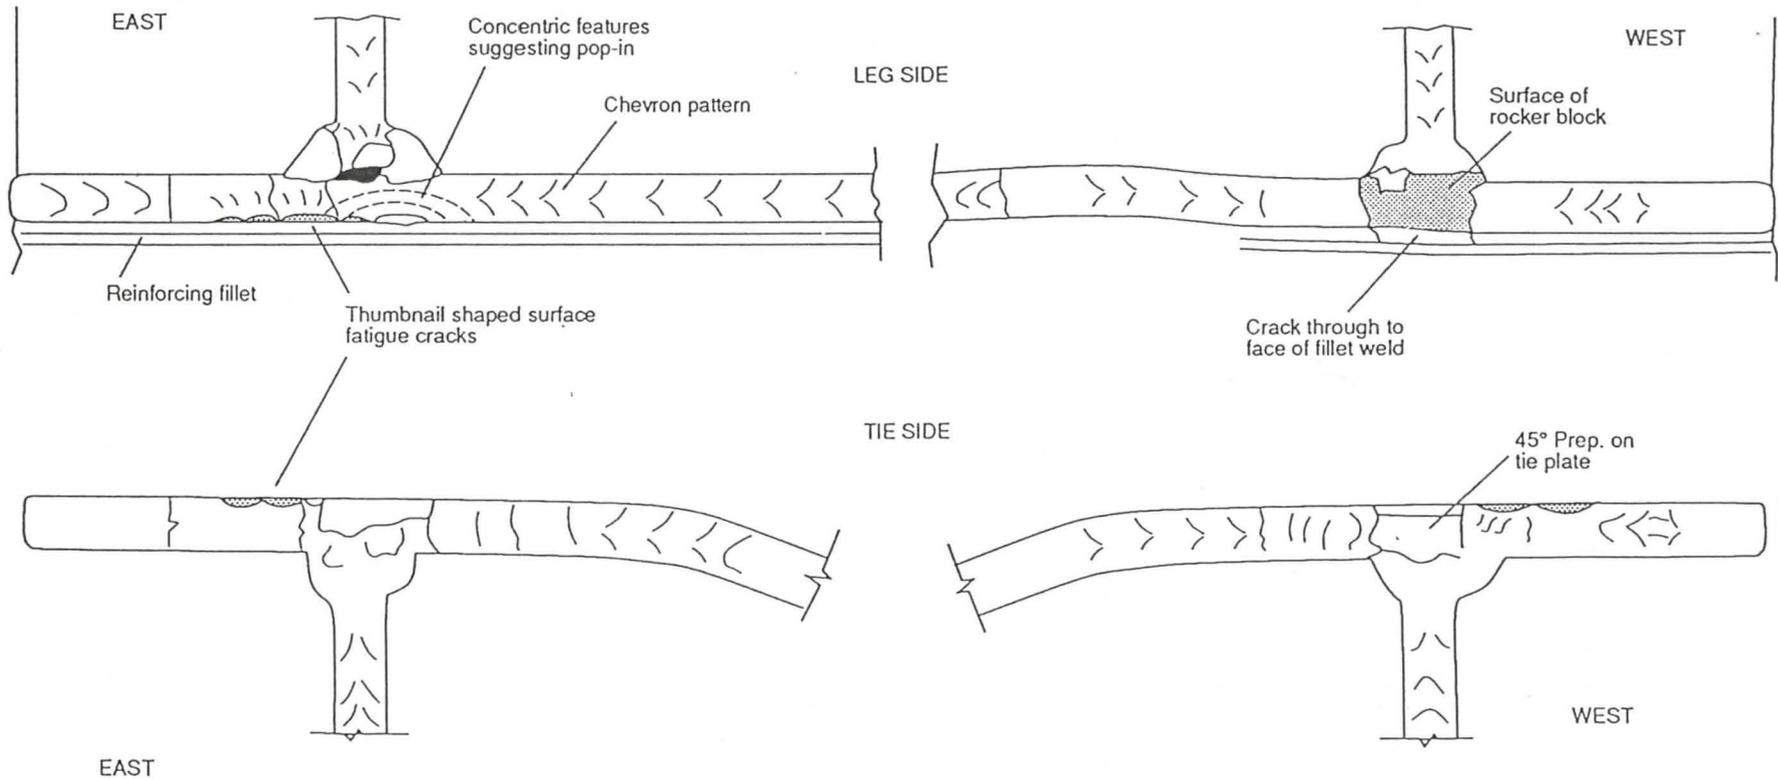
Figure 78. Figure 82 illustrates the main features of the fracture faces. (Graville, 1995) (In Figure 82 the upper portion of the Figure is the equivalent to looking at Figure 78, the leg side of the connection. The lower portion of Figure 82 is the mating half of the connection on the tie-brace side, which is equivalent to looking at Figure 79 upside down.)

**FIGURE 82: Sketch illustrating main features on the fracture faces.**  
 (Graville, 1995)

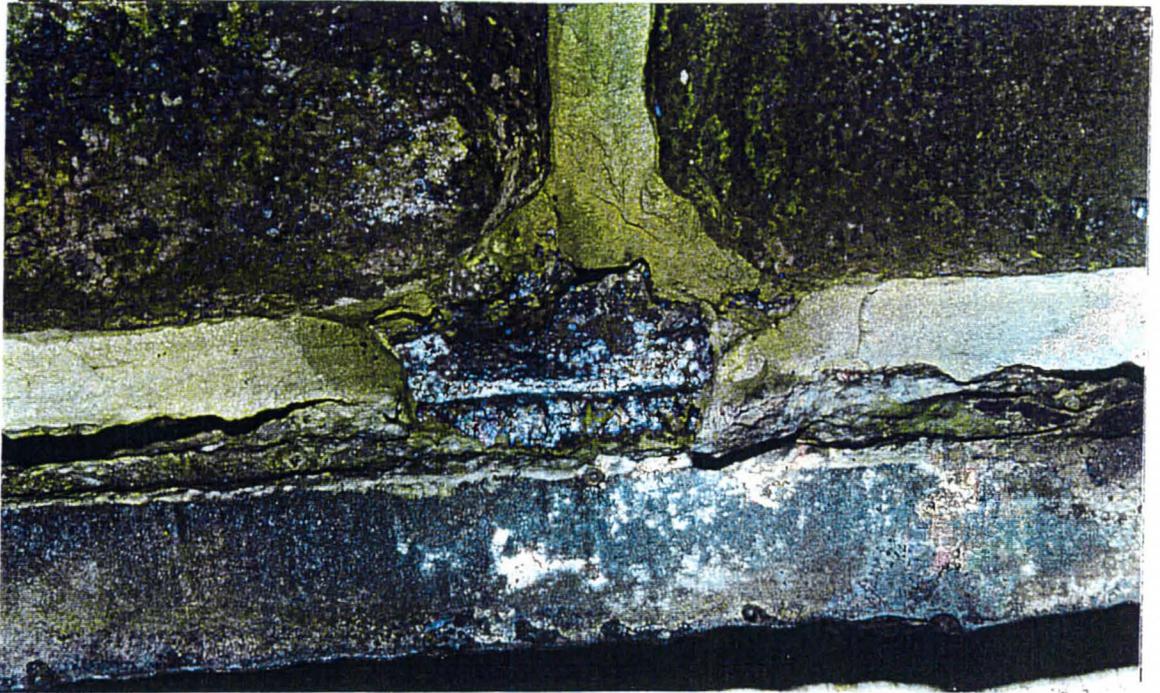
**FIGURE 83:** Closeup view of fracture face where the tie-plate intersects the west gusset. (Wood, 1995)

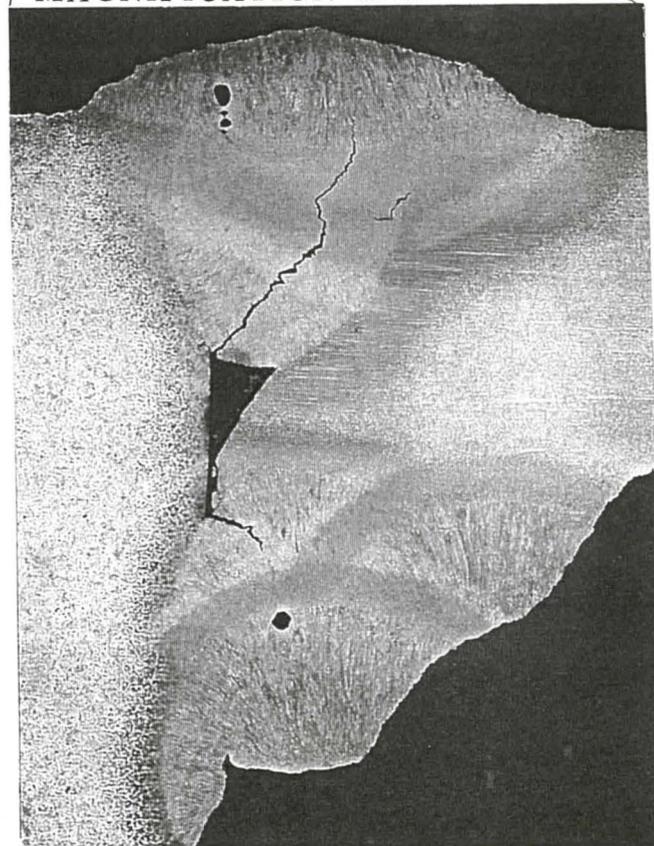
Figure 87 is a section of the tie-plate to rocker block weld which shows obvious lack of penetration into the root of the weld. Clearly, no attempt was made at the time the Ore Bridge was fabricated to make this a complete penetration groove weld, although the original drawings suggest it should have been completely penetrated. The reinforcing fillet weld underneath the tie-plate is also clearly visible. The toe of the fillet weld, where the fatigue cracks initiated, is noted. Figure 88, taken at another location along the same weld and viewed from the opposite direction, not only shows lack of penetration but cracks emanating from the root of the welds and gas pockets in the welds.

**FIGURE 88: Magnified view of the tie-plate to rocker block weld. (Wood, 1995)**

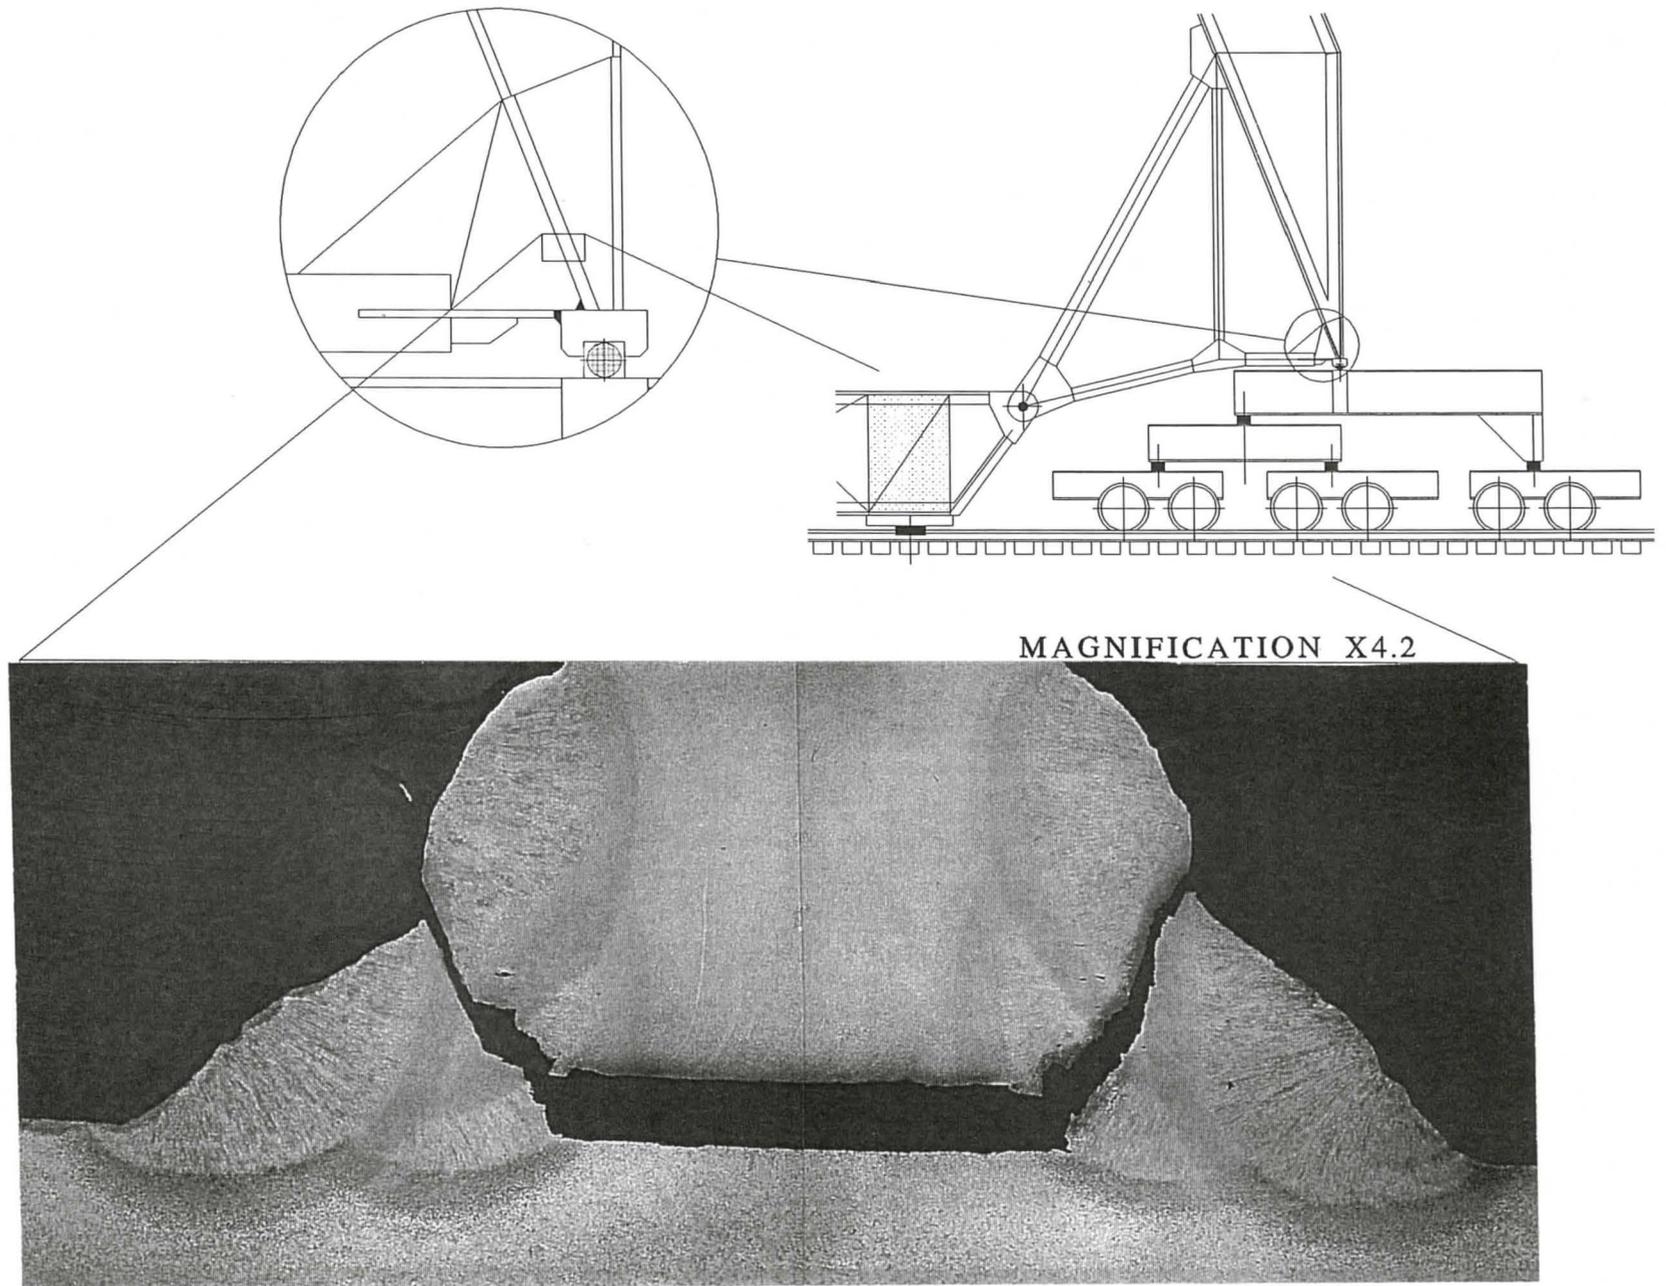
Figures 89 and 90 were taken looking down on the fillet welds joining the gussets to the inside of the south leg. The welds fractured, no doubt as a result of the collapse, however there were indications of prior cracking at the root of the welds and intermittent fatigue cracks along the length of the welds. (Wood, 1995) Gas pockets (porosity) are clearly visible in the welds in Figure 90.

**FIGURE 89: Magnified view of west gusset welds to inside face of the South Leg. (Wood, 1995)**

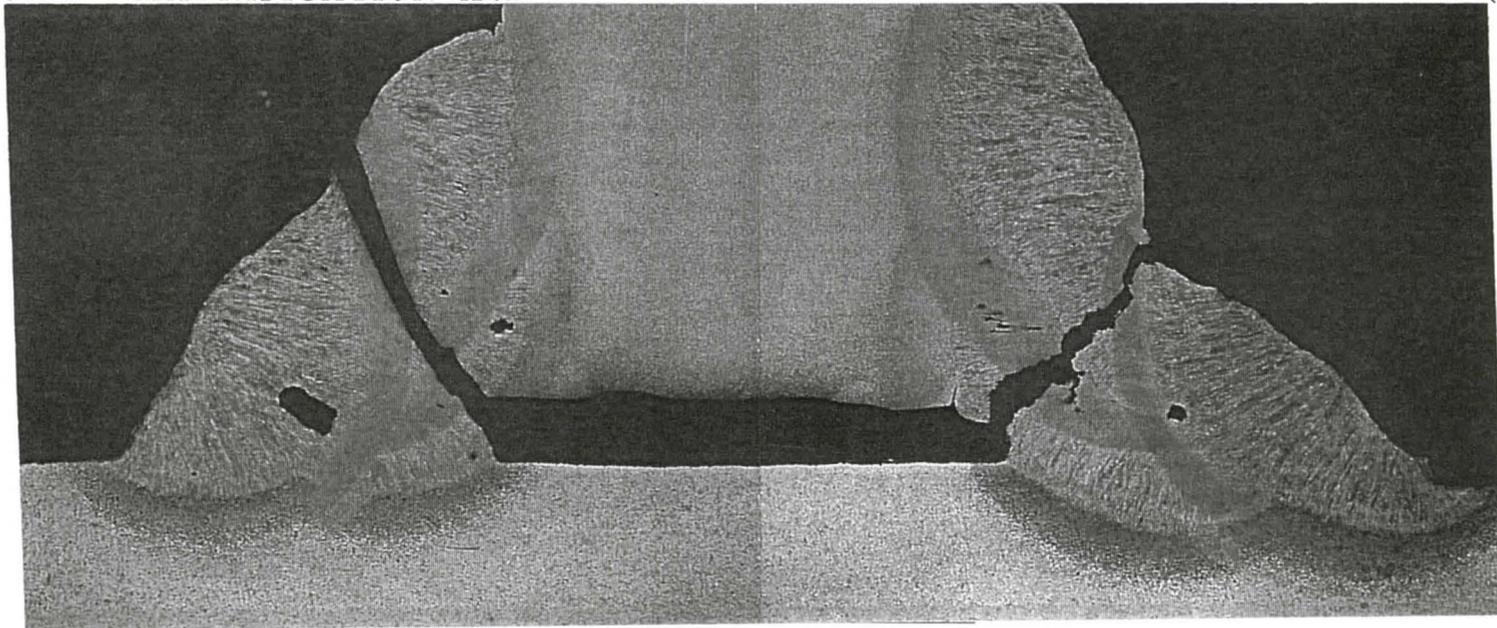
**FIGURE 90: Magnified view of east gusset welds to inside face of the South Leg. (Wood, 1995)**

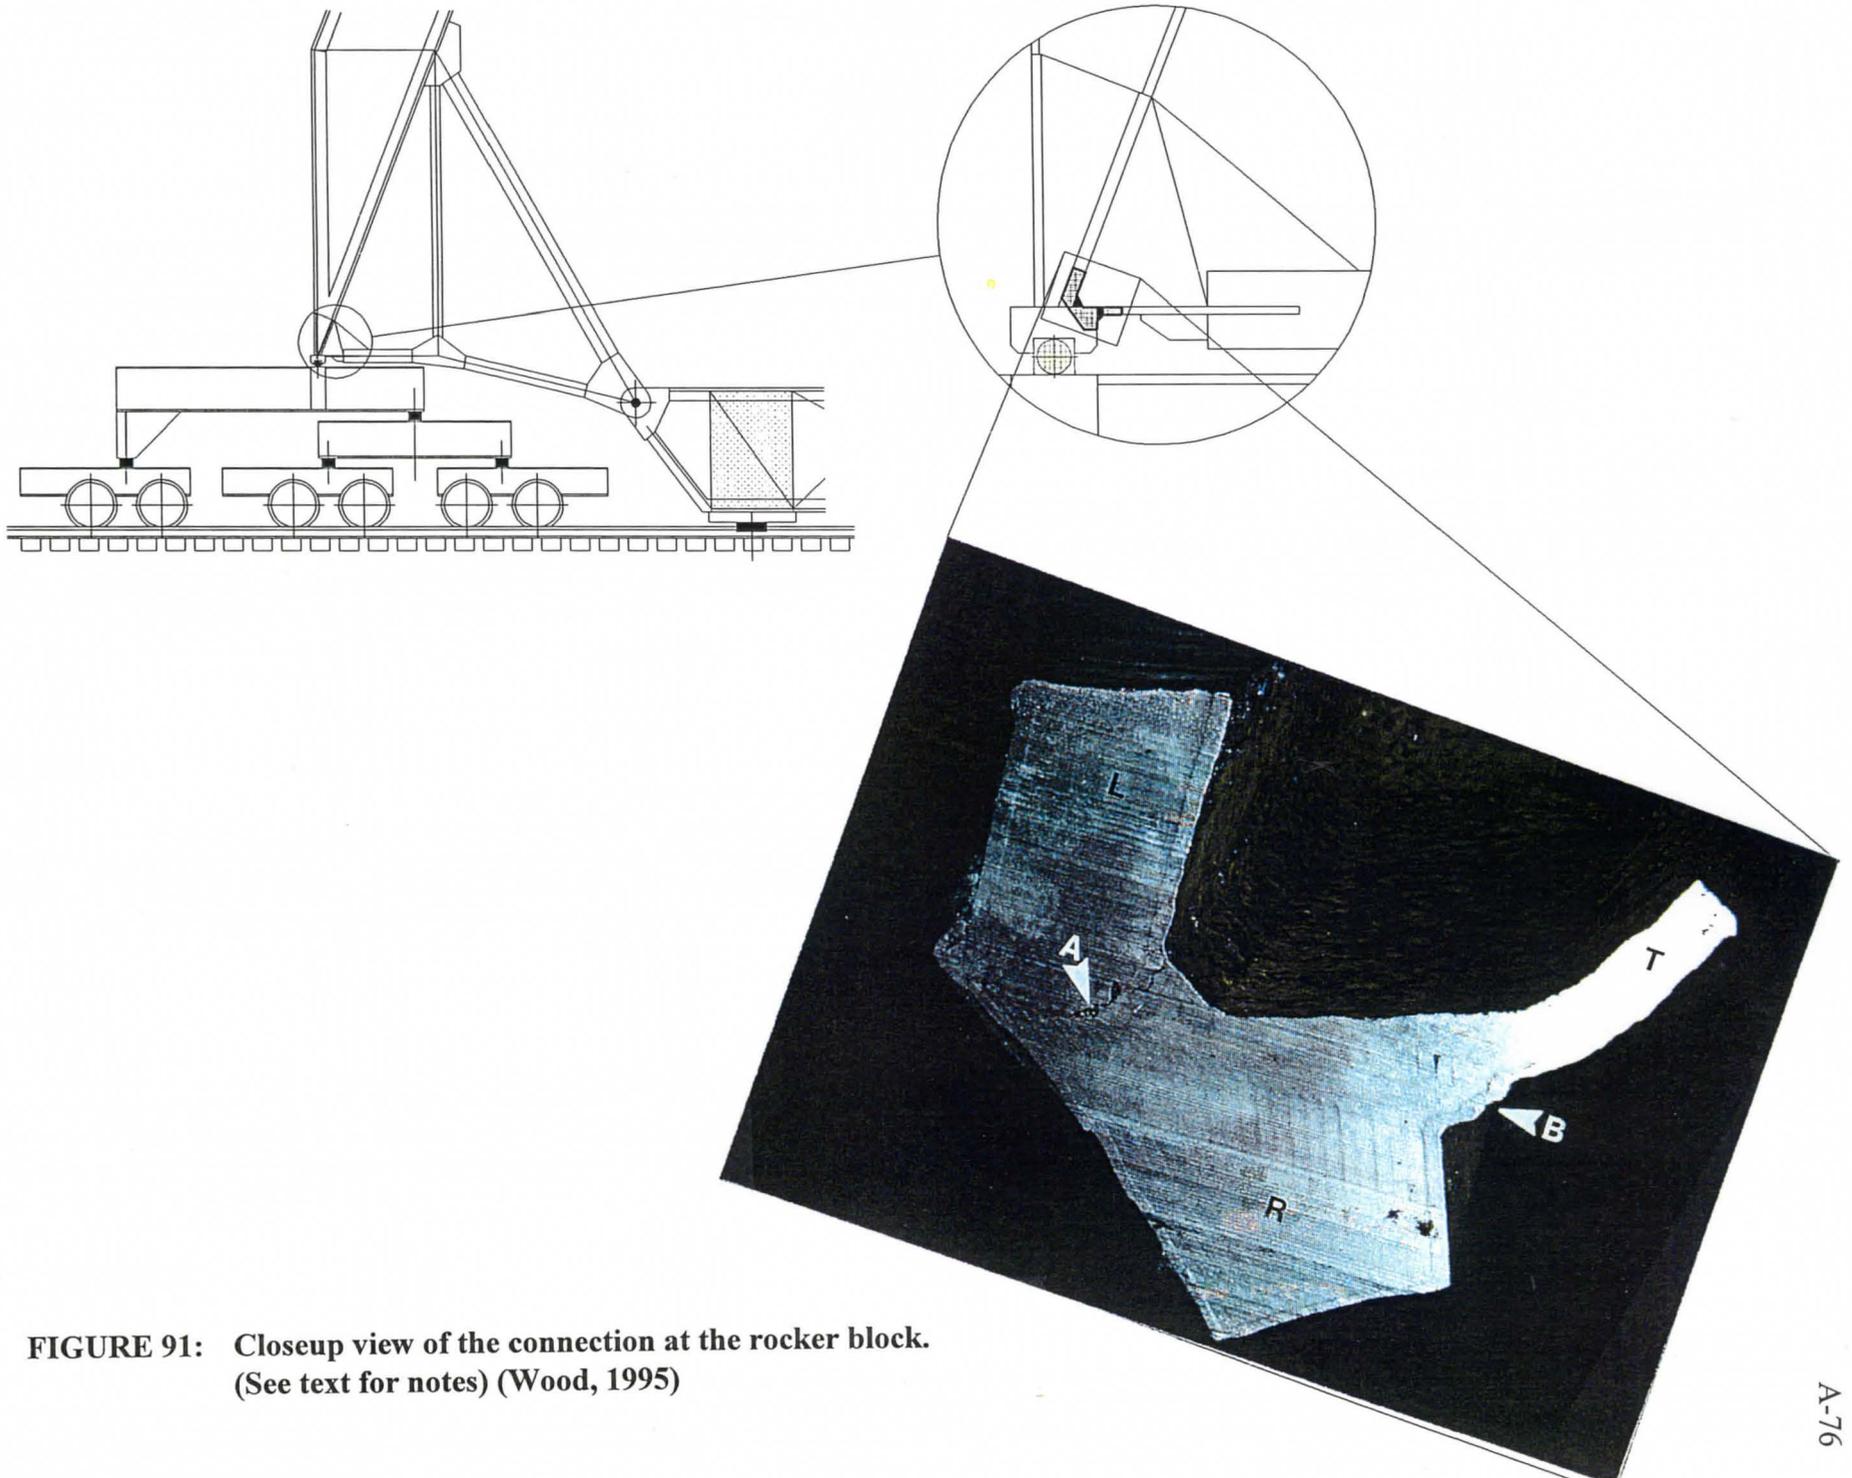
Figure 91 is a portion of the tie-plate (T), rocker block (R) and inside leg plate (L) which were joined by welding. The weld (B) between the tie-plate and rocker block was sound, however there was the previously observed lack of penetration at the root of the weld. The weld (A) between the rocker block and the inside leg plate however, was cracked the entire length of the weld.

**FIGURE 91:** Closeup view of the connection at the rocker block.  
(See text for notes) (Wood, 1995)

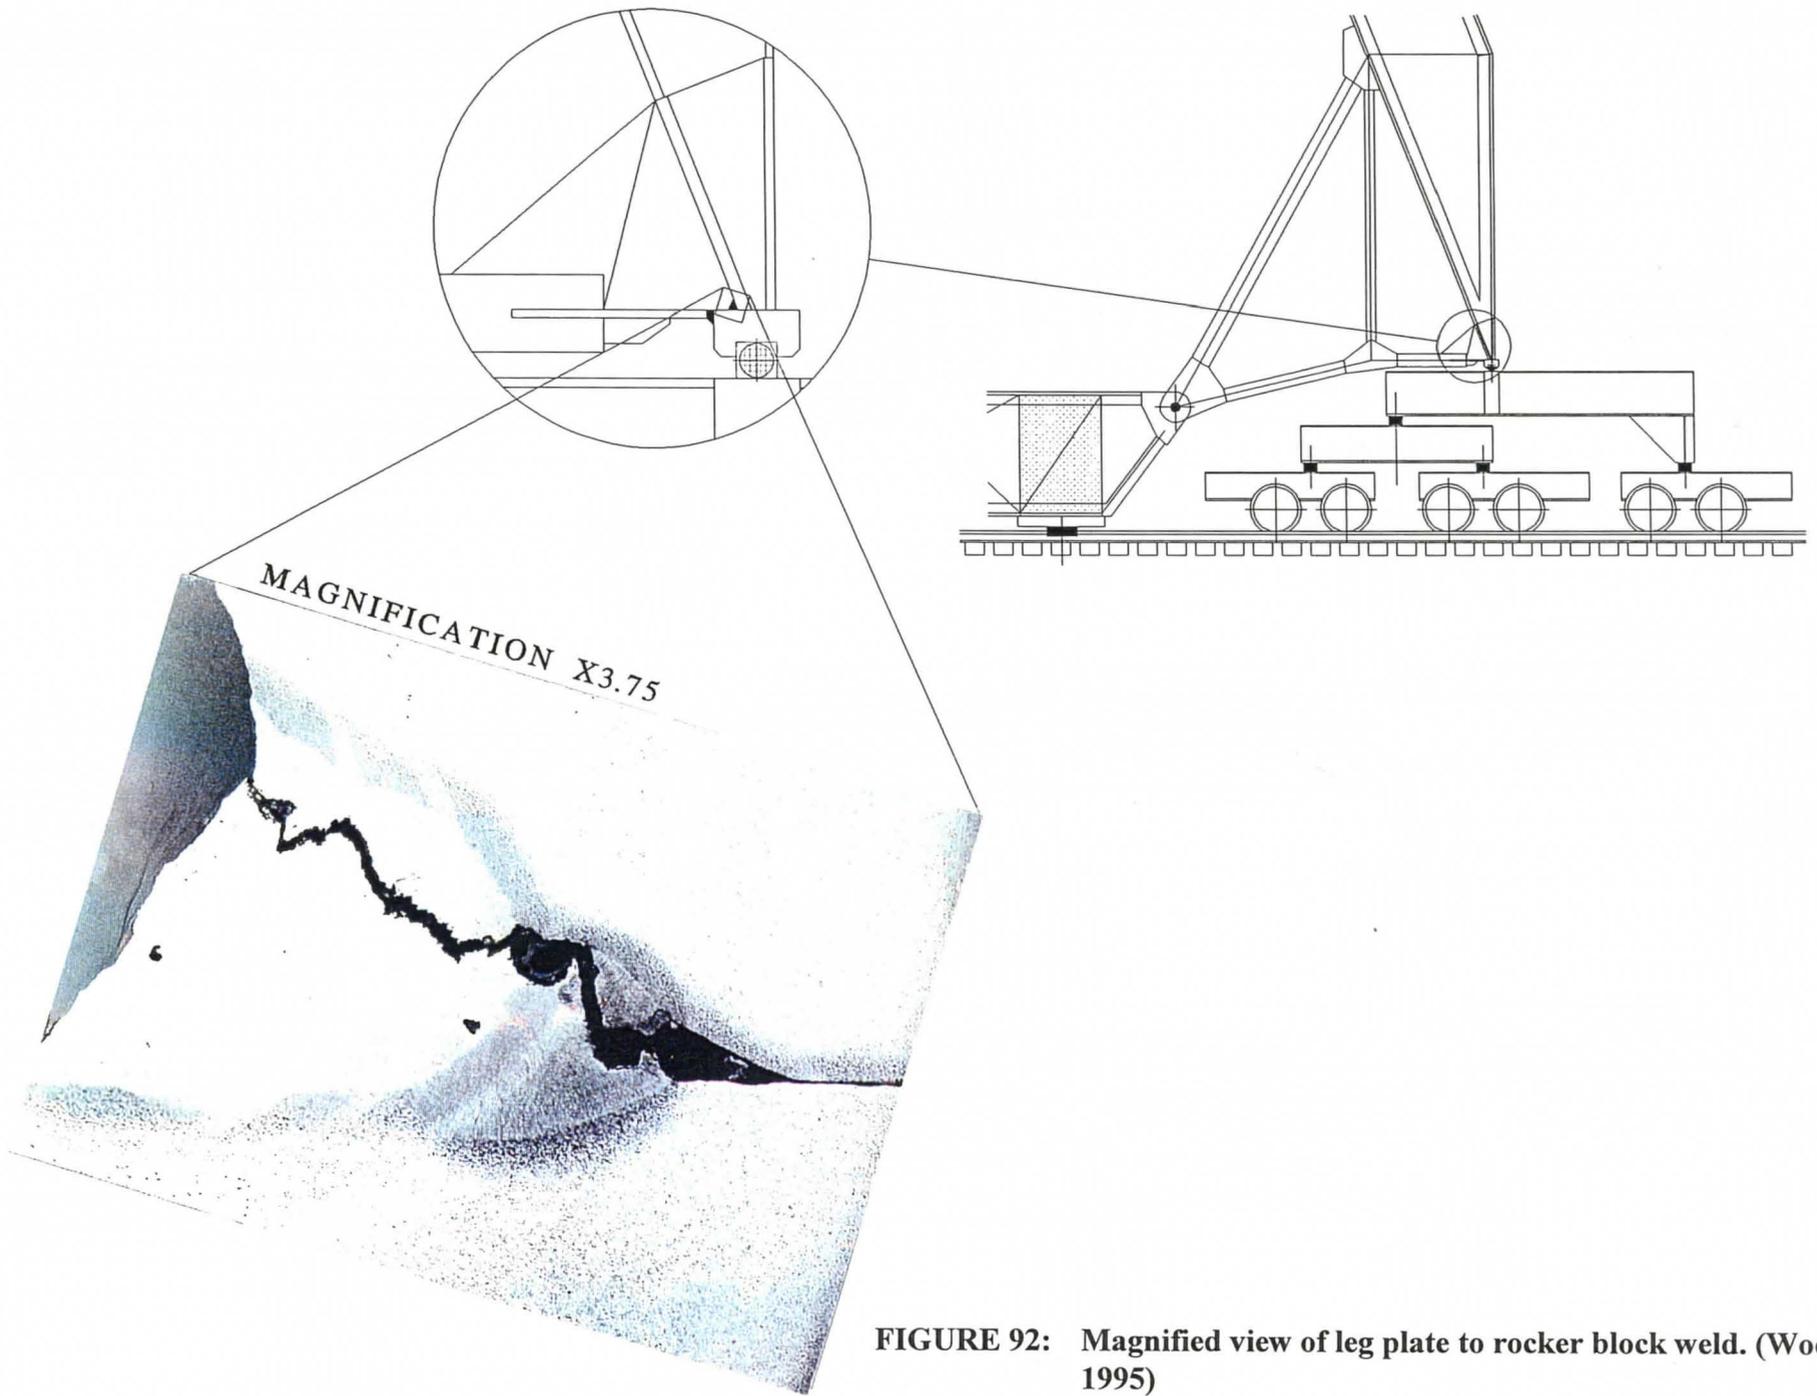
Upon close examination, the crack in Figure 91 appeared to have initiated from the root of the weld and probably failed instantaneously, Figure 92. (Wood, 1995) Combined with the fact that the surfaces of the crack were heavily corroded with a very tenacious rust, it suggested this crack may have occurred while the Shear Leg was still being fabricated, in 1950.

**FIGURE 92: Magnified view of leg plate to rocker block weld. (Wood, 1995)**

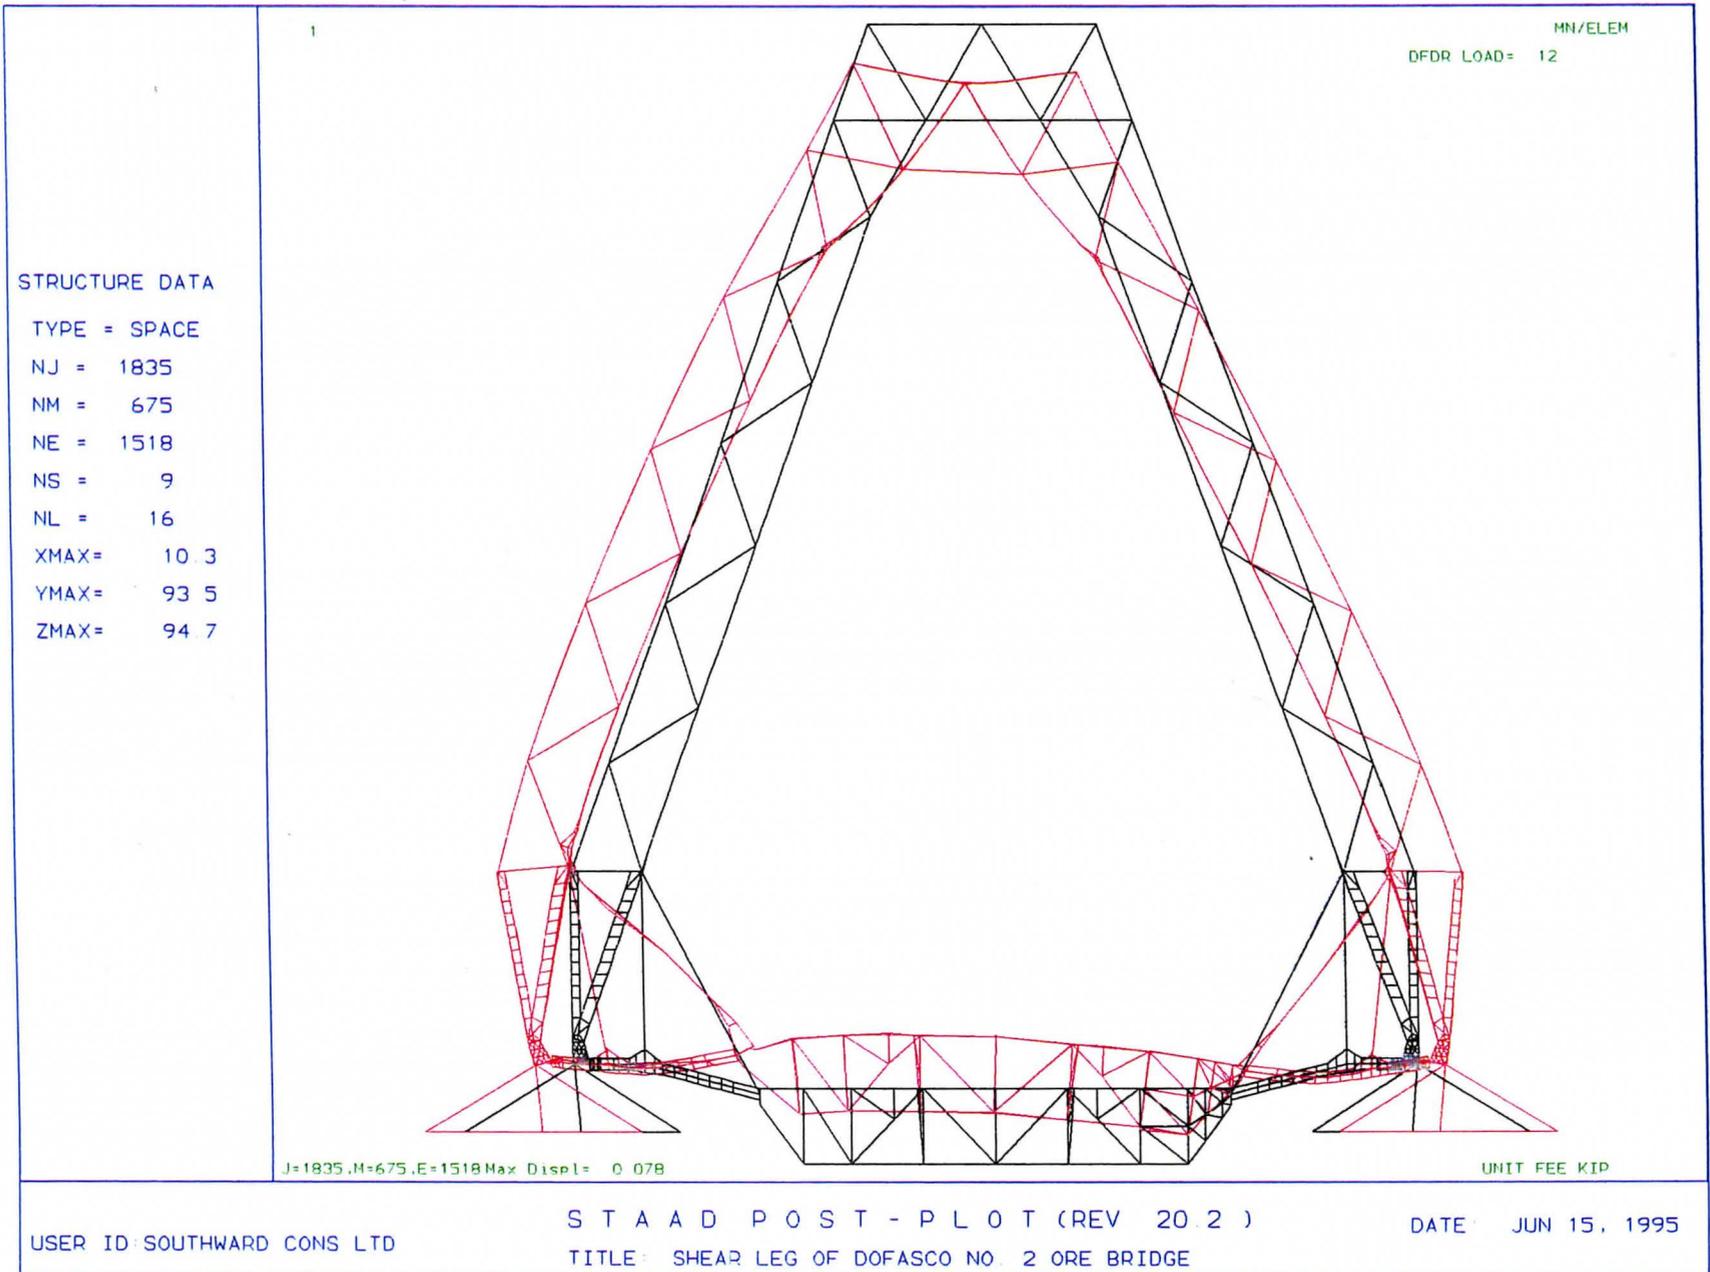
Prior to the addition of the hopper, the sill truss and tie-braces connecting it to the Shear Leg were designed simply as a tension tie. Because the sill truss is lower than the pins at the bottom ends of each of the legs, the sill truss lifts under the large tensile tie forces, as depicted in Figure 93. The original undeformed shape of the Shear leg is shown in black in the Figure and the deflected shape in red, magnified for clarity. With the addition of the hopper however, the loading on the sill truss and in the tie-braces changed significantly.

**FIGURE 93: View of deflected shape of the Shear Leg (red) under gravity loading without the hopper relative to its undeformed shape (black).**
