**THE COLLAPSE  
OF  
THE DOFASCO NO. 2 ORE BRIDGE  
MARCH 28th 1995  
HAMILTON ONTARIO**

TIMOTHY VERHEY, B.Eng.

A Project

Master of Engineering

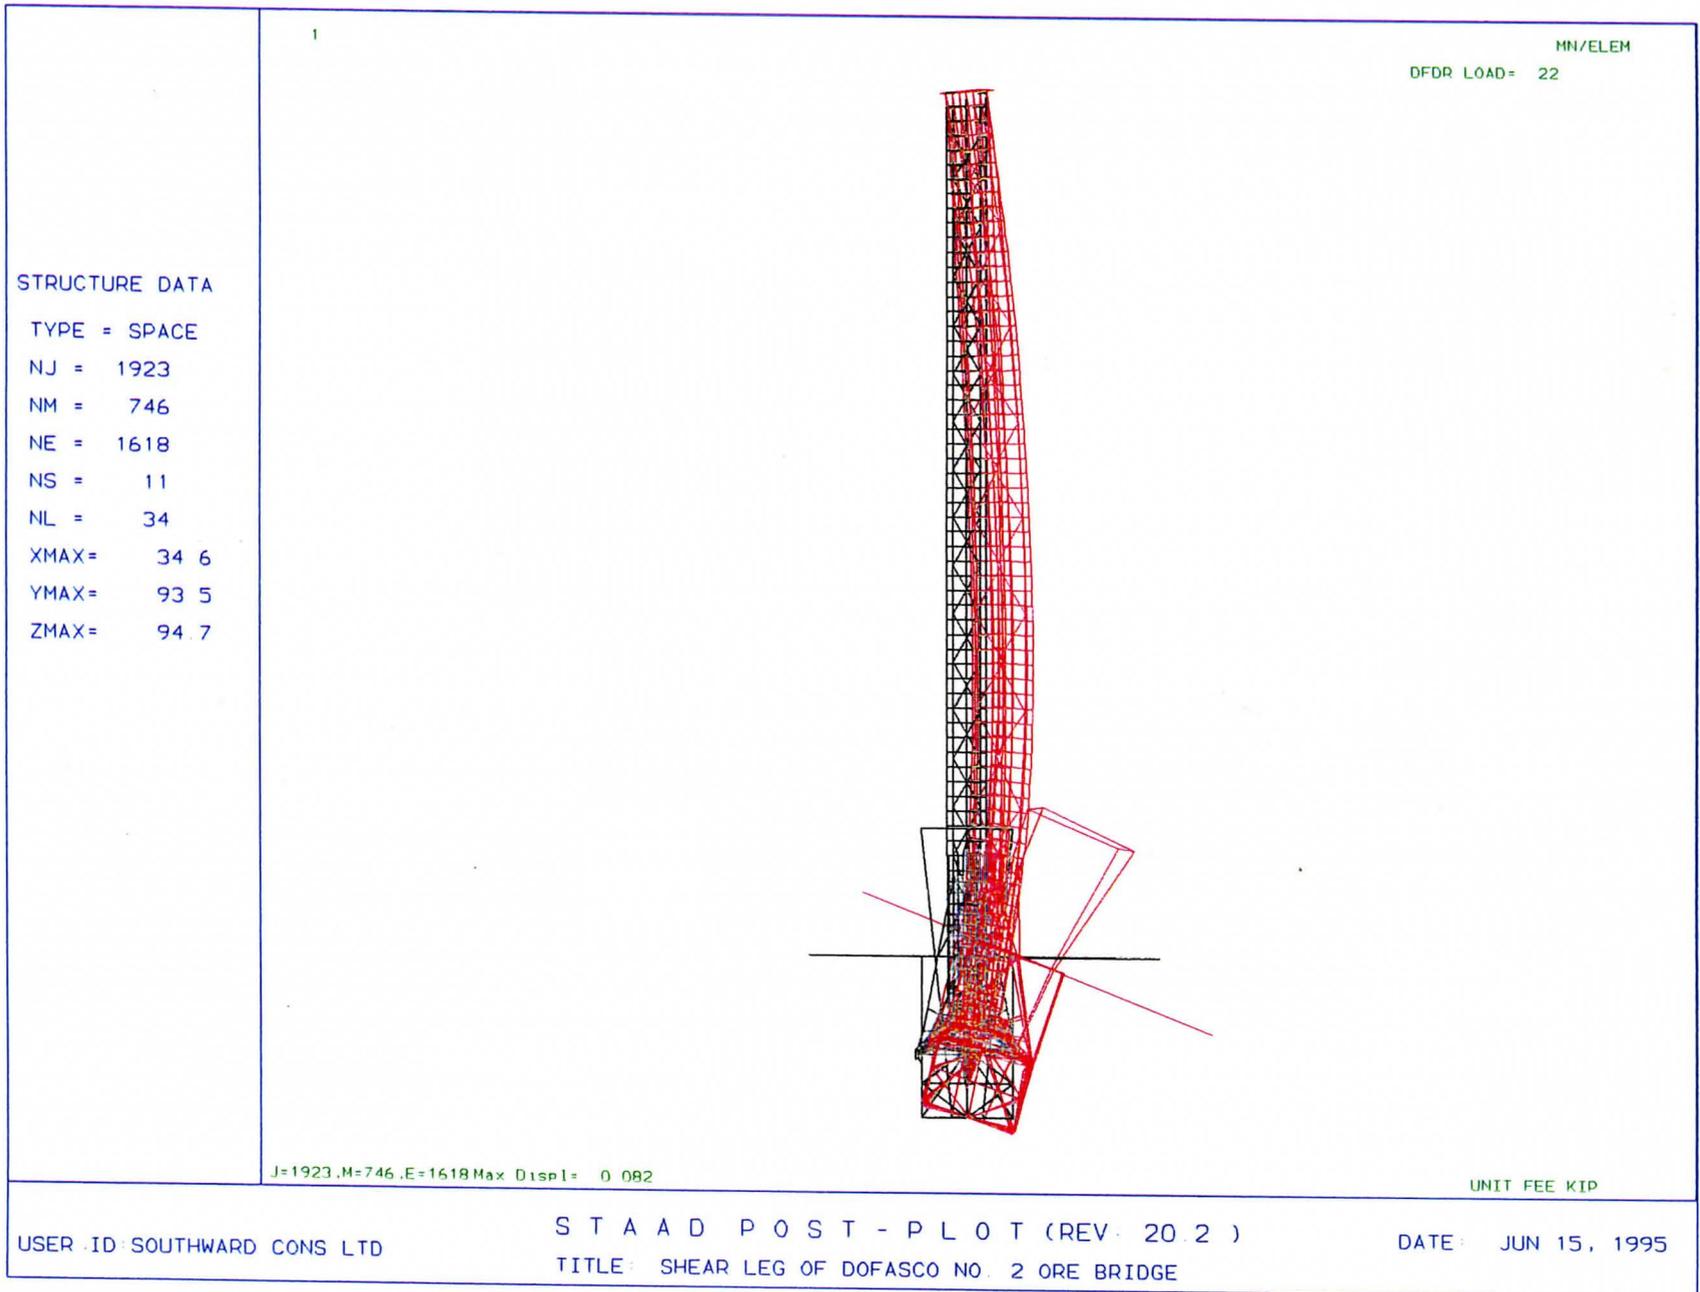
Figure 94 records the response of the Shear Leg, viewed from the north or south, to an east/west rocking of the hopper. The original undeformed shape of the Shear Leg is shown in black and the deflected shape in red, magnified for clarity. It is important to

**FIGURE 94: View of lateral displacements of the Shear Leg (red) under lateral loading from the hopper relative to its undeformed shape (black).**

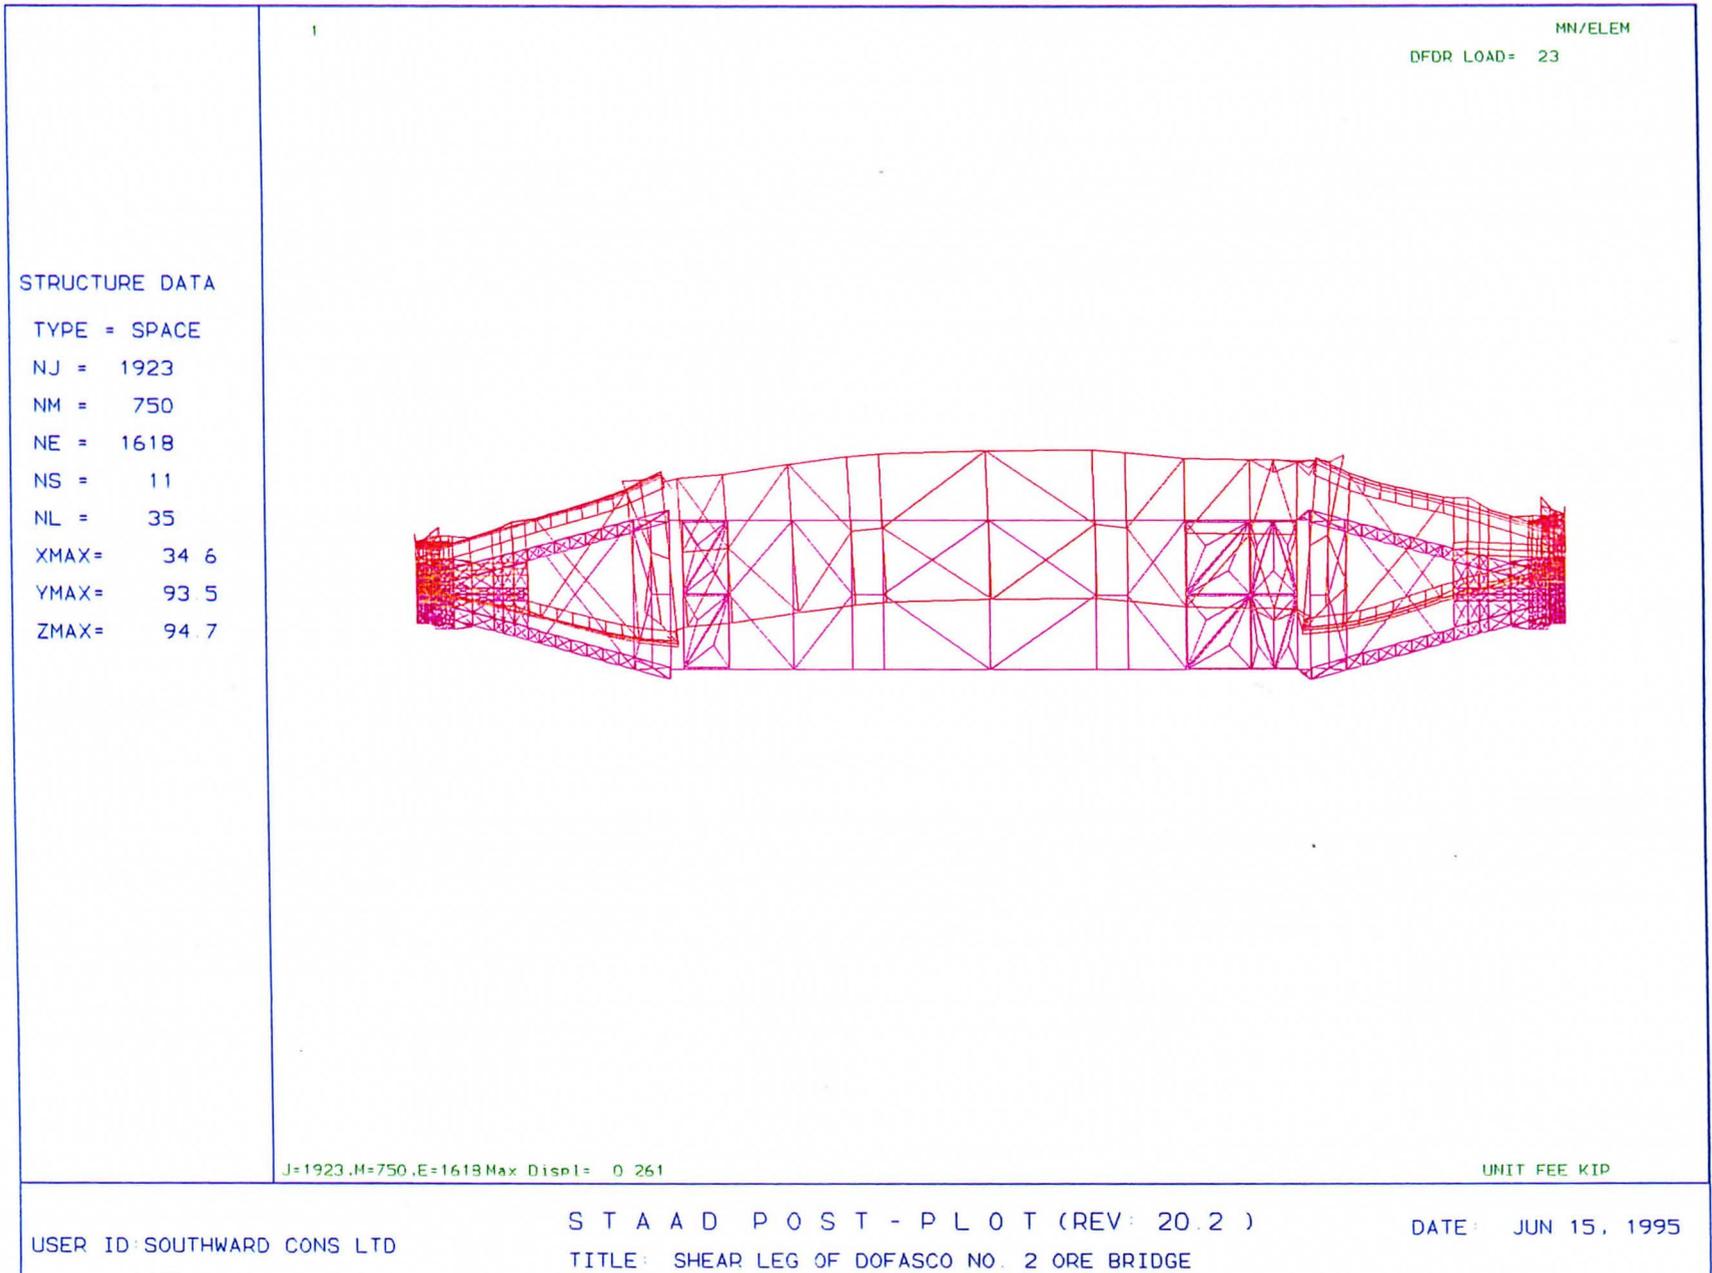
Rocking of the hopper causes the upper guides to rotate about the hopper trucks, which results in the top chord of the sill truss and the tie-braces being bent in a horizontal plane. Figure 95 depicts this horizontal bending of the sill truss and tie-plate, viewed from above. Again, the deformed shape, in red, is magnified for clarity and superimposed on the undeformed shape, in purple. Bending the sill truss bends and twists the north and south legs of the Shear Leg because of the stiffness of the diagonal brace and the tie-plate which connect the sill truss to the bottom of the legs.

**FIGURE 95: View of the lateral bending of the top of the sill truss (red) under lateral loading from the hopper (purple).**

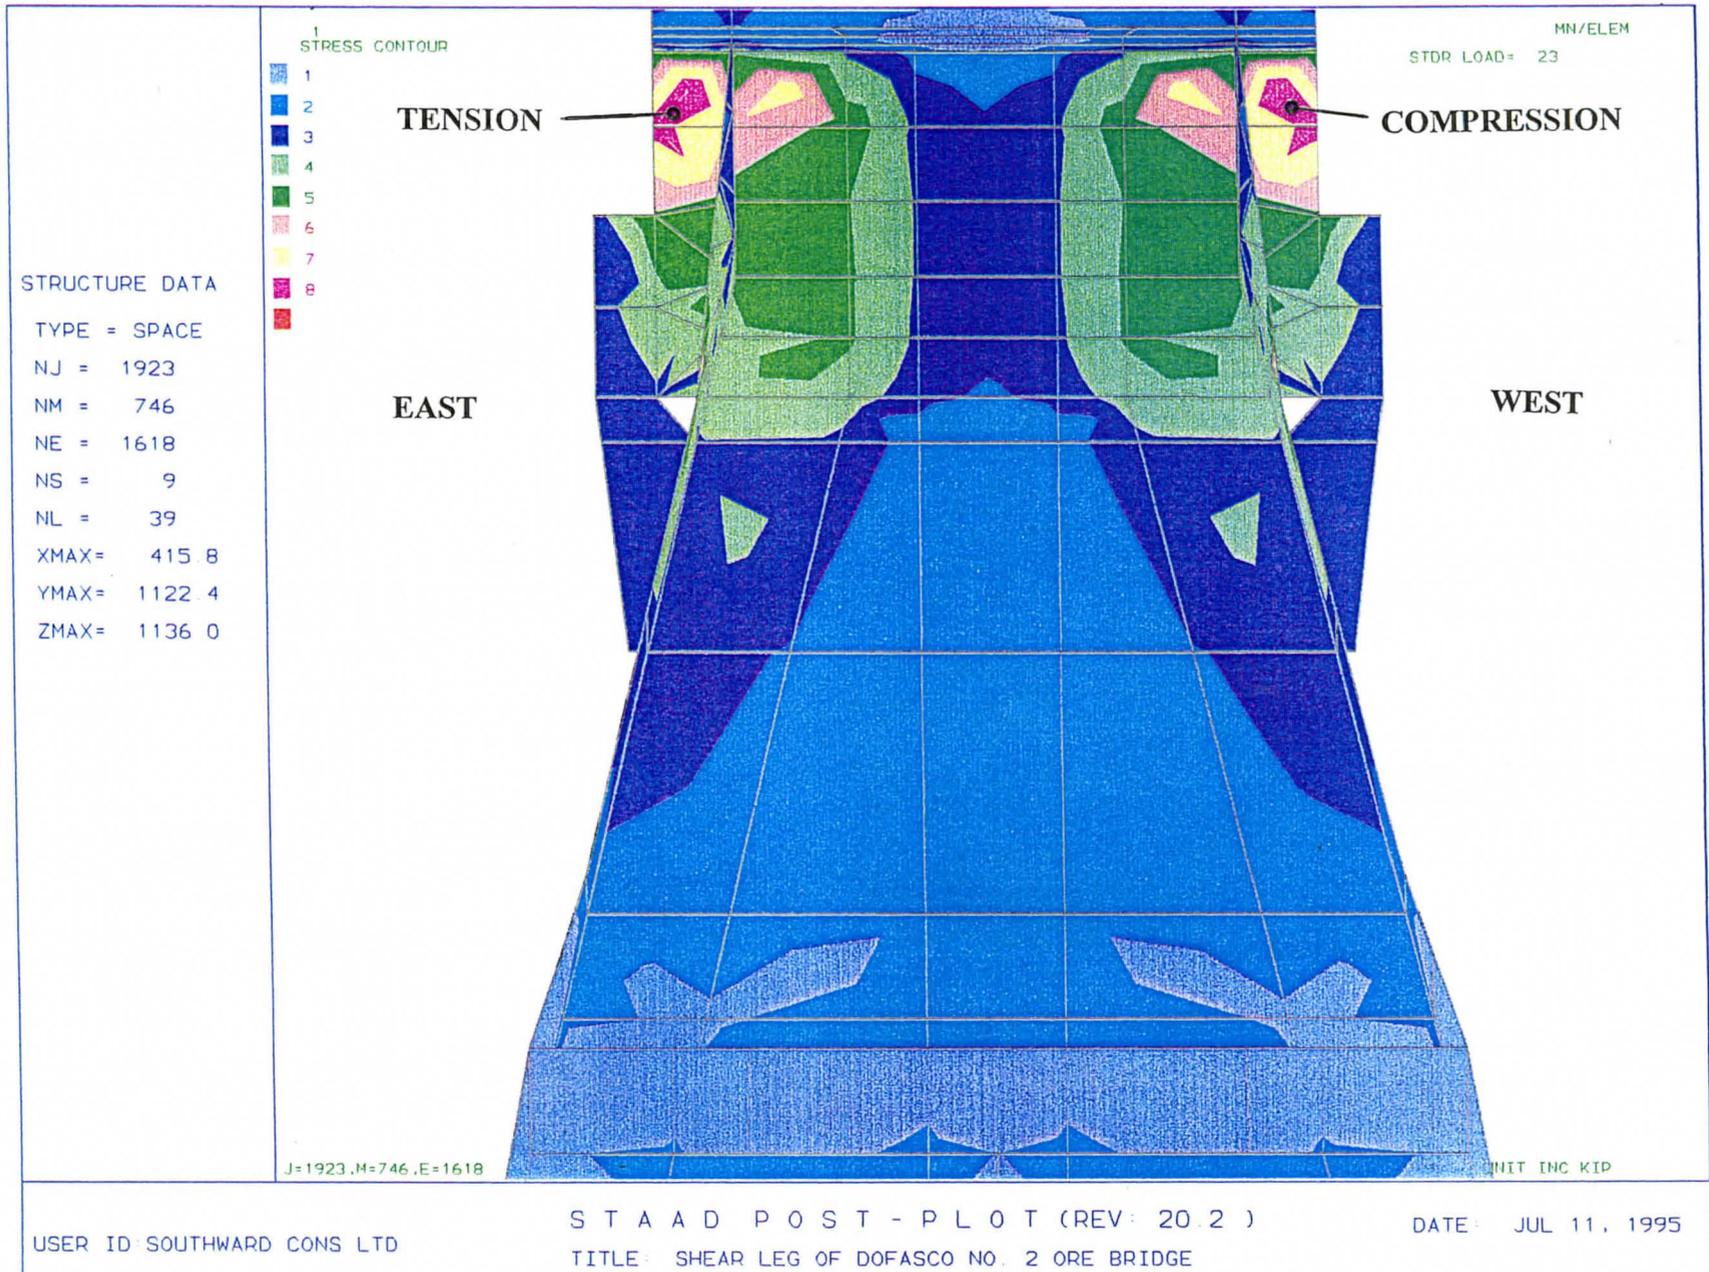
Assuming the total movement of the hopper is 6", i.e. 3" in either direction, bending stresses are created at the outer edges of the tie-plate which exceed 8 ksi, Figure 96. The stress contours in Figure 96 record the magnitude of stress but do not differentiate between tension and compression. Therefore, rocking of the hopper back and forth will result in a complete reversal of these stresses creating a stress range in the tie-plate of over 16 ksi, not including the effects of any stress raisers or other loadings.

If the total movement at the top of the hopper is 12" the stresses shown in Figure 96 double, the maximum stress increases to 21 ksi and the stress range doubles to 32 ksi.

**FIGURE 96:** Finite element analysis results at the base of the South Leg showing maximum principal stresses at the edges of the tie-plate.

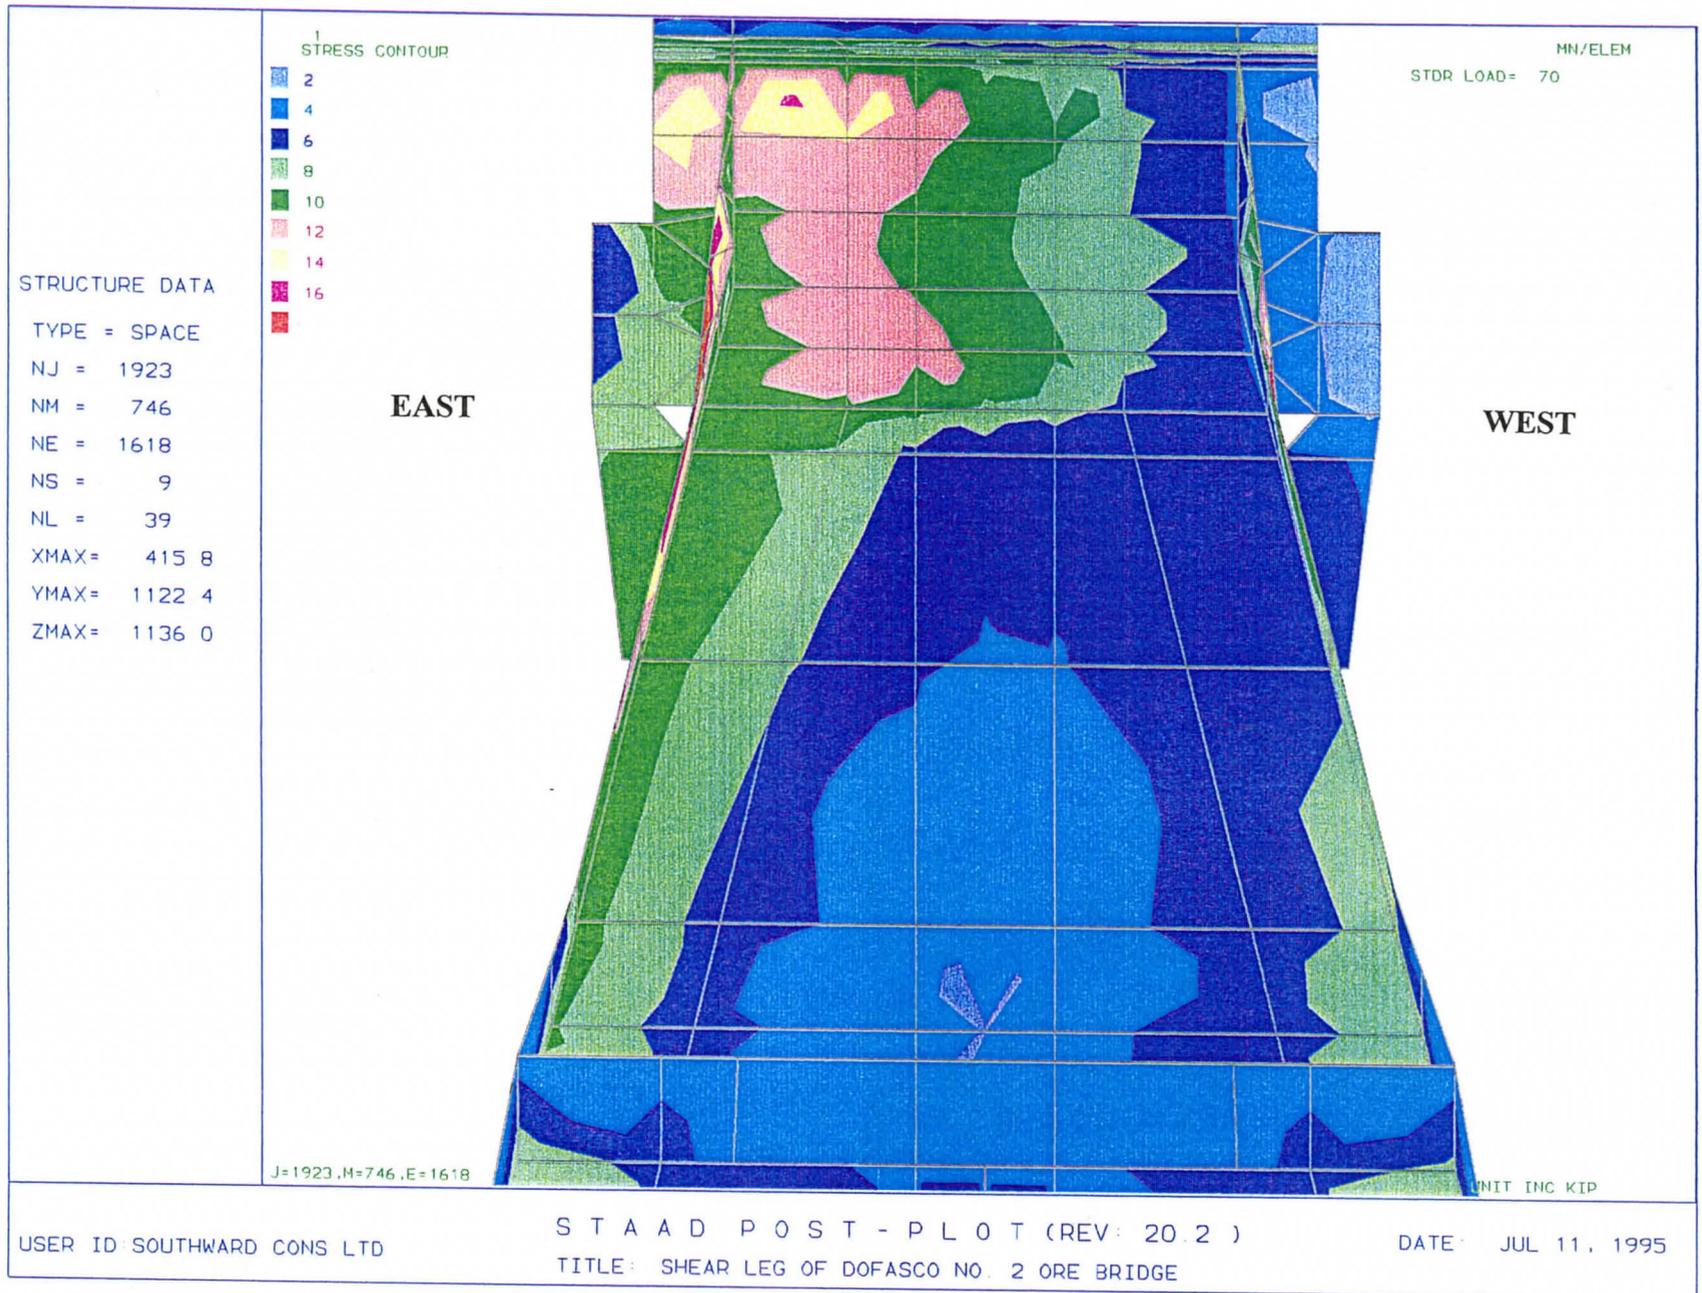
Combining the rocking motion of the hopper with the loads in the tie-plate from the main span creates a complex state of stress, with the maximum occurring in the vicinity of the intersection of the tie-plate with the gusset where the fatigue cracks existed and the brittle fracture initiated, Figure 97. There is evidence of weld repairs in this region on the top

**FIGURE 97: Finite element analysis results at the base of the South Leg showing maximum principal stresses by combining gravity loading with a forced lateral displacement of the hopper.**

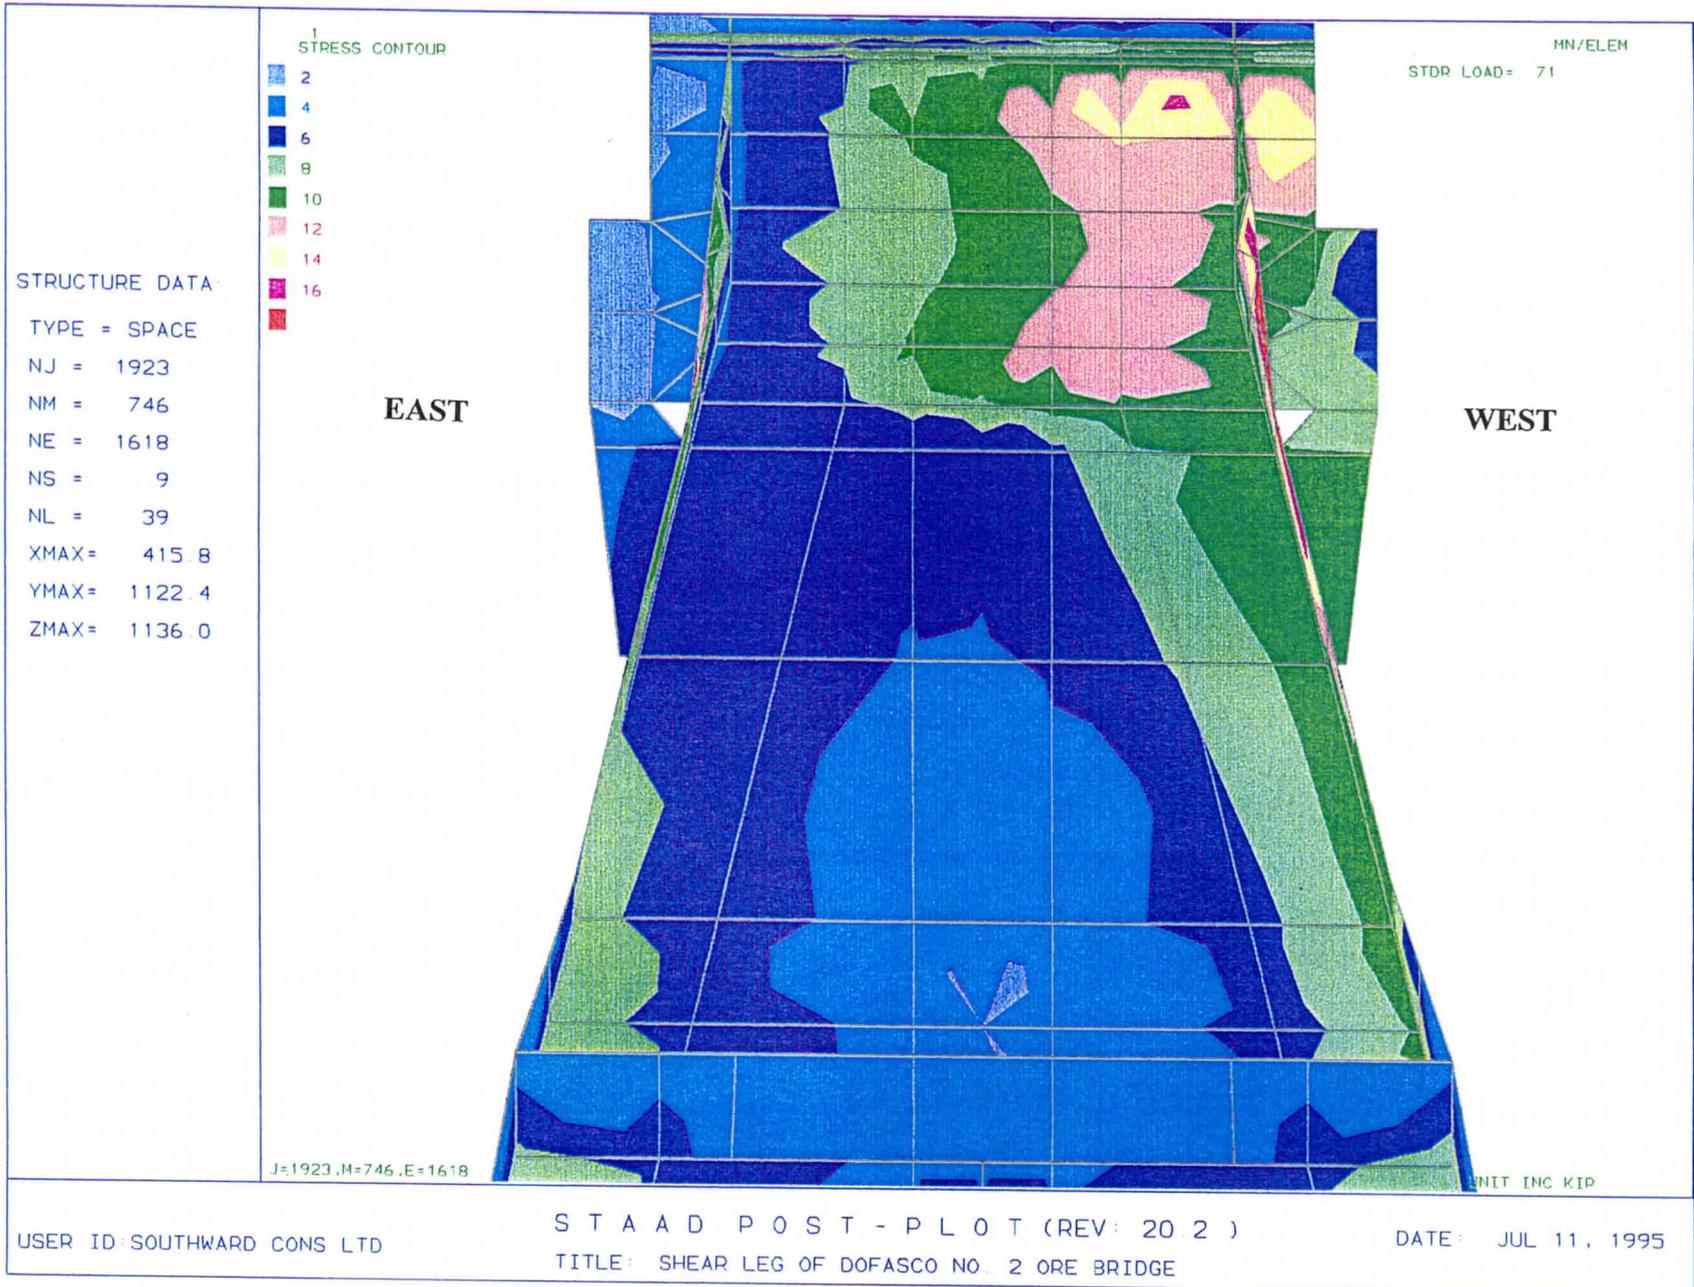
surface of the tie-plate on the east side of the north leg of the No.2 Ore Bridge Shear Leg and on the underside of the tie-plate, along the toe of the reinforcing fillet weld. Rocking the hopper shifts the maximum stresses to the opposite side of the tie-plate, Figure 98. These results should be compared to the relatively uniform stress distribution which existed in the tie-plate prior to the hopper being added, Figure 99.

**FIGURE 98: Finite element analysis results at the base of the South Leg showing maximum principal stresses by displacing the hopper in the opposite direction.**

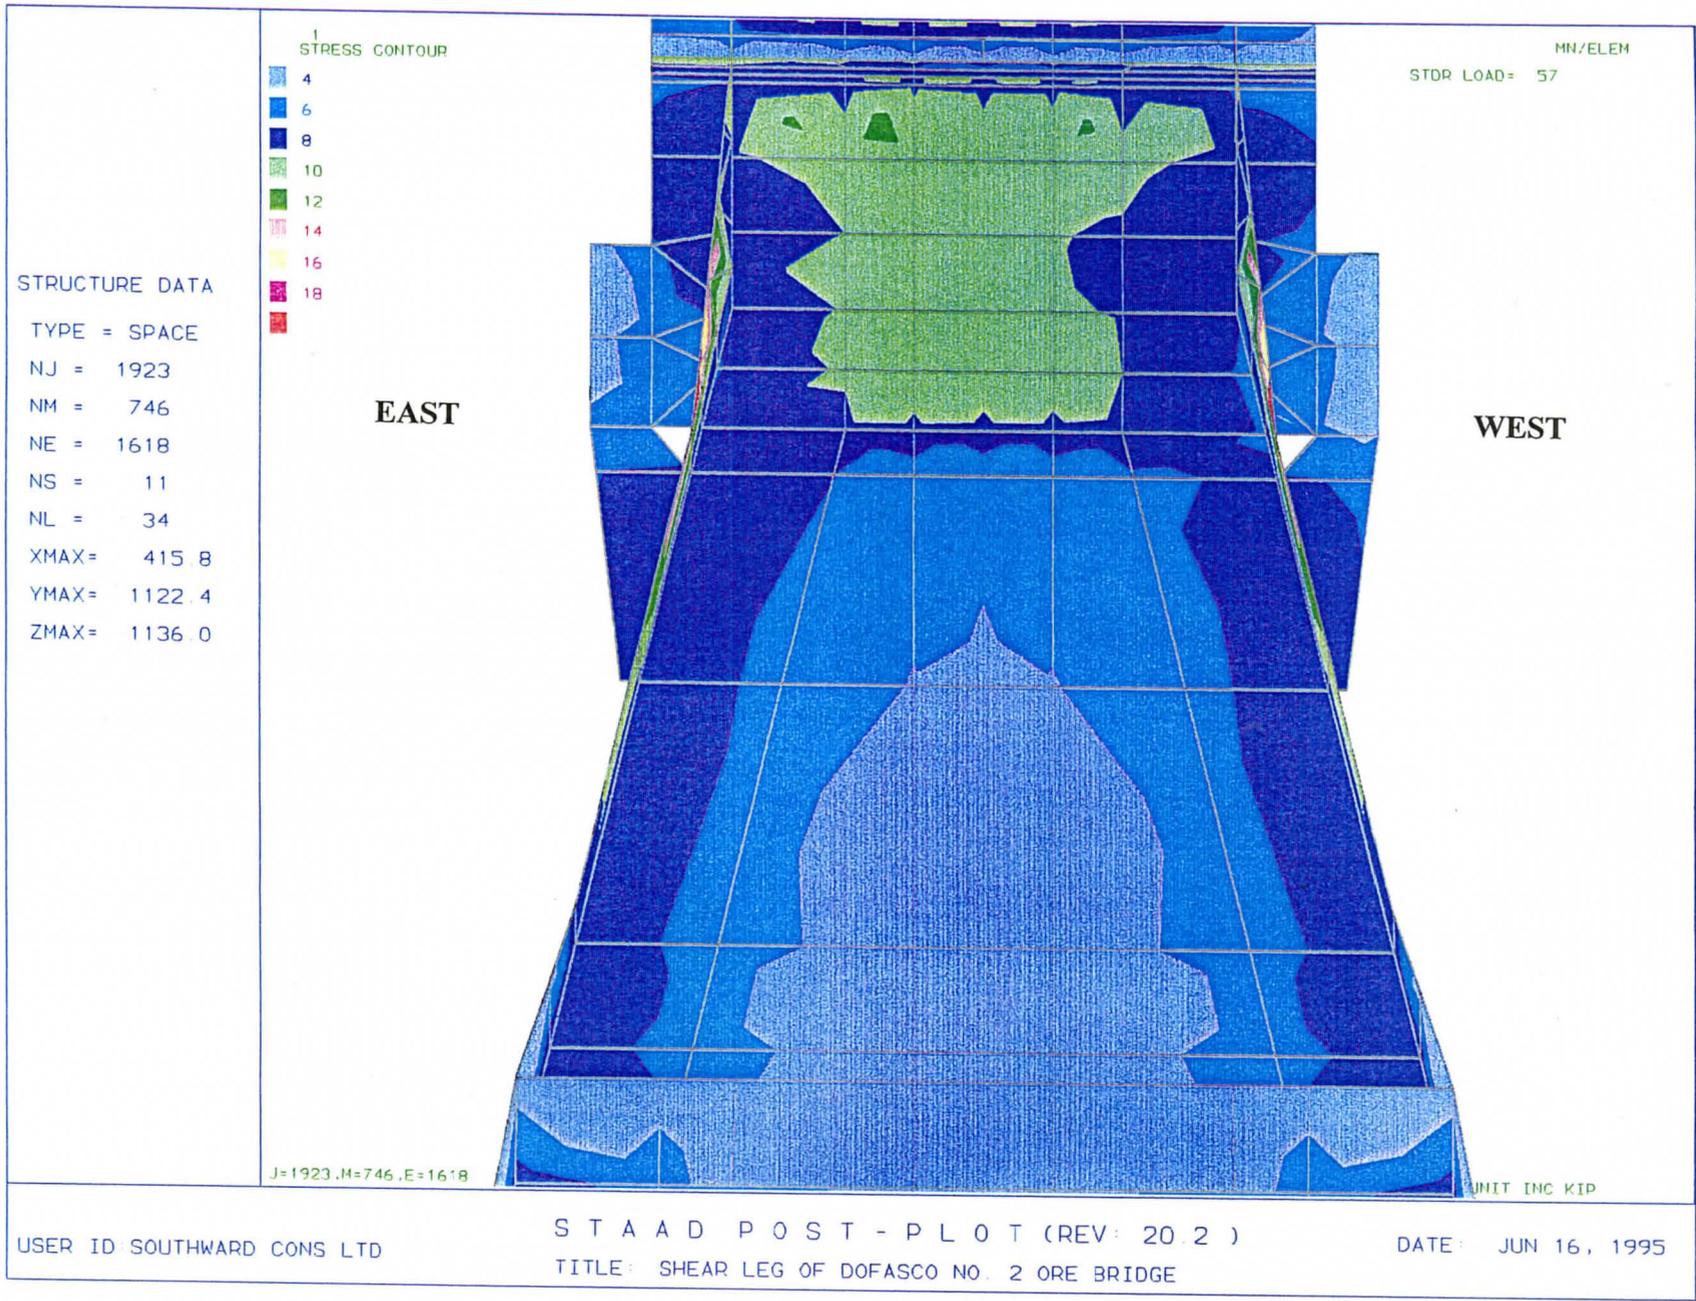
**FIGURE 99: Finite element analysis results at the base of the South Leg showing maximum principal stresses in the tie-plate from uniform gravity loading.**
