THE SURFACE AND SUBSURFACE CHARACTERIZATION OF RETRIEVED METAL-ON-POLYETHYLENE HIP PROSTHESES USING ELECTRON MICROSCOPY

A Thesis Submitted to the School of Graduate Studies in Partial Fulfilment of the Requirements for the Degree of Master of Applied Science

McMaster University © Copyright by Vicky Vuong, March 2015

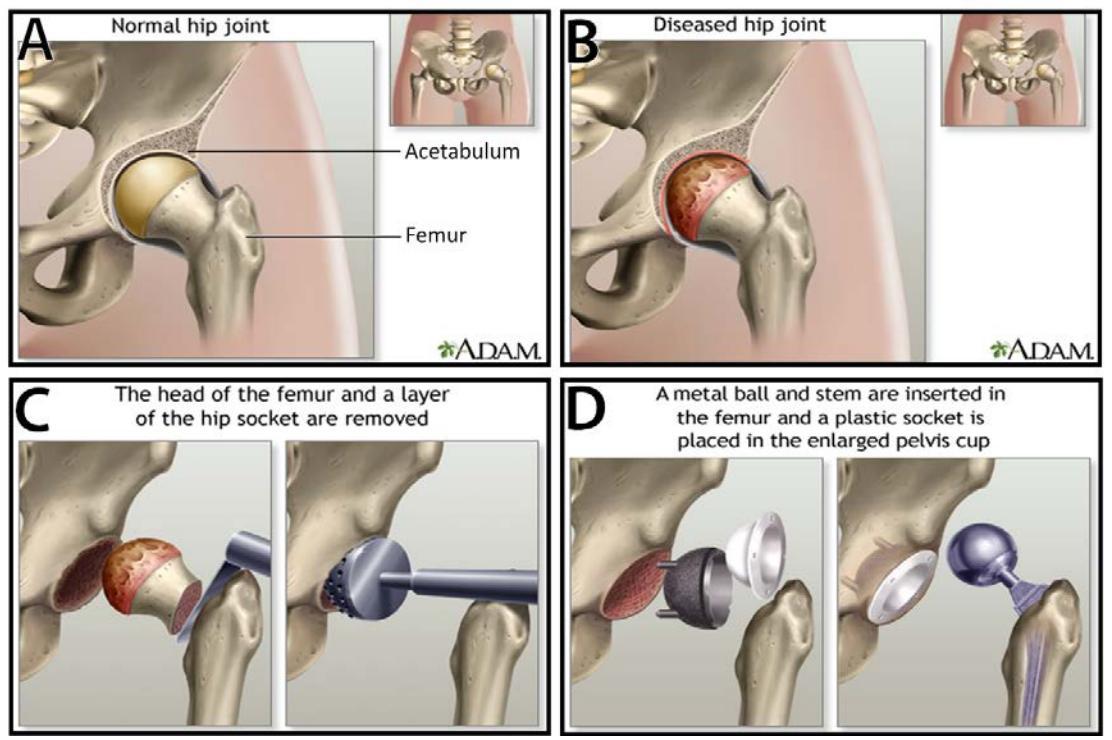
Figure 1.1 Illustration of hip joint anatomy and the THA procedure. A) Normal hip joint indicating the acetabulum and femur, two major components of the joint. B) Diseased hip joint showing arthritis of the articular hyaline cartilage on the femoral hard. C) Removal of the diseased femoral head and removal of cartilage and subchondral bone from the acetabulum. C) Insertion of the three major components of a hip prosthesis: metallic acetabular cup, polyethylene acetabular lining and metallic femoral head component <u>http://www.nlm.nih.gov/medlineplus/hipreplacement.html</u>.

Total hip arthroplasty is an orthopaedic procedure that involves the removal of the degenerated cartilage and subchondral bone in the hip joint followed by the insertion of a prosthetic hip implant (Fig 1.1B-D). A conventional prosthesis is composed from three major components: a polyethylene acetabular cup (may consist of a separate acetabular cup and lining), a metallic femoral head component and a metallic stem component (Fig 1.1D). The implant is stabilized by the insertion of the stem into an

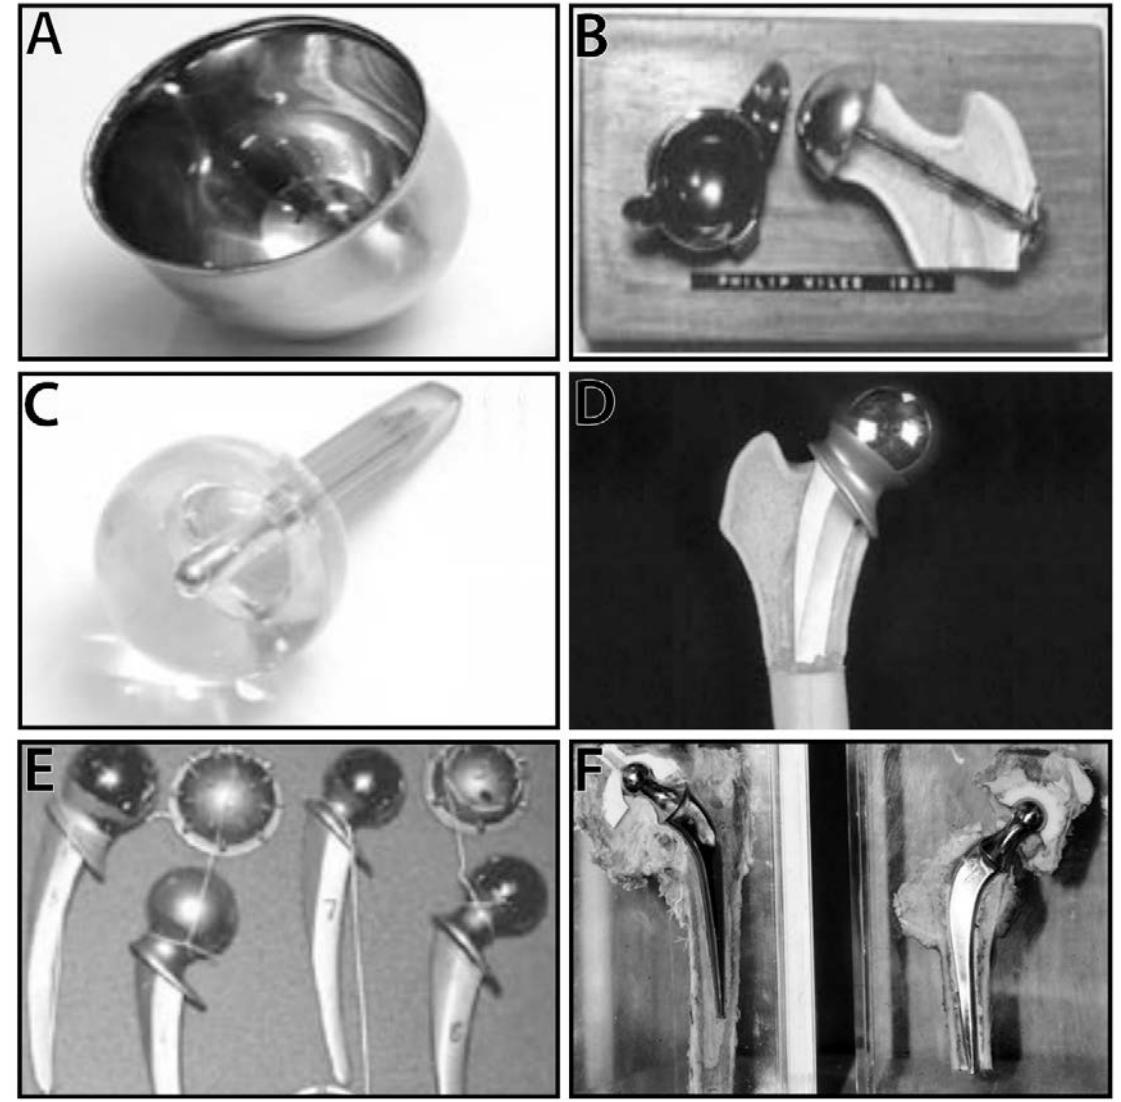
Figure 1.2 Early attempts at total hip arthroplasty prostheses. A) Smith-Peterson hip mould, 1937. B) Wiles' acetabular cup and resurfacing head of femur, 1938. C) Judet brothers' acrylic femur head-replacement, circa 1940. D) Thompson intramedullary prosthesis, 1953. E) McKee total hip replacement, 1956. F) Charnley prostheses. On left, PTFE acetabular cup after years of use, on right, UHMWPE cup after years of use [7].

It was in 1938 when Philip Wiles performed the first hip arthroplasty using a stainless steel prosthesis [3], [4] (Fig 1.2B). Other early experimentations with THA prostheses in the 1900s included the use of ivory (Themistocles Glück, Berlin, 1891), glass (Marius Smith-Petersen, United States, 1886-1953), rubber (Pierre Delbet, France, 1861-1925), and acrylic (Judet brothers, France, 1901-80 and 1905-95, respectively) (Fig. 1.2C). Unfortunately, these materials were either prone to fracture early after implantation or found to be highly susceptive to wear in the patient. In 1950, Frederick Röeck Thompson developed a custom made Vitallium[®] hip prosthesis (Fig. 1.2D) which was first inserted into a patient by Nebraskan surgeon, Austin Moore. The fully metallic (cobalt-chromium-molybdenum (CoCrMo) alloy) Thompson Vitallium® prosthesis was the first widely distributed THA product. Shortly after, in the 1960s, English surgeon Kenneth McKee and Peter Ring were individually working to improve the design and fixture of the original Thompson metal-on-metal articulation (Fig. 1.2E). Although some of Ring's early prostheses offered up to 97% survival at 17 years post implantation, his and McKee's models saw a high incidence of failure resulting from loosening of the components [3], [4]. In the 1970s, their hard-on-hard articulation models were quickly dismissed in favor of the models developed by Sir John Charnley.

hesitation to continue due to the catastrophic failure of PTFE, Charnley was introduced to Ultra High Molecular Weight Polyethylene (UHMWPE, produced by Hoechst, Germany), a polymer with similar chemistry to PTFE. After extensive testing, the UHMWPE proved to have superior wear properties, low friction, and high impact strength [4], [8], [9]. The first UHMWPE acetabular cup was inserted in 1962 and Charnley's hard-on-soft articulations proved a strong rival to the second generation of hard-on-hard articulations ever since (Fig. 1.2F).

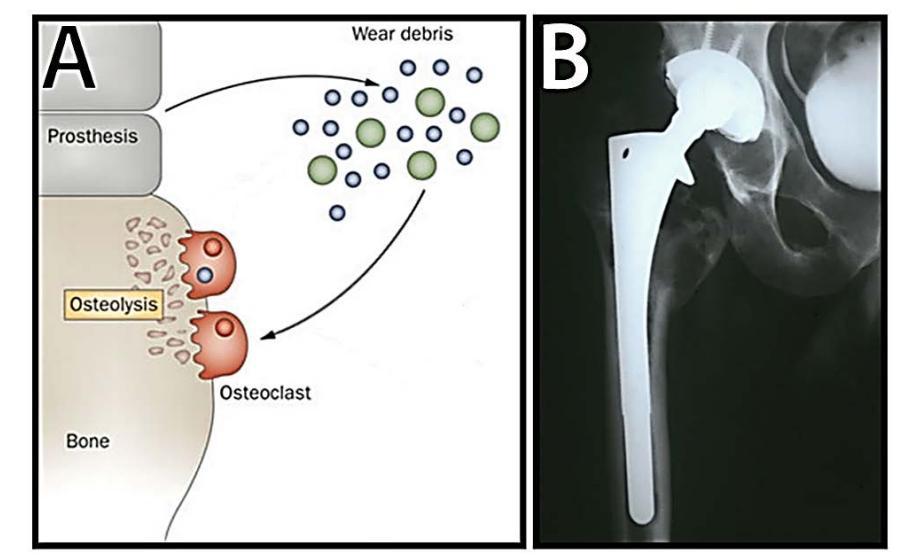
Figure 1.4 Wear debris-induced osteolysis. A) Schematic of osteolysis induced by the release of wear particles from the articulating interface of the prosthesis B) X-ray showing osteolysis and aseptic loosening of a THA prosthesis in a patient [33].

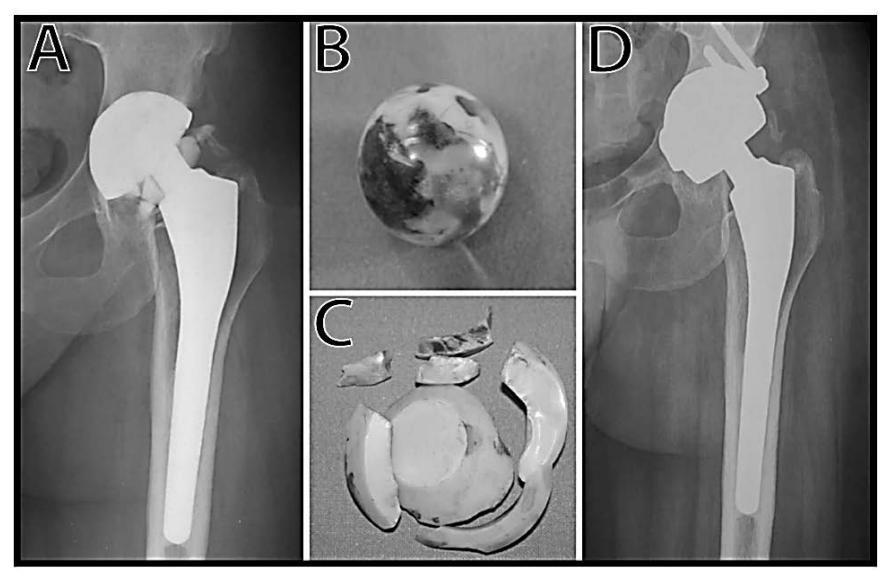
Figure 1.6 Catastrophic failure of ceramic THA prostheses. A) Preoperative radiograph showing catastrophic failure of a ceramic liner. B) The retrieved ceramic head grossly damaged because of contact with metal back. C) Retrieved fractured ceramic liner. D) Postoperative radiograph after cup revision and bearing surfaces exchange to MoM coupling [48].

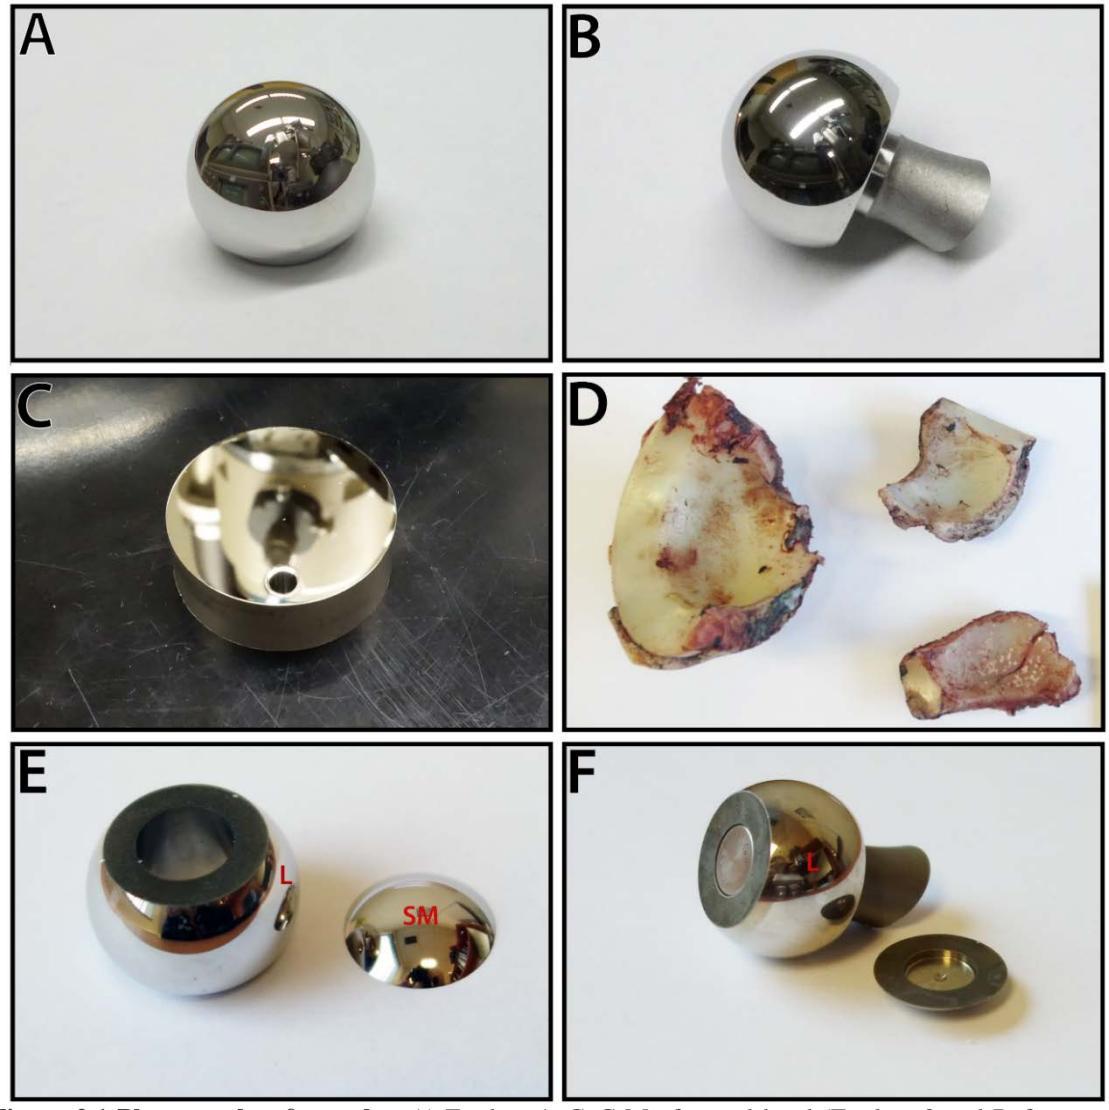
**Figure 2.1 Photographs of samples.** A) Explant 1, CoCrMo femoral head (Explant 2 and Reference 1 look identical in photographs). B) Explant 3, CoCrMo femoral head. C) Reference 2, CoCrMo puck. D) Explant 4, UHMWPE acetabular cup fragments. E) Explant 1, after EDM cutting. SM is the superior medial region and L is the lateral region F) Explant 3, after EDM cutting. L is the lateral region.

The samples investigated consists of several CoCrMo femoral head components and one UHMWPE acetabular cup from MoP hip implants. All samples were provided courtesy of collaborators from Uppsala University and Uppsala University Hospital, Sweden. Three of the samples consisted of retrieved CoCrMo femoral head components implanted for a duration of between 2 to 15 years (Fig. 2.1A, B). All retrieved samples were removed for a primary revision surgery and the reasons for removal were due to instability or aseptic loosening and wear. The two reference samples consisted of a new, unimplanted wrought CoCrMo femoral head (reference sample looks like photograph in Fig. 2.1A) and a cast CoCrMo puck (Fig. 2.1C) manufactured using the same process as the femoral head components. Lastly, one UHMWPE acetabular cup component (Fig. 2.1D) was also examined. Detailed information on the samples are summarized in Table 1 and photographs of samples are in Figure 2.1.

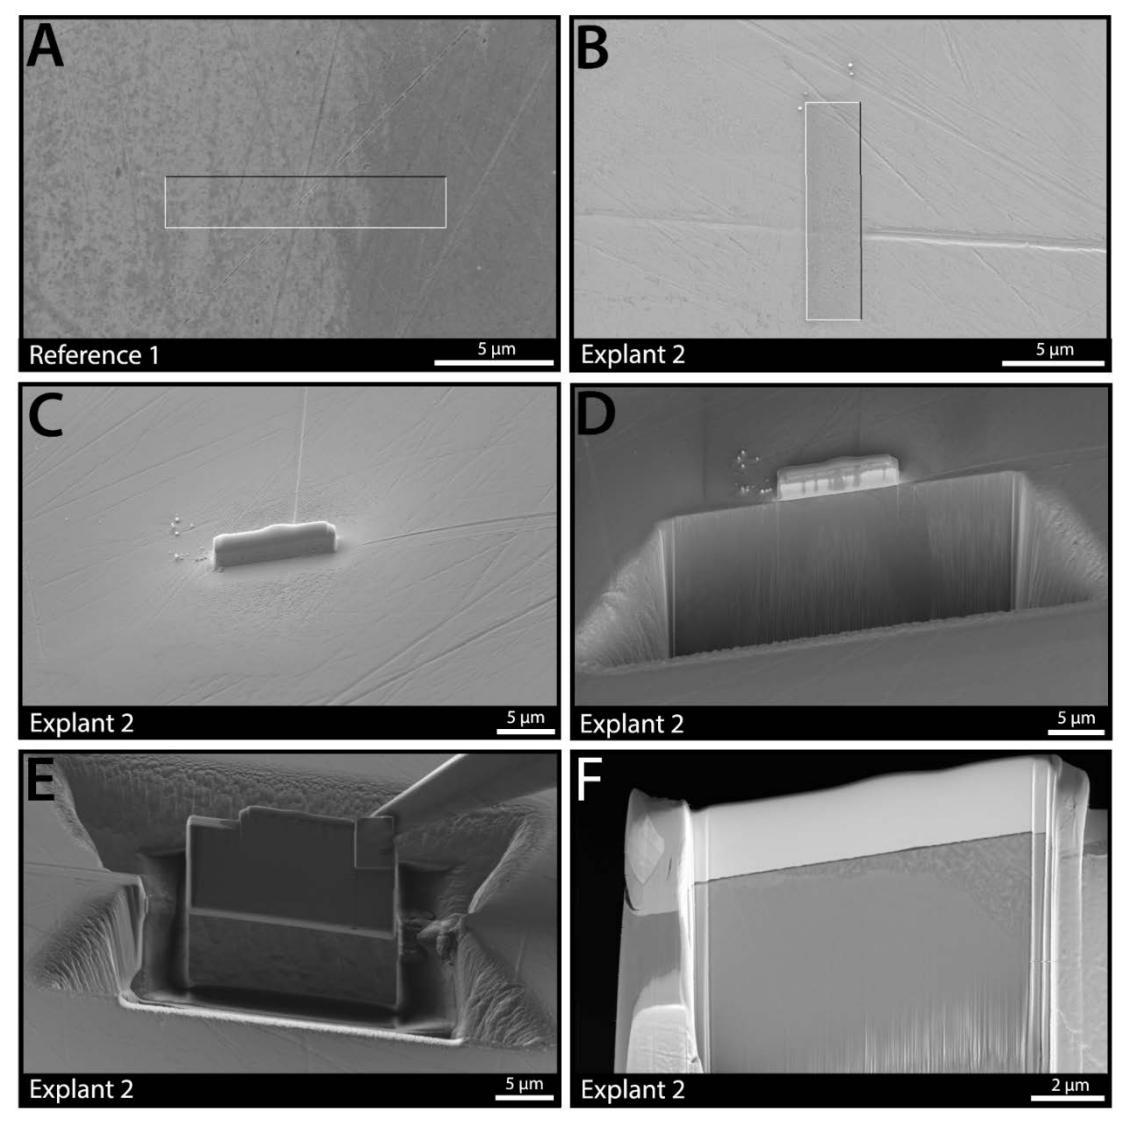
**Figure 2.2 Focused ion beam preparation of TEM samples.** A) Example of area selection for Reference 1 over shallow manufacturing-induced scratches. B) Example of area selection for Explant 2 over deeper irregular scratches. C) Areas of interest are coated with a protective layer of carbon and tungsten. D) Trenches around the area of interest are milled using the Ga⁺ ion beam. E) A micromanipulator is used to extract the TEM sample and attach it onto a TEM grid. F) TEM sample is then thinned to electron transparency for the TEM.

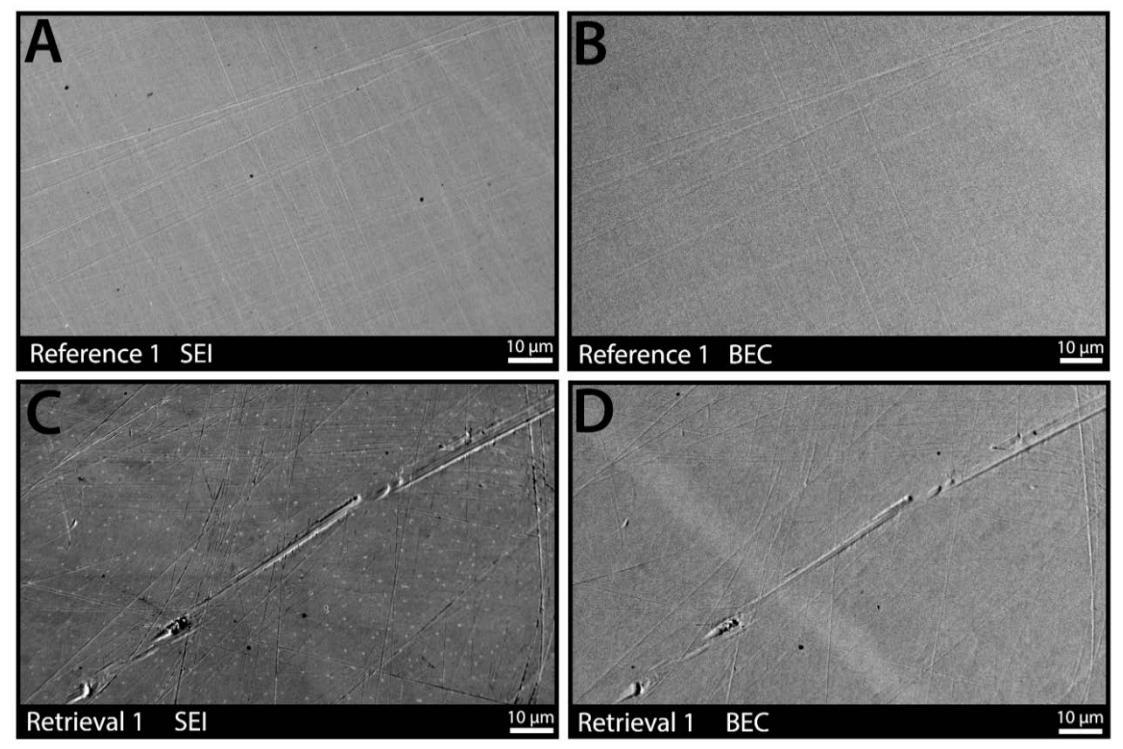
**Figure 3.1 SEM of the surface of wrought femoral head samples.** A) and B) SEI and BEC micrographs, respectively, of the surface of Reference 1. Scratches are shallow, linear and uniform. C) and D) SEI and BEC micrographs, respectively, of the surface of Retrieval 1. Deeper, more abundant, irregular scratches are visible on the surface.

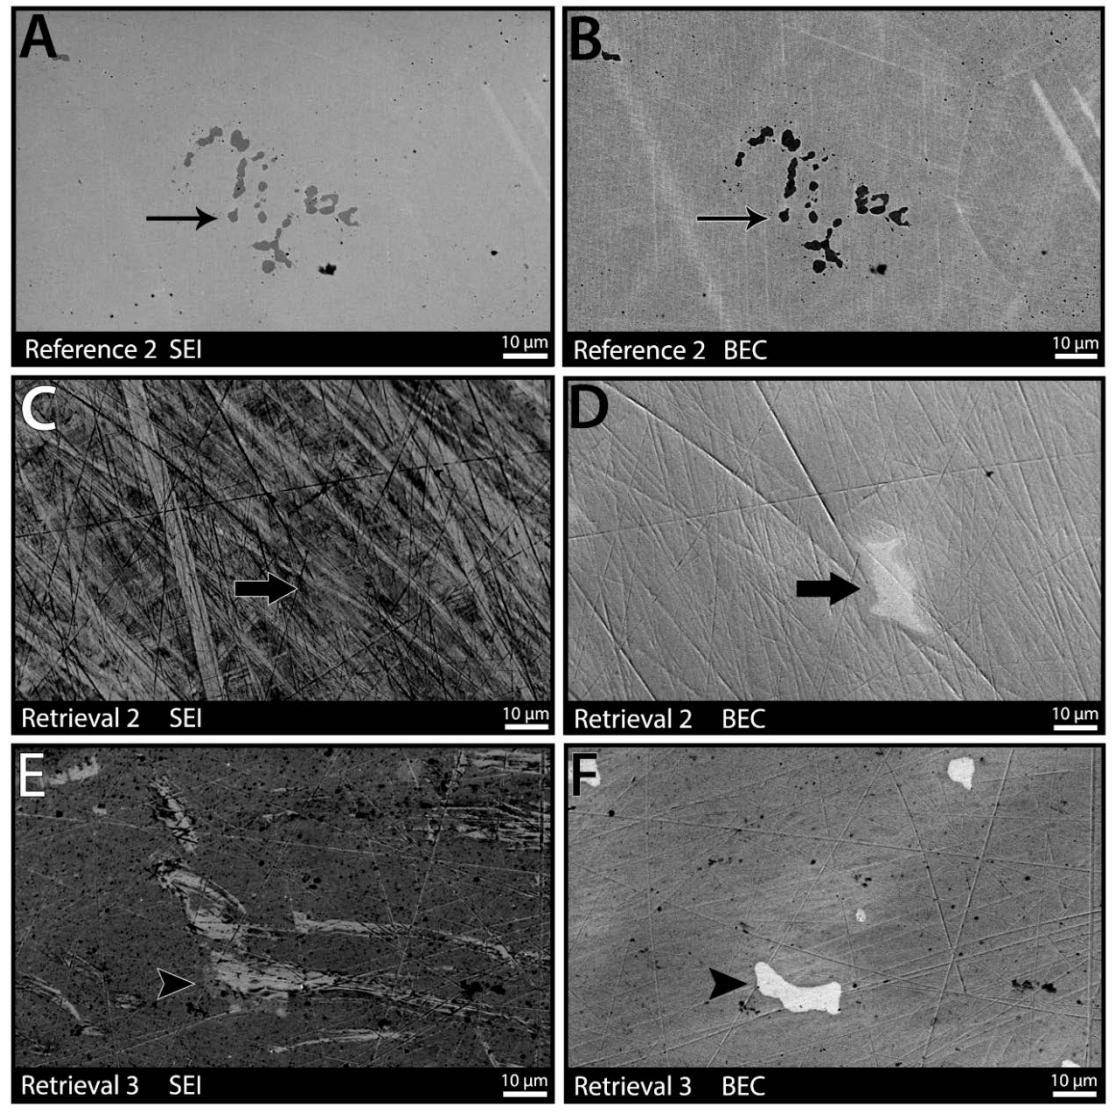
**Figure 3.2 SEM of the surface of cast femoral head samples.** A) and B) SEI and BEC micrographs, respectively, of the surface of Reference 2. Scratches are shallow, linear and uniform. Arrow pointing to a carbide on the surface. C) and D) SEI and BEC micrographs, respectively, of the surface of Retrieval 2. Deeper, more abundant, irregular scratches on the surface. The arrow points to a hard phase more easily identified in the BEC micrograph (D). E) and F) SEI and BEC micrographs, respectively, of the surface of Retrieval 3. Deeper, more abundant, irregular scratches on the surface. The arrowhead points to a hard phase more easily identified in the BEC micrograph (D).

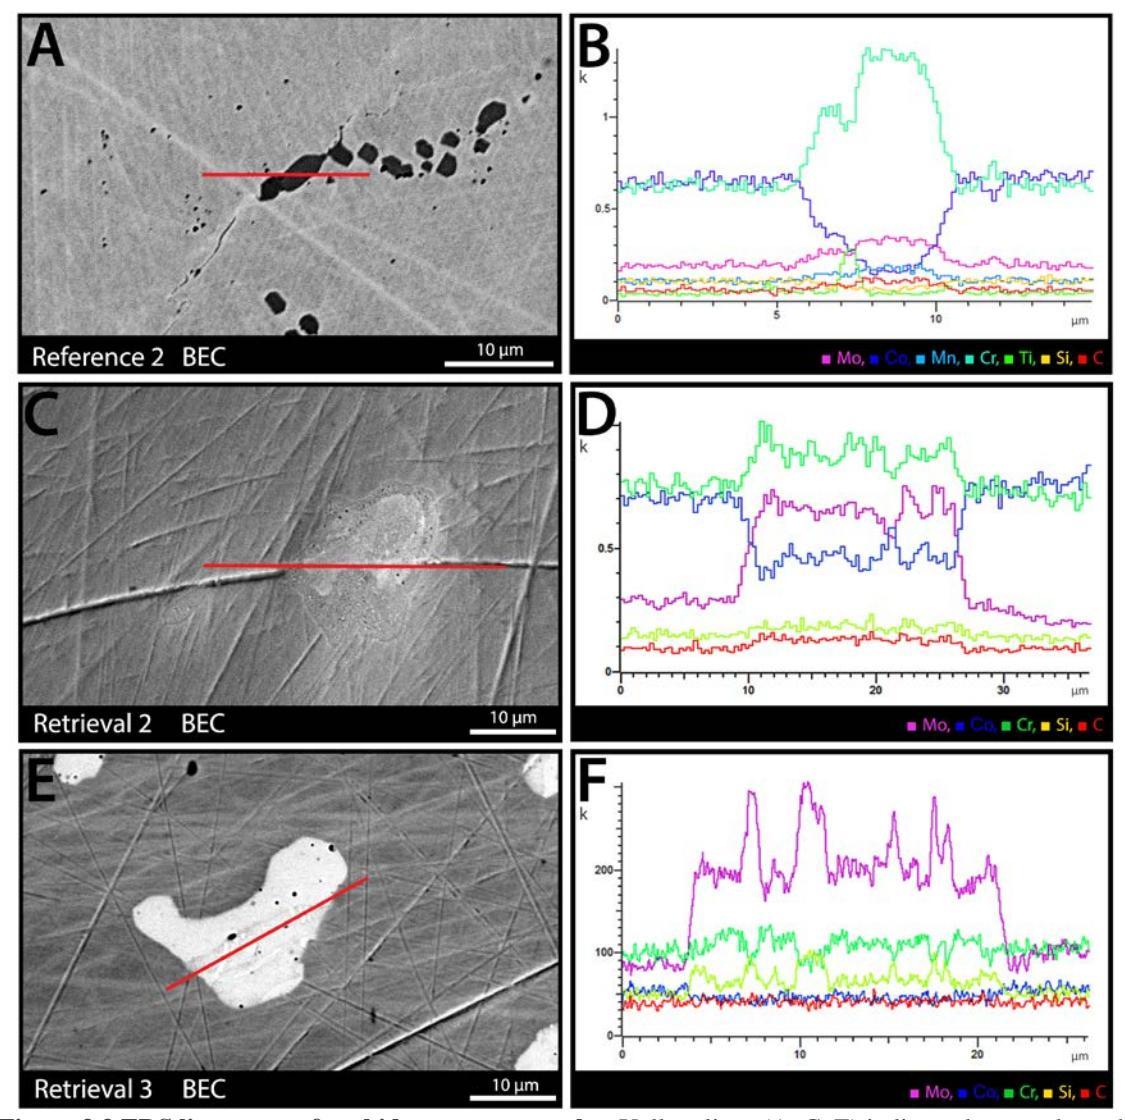
**Figure 3.3 EDS line-scans of carbides on cast samples.** Yellow lines (A, C, E) indicate the area through which the graph was generated. A) and B) BEC micrograph and EDS line-scan of Reference 2 hard phase. C) and D) BEC micrograph and EDS line-scan of Retrieval 2 hard phase. E) and F) BEC micrograph and EDS line-scan of Retrieval 3 hard phase.

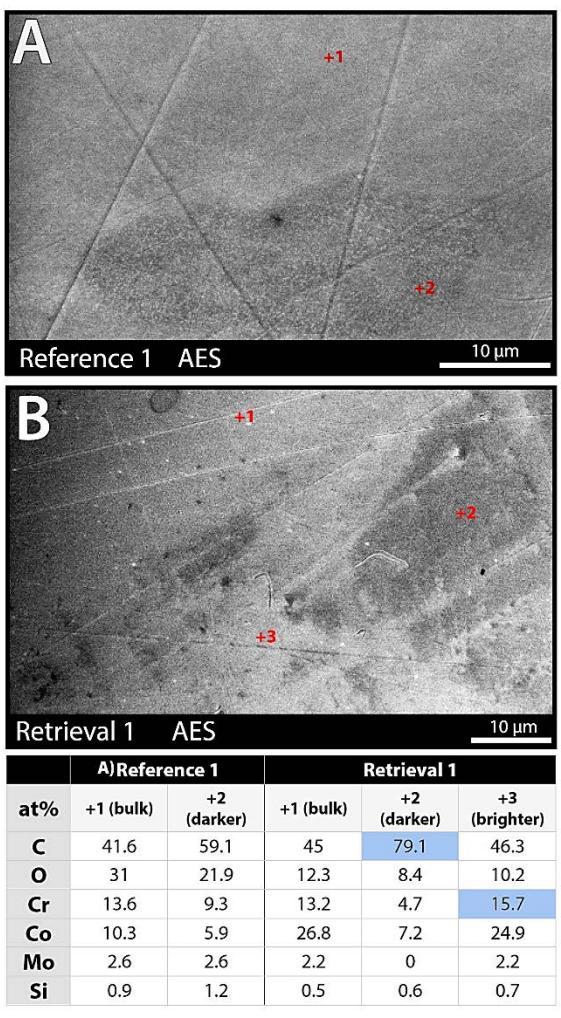
**Figure 3.4 AES point analysis of wrought samples.** The numbers (e.g. +1, +2, +3) indicate points at which compositional analysis was taken. The bulk areas correspond to areas where the contrast is representative of the majority of the surface. Elemental compositions at the points of interest are presented in atomic percentage (at%) in the table below. The highlighted values are increases in elemental composition in comparison to the bulk values. The detection limit for EDS is approximately  $\pm 0.5$  at%. The highlighted values are increases in elemental composition to the bulk values.

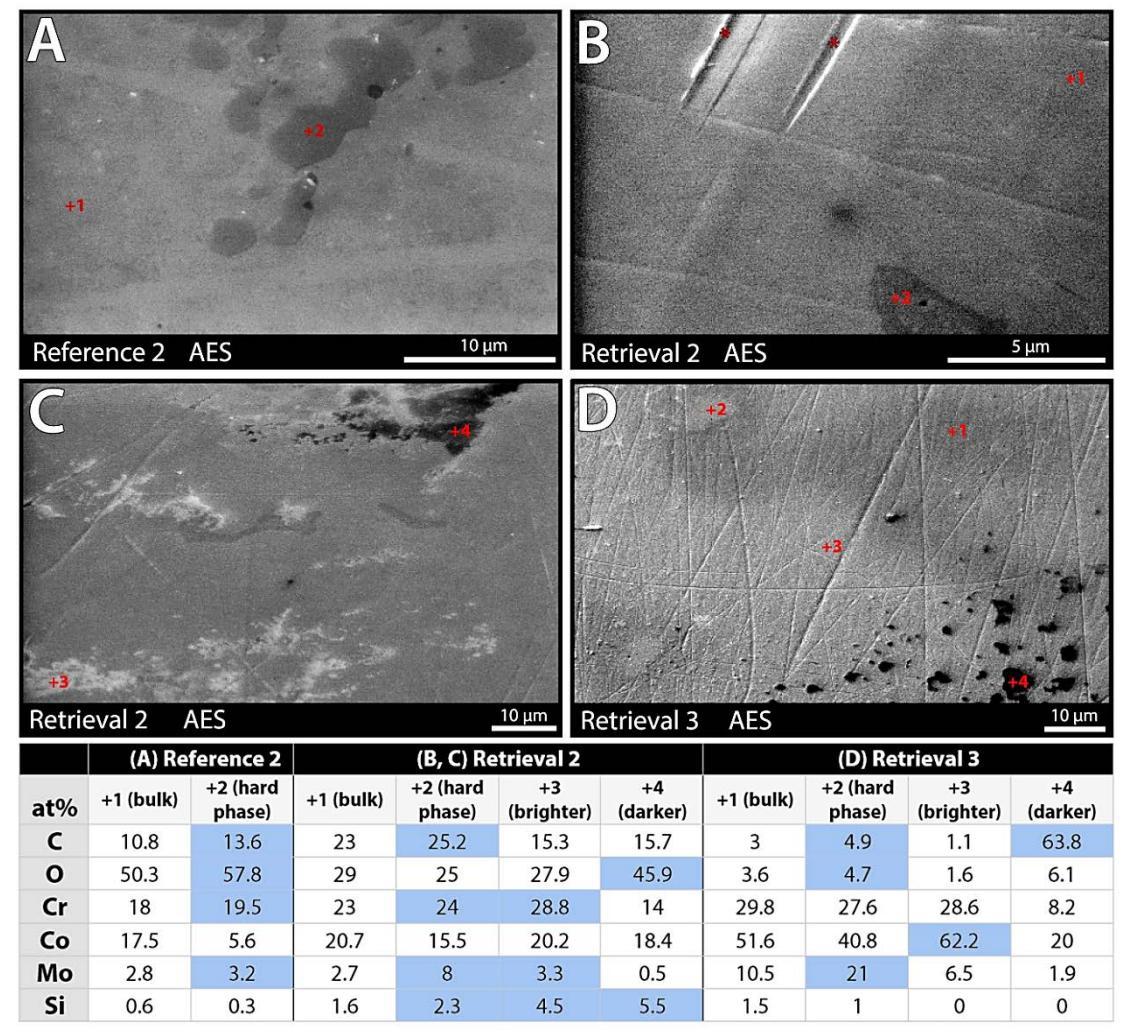
Figure 3.5 AES point analysis of cast samples. The numbers (e.g. +1, +2, +3) indicate points at which compositional analysis was taken. The bulk areas correspond to areas where the contrast is representative of the majority of the surface. B) * point spectra were taken over scratches however the compositions were not notably different from the bulk material, therefore not included in the table. Elemental compositions at the points of interest are presented in atomic percentage (at%) in the table below. The highlighted values are increases in elemental composition in comparison to the bulk values. The detection limit for EDS is approximately  $\pm 0.5$  at%.

Retrieval 3, compared to the bulk, the hard phase (+2) had an increase in C, O, Mo and a decrease in Co, and a slight decrease in Cr, these results are similar to those obtained in the SEM EDS line-scans. The brighter area (+3) had a greater amount of Co and the darker area (+4) had a much greater amount of C (Fig. 3.5D).

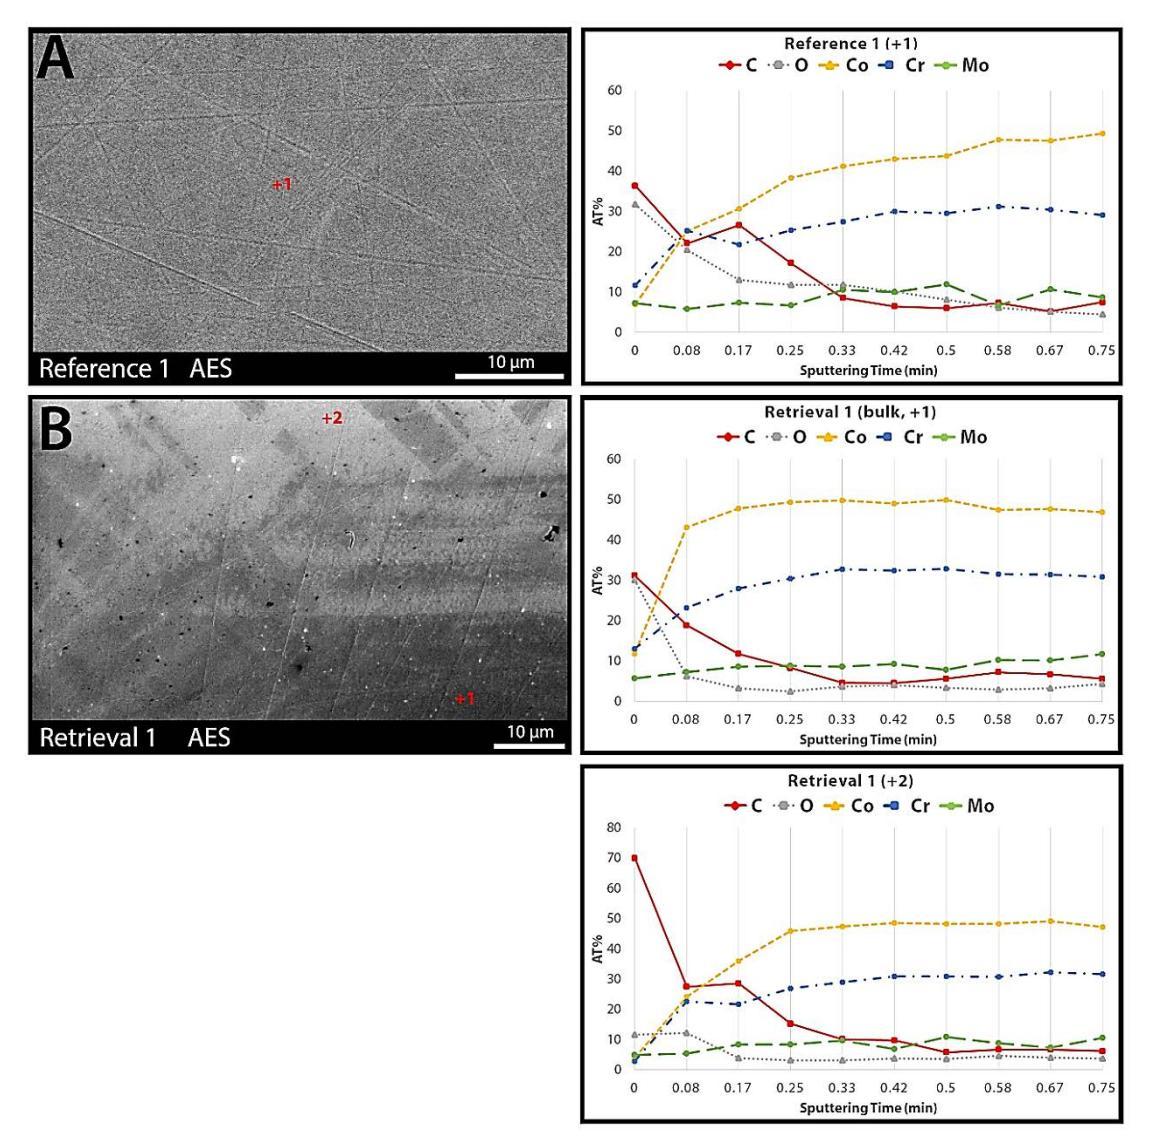
**Figure 3.6 AES depth profiling of wrought samples. A)** and B) SEM micrographs of Reference 1 and Retrieval 1, respectively, showing the areas of interest where the depth profiles were acquired and corresponding depth profile graphs. The estimated sputtering depth rate for CoCrMo is 30nm/min.

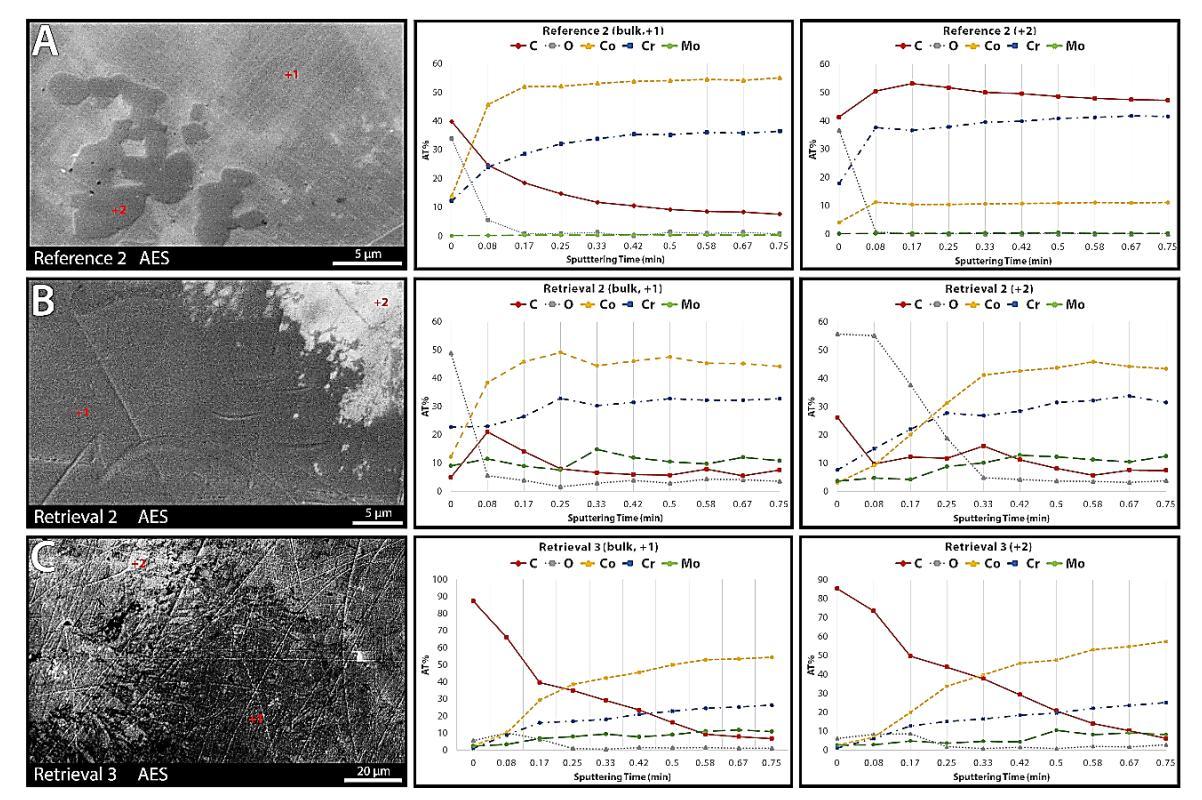
**Figure 3.7 AES depth profiling of cast samples.** A) to C) SEM micrographs of Reference 2, Retrieval 2 and Retrieval 3, respectively, showing the areas of interest where the depth profiles were acquired and corresponding depth profile graphs. The estimated sputtering depth rate for CoCrMo is 30nm/min.

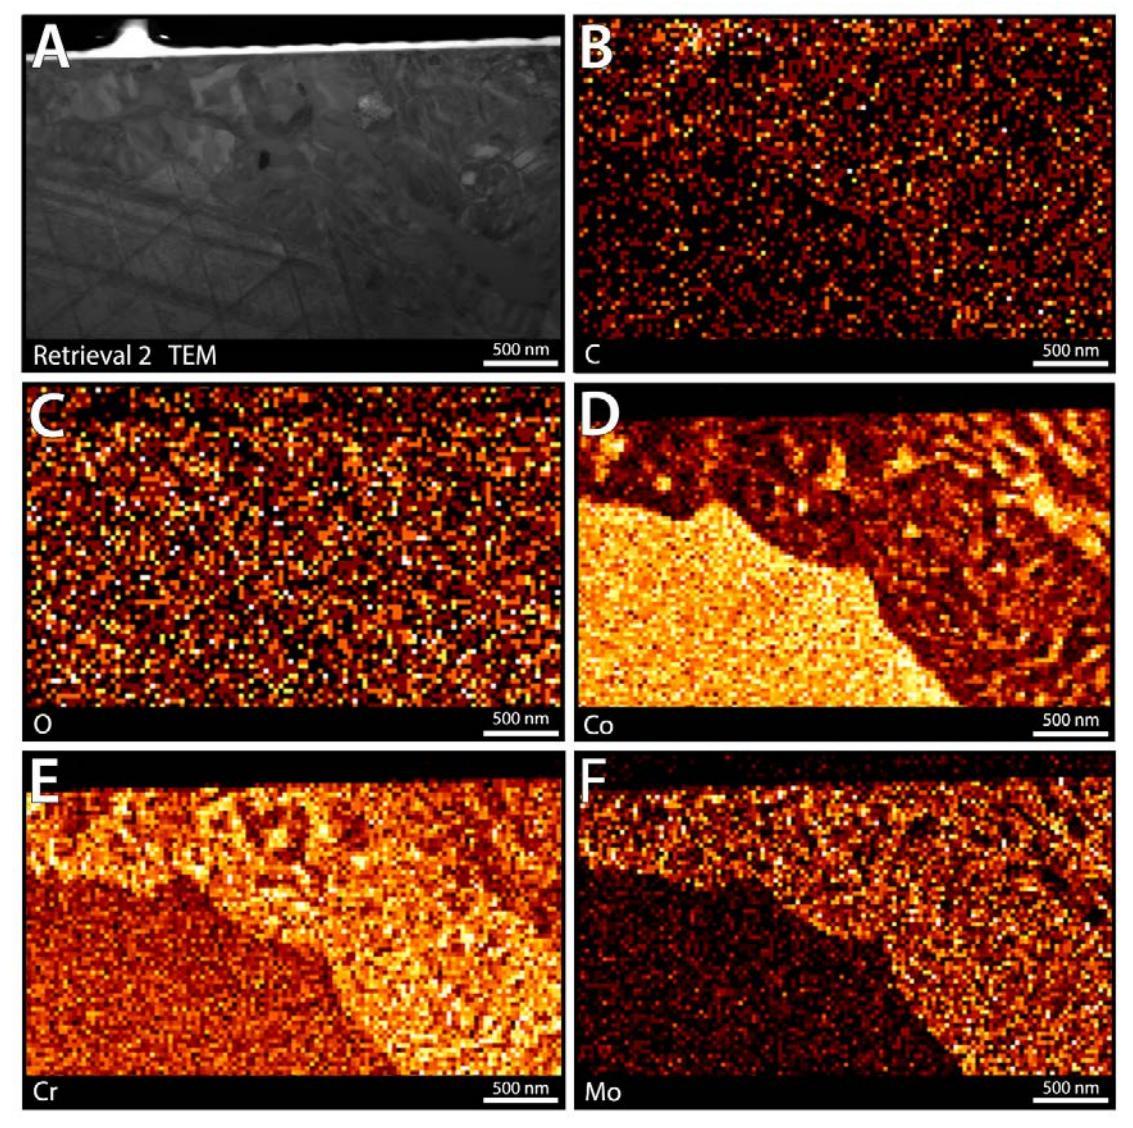
**Figure 4.1 TEM EDS map of a hard phase from Retrieval 2.** A) TEM micrograph of area where the EDS map was acquired. A) to F) Elemental maps of C, O, Co, Cr, and Mo, respectively. The hard phase has an abundance of Cr (E) and Mo (F) and a depletion of Co (D) except in areas where there are mixed phases containing large amounts of Co.

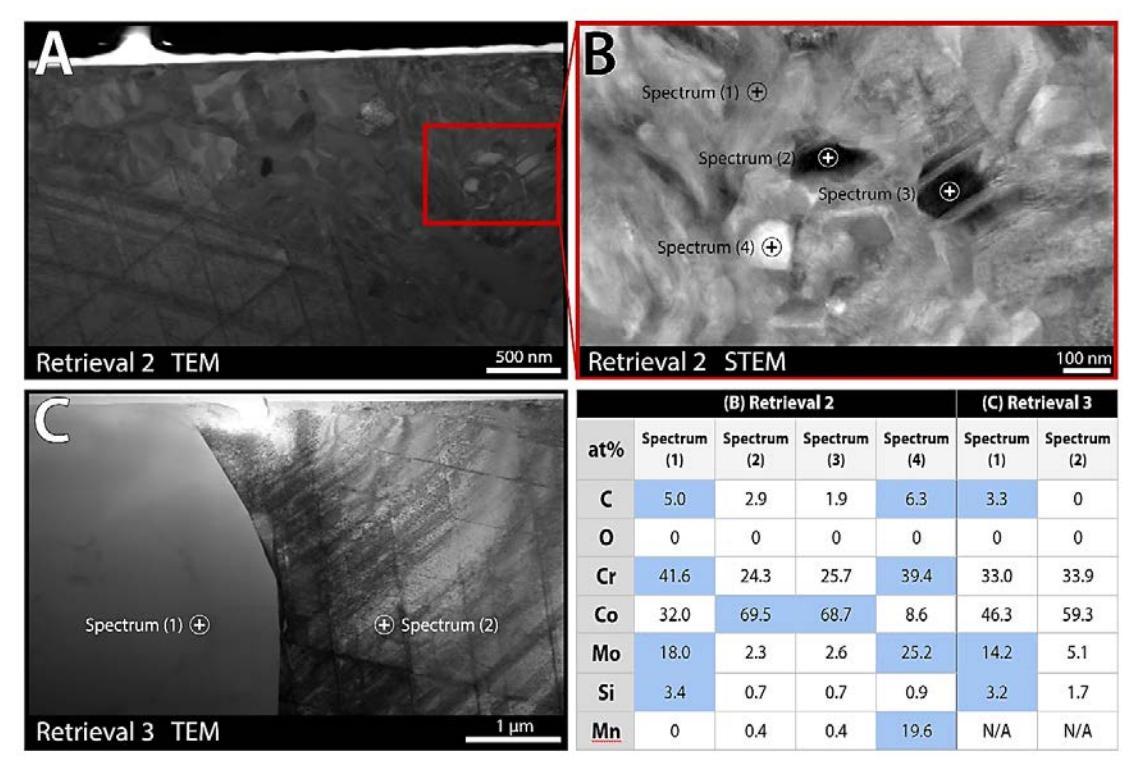
**Figure 4.2 TEM EDS point spectra elemental analysis within a hard phase from Retrieval 2 and Retrieval 3.** A) TEM micrograph of the area where EDS point spectra were acquired from Retrieval 2, B) points indicating where each spectrum was acquired from the particulates within the hard phase. C) Two points on Retrieval 3 indicating where the spectra were acquired, spectrum 1 corresponds to the hard phase and spectrum 2 corresponds to the bulk material. The table shows the atomic percentage of elements present at each point of interest. The highlighted values are increases in elemental composition in comparison to the bulk values.

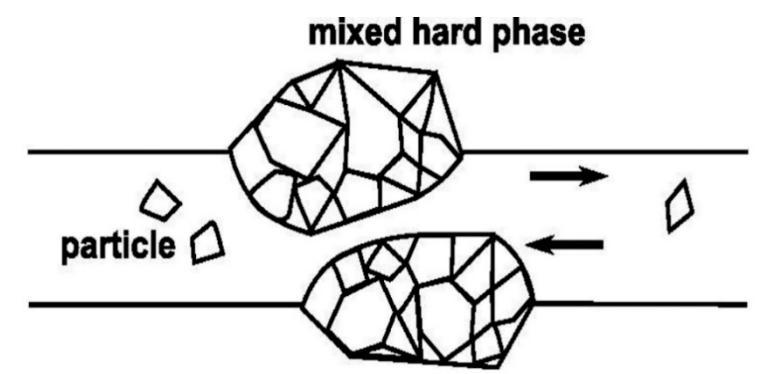
**Figure 4.3 Schematic of nanoparticles generated from mixed hard phases during wear.** Adapted from Liao et al. 2012 [86].

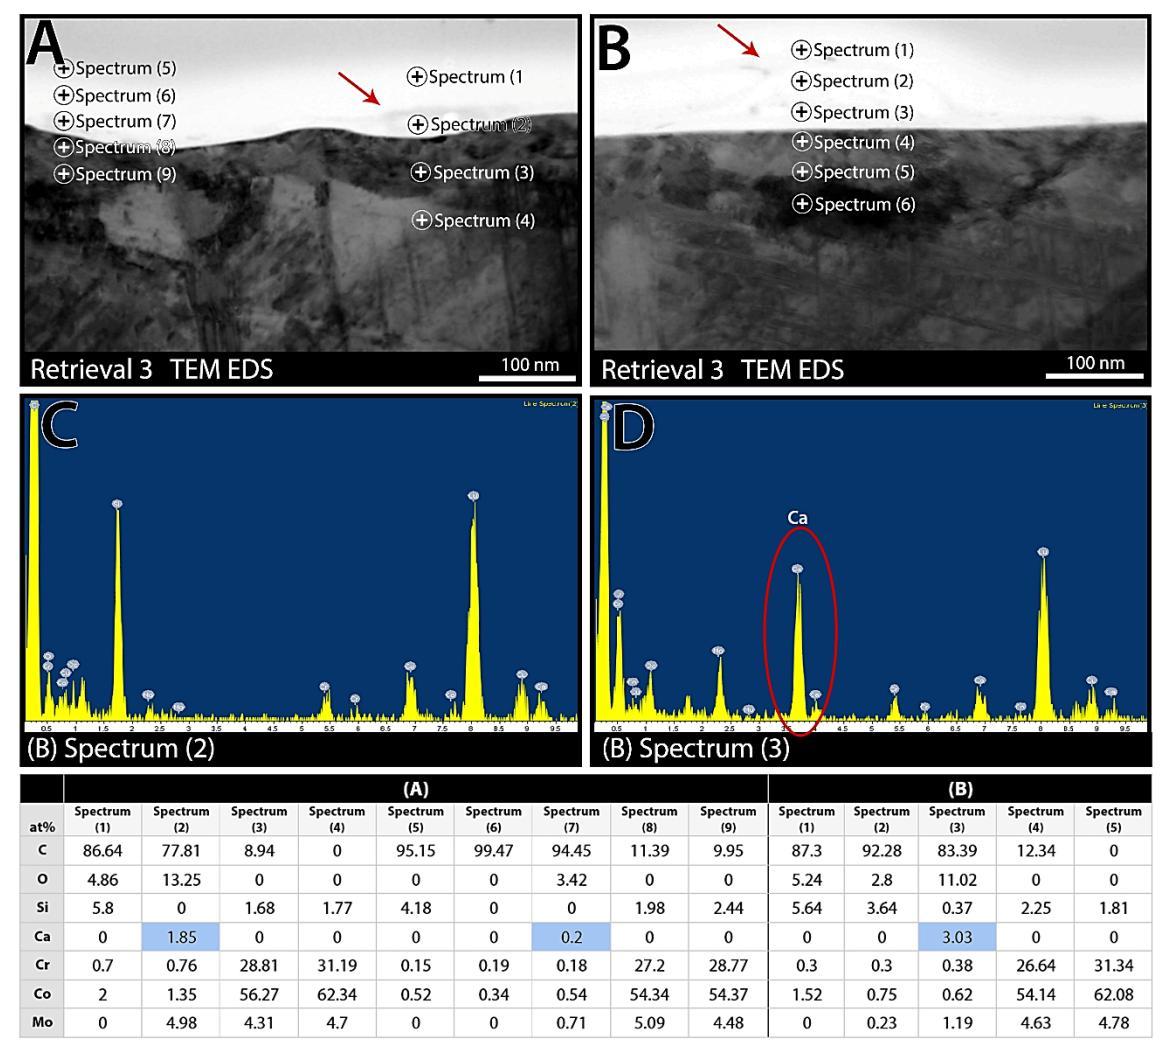
**Figure 4.4 TEM EDS point spectra elemental analysis through the tribological layer and base metal on Retrieval 3**. A) and B) Points at which EDS spectrum was acquired. Arrows point to areas where a residual layer is visible above the bulk material. The atomic composition of elements is presented in the table below. Calcium was detected at points above the surface of the bulk material (amounts are highlighted on the table in blue). C) and D) are two examples of elemental spectra where in C) there is no Ca peak and in D there is are two evident Ca peaks at approximately 3.7 keV and 4.0 keV.

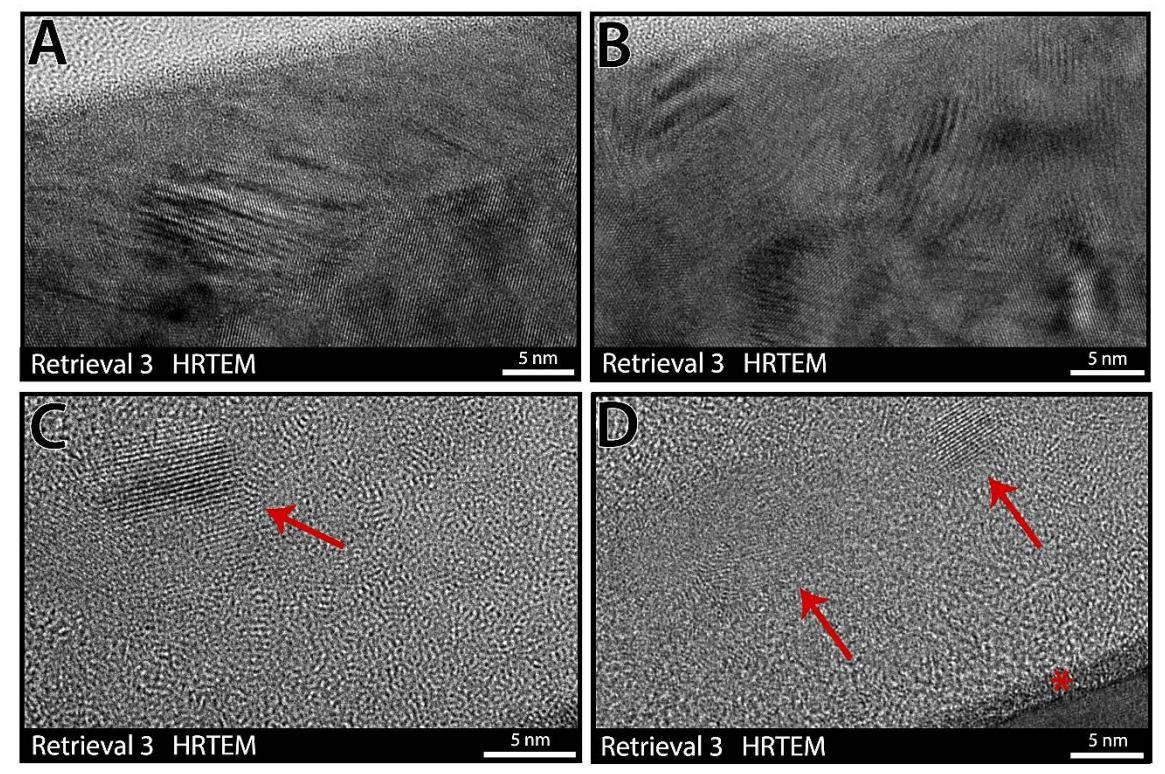
**Figure 4.5 HRTEM micrographs from Retrieval 3.** A) and B) HRTEM micrographs of the nanocrystalline layer, showing the alignment of nanocrystals near the surface. C) and D) are HRTEM micrographs of the residual layer above the bulk material. Arrows point to areas where a nanocrystalline particle is found above the bulk material. The asterix (*) in D) indicates the potential oxide layer directly above the metallic surface of the sample.

Figure 4.5 depicts select high resolution TEM micrographs of the nanocrystalline layer (A and B) and nanocrystalline particles identified between 5 - 20 nm from the surface of the retrieval (C and D, arrows). The particles ranged between 5 - 20 nm in size and appeared either at isolated areas or in clusters of two to five nanoparticles. A defined layer was visible just above the metallic surface, as indicated by the asterix (*) in Figure 4.5 D. This layer may be a surface oxide layer known to form on CoCrMo alloys consisting of chromium oxide (Cr₂O₃), and molybdenum oxide (Mo⁺⁴, Mo⁺⁵, Mo⁺⁶) to a lesser extent [98]–[101].

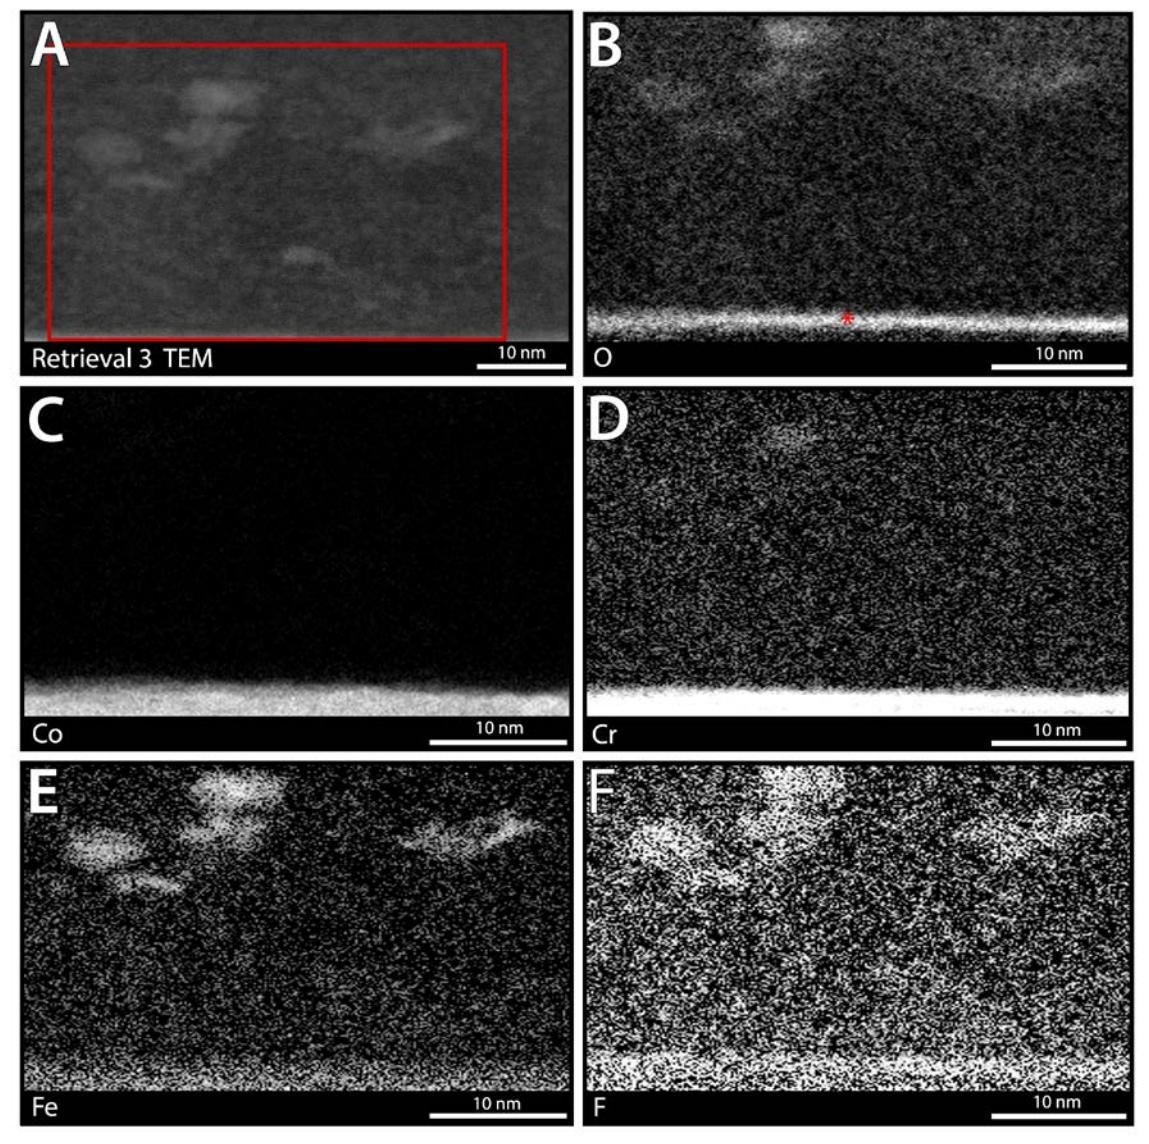
**Figure 4.6 EELS mapping on the nanoparticles.** A) TEM micrograph of area selected for EELS analysis. B) to F) EELS elemental maps for O, Co, Cr, Fe, and F, respectively. The maps show that the particles are enriched in Fe, O, and F. The asterix (*) in B indicates oxide layer above the metallic surface.
