THE SURFACE AND SUBSURFACE CHARACTERIZATION OF RETRIEVED METAL-ON-POLYETHYLENE HIP PROSTHESES USING ELECTRON MICROSCOPY

A Thesis Submitted to the School of Graduate Studies in Partial Fulfilment of the Requirements for the Degree of Master of Applied Science

McMaster University © Copyright by Vicky Vuong, March 2015

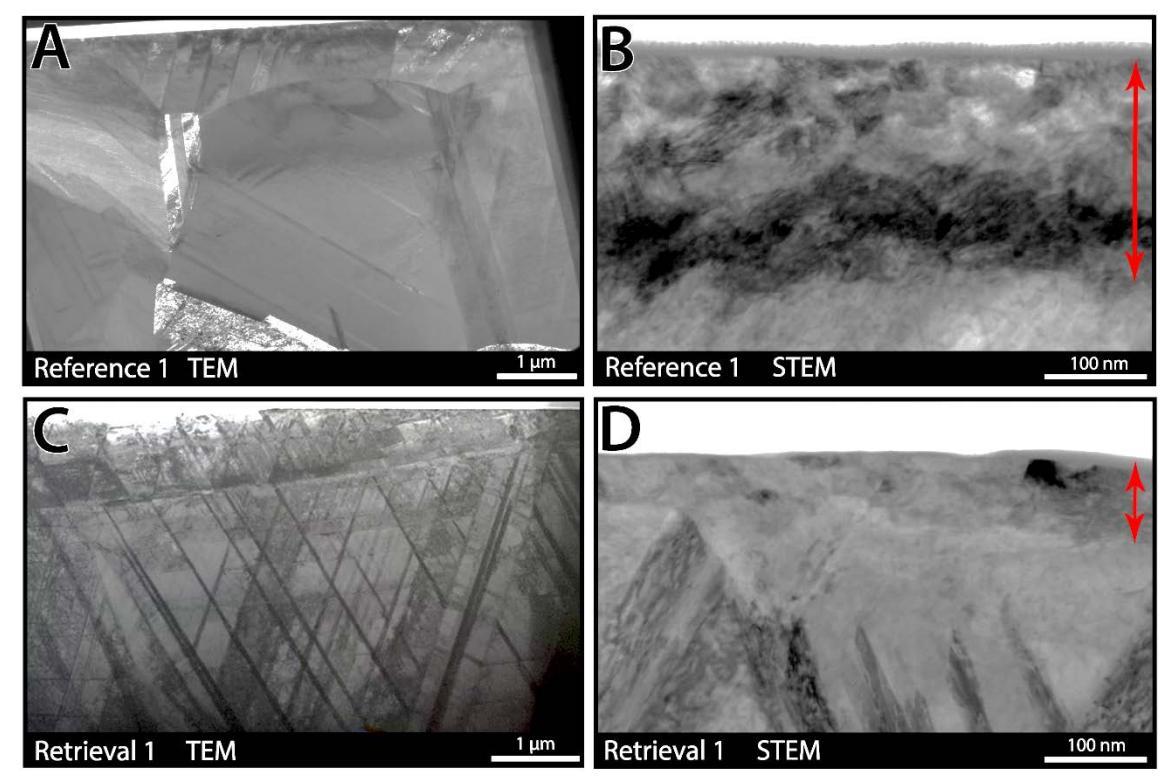
**Figure 4.7 TEM micrographs of the subsurface microstructure in the wrought samples.** A) and B) show TEM low magnification, overviews of the subsurface microstructure. B) and D) show STEM micrographs of the subsurface nanocrystalline layer. The arrows show the maximum thickness of the nanocrystalline layer in the micrograph.

TEM of the FIB cross-sectional preparations revealed a subsurface nanocrystalline microstructure across all of the samples (Fig. 4.7 and Fig. 4.9). The subsurface microstructure was particularly evident using bright-field STEM at higher magnifications. The nanocrystalline layer on wrought Reference 1 was approximately 200 nm in thickness (Fig. 4.7B). The nanocrystalline layer was quite variable on Reference 2, between 20 nm to 100 nm (Fig. 4.9B). The nanocrystalline layer on Retrieval 1 ranged from 40 to 100 nm in thickness; approximately 350 nm in Retrieval 2; and 100 nm in Retrieval 3 (Fig. 4.7 and Fig. 4.9). Additionally, STEM EDS mapping of the nanocrystalline layer showed that the layer had the same elemental composition as the bulk alloy material below (Fig. 4.10).

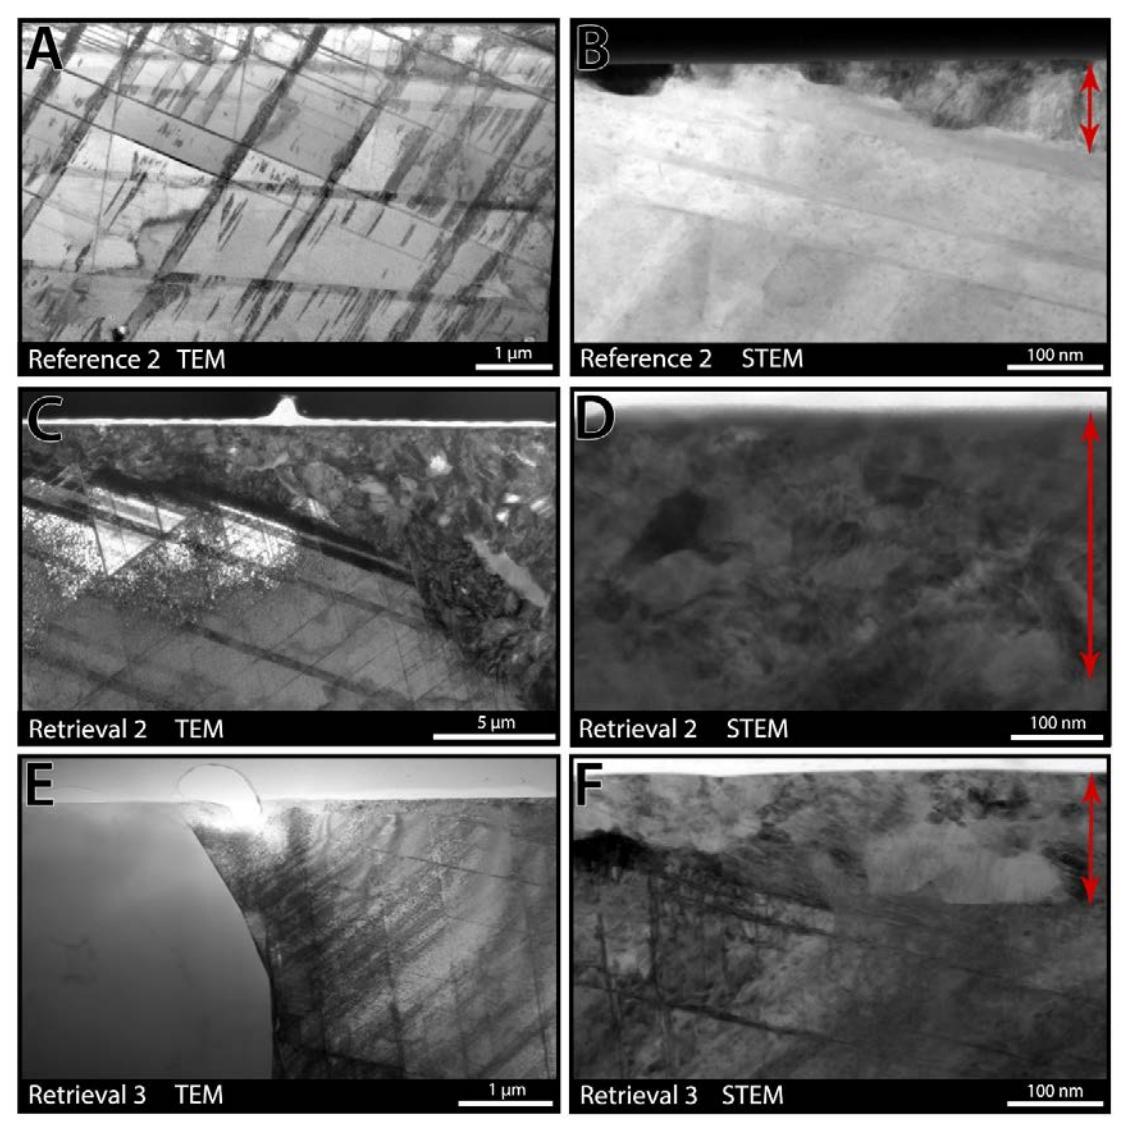
**Figure 4.9 TEM micrographs of the subsurface microstructure in the cast samples.** A), C), E) show TEM low magnification, overviews of the subsurface microstructure. B), D), F) show STEM micrographs of the subsurface nanocrystalline layer. The arrows show the maximum thickness of the nanocrystalline layer in the micrograph.

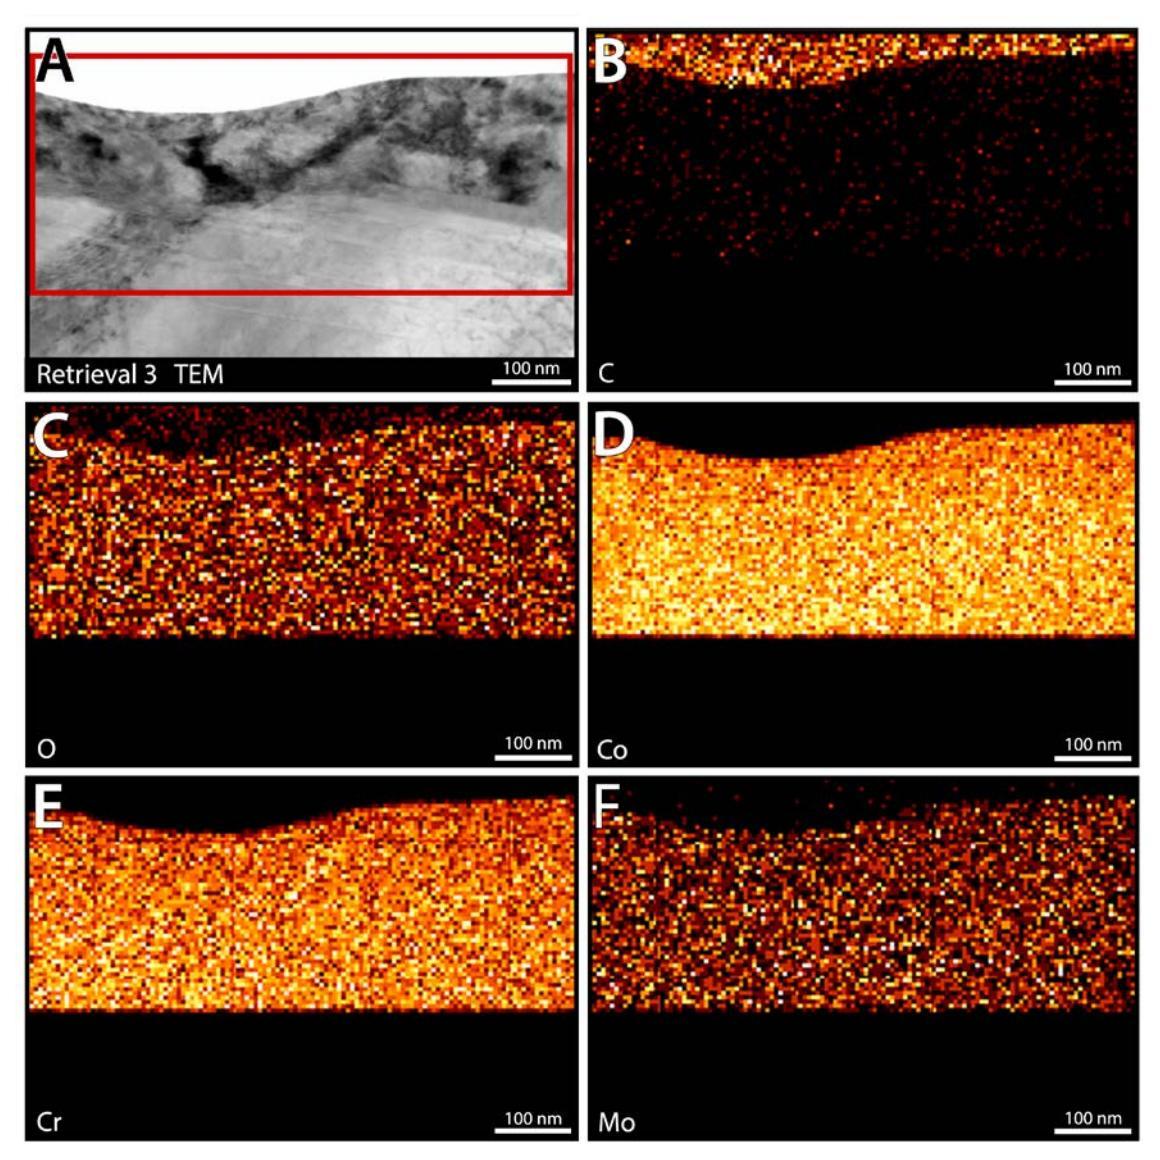
**Figure 4.10 STEM EDS map of nanocrystalline layer.** A) to B) The elemental EDS maps show no distinction of elemental variation between the nanocrystalline layer and the base alloy material.

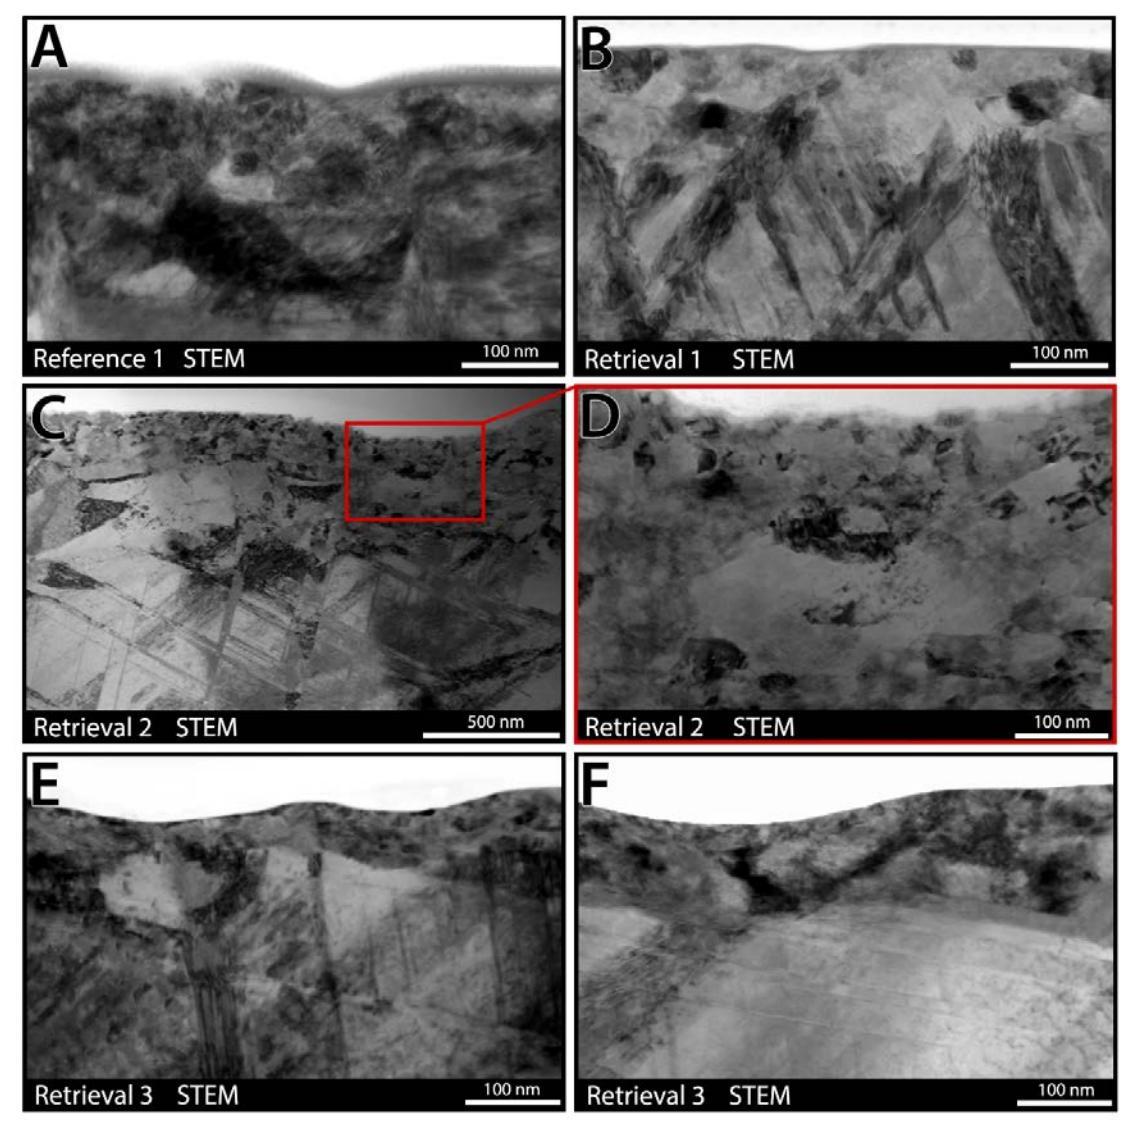
**Figure 4.11 STEM micrographs of the subsurface microstructure under scratches on the surface.** A) and B) The nanocrystalline layer under the shallow scratches do not show very big changes whereas the nanocrystalline layer under the deeper scratches C) to F) appear to follow the contours of the scratches.

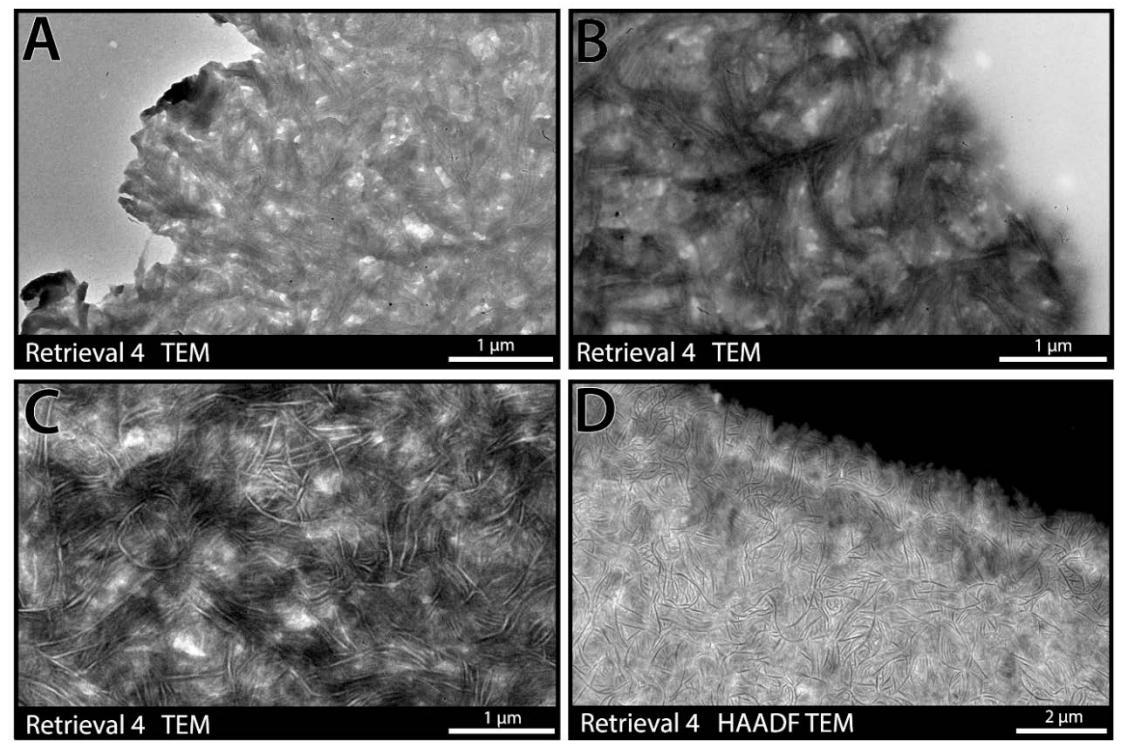
**Figure 4.12 TEM of subsurface microstructure of UHMWPE sample.** A) and B) Micrographs showing the individual polymer chances at the articulating surface. C) TEM micrograph showing the organization of polymers deeper into the sample. D) HAADF STEM micrograph of the polymer at the articulating surface.
