# THE EFFECT OF H<sub>2</sub>SO<sub>4</sub> SURFACE PRE-TREATMENT ON THE STRESS CORROSION CRACKING OF MAGNESIUM ALLOY AZ31B

By BRYCKLIN M.WILSON, B.ENG.

A Thesis

Master of Applied Science

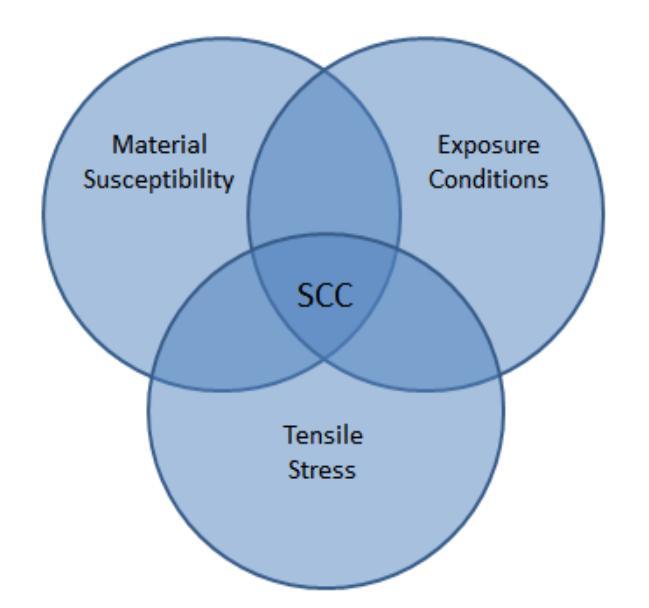
Figure 2-1: Stress corrosion cracking (SCC) criteria

Stress corrosion cracking, SCC, is defined as the initiation and propagation of cracks due to the combined influence of a constant noncyclical load and a corrosive environment. SCC occurs as a synergistic effect of three main criteria (shown in Figure 2-1): material susceptibility, exposure conditions and applied tensile stress [4].

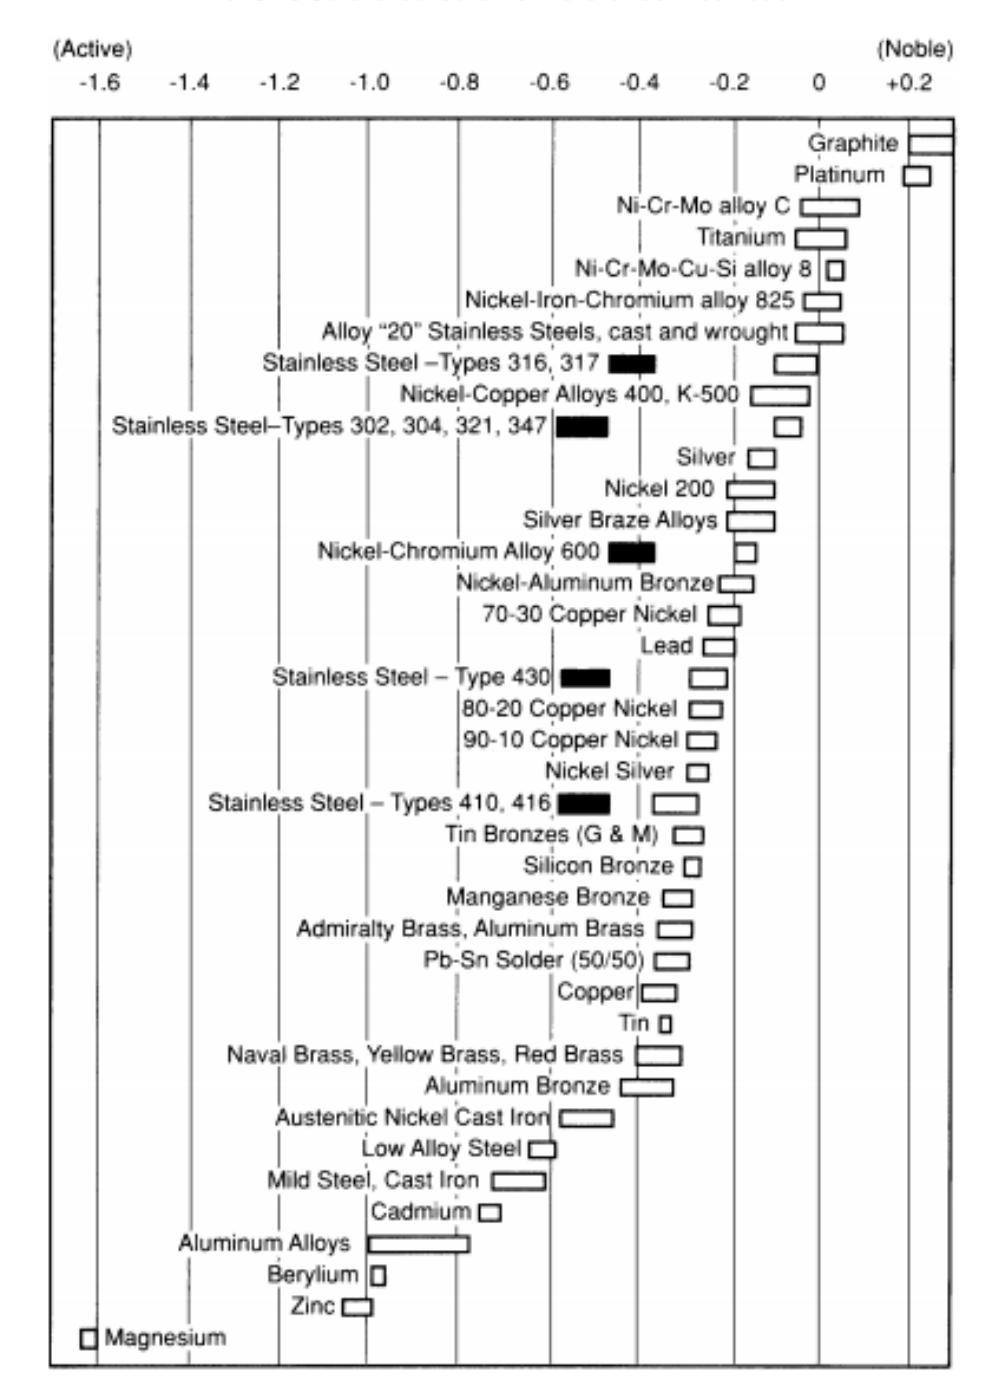
Volts vs Saturated Calomel Reference Electrode

Figure 2-3:Galvanic series of metals [21]

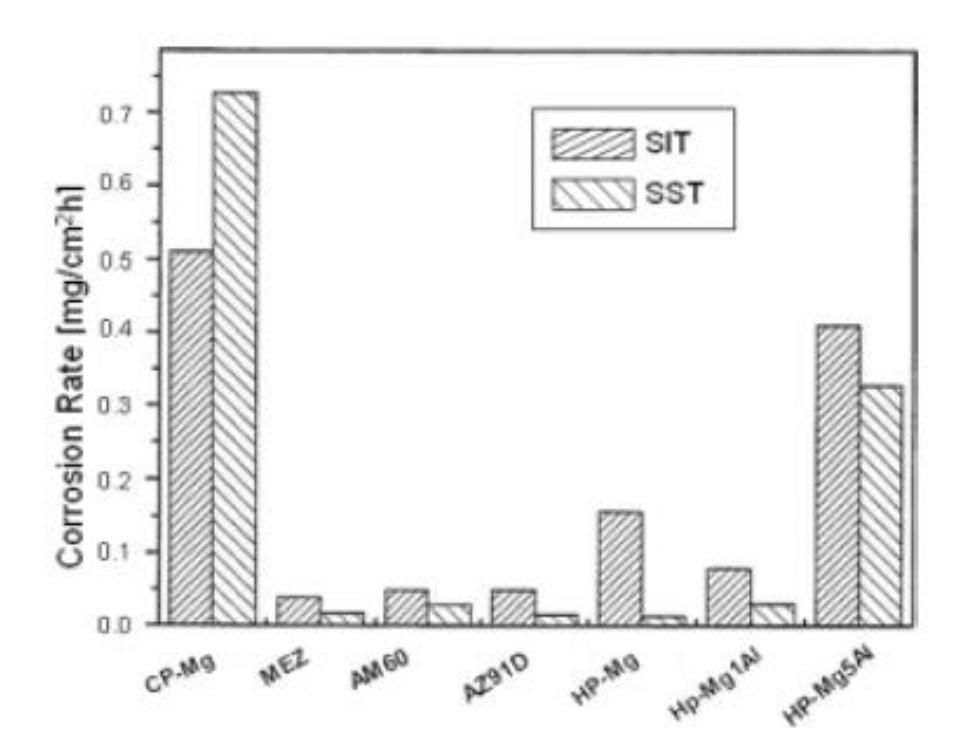
Figure 2-4: Comparison of corrosion rates of High Purity alloys (HP) and commercially pure Mg (CP) in both Salt Immersion Testing (SIT) and Salt Spray Testing (SST) [20].

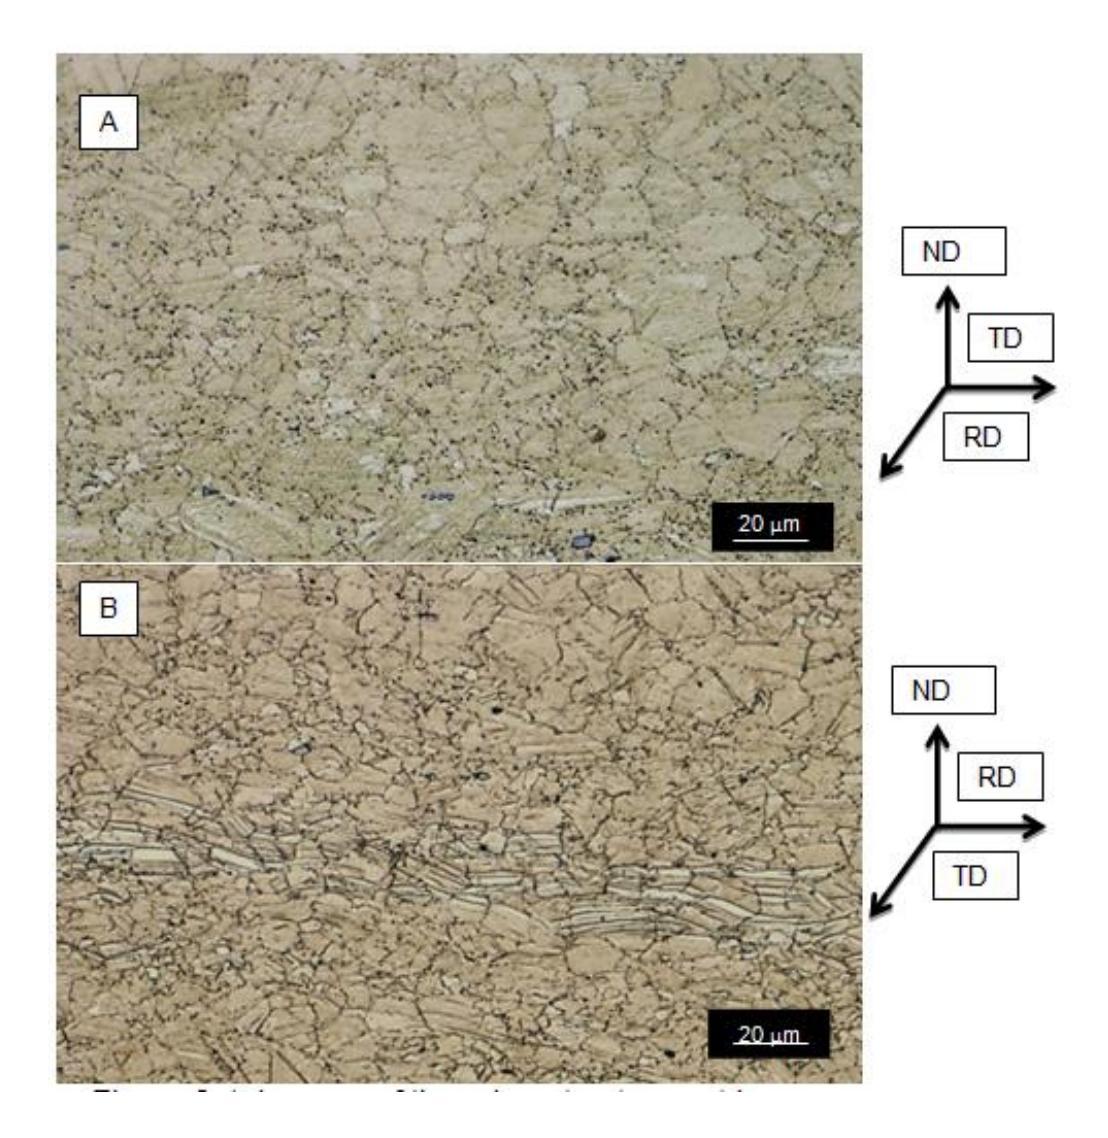
Figure 4-1: Images of the AZ31B-H24 microstructure cut in cross-section of the: (A) transverse direction and (B) rolling direction

The unexposed, as-received (AR) material was mounted in crosssection for microstructural observation. Samples were ground with abrasive papers to 4000 grit and then polished to a mirror finish using an OPS water-free silica colloidal suspension. Samples were then etched and observed using light optical microscopy (LOM). Typical microstructures are shown in Figure 4-1. The etchant used for all metallography was a picric acid solution (2.1 g C<sub>6</sub>H<sub>3</sub>N<sub>3</sub>O<sub>7</sub> [picric acid], 25 mL C<sub>2</sub>H<sub>6</sub>O [ethanol] and 5 mL C<sub>2</sub>H<sub>4</sub>O<sub>2</sub> [acetic acid]). The average grain size was evaluated using the linear intercept method according to ASTM E122-09 [46]. The average grain size for the material in both the rolling and transverse directions was approximately 8.6 ± 1.3 µm.

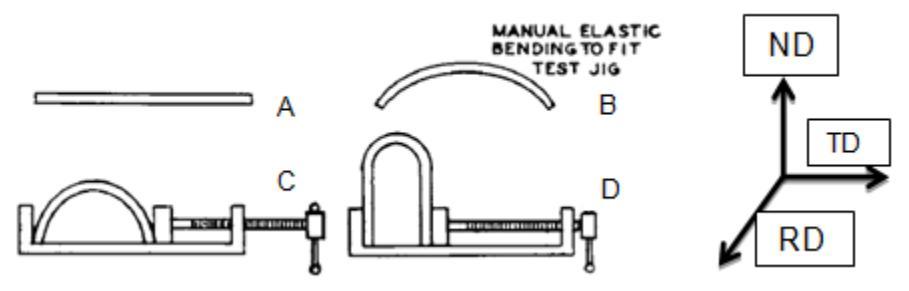
Figure 4-2: ASTM G30 U-bend two-stage process [45].

deformation to maintain a "U" shape after unloading (Figure 4-2 A and B) followed by a final bending operation to induce a static applied load on the bend just prior to exposure (Figure 4-2 C and D).

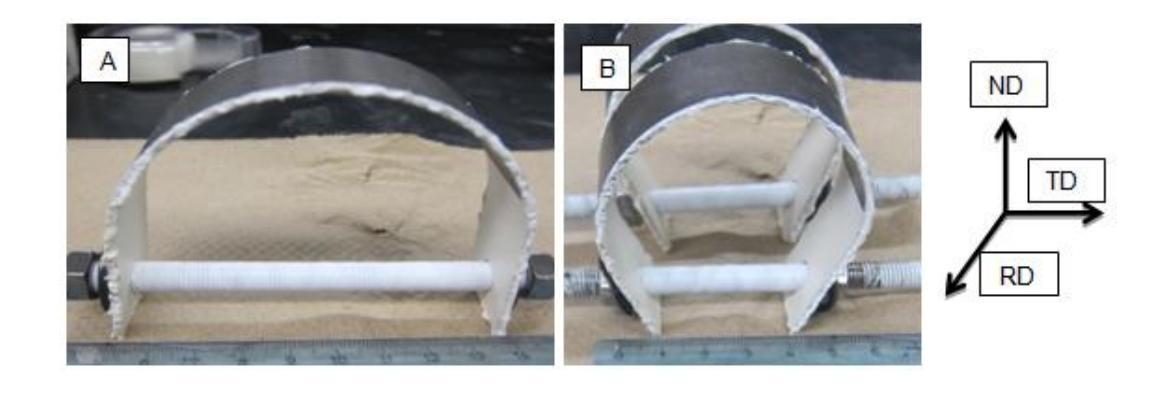
Figure 4-3: Two stage U-bend loading process as per ASTM G30 prior to exposure: (A)Stage 1 unloaded sample with 9 cm distance (B) Stage 2 loaded sample to 3 cm distance

Figure 4-3 shows an as-received U-bend sample after completion of these preparation steps, just before exposure. The second stage loading (shown in Figure 4-2 C and D) was done by tightening the stainless steel load bolt until the ends were 3 cm apart, as shown in Figure 4-3 B. The geometry of the U-bends and load bolt prevented tightening to gaps smaller than 3 cm.

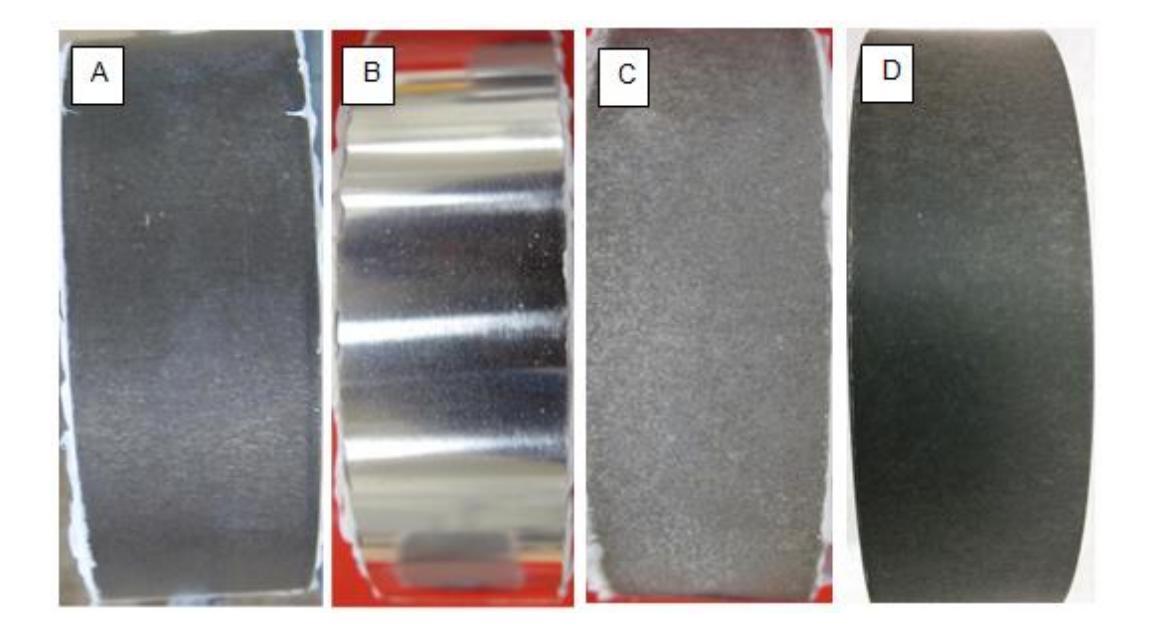
Figure 4-4: As-prepared U-bend of each surface condition: (A) AR (B) MP (C) AC\*, MP-AC, A-AC (D) O-AC

\* Note: No visible differences were seen for all H2SO4-cleaned samples; thus, the AC surface shown is representative of the AC, MP-AC and A-AC surfaces.

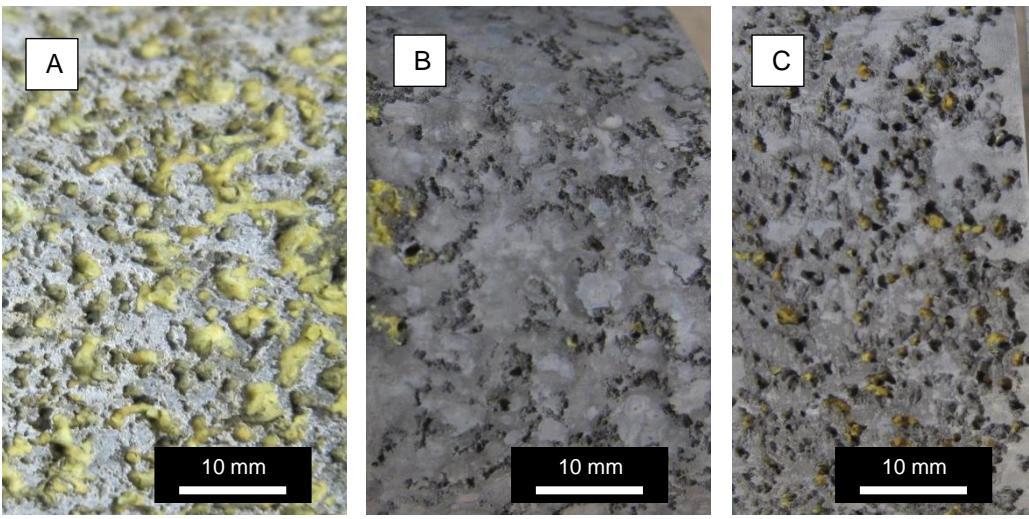
Figure 5-1: 5 wt% NaCl post exposure surfaces: (a) AR, (b) MP and (c) AC.

The results showed that the 5 wt% NaCl solution was far too aggressive to produce SCC. The only mode of corrosion observed on all three surfaces for this exposure was pitting. The pitting damage was most extensive for the AR surface. All but two exposed U-bends had undergone localised pitting corrosion which perforated through the sample. A photograph documenting the typical corrosion mode on the as-received (AR), mechanically-polished (MP) and H<sub>2</sub>SO<sub>4</sub>-cleaned (AC) U-bend surface is shown in Figure 5-1. Aggressive pitting covered most of the exposed surface in each case. The severity of pitting was highlighted by the residual yellowish green deposit left behind in the base of pits from the post exposure cleaning step (i.e. 200 g/L CrO<sub>3</sub>, 10 g/L AgNO<sub>3</sub>). Deeper pits trapped some of the cleaning solution despite the ultrasonic cleaning in acetone, which precipitated the green solid product observed upon evaporation.

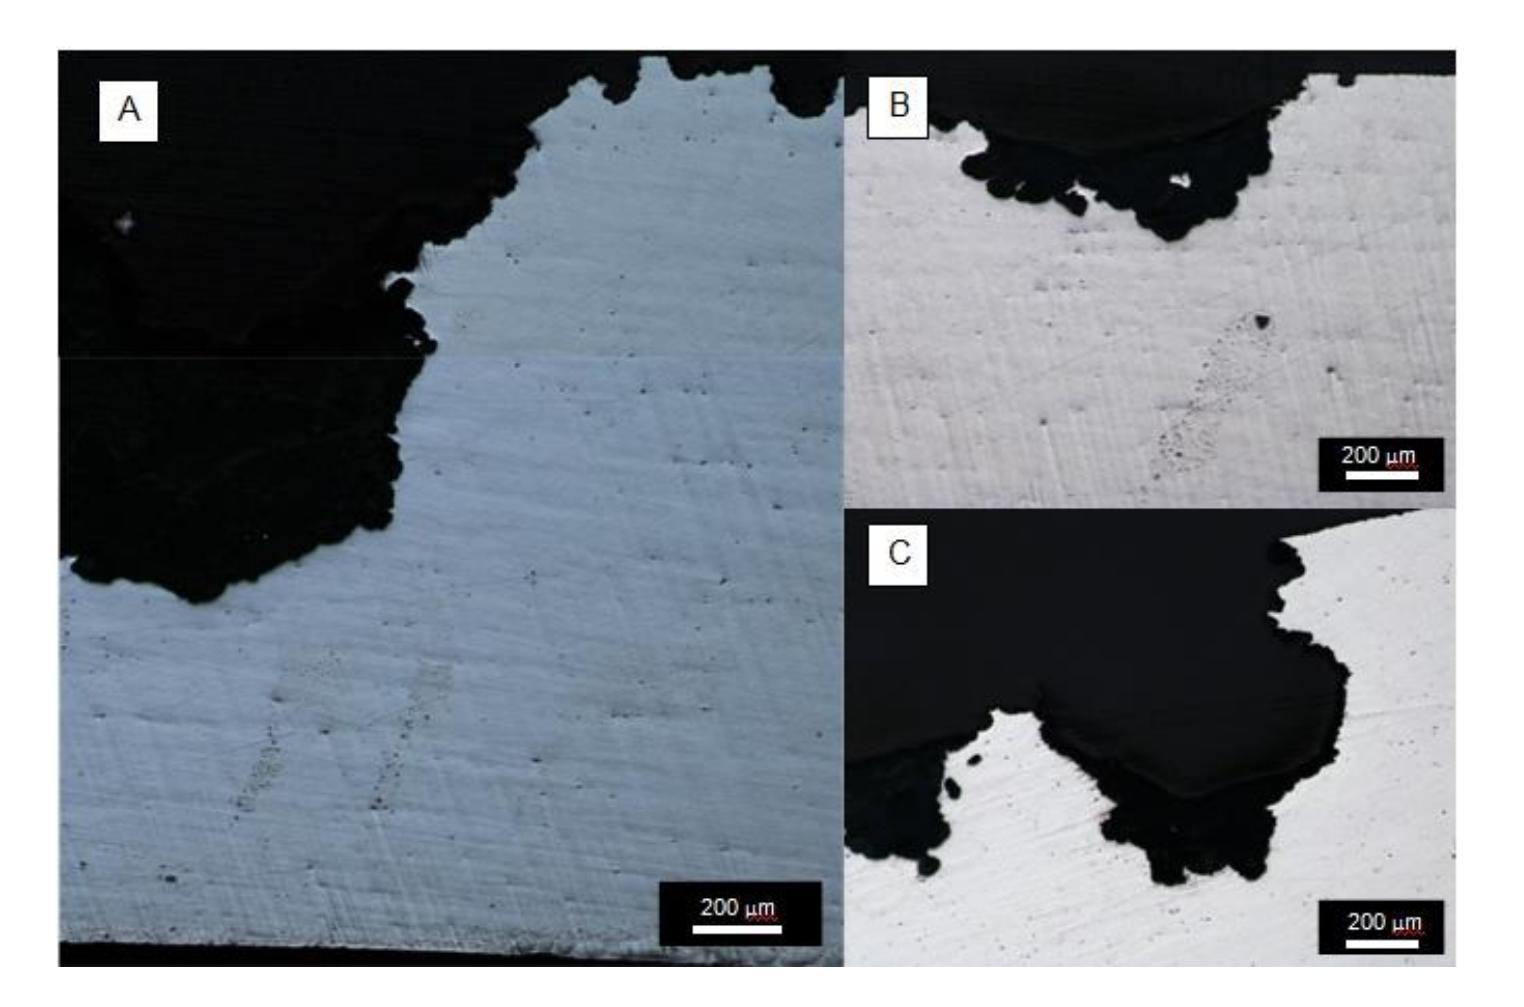
Figure 5-2: 5 wt% NaCl exposure – pitting damage observed on the (A) AR (B) MP (C) AC surfaces as observed in cross-section.

Exposed U-bends were cross-sectioned and observed using LOM. Cross-sectional images can be seen in Figure 5-2. The average pit depth on the AR surface was  $1.52 \pm 0.32$  mm. There was a notable decrease in the depth and severity of pitting for the MP and AC surface conditions. There was no significant differences between MP and AC surface surfaces. The average pit depth for the MP and AC samples was  $1.0 \pm 0.32$  mm.

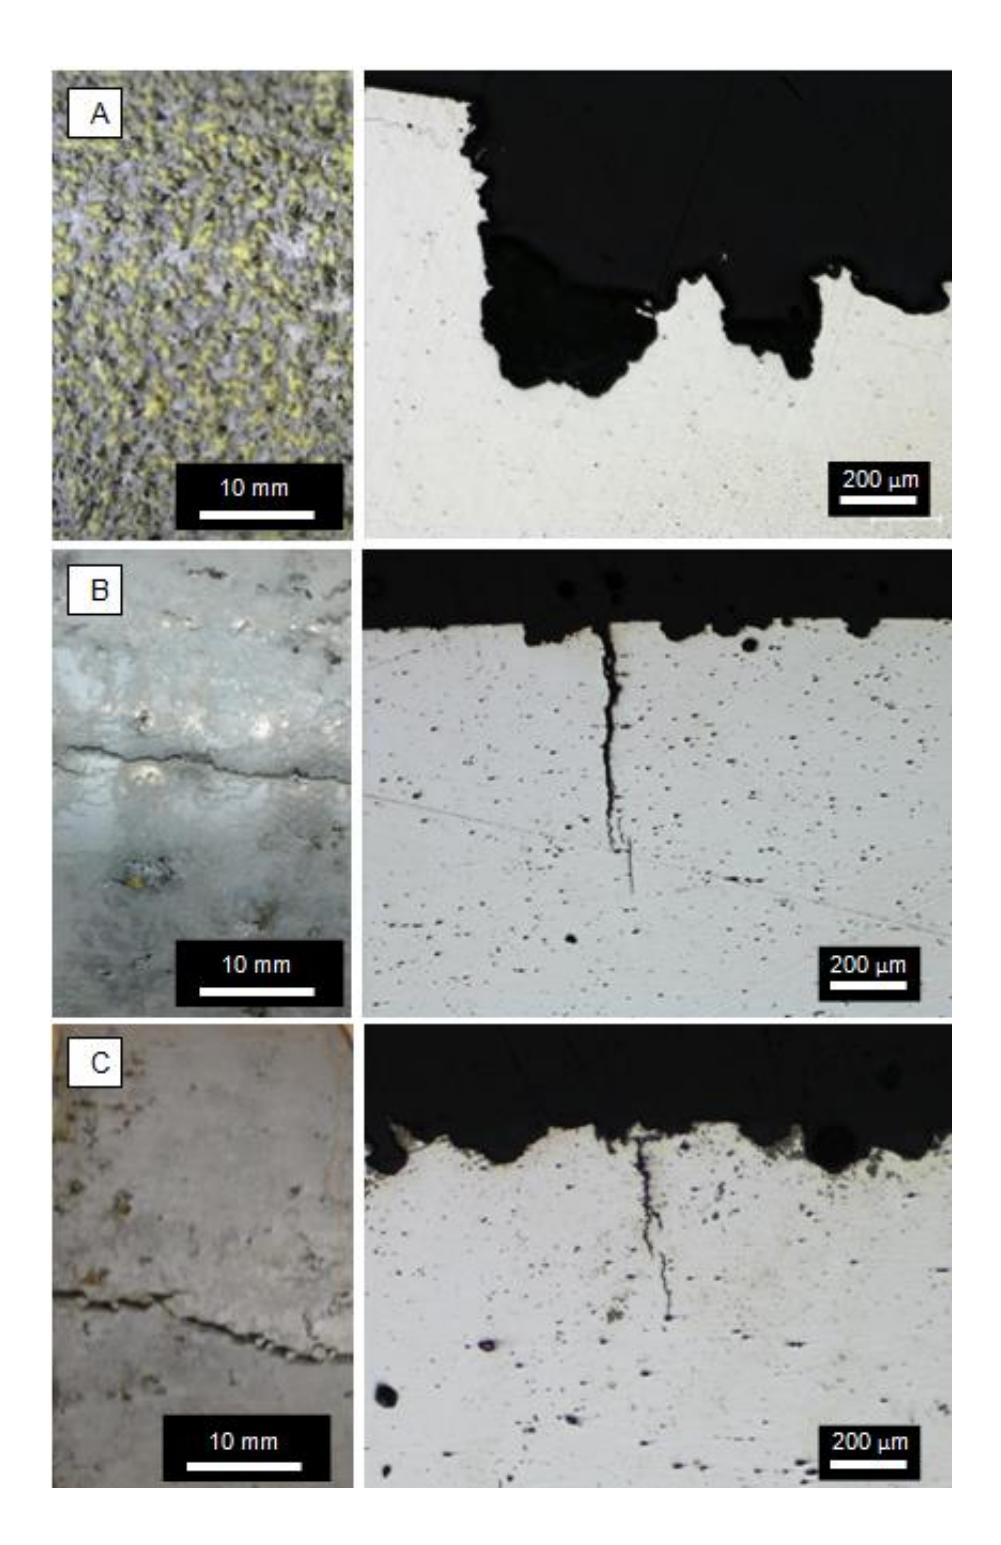
Figure 5-3: Plan-view and cross-sectional view of the corrosion damage observed on the (A) AR (B) MP (C) AC U-Bend surfaces after exposure for 5 days in 0.5 wt% salt fog at  $35^{\circ}$ C

Ten U-bend samples for both the MP and AC surfaces were exposed for 5 days. During this time all samples had developed SCC, which propagated to failure. The post-exposure surface appearance of both the MP and AC U-bends is shown in Figure 5-3.

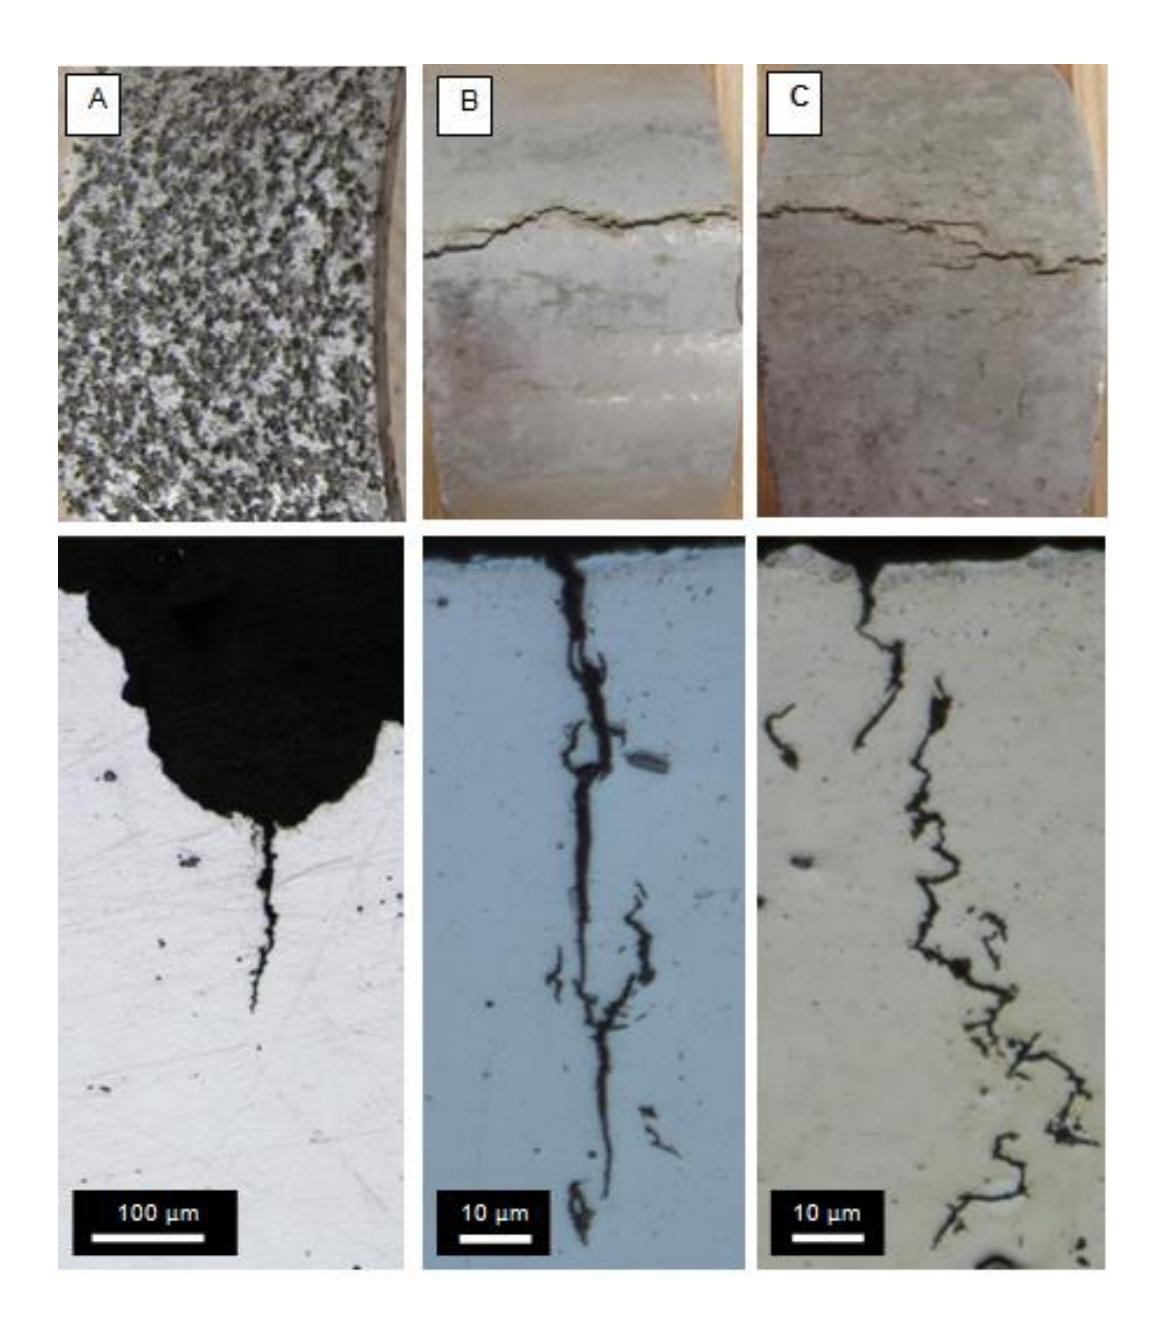
Figure 5-4: Photograph showing the typical appearance of plan-view and cross-section views of (a) AR, (b) MP, and (c) AC surface condition after exposure in 0.05 wt% NaCl salt fog at 35 °C

Due to the SCC observed in both the MP and AC U-bends, the 0.05 wt% salt fog environment proved to be the most appropriate for further study of the effect of surface condition on the SCC resistance of AZ31B-H24 sheet material. Due to the pitting corrosion observed, the AR surface condition exhibited higher SCC resistance despite being more significantly damaged overall; Parkins [18] showed that aggressive environments that enhance local corrosion and pitting tend to decrease the stress intensity factor and sharpness of the crack tip to inhibit SCC propagation. It is also noted that the AR condition is not an industrially relevant surface condition. Industrial practice for the use of AZ31B-H24 incorporates surface conditioning pre-treatments prior to the application of coatings. As a result, no subsequent testing was conducted using U-bends with the AR surface condition due to the aggressive local corrosion observed to better focus on the studies of SCC resistance.

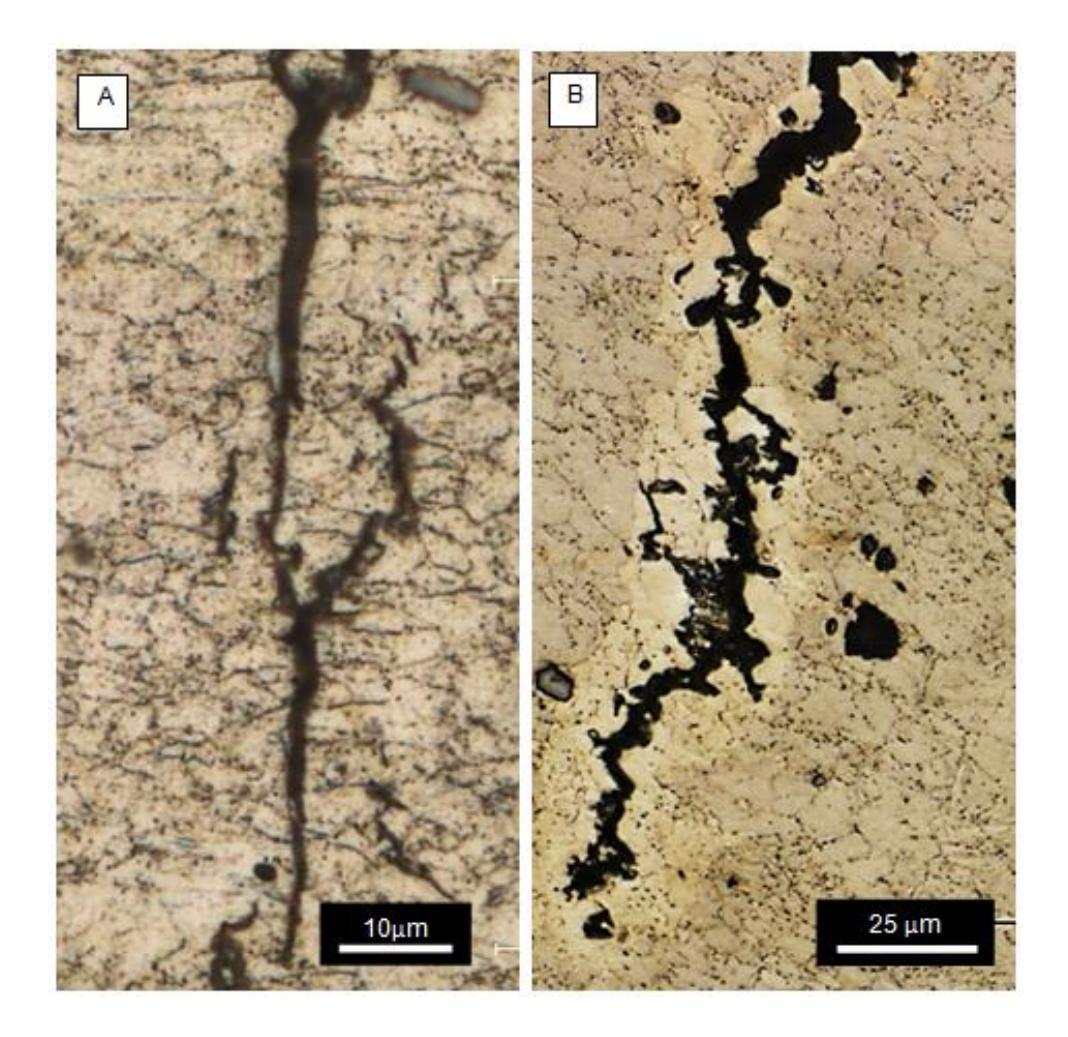
Figure 5-5: Etched cross-section images of the SCC found within the Ubends that were (a) MP and (b) AC after exposure in 0.05 wt.% NaCl salt fog at 35°C until fracture.

were observed. The images shown in Figure 5-5 are representative of cracks found in the U-bends. The MP U-bends showed characteristics of TGSCC: i.e. cracks linearly propagating through bulk grains. However, the AC U-bends showed characteristics of IGSCC: i.e. jagged, multi-directional cracks propagating along grain boundaries.

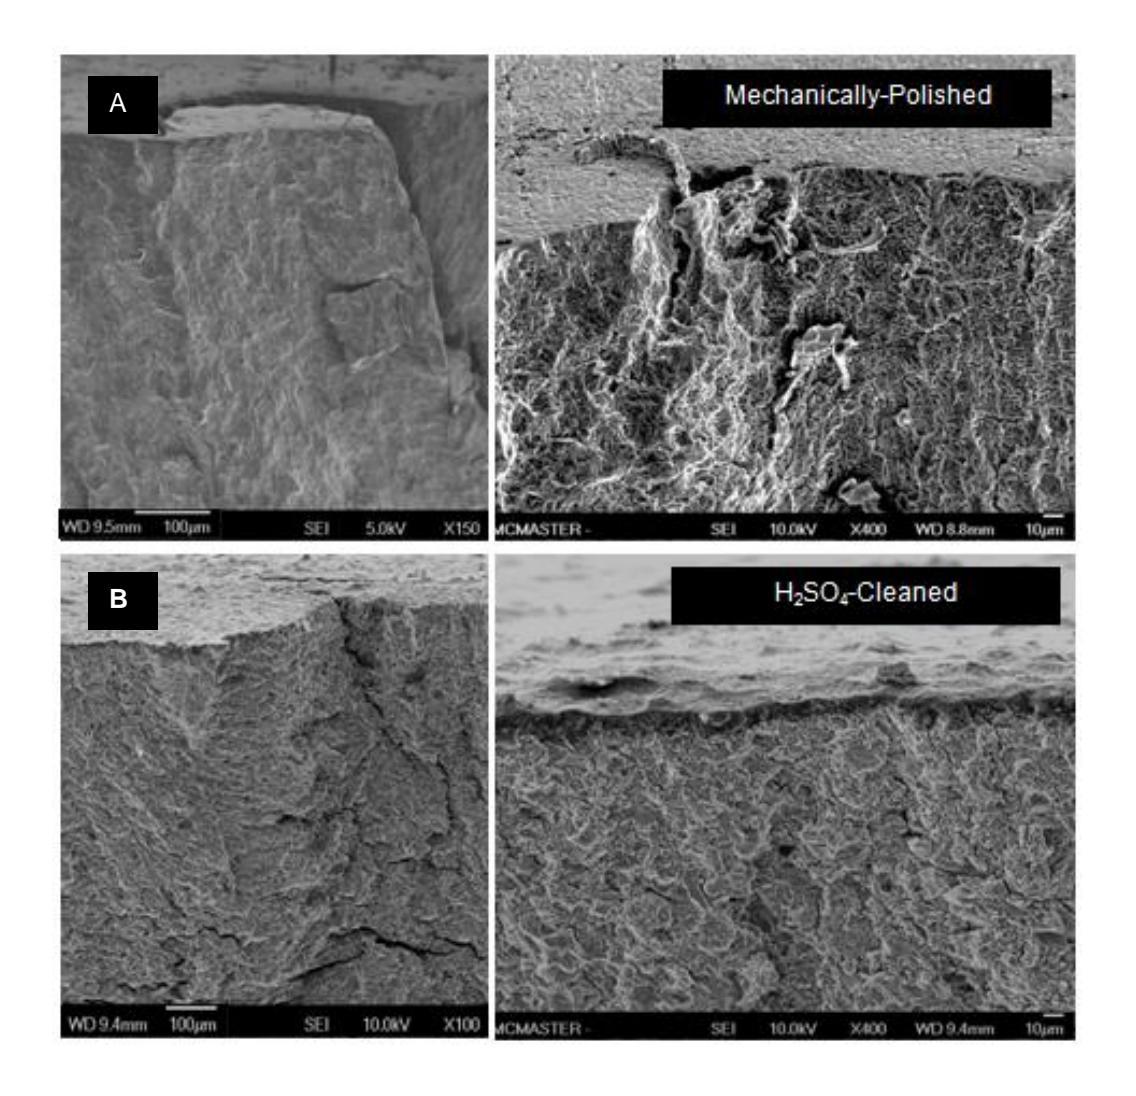
Figure 5-6: SEM images of the post-exposure SCC fracture surface of a (A) MP and (B) AC U-bend after exposure to 0.05 wt.% NaCl salt fog at 35°C.

An examination of a fracture surface from each surface condition was conducted using SEM. Secondary electron images of the fracture surface of a MP and AC U-bend are shown in Figure 5-6. Both fracture surfaces show evidence of brittle fracture associated with SCC. This is characterized by the cleavage and beach markings across the fracture surface seen as the bright contrasting lateral striations across the fracture surfaces. The notable difference between the two was the contrast and faceted fracturing seen on the IGSCC (AC) fractured surface. The IGSCC was characterized by this faceted structure because of the cracking propagated down grain boundaries, leaving sharp interfaces. The TGSCC (MP) fracture surface, on the other hand, was much smoother due to the linear propagation of cracks through grains along crystallographic planes.

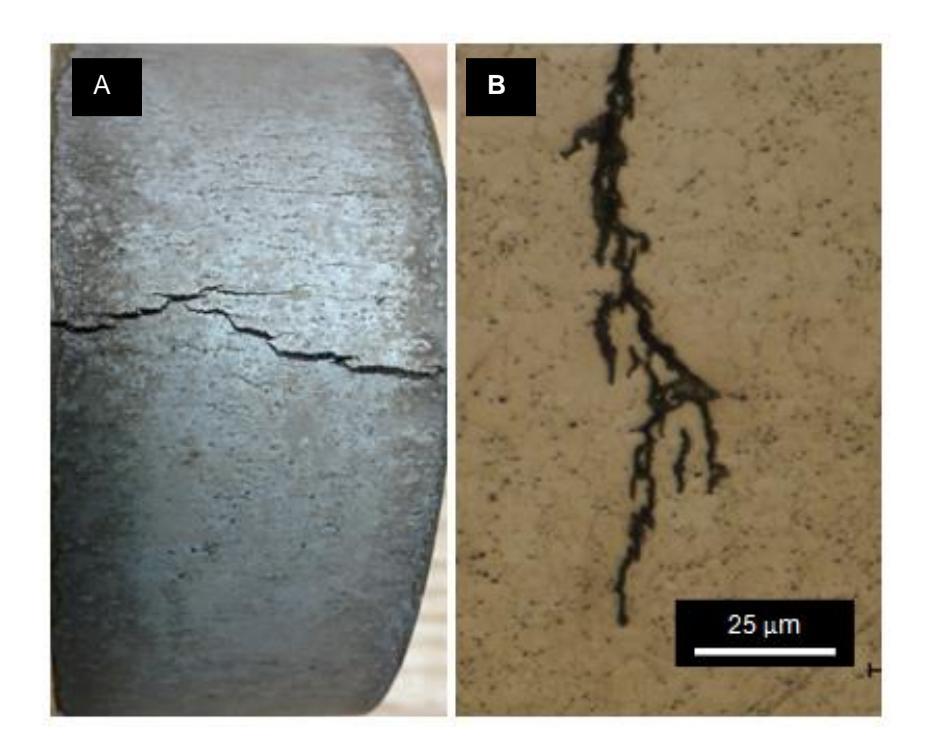
Figure 5-7: Image of the fractured U-bend showing the SCC within a MP-AC U-bend (A) plan-view and (B) cross-section after exposure in 0.05 wt.% NaCl salt fog at 35°C

propagated to fracture after an additional 1 h of exposure. Images of the fractured U-bend sample showing the SCC in plan-view and in cross-section are shown in Figure 5-7.

The images shown in Figure 5-7 are representative of the results seen for all MP-AC samples. The crack tip shown in the cross-section image [Figure 5-7 (B)] can be compared to those in Figure 5-5, where it can be seen that the mode of cracking was similar to that of the AC U-bend samples. This shows that the effect of  $H_2SO_4$ -cleaning on SCC

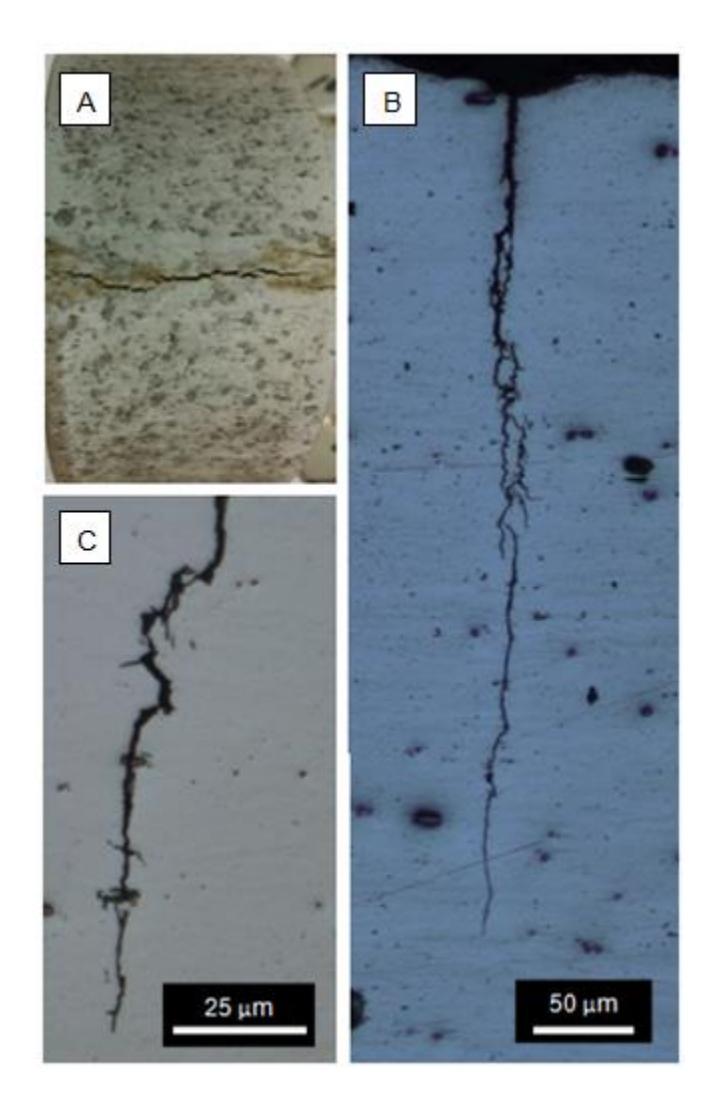
Figure 5-8: Image of the fractured O-AC U-bend showing the SCC within in (A) plan-view (B) lower magnification cross-section and (C) higher magnification cross-section after exposure in 0.05 wt.% NaCl salt fog at 35°C.
#### 5.3 Surface Condition Characterization Results

mode of cracking, as imaged in cross-section, showed characteristics of TGSCC similar to those observed for the MP U-bends.

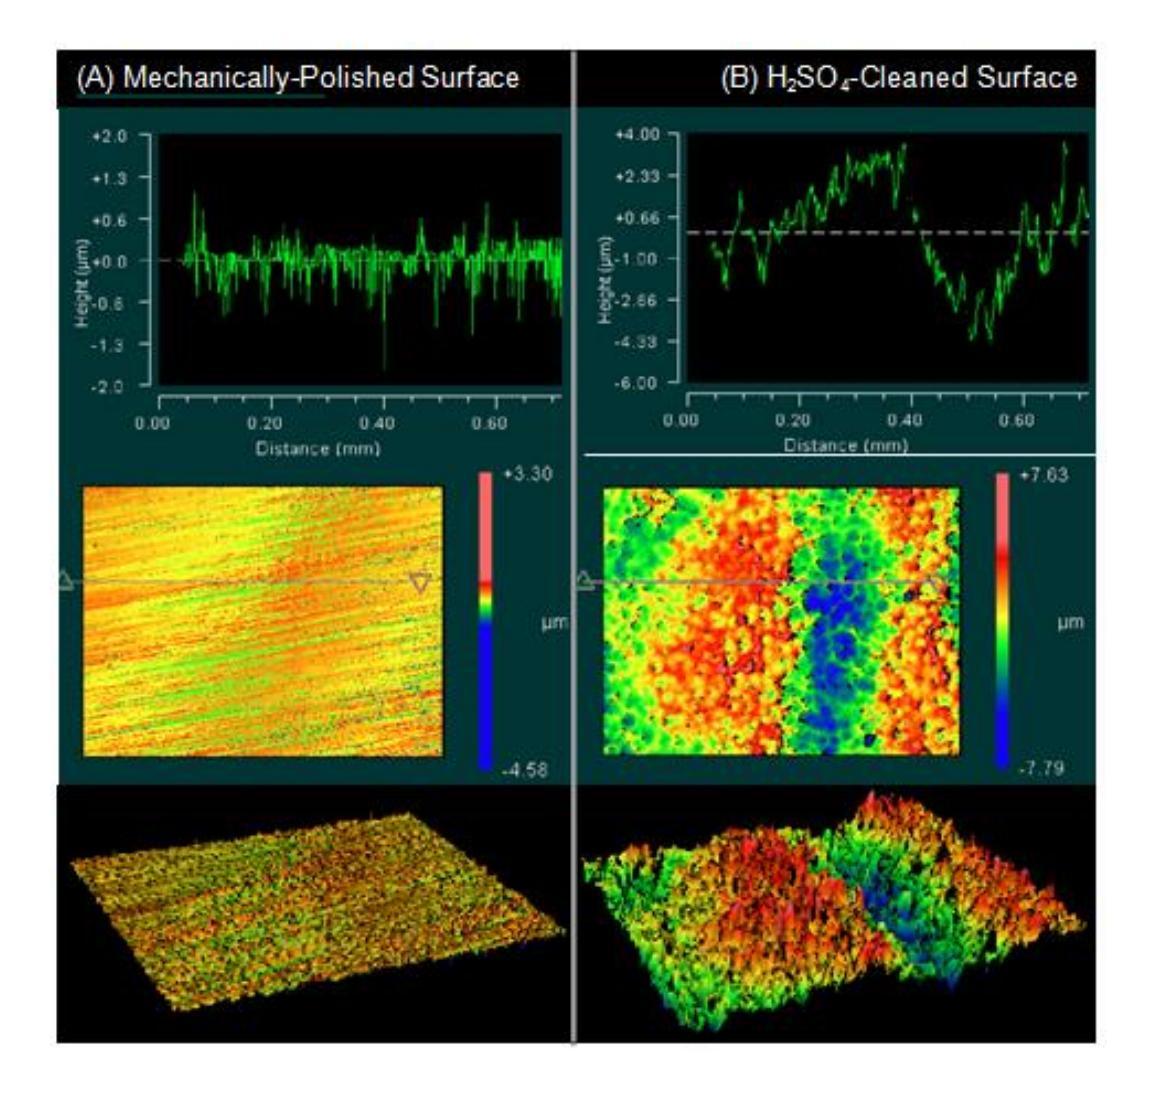
Figure 5-9: Interferometer results of pre exposed (a) MP and (b) AC surfaces. The differences in scale between the two datasets should be noted.

An examination of the unexposed MP and AC surfaces was conducted using an interferometer to investigate the geometric differences between the two surface conditions prior to salt fog exposure. These results can be seen in Figure 5-9.

It is evident from Figure 5-9 that the AC surface was significantly rougher. The average roughness ( $R_a$ ) measured across the ten areas sampled was 1.367 ± 0.11 µm. This same measurement for the MP surface was only 0.165 ± 0.03 µm. Although there is a considerable difference between these  $R_a$  values it is an average value across the

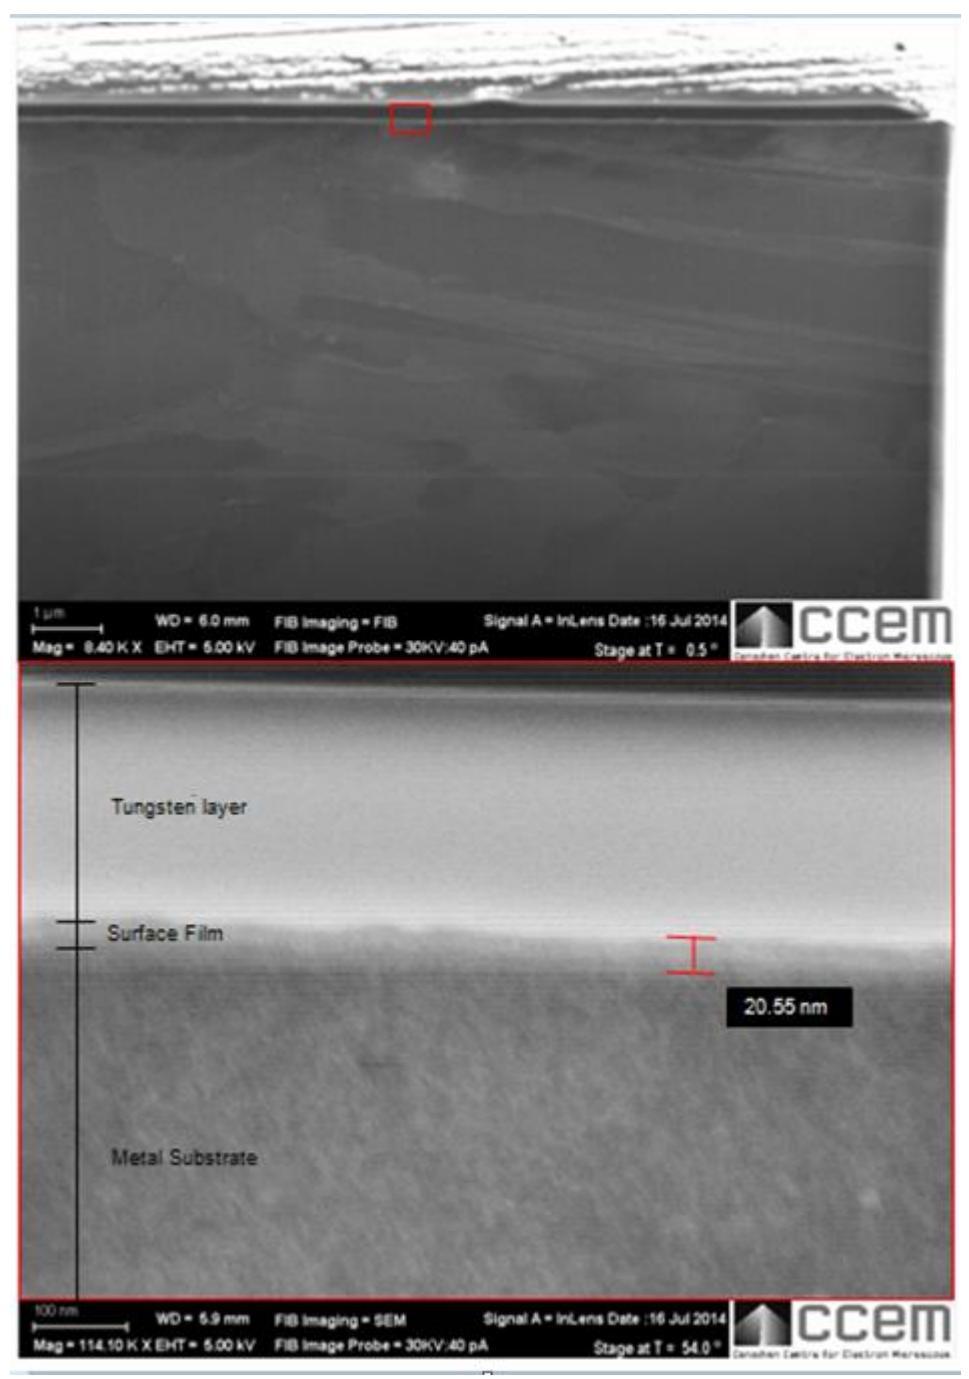
Figure 5-10: SEM-FIB cross-sectional examination of the air formed

surface film formed after MP surface conditioning.

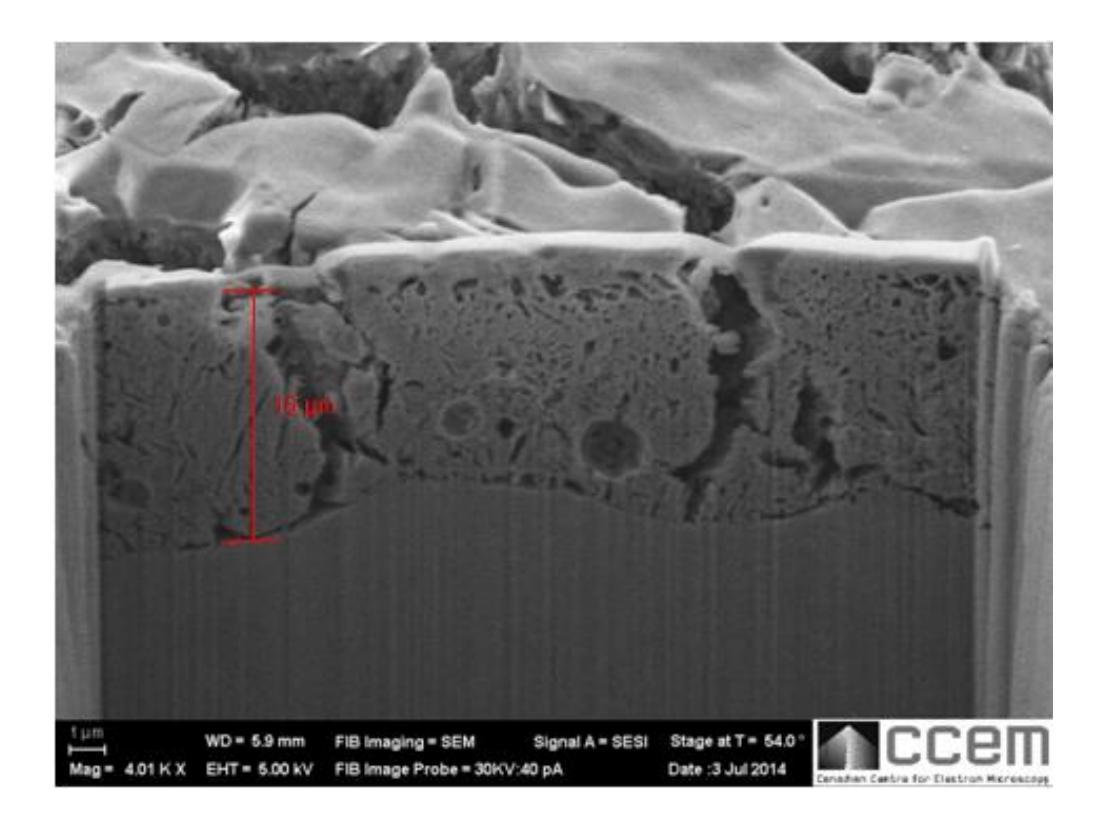
Figure 5-11: SEM-FIB cross-sectional examination of the surface film formed on AZ31B as a result of the AC surface condition.

in red is the outline of the original  $H_2SO_4$  formed film along with the two main cracks that could be seen in Figure 5-11.

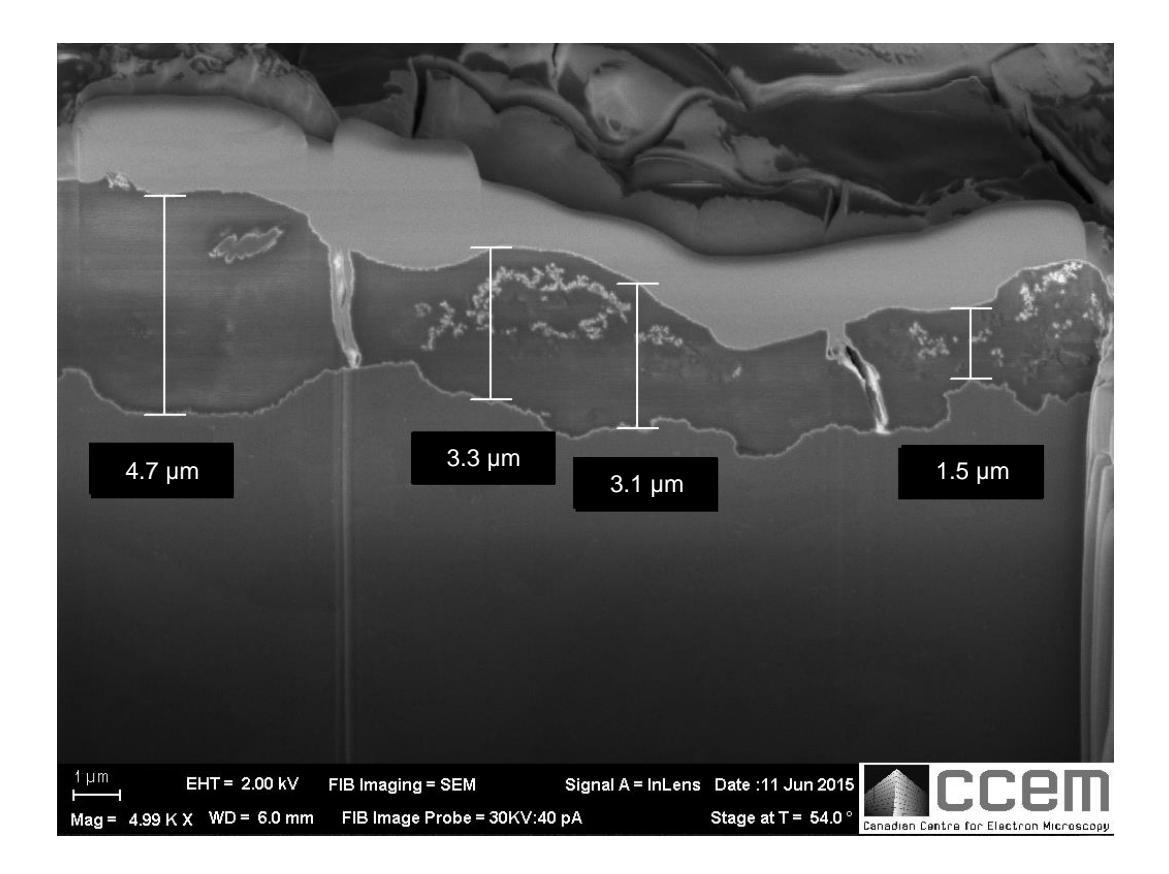
Figure 5-12: SEM-FIB cross-sectional examination of the surface film formed on AZ31B as a result of the O-AC surface preparation.

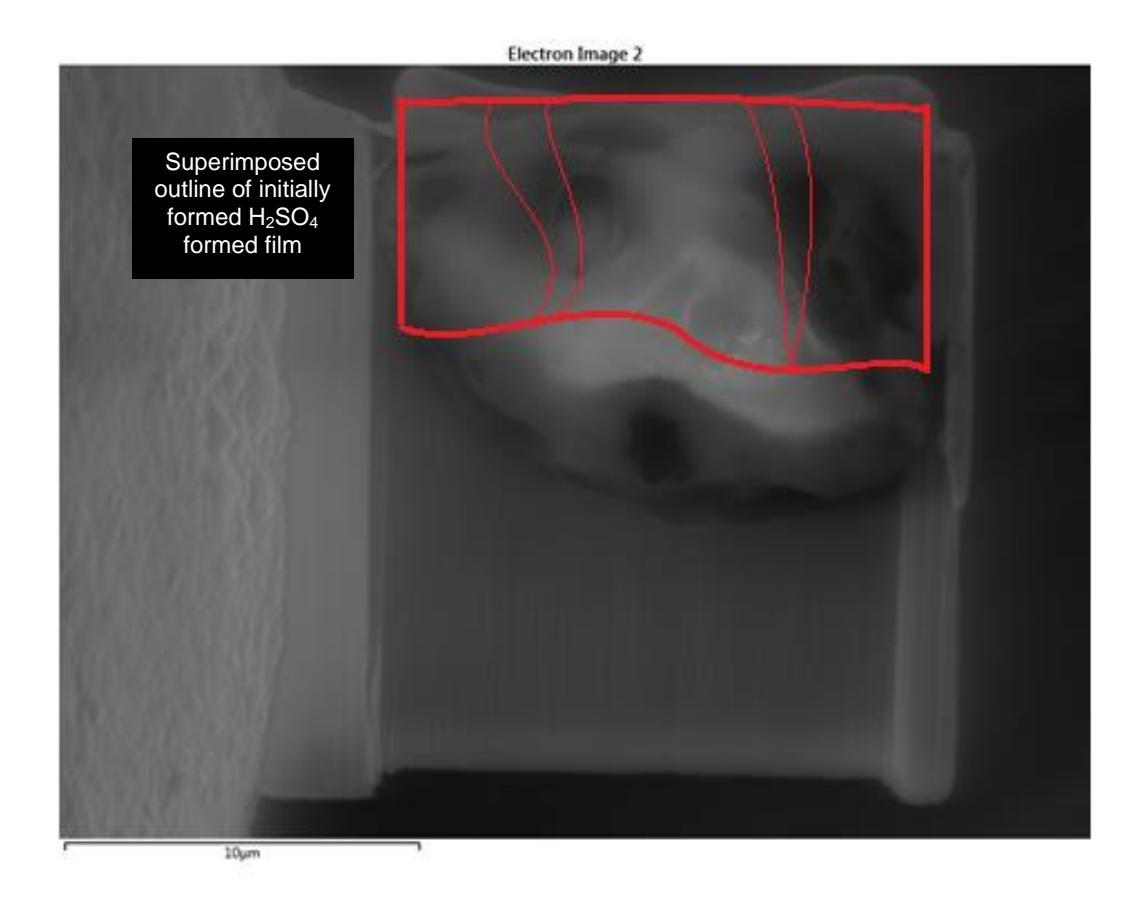
Figure 5-13:SAM characterization of an AC cross-sectional lift-out; an oxide growth formed on the surface during transfer from the FIB-SEM.

A FIB-prepared cross-sectional sample of the AC surface film across the film-metal interface was lifted out and characterized with SAM. The lifted out view of the cross-section was prepared for Auger characterization of the film/metal interface. The sample was transferred from the FIB-SEM to the SAM, during which time it was exposed to air for approximately 5 min. Upon viewing the sample in the SAM, a large oxide growth formed on the cross-sectional surface at the film/metal interface this can be seen in Figure 5-14. Superimposed on Figure 5-13
