# THE EFFECT OF H<sub>2</sub>SO<sub>4</sub> SURFACE PRE-TREATMENT ON THE STRESS CORROSION CRACKING OF MAGNESIUM ALLOY AZ31B

By BRYCKLIN M.WILSON, B.ENG.

A Thesis

Master of Applied Science

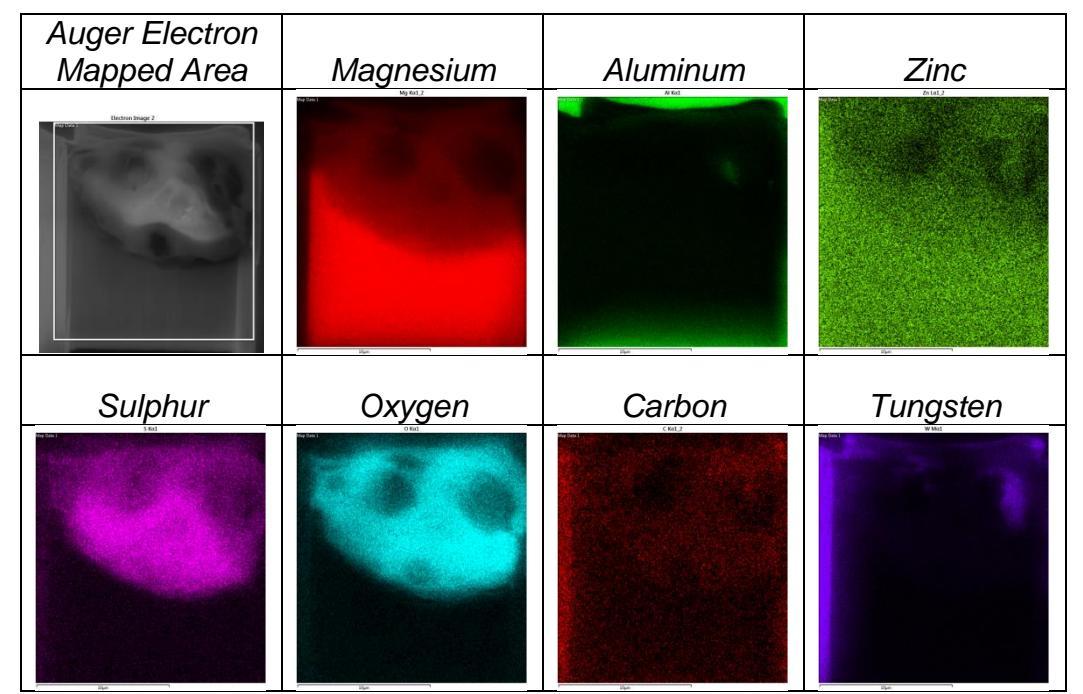
Figure 5-14: Auger electron mapping of the AC surface film.

Auger electron elemental mapping in the SAM was conducted, the results of which are shown in Figure 5-14. It was found that the additional corrosion product that was formed was primarily comprised of magnesium, sulphur and oxygen. Note that the tungsten detected was

from the protective coating applied during the FIB milling process and the contents of zinc, aluminum and carbon were too low to be accurately detected. The additional corrosion product may have formed in one of two ways: either from the transformation of the original MgO film to a sulphur containing product or as a result of a corrosion reaction at the magnesium oxide film interface. Regardless, the sulphur and oxygen is believed to have played a critical role in the formation of the additional corrosion product. Although it was not validated, it was likely that the sulphur was contained within the AC surface pre-treatment film. Both the rate and severity at which this growth formed is indicative of the exposure that occurred during the salt fog experiments. This porous and reactive film engenders the rapid mass transfer of the possible aggressive ions in addition to the aggressive salt fog environment to the metal interface.

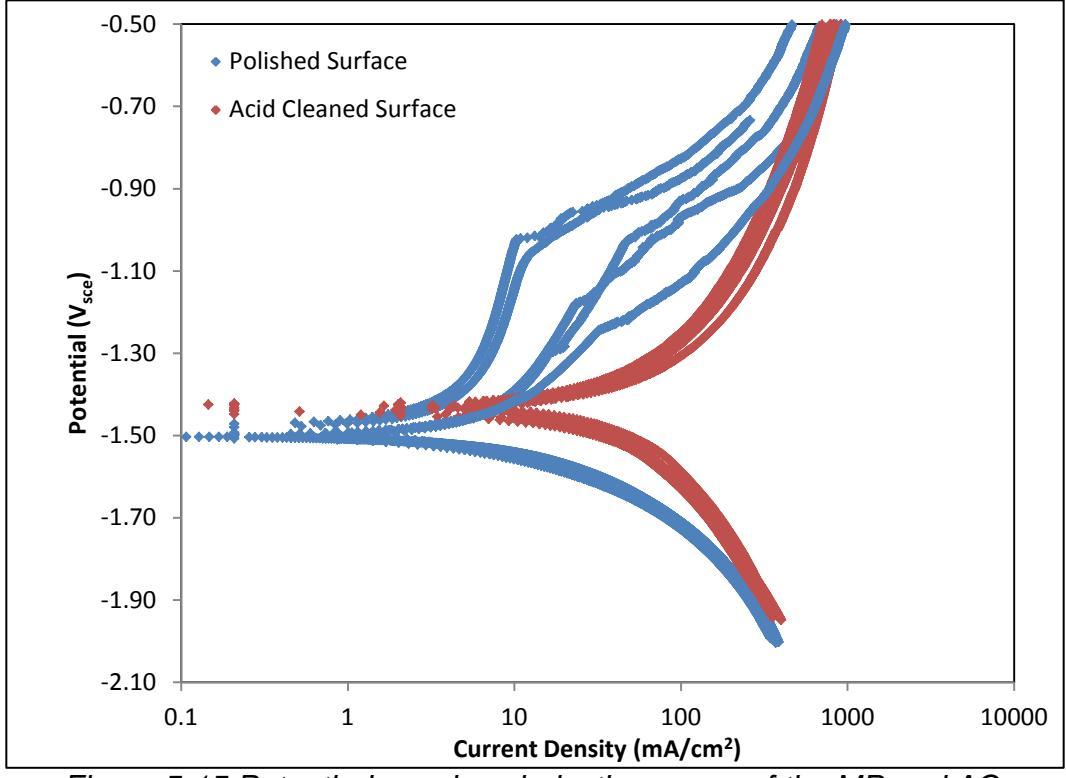
Figure 5-15:Potentiodynamic polarization scans of the MP and AC surfaces for 0.05 wt% NaCl exposure.

Potentiodynamic polarization scans of the MP and AC surfaces were conducted to identify any differences in electrochemical behaviour between the two surface conditions. Five samples of each surface condition were tested to ensure a consistent and repeatable behaviour. The results of these tests are shown in Figure 5-15.

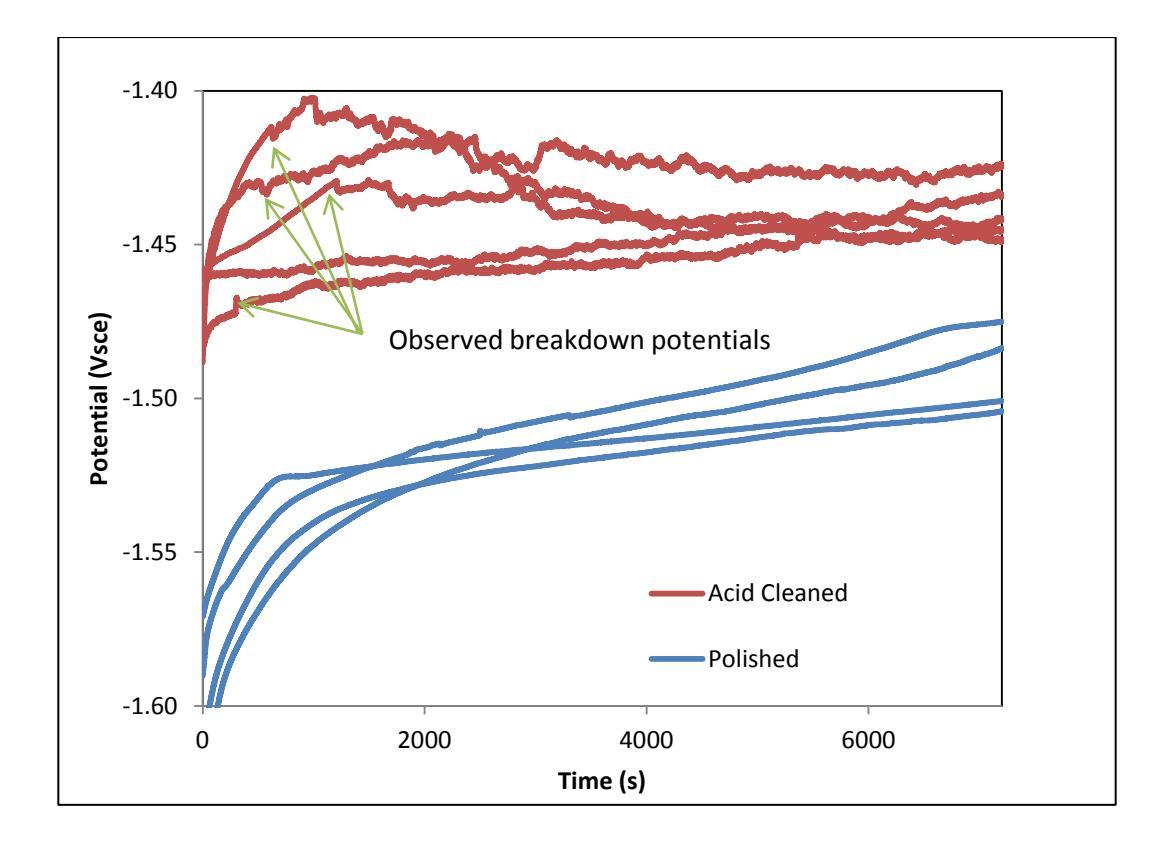
Figure 5-16:  $E_{OCP}$  measurement of MP and AC samples.

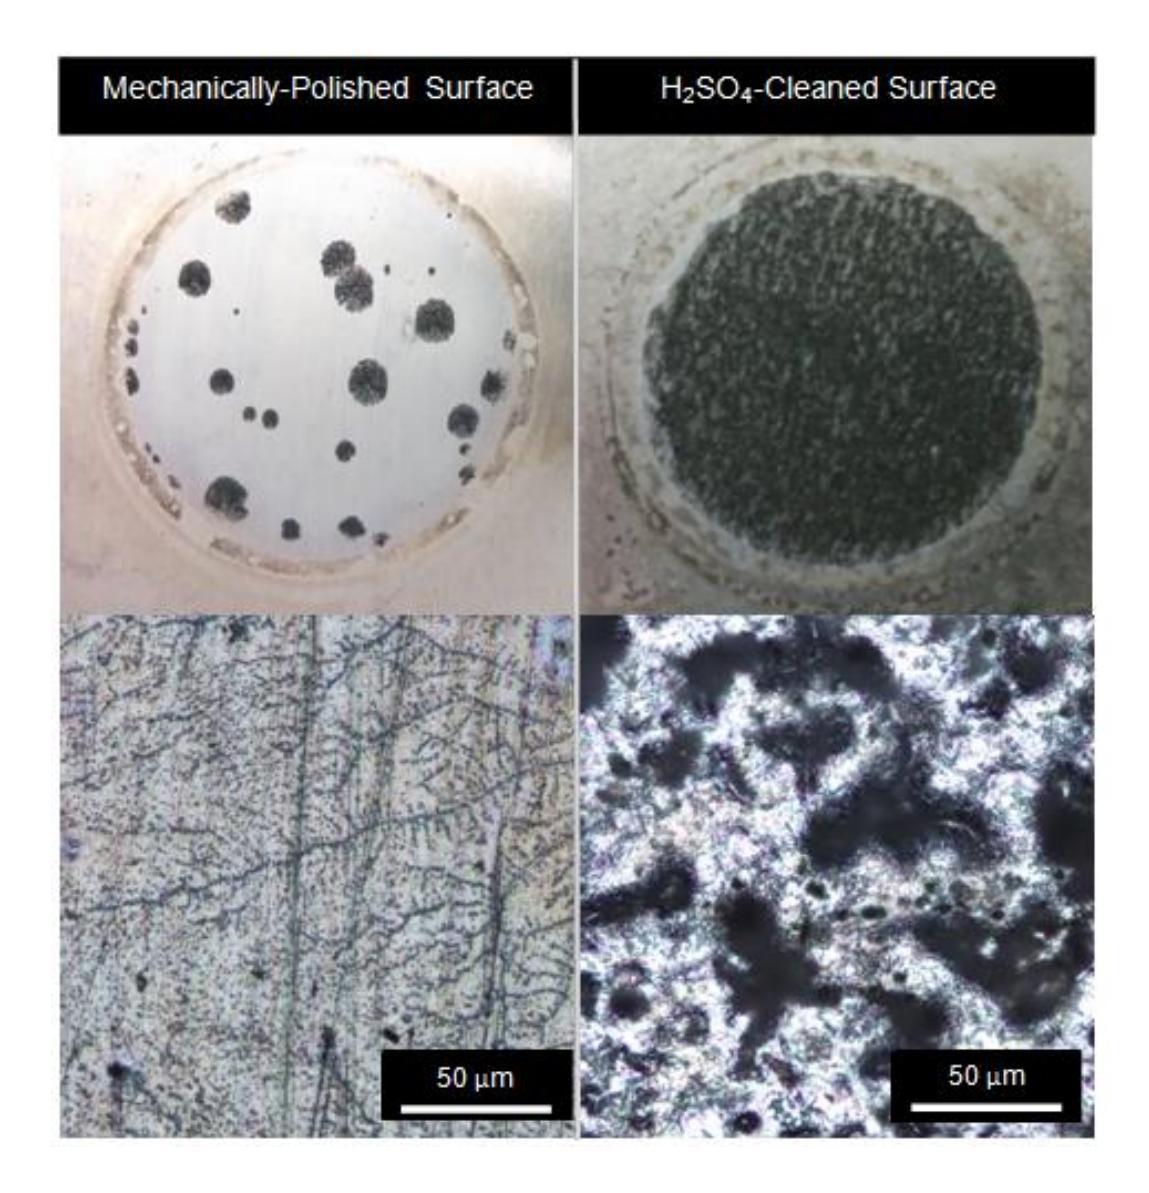
Figure 5-17: Post exposure image of (a) polarized MP surface and (b) polarized AC surface.

surface was more localized in nature, which is consistent with the breakdown seen during anodic polarization whereas the AC polarization sample was visibly corroded across the entire surface. This was consistent with the observed anodic current densities which were higher for the AC surfaces.

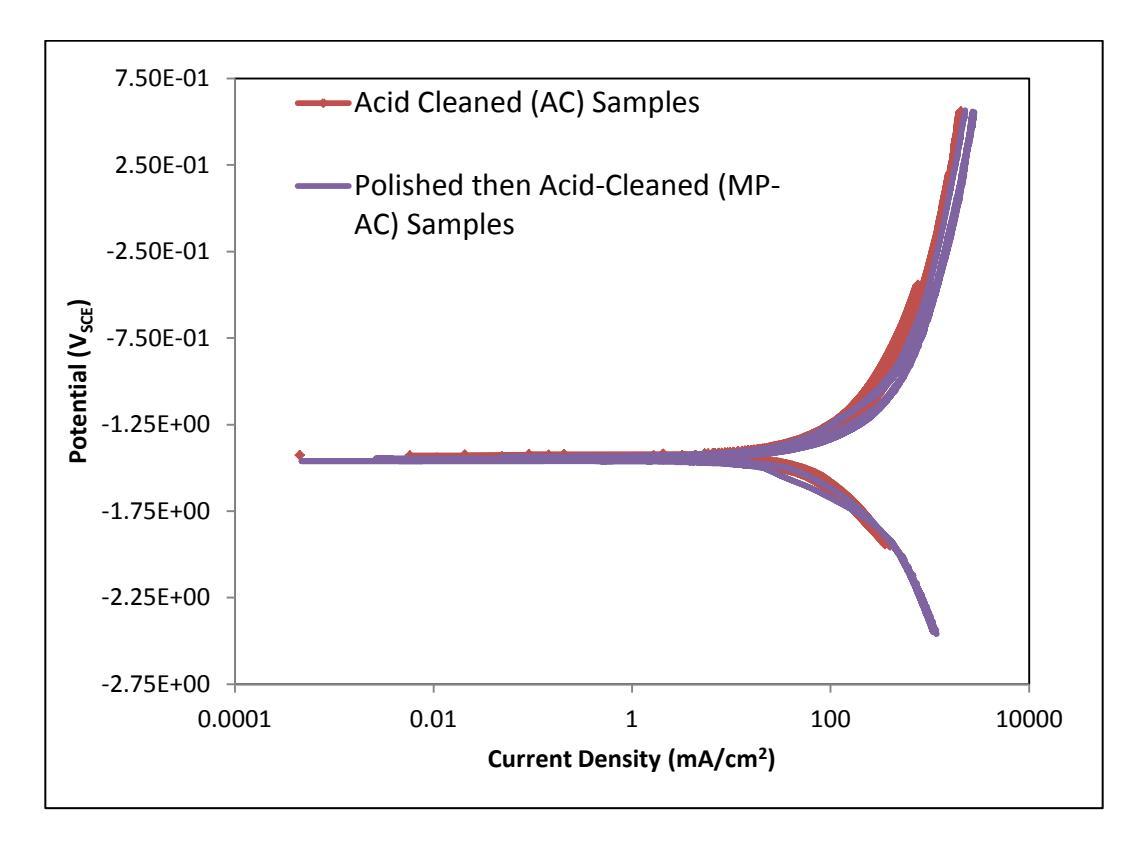
Figure 5-18: Potentiodynamic polarization behaviour of the MP-AC surfaces compared to AC surfaces.

this is consistent with the results of the salt fog testing. In addition, there were no visible differences (microscopic or macroscopic) in the corrosion observed between MP-AC and AC surfaces.

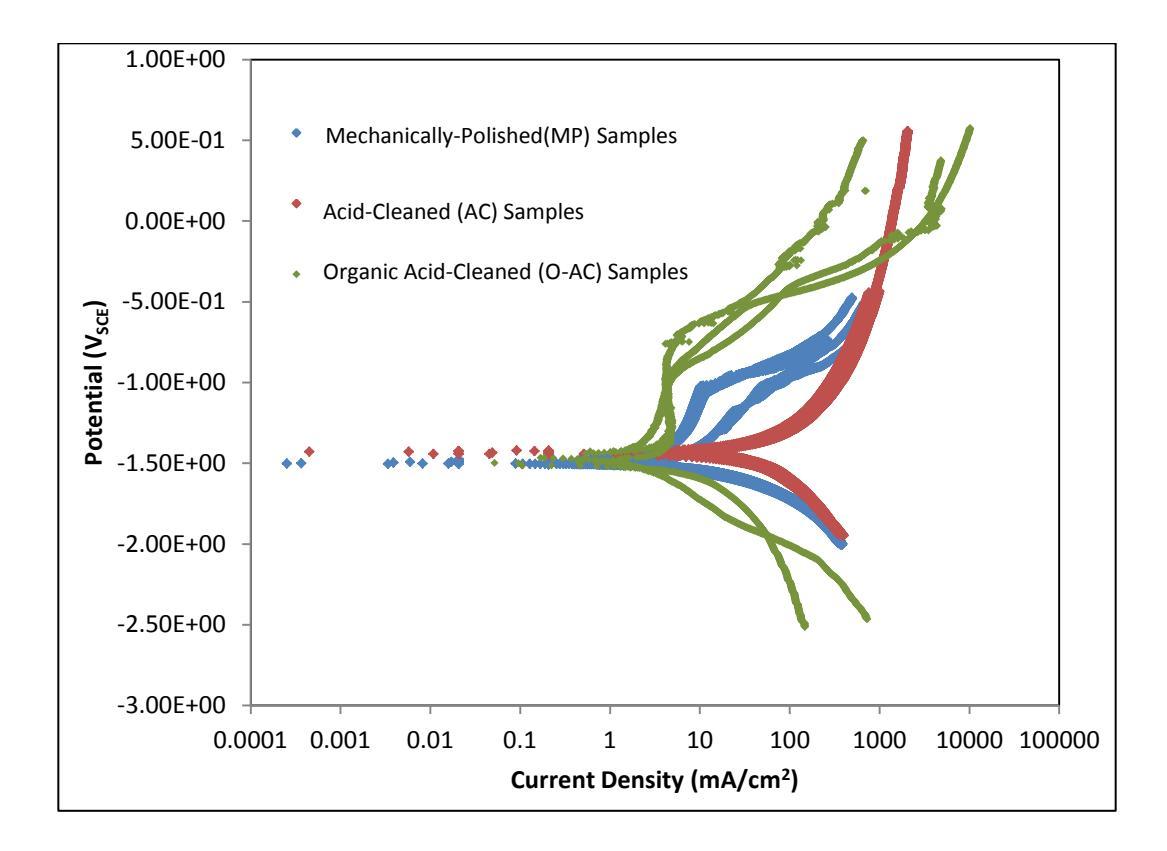
Figure 5-19: Potentiodynamic polarization behaviour of the O-AC surfaces compared to MP and AC surfaces.

U-bend salt fog testing. The results shown in Figure 5-19 have been superimposed on potentiodynamic scans of MP and AC surfaces to show the comparison. This comparison can also be correlated to the data summarized in Table 5-3, it can be noted that the two surface conditions with a compact relatively continuous film exhibited a breakdown during anodic polarisation. It should also be noted that although the O-AC and AC samples had much thicker films than the MP samples, it is only the AC sample that exhibited faster corrosion kinetics. This can also be attributed to the porosity of the film. The thicker film on the AC samples is porous which provides little protection to the metal surface, the thicker film on the O-AC sample however is much more compact and uniform which can provide protection until the film breakdown occurs.

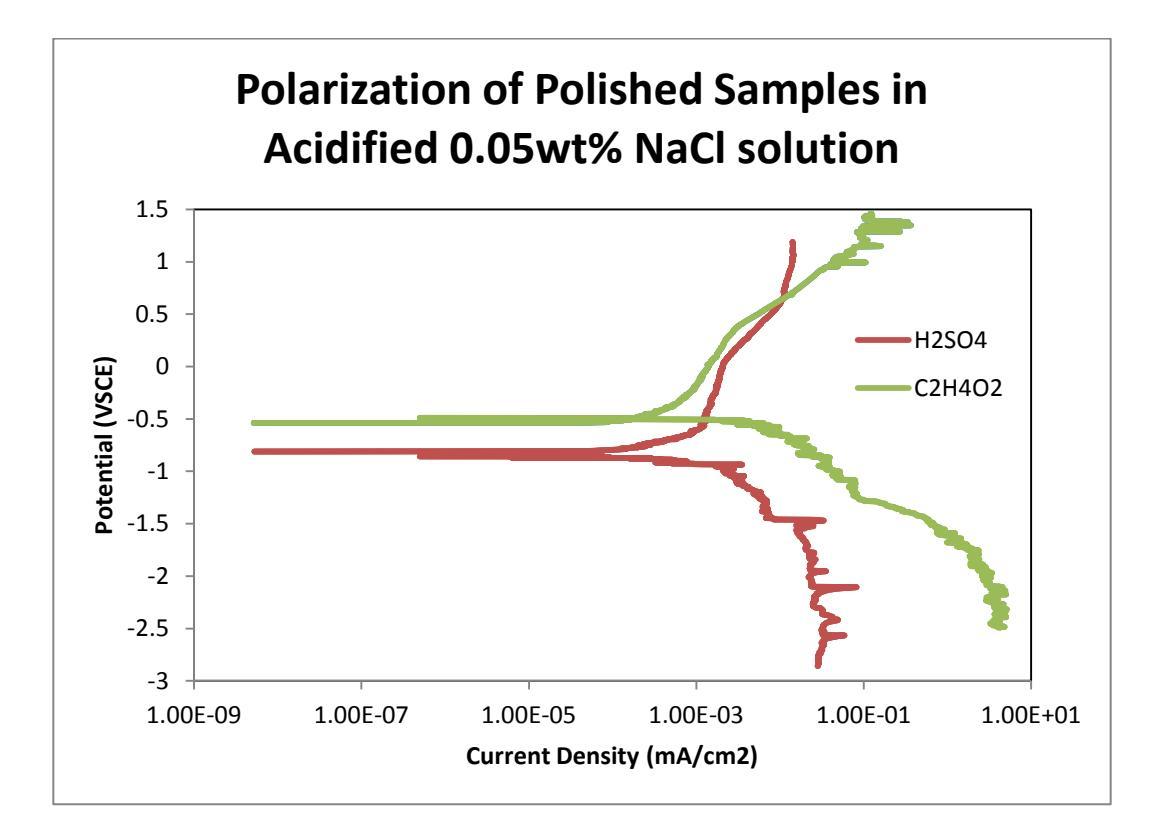
Figure 5-20: Potentiodynamic polarization measurements of polished samples exposed to acidified salt solutions.

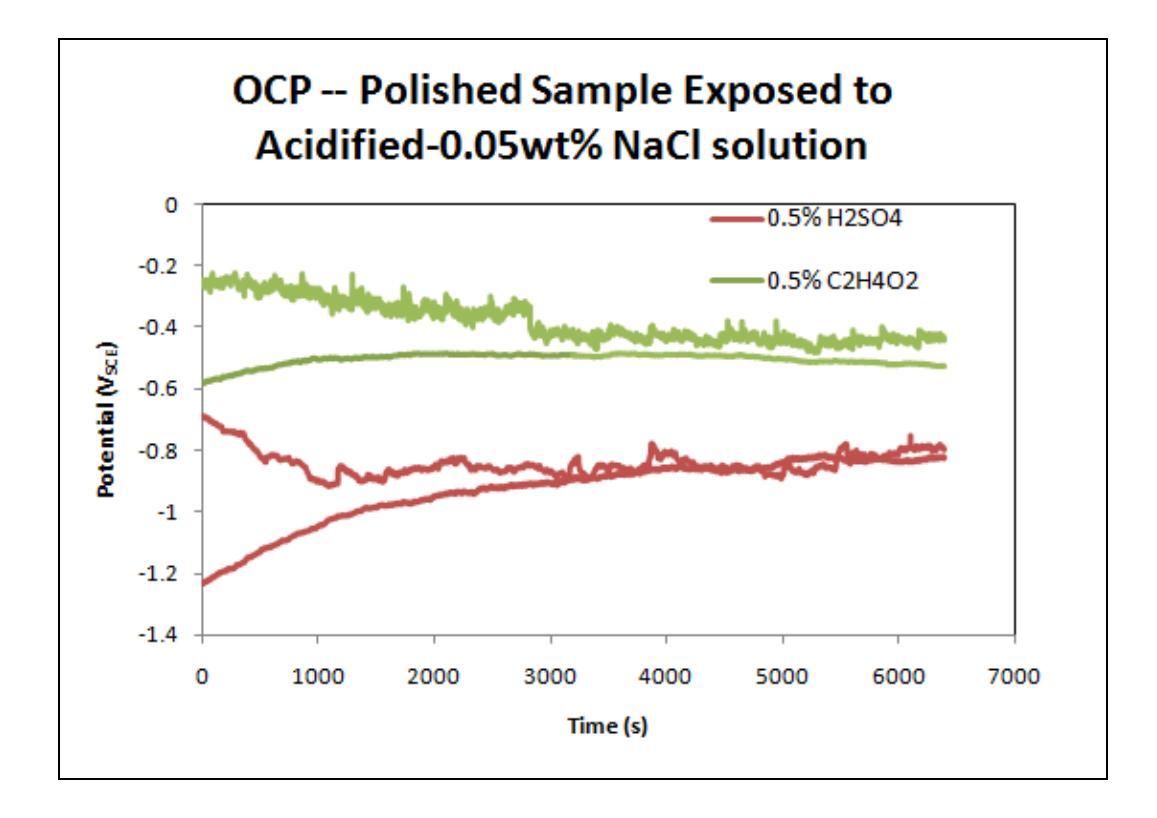
Figure 5- 21:  $E_{OCP}$  Measurements of mechanically-polished surfaces exposed under acidified salt solution conditions.

potential. Additionally the OCP measurements in Figure 5- 21 show that the open circuit potential of O-AC samples was higher.

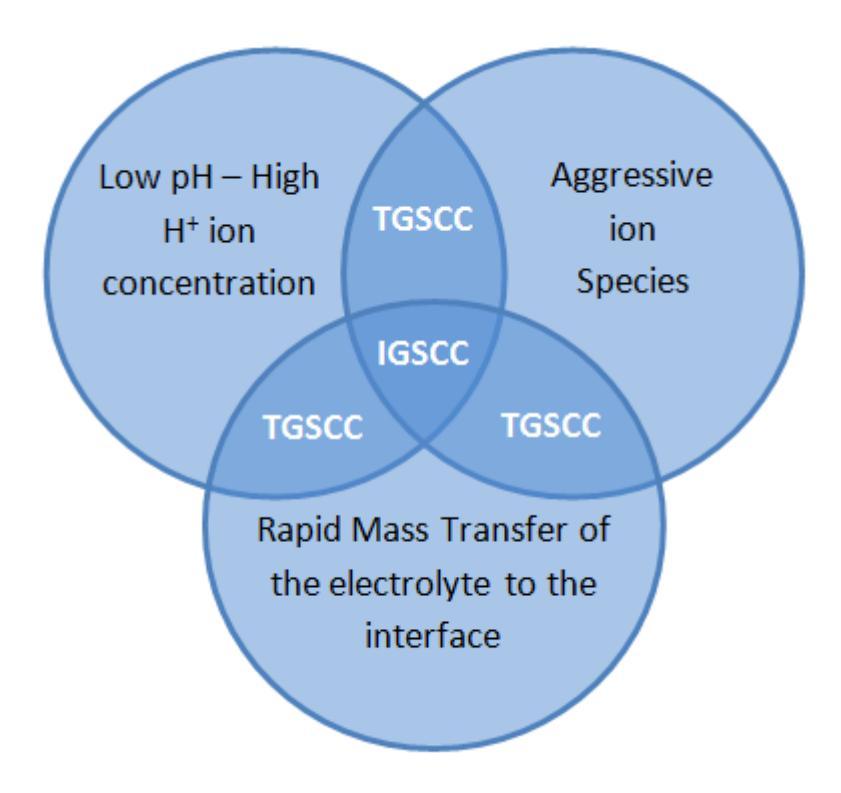
Figure 6-1:Contributing factors required for IGSCC to occur

and A-AC samples. However, when lacking one of these three, the mode of SCC would be transgranular as seen in the MP and O-AC samples.
